JOB NO. S67771

CLAIM No. NRP267377484

MRS P WRIGHT - 381 REDDALL PDE, MOUNT WARRIGAL NSW 2528

Specialist Report Type: ROOF

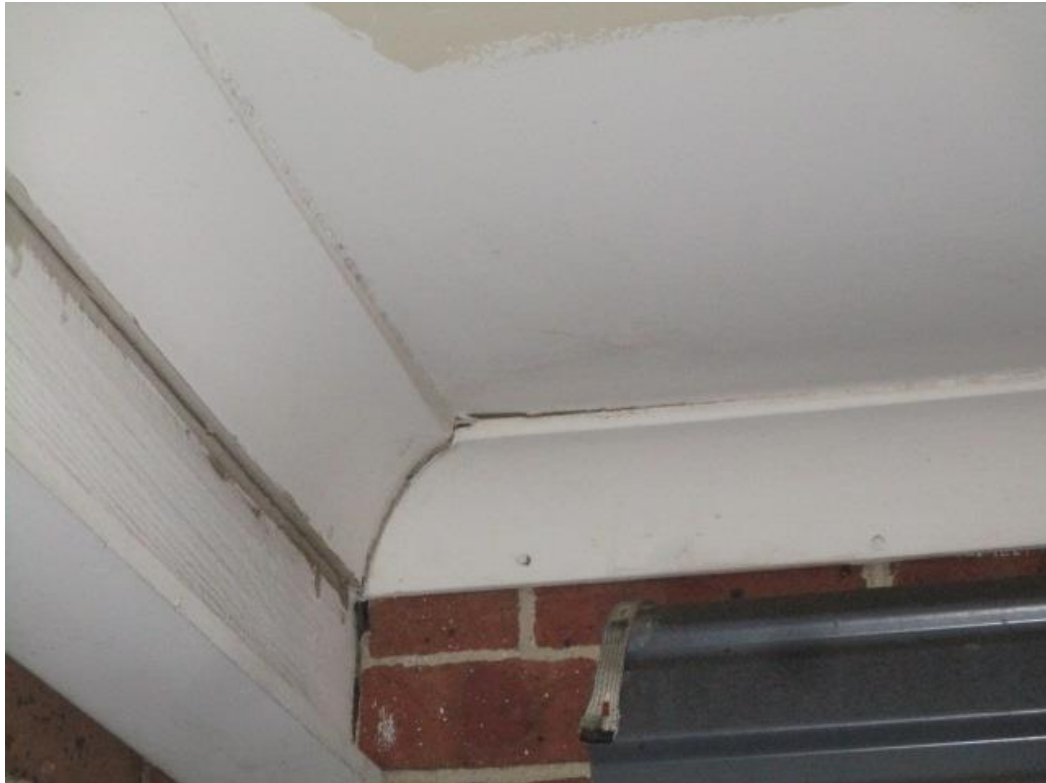
There is sagging in the garage ceiling in multiple areas.

The sagging ceiling and cornice are consistent with glue failure over time, not a one off event.

S67771-WRIGHT\cornice sag close up

The ceiling needs to be replaced and an estimate for that is provided.

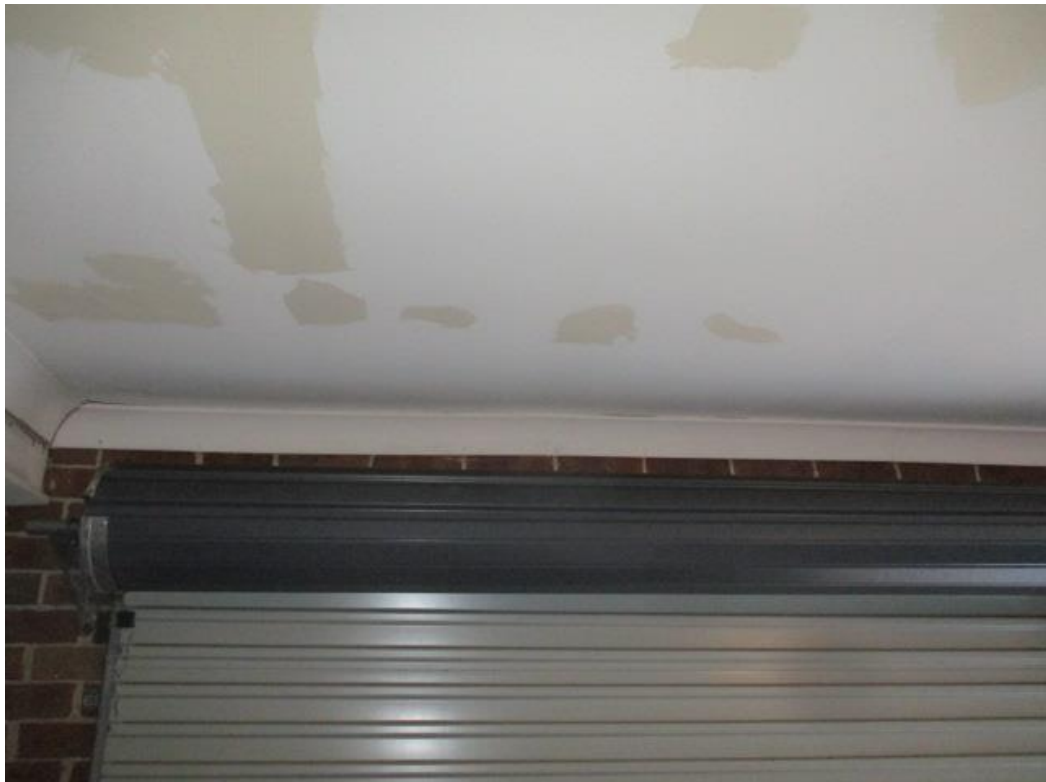
S67771-WRIGHT\Cornice sag front of garage overview

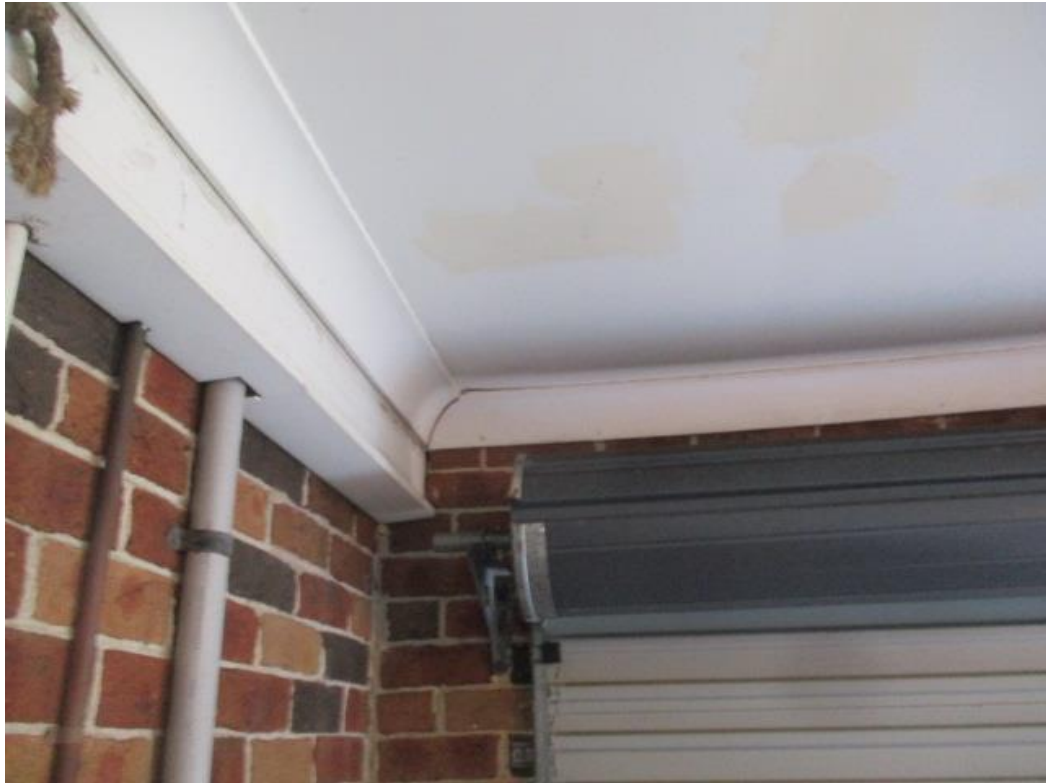
S67771-WRIGHT\Cornice sag

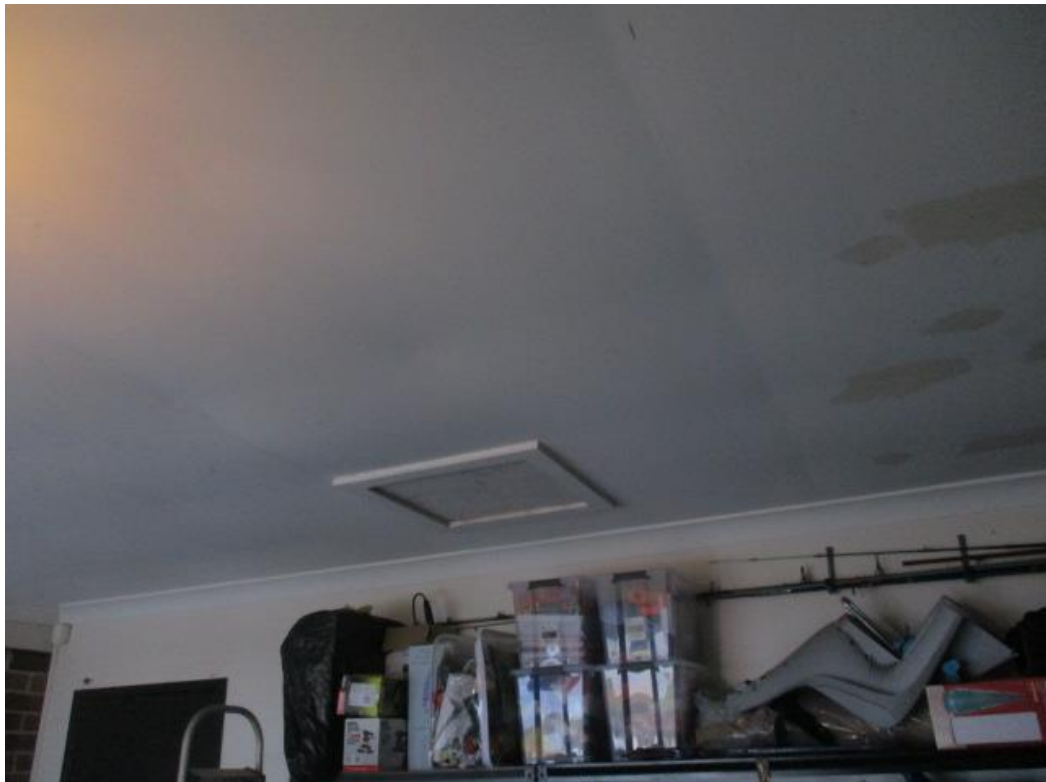
Roofer found no evidence of water ingress. The photos in the roof space show sagging plasterboard ceiling indicating glue failure, which is consistent with the sagging cornice viewed from below, and previous repairs to both sides of the garage.

S67771-WRIGHT\Lines in ceiling indicating glue failure

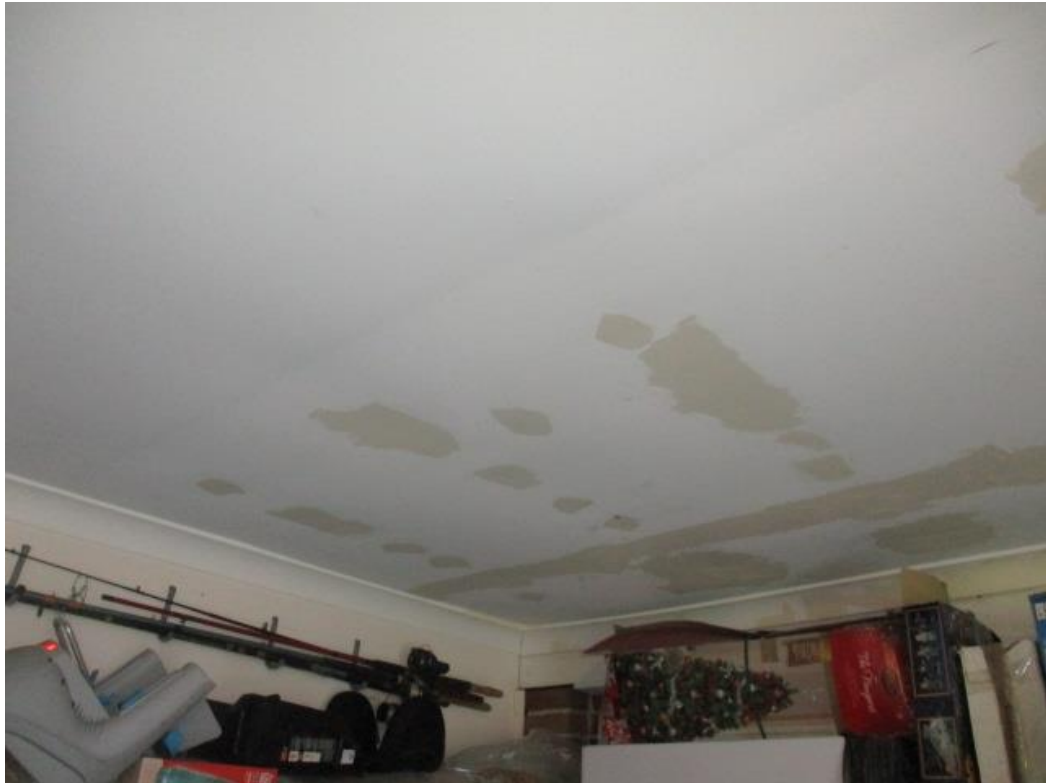
There is also previous repairs to both the left hand side and right hand side of the ceiling in separate areas

S67771-WRIGHT\Previous ceiling repairs right hand side

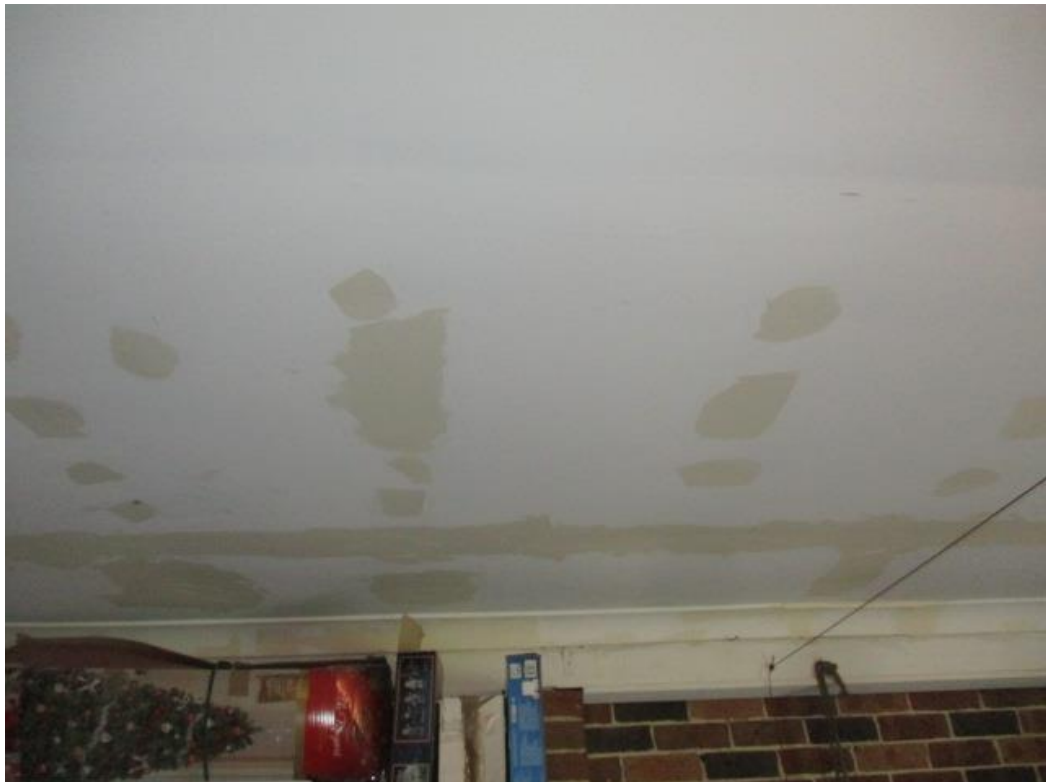
S67771-WRIGHT\Previous ceiling repairs right hand side2

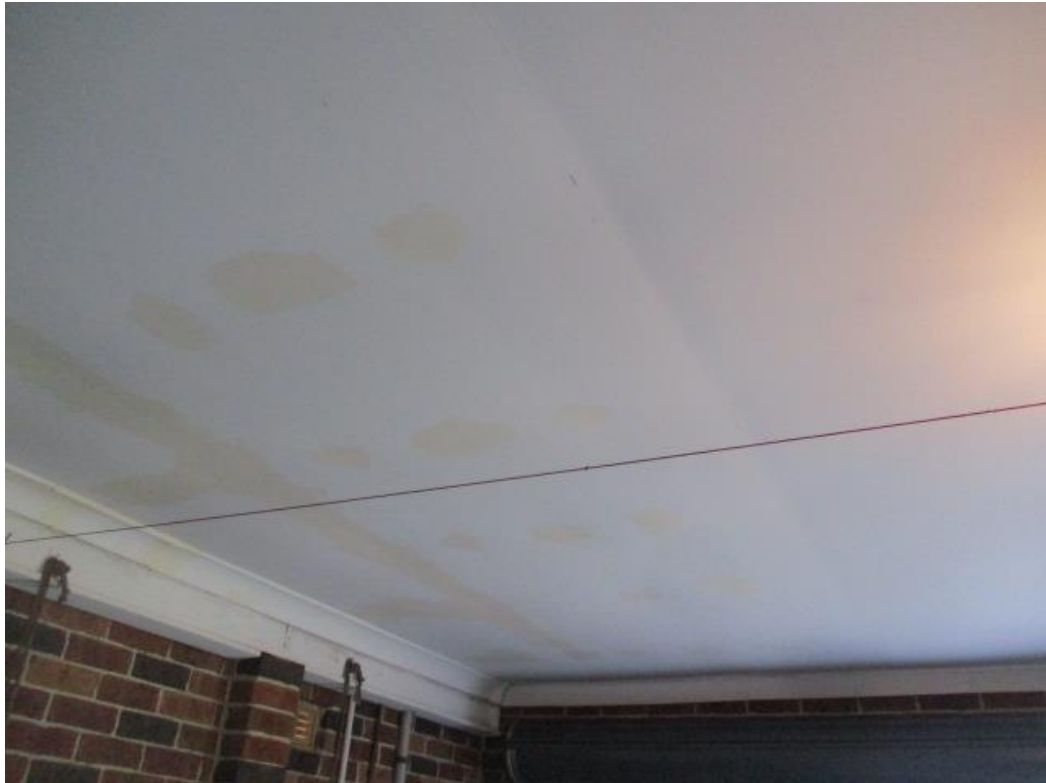
S67771-WRIGHT\Previous ceiling repairs right hand side3

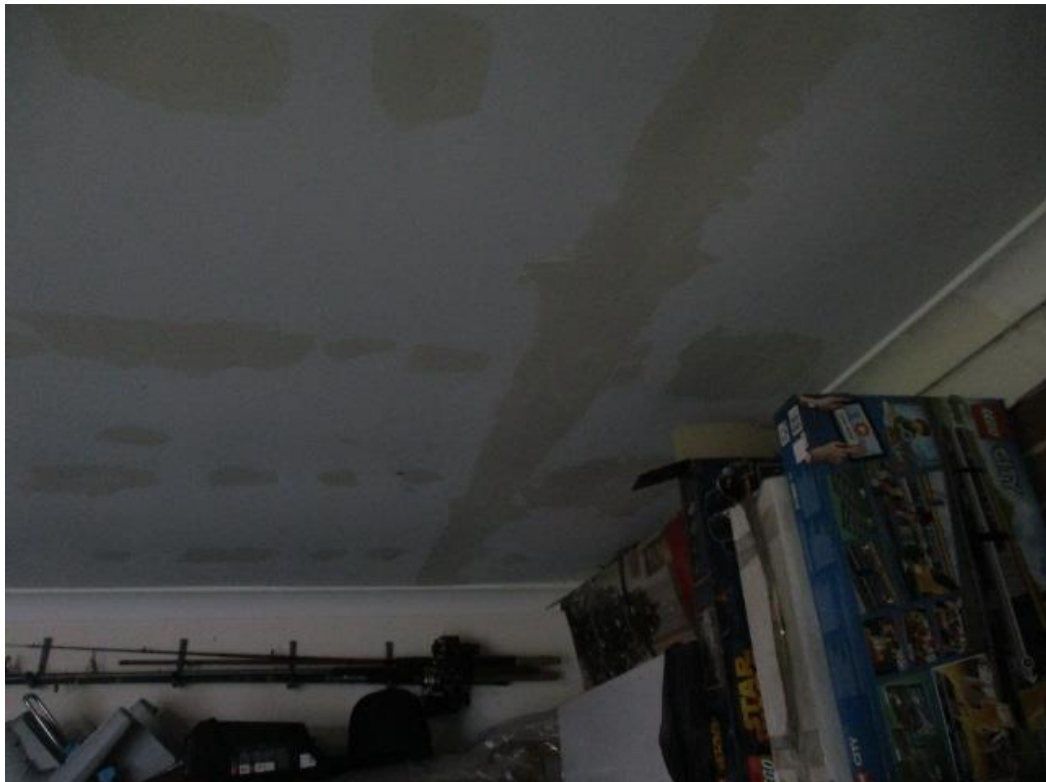
S67771-WRIGHT\Previous glue failure repairs

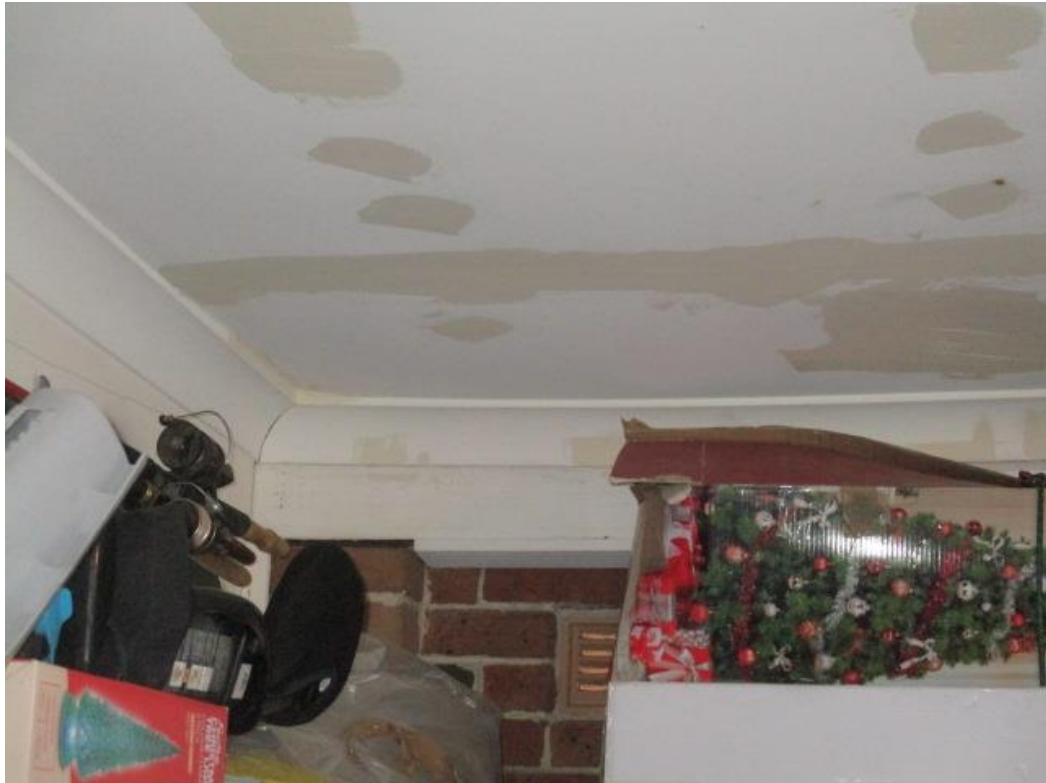
S67771-WRIGHT\Previous glue failure repairs2
