## **Traffic Accident Report**

General Vehicle Information							
Make:	Mazda	Body Type:	SUV	Fuel:	Petrol		
Model:	Axela	Cylinders:	4	Transaxle:	2WD		
Reg. year:	2016	Seating Cap.:	5	Steering Pos.:	Right hand		
Model #:	AX45	Odometer:	28390 km	Transmission:	Automatic		
Engine Number:	AX45-5689	Rating CC:	2000cc	Colour:	RED		
Reg. No.:	TBA	Import Type:	Japanese	Body Grade:	2.01

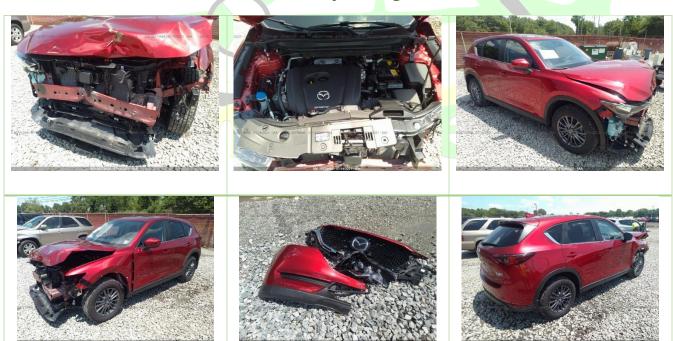
## **Pictures of Damages**

Record of Damages						
Bonnet:	Major damages (repairable)	Left Headlight:	Completely destroyed			
Right Fender:	No damage	Radiator:	Minor Damages (repairable)			
Left Fender:	Major damages (repairable)	Engine Bay:	Bent at the Front			
Front Bumper:	Completely destroyed	Fog lights:	Completed Destroyed			
Crash Bar:	Major Damages (needs replacement)	Air bags:	None Deployed			
Grill:	Completed destroyed	Right Front door:	No Damage			
Right Headlight:	Minor damages	Left Front Door:	Slight Damages
