Traffic Accident Report

General Vehicle Information						
Make:	FORD	Body Type:	SUV	Fuel:	Petrol	
Model:	Explorer	Cylinders:	6	Transaxle:	4WD	
Reg. year:	2017	Seating Cap.:	7	Steering Pos.:	Left hand	
Model #:	FEX17	Odometer:	50452 km	Transmission:	Automatic	
Engine Number:	FEX17-5678	Rating CC:	1987cc	Colour:	White	
Reg. No.:	ТВА	Import Type:	United States of America	Body Grade:	2.01

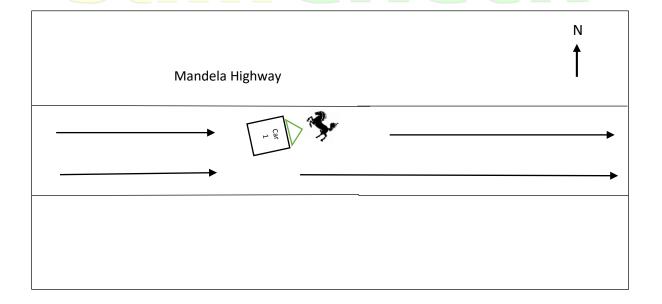
Road Diagram

On Saturday, April 29, 2021 the Ford (Car1) motor car was traveling along Mandela Highway in an easterly direction heading towards Spanish Town Road.

Whilst driving along the road way a horse run in the middle of the road causing the driver to swerve the car to avoid hitting the animal. Subsequently, the car hit the horse causing damages to the front and killing the animal.
