1 THE CASUALTY

2 THE VESSEL "VIKING SALLY"

The German 'Group of Experts' has now - as far as possible - completed its investigation of the foundering of the M. V. ESTONIA, a disaster that has taken the greatest toll of human life in the Baltic Sea in times of peace. The German 'Group of Experts' has during the past five years performed a difficult investigation in a partly hostile and reluctant environment. The work was carried out during the first two years - 1995/1996 - in close co-operation with the Swedish leader of the Technical Group of the Joint Accident Investigation Commission of Estonia, Finland and Sweden (JAIC), Börje Stenström († February 1997), and also with the Finnish member of the Technical Group, Dr. Tuomo Karppinen and the expert Dr. Klaus Rahka. All the investigation results of this 'Group of Experts' were submitted either verbally in joint meetings with the members and the experts from Estonia, Finland and Sweden attending or in letters with attached photos and/or video film documentation to the JAIC. This documentation and information concerned the design, construction and building of M. V. ESTONIA in general and the locking devices of the bow visor in parti

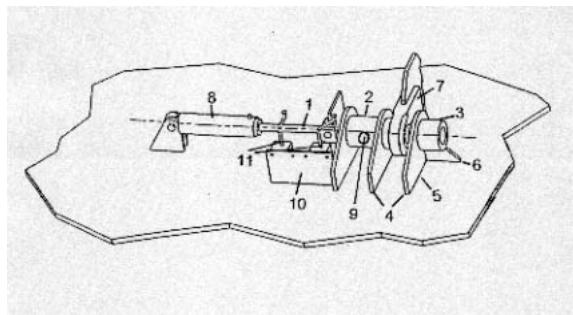
This locking device consisted of a locking bolt (1), movable horizontally in a transverse direction, guided in a bolt housing (2). In extended position the tip of the bolt engaged a support bushing (3). The bolt housing was fixed to the forepeak deck by means of two steel lugs (4) and the bushing was installed in a third similar lug (5), to which a support bracket (6) was fitted. A mating lug (7), attached to the visor itself, was located between the bolt housing and the support bushing when the visor was in the closed position and the extended bolt then engaged the hole in the mating lug.

The bolt was moved in the bolt housing between the retracted position and the extended position by means of an hydraulic actuator (8), operated from the control panel located behind the bow and the ramp on the car deck. A spring-loaded mechanical plunger (9), perpendicular to the bolt, engaged grooves in the bolt in the open and closed position, thereby securing the bolt mechanically in its extreme positions, regardless of hydraulic pressure. The bolt was also locked hydraulically at any time because the hydraulic fluid was trapped in the system, regardless of whether the hydraulic system was under pressure or not.

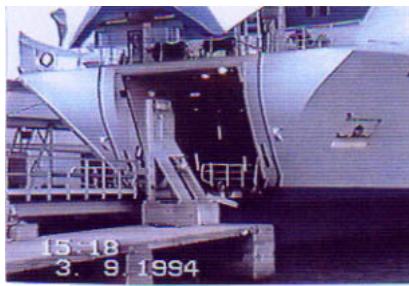
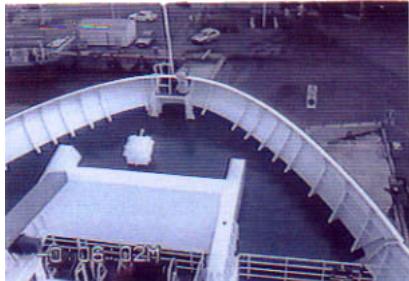
On my last trip to Tallinn before the casualty (I missed one sailing) my car was on the hanging deck at starboard side. Thus I could not see what was going on at the ramp and the visor when being opened. I saw, however, crew members working at the bow ramp before it was lowered down. When I drove down the ramp I saw the equipment for either welding or burning (gas bottles) laying at port side near ramp. We had to wait longer than normal, maybe half an hour or more before the bow ramp opened. I remember this clearly, because I had people waiting for me at the quay who had left before I was from board because it took so long. It could be the time when I saw the visor moving up and down several times before the bow ramp opened combined with banging noises and also hammering.«

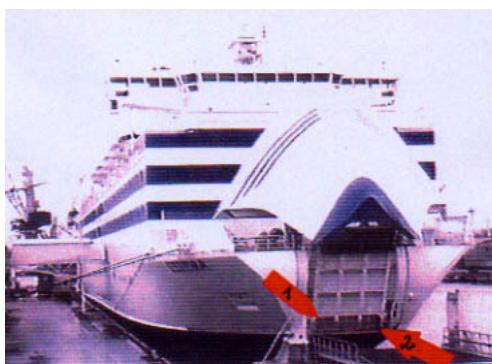
The picture below shows ESTONIA at her berth in Tallinn with open visor and closed bow ramp. The arrow no. 1 points to the oil covered lower part of bow ramp which demonstrates the height of the water level with hydraulic oil floating on top inside of the visor when the vessel was at sea in calm weather. Arrow no. 2 points to the bow ramp hinges which are on car deck level.

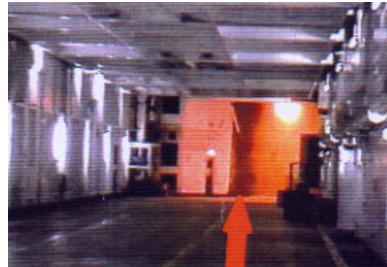
*»When I was sitting in my car in a position close behind the bow ramp waiting for the ramp to open, I remember having frequently seen crew members pulling steel plates across the gap between the open bow ramp and the car deck. I know that this gap is normally closed by steel flaps, but these had been dismounted with certainty at the port side. There were now holes in the flaps on both ends into which crew members were putting hooks by means of which they were pulling the flaps across the gap when the ramp was open and to the side before the ramp was closed.
The area with missing flaps at the port side of the closed bow ramp can be seen on the following video prints (see arrows).«*

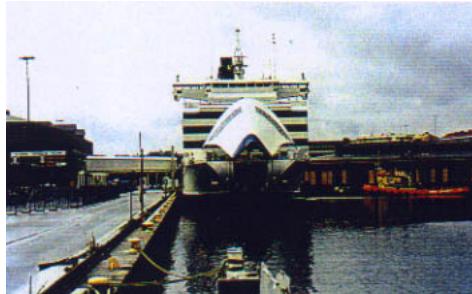
»I had frequently been on the forward part of the 8th deck upon departure from Stockholm and do remember having quite often seen the visor open.« (See photo below.)

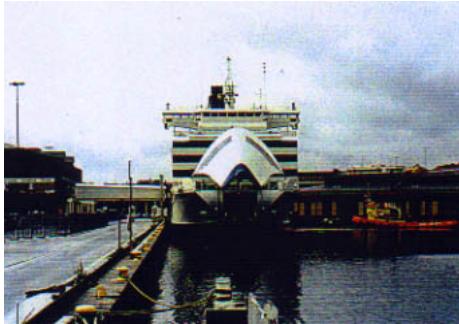
One of the viewers of the 'EFTERLYS' program reported that he saw the ESTONIA in July 1994 at her berth in Stockholm with open visor and open bow ramp, which was categorically denied by N&T, ESCO and the JAIC members.

The following picture proves it. It was made by a German tourist in July 1994.

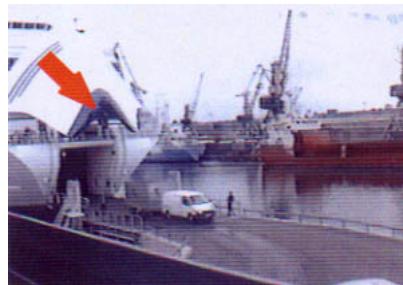
The picture below shows ESTONIA at her berth in Tallinn with open visor and bow ramp on 30.03.94, i.e. more or less at the end of the ice winter which had left visible traces to the visor's structure - see arrow.

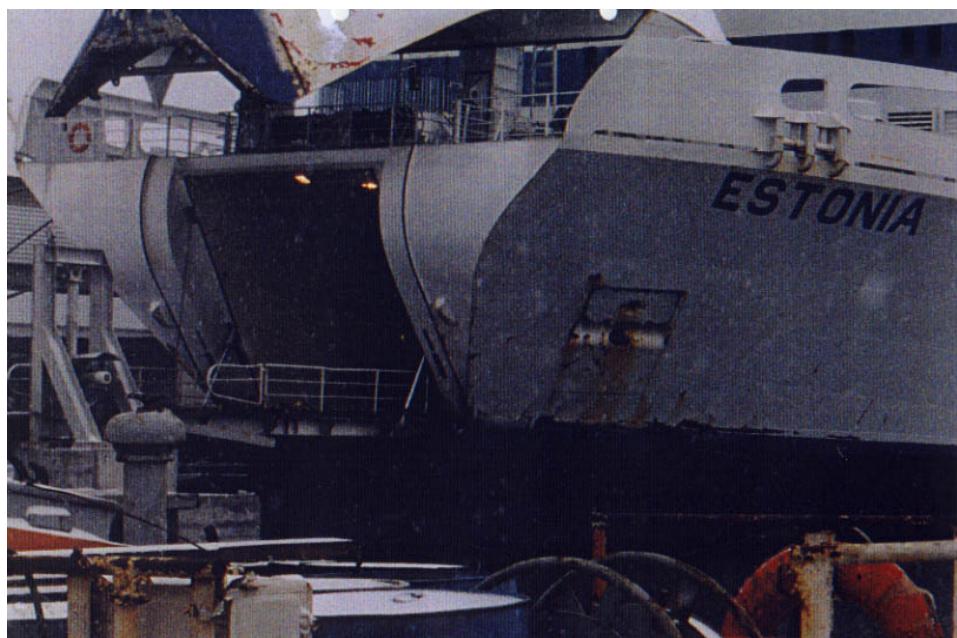
The ice situation is demonstrated on the ice chart of 28.03.94 which is attached as [Enclosure 12.4.2.152](#) and two photos showing the cruise vessel SALLY ALBATROSS sitting aground outside Porkkala (opposite Tallinn) in heavy ice during February/March 1994. The photos attached as [Enclosure 12.4.2.153](#) clearly demonstrate the ice conditions which were prevailing at this time in the Gulf of Finland. The effect these ice conditions had on the visor and foreship of the ESTONIA can be seen on the photo below which was made on 24.03.94.

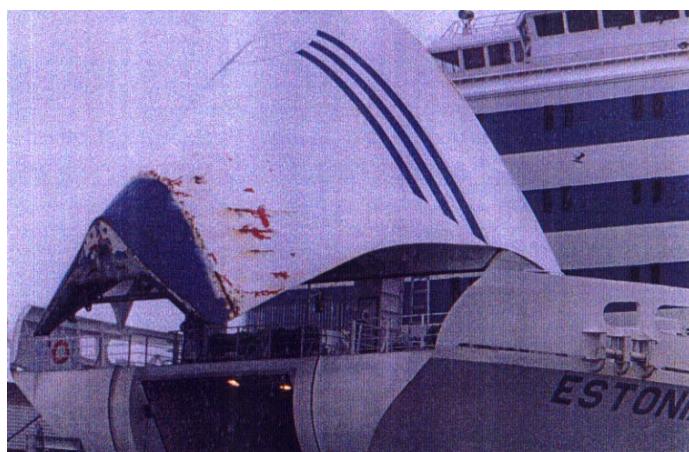
The results of such reckless navigation are clearly visible on the large photo on the previous page which was taken on the following day, 25 March 1994, in Tallinn by the professional photographer Li Samuelson.

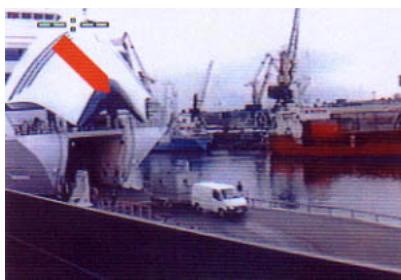
The damage sustained by the visor while proceeding at full speed through ice barriers several meters high and using the vessel as an ice breaker is demonstrated by the preceding photo and can also be seen on the video image below made from a film of 30.03.94.

As a result of the sustained severe structural damages and in combination with the different lifting speeds of the actuators and severely worn out hinge bushings, the visor became increasingly misaligned and out of geometry.

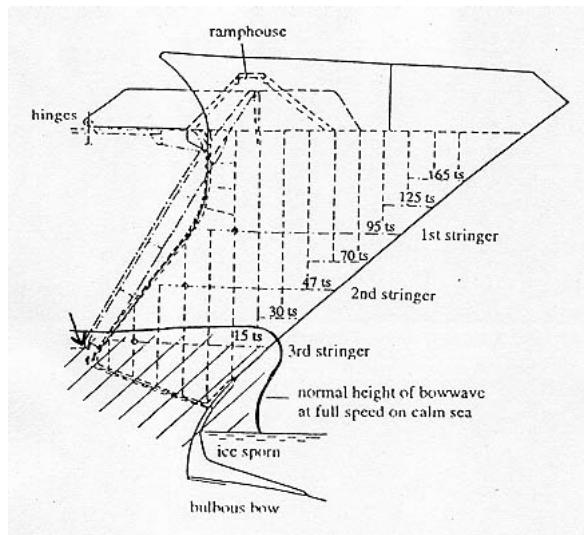
Since the lower part of the deck opening with the missing and/or damaged rubber packings (see arrow on drawing) was below the 3rd stringer level of the closed visor, it is obvious that water penetrated the car deck already in calm sea when the vessel was on full speed (height of bow wave ca. 2.5 m). It is also obvious that the water inside the visor rose when the vessel was pitching in head seas. The height of the water inside the visor depended on the height of the outside water level, i.e. when the ferry was taking green water on the forecastle for a certain time the visor would fill up more or less completely with respective water pressure on the leakage of the bow ramp.

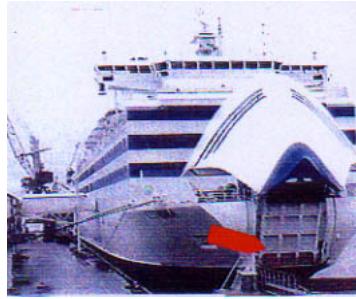
Note: The picture on the next page was taken in October 1993 and shows the lower part of the closed bow ramp severely stained by oil, most probably hydraulic oil, which cannot just be explained by normal leakages.

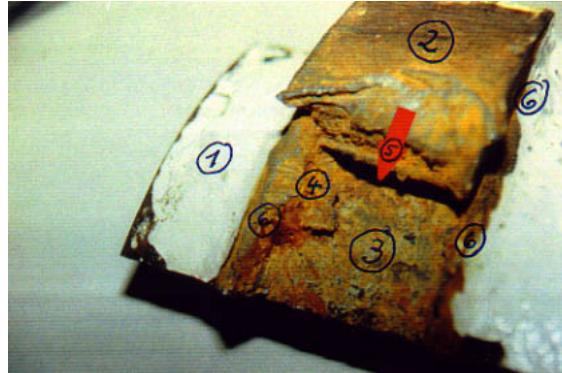
photo of stb. inner bushing recovered by divers

In summary of these three statements it has to be concluded that the welding seams between the bushings and hinge plates of the visor hinges were visibly cracked up to 10 cm at the beginning of August 1994, less than 8 weeks before the casualty.

The photo below shows a part cut out of the bushing recovered by divers from the wreck. It is most probably the starboard inner bushing as will be explained in Chapter 30.

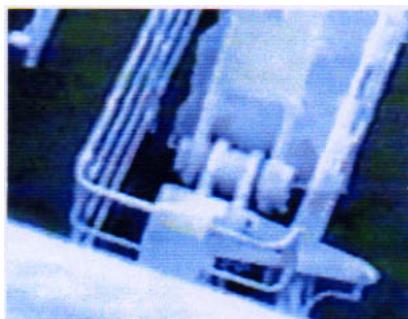
b.) That there was something seriously wrong at least with the starboard hinge arrangement of the visor well before the casualty becomes very obvious when having a close look at the **video film made by a passenger upon departure from Tallinn on 17 September 1994**, i.e. 10 days before ESTONIA's last sailing. He stood on the open forepart of the 8th deck and with his video camera filmed the closing of the visor. Thereby he zoomed in on the starboard hinge arrangement. The subsequent evaluation of the video proved that the starboard visor hinges were totally misaligned with the lower part of the outer bushing as well as the securing plate missing. The video was analysed and evaluated in detail by the Reconnaissance Expert Bryan Roberts of Churchgate/UK and his report is attached as [Enclosure 12.5.180](#).

The print is shown below and the enlargement is attached as [Enclosure 12.5.181](#).

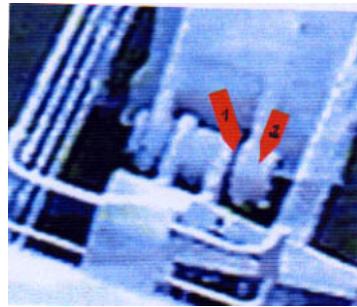
Although the distortion and misalignment of the starboard hinge is clearly visible to everybody, the Swedish part of JAIC gave a copy of the film to the Military Intelligence Service, who produced the picture attached as [Enclosure 12.5.181.1](#), which evidently shows the same. Nevertheless, the Intelligence people declared the whole film to be unreliable since 5 out of about 800 sequences had been slightly "jumping", which was accepted by the JAIC as well as N&T and the film from then on was ignored by the JAIC and consequently is also not mentioned in their Report. What the film really shows becomes clear on the enlargement below, viz. some major deficiencies:

- the gap between the starboard vessel hinge plate and the outer bushing is much too large (Arrow 1).
- the outer bushing is sticking much too far out of the outer visor hinge plate (Arrow 2) (which explains the large gap mentioned above).
- the lower part of outer bushing is missing.
- the securing plate is missing and the outer end of the bolt is not visible.
- the outer bushing appears to be twisted anti-clockwise.
- the inner bushing appears to be twisted anti-clockwise.

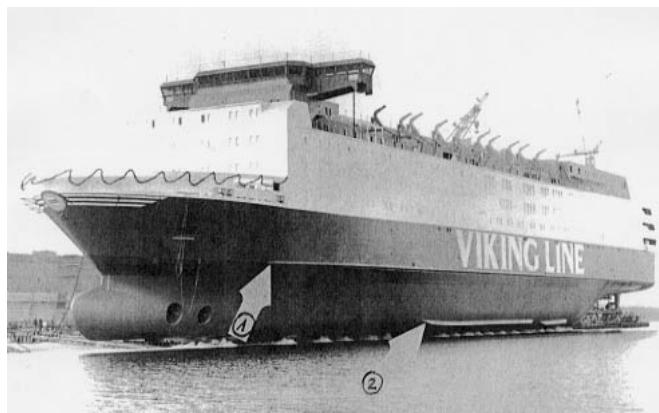
Note: The picture below shows the vessel's port side while still on slip. Arrow 1 indicates the forward end of the fenderbar, arrow 2 the forward end of the bilge keel.

- When he was at the forward part of the fenderbar he saw something like a fin sticking out of the hull, dark like the bottom, maybe 1.5 m or less, looking like a propeller blade of a plane. It was not moving.

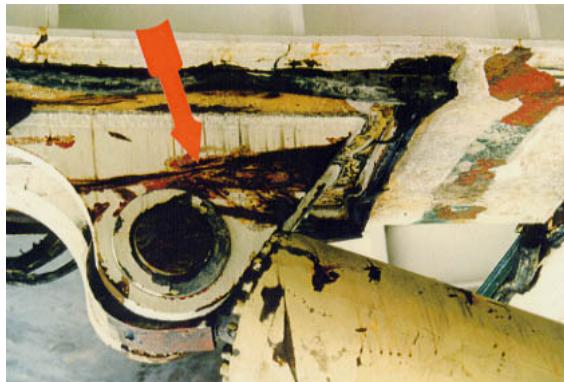
It must have taken some time for the visor lugs to cut through this deck beam while the visor moved forward/aft in the sea state ending when the visor lug plates had finally cut through this strong deck beam. It has to be assumed that during this cutting process at least the paint on both the inner and the outer lug plates should have been destroyed in way of the contact area. This was, however, evidently only the case with the inner lug plate as can be seen on the picture overleaf.

The lug plate has very deep and - at the upside - straight scoring marks, almost engraved, which indicate

- (a) the movements of the visor and
- (b) that the weight of the visor was to some extent resting on this inner lug plate which caused these very deep scraping marks, whilst the opposite side, i.e. the outer lug plate, remained completely unaffected as visible on the next picture.

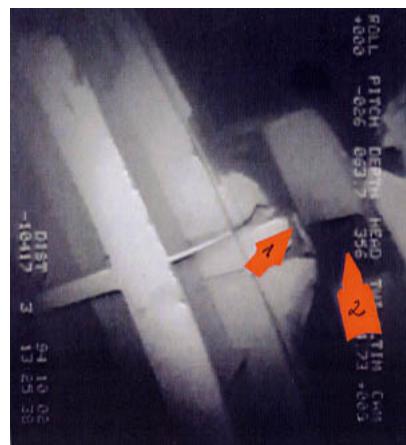
The following picture shows the misalignment between the mating lug at the ramp side and the opening in the front bulkhead out of which the hook would extend, i.e. it was impossible for the hook to engage the mating lug in this condition. This explains the undamaged condition of both hook and mating lug.

Arrow 1 points to the mating lug at the ramp

Arrow 2 points to the location where the hook would reach out of the opening

Note: The 4 inches = 100 cm misalignment between the bolts on the ship's side and the mating pockets on the port side of the bow ramp as reported by the diver must logically exist also between the ramp hook on the ship's side and the mating lug on the bow ramp. This is further evidence that neither the bolts could have engaged the mating boxes nor the ramp hook the mating lug on the port side.

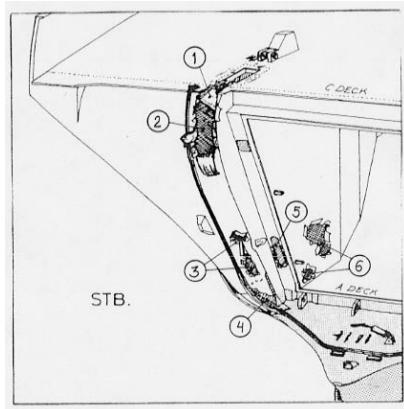
S4 -Starboard Front Bulkhead

The area under investigation is restricted to the starboard front bulkhead of the wreck as shown on the drawing below. There is no sheet available for this area. For easy reference the explanations will be given by photos/video images incorporated into the text. The numbers on the drawing indicate the damage areas which shall be explained and illustrated as follows:

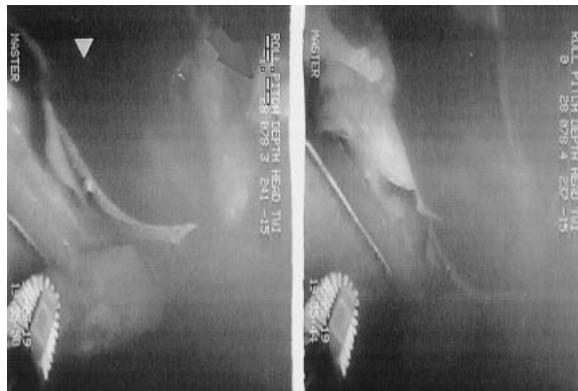
Area No. 2 shows the damage further down the front bulkhead. Note the torn open steel bent to starboard and to port.

The arrow on the left picture points to the severely distorted mating lug for the ramp hook.

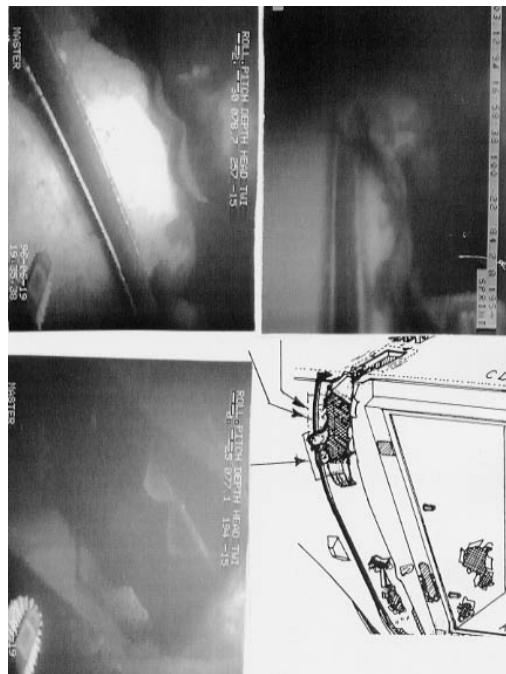
The picture below shows the lowest part of the damage, i.e. an almost horizontal, slightly upwards pointing steel flap.

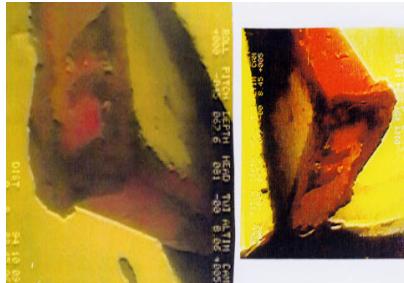
The next images show the lug of the hydraulic side lock which was evidently torn off the visor bulkhead together with the welding seams by which it had been welded to the bulkhead.

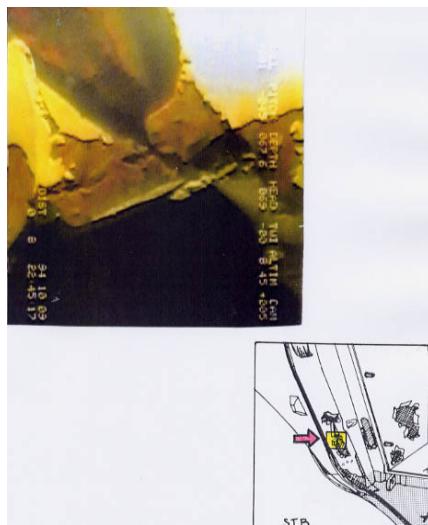
The next image shows the broken bulkhead part between the opening with the lug of the hydraulic side lock and the much enlarged opening for the manual side lock below.

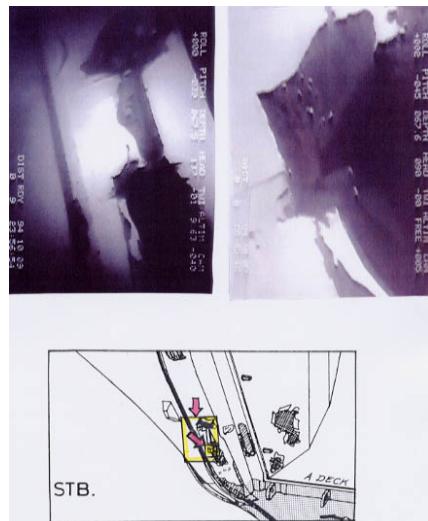
The following pictures show the upper part of the enlarged opening for the manual side lock.
Note the steel bent from inside to outside.

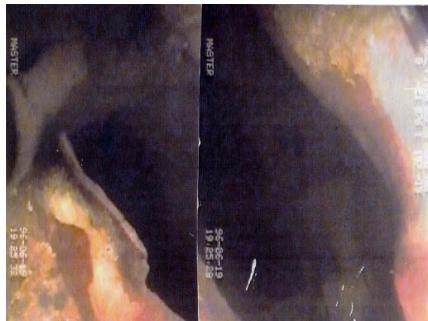
The two pictures below show the enlarged opening for the hooks of the manual side locks with the steel plating bent from inside to outside and the edges cracked.

On the right picture the not engaged mating part of the manual side lock is visible in the background. Furthermore a "soft" indentation can be seen on the inside of the substantially enlarged opening.

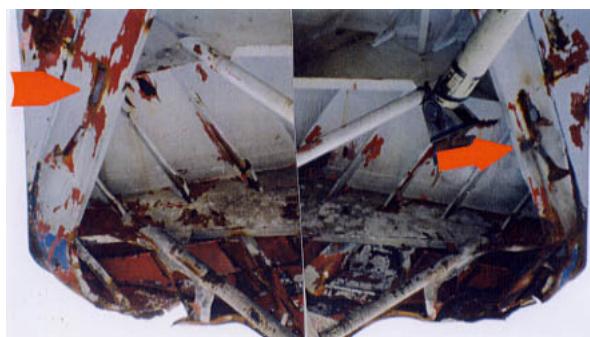
Next pictures follow which show the starboard lower aft bulkhead of the visor having been directly opposite to the corresponding parts of the starboard front bulkhead of the wreck. In comparison also the port lower aft bulkhead is shown.

The picture on the right left shows the area of interest on the starboard side, the picture on the left shows the corresponding port side. It shows a completely different damage picture: no smoke marks, no steel tongue torn off the bulk-head and no twisted hooks. Two of the following four pictures on the next page show those areas at the port and starboard aft bulkhead of the visor where the lugs of the side locks had been welded to and the hooks for the manual side locks were fitted. The other two are close-ups of the upper parts of the area where the lugs had been welded. The right side shows the part of the starboard visor bulkhead directly opposite the above explained damage area. The smoke marks are still clearly visible although the visor had been on the sea bottom for 7 weeks. The hooks are distorted in a way which is technically not explainable. The area is dark. The picture on the left shows the corresponding port side as comparison with a complete different damage picture, with no smoke marks, no steel tongue torn out of the bulkhead and no twisted hooks and a generally clean appearance. The two close-ups arranged below the above mentioned photos show the respective upper parts of those openings in the bulkhead. They do illustrate the difference very clearly. While the port side shows normal steel clean of corrosion, the starboard side shows steel which had obviously been exposed to heat and pressure force: The metal is distorted and pushed out, the stiffener is detached from the bulkhead. See also Chapters 30 and 32.

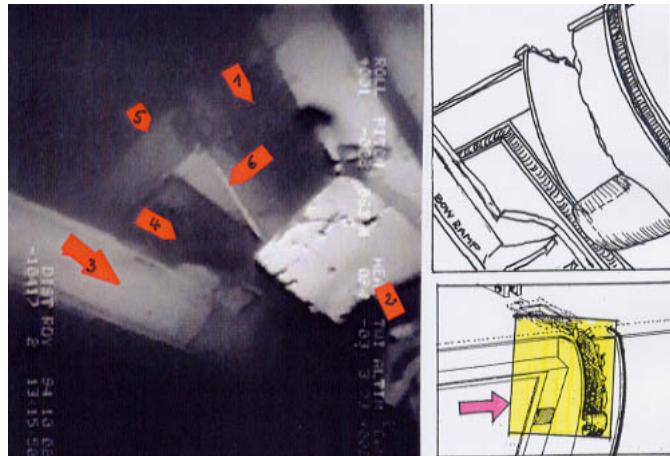
Arrow 3 points to the slightly open bow ramp, arrow 4 to the car deck opening and arrow 5 to the forecastle deck.
Arrow 6 points to a wire running from forecastle deck down beside the bow ramp, which was no more there when the divers came.

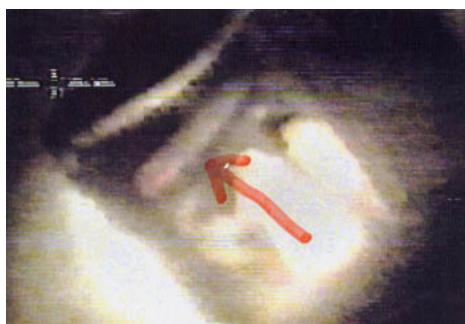
Area No. 2

- concerns the opening in the recess of the front bulkhead for the ramp hook. The hook has been identified inside this opening. The red arrow on the image below is pointing to the hook which is obviously intact and in locked condition.

The image above is a view into the opening in the front bulkhead recess inside of which the port ramp hook should have engaged the mating lug at the ramp during the closing procedure which it evidently did not do during the last voyage. This has already been explained under P 3 - Port Forecastle deck.

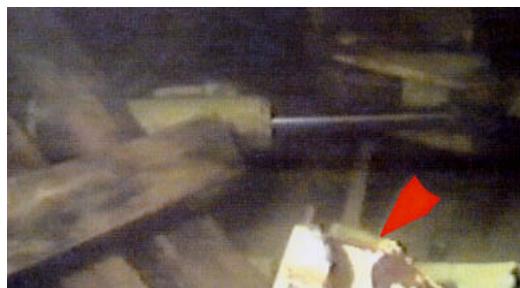
The image below was made when the ROV looked into the opening in the forecastle deck for the port visor actuator. The actuator of the ramp hook with part of the hook arrangement and the remains of the cut through deck beam - see arrow - are clearly visible.

Note: When the ROV looked into the corresponding deck opening for the starboard visor actuator only the remains of the cut through deck beam were visible. The ramp hook arrangement was obviously no more in place.

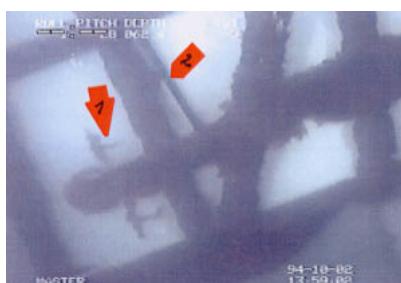
Area No. 3:

The following image shows transverse contact marks above the opening for the hydraulic side lock - see arrow 1 - which presumably resulted from the visor moving forward/aft during the time it took the visor arm lugs to cut through the deck beam.

Arrow 2 on the above image points to a wire running across the front bulkhead and the bow ramp to the starboard side and apparently from the port fair leads of the forecastle deck (there is no other possibility where a wire could come from). The image was made from the video tape produced by ROV on 02.10.94 - see Subchapter 25.1 - because on subsequent videos the wire is no more visible.

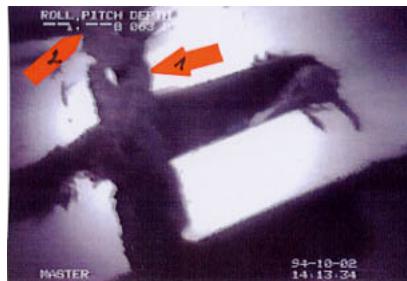
The next image - made from the same video tape - shows the same area, but slightly further down (in normal condition). Arrow 1 points to a double rope coming up from the gap between bulkhead/ramp and rising up due to its floatability.

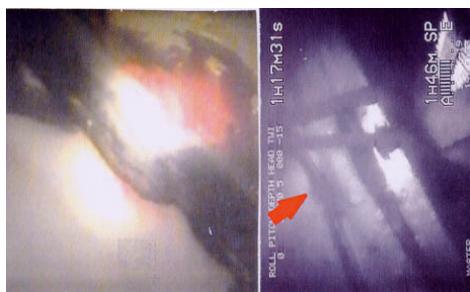
Arrow 2 points to a damage area in way of the rubber packings which is better visible on the right image below made from the 1996 video tape. The double rope was then still there because it is jammed in, though in slightly changed position. The damage area is more clearly visible - see arrow.

The left image above was taken from diver video B40c and is a close up of the same damage area. It shows that the rubber packing including flat bar channel has been pressed flat on a distance of about 200 mm. This could have been caused by a single wire or wire running from the bow ramp around the edge of bulkhead/hull plating up to the fair leads on the forecastle deck and further to one of the winches. Alternatively the damage could have been caused by the port aft edge of the visor bottom in the final stage of the visor separating from the vessel - see Chapter 31 - or it could have been an old damage because the corresponding area on the aft bulkhead of the visor does not show rubbing marks from the rubber packing. See the picture on the next page. A similar damage does not exist at the starboard front bulkhead.

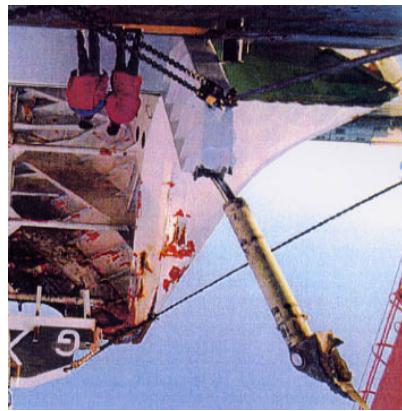
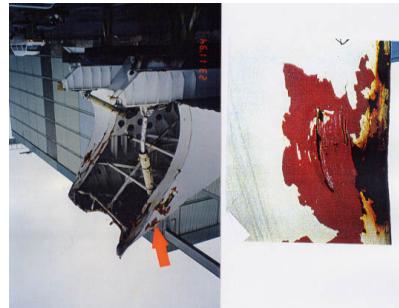
The starboard actuator, to the contrary, was found to be fully extended with the piston rod bent. It had apparently been the last connection between the vessel and the visor except for the bow ramp, the fore-castle deck and bulbous bow.

The area indicated by the arrow and the close up was probably struck by the foundation of the starboard actuator after the actuator had moved out of the front bulkhead of the vessel. - See also Chapter 30 - The Visor.

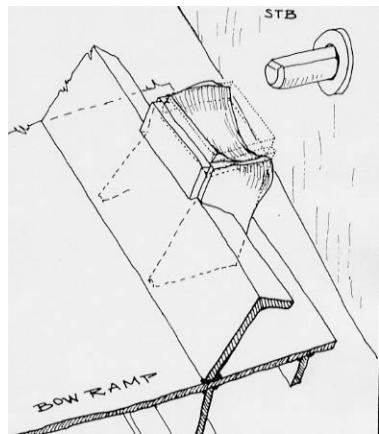
No. 1.2.2 - **The lower mating pocket on starboard side** is crushed, i.e. the top plate and the longitudinal side plate were pushed in, the upper and lower side plates were still in position, but bent inwards. The damage picture is actually opposite to what it should be if the bolt would have engaged an intact pocket and the bow ramp would have been forced open. Then the top plate would have been pushed by the bolt from inside to the outside and probably broken.

Unfortunately the video quality is extremely poor because when the diver saw the pushed in condition of the pocket he started to rub it with his glove and the picture became totally foggy as can be seen. Nevertheless, the contours of the mating box are visible and are made more clear by the drawing next to the image below.

The diver started to explain this unusual and unexpected damage in this location, but was stopped by the supervisor who said: "They are just interested whether the bolt is fully extended." The diver, turning away from the crushed pocket: "The bolt is fully extended." The only possibility of such damage being caused in such a location was by closing the ramp by force when the bolt was already extended. Therefore, it has been assumed that the bolt had been extended when the ramp was closed some time before the casualty and the top plate and the adjacent longitudinal plate were pushed in, as visible. Never since this occurrence was it possible to close and lock the ramp properly.

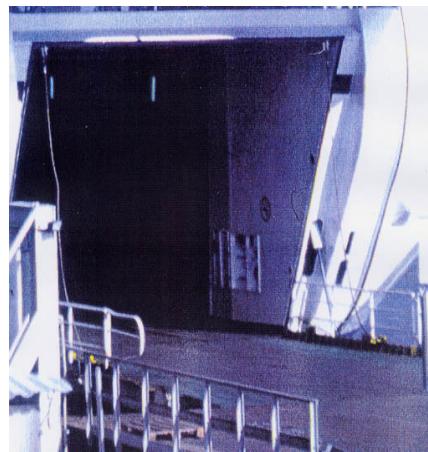
The port actuator and its fastening.

The picture below shows the port actuator extending out of its opening in the recess of the front bulkhead.

Due to the ramp being pressed to starboard the port recess of the front bulkhead is visible with the opening of the actuator.

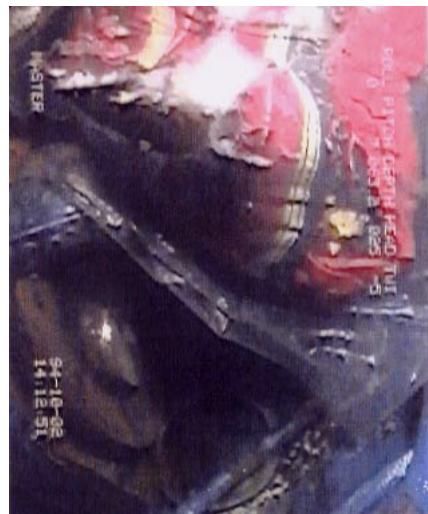
The following image taken from the 02.10.94 video shows the location of the port outer hinge which slipped off, intact outer lug some distance away from its original position because evidently a gap had opened and the ramp became detached from the vessel in this area and through this gap between forepeak deck and bottom of ramp water could freely penetrate onto the car deck from the visor which was always water-filled at sea. This gap was plugged by mattresses - see the blue transverse one above the hinge remains - the vertical plastic sheet to the right of the blue mattresses, the red/white bedding next to the plastic sheeting. The videos from 02. and 09.10.94 are showing blankets and rags further up in the gap between ramp and bulkhead.

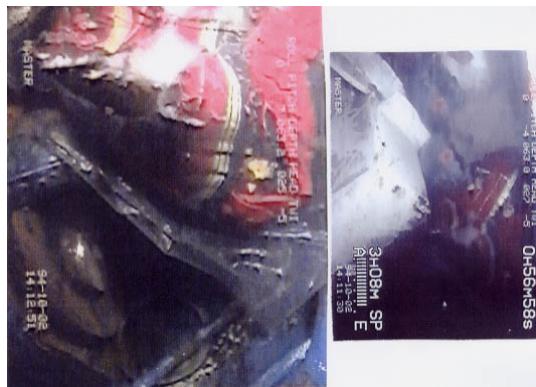
Also the following image shows the same area, but slightly further to starboard. The rubbing marks on the bedding indicate that it had been in place during several openings/closings of the bow ramp.

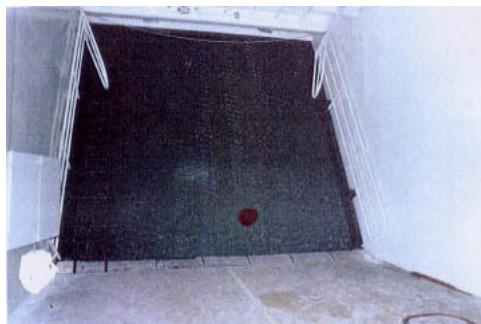
The inside of the bow ramp is only briefly visible when the diver climbs up the starboard side to the flaps at car deck level, pulls himself up along these flaps to the port side hinges and further to the lower securing bolt with mating pocket. On the ramp plating there are two areas with burnt and/or damaged paint, i.e.:

- There is an area of ca. 1 m² located between the upper flaps and the level of the car deck opening where the paint is burnt and the plating is severely distorted. The area is inside the ramp house when the ramp is closed.
- The lower area is located in the 3rd row of steel profiles, looking from starboard, which are welded to the ramp plating and the 6th or 7th profile from car deck level as indicated on the picture below by the dark spot. The paint of the plating as well as the two flaps below looks reddish/brown. The plating otherwise does not look affected, but the two flaps are bent and distorted and the car deck plating in way appears to be affected.

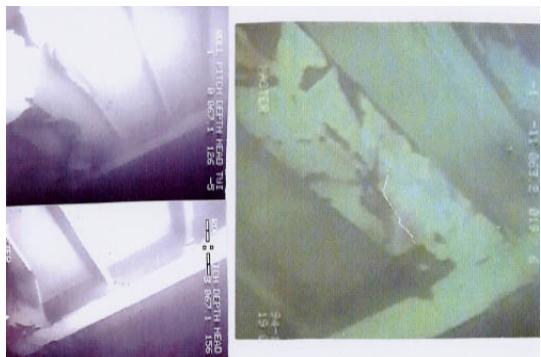
The two images below show on the left side the starboard lower port side with the outer vertical girder cracked off the bottom transverse girder, the ramp plating and the 2nd transverse girder and which is twisted by about 70° - No. 1 on drawing. The image on the right side shows the corresponding port girder with some scorings only and damage further up.

The dramatic damage to the starboard girder cannot have been caused by contact with the forepeak deck, because if the ramp would have smashed onto this deck also the port side should have been damaged. Also the nature and extent of this damage to the starboard girder does exclude that the damage was caused by impact on the forecastle deck.

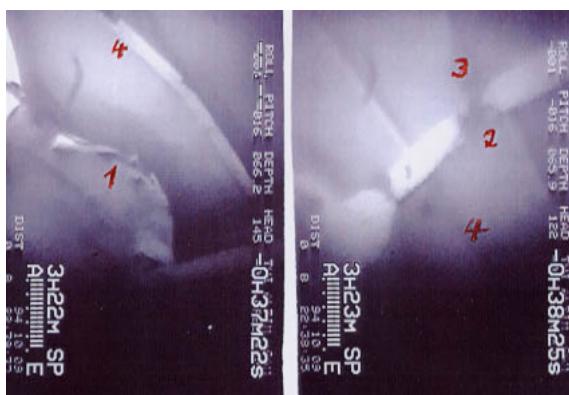
The left picture shows the lower part of the port outer vertical girder, cracked off above and below and twisted up to 70° - damage No. 1 on the drawing as well as damage No. 4. The right picture shows damages Nos. 2, 3, 4.

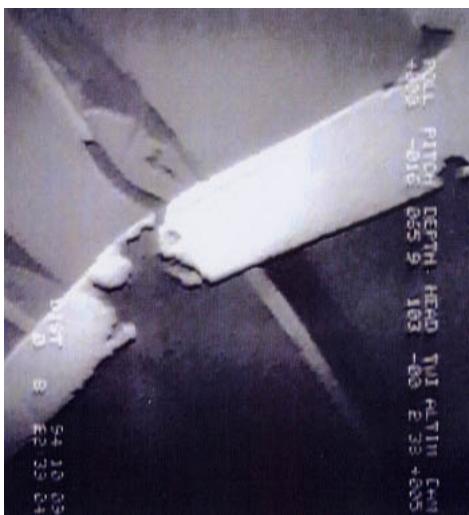
Below is an enlargement of damage No. 2.

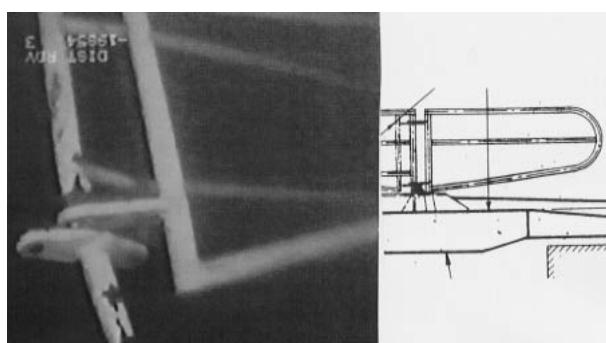
As parts of the starboard rail, the 4th section with the attached 5th moveable section, were found on the seabed already on 02.10.94 by ROV "Jutta II" - see the image on the next page - the available footage has been evaluated for indications of the bow ramp rails.

It is obvious that it is the starboard side because the movable part is always fixed at the inside of the fourth section if the ramp is open, as visible here and it is also obvious that the lower, bent part was the part attached to the ramp. It is further apparent that the vertical stanchion had been bent and finally cracked off by a force acting from port to starboard.

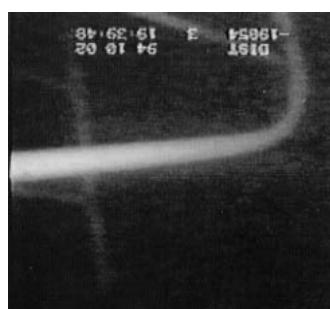
The image below shows the aft lower part of the movable fifth section which confirms the before said.

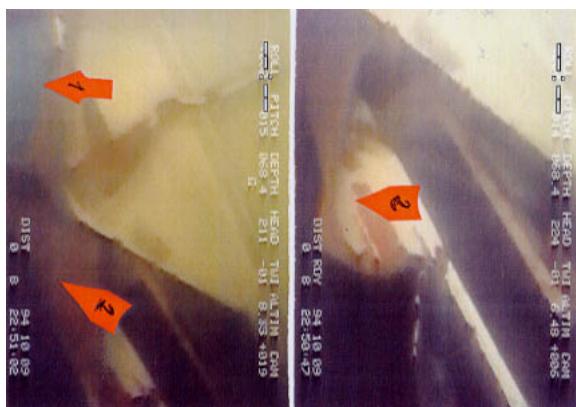
- On the same video tape from 09/10.10.94 two wooden pallets are visibly jammed between the ramp and the recess of the starboard front bulkhead just below (above) the starboard mating lug for the ramp hook. The area is not visible in detail on the 02.10.94 footage, but when the diver inspected the area on 03.12.94 the pallets were definitely no more in place.

The 2 images following show the area in question. Arrow 1 on the left image, points to the landing to which the mating lug for the starboard ramp hook was fastened and which was apparently pushed upwards - see arrows 2 on both images.

It can be excluded that these pallets floated into this position at the very moment when the ramp was pushed closed by the visor while the sinking vessel was already heeling to 130/140°. It has also to be excluded that the pallets floated out of the jammed-in condition by themselves as visible on the footage made on 09.10.94. This means that it has to be assumed that the pallets were manually put into position to avoid total closure of the ramp at some stage and, further, that they probably floated away when the ramp was also manually opened further at sometime after the 09.10.94 but before 03.12.94.

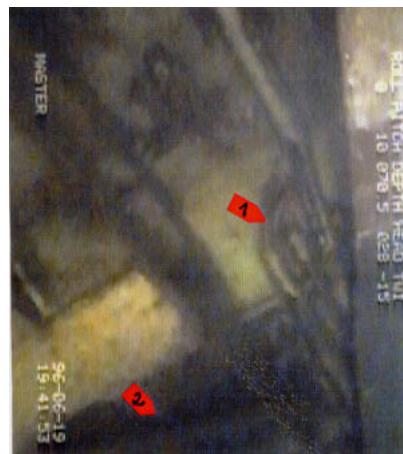
- When diver 1 (David) inspected the outside of the ramp on 03.12.94 he found a running wristwatch in the lower part of the ramp, i.e. in one compartment above the broken starboard hinges. It turned out that the watch belonged to diver 2 (Mark) indicating that he must have been there before apparently engaged in other activities not shown on the available video footage. See the ramp drawing on page 869.

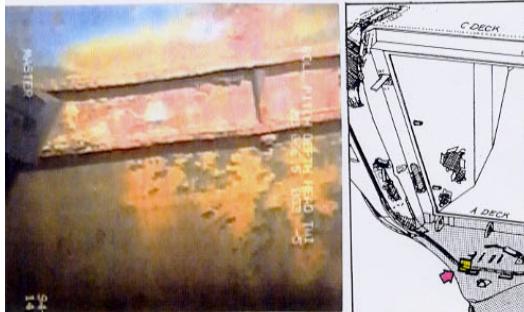
- Nos. 2, 4, 5, 6 show either empty flatbar channels where the rubber packings were supposed to be - which is also confirmed by the image below - or show the rubber packing lying loosely on the flatbars into which they should be fitted and bolted. The evaluation of the video films - of which these 3 pictures are just a small selection - prove that the rubber packings were only in place at the starboard side from forward of the Atlantic lock to the "corner of the mouth" and these were in a rather poor condition. Along the whole port side up into the "corner of the mouth" there were no rubber packings. The diver followed the flatbar - channel for the rubber packings from the top of the starboard front bulkhead via the forepeak deck to the top of the port front bulkhead which is documented on video tape B40c. The two images below are just a confirmation of the findings explained above.

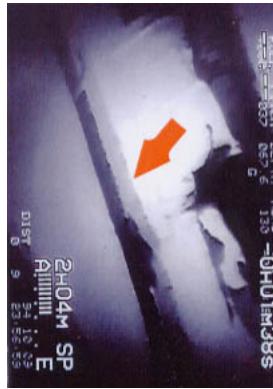
The lower part of the starboard front bulkhead in way of the hydraulic and manual side locks - see also further forward in this chapter, the starboard front bulkhead - is shown on the following images. The first one shows the upper part of the opening for the manual side lock with the rubber packing to the left. Between opening and rubber

packing the bulkhead is visibly bulged - see arrow - i.e. the bulkhead is pushed out around the opening for the manual hook and increasingly deeper down the bulkhead. This can be seen from the next image below - arrow 1. In addition, there is a very deep fold - see arrow 2 - as well as damage in way of the rubber packings - arrow 3.

Apparently the fold occurred between the rubber packing and the outer edge of the front bulk-head and extends down towards the forecastle deck where the front bulkhead was torn off the fore-peak deck plating and its inner side was twisted upwards. See the image below.

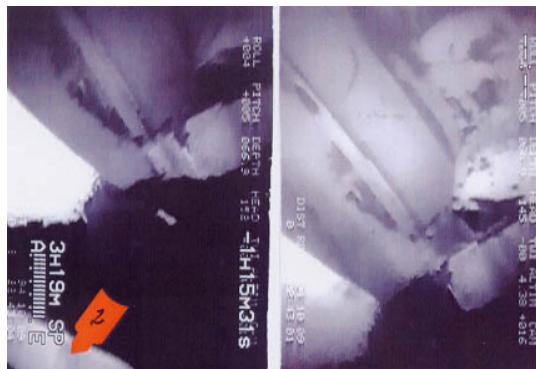
On the right image arrow 1 points to the change over from white to blue paint which should actually continue according to the red-dotted line, however, this is not the case due to the considerable distortion of the complete area which was apparently pushed forward where the visor was at the time.

The following two images show the area adjacent to this pushed-out lower part of the front bulkhead, the recess with the torn-off and severely bent lower part of the outer vertical girder of the bow ramp. Apparently the deck/bulkhead is open in way of these severe distortions which also extends downwards.

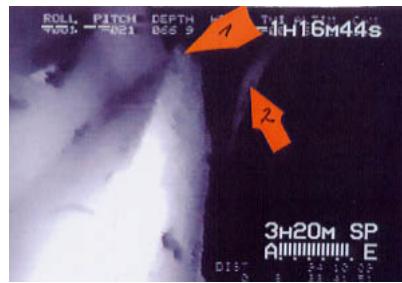
The next image looking from upside down shows the lower part of the front bulkhead twisted to port - see arrow 1 - while the initially lowest part of the bulkhead having been welded to the forepeak deck was cracked off and bent to starboard against the deck edge -see arrow 2 on this and the above image.

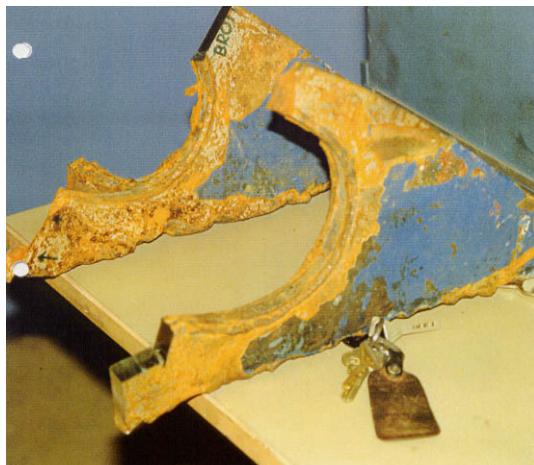
The pictures Nos. 4 and 5 show the starboard and the centre lugs in the Royal Technical University in Stockholm (KTH) in February 1995. They had been cut off the forepeak deck and were recovered by divers on 4th December 1994 and subsequently examined by the KTH. Below a photo of the starboard and centre lugs taken at the KTH, Stockholm in February 1995 is shown in order to illustrate to the reader the actual condition. Particular attention is drawn to the lower fracture area of the starboard lug.

(3) The upper part of the starboard lug was found to be bent to starboard, while the upper parts of the centre and port lugs were straight. The lower part of the starboard lug was straight while the lower parts of the centre and port lugs were bent to port.

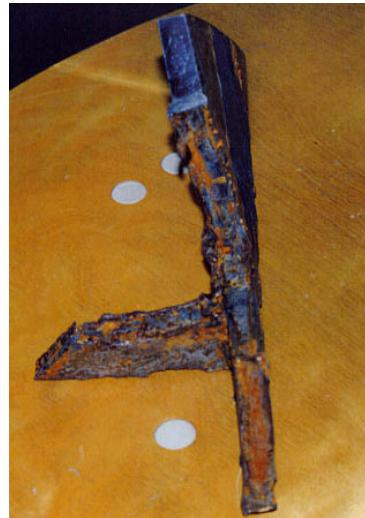
- The photo below shows the starboard lug looking from forward to aft. Attention is drawn to the lower fracture area and the bending of the lug.

- The other welding seams between lugs/bushing were fill-up welds of just 3 mm instead of 7-8 mm in the original condition.
- In particular the lower fracture surface of the starboard lug showed severe corrosion even though blank metal without any corrosion could be seen on the insides of the lugs and on the upper part of the bolt despite these parts should have become exposed to seawater at the same time as the lower fracture surface of the starboard lug. This could indicate that the fracture - at least of the starboard lug - existed already before the casualty.

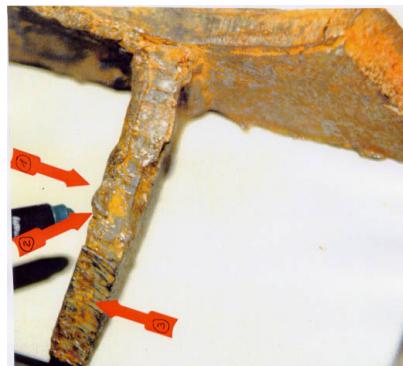
- Next an enlargement of the support bracket attached to the outside of the starboard lug is shown.

- The support bracket at the outer side of the lug (arrow 1) is larger than the original, which is evident because it overlaps the end of the welding seam (arrow 2) which marks the end of the bushing. The support bracket is about 12 mm larger compared to the original one made according to the von Tell drawing No. 49111- 373.

- The oblique end of the bracket is just burnt, not grinded (arrow 3). It is considered impossible that the bracket would have left blacksmith's shop of the Meyer Werft in such a condition - see also Subchapter 2.4.6;

- The welds are thin and interrupted, respectively cracked, because they are so thin, which is demonstrated by the corroded surface of the inner side of the lug normally covered by the bushing. As long as the welding seams are intact the space between bushing/lug is airtight, i.e. without oxygen, which was burnt by the heat of the welding process. This was obviously no more the case since some time before the bushing was torn off, because substantial corrosion was able to develop.

- The forward and aft welding seams between bushing and support bracket are not connected at the outer end (or closed, as the welders say), thus water could penetrate. This confirms the unprofessionalism of the welder who did these repair welds.

- The welding seams in way of the outer side of the starboard lug including support bracket/support bushing were poor quality repair welds made when the lug was in upright condition.

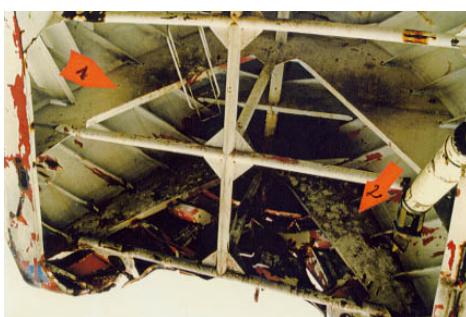
- As the Atlantic lock could no more be closed hydraulically already since some time before the casualty (probably since the ice winter, March/April 1994) crew members had to go down inside the visor each time before arrival and after departure Tallinn and hammer the bolt open respectively closed through the deformed lugs of the Atlantic lock. Thus they walked from forward to aft and back over the stringers through the freshly settled oil which caused the footprints as can be seen on the next pictures.

- The photograph on the next page was made mid January 1995. It shows a view into the visor with the partly oil stained 2nd stringer (arrow 1) and the completely oil covered stringer 3 (arrow 2).

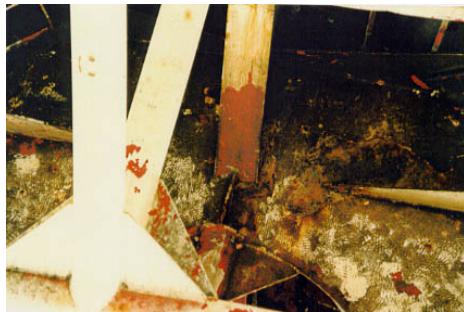
- Also the picture on the next page shows in detail that the footprints were so fresh and clear that even the size of the rubber boots could have been identified. It also demonstrates that there must have been quite some activities down in the visor before the last arrival and after the last departure from Tallinn which cannot just be explained with one or two men going down to hammer the bolt of the Atlantic lock open and closed. There were certainly also other activities going on as will be explained later.

Note: The last time the hydraulic oil settled down on stringer 3 has been before arrival Tallinn in the morning of 27.09.94 when the speed was reduced, the bow wave became small and the water streamed out of the visor. Thereafter the crew entered the visor to hammer open the Atlantic Lock and possibly to carry out other activities. The crew went again inside the visor after departure to hammer the bolt into the Atlantic Lock lugs and to carry out other activities. Subsequently the vessel picked up speed, the bow wave was raising again and the inside of the visor filled within the following hours more or less completely with water, which only left with the lifting of the visor after the casualty. Consequently the fresh footsteps originate from before arrival and after departure on 27.09.94.

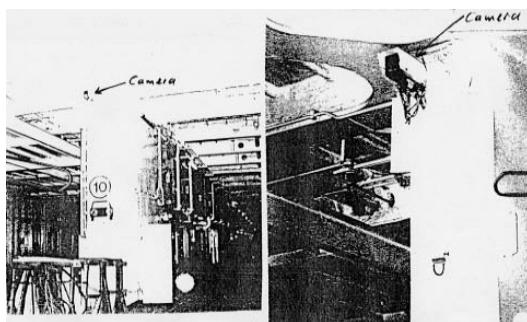
(1) the statement of the watch engineer Margus Treu that a jet of water hit the lens of the video camera transferring pictures from the partly open bow ramp to the monitor in the engine control room (ECR) where he was watching - see his statement dated 29.09.94 Turku - [Enclosure 21.2.3.263](#). Treu believed that this water jet came from the partly open bow ramp, which however is not possible because the camera is fitted at the forward part of the centre casing underneath the ceiling. The distance to the bow ramp is 25 m and the height above car deck is about 5 m - see the pictures below taken on board the near-sister DIANA II where the camera was installed as on ESTONIA.

It can thus be excluded that water penetrating the bow ramp at that relatively early stage could have reached the camera in such high position as much as the car deck between bow ramp and camera was full of trucks and cars.

It is much more likely that the camera lens was hit by a jet of water from the sprinkler installation which had been activated manually in the forward part of the car deck.

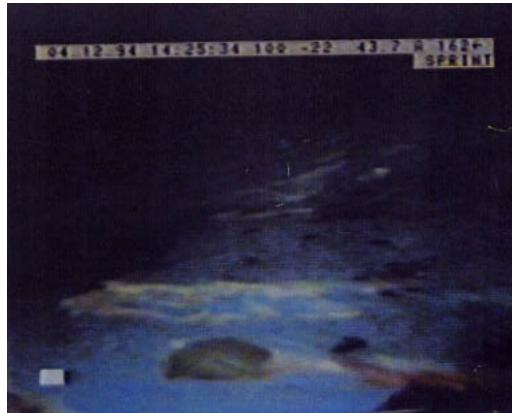
The following image shows white contact marks on the port side of the bulbous bow further aft than the previous one.

The pictures do confirm contact with some object which could have been quite strong considering the very strong construction of the bulbous bow, i.e. a weaker construction might have sustained heavy damage due to contact with the strong bulbous bow as indicated by the above paint and scoring marks.

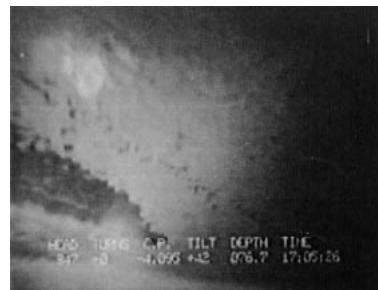
When looking at the images presented here it is difficult to assume that this vessel had been in drydock only 8 months before, because the starboard side is really in a very bad condition, actually much worse as it is possible to demonstrate by images. Very deep indentations between the frames and deep scoring marks, partly not even corroded, are the rule, however, in some particular areas the plating is even holed as e.g. can be seen from the image below.

From the damage appearance it has to be concluded that the plate was severely corroded, i.e. the hole was neither caused by an impact of ex- or implosion but by corrosion. This is easily possible if the coating and/or anode protection of a ballast water tank, e.g. a heeling tank, was not in order.

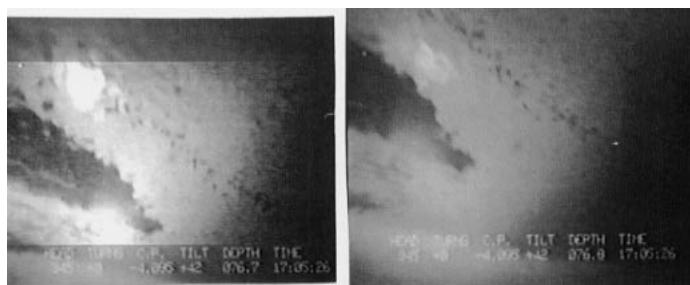
Enhancement by means of special equipment confirmed indeed that the plating is holed - See the enhancement below.

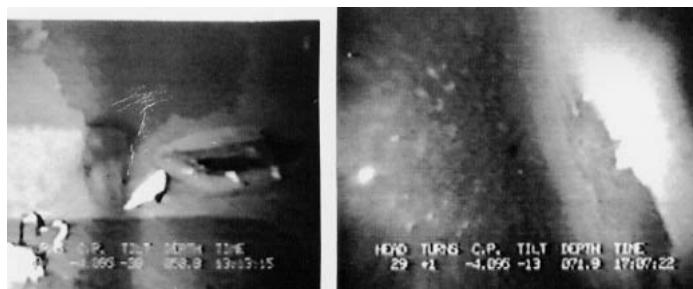
The following two images show an area which is apparently also holed, but not by corrosion because the edges are too sharp.

In any event the ferry ESTONIA departed from Tallinn on her last voyage with one or more starboard ballast water tanks, possibly even the heeling tank, open to the sea. As stated above - see Chapter 17 - revised stability calculations showed that the vessel must have had about 200 ts additional weight on the starboard side which could not be pumped. The theoretical possibilities of unconfirmed flooding of compartments through holes to the outside was discussed as the reader may remember. The possibility now turns to a fact. The vessel had holes in her underwater shell plating. The obvious effect on the seaworthiness of the ferry needs not to be discussed. The fact that the JAIC, having worked on the interpretation of those videos, does not mention anything in this regard, is undebatable too.
