1 THE CASUALTY

2 THE VESSEL "VIKING SALLY"

The German 'Group of Experts' has now - as far as possible - completed its investigation of the foundering of the M. V. ESTONIA, a disaster that has taken the greatest toll of human life in the Baltic Sea in times of peace. The German 'Group of Experts' has during the past five years performed a difficult investigation in a partly hostile and reluctant environment. The work was carried out during the first two years - 1995/1996 - in close co-operation with the Swedish leader of the Technical Group of the Joint Accident Investigation Commission of Estonia, Finland and Sweden (JAIC), Börje Stenström († February 1997), and also with the Finnish member of the Technical Group, Dr. Tuomo Karppinen and the expert Dr. Klaus Rahka. All the investigation results of this 'Group of Experts' were submitted either verbally in joint meetings with the members and the experts from Estonia, Finland and Sweden attending or in letters with attached photos and/or video film documentation to the JAIC. This documentation and information concerned the design, construction and building of M. V. ESTONIA in general and the locking devices of the bow visor in parti

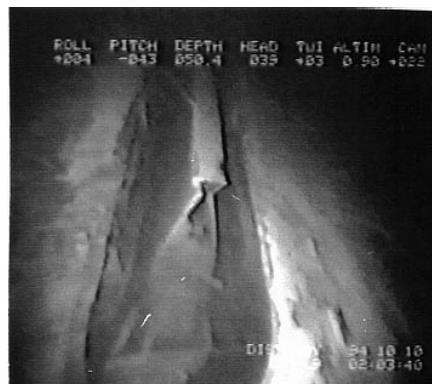
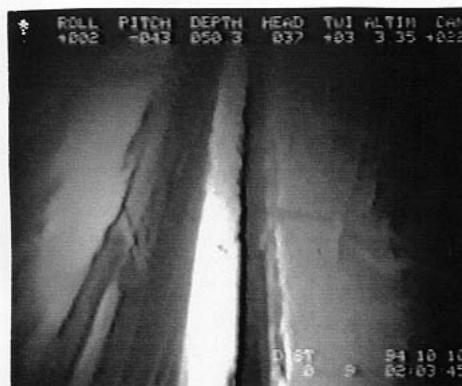
In January 1994 the ESTONIA was fitted with stabilisers of make Brown Brothers which had allegedly been in operation at the time of the casualty. According to 3rd engineer Margus Treu, the fins should retract automatically at speeds below 4 kn, therefore he does not believe that survivors could have seen the port stabiliser still out when the vessel was already almost on the side - see [Enclosure 21.3.271](#) - Protocol of Landvetter meeting on 31.03.95. In all probability Margus Treu is right because only after proper questioning of the survivors Pierre Thiger, Tony Spuhl and Mats Hillerström did it turn out that what they believed to have been the stabiliser was much too much forward to assume it could have been the stabiliser. They saw something big, partly white, partly dark, vertically bigger than transverse, which was moving in/out and/or up/down, very far forward, almost at the bow. They saw it still when the vessel was on the side already. The statement of Pierre Thiger taken on 08.10.99 is attached as Enclosure 29.6.414 and the statement of Tony Spuhl taken on 10.10.99 is attached as Enclosure 29.6.415. The statement of Mats Hillerström is not yet available. The actual stabiliser, however, is installed in a pocket behind the heeling tank on 0-dek level, i.e. about midships. When the witnesses were informed accordingly they categorically denied having seen anything moving in this area. This leads to the conclusion that the survivors had seen the visor, then still hanging on the bow ramp with the bottom attached to the forepeak deck and ice-knife of the bulbous bow. This leaves the trainee mate Einar Kukk who has stated - see [Enclosure 21.2.1.251](#) - that the stern was down to the stabiliser fin level. But he did not say that the fin was out. Therefore, it has to be assumed that the survivors actually meant the visor when they mentioned the stabiliser during the last stage before leaving the vessel. In any event the port stabiliser fin was found to be in its pocket during the ROV inspection on 09/10.10.94 - see the images below.

In summary it has to be concluded that the **port stabiliser** in all probability moved into its pocket when the speed dropped below 4 kn which had been the case already before the big heel. It has further to be concluded that the object seen by some of the survivors far forward on the port side, which was moving in/out or up/down, was most likely the visor. These observations were still being made when the vessel was already on her side, i.e. at 01.30 hours or later.

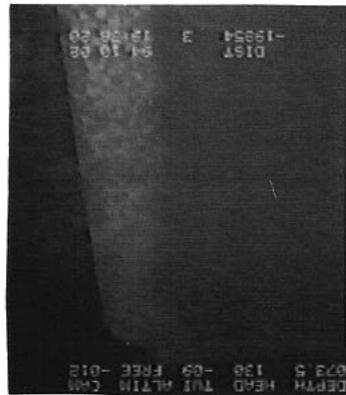
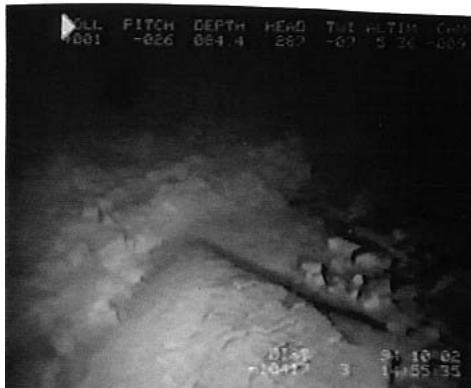
Alternatively the stabiliser fin could have broken off by the object sliding against the vessel's starboard side by which the scraping noises were caused. The noise scenario for Bengt Nilsson would have been the same. Therefore the video footage showing the ROV inspection of the sea bottom was analysed and the following two images were found which could show parts of the stabiliser fin.

As to the **starboard stabiliser** there are strong indications that it broke off or was broken off and is resting on the sea bottom now. In both cases a substantial water ingress into the engine room - at least 2 watertight compartments were affected - would have been the result for which there are also indications, because Henrik Sillaste has testified that the bilge pumps were running and Margus Treu has stated they were trying to pump water out of the ship. As it is not possible to pump water from the car deck they can only have pumped from 1st deck and 0-deck.

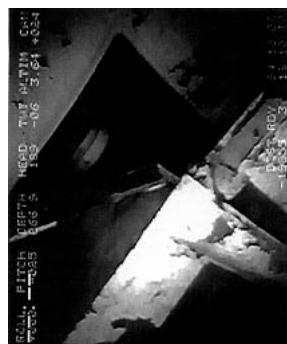
As the superstructure in way of the port side aft part of the 8th and 7th decks were found to be indented and bulged by the divers it has to be assumed that she was somewhat more heeled to port when touching the sea bottom as a result of which the above indentations were caused.

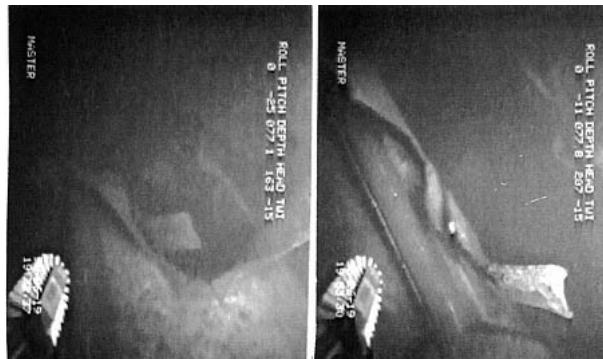
The upper void space behind the starboard front bulkhead shows considerable damage to the bulkhead plating with the plating bent from inside to outside and frequently cracked. This had obviously been possible because the upper part of the visor moved forward after the starboard hinges and side lock had failed and never contacted the front bulkhead again, because at the lower end of the blown open plating a big steel part is extending almost horizontally which otherwise would have been pressed back. The same refers to the steel tongue extending from the visor plating in way which was also not pressed against the bulkhead.

The image below on the left shows the lower part of the damaged upper front bulkhead looking from bottom to top. The image on the right shows the damage further up.

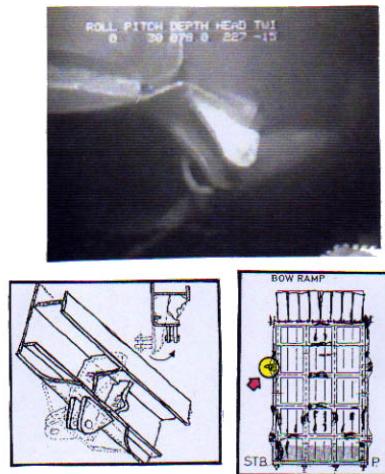
The following image shows the upper part of the same damage with the severely distorted and upwards bent mating lug for the starboard ramp hook.

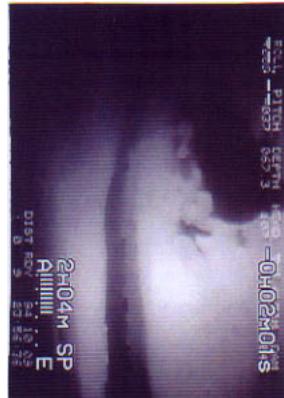
- The front bulkhead plating below the area of the hydraulic side lock was pushed outwards with exception of the rubber packing - see image below. It is clearly visible that the rubber packings, normally extending beyond the bulkhead, are in some sort of fold indicating that the surrounding plating was deformed towards the outside.

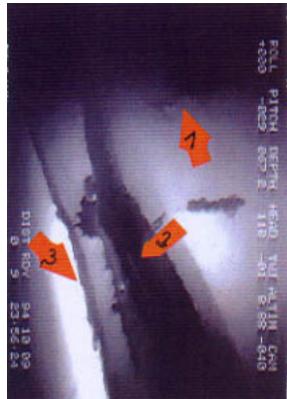
- The next image shows the area further down the bulkhead. Arrow 1 points to the lower edge of the opening for the hook, arrow 2 to the rubber packing and arrow 3 to the deep, sharp fold to starboard of the rubber packing, which extends from forepeak deck level up to the side becoming narrower the further up it runs. It is obvious that the surrounding bulkhead plating was deformed towards the outside of both sides of this fold and also between the rubber packing and the inner bulkhead edge.

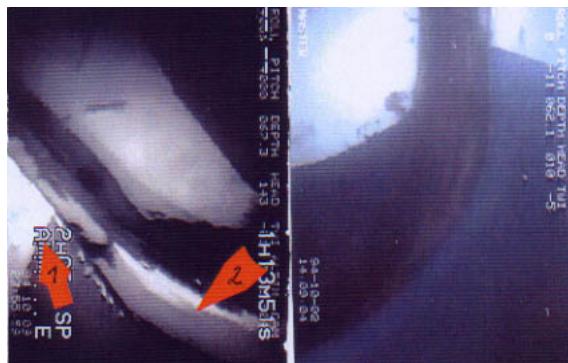
- Further down the front bulkhead in the so-called "corner of the mouth", the area to the outside of the rubber packing is cracked open over some 300 mm - see left image below. The bottom part of the front bulkhead is severely deformed and apparently cracked off the forepeak deck as well as cracked off the inner bulkhead plating and probably also off the outer shell plating as can be seen from the left image below.

arrow 1 = change over from blue to white paint. On the image below the arrow points to the respective area on the opposite port side.
arrow 2 = points to the torn off and dislocated lower parts of the front bulkhead. The right image shows the corresponding intact port side.

Note: As the visor was resting against this area when a possible explosion occurred, the bulkhead could not burst open to forward and the pressure obviously escaped downwards and to the sides. Thereby the complete lower part of the front bulkhead was torn off the recess on the inside, off the shell plating on the outside, and off the forepeak deck on the lower side. Actually the area indicated by arrow 2 should be blue as can be seen from the image beside it showing the respective port side.

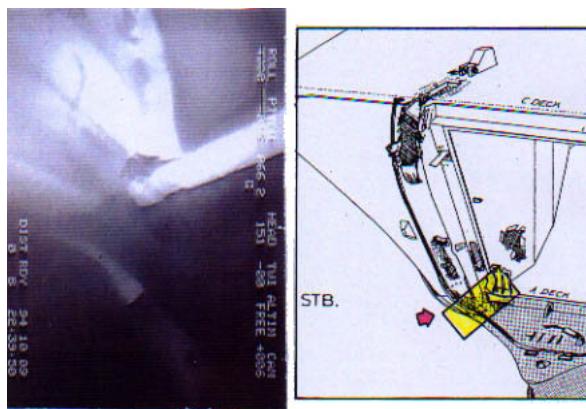
- Next to the cracked open inner bulkhead plating, the lower section of the starboard outer vertical girder of the bow ramp - being immediately next to the cracked plating when the ramp is closed. It is noted to be cracked off both from the upper and the lower transverse girder as well as from the bow ramp plating and extremely deformed and pushed to port. - See the image below with the explanatory drawing and also the extensive photo documentation in Subchapter 29.2.

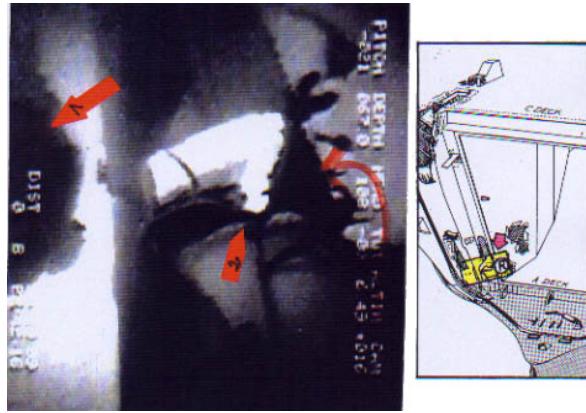
- Slightly further up, the landing of the fastening of the starboard bow ramp actuator was noted to have been cracked open, severely deformed, with the fastenings of the actuator missing and the actuator broken twice. See the following image.

Arrow 1 points to the enlarged opening in the front bulkhead for the manual hook and arrow 2 points to the burst open landing to which the starboard bow ramp actuator had been attached.

Due to the extent of this damage it has to be assumed that additional areas were affected, e.g. the bottom part of this and the adjacent void spaces, and the bulkhead towards the car deck. The appearance of the corresponding parts of the starboard lower aft bulkhead of the visor do confirm that the damage existing in way of the lower starboard front bulkhead of the vessel and the adjacent area was most probably caused by the same occurrence, viz.:

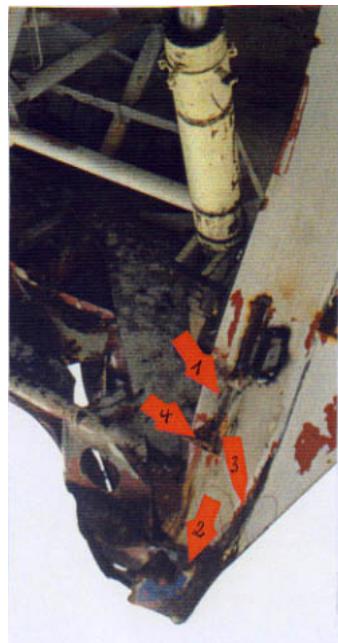
- the area between the lug and the hook shows intense smoke marks and had obviously been exposed to heat (arrow 1).
- the bulkhead plating at the change-over from white to blue and deeper is cracked at least twice with the plating severely distorted and plating parts torn out (which excludes pounding) - (arrow 2).
- a deep fold in way of the contact area with the flatbars housing the rubber packing of the vessel runs up the aft bulkhead from visor bottom to the hooks (arrow 3).
- the way the two hooks were crushed together (arrow 4).

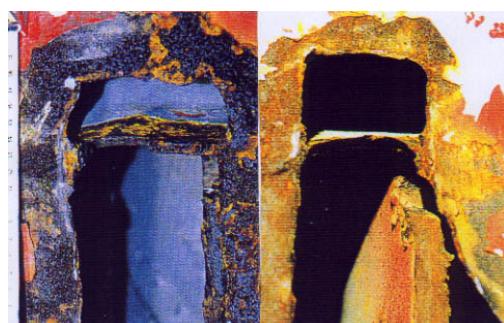
The two pictures below were taken from page 168 of the JAIC Report. The left picture shows the port aft bulkhead of the visor and the right one the starboard one, both in way of the initial location of the lugs for the hydraulic side locks. See also Chapter 30.

It is most likely that the starboard side had been exposed to considerable heat which is indicated by the corroded surface as a result of the changed metal structure. It is also most likely that the starboard side had been exposed to pressure from inside to outside which is indicated by the distortions and the cracked off stiffener, indicating a possible explosion in way. - See also Subchapter 37.7.

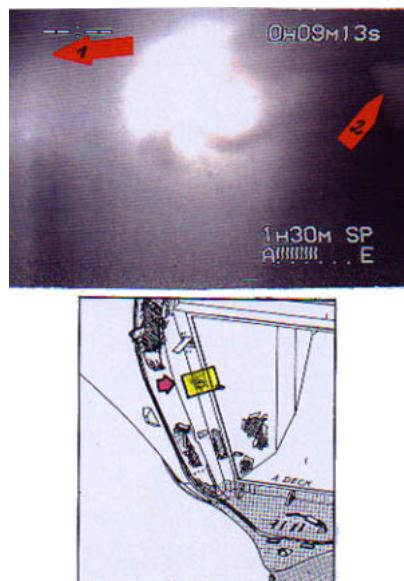
The image on below shows the area of the recess bulkhead between the lug for the preventer wire and the upper mating box. Arrow 1 points to the rubber packing of the bow ramp and arrow 2 points to the edge of the bow ramp. Between the arrows a metal flap is visible which is apparently part of the recess. Transferred to the front bulkhead around the corner this is the area of the big damage above the lug of the hydraulic lock. See also the above drawing.

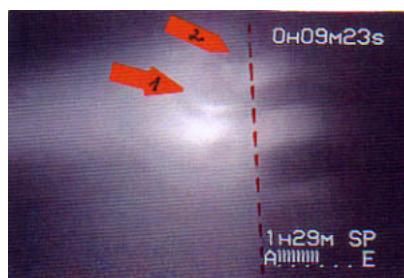
The next image shows the black/yellow painted tire-protection bar edge of the bow ramp to the right with the remains, i.e. the inner part of the fastening, for the starboard ramp actuator - see arrow 1.

It is further visible that the edge of the ramp is bent up - arrow 2 - above the line of the recess bulkhead - see red dotted line.

This is the area where the broken piston rod of the actuator was seen from the outside to be jammed in between the ramp and the recess.

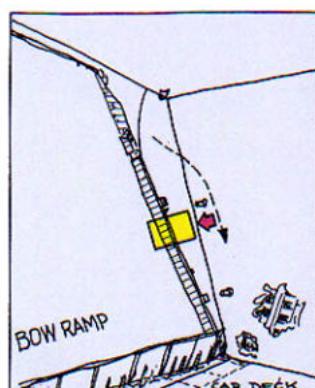
The next image shows the crushed lower mating box which was ignored by the diver. See arrow. This is most probably old damage, see Subchapter 29.2.

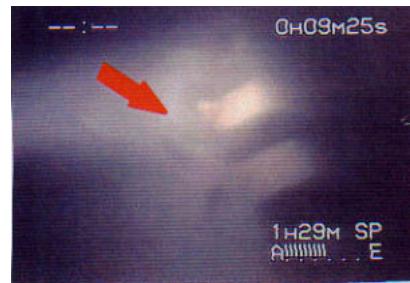
From about this position the diver looks to his left to the bulkhead of the void space with cracked open plating and pallets/other debris dropping out of the opening.

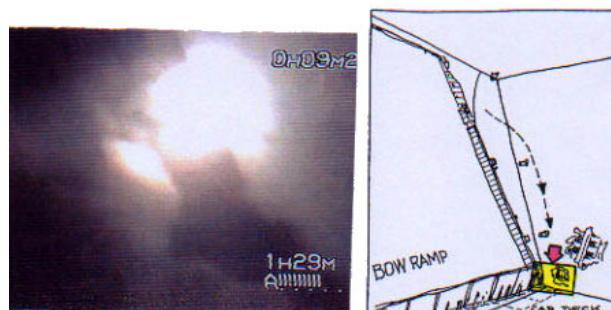
The diver looks directly into the big hole in the bulkhead and more debris becomes visible - see image below.

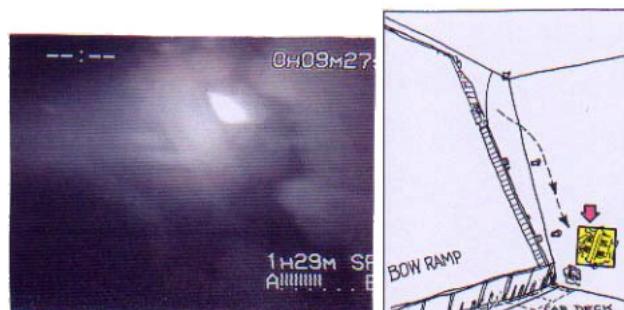
The diver looks down towards the lower flaps of the bow ramp and sees the first one on starboard side in raised condition - arrow 1 - and next to the flap he sees another hole in the bulkhead - see arrow 2.

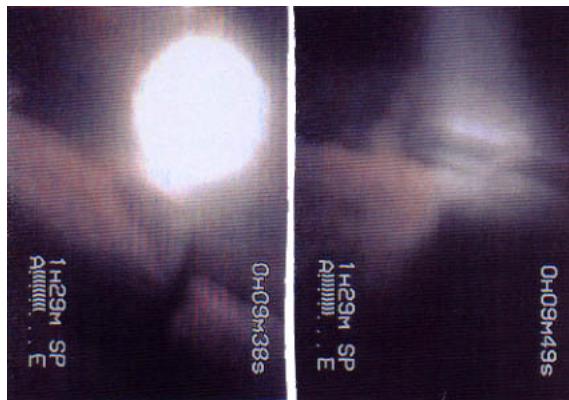
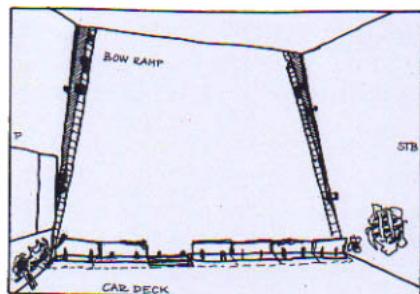
The eight flaps of the bow ramp covering the gap between the car deck and the open ramp were found to be in different condition: some were well painted, green and intact, while others - in the middle - were brownish/red and partly damaged. See the two images below.

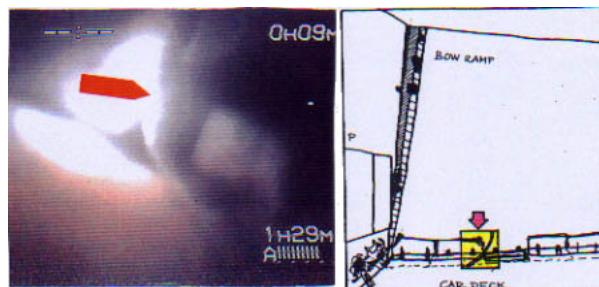
The next image shows the second flap from port upright and the third one from port down and in between some rope or wire - see arrow.

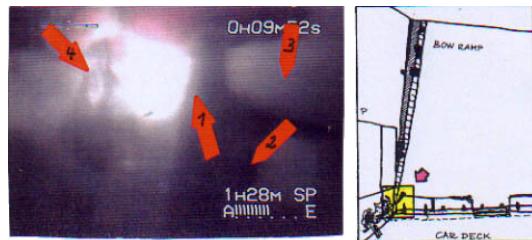
The next image shows the first flap on the port side of the ramp - arrow 1, the lowest point of the raised black/yellow ramp edge - arrow 2, the vertical bulkhead into which the control panel was installed - arrow 3, and the damage area commencing in way of the car deck plating - arrow 4 - and extending into the vertical bulkhead below the control panel. This will be explained in the following item (3) - The Void Space Behind the Port Front Bulkhead.

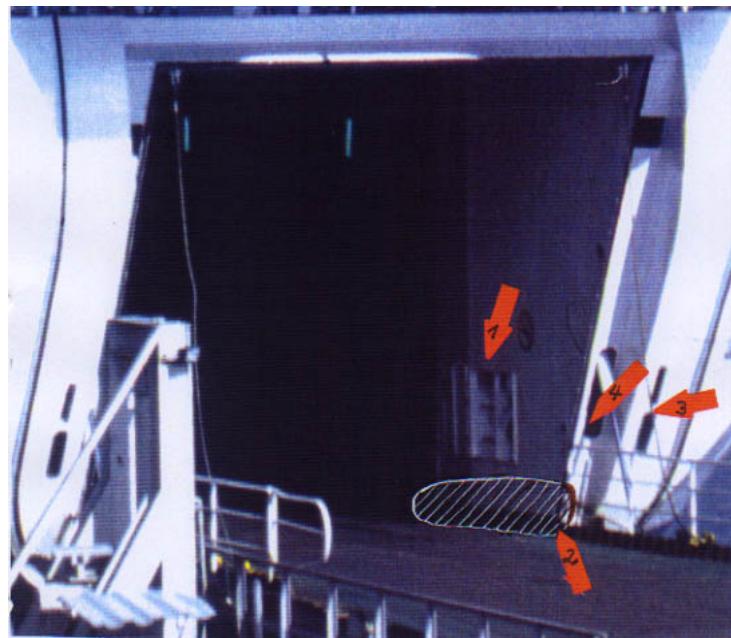
arrow 1 = control panel

arrow 2 = bottom end of raised black/yellow ramp edge and first flap from port side

arrow 4 = opening for ramp actuator - the arrow points to the position of the actual fastening when the ramp was in closed condition.

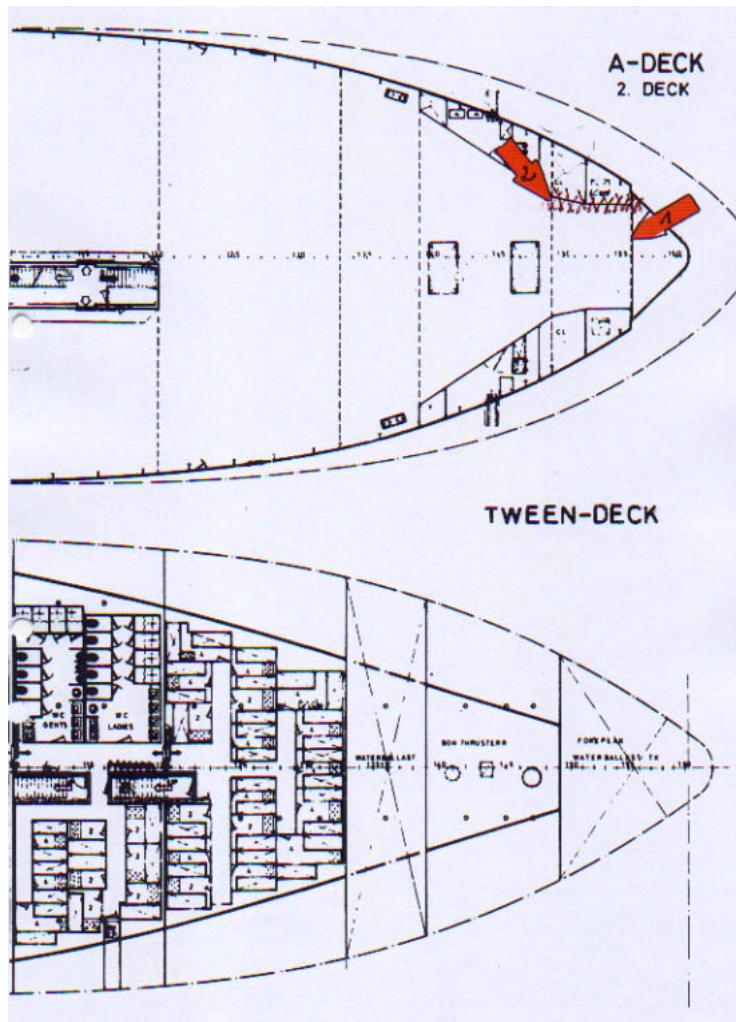
The drawing below is a part of the general arrangement plan of the vessel which shows the forward part of A-deck = car deck and the area directly below on tween deck = 1st deck. The red hatched area shows the damage area which can be seen on the images explained on the previous pages. The distance from the bow ramp - arrow 1 - to the corner of the bulkhead - arrow 2 - is about 4 m. Below the dotted line the bow thruster space begins, before that space the full forepeak was located.

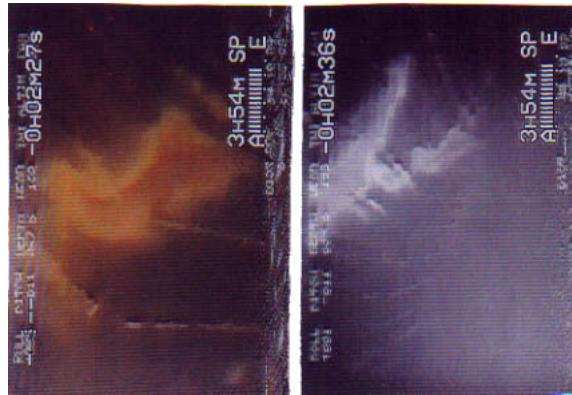
The respective inside of the bow ramp shows severe deformation and a burnt area in way. See the images below.

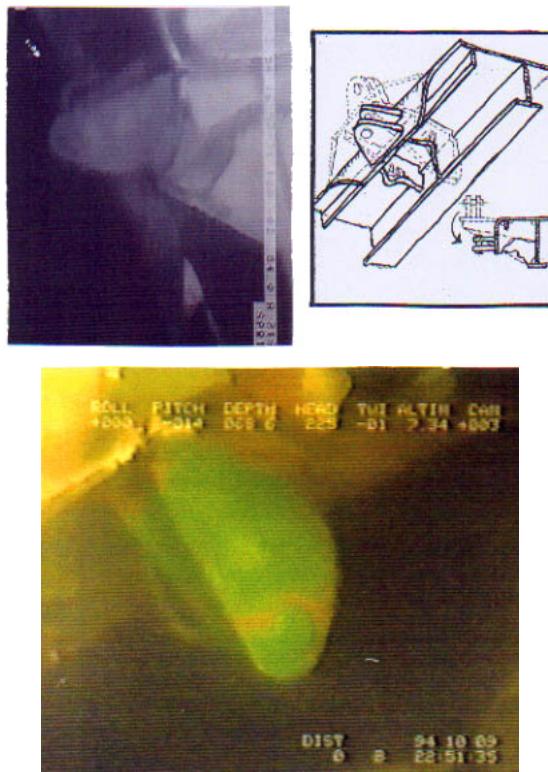
- The pushed up landing of the mating lug for the starboard ramp hook. See images below and on page 1106.

The landing with the apparently unaffected lug was pushed to starboard and upwards which has now also been verified by the expert Brian Braidwood and the results are confirmed in his "Supplementary Report" - see Subchapter 34.7.1. - [Enclosure 34.7.1.435.1](#). In summary of the before explained items (1) to (4) it has to be assumed that the damages shown on the drawing behind the next page had been caused by explosion.

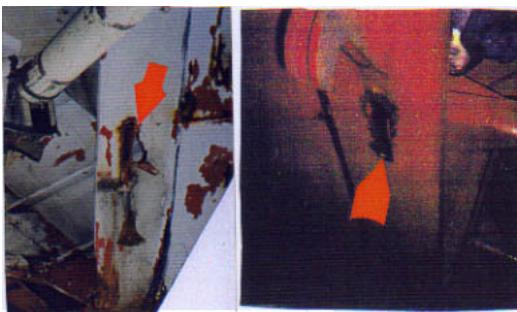
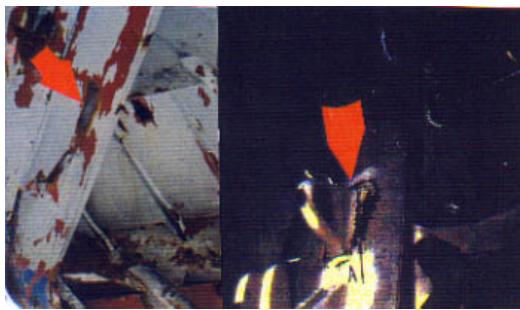
- A comparison of the damage to the side lock lugs of DIANA II / ESTONIA is shown below.

According to the ship's command the torn off starboard lug was lost. This is possible as first the lug hangs on the bolt of the hydraulic locking device and after opening the same it falls into the water. As noticed from the letter of the B.V. lawyer Johnsson, the repairs had already been commenced when the B.V. surveyor boarded the vessel. Thus practically neither the class nor the safety board ever saw the damage in its original condition.

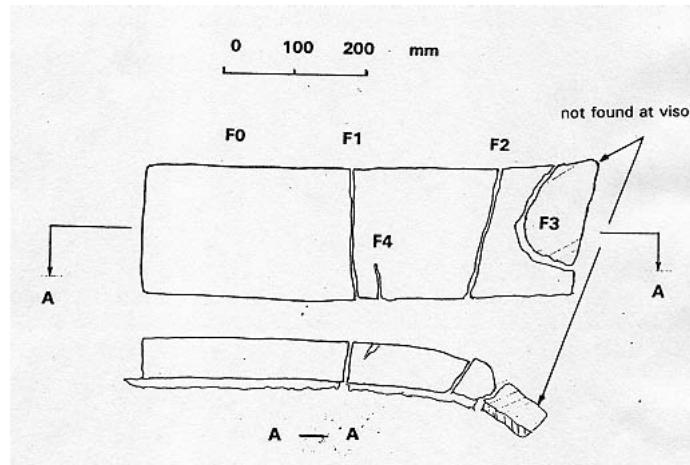
The investigation of fracture F1 - F4 ascertained that all the transverse fracture had started and penetrated from the outside by corrosion assisted fatigue cracking. In addition, fractures F2 and F3 reveal major bending displacements of their flanks, in particular fracture F3 reveals a specific bending angle of about 70° combined with severe bending deformation following the original crack development.

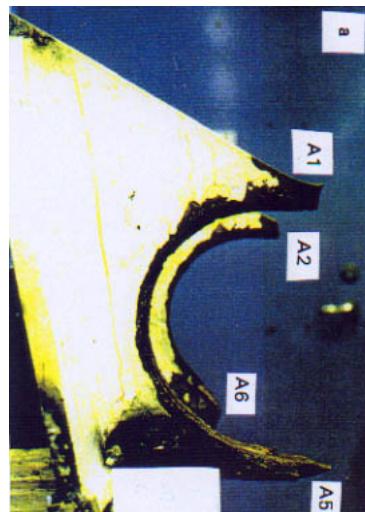
The following picture shows the broken port visor lug plates with the fractures A1, A2, A5 and A6.

The outer port side shows a vertical to slightly horizontal bending to port side at the fracture at the lower part of the remaining bore. The inner port side lug and both starboard lugs - see picture below - did not exhibit significant bending deformations. The picture below shows the broken starboard visor lug plates with fractures A3, A4, A7, A8:

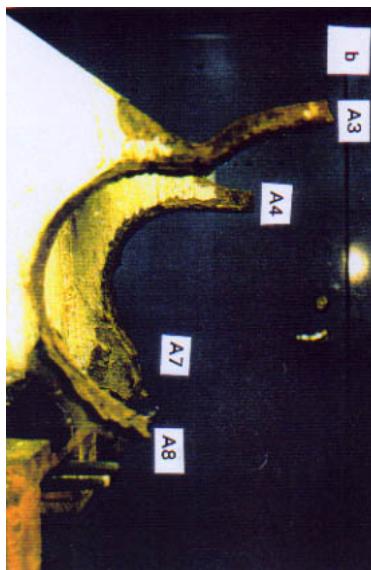
The failure of the visor hinges occurred by fractures A1-A8 of the visor lug plates together with the fillet welds to the support bushings. The bolts had been ripped out of the hinges, together with the bushings.

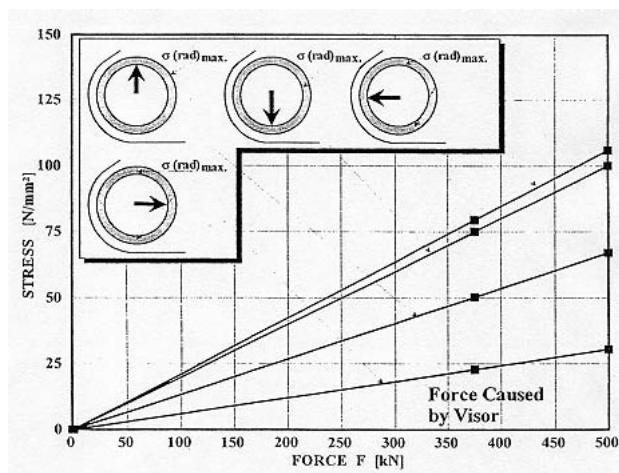
For example, the normal visor opening procedure created a vertical down force of maximum 375 kN on each hinge lug based on nominal visor weight and respective leverages and resulted in maximum radial stress in the fillet weld found at the location as marked by the circle in the drawing below together with the stress distribution in radial direction. Accordingly the opening procedure would thus create a local radial weld joint stress of 75 N/mm².

It is thus obvious that, during opening of the visor, the location of maximum radial fillet weld stress is found in the same region where fatigue cracking of those fillet welds initiated. However, also the other assumed directions of loads on the visor hinges would provide maximum radial stress locations. In particular, a similar stress range as for the opening procedure would result from an assumed afterwards force on the hinges. Such an afterwards load could have created the conditions for crack initiation and failure of the hinge plates, following the failure of the fillet.

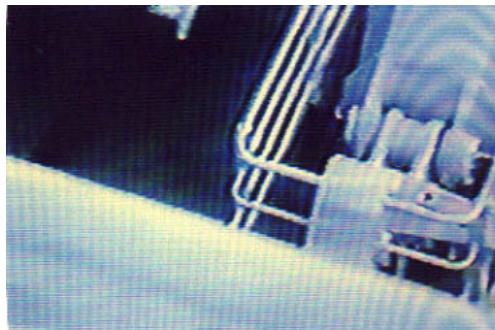
On the evening of 17.09.94, i.e. 10 days before ESTONIA's last departure from Tallinn, a Swedish passenger was standing on the forward open part of deck 7 and filmed the closing of the visor, the handling of the mooring lines by the deck crew and, finally, he zoomed in on the starboard visor hinges. The first copy of the original film was made available to this 'Group of Experts' and a first internal analysis revealed that the starboard visor hinge was in an absolutely disastrous condition as can be seen on the image below.

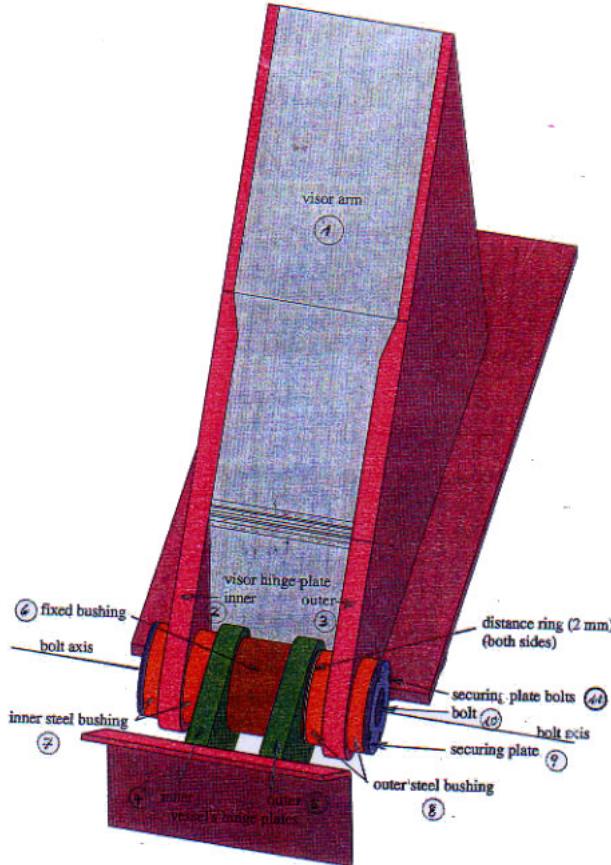
For explanation purposes a computer drawing of the hinge arrangement was made and the figures 1 - 12 point to the relevant components as outlined below:

- 1 Visor Arm
- 2 Inner Visor Hinge Plate
- 3 Outer Visor Hinge Plate
- 4 Inner Vessel Hinge Plate
- 5 Outer Vessel Hinge Plate
- 6 Fixed Bushing
- 7 Inner Steel Bushing
- 8 Outer Steel Bushing
- 9 Securing Plates (both sides)
- 10 Visor Arm Bolt and Bolt Axis
- 11 Securing Plate and 4 bolts (both sides)
- 12 Distance Ring (both sides)

The object of the report was to detect and identify any structural rupture or damage which could have contributed to the loss of the Ro-Ro ferry ESTONIA. For identification of components bracketed numbers, for example (5) in the text refer to annotations on the drawings, on the previous page. A detailed examination of the video tape showed the only damage to be identified limited to the starboard visor hinge.

This Report is based on Video Tape Images showing disruption to the structure of the Ferry "Estonia", especially in the area of the Starboard Hinge Plates (2) and (3), and on the Bolt Axis (10). This damage is very significant, especially so when the components involved form part of a load bearing assembly liable to operate in heavy sea conditions.

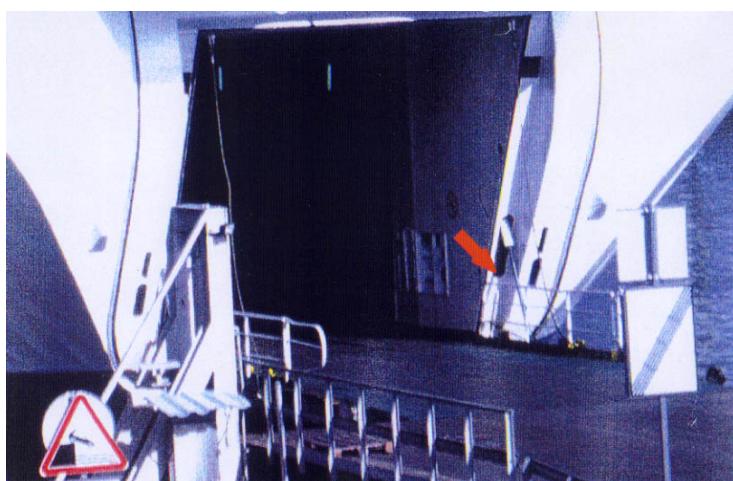
The picture following this demonstrates the conditions that the Swedish inspectors and their trainees found on the open bow ramp. The arrow points to the location where at that time an angle iron was fitted.

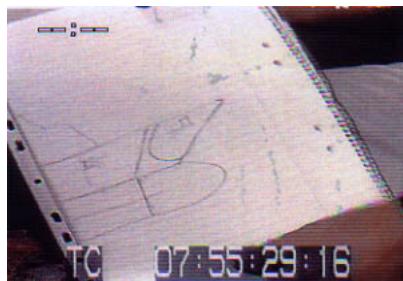
The picture behind this page shows the car deck opening with the open bow ramp. The arrow points to the position from where Sjöblom/Zahlée looked over the rail of the bow ramp. It is quite obvious that they could not see much of the rubber packing.

Ake Sjöblom made the following drawing and points to the area which is indicated by the arrow meaning both port and starboard side.

It should be noted that Åke Sjöblom has placed the bow ramp, which is the upper extension of the collision bulkhead on top of the collision bulkhead which was not the case on ESTONIA and also not on DIANA II, the near-sister, for which he had then been responsible for about 2 years already with his Malmö inspection office of Sjöfartsverket as the National Maritime Administration.

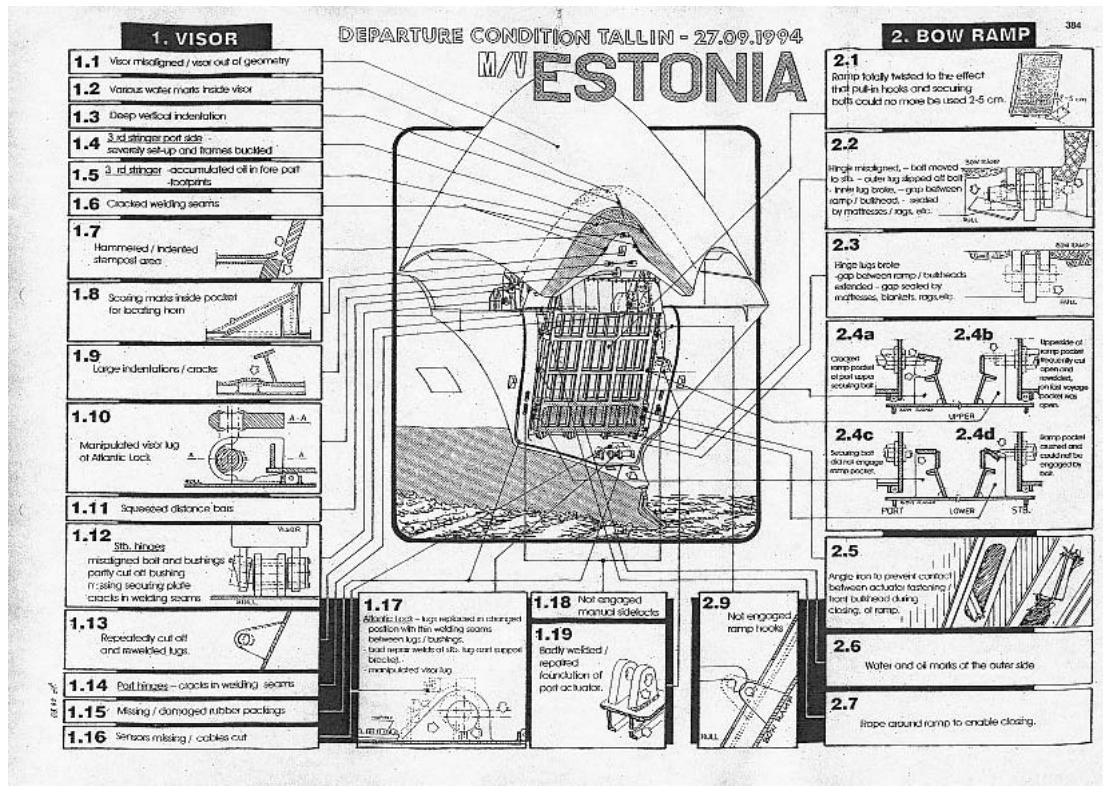
In addition, these deficiencies are shown on a drawing of the foreship with open visor which is integrated into this report and forms the following page.

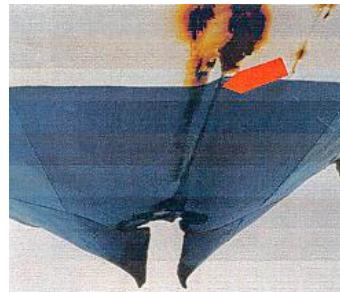
The shell plating as well as the internals are very severely damaged in two places, viz. there is a deep vertical indentation in the bow leading upwards from the stempost for about 2 m, as can be seen on the picture below from the outside,

The arrow points to the deep indentation which is completely painted and the paint does not show contact marks. The following photos showing the inside of the same area do confirm the deep indentation in a very strong part of the visor to be of old origin.

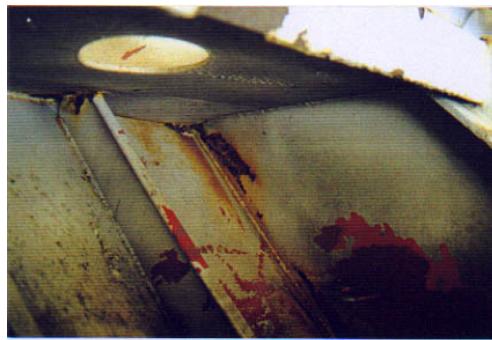
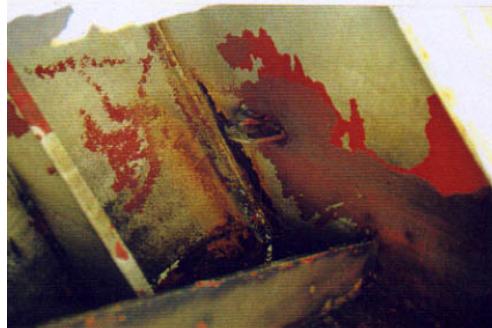
Furthermore, the shell plating as well as the 3rd stringer at the port side are severely indented and set up with the frames buckled which had been sustained already some time before the casualty. - See the pictures above.

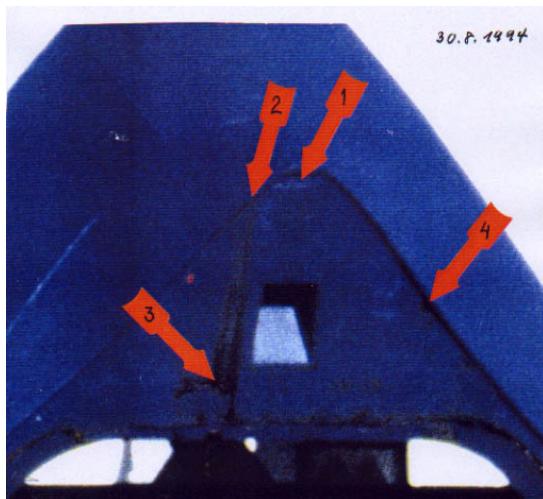
The condition of the visor bottom with stempost is evident from the picture below taken on 30.08.94.

Arrow 1 - Indentation in the foremost part of the visor bottom indicating that the visor's initial position was changed to forward most probably due to misalignment of the whole structure. This led to contact between the visor bottom and the stempost on the forepeak deck. Since the visor bottom in this area is not constructed to take up load, the bottom became indented and cracked.

Arrow 2 - Indicates a cracked welding seam through which water penetrated and created the rust stripes.

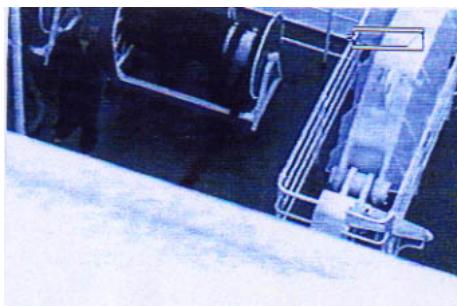
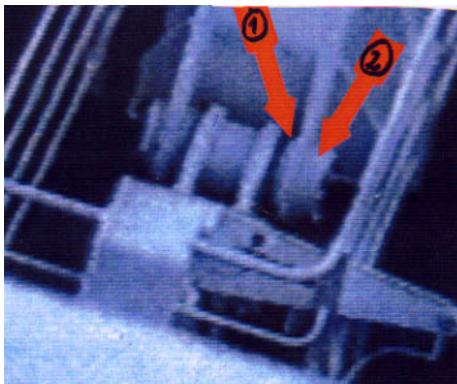
Obviously also the visor hinges had become affected because on 17 September 1994, i.e. 10 days before the last departure, a passenger filmed the visor and, in particular, the starboard visor hinges in Tallinn during the closing procedure.

The passenger was standing in front of deck 7 and filmed the closing of the visor, finally zooming in on the starboard hinges. The video-prints below are part of the film. Picture 2 is an enlargement of Picture 1.

On Picture 2 there are obviously several major deficiencies visible, viz.

(a) the gap between the starboard vessel hinge plate and the outer bushing is much too large (arrow 1).

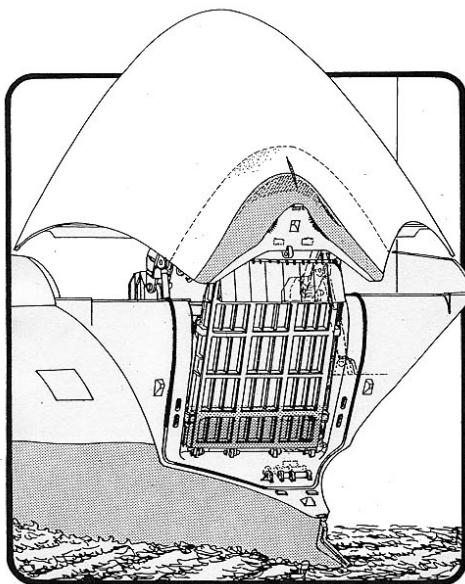
The last Finnish crew had requested the renewal of 15 m of rubber packing in way of the visor for the then planned yard time in January 1993, because the rubber packing had last been renewed in January 1991. This meant a renewal of the entire packing on the forepeak deck plus about 2 m up each front bulkhead as demonstrated by the following drawing.

Since the new technical managers N&T were of the opinion that visors are full of water at sea anyway, the rubber packings were not renewed in January 1993 and also not later. This means that the visor became quickly filled up with water at sea up to the height of the outside water level. In calm sea it was the height of the bow wave which filled the visor up to the 3rd stringer, however, the worse the weather was and the deeper the bow was diving into the waves, the higher the water rose inside the visor.

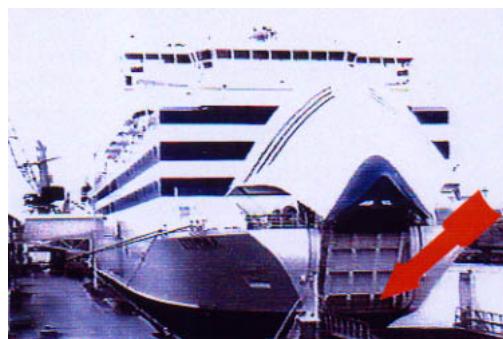
The following picture shows the ESTONIA in Tallinn, with open visor but closed bow ramp so that the otherwise invisible underside of the bow ramp is shown with the lowest section being dark - see arrow. Doubtless this was caused by the water inside the visor with hydraulic oil from the leaking cylinders swimming on top of the water surface. When the vessel reduced speed and the bow wave became smaller and finally disappeared completely when the vessel was alongside, the water streamed out of the visor and the oil settled everywhere inside the visor, also on the bow ramp which forms the aft inside of the visor. The water streaming out of the visor was observed by many passengers when the vessel was alongside in Stockholm with closed visor and, among others, also by the skipper of the Sandhamn pilot boat as well as by several pilots when the ferry was slowing down during the approach to the pilot boat.

It is obvious that at sea inside the visor the conditions in a partly filled ballast water tank did exist with resultant sloshing effects causing additional loads on hinges and locking devices and vibrations to the whole visor, the consequences of which are described in Subchapter 34.3.

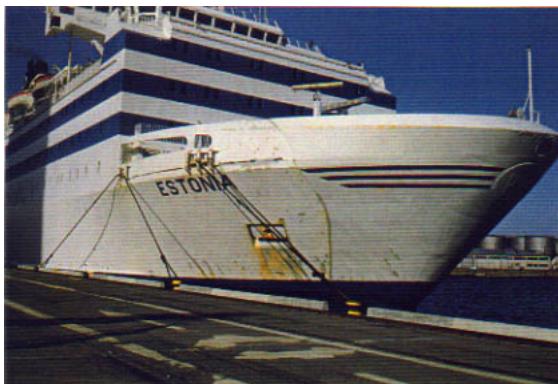
The crew had severe problems to lift up the ramp at all which was only possible after some temporary measurements had been carried out. Ever since, the misalignment of the ramp increased visibly and the problems were growing daily.

Also the rubber packings around the car deck opening, which should be sealed tight by a properly closed and locked bow ramp, apparently did no more seal watertight since some considerable time already, because the last Finnish crew had ordered 10 m of rubber packing to be renewed at the next yard time which was planned for January 1993 - see Subchapter 3.4. - as mentioned before. This was more than half of the total length of the rubber packings, but also these packings were never renewed.

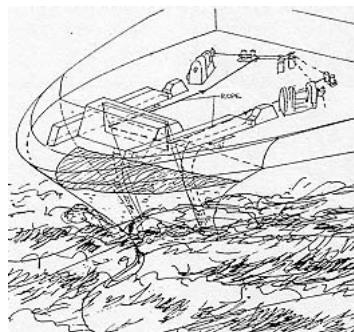
Consequently it has not been possible for the crew to secure the bow ramp at all by its four securing bolts. The same refers to the port ramp hook which could not engage its mating lug at the ramp, due to the misalignment of the port ramp side as it was demonstrated already by the distance of ca. 100 mm between the mating pockets and bolts. The obvious fact that the port ramp hook had never engaged its mating lug is further confirmed by the intact hook and the intact, unbroken lug. Both hook and lug are visible among other things on the diver video B40a. - See also Subchapter 34.6.

The starboard ramp hook, however, is nowhere visible and the location where it should be, is empty. It has thus to be assumed that also this hook had not engaged its mating lug at the ramp, which means that the ramp had just been closed by the actuators - as stated before - to an remaining opening of 4-5 cm. Due to several mooring ropes and two wires found in way of the ramp and respective indications on the ramp - see Chapter 29.2 - it has to be assumed that the crew tried to close the ramp completely by means of mooring ropes and/or wires probably pulled tight by means of the mooring winches on the forecastle deck.

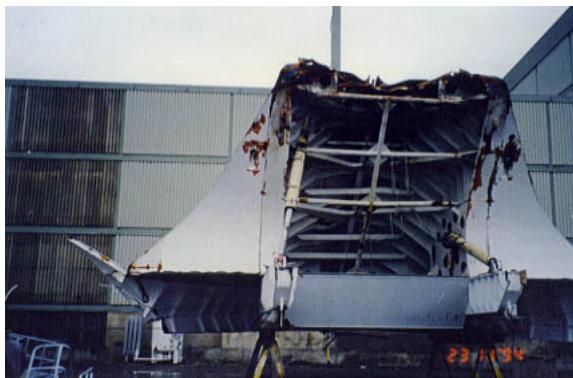
During the time from 16-18 November 1994 the visor was lifted by the Finnish multi-purpose ice breaker NORDICA - assisted by the Swedish mine hunter FURUSUND - and brought to Hangö - see Enclosure 24.408.1 - where it was lifted ashore and placed on the premises of Levator Oy, still in upside down condition. It was left in the open air, totally unprotected, but still in remarkably good condition until 20.11.99. On this day the visor was picked-up by the Swedish navy and transported to Sweden.

The picture below was taken on 23.11.94.

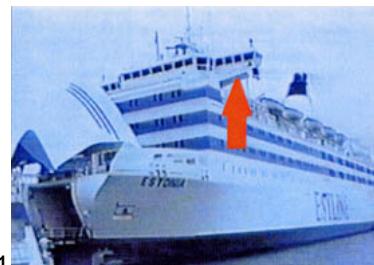
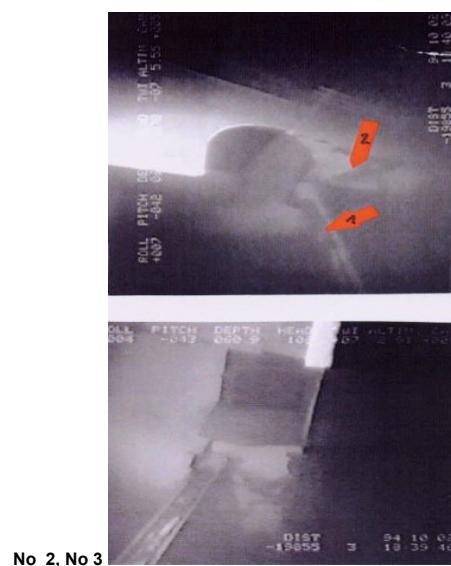
as to (1): The torn and broken open underside of the port bridge wing.

The area in question and the extent of this unusual damage at an unusual location shall be illustrated by a number video images. The first ones were made from footage produced already on 02.10.94, i.e. 4 days after the casualty, and the last ones at the diving investigation between 01-04.12.94. The arrow on the picture below points to the area in question.

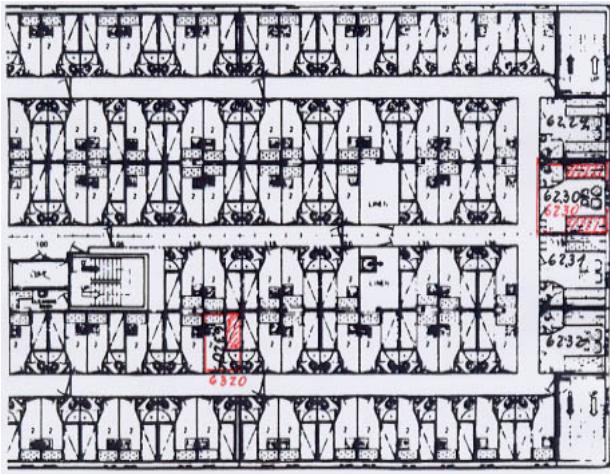
According to video B40a and the video tape log page - attached as [Enclosure 27.411](#) - the diver entered the forward part of deck 6 and tried to enter cabin 6132, which had been occupied by a member of the Stockholm Police ST-Section, but failed, then tried the next cabin 6135 but failed again and then 6134 also without success. The diver returned to the outside for tools and moved in again, broke open cabin 6132 - found a suitcase without name tag and left it behind. He then worked his way to cabin 6230 which was the 2nd cabin from port side of the four luxury cabins in the fore part of deck 6 overlooking the foreship. According to the statement of purser Andres Vihmar of 15.05.96 - see [Enclosure 14.195](#) - this cabin had been assigned to the master of the second crew, Captain Avo Piht. In the alleyway in front of this cabin the diver found a body. The diver, obviously receiving instructions through his second earphone not audible on the available video, broke up the door and headed straight for a suitcase, which was open but - according to the diver - apparently nothing was missing (how could he know?) and the suitcase had a label with the name Alexander Vorodin. The diver carried the suitcase out of the accommodation and it was apparently hoisted up to the diving platform. The diver subsequently broke open or tried to break open the cabins in the vicinity of cabin 6230, all of which had been occupied by members of the ST-Section of the Stockholm Police. The owner of the suitcase, Alexander Vorodin, had been on board together with his uncle and nephew, and all three survived. According to the first and only statement of Alexander Vorodin and to the 2nd statement of his uncle, Vasili Krjutjikov, they had been in cabin 6320. In his 1st statement Vasili Krjutjikov testified, however, that they had been in cabin 6230 - [Enclosure 14.196](#) - which was indirectly confirmed by his young nephew Vassili Vorodin - see his statement [Enclosure 21.3.4.341](#) - who testified that he had been thrown out of his bed to the floor by the big heel and thereafter they had looked out of the window and seen the vessel heeling heavily to starboard. As can be seen from the drawing below showing the forepart of deck 6 - cabin 6320 is an inner cabin without windows and with only 2 beds (1 upper/1 lower) which are arranged athwartships, thus no one would be thrown out these beds if the vessel suddenly heeled to starboard. Cabin 6230, however, has 2 upper and 2 lower beds which are arranged in longitudinal direction, i.e. if the vessel suddenly heeled to starboard somebody in the port side beds could be thrown to the floor as it happened to Vassili Vorodin. Furthermore this cabin has two windows overlooking the foreship.

Consequently the Vorodins had been in cabin 6230 which is also confirmed by the presence of the suitcase of Alexander Vorodin in this cabin. The question is why did Andres Vihmar testify to the police that it was the cabin of Captain Avo Piht where the suitcase of Alexander Vorodin was found, who had the reputation of being a weapons smuggler, and was therefore so interesting to the criminal police of Stockholm. A transcript with the voice communication during the above explained examinations is attached as Enclosure 27.412.

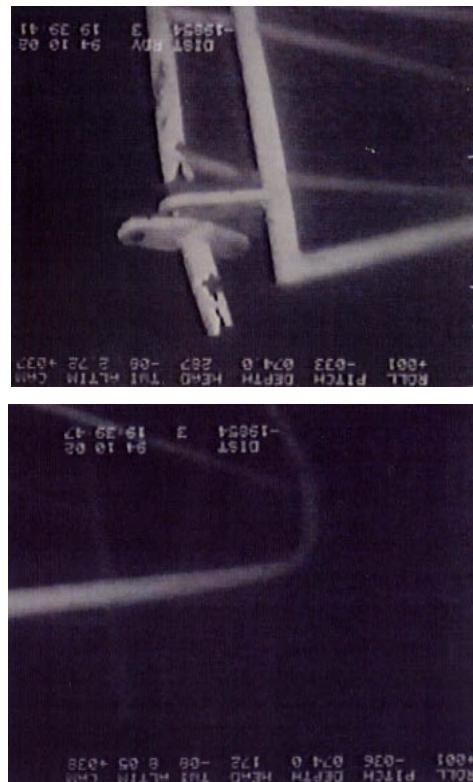
Upon evaluation of the video tapes by Disengage parts of the bow ramp rails were identified on the sea bottom and the images shown below and overleaf were produced.

The two images above made by ROV on 2.10.94 already clearly and without doubt prove that it is the forward section with movable part of the starboard bow ramp rail which is resting on the bottom of the sea.

A reconstruction of the ROV track commencing at the stern of the wreck revealed that these rail parts are located about 250 m to the south of the stern and about 80 m to the south-east of an area where the video was cut three times, each time for about 1 minute.

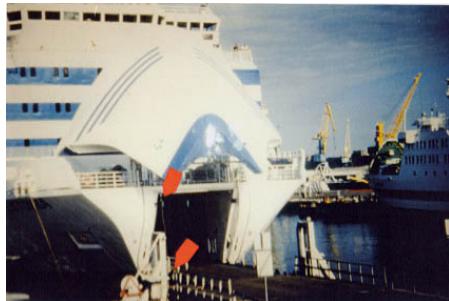
The arrows on the picture above point to the shackles by which the starboard preventer wire is connected to vessel and bow ramp. The system on the port side is identical.

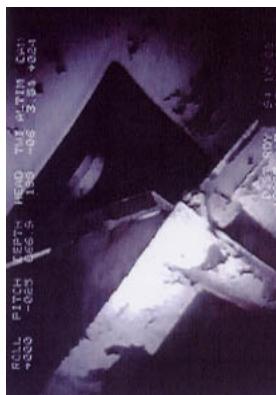
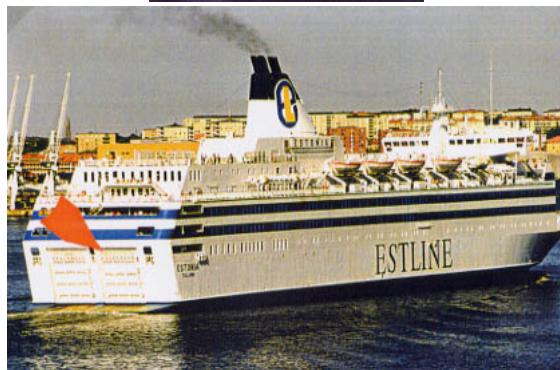
The image below shows the inside of the upper starboard stern ramp to be partly open. It was taken from the ROV video dated 09.10.94. The arrow on the picture further down points to the area in question. This fact will be explained in detail in Subchapter 29.7.

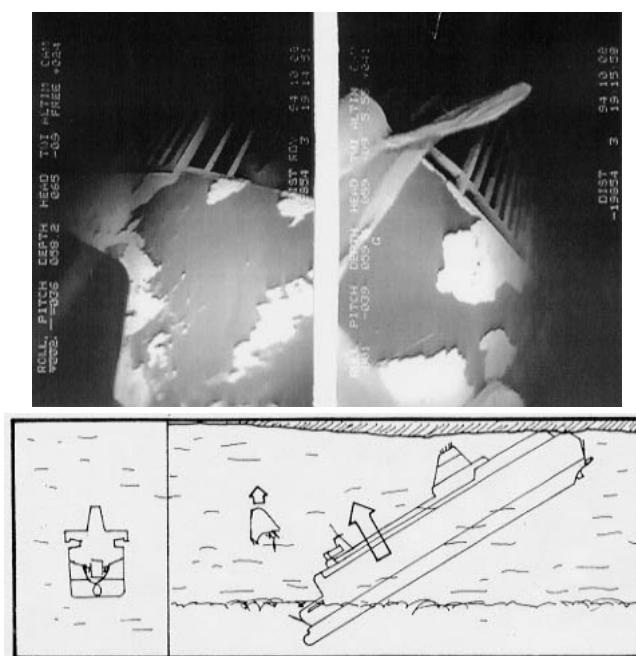
Note: This door could only be opened by crew members. The aft parts of the superstructures in way of decks 7 and 8 on the port side were found to be partly distorted and buckled. Large flakes of paint were scored off the aft parts of decks 5 and 6 - see the two images below - which was most probably caused when the vessel was in upside down condition with the stern already aground and the bow still above the water. - See the drawing below.
