1 THE CASUALTY

2 THE VESSEL "VIKING SALLY"

The German 'Group of Experts' has now - as far as possible - completed its investigation of the foundering of the M. V. ESTONIA, a disaster that has taken the greatest toll of human life in the Baltic Sea in times of peace. The German 'Group of Experts' has during the past five years performed a difficult investigation in a partly hostile and reluctant environment. The work was carried out during the first two years - 1995/1996 - in close co-operation with the Swedish leader of the Technical Group of the Joint Accident Investigation Commission of Estonia, Finland and Sweden (JAIC), Börje Stenström († February 1997), and also with the Finnish member of the Technical Group, Dr. Tuomo Karppinen and the expert Dr. Klaus Rahka. All the investigation results of this 'Group of Experts' were submitted either verbally in joint meetings with the members and the experts from Estonia, Finland and Sweden attending or in letters with attached photos and/or video film documentation to the JAIC. This documentation and information concerned the design, construction and building of M. V. ESTONIA in general and the locking devices of the bow visor in parti

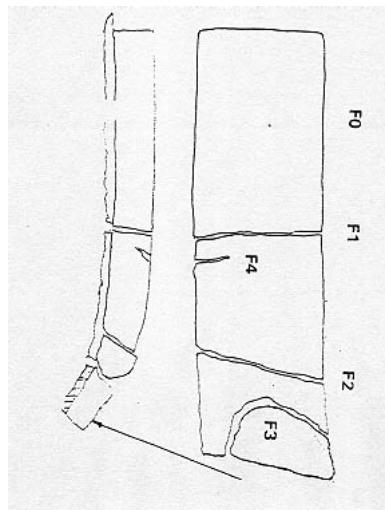
5 - shows the collapsed stempost area. The stempost was found to have cracked four times - see drawing 6 - apparently by fatigue, of which the lower crack penetrated completely some time before the casualty and the lower part, F 3 on the drawing, had disappeared leaving a gap in the stempost respectively a hole in the bottom of the visor. The drawing No. 6 also shows that the INERTA ice paint - last applied in January 1994 - had penetrated the cracks F 1, F 3 and F 4 up to 50% of the thickness of the stempost. This means that the stempost had been cracked through up to 50% already in January 1994. See also Subchapters 12.5 and 34.4.

(3) At least 2 fatigue cracks had penetrated the stempost already by about 50% when ice paint was applied the last time which was between 10 and 14 January 1994 in the shipyard at Naantali. During the following nine months up to the casualty the cracks had to propagate further and the lowest one did fully penetrate the stempost which led to the breaking away of part F 3 (see drawing below) and the creation of a corresponding hole in the visor bottom and, consequently, the faster flooding of the visor inside at sea.

The below drawing shows the fatigue cracked stempost from the side and from forward.

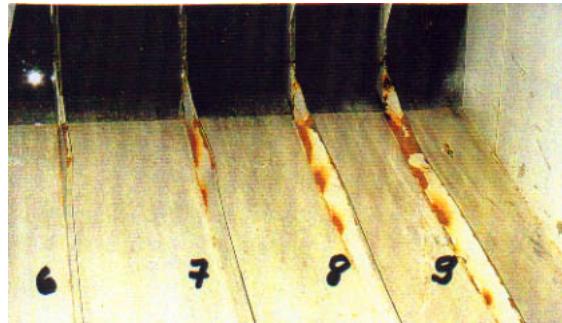
There is no sheet available for this part of the visor. The pictures show the inside of the aft part of the ramp house with 9 vertical webs each at its forward- and aft-parts. The webs are of the hp profile-type and measure 160 x 7 mm. The 4 webs at the port side of the aft part - numbered 6 to 9 - were indented to varying extent as can be seen on the picture below. Web 6 was evidently just slightly touched while web 9 was pushed flat.

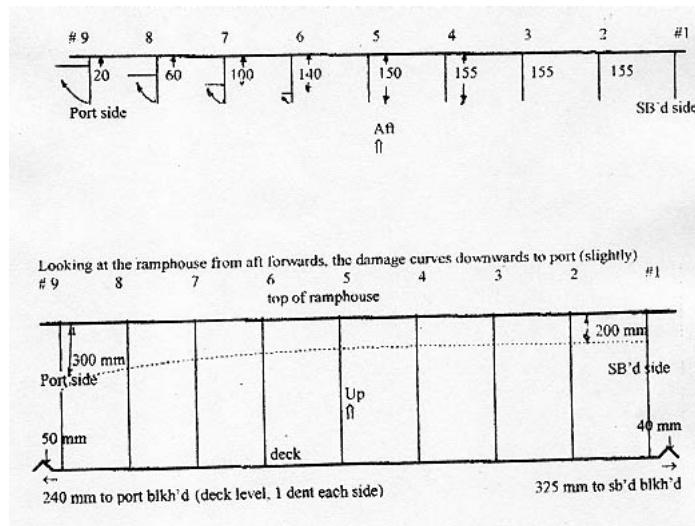
»Undamaged webs are abt. 155 mm high. There are 9 pcs webs in all. Webs # 1 to 4 from the sb side are essentially undamaged, but the paint has been scraped off all of them in a line abt 20 mm down from the ramphouse upper horizontal surface plate (top). Web # 5 is already very slightly deflected towards port and measures at 150 mm (against 155, see above). Web # 6 is deflected so that 140 mm remains, # 7 has 100 mm, # 8 has 60 mm and # 9 has 20 mm standing, while the rest of that web has been deflected to port. The depth of damage (deflection) is thus quite linear between webs 6 and 9. However the point of max damaged paint at # 1 to max deflection at # 9 seems to follow a gentle curve dropping downwards as you look to port. The ramphouse after plate with the damaged webs below.«

The damage configuration revealed by the above measurements indicates that the visor must have been misaligned by 4°-5° in forward/aft direction if the indentations should have occurred by contact with the bow ramp, i.e. the port side of the visor had to be about 300 mm further forward than the starboard side. In other words, the port side of the visor must have moved forward while the starboard side was held back. Before such forward movement of the visor is possible at all and contact between the aft part of the visor's ramp house and the upper part of the bow ramp is possible, several initially built in obstacles have to be overcome as demonstrated by the drawing on the following page.

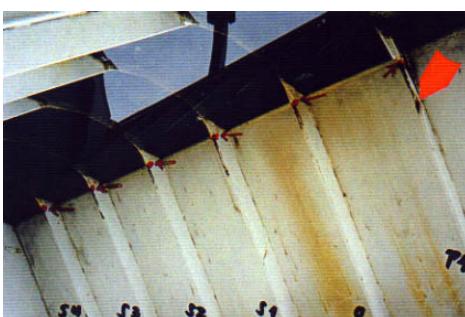
The arrow indicates the point of contact on web 9. The next frame 5, which is the centre line, and the following frames to starboard have no marks at this level.

This means that when web 9 came in contact with the port side of the bow ramp and was pressed together from 160 mm to 20 mm the corresponding web 1 at the starboard side of the ramp house was 360 / .160 = 200 mm away from the starboard side of the bow ramp. Due to the narrow construction, such a misalignment of the visor is not possible as long as the visor lugs move within the forecastle deck area aft of the deck-beam at frame 159 and as long as both actuators are connected to the B-deck. As will be shown on sheet P 4 + S 4 this was no more the case with the foundation of the port actuator. Also visible on the two pictures above are slight scorings inside the ramp house from web 1 through web 9 which could indicate a slight contact at another time, earlier or later (see red arrows on both pictures). The scoring marks are just below the brackets between vertical/horizontal webs which would be the

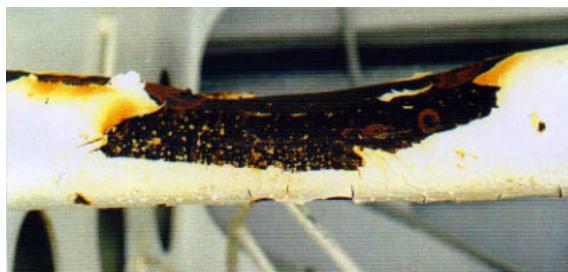
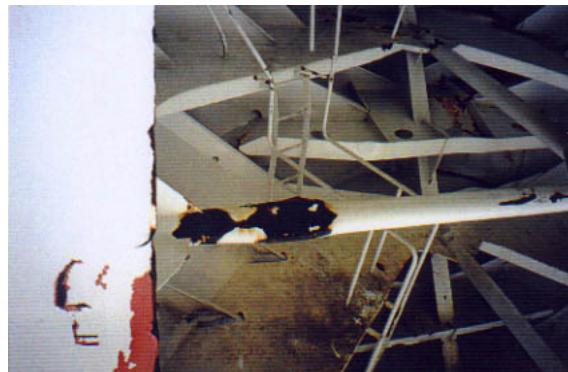
taken from the ROV video made on 09.10.94 which shows the port outer girder underside of the bow ramp in way of the contact area with the above-mentioned crossbar. There is no damage, the paint is completely unaffected (the diagonally running stripe being a wire).

It is obvious that this quite heavy damage shown on the picture on page 961 was caused by impact - see close-up below - and that this impact did not happen too long ago because the cracked paint is still hanging loose. It cannot have been caused by the ramp, at least not at an early stage as explained before. The damage must have been caused when the visor was labouring on the ramp for more than 30 minutes until the heel of the vessel was sufficiently big to let the visor slide off the ramp. During this time, this and other damage to the

port side of the visor was created by heavy contact with the ramp.

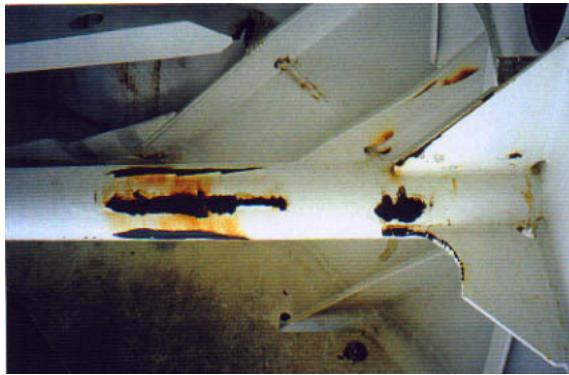
The scoring marks - arrow 1 on the photo on page 961 - at the starboard side of the same crossbeam in way of the first stringer level are not casualty related because except for the middle one the respective areas cannot be reached by the bow ramp. It has to be assumed that these scorings were caused by other means before the casualty.

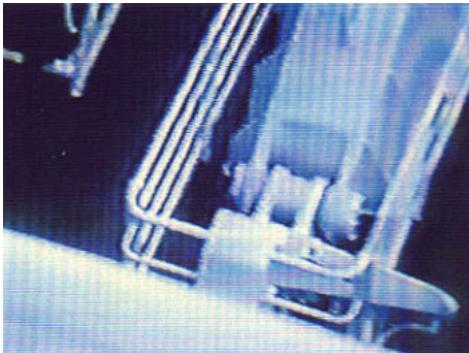
1 - shows the remains of the starboard hinge plates still attached to the visor (they were cut off upon the instructions of the JAIC in January 1995 and were transported to the Royal Technical Institute (KTH) in Stockholm for examination). The very bad condition, especially of the outer hinge plate is obvious. The deep burning marks and the missing metal are striking. All this is confirmed by the video film made by a passenger on 17.09.94 from the open forepart of deck 8 - see also Subchapter 12.5 - i.e. 10 days before the catastrophe. The image below shows a sequence of this video.

It demonstrates that,

- the whole hinge arrangement is severely misaligned;
- the outer bushing is extending too much to the outside and is twisted;
- the lower part of this bushing as well as the securing plate are missing;
- there is a big gap between the inner part of this bushing and the outer hinge plate fitted on the forecastle deck;

just to mention the main and most obvious deficiencies. The video tape was analysed in detail by the British Reconnaissance expert Bryan Roberts and his findings are discussed in Subchapters 12.5 and 34.9 and his report is attached as [Enclosure 12.5.180](#).

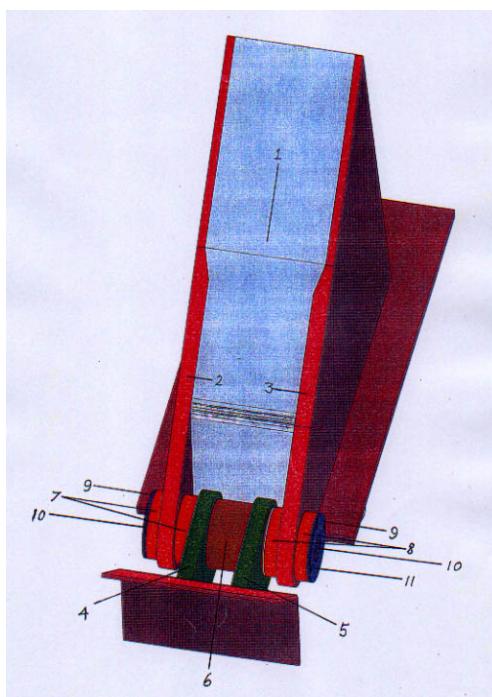
The drawing was taken from the report of Bryan Roberts.

The bushing, obviously having broken out of this inner hinge plate, was recovered by divers and was thus available for examination also by the metallurgical expert on behalf of this 'Group of Experts' and reference is made to the Report of Prof. Dr. Hoffmeister - see Subchapter 34.4 - [Enclosure 30.417](#). Further, the recovered bushing is shown in detail on Sheet 3 and shall be discussed subsequently.

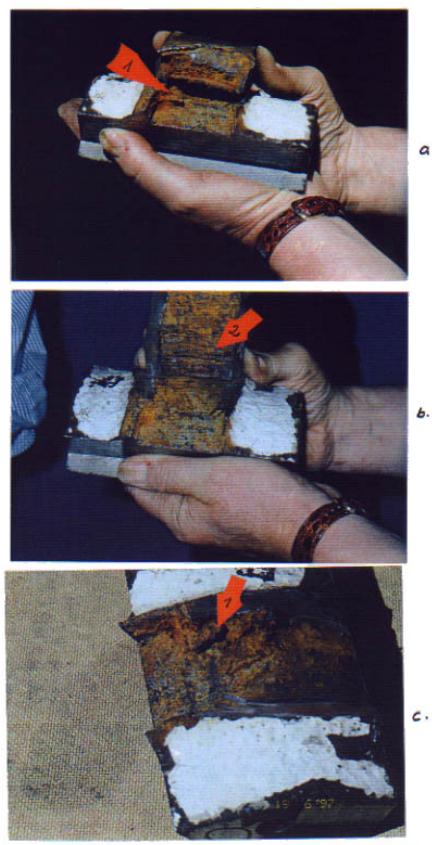
- The inside of the hinge plates were damaged by deep burning marks (see arrow 2 on picture b) from which crack propagation into the material of the hinge plates started and after the cracks had penetrated 50-60% of the material the remaining part of the hinge plate failed in the shear mode.
- The surface of the bushing, corresponding to the inside of the hinge plate with the burning marks explained above, does not show burning marks, therefore it has to be assumed that the original bushing was burned out some time before the casualty and replaced by the present one.
- The gap between bushing and hinge plate in way of the fracture area was about 25 mm indicating that the bushing did not fit into the hole of the hinge plate because the bushing was too small.

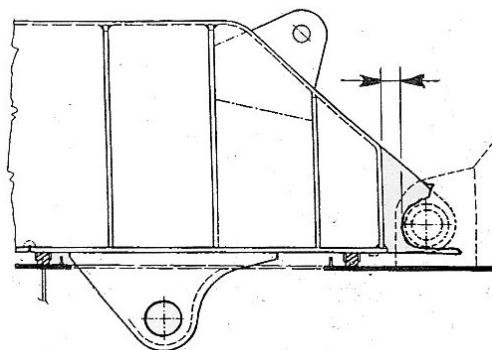
Note: When measuring the distances from the vertical welding seams between face plates and hinge plates and the inside of the bores through the hinge plates it becomes evident that at the starboard hinge plates there is about 15 mm less material than at the port hinge plates. This means that the visor was misaligned at least by this distance of 15 mm in the forward / aft direction. See the drawing below.

This means that the distance between the 2 arrows above was 15 mm smaller at the starboard hinges compared to the port hinges. This was certainly one of the reasons why the starboard hinges broke first and the port hinges were holding for some time longer.

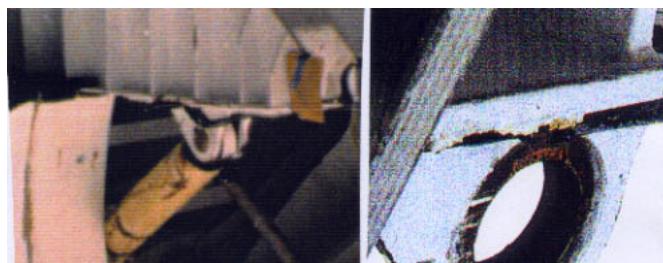
1/2 - show the outer lug plate of the actuator underneath the visor arm which is evidently completely undamaged with the white paint untouched, which is confirmed by the two pictures below.

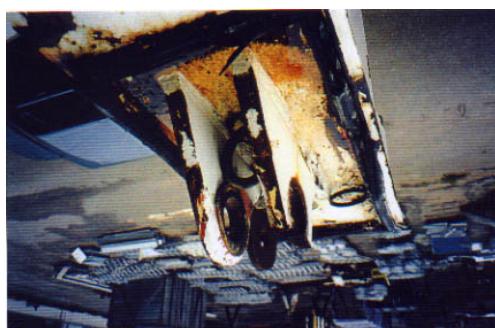
3/4/5 - show the opposite inner lug plate with very deeply engraved scraping marks, furthermore all three pictures show that the rubber packing, which is supposed to seal the opening for the actuator in the forecastle deck, is - contrary to the starboard side - torn and damaged.
This picture on the next page shows the damaged and torn rubber packing indicating movement of the visor without this side having been raised up.

(1) The outer lug plate is completely untouched while the inner lug plate shows very deeply engraved scraping marks. This means that at the time when the lug plates were cutting through the deck plating and the deck beam the vessel must have heeled already considerably to starboard. Therefore the centre of gravity of the visor had shifted from forward to starboard and the force direction was no more to forward/downwards but starboard/downwards. Thus the weight of the visor in athwartships direction was now carried by the inner port and the outer starboard lug plates because the locating horns gave no more transverse support as the visor had moved too much forward.

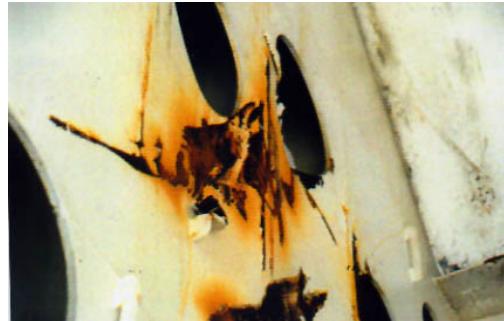
1 - shows the port actuator in jammed condition inside the inner longitudinal bulkhead of the visor. The spherical bearing of the actuator allows a 15° deviation to both sides. The actuator evidently swung into this jammed position after the visor had moved enough forward and after the bow ramp inside the visor was low enough. Thereafter the actuator remained in this position until being dismounted by MacGregor, Turku, in February 1995. The picture below shows the port inner bulkhead after the actuator had been removed.

Measurements revealed and photos confirm that the foundation of the actuator has not been in contact with the plating of the inner longitudinal bulkhead of the visor. Therefore the above visible indentations, scraping and scoring marks have been caused when the visor was hanging on the bow ramp. See also Subchapter 29.2 - The Bow Area - and P 7 further down in this subchapter.

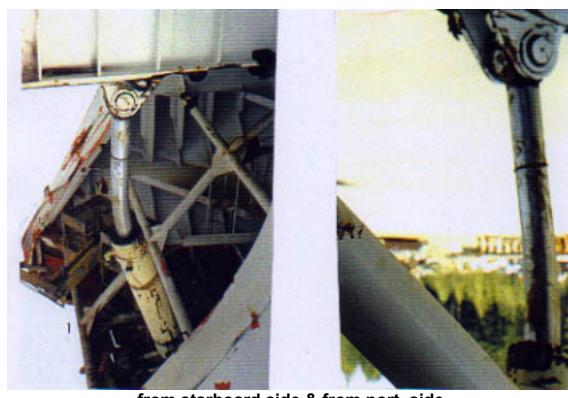
from starboard side & from port side

1.1 - shows the piston rod of the port actuator which is deeply scored on the starboard side at a distance of 520-600 mm from the lug plates underneath the visor arm.

Note: The starboard actuator which the JAIC did not consider worthwhile for examination shows less scoring on the piston rod as can be seen on the pictures below.

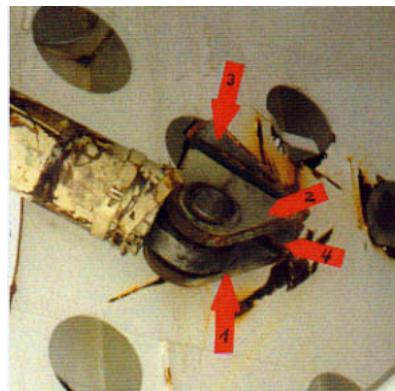
In consequence of this statement the photos showing the damage condition of this foundation have been analysed in detail and the result is outlined below: The foundation of the visor actuators did consist of two strong lugs welded to the B-deck and which were supported by two longitudinal and two transverse stiffeners. The picture below shows the port foundation with actuator still attached to the recovered visor. The arrows indicate the different components.

- arrow 1 = port outer lug plate of actuator foundation
- arrow 2 = port inner lug plate of actuator foundation

- arrow 3 = port inner stiffener (deformed)
- arrow 4 = port outer stiffener

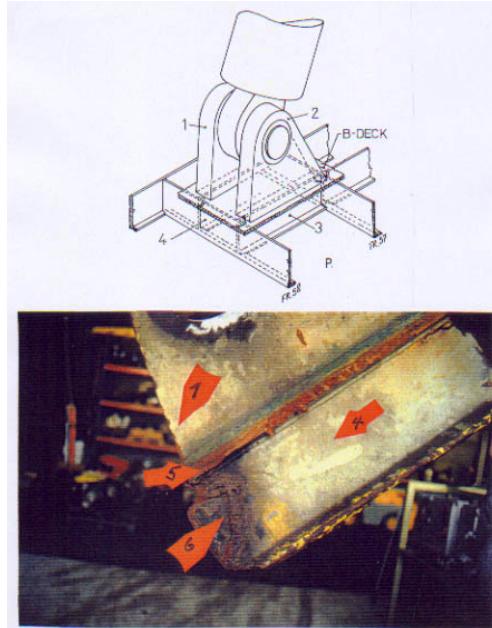
On the above photograph the reader looks on the lower part of the port outer lug plate (arrow 1), i.e. from port to starboard. Arrow 5 points to the remains of the B-deck, to which the port outer stiffener (arrow 4) is still welded. In the forward part of that stiffener an old temporary repair with very poor welding seams is visible (arrow 6). A close-up is shown below.

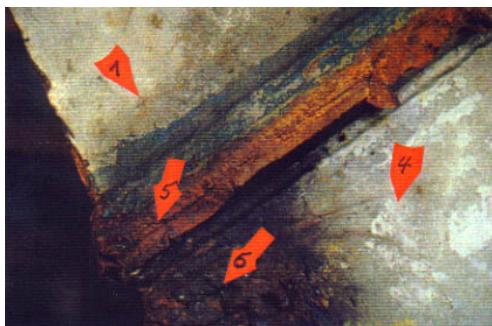
The lug plate (1) was obviously only partly connected to the B-deck as can be seen from the above photo when it was ripped off the B-deck (5) and only a small part connected by the welding seams (green paint) remained with the actuator foundation. The deck as well as the stiffener were pre-damaged - see Subchapter 34.4 - [Enclosure 30.417](#) - which is indicated by the damage repair, but also by the more or less straight cracking of the stiffener forward and aft of the lug plate, as can be seen on the following photograph.

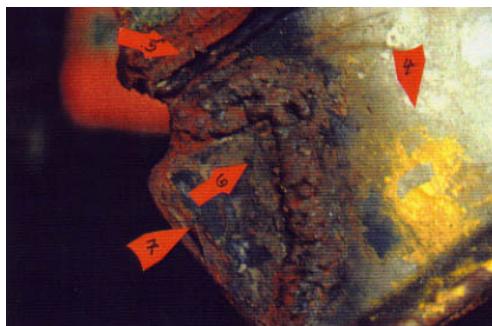
Due to the relatively straight cracks (7) directly below the forward and aft parts of the lug plates, it has to be assumed that the stiffeners in way were affected by fatigue cracks. The cracks had developed during some considerable time before the casualty due to load changes during opening/closing of the visor and did most probably propagate more quickly during the last month before the casualty because of the increasing difficulties with the visor, especially with the port side. See Subchapter 12.4 / 12.5. The following drawing demonstrates the above.

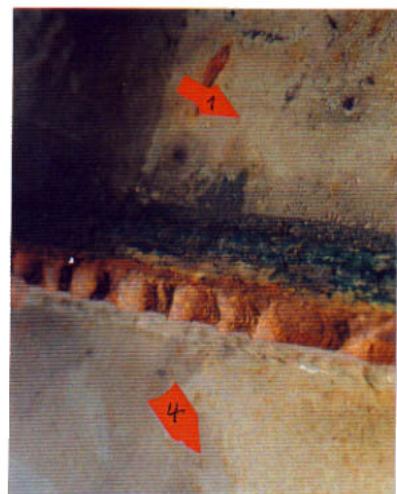
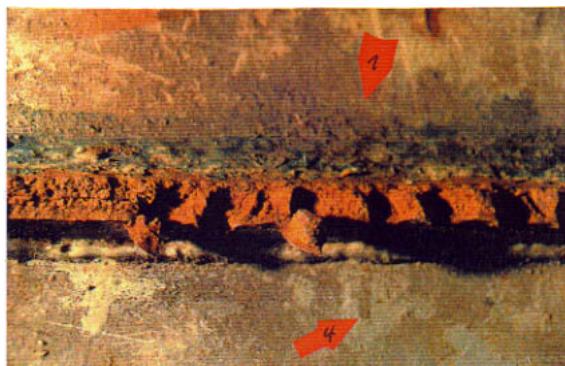
The following photographs indicate the condition of the B-deck in way of the port visor actuator foundation. The reader looks to the port outer lug plate and follows on the next 4 photos the ripped off B-deck remains from forward to aft of the outer lug plate. For easy reference the photographs are marked with the previously used arrow numbers.

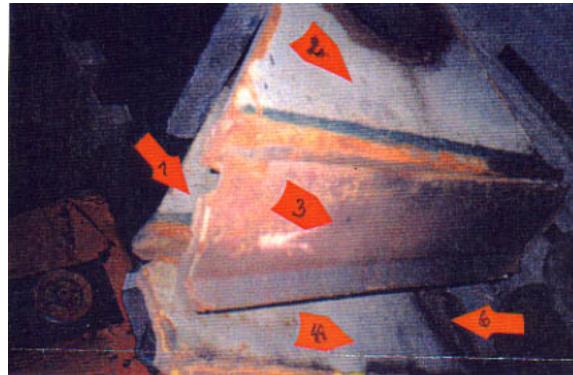
The following photograph shows the actuator foundation after it was removed and taken to the workshop of MacGregor, Turku for examination/testing on behalf of the JAIC. The arrows show the same numbers as used above.

As it is obvious from the close-ups below, the stiffener (3) was hardly spot-welded and thus only slightly connected with the B-deck. As this part of the stiffener is not painted at all - see the next photo to which the reader looks on the port inner lug plate from starboard to port - it is no more original, i.e. has been installed subsequently when the vessel was trading already.

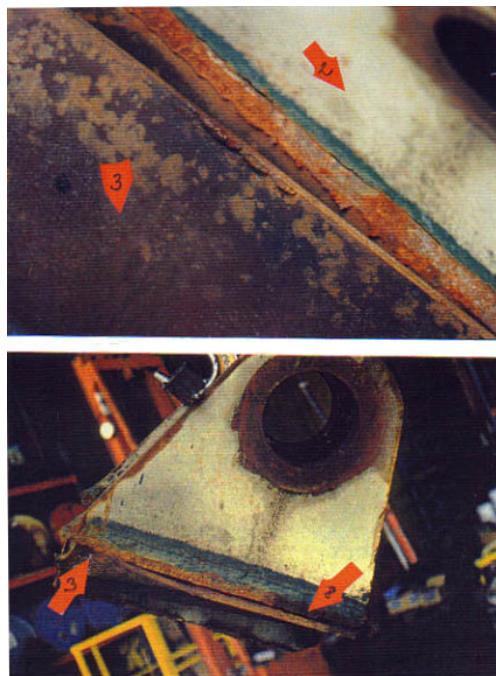
The following photograph shows the port visor actuator foundation after parts had been cut out for testing purposes. The foundation lies on its port outer lug plate. In the front the port outer stiffener (4) is visible, which is fully welded to the B-deck (5). Further at the forward right corner the old temporary repair with the very poor welding seams (6) is visible from inside. For cutting purposes the port inner stiffener (3) had been removed.

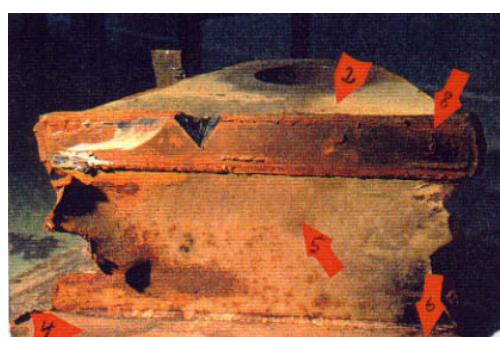
The apparent fact that this stiffener (3) had been disconnected from the B-deck (5) respectively since the last repair was never really fitted to it, is further confirmed by a part of the welding seam - see arrow 8 - on the previous two photos - apparently being soaked with oil while the stiffener below is unaffected. This means that this stiffener was not welded to the B-deck.

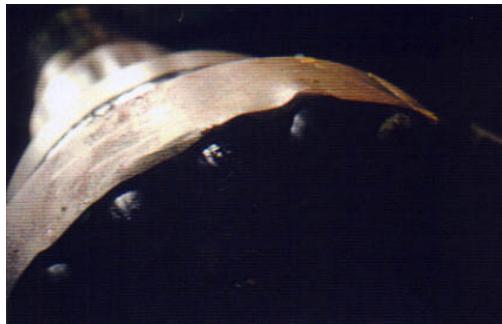
"... it was noticed that there were heavy damages at the distance when the piston rod is about 400 mm open. The damages were on the starboard side of the piston rod. Damages were also noticed on the piston cover's fixing screws. The ends of these hexagon screws were like hammered." (See [Enclosure 29.413](#))

The picture below demonstrates the above.

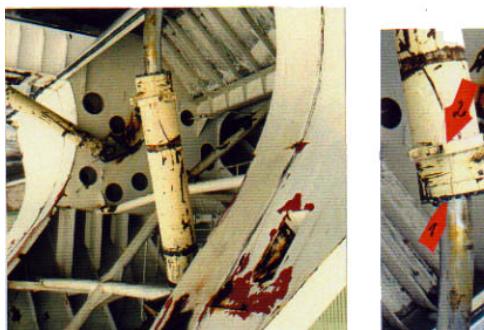
This is different at the starboard actuator as can be seen from the pictures on the next page with close-up of the area of interest. The arrow 1 points to the hexagon screws looking absolutely identical and which are evidently not hammered at all. Arrow 2 points to a clamping ring in apparently undamaged condition which had obviously not been exposed to hammering or otherwise heavy contacts. The differences between the external conditions including the hexagon screws of the port and starboard actuators can be explained as follows:

- The port actuator: Cover and hexagon screws on the piston rod side are severely hammered. The clamping ring is missing. The outside of the actuator shows heavy longitudinal scoring marks. The piston rod shows heavy damage on starboard side at a opening stage of ca. 400 mm.

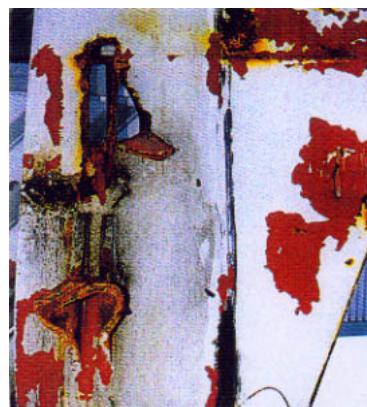
2, 3 - show the area of the missing side lock lug and the considerably bent hooks of the manual side locks from the top and from the side. The side view shows that the area in way of the pushed out steel tongue - see arrow 1 - is bulged outwards indicating pressure from inside to outside, whereas the plating between the hole for the lug and the hooks shows smoke marks, which are explained in Chapter 32. Around the opening for the lug burning/welding marks from the cutting off and the subsequent rewelding of the lug are visible. The following picture has been taken from the JAIC Report and clearly confirms the above.

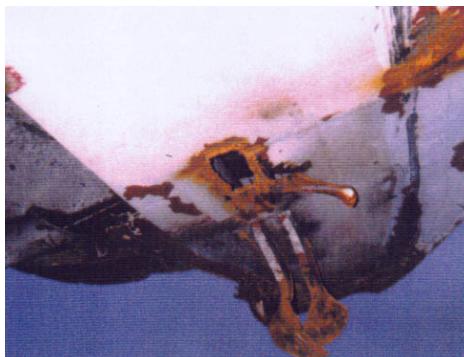
The picture below taken on 23.11.94 shows the lower part of the starboard aft visor bulkhead including the area under discussion looking downwards which is obviously very dark.

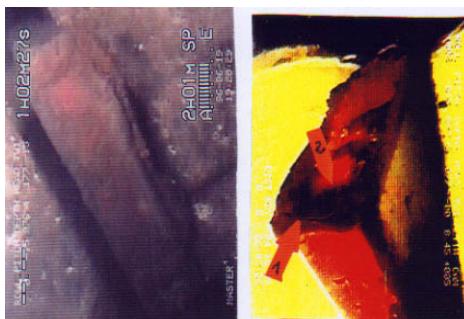
It is also obvious from the condition of the starboard lug as can be seen from the two video images of the corresponding lug still attached to the bolt on the wreck that the lugs had been repeatedly cut off and re-welded.

The very thick welding seam on the lower part - see arrow 1 - is actually a build-up of several welding seams, i.e. weld on top of the previous weld without grinding away of the remnants. It is obvious that the bulkhead part attached to the lug - see arrow 2 - had not been torn out of the bulkhead during the casualty scenario but much earlier because, due to the thickness of the accumulated welding seams, this original part of the visor bulkhead (Viking Line colour) could not come in contact with the adjacent visor plating. Consequently, it has to be assumed that each time the lug was cut off by burning it was just stuck into the respective hole in the bulkhead and welded from both sides, if at all - see also Chapter 29 - S 4.

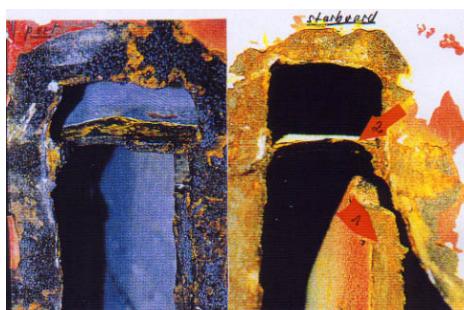
The next pictures - also taken from the JAIC's Report - show the upper parts of the holes in the visor bulkheads where the lugs had been fitted.

The analysis and comparison of both pictures reveal the following:

(1) The plating around the port holes is unaffected. Some remains of welding seams are visible at the upper right corner and at the right (inside) there are indications that welding seams could have been there. At the outside (left side) there are no such indications which refers also to the upper hole. Only few spots of corrosion can be seen. In summary it has to be assumed that the lug had not or only to a very limited extent been welded from the outside.

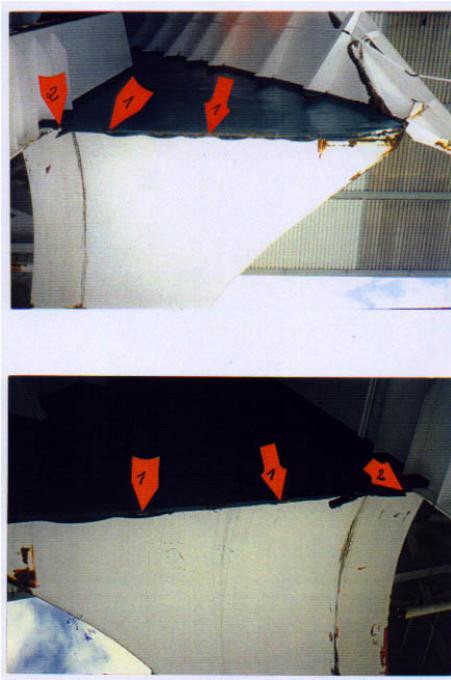
In addition, attention has to be drawn to both aft parts of the visor deck shown on the two pictures overleaf. The corroded areas indicated by arrow 1 on both sides have been the spots where the visor had been welded to the vessel at the time when the bushings of the starboard visor hinges were renewed. This was the time when ESTONIA berthed in Tallinn stern first - see the statement of Torbjörn Cederqvist - [Enclosure 12.4.3.157](#) and Subchapter 12.4.3 - the cars left the ferry via the stern ramps instead of the bow ramp as it is normally the case in Tallinn.

Arrows 2 on both sides indicate the corner between visor deck/aft bulkhead and visor arms along which the rope was running by which the bow ramp was kept close as tight as possible. The drawing below show the forecastle deck with the two winch drums by which the rope was heaved tight and the two fairleads around which the rope was running.

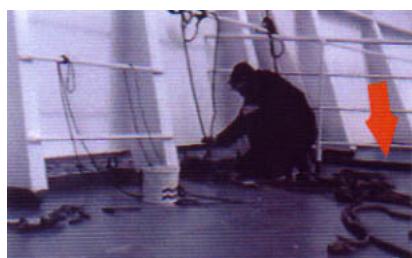
According to the observation of Bo Pettersson the port outer edge of the visor was extending the forecastle deck to such an extent that he could see the water through the gap. He estimated the difference between visor and forecastle deck to have been about 100 mm. Although crew members hammered with sledge hammers on the edge, the condition did not change and they gave up.

The image following shows the area in question. The arrow indicates where the crewman was hammering.

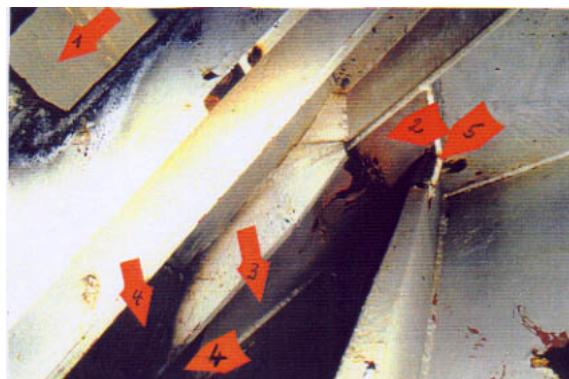
(a) The locating horn does not reach its pocket anymore and caused damage to the plating below - see picture 4 - which was tried to be rectified by welding doubler plates - see picture 5 - below the holed plating and the picture below.

arrow 1 = opening cut around the holes where the lug had been located
 arrow 2, 3, 4 = doublers fitted
 arrow 5 = buckled bracket

The fitted doublers and the buckled bracket points to an area exposed to high stresses and apparently also to damage which has certainly to be seen in connection with the severe misalignment of the visor.

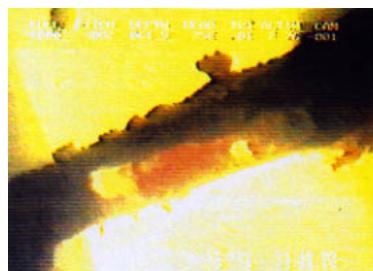
The following image shows the lug attached to the bolt inside the vessel before it was pulled out by the diver. Contrary to the starboard side this lug rested inside the bulkhead as visible, although it was on the high port side.

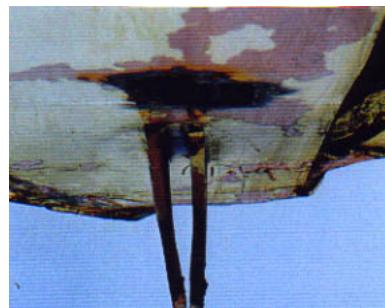
The hooks for the manual side lock were just bent together, as can be seen on the picture on the next page. The area around the lug location shows burning marks obviously from cutting off the lug by flame cutting - see arrow - but no smoke marks as on the starboard side and the plating was not pushed out/distorted.

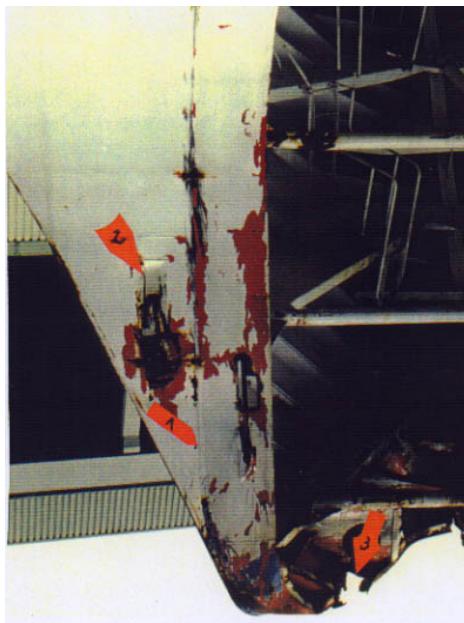
7 - shows the rubbing marks from the rubber packings at the vessel's front bulkhead which are straight in the upper part and slightly irregular in the lower part. The picture on the next page shows the lower port aft bulkhead. It becomes evident that the area below the pocket for the locating horn does not show any rubbing marks - contrary to the starboard side - which leads to the conclusion that the rubber packings at the front bulkhead of the vessel were missing also in this important location - see arrow 1.

The pressure mark of the locating horn inside the pocket - see arrow 2 - indicates pressure on the visor from port to starboard, which is a further indication for the severe misalignment of the visor.

Arrow 3 indicates a damage apparently caused when the visor fell off the bow ramp in the final stage when the heel of the vessel was already 120°/130° to starboard. This will be further explained in the following item 6 - The Visor Bottom.

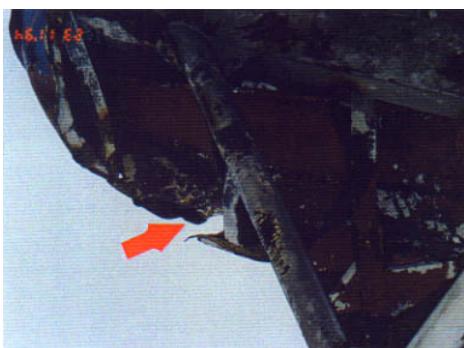
8 - shows the lower aft bulkhead/visor bottom which is only moderately damaged compared to the starboard side - see also the picture below.

The arrow points to a damage to the port aft edge of the visor bottom which apparently occurred when the visor moved transversely from port to starboard. This will be explained in Chapter 31 - The Casualty Scenario. See also picture 5 on the following Sheet 6.

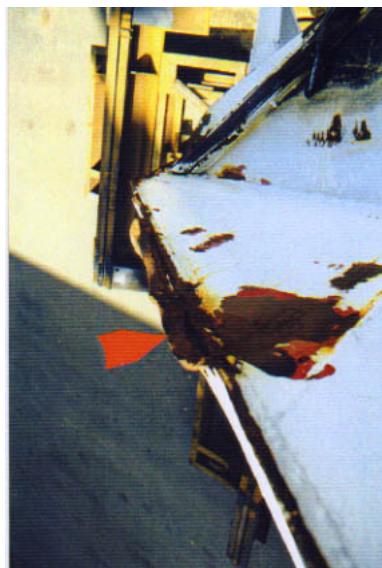
1 - shows the upper part of the aft bulkhead with the moderately affected recess which has already been discussed at the beginning of this item. The picture on the next page shows the recess as enlargement with damage at the edge of the shell plating - see arrow - which obviously occurred when the visor was moving in the transverse, i.e. athwartships, direction. - See also Chapter 31 - The Casualty Scenario.

(7) The recess at the upper part of the port aft bulkhead of the visor was damaged when the visor was moving transversely respectively athwartships.

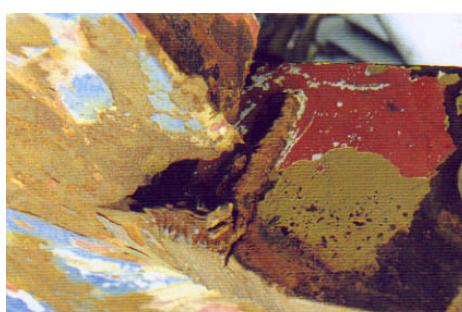
1 - shows the visor lug being part of the Atlantic lock. Arrow 1 points to the previously burnt off part of the lug with cracks propagating from burning marks (arrow 2). The lug apparently became twisted to starboard when the visor moved abruptly to starboard until its port inner bulkhead rested on the port side of the bow ramp. The deep crack in the bottom of the visor to port of the lug confirms this. It further indicates that the visor lug was about to crack off the visor bottom when the lugs on the forepeak deck failed first. This is underlined by the impressive picture below indicating an upwards and to starboard movement of the visor when this big crack propagated and came to a stop when the lugs on the forepeak deck failed.

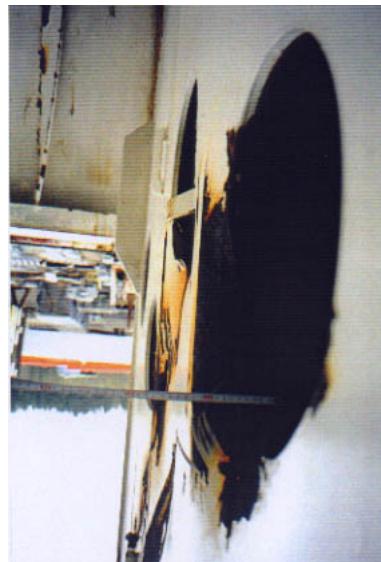
1 / 2 - show the port inner longitudinal bulkhead with scraping/scoring marks at the lower aft part - see arrow 1 - and very deep indentations with the steel plating partly torn - see arrow 2 - and enlargement picture 1.1. The picture below shows that the plating was actually pressed into the bulkhead up to 120 mm.

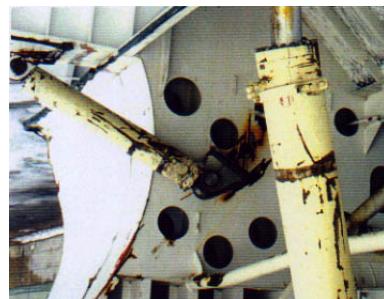
It is quite obvious that these deep indentations cannot have been caused when the port actuator was swinging inside the longitudinal inner bulkhead (due to the existing starboard list of visor and vessel) and got jammed there, as evident from the picture below.

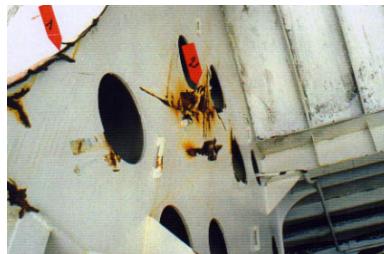
After the actuator had been dismounted by MacGregor, Turku in February 1995 the area looked as it is shown by the following picture. Arrow 1 indicates the area at the edge of aft and inner bulkheads where the aft bulkhead is slightly extending the inner bulkhead and where metal parts were torn off when the actuator moved into its jammed positions. A detailed evaluation of this and other pictures did reveal that neither the actuator nor its foundation had come in contact with the bulkhead which is due to the angle between the fastening point at the lugs below the visor arm and the bulkhead edge. The actuator was able to swing into this position because of its spherical bearings which allow deviation of up to 15° to each side.

It is thus proven with sufficient certainty that the severe damage as well as the scraping and scoring marks were only caused by the bow ramp then lying inside the visor on the beam structure and the visor resting on the bow ramp in way of the damage area under discussion. This shall be explained in more detail in Chapter 31 - The Casualty Scenario.

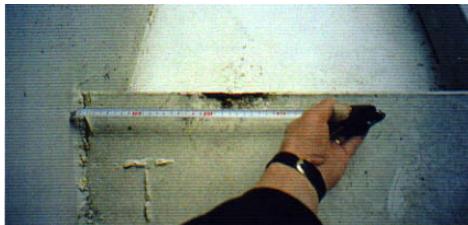
2 - shows the lower inside of the visor with the lower transverse beam in way of the 3rd stringer. This beam was found to be very severely scored and scraped, which was most probably caused during the lifting operation. The picture also demonstrates the very severely set up visor bottom which is underlined by the close-up No. 10 and explained by detail drawing No. 8. There are two further contact marks in way of the deck beam at the lower forward part of the ramp house, viz. in the most port and most starboard frame spaces, which were evidently also caused by the bell cranks of the ramp when the visor moved further forward and downwards and the vessel was already severely heeled to starboard already. See also sheet 2 - The Ramp House. The picture below indicates the short distance to the port bulkhead because of the starboard heel.

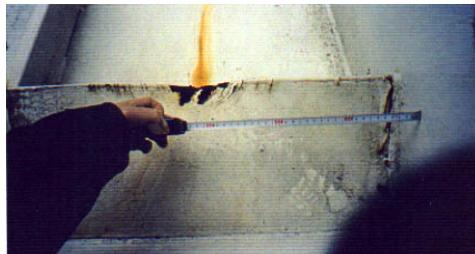
The picture below shows the starboard side with the longer distance to the starboard bulkhead also due to the starboard heel of visor and vessel.

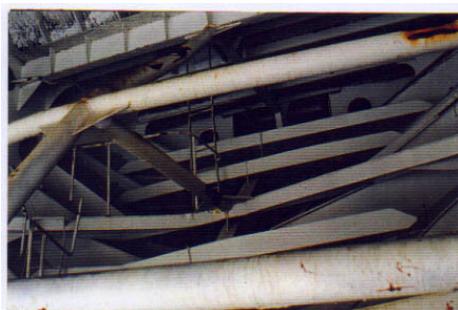
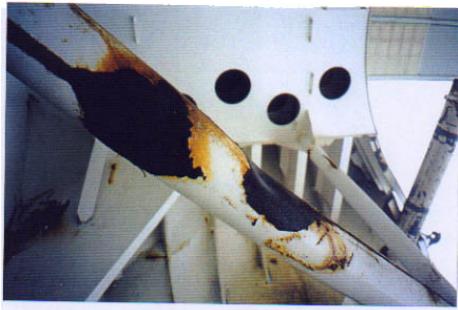
The two pictures below show the damage to the top and port side of the vertical beam.

- (1) The upper cross-beam shows damage at two locations on the port side which cannot have been caused by the bow ramp, because there was no corresponding damage at the ramp.

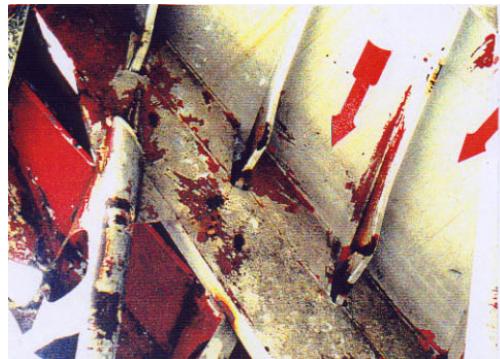
- (3) The visor had always been full of water to the outside level when the vessel was at sea. See the photo below.
- (4) The hydraulic cylinders/pipes were leaking which caused hydraulic oil to swim on the water surface inside the visor which settled down once the water left the visor.

- (5) People had been very active inside the visor, in particular on the 3rd stringer. The majority of the footprints are fresh and not covered by oil, thus originate from the time before arrival and after departure Tallinn on September 27, 1994.

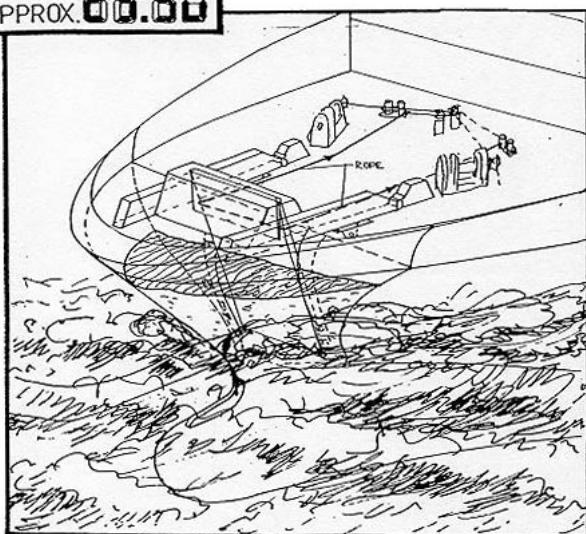
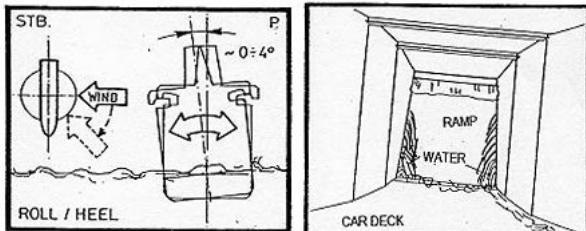
APPROX. 88.88

1. Due to increasing wave height and deep pitching of the ferry the water level inside the visor rose higher and the pressure on the "sealing" material
2. Water entered the car deck in increasing quantities.
3. The ferry made very hard pitch movements.
4. The bow ramp was kept more or less closed by the rope and the water pressure from the visor side, however water penetrated at both sides of the ramp
5. This was the condition on board the ESTONIA when she met "AMBER".

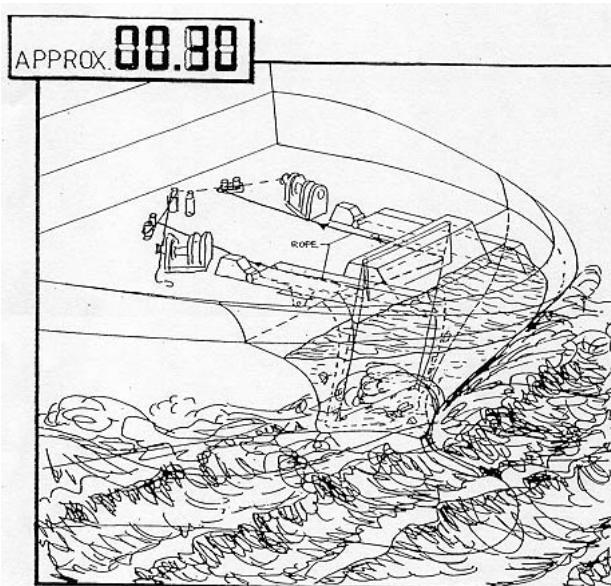
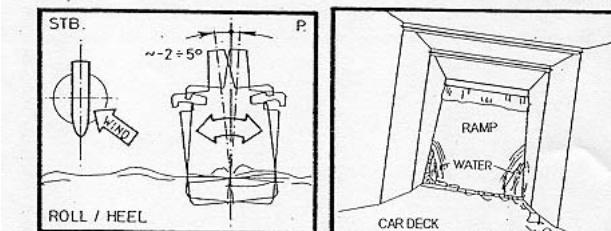
1. Stabilisers activated and possibly problems with starboard fin.
2. Vessel took green water on forecastle deck due to very heavy pitching movements.
3. Water level inside visor was rising to about 1st stringer level.
4. Water ingress onto car deck had been increasing for some time but, the accumulation of big water quantities on starboard side was avoided by the slightly open starboard stern ramp.

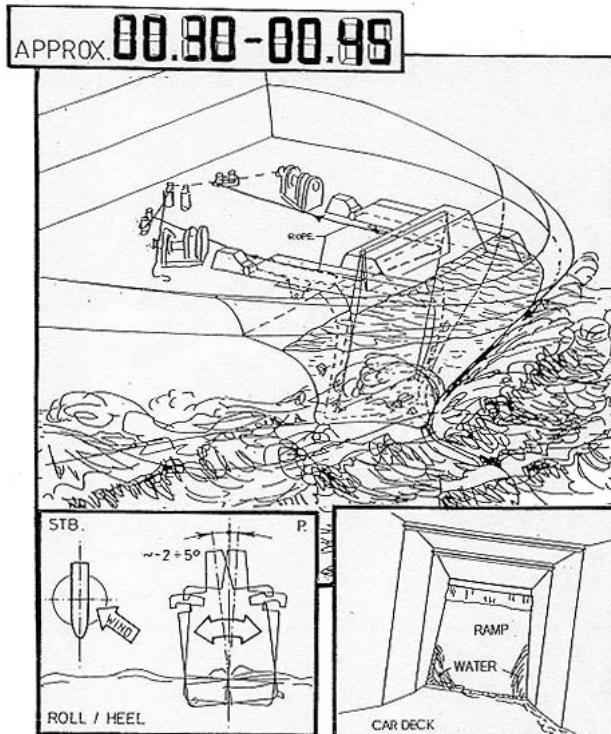
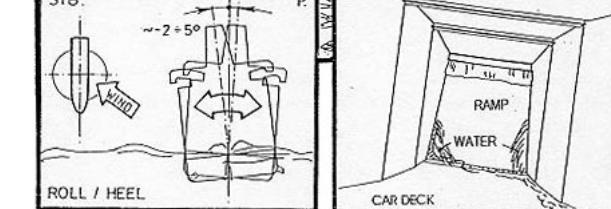
1. Low banging noises continued
2. Port stabiliser fin activated, crew started to work on the starboard fin.
3. The watch A.B. noted alot of water on the car deck, alarmed the bridge and crew was activated
4. The course was changed to starboard and the ferry began to roll heavily, whereafter the vessel was turned back to port and stated to pitch heavily. The speed was reduced.
5. The crew was working on the car deck to control the water ingress which turned out to be impossible.
6. The vessel made deep, slow pitch movements and was slightly rolling, more to starboard, less to port.

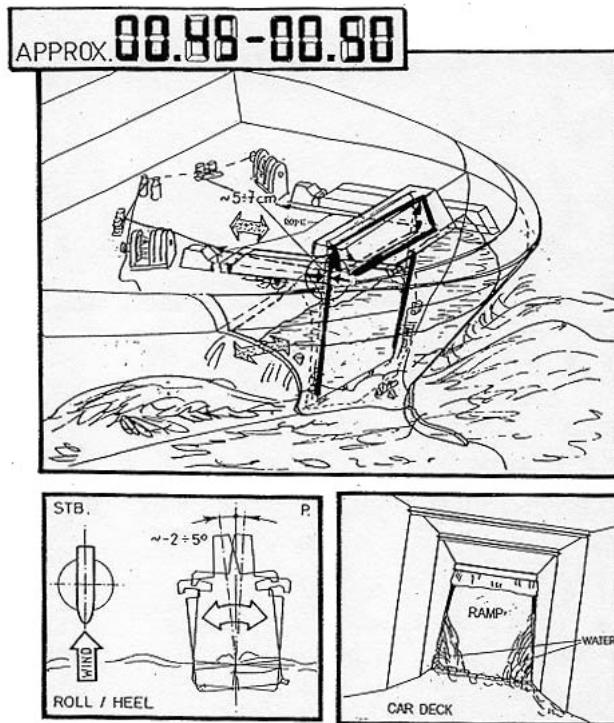
1. The crew members went on the forecastle deck through the door on deck 5 and tried to heave the rope holding the bow ramp which failed probably due to the green water taken on the forecastle deck.
2. The bow was held by the actuators and lowered down inside the visor.
3. The crew somehow managed to start the hydraulic pumps under extremely difficult conditions due to the water on the deck and the moving cars.
4. The substantially pre-damaged STB. Visor hinges failed followed by the equally pre-damaged STB side lock.5. The starboard side of the visor moved forward, the lugs cut through the deck plating and struck against the deck beam aft frame 159, the visor was pushed back when the vessel was diving into the next wave trough causing the broken visor hinge parts to smash against the hinge parts on the forecastle deck.

The starboard side of the visor was 5-7 cm moving forward/aft between the deck beam at frame 159 and the hinge parts on forecastle deck which created the heavy metallic banging noises scaring many passengers. The lug plates underneath the starboard visor arm came in contact with the adjacent plating and sustained scoring marks on the inside and on the outside because the vessel was only slightly heeled to starboard, still pitching in head seas and only slightly rolling. The port visor hinges remained intact for the time being.

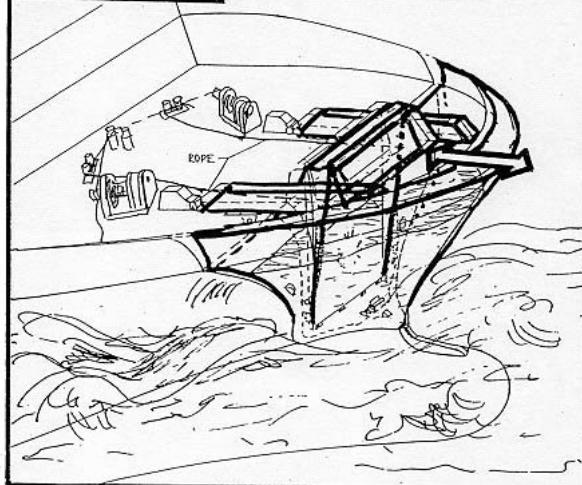
APPROX. **88.88**

1. Also the port hinges and the port side lock failed and the visor moved forward/aft between the deck beam at frame 159 and the hinge parts on

2. Simultaneously hard scraping noises were caused by the upper flaps of the ramp scraping along the vertical beam inside the visor due to the movements in the sea

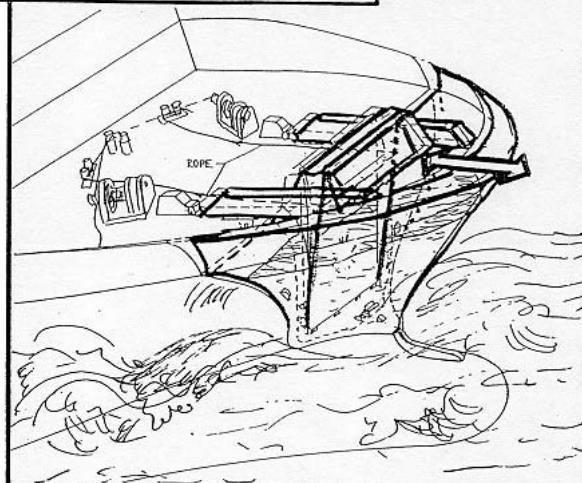
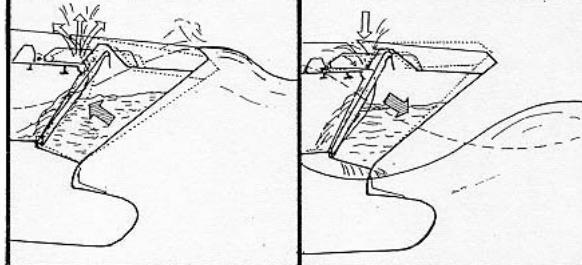
APPROX. **88.88 - 88.88**

1. Hard metallic banging/knocking and scraping noises.

2. Visor moving forward /aft between the deck beam at the frame 159 and the forecastle deck parts of the hinges, the lugs underneath the visor arms were cutting through the deck beam.

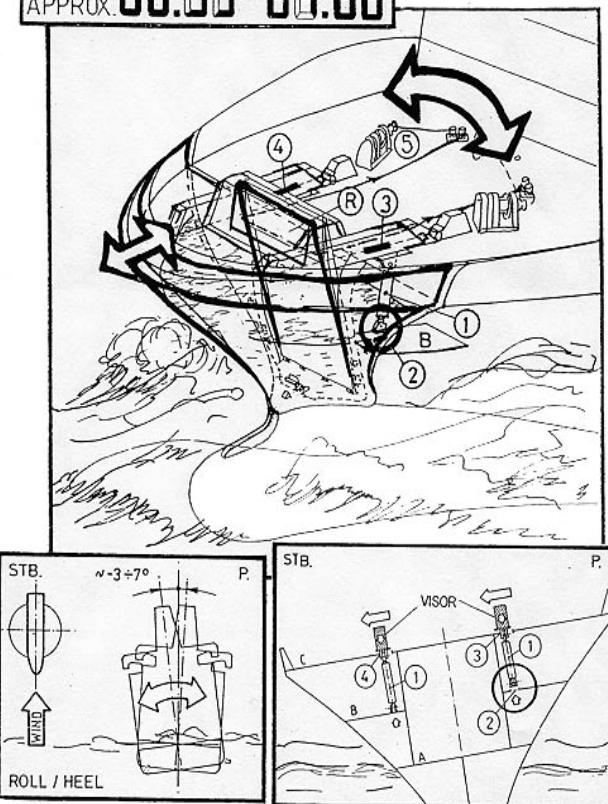
APPROX. 08.00 - 08.00

1. Hard metallic banging/knocking and scraping noises.
2. Crew tried to hold the visor by means of the hydraulic actuators (1) and the bow ramp by ropes (5)
3. The port actuator was torn off its foundation on B-deck.(2)
4. Deep contact marks occurred on the visor lug plates port inside/ starboard inside and outside. (3+4)
5. The vessel was slowly turned further to port and started to pitch and to roll.
6. The crew abandoned the attempts to hold the visor close to the bow ramp and rushed up to deck 7. The ropes remained around the bow ramp and on the winch drums on the forecastle deck.

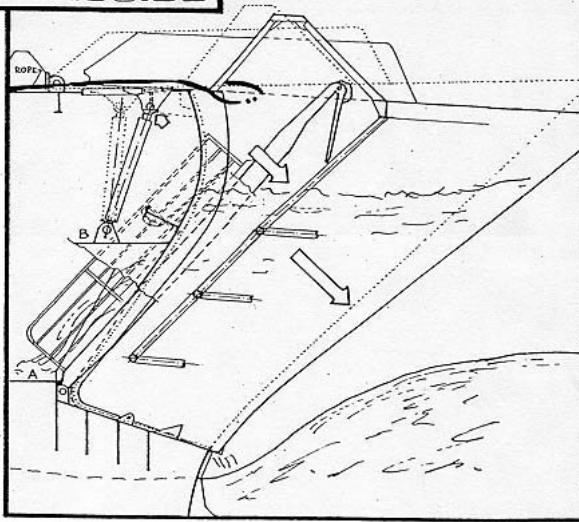
APPROX. 88.88

1. The visor lugs finally cut through the deck beam and the visor moved forward, the forepeak deck penetrated the visor bottom.

2. The vessel was now more rolling than pitching.

3. The ramp was inside the visor while the visor moved forward.
