1 THE CASUALTY

2 THE VESSEL "VIKING SALLY"

The German 'Group of Experts' has now - as far as possible - completed its investigation of the foundering of the M. V. ESTONIA, a disaster that has taken the greatest toll of human life in the Baltic Sea in times of peace. The German 'Group of Experts' has during the past five years performed a difficult investigation in a partly hostile and reluctant environment. The work was carried out during the first two years - 1995/1996 - in close co-operation with the Swedish leader of the Technical Group of the Joint Accident Investigation Commission of Estonia, Finland and Sweden (JAIC), Börje Stenström († February 1997), and also with the Finnish member of the Technical Group, Dr. Tuomo Karppinen and the expert Dr. Klaus Rahka. All the investigation results of this 'Group of Experts' were submitted either verbally in joint meetings with the members and the experts from Estonia, Finland and Sweden attending or in letters with attached photos and/or video film documentation to the JAIC. This documentation and information concerned the design, construction and building of M. V. ESTONIA in general and the locking devices of the bow visor in parti

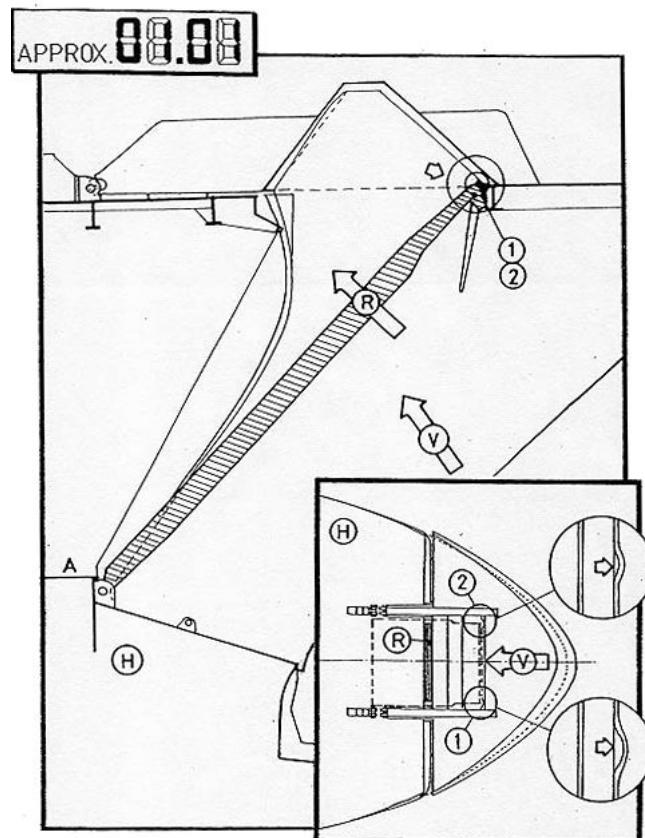
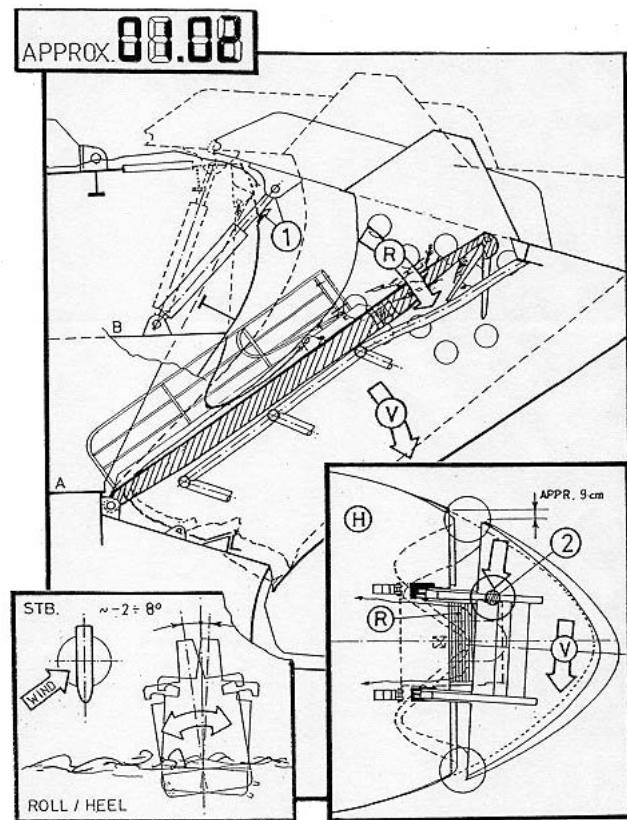
1. Vessel rolling more to starboard/less to port .
2. Visor lugs broke through the front bulkheads and did not support the visor anymore against moving towards the deeper starboard side (1)
3. With a big crash the visor fell abruptly about 10 cm to starboard until the inner port bulkhead was resting on the upper part of the bow ramp (2).
4. The visor was now extending the starboard front bulkhead of the vessel and the port front bulkhead was extending the visor.
5. The atlantic lock failed.

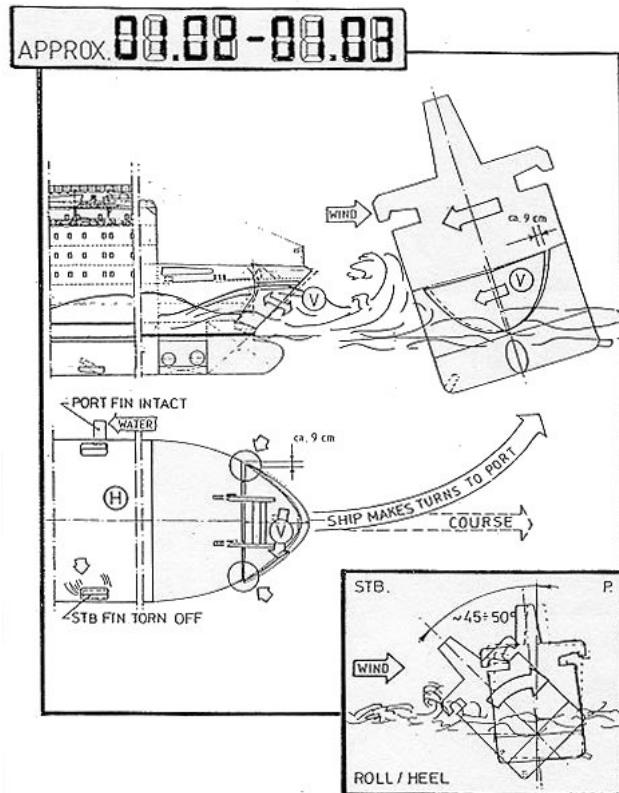
1. The vessel stopped abruptly. Water penetrated from O-deck under pressure.
2. The slow port turning increased rapidly while the vessel heeled wide over to starboard -ca. 45o-50o, and came back to ca. 10o STB heel after the turning had stopped. The wind and waves now came from starboard abeam.
3. The heeling to STB increased stepwise with roll movements.

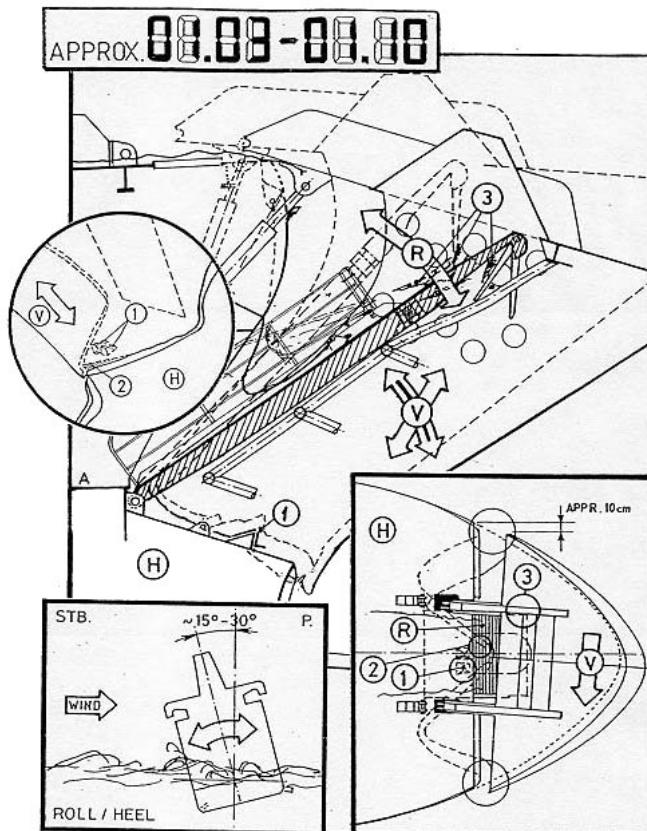
1. Approx 01.08-01.10 hrs the main engine shut-down automatically at a stoboard heel of ca 30o.
2. The visor was held by the bow (3) ramp and by the forepeak deck increasingly penetrating the visor bottom (1)(2).
3. The intact starboard actuator was resisting the forward movement of the visor.

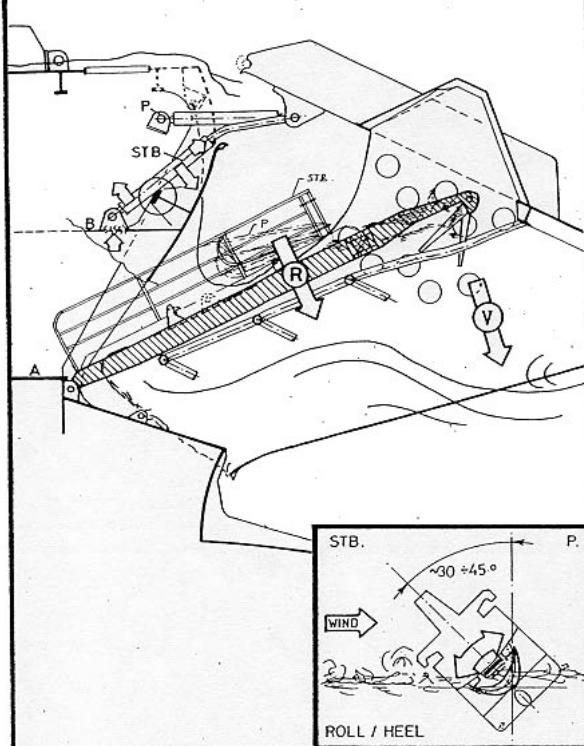
The visor moved further forward with the starboard actuator extending and the forepeak deck pressing into the visor bottom. The strong ice plates supported the visor further from falling off to the starboard and the further the visor moved forward the deeper the forepeak deck pressed into the visor bottom.

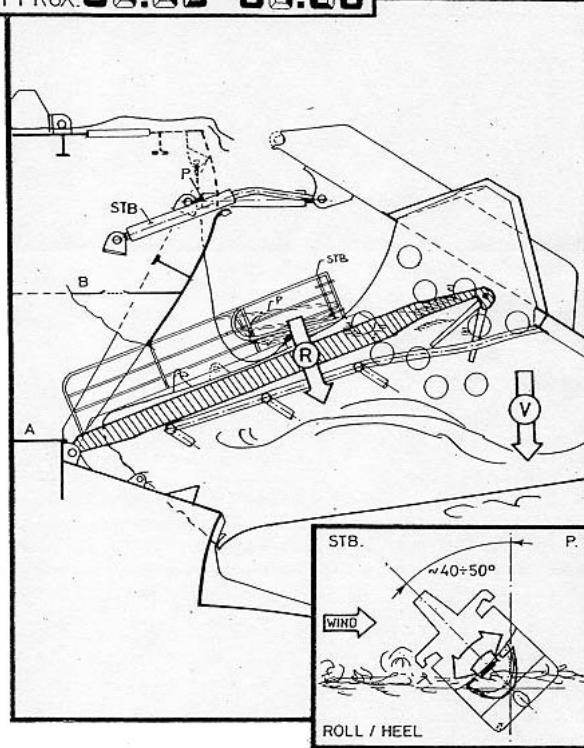
APPROX. 08.00 - 08.20

1. After the vessel had stabilised for some time at a heel of about 40o-50o the heeling increased again.
2. The visor moved further forward and downwards and also the starboard actuator was torn off its foundation and broke through the front bulkhead as did the port one.
3. The port actuator was completely retracted while the starboard actuator was fully extended with the piston rod bent.
4. The visor was still hanging on the ramp and was still supported against falling off to starboard by the forepeak deck being pressed into the visor bottom.

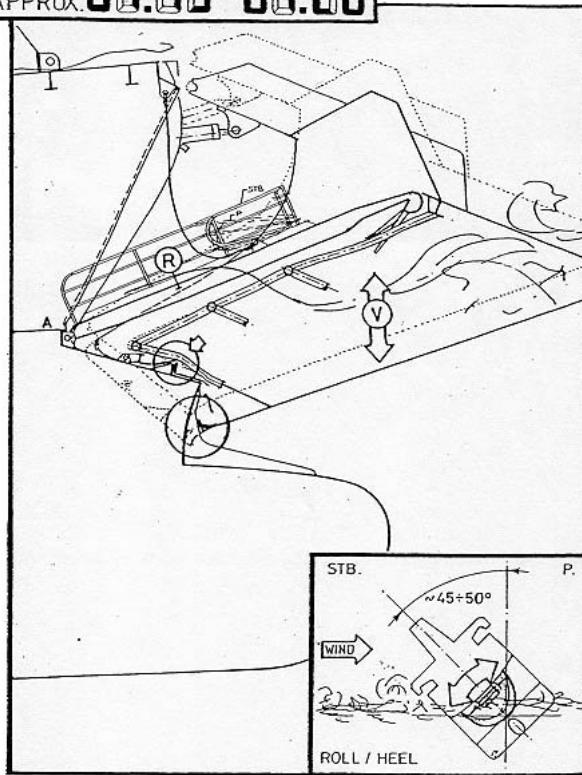
APPROX. 08.00 - 08.20

The vessel was still rolling stepwise and the visor with the bow ramp inside was labouring up and down and from port to starboard in the seaway.

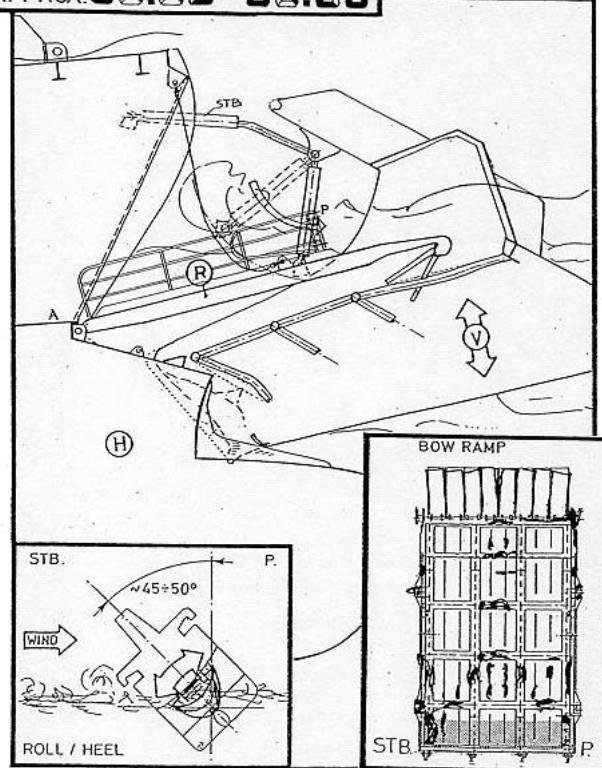
APPROX. 88.88-88.88

1. The port actuator broke through the front bulkhead, swung forward and got and crashed against the bow ramp
2. The structure of the ramp was continuously and very severely deformed by the heavy and changing weight of the visor.

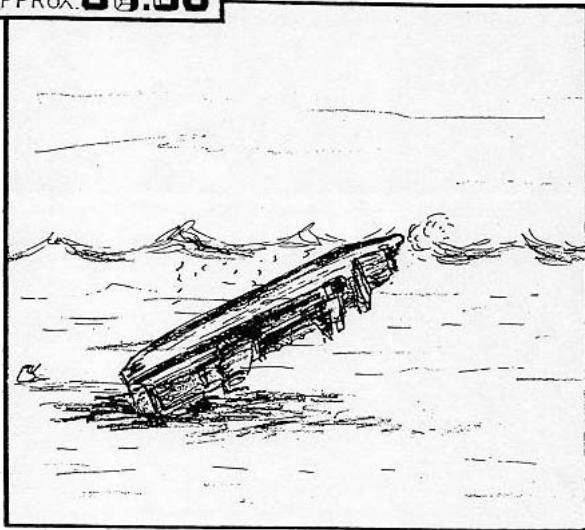
APPROX. **08.90**

1. The Vessel sank stern first.
2. The bow was still above water when the stern was already on the sea bottom.
3. The visor sank about 1nm west of the wreck upside down.

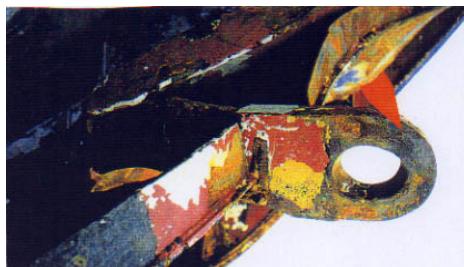
In April 1995 the JAIC published the "PART-Report covering technical issues on the capsizing on 28 September 1994 in the Baltic Sea of the ro-ro passenger vessel MV Estonia" which included also certain picture material, among others the picture below showing the aft part of the visor bottom with the visor lug being part of the Atlantic lock.

The blue coloured part of the lug - see arrow - looked as if having been exposed to heat which was unusual since this part had been below water. The JAIC was contacted and it turned out that samples had been taken already on 25 November 1994 and had been examined upon request of the Central Criminal Police in Finland and Kari Lethola as chairman of the Finnish part of the JAIC on 30.03.95. The tests were carried out on 30.05.95 by the Criminal Laboratory Technical Division, Helsinki. The "available" documentation was received - already translated into English - from Kari Lethola.

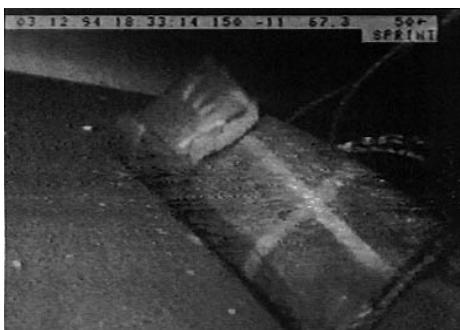
After a relatively silent 1998 when most of the interested people were analysing and subsequently criticising the report of the JAIC a new person appeared in Sweden apparently with sufficient time, and an undisturbed mind, to analyse again all the publicly available video footage and documentation on this subject collected by the JAIC. He found among other things on the video B40b, made by the SPRINT ROV on 03.12.94, a package on the port superstructure in way of the 5th deck which appeared suspicious to him. Video images were made and shown among others also to experts in explosives in Sweden and Germany. See the following image.

Both identified the package with about 90% certainty to be an explosive charge used underwater.

Evaluation of the footage made by ROV on 02. and 09.10.94 revealed, however, that the package had not been at the identified location on the 5th deck on these dates, thus must have been placed there between the 09.10. and 03.12.94 and therefore could not be casually related.

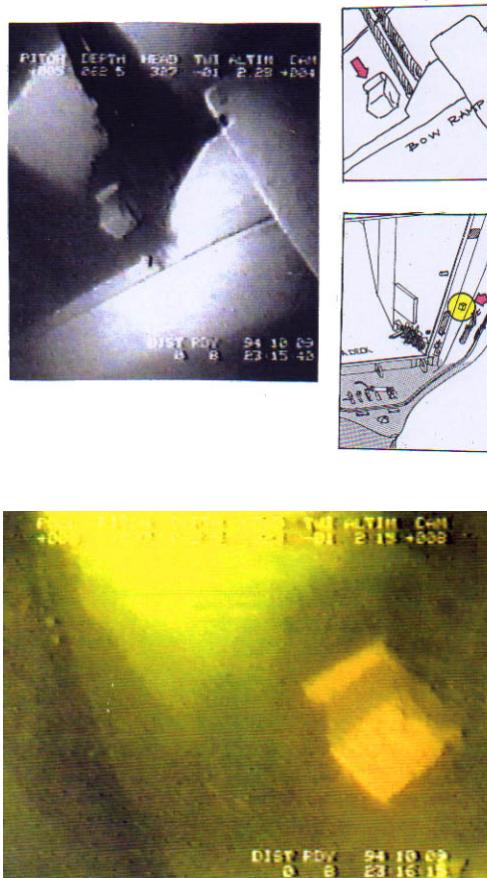
The cube was clearly visible and had been closely looked at by the ROV during the inspection on 09.10.94, it could not, however, be found on the 02.10.94 videos which was possibly due to restricted visibility and was definitely not in this location on the SPRINT ROV made on 03.12.94 respectively on the diver video of the same date.

Images were made from the orange coloured cube and identified by all three experts from Sweden, England and Germany with a high degree of probability as an "explosive charge". See the following two images.

As this charge attached in way of a very sensitive area - the port side locking devices of the visor and the fastening of the port bow ramp actuator - obviously did not explode, the corresponding area of the starboard side was analysed for possible explosion damage which was positively identified by the underwater explosive expert Brian Braidwood. This resulted in a further analysis of the available video footage all received from the JAIC. The results are outlined in the following subchapters.

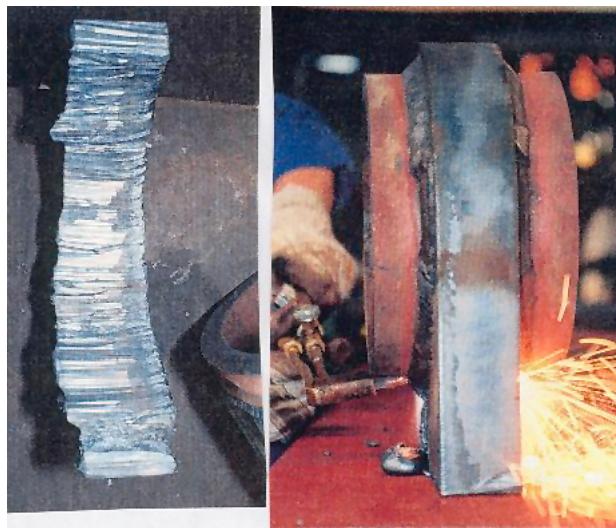
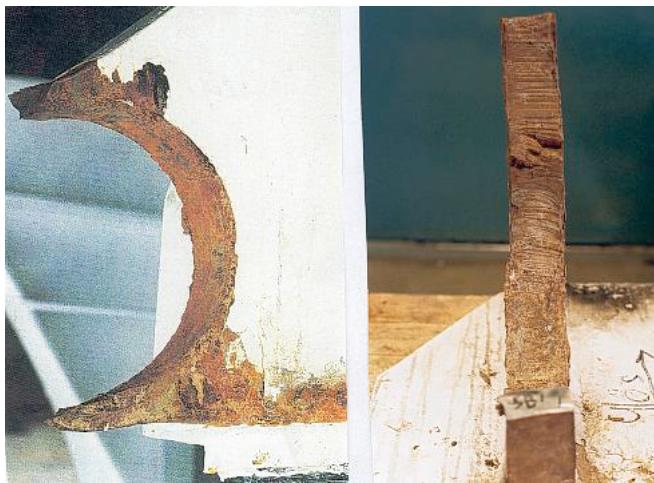
- all four arms do not have identical appearances as it is evident from the two photos below, the left one shows the port outer visor arm and the right one the starboard inner visor arm.

Evidently the starboard visor arm plate looks identical to the test burnt installation part - see the photo above - and the port one is smooth without burning marks at all. A detailed inspection even revealed indications of circumferential drilling marks as initially the holes were drilled at newbuilding - see Subchapter 2.4.6. Therefore this 'Group of Experts' has always taken and still does take the view that the port bushings were still original while the starboard ones were very unprofessionally replaced. How gross negligently this replacement was carried out became fully clear when a passenger video was made available to this 'Group of Experts' in 1996 - see Subchapter 39.2.
