##### **2 THE VESSEL "VIKING SALLY"**

The German 'Group of Experts' has now - as far as possible - completed its investigation of the foundering of the M. V. ESTONIA, a disaster that has taken the greatest toll of human life in the Baltic Sea in times of peace. The German 'Group of Experts' has during the past five years performed a difficult investigation in a partly hostile and reluctant environment. The work was carried out during the first two years - 1995/1996 - in close co-operation with the Swedish leader of the Technical Group of the Joint Accident Investigation Commission of Estonia, Finland and Sweden (JAIC), Börje Stenström († February 1997), and also with the Finnish member of the Technical Group, Dr. Tuomo Karppinen and the expert Dr. Klaus Rahka. All the investigation results of this 'Group of Experts' were submitted either verbally in joint meetings with the members and the experts from Estonia, Finland and Sweden attending or in letters with attached photos and/or video film documentation to the JAIC. This documentation and information concerned the design, construction and building of M. V. ESTONIA in general and the locking devices of the bow visor in particular,

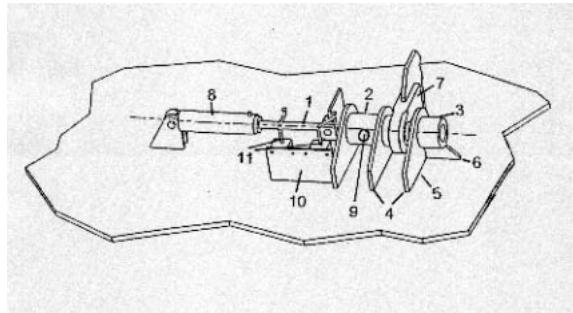
This locking device consisted of a locking bolt (1), movable horizontally in a transverse direction, guided in a bolt housing (2). In extended position the tip of the bolt engaged a support bushing (3). The bolt housing was fixed to the forepeak deck by means of two steel lugs (4) and the bushing was installed in a third similar lug (5), to which a support bracket (6) was fitted. A mating lug (7), attached to the visor itself, was located between the bolt housing and the support bushing when the visor was in the closed position and the extended bolt then engaged the hole in the mating lug.

The bolt was moved in the bolt housing between the retracted position and the extended position by means of an hydraulic actuator (8), operated from the control panel located behind the bow and the ramp on the car deck. A spring-loaded mechanical plunger (9), perpendicular to the bolt, engaged grooves in the bolt in the open and closed position, thereby securing the bolt mechanically in its extreme positions, regardless of hydraulic pressure. The bolt was also locked hydraulically at any time because the hydraulic fluid was trapped in the system, regardless of whether the hydraulic system was under pressure or not.

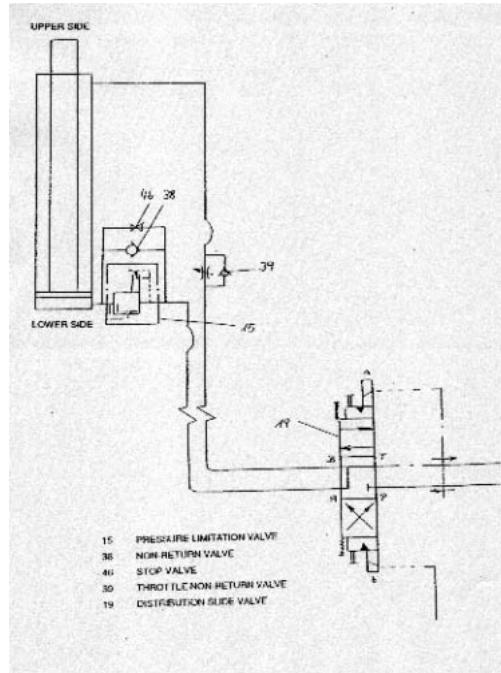
- When the distributing slide valves were moved (19) from right to left, oil would flow from the pressure pipes (P) to the piston undersides, the piston rods moved upwards and the visor opened. The oil at the piston rod sides flowed undisturbed through valves 39 into the return pipes (T).

- When the distributing slide valves were moved from left to right the oil flow reached in throttled condition (39) the upper cylinder chambers (piston rod side). The pressure in the upper cylinder chambers pushed the pistons downwards. Also the weight of the visor acted on the pistons. At the underside of the pistons overpressure developed as the stop valves (46) closed, the non-return valve (38) prevented oil flow in this direction and the pressure limitation valves (15) were not yet open. Only if excessive pressure had built up at the lower sides of the pistons would the pressure limitation valves (15) open and the visor move downwards.

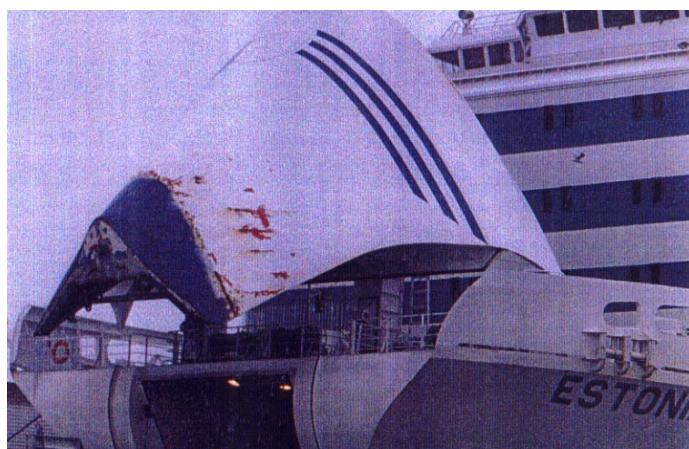
The results of such reckless navigation are clearly visible on the large photo on the previous page which was taken on the following day, 25 March 1994, in Tallinn by the professional photographer Li Samuelson.

The ice damage sustained by the visor during the months of February and March 1994, when the Gulf of Finland and the Northern and Middle Baltic were more or less continuously covered by ice (see Subchapter 12.4.2), were roughly repaired by replacing parts of shell plating and bottom of the visor in Tallinn whilst the vessel remained in service. The renewed parts are still visible on the visor.

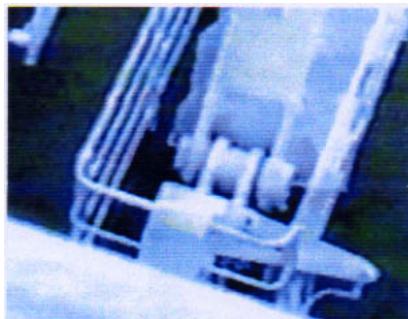
b.) That there was something seriously wrong at least with the starboard hinge arrangement of the visor well before the casualty becomes very obvious when having a close look at the **video film made by a passenger upon departure from Tallinn on 17 September 1994**, i.e. 10 days before ESTONIA's last sailing. He stood on the open forepart of the 8th deck and with his video camera filmed the closing of the visor. Thereby he zoomed in on the starboard hinge arrangement. The subsequent evaluation of the video proved that the starboard visor hinges were totally misaligned with the lower part of the outer bushing as well as the securing plate missing. The video was analysed and evaluated in detail by the Reconnaissance Expert Bryan Roberts of Churchgate/UK and his report is attached as [Enclosure 12.5.180](#).

The print is shown below and the enlargement is attached as [Enclosure 12.5.181](#).

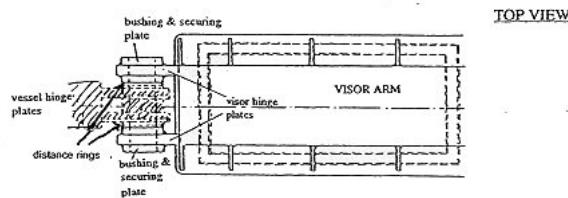
On the other hand, he had told Klaus Rahka during the questioning at Hangö on 24.03.95 that he had painted the visor hinges green and white and - as clearly visible on the video image on the following page showing the starboard hinge bolt - there is quite a lot of green paint on the bolt which could not possibly have got there as long as the hinges were in their original, intact condition because then it was practically a closed system, i.e. paint could not reach the bolt. The intact system has no gap as can be seen from the drawing below showing the intact starboard hinge arrangement.

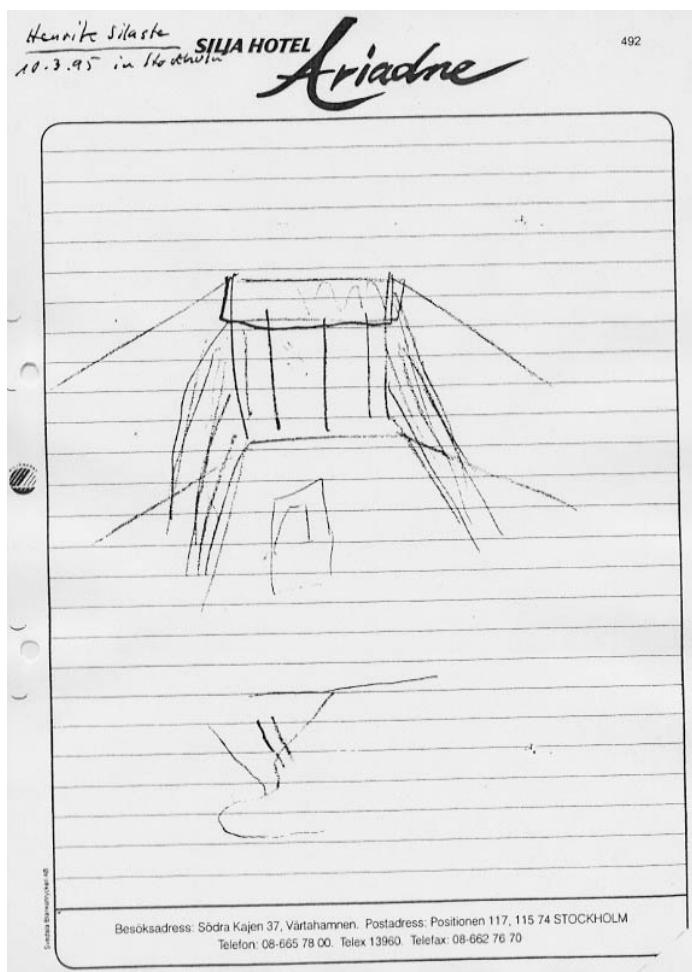
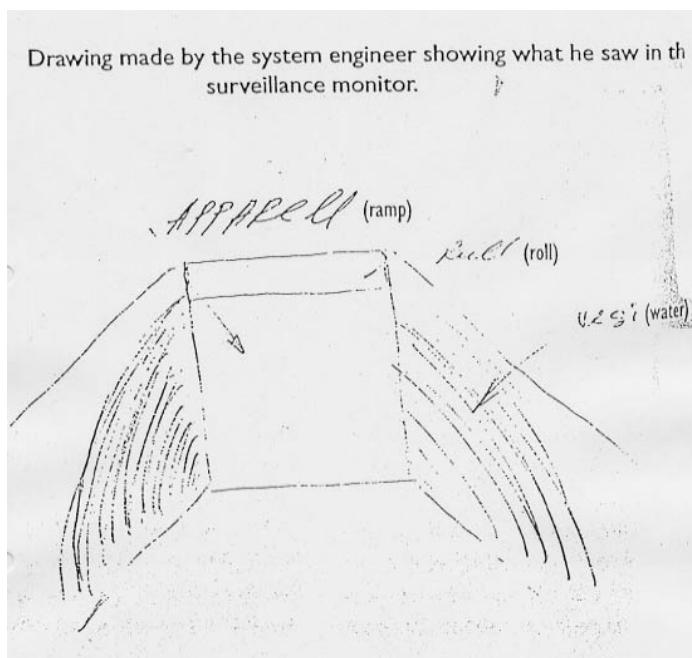
Already in January 1996 he was again interrogated by the Estonian security police when he made another drawing showing the same condition of the slightly open bow ramp with water pressing through at both sides. Both drawings are shown below.

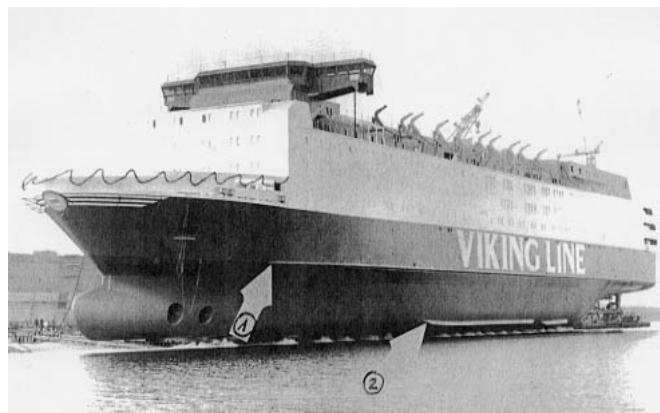
- When he was at the forward part of the fenderbar he saw something like a fin sticking out of the hull, dark like the bottom, maybe 1.5 m or less, looking like a propeller blade of a plane. It was not moving.

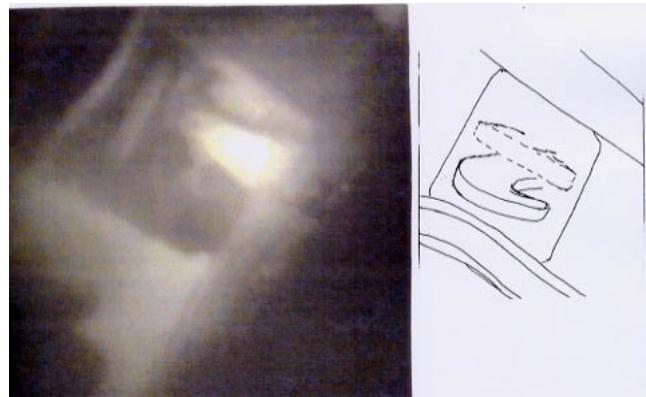
From subsequently obtained video footage - evaluated by Disengage - it was ascertained that the port ramp hook was intact and complete, i.e. neither broken nor bent straight. This means that this hook had not been engaged in its mating lug because this lug is also intact with the bolt undamaged. - See also item 6. The following image shows the intact ramp hook, the adjacent drawing explains the image.

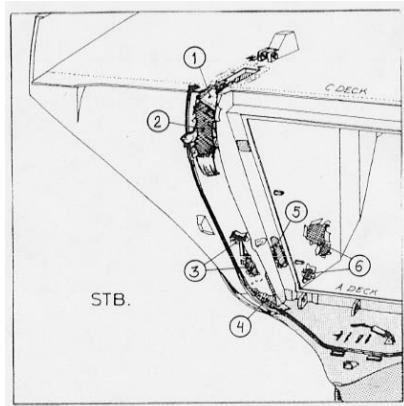
#### S4 -Starboard Front Bulkhead

The area under investigation is restricted to the starboard front bulkhead of the wreck as shown on the drawing below. There is no sheet available for this area. For easy reference the explanations will be given by photos/video images incorporated into the text. The numbers on the drawing indicate the damage areas which shall be explained and illustrated as follows:

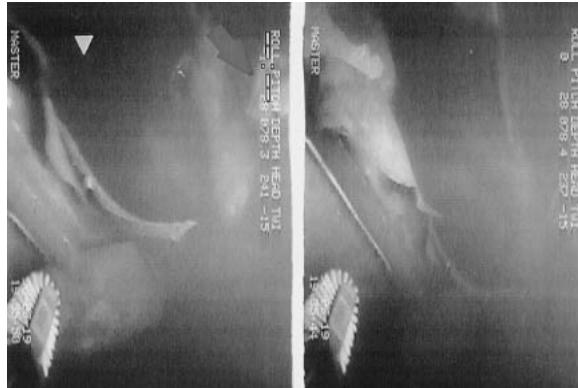
Area No. 2 shows the damage further down the front bulkhead. Note the torn open steel bent to starboard and to port.

The arrow on the left picture points to the severely distorted mating lug for the ramp hook.

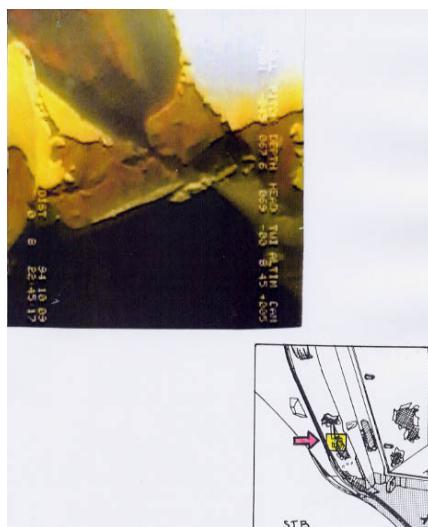
The next image shows the broken bulkhead part between the opening with the lug of the hydraulic side lock and the much enlarged opening for the manual side lock below.

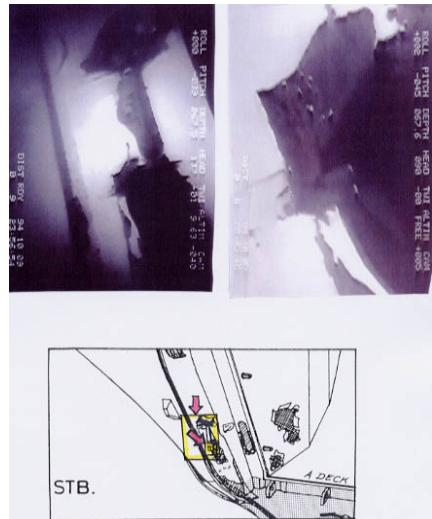
The following pictures show the upper part of the enlarged opening for the manual side lock.  
Note the steel bent from inside to outside.

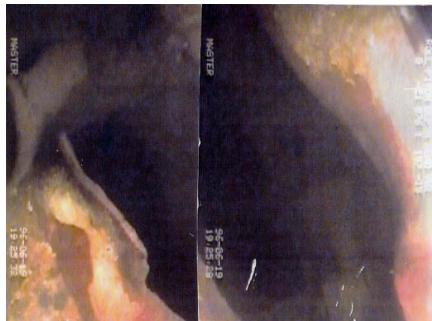
The two pictures below show the enlarged opening for the hooks of the manual side locks with the steel plating bent from inside to outside and the edges cracked.

On the right picture the not engaged mating part of the manual side lock is visible in the background. Furthermore a "soft" indentation can be seen on the inside of the substantially enlarged opening.

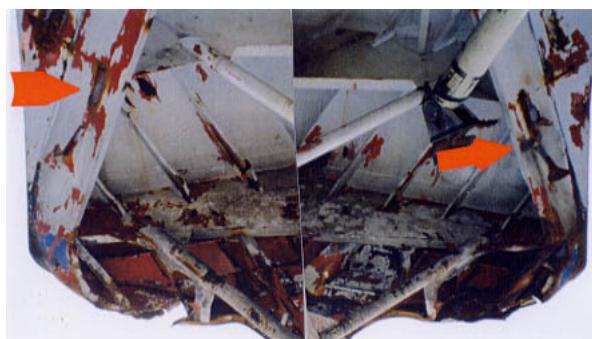
Next pictures follow which show the starboard lower aft bulkhead of the visor having been directly opposite to the corresponding parts of the starboard front bulkhead of the wreck. In comparison also the port lower aft bulkhead is shown.

The picture on the right left shows the area of interest on the starboard side, the picture on the left shows the corresponding port side. It shows a completely different damage picture: no smoke marks, no steel tongue torn off the bulk-head and no twisted hooks. Two of the following four pictures on the next page show those areas at the port and starboard aft bulkhead of the visor where the lugs of the side locks had been welded to and the hooks for the manual side locks were fitted. The other two are close-ups of the upper parts of the area where the lugs had been welded. The right side shows the part of the starboard visor bulkhead directly opposite the above explained damage area. The smoke marks are still clearly visible although the visor had been on the sea bottom for 7 weeks. The hooks are distorted in a way which is technically not explainable. The area is dark. The picture on the left shows the corresponding port side as comparison with a complete different damage picture, with no smoke marks, no steel tongue torn out of the bulkhead and no twisted hooks and a generally clean appearance. The two close-ups arranged below the above mentioned photos show the respective upper parts of those openings in the bulkhead. They do illustrate the difference very clearly. While the port side shows normal steel clean of corrosion, the starboard side shows steel which had obviously been exposed to heat and pressure force: The metal is distorted and pushed out, the stiffener is detached from the bulkhead. See also Chapters 30 and 32.

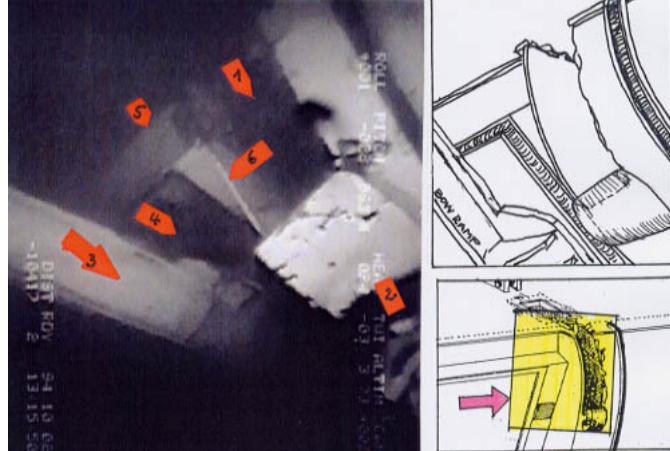
Arrow 3 points to the slightly open bow ramp, arrow 4 to the car deck opening and arrow 5 to the forecastle deck.  
Arrow 6 points to a wire running from forecastle deck down beside the bow ramp, which was no more there when the divers came.

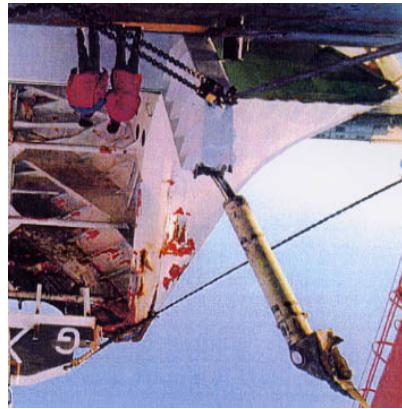
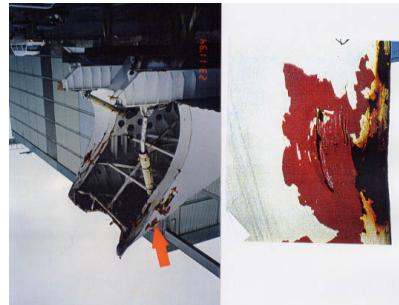
The starboard actuator, to the contrary, was found to be fully extended with the piston rod bent. It had apparently been the last connection between the vessel and the visor except for the bow ramp, the fore-castle deck and bulbous bow.

The area indicated by the arrow and the close up was probably struck by the foundation of the starboard actuator after the actuator had moved out of the front bulkhead of the vessel. - See also Chapter 30 - The Visor.

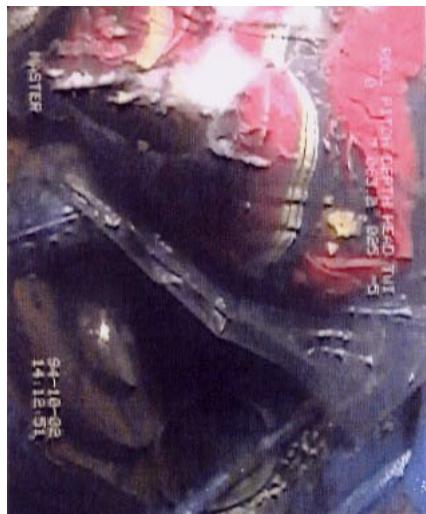
The following image taken from the 02.10.94 video shows the location of the port outer hinge which slipped off, intact outer lug some distance away from its original position because evidently a gap had opened and the ramp became detached from the vessel in this area and through this gap between forepeak deck and bottom of ramp water could freely penetrate on to the car deck from the visor which was always water-filled at sea. This gap was plugged by mattresses - see the blue transverse one above the hinge remains - the vertical plastic sheet to the right of the blue mattresses, the red/white bedding next to the plastic sheeting. The videos from 02. and 09.10.94 are showing blankets and rags further up in the gap between ramp and bulkhead.

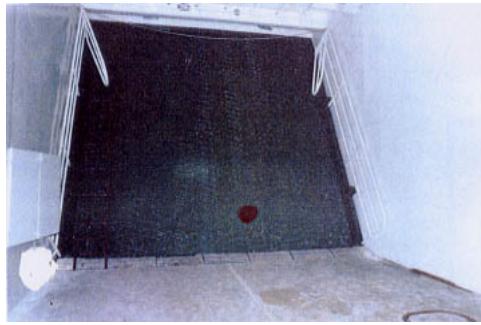
- There is an area of ca. 1 m<sup>2</sup> located between the upper flaps and the level of the car deck opening where the paint is burnt and the plating is severely distorted. The area is inside the ramp house when the ramp is closed.
- The lower area is located in the 3rd row of steel profiles, looking from starboard, which are welded to the ramp plating and the 6th or 7th profile from car deck level as indicated on the picture below by the dark spot. The paint of the plating as well as the two flaps below looks reddish/brown. The plating otherwise does not look affected, but the two flaps are bent and distorted and the car deck plating in way appears to be affected.

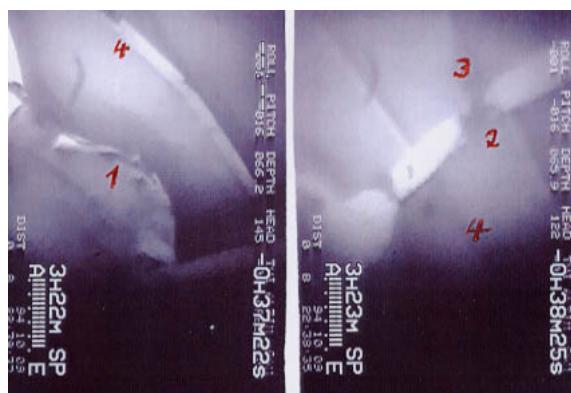
Also damage No. 5 is dubious because the area has obviously been damaged twice, viz.

- (1) at first horizontally (the black looking area) and
- (2) secondly diagonally.

The left picture shows the lower part of the port outer vertical girder, cracked off above and below and twisted up to 70° - damage No. 1 on the drawing as well as damage No. 4. The right picture shows damages Nos. 2, 3, 4.

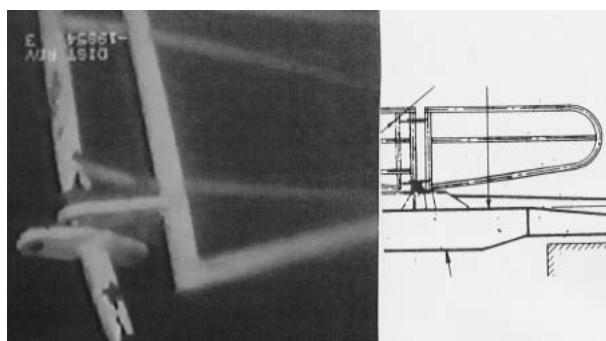
As parts of the starboard rail, the 4th section with the attached 5th moveable section, were found on the seabed already on 02.10.94 by ROV "Jutta II" - see the image on the next page - the available footage has been evaluated for indications of the bow ramp rails.

It is obvious that it is the starboard side because the movable part is always fixed at the inside of the fourth section if the ramp is open, as visible here and it is also obvious that the lower, bent part was the part attached to the ramp. It is further apparent that the vertical stanchion had been bent and finally cracked off by a force acting from port to starboard.

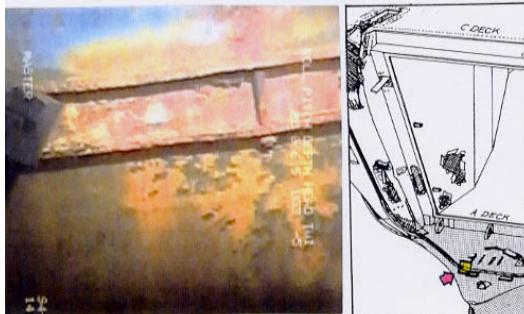
- Nos. 2, 4, 5, 6 show either empty flatbar channels where the rubber packings were supposed to be - which is also confirmed by the image below - or show the rubber packing lying loosely on the flatbars into which they should be fitted and bolted. The evaluation of the video films - of which these 3 pictures are just a small selection - prove that the rubber packings were only in place at the starboard side from forward of the Atlantic lock to the "corner of the mouth" and these were in a rather poor condition. Along the whole port side up into the "corner of the mouth" there were no rubber packings. The diver followed the flatbar - channel for the rubber packings from the top of the starboard front bulkhead via the forepeak deck to the top of the port front bulkhead which is documented on video tape B40c. The two images below are just a confirmation of the findings explained above.

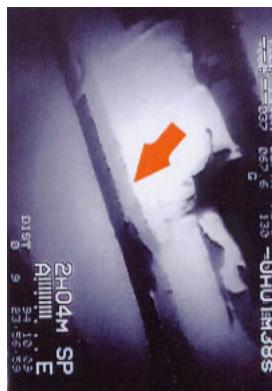
The lower part of the starboard front bulkhead in way of the hydraulic and manual side locks - see also further forward in this chapter, the starboard front bulkhead - is shown on the following images. The first one shows the upper part of the opening for the manual side lock with the rubber packing to the left. Between opening and rubber

packing the bulkhead is visibly bulged - see arrow - i.e. the bulkhead is pushed out around the opening for the manual hook and increasingly deeper down the bulkhead. This can be seen from the next image below - arrow 1. In addition, there is a very deep fold - see arrow 2 - as well as damage in way of the rubber packings - arrow 3.

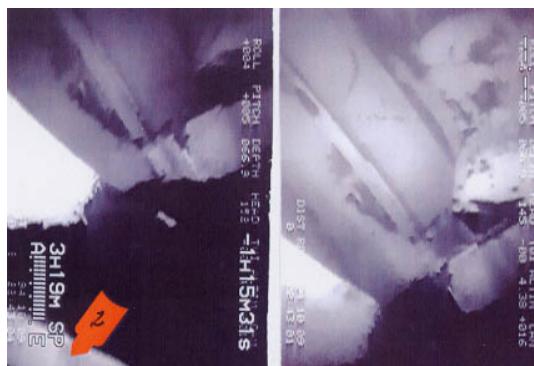
The following two images show the area adjacent to this pushed-out lower part of the front bulkhead, the recess with the torn-off and severely bent lower part of the outer vertical girder of the bow ramp. Apparently the deck/bulkhead is open in way of these severe distortions which also extends downwards.

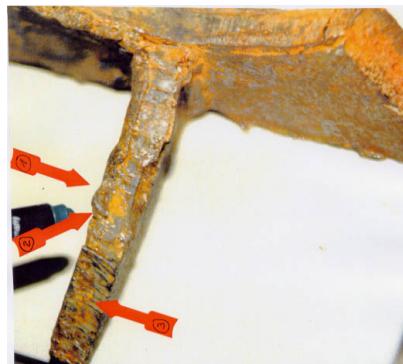
- Next an enlargement of the support bracket attached to the outside of the starboard lug is shown.

- The support bracket at the outer side of the lug (arrow 1) is larger than the original, which is evident because it overlaps the end of the welding seam (arrow 2) which marks the end of the bushing. The support bracket is about 12 mm larger compared to the original one made according to the von Tell drawing No. 49111- 373.

- The oblique end of the bracket is just burnt, not grinded (arrow 3). It is considered impossible that the bracket would have left blacksmith's shop of the Meyer Werft in such a condition - see also Subchapter 2.4.6;

- The welds are thin and interrupted, respectively cracked, because they are so thin, which is demonstrated by the corroded surface of the inner side of the lug normally covered by the bushing. As long as the welding seams are intact the space between bushing/lug is airtight, i.e. without oxygen, which was burnt by the heat of the welding process. This was obviously no more the case since some time before the bushing was torn off, because substantial corrosion was able to develop.

- The forward and aft welding seams between bushing and support bracket are not connected at the outer end (or closed, as the welders say), thus water could penetrate. This confirms the unprofessionalism of the welder who did these repair welds.

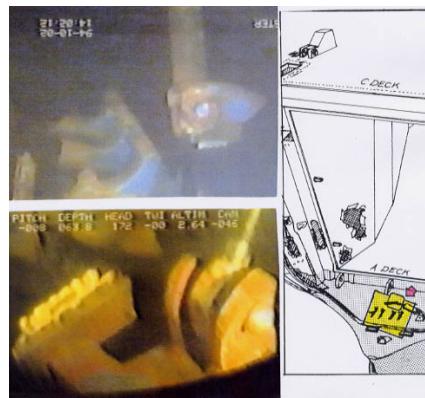
- This was no more the case at the time of the casualty as can be seen from images 13/15 and from the image below made from the ROV videos of 02.10.94 and 09.10.94, because evidently the contact plate was bent from starboard to port when the bolt was in original condition.

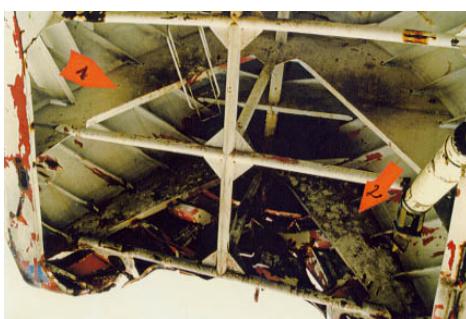
- The photograph on the next page was made mid January 1995. It shows a view into the visor with the partly oil stained 2nd stringer (arrow 1) and the completely oil covered stringer 3 (arrow 2).

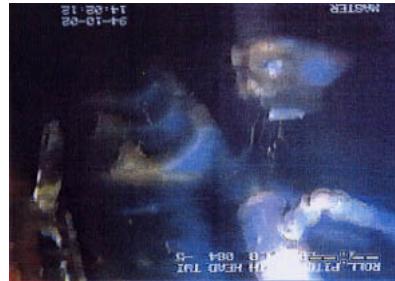
- Whilst the bending of the lugs is doubtless due to the powerful hammering by crew members when trying to force the bolt through the deformed lugs of the Atlantic lock, it is evident from the hammering marks on the contact plate, as visible on the next image, that they sometimes also hammered against this plate when trying to open the bolt. The following image, taken from the Part-Report of the JAIC, shows these lugs to be full of hammering marks, which are shining like new, without any traces of corrosion, although the fracture surfaces of the broken lugs are heavily corroded.

It appears strange that hammering marks, undoubtedly originating from hammering about 6 hours before the casualty, appear without any corrosion as can be seen on the above image, whilst fracture surfaces, which are said to originate from fracturing at the time of the casualty, i.e. were exposed to seawater only about 6 hours later, are severely corroded as can also be seen on the same image. This raises doubt whether the lugs of the Atlantic Lock really fractured only during the casualty or much earlier already.

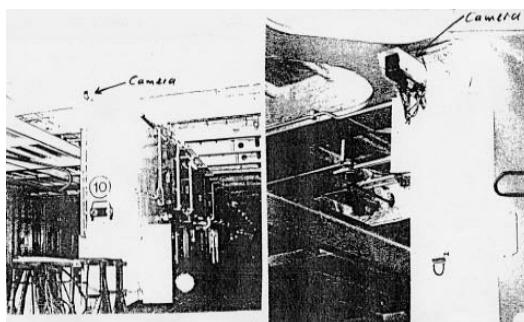
(1) the statement of the watch engineer Margus Treu that a jet of water hit the lens of the video camera transferring pictures from the partly open bow ramp to the monitor in the engine control room (ECR) where he was watching - see his statement dated 29.09.94 Turku - [Enclosure 21.2.3.263](#). Treu believed that this water jet came from the partly open bow ramp, which however is not possible because the camera is fitted at the forward part of the centre casing underneath the ceiling. The distance to the bow ramp is 25 m and the height above car deck is about 5 m - see the pictures below taken on board the near-sister DIANA II where the camera was installed as on ESTONIA.

It can thus be excluded that water penetrating the bow ramp at that relatively early stage could have reached the camera in such high position as much as the car deck between bow ramp and camera was full of trucks and cars.

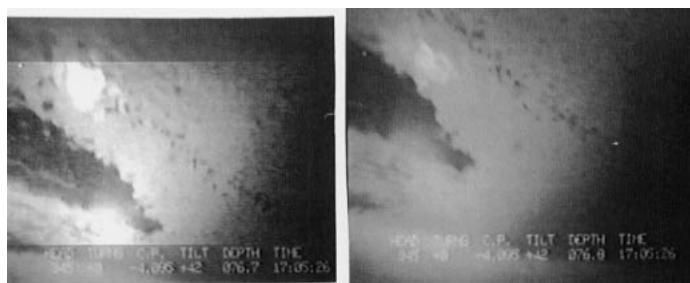
Enhancement by means of special equipment confirmed indeed that the plating is holed - See the enhancement below.

From the damage appearance it has to be concluded that the plate was severely corroded, i.e. the hole was neither caused by an impact of ex- or implosion but by corrosion. This is easily possible if the coating and/or anode protection of a ballast water tank, e.g. a heeling tank, was not in order.

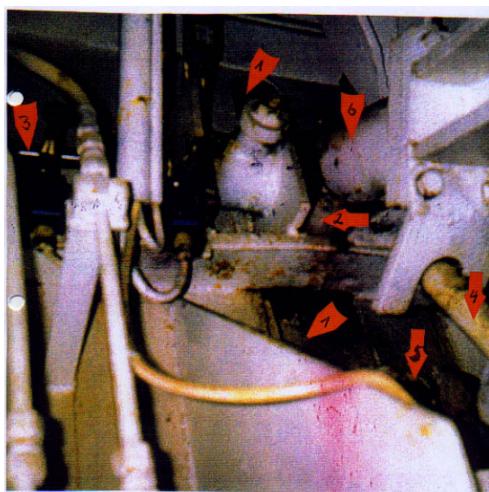
The lower void space - on A-deck - car deck level - was located directly below the upper one - on B-deck - and contained the hydraulic and manual side lock arrangements as can be seen on the picture below which is explained by 6 arrows. The visor is closed.

- arrow 1 = opening in front bulkhead with visor plating behind through which the lug of the hydraulic side lock was extending
- arrow 2 = lug of hydraulic side lock
- arrow 3 = cylinder and piston rod of hydraulic side lock
- arrow 4 = hinged eyebolt with nut of manual side lock
- arrow 5 = 2 hooks of manual side lock
- arrow 6 = ice cylinder
- arrow 7 = opening for hooks of the manual side lock with visor plating behind.

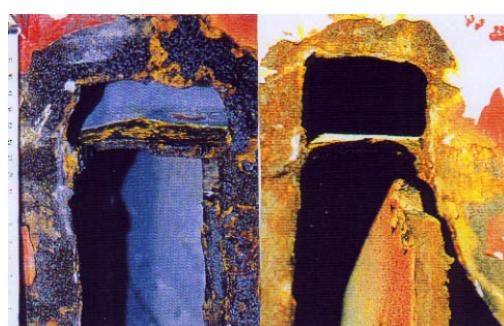
The two pictures below were taken from page 168 of the JAIC Report. The left picture shows the port aft bulkhead of the visor and the right one the starboard one, both in way of the initial location of the lugs for the hydraulic side locks. See also Chapter 30.

It is most likely that the starboard side had been exposed to considerable heat which is indicated by the corroded surface as a result of the changed metal structure. It is also most likely that the starboard side had been exposed to pressure from inside to outside which is indicated by the distortions and the cracked off stiffener, indicating a possible explosion in way. - See also Subchapter 37.7.

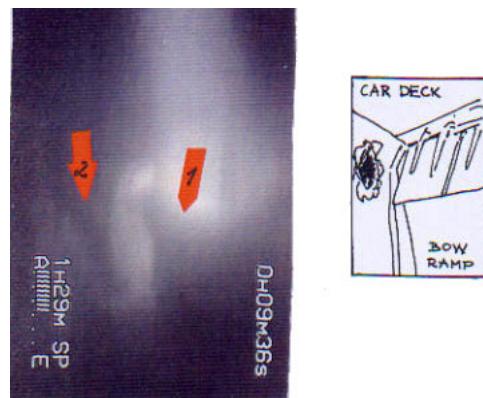
The diver looks down towards the lower flaps of the bow ramp and sees the first one on starboard side in raised condition - arrow 1 - and next to the flap he sees another hole in the bulkhead - see arrow 2.

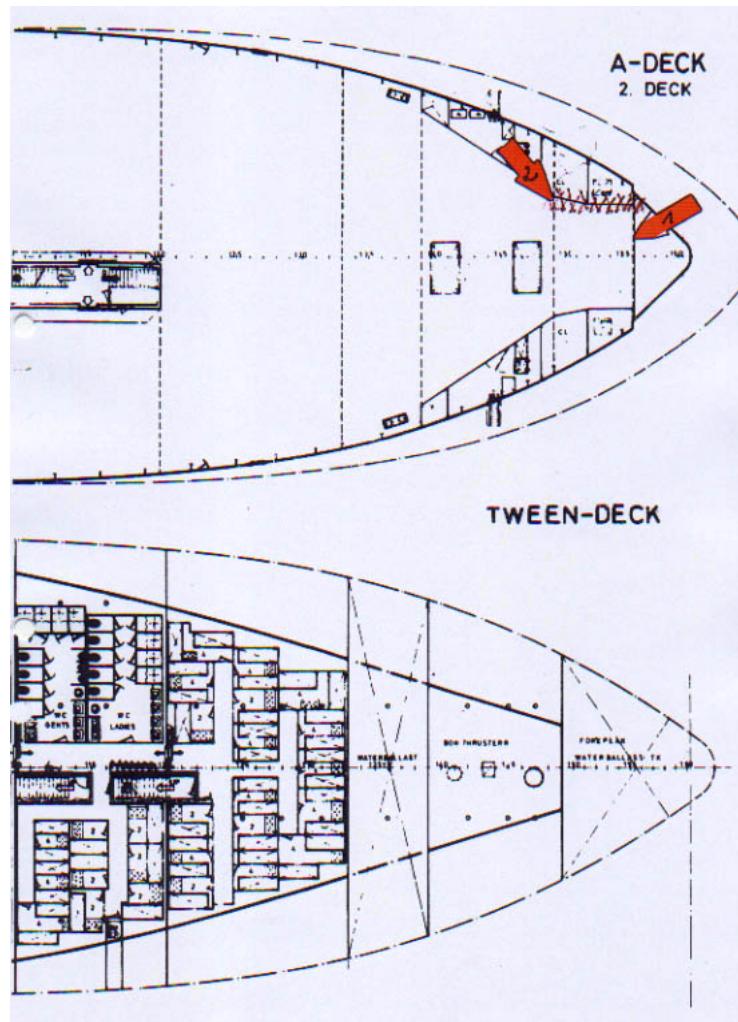
The drawing below is a part of the general arrangement plan of the vessel which shows the forward part of A-deck = car deck and the area directly below on tween deck = 1st deck. The red hatched area shows the damage area which can be seen on the images explained on the previous pages. The distance from the bow ramp - arrow 1 - to the corner of the bulkhead - arrow 2 - is about 4 m. Below the dotted line the bow thruster space begins, before that space the full forepeak was located.

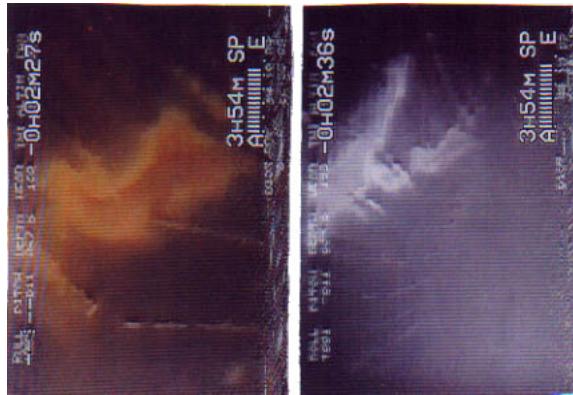
The respective inside of the bow ramp shows severe deformation and a burnt area in way. See the images below.

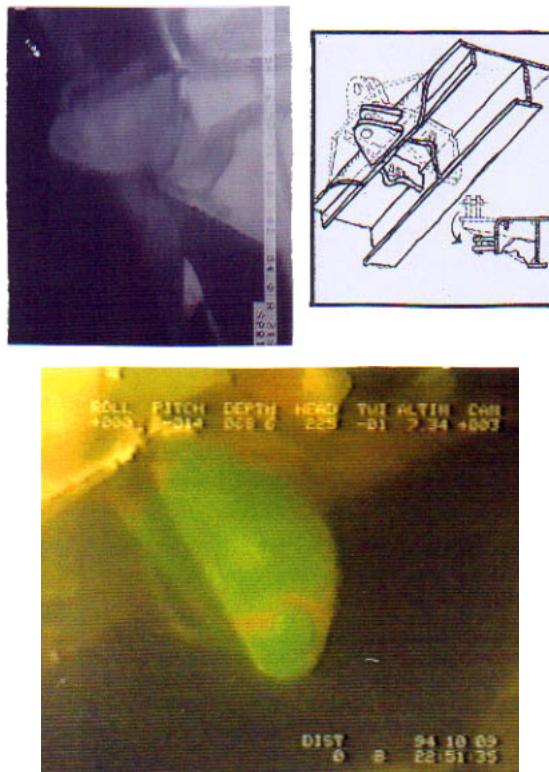
- The pushed up landing of the mating lug for the starboard ramp hook. See images below and on page 1106.

The landing with the apparently unaffected lug was pushed to starboard and upwards which has now also been verified by the expert Brian Braidwood and the results are confirmed in his "Supplementary Report" - see Subchapter 34.7.1. - [Enclosure 34.7.1.435.1](#). In summary of the before explained items (1) to (4) it has to be assumed that the damages shown on the drawing behind the next page had been caused by explosion.

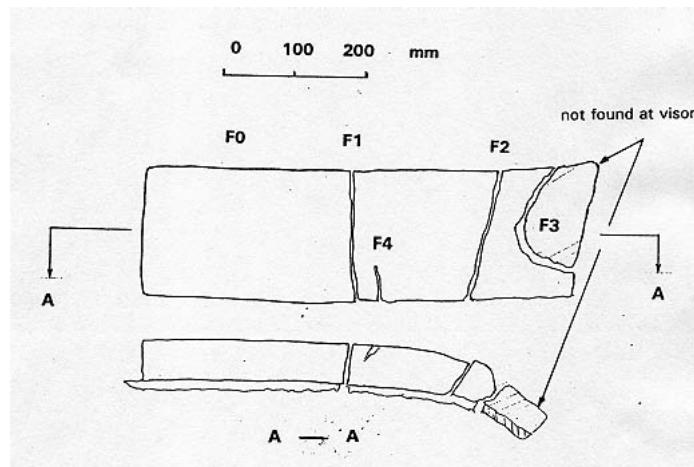
The welds between stempost and shell plating of the visor had failed already during normal service by a spectrum of cyclic loading providing tensile stress at the crack initiation points together with long term corrosive action of seawater after opening of the welds. As a consequence the stempost had not only been separated from the shell plating during normal service but the stempost being a vital part in its load-carrying function was in itself found to be split up into four parts by crack development well before the casualty. The drawing on the next page shows the cracks F1 - F4 of which F1 had penetrated the thickness of the stempost to about 40% and blue paint was found inside the crack. It could be verified that these traces of blue paint originated from penetration of the outside paint into the crack opening at the time the crack had penetrated the stempost already to the extent of about 40% of its thickness.

The investigation of fracture F1 - F4 ascertained that all the transverse fracture had started and penetrated from the outside by corrosion assisted fatigue cracking. In addition, fractures F2 and F3 reveal major bending displacements of their flanks, in particular fracture F3 reveals a specific bending angle of about 70° combined with severe bending deformation following the original crack development.

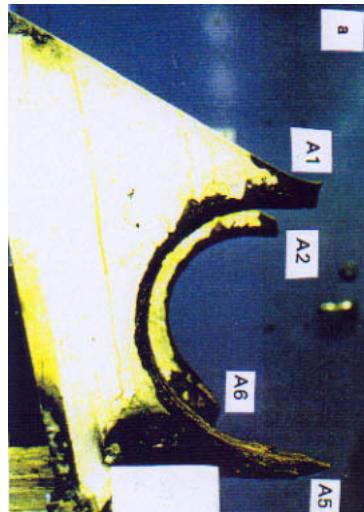
The following picture shows the broken port visor lug plates with the fractures A1, A2, A5 and A6.

The outer port side shows a vertical to slightly horizontal bending to port side at the fracture at the lower part of the remaining bore. The inner port side lug and both starboard lugs - see picture below - did not exhibit significant bending deformations. The picture below shows the broken starboard visor lug plates with fractures A3, A4, A7, A8:

The failure of the visor hinges occurred by fractures A1-A8 of the visor lug plates together with the fillet welds to the support bushings. The bolts had been ripped out of the hinges, together with the bushings.

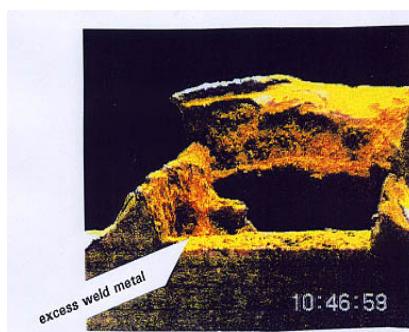
The fracture of the recovered hinge bushing was fitting to the fracture of the inner starboard hinge lug. It exhibits a gap of about 4-6 mm between lug bore and support bushing. This gap is almost entirely filled with corrosion products, presumably magnetite, which is also found in thick layers at a location where both hinge late and fillet weld failure are represented together with some excess weld metal, see arrow on the picture below which may have provided a local notch effect.

In another cross section, also severe corrosion inside the gap is identified and the surface of the hinge bore and the bushing exhibit a considerable misalignment, which, during welding of the left fillet weld, was overcome by a buffering layer. The misalignment corresponds to asymmetric burning marks, for example of the inner starboard hinge.

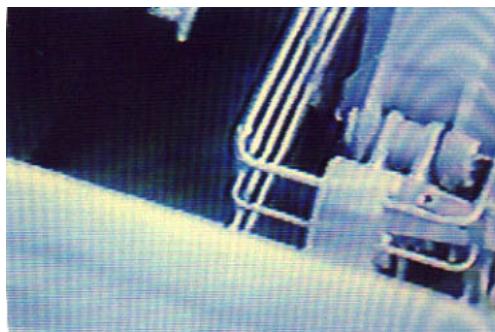
On the evening of 17.09.94, i.e. 10 days before ESTONIA's last departure from Tallinn, a Swedish passenger was standing on the forward open part of deck 7 and filmed the closing of the visor, the handling of the mooring lines by the deck crew and, finally, he zoomed in on the starboard visor hinges. The first copy of the original film was made available to this 'Group of Experts' and a first internal analysis revealed that the starboard visor hinge was in an absolutely disastrous condition as can be seen on the image below.

The object of the report was to detect and identify any structural rupture or damage which could have contributed to the loss of the Ro-Ro ferry ESTONIA. For identification of components bracketed numbers, for example (5) in the text refer to annotations on the drawings, on the previous page. A detailed examination of the video tape showed the only damage to be identified limited to the starboard visor hinge.

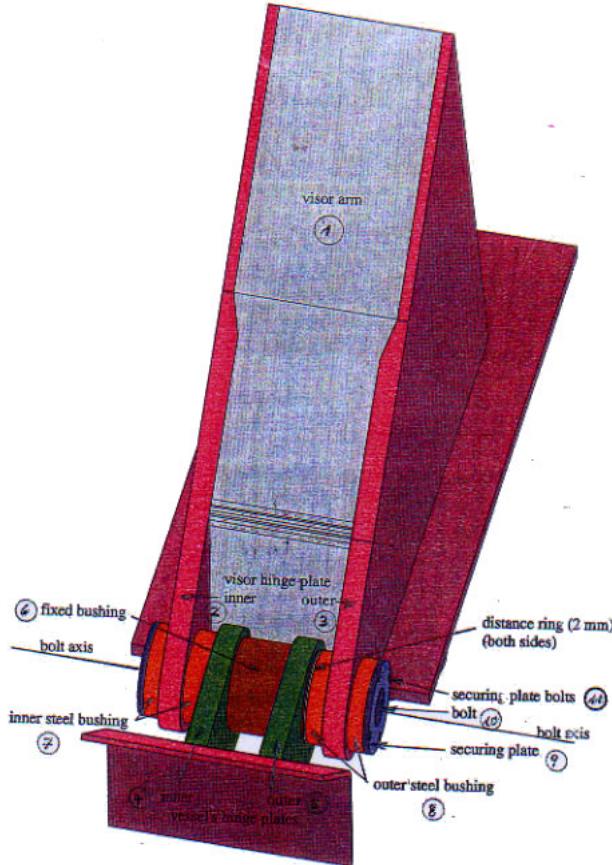
For explanation purposes a computer drawing of the hinge arrangement was made and the figures 1 - 12 point to the relevant components as outlined below:

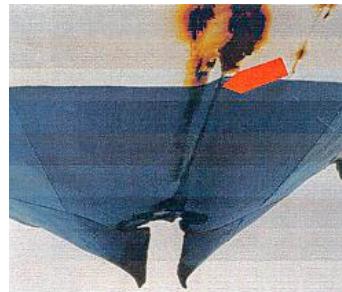
The shell plating as well as the internals are very severely damaged in two places, viz. there is a deep vertical indentation in the bow leading upwards from the stempost for about 2 m, as can be seen on the picture below from the outside,

The arrow points to the deep indentation which is completely painted and the paint does not show contact marks. The following photos showing the inside of the same area do confirm the deep indentation in a very strong part of the visor to be of old origin.

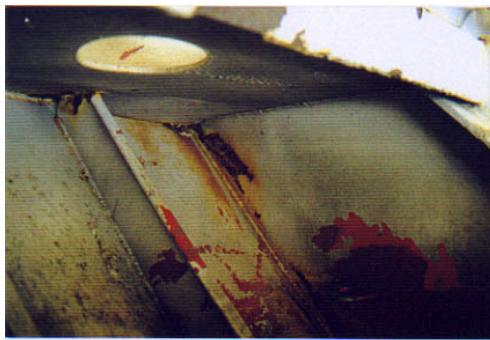
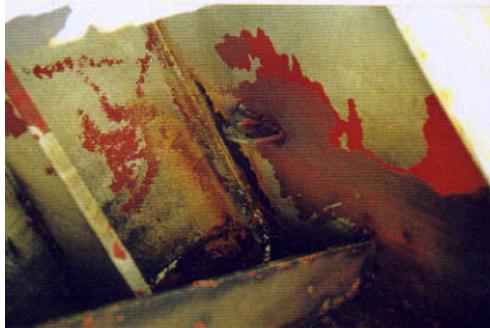
Furthermore, the shell plating as well as the 3rd stringer at the port side are severely indented and set up with the frames buckled which had been sustained already some time before the casualty. - See the pictures above.

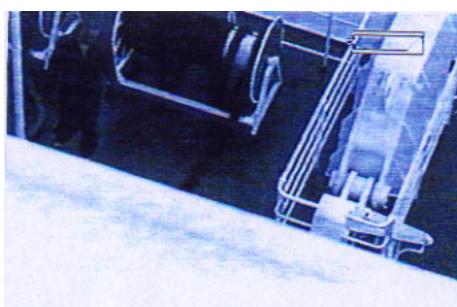
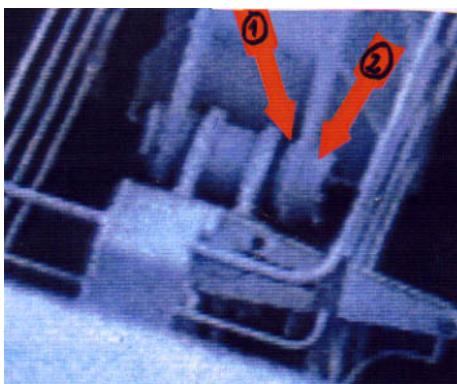
The passenger was standing in front of deck 7 and filmed the closing of the visor, finally zooming in on the starboard hinges. The video-prints below are part of the film. Picture 2 is an enlargement of Picture 1.

On Picture 2 there are obviously several major deficiencies visible, viz.

(a) the gap between the starboard vessel hinge plate and the outer bushing is much too large (arrow 1).

(c) the lower part of outer bushing is missing.

(d) the securing plate is missing and the outer end of the bolt is not visible.

All this indicates that the steel- and bronze-bushings of the starboard visor hinge arrangement had been replaced some time ago in a very unprofessional way with an extremely poor standard of workmanship.

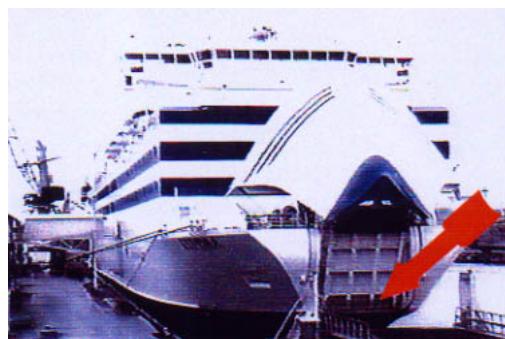
The following picture shows the ESTONIA in Tallinn, with open visor but closed bow ramp so that the otherwise invisible underside of the bow ramp is shown with the lowest section being dark - see arrow. Doubtless this was caused by the water inside the visor with hydraulic oil from the leaking cylinders swimming on top of the water surface. When the vessel reduced speed and the bow wave became smaller and finally disappeared completely when the vessel was alongside, the water streamed out of the visor and the oil settled everywhere inside the visor, also on the bow ramp which forms the aft inside of the visor. The water streaming out of the visor was observed by many passengers when the vessel was alongside in Stockholm with closed visor and, among others, also by the skipper of the Sandhamn pilot boat as well as by several pilots when the ferry was slowing down during the approach to the pilot boat.

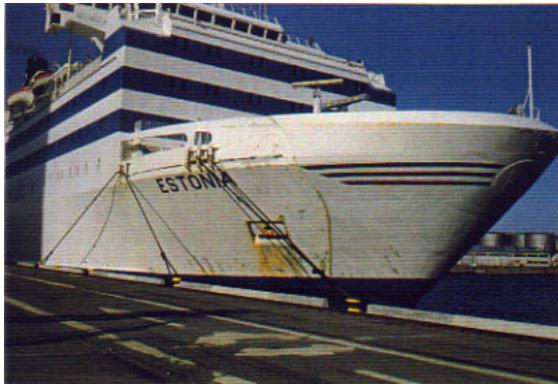
All this led, of course, in time to a considerable reduction of the load-carrying capacity similar as with the hydraulic side locks of the visor. Also the hinges of the bow ramp were severely affected, in particular the port outer hinge. This very heavy hinge arrangement was already damaged before the vessel was taken over by her new owners in January 1993, because the old Finnish crew had already requested renewal at the planned yard time in January 1993 - see Subchapter 6.5.1. Nothing was done by N&T and since the mates of the ESTONIA performed the loading and discharging of the cars and trucks reportedly rather carelessly, the vessel very often had a list during loading or unloading which finally broke the port hinge completely according to the report of a truck driver being an eye witness.

Also the rubber packings around the car deck opening, which should be sealed tight by a properly closed and locked bow ramp, apparently did no more seal watertight since some considerable time already, because the last Finnish crew had ordered 10 m of rubber packing to be renewed at the next yard time which was planned for January 1993 - see Subchapter 3.4. - as mentioned before. This was more than half of the total length of the rubber packings, but also these packings were never renewed.

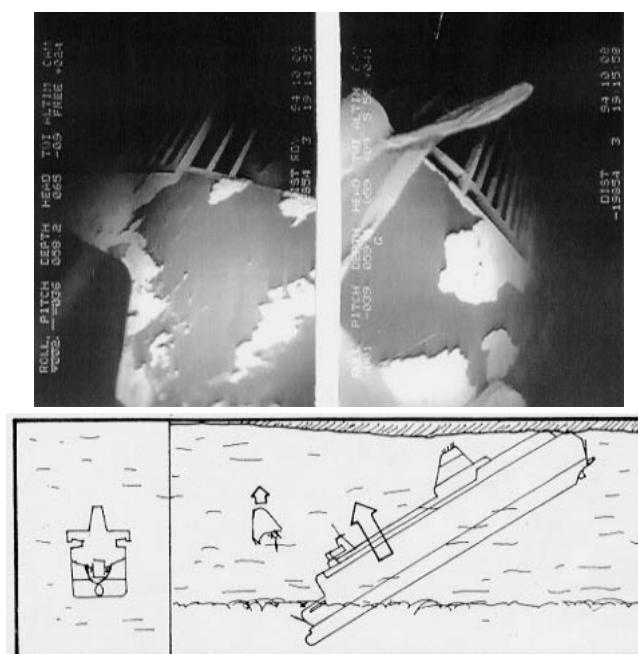
The Estonian flag car/passenger ferry ESTONIA - pictured below - departed from Tallinn on 27 September 1994 at about 19.15\* to 19.30 hours for a scheduled voyage to Stockholm. Reportedly she was carrying 989 people - 803 passengers and 186 crew members - as well as 40 trucks/trailers, 25 passenger cars, 9 vans and 2 buses. Despite the completely filled port heelung tank she had a 1° starboard list at departure.

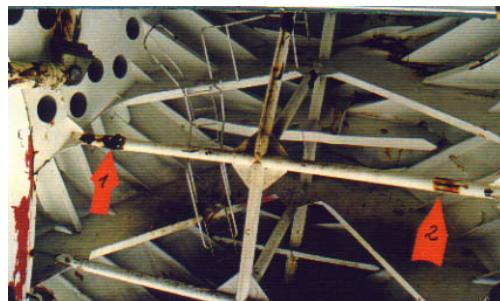
Although the upper transverse crossbar inside the visor shows respective damage - see arrow 1 on the picture below - the corresponding part at the port outer longitudinal girder of the bow ramp does not. This is confirmed by the image further down,

taken from the ROV video made on 09.10.94 which shows the port outer girder underside of the bow ramp in way of the contact area with the above-mentioned crossbar. There is no damage, the paint is completely unaffected (the diagonally running stripe being a wire).

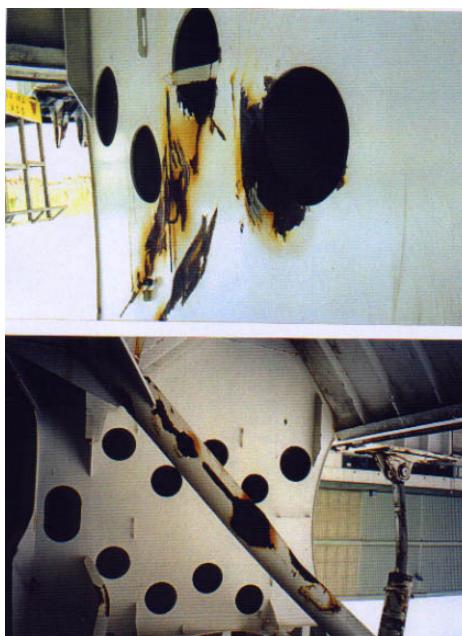
Finally attention has to be drawn to one indentation pushed at each side into the forward deck beam of the visor, i.e. the lower side of the forward part of the ramp house as indicated on the two pictures on the next page. According to drawing on page 956 the port indentation is 240 mm away from the inner bulkhead and the starboard one 325 m. This means that these indentations were most probably caused by the bell cranks being the most upwards extending parts of the bow ramp. This must have occurred at a time when the visor was hanging on the bow ramp already, i.e. the contact area having been the port inner bulkhead. Therefore the distance between bow ramp and port inner bulkhead has as small as possible - 240 mm - while the opposite distance between the bow ramp and the starboard inner bulkhead was as big as possible - 325 mm. This is also the explanation for the apparent fact that the port inner bulkhead was very severely distorted and partly cracked while the starboard inner bulkhead remained completely unaffected even without paint scratches. See also S 4 and P4 - The Inner Bulkheads - further down.

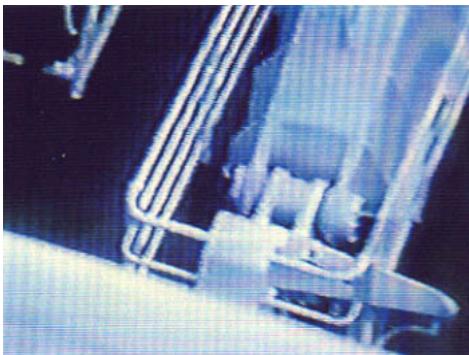
1 - shows the remains of the starboard hinge plates still attached to the visor (they were cut off upon the instructions of the JAIC in January 1995 and were transported to the Royal Technical Institute (KTH) in Stockholm for examination). The very bad condition, especially of the outer hinge plate is obvious. The deep burning marks and the missing metal are striking. All this is confirmed by the video film made by a passenger on 17.09.94 from the open forepart of deck 8 - see also Subchapter 12.5 - i.e. 10 days before the catastrophe. The image below shows a sequence of this video.

It demonstrates that,

- the whole hinge arrangement is severely misaligned;
- the outer bushing is extending too much to the outside and is twisted;
- the lower part of this bushing as well as the securing plate are missing;
- there is a big gap between the inner part of this bushing and the outer hinge plate fitted on the forecastle deck;

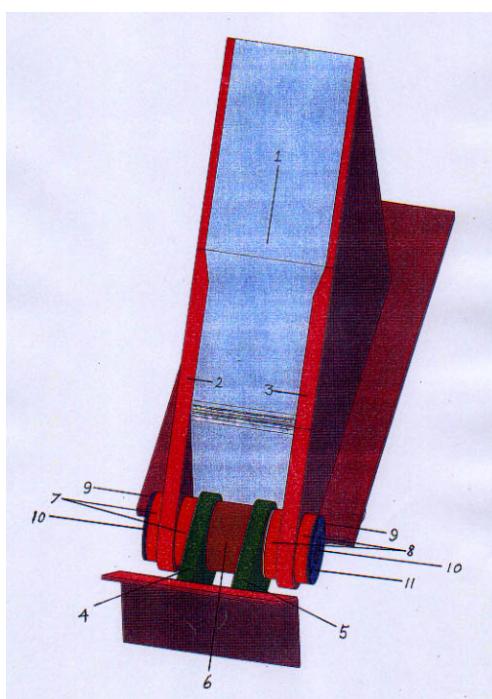
The bushing, obviously having broken out of this inner hinge plate, was recovered by divers and was thus available for examination also by the metallurgical expert on behalf of this 'Group of Experts' and reference is made to the Report of Prof. Dr. Hoffmeister - see Subchapter 34.4 - [Enclosure 30.417](#). Further, the recovered bushing is shown in detail on Sheet 3 and shall be discussed subsequently.
