##### **2 THE VESSEL "VIKING SALLY"**

The German 'Group of Experts' has now - as far as possible - completed its investigation of the foundering of the M. V. ESTONIA, a disaster that has taken the greatest toll of human life in the Baltic Sea in times of peace. The German 'Group of Experts' has during the past five years performed a difficult investigation in a partly hostile and reluctant environment. The work was carried out during the first two years - 1995/1996 - in close co-operation with the Swedish leader of the Technical Group of the Joint Accident Investigation Commission of Estonia, Finland and Sweden (JAIC), Börje Stenström († February 1997), and also with the Finnish member of the Technical Group, Dr. Tuomo Karppinen and the expert Dr. Klaus Rahka. All the investigation results of this 'Group of Experts' were submitted either verbally in joint meetings with the members and the experts from Estonia, Finland and Sweden attending or in letters with attached photos and/or video film documentation to the JAIC. This documentation and information concerned the design, construction and building of M. V. ESTONIA in general and the locking devices of the bow visor in particular,

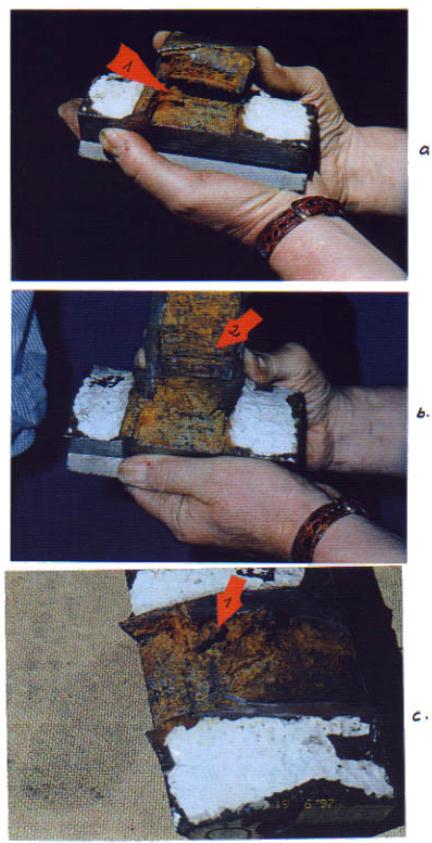
2, 3, 6 - show part of this bushing with part of the fractured visor hinge plate still attached to it. This part is shown in more detail after the hinge-plate part had been cut off on the following page (pictures a - c). The pictures reveal the following:

- The welding seams between bushing and hinge plate are of poor quality and only 7-8 mm thick whereas the originals were about 15 mm thick.
- The same welding seams apparently cracked frequently and it had been attempted to close the cracks by welding which resulted in welding material penetrating through the cracks into the gap between the hinge plate and bushing. See arrows 1 on pictures a and c.
- The surface of the bushing in way of the hinge plate shows corrosion which indicates that the space between bushing/hinge plate, which should be sealed airtight by the welding seams, had not been airtight anymore for some time already obviously due to the crack propagation in the too thin welding seams and/or due to unprofessional welding.

- The inside of the hinge plates were damaged by deep burning marks (see arrow 2 on picture b) from which crack propagation into the material of the hinge plates started and after the cracks had penetrated 50-60% of the material the remaining part of the hinge plate failed in the shear mode.
- The surface of the bushing, corresponding to the inside of the hinge plate with the burning marks explained above, does not show burning marks, therefore it has to be assumed that the original bushing was burned out some time before the casualty and replaced by the present one.
- The gap between bushing and hinge plate in way of the fracture area was about 25 mm indicating that the bushing did not fit into the hole of the hinge plate because the bushing was too small.

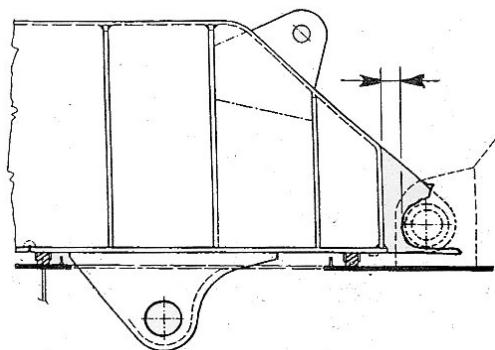
Note: When measuring the distances from the vertical welding seams between face plates and hinge plates and the inside of the bores through the hinge plates it becomes evident that at the starboard hinge plates there is about 15 mm less material than at the port hinge plates. This means that the visor was misaligned at least by this distance of 15 mm in the forward / aft direction. See the drawing below.

This means that the distance between the 2 arrows above was 15 mm smaller at the starboard hinges compared to the port hinges. This was certainly one of the reasons why the starboard hinges broke first and the port hinges were holding for some time longer.

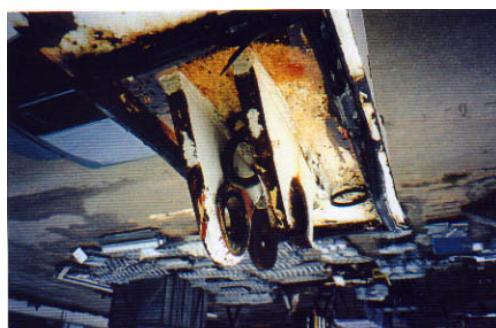
3/4/5 - show the opposite inner lug plate with very deeply engraved scraping marks, furthermore all three pictures show that the rubber packing, which is supposed to seal the opening for the actuator in the forecastle deck, is - contrary to the starboard side - torn and damaged.  
This picture on the next page shows the damaged and torn rubber packing indicating movement of the visor without this side having been raised up.

(1) The outer lug plate is completely untouched while the inner lug plate shows very deeply engraved scraping marks. This means that at the time when the lug plates were cutting through the deck plating and the deck beam the vessel must have heeled already considerably to starboard. Therefore the centre of gravity of the visor had shifted from forward to starboard and the force direction was no more to forward/downwards but starboard/downwards. Thus the weight of the visor in athwartships direction was now carried by the inner port and the outer starboard lug plates because the locating horns gave no more transverse support as the visor had moved too much forward.

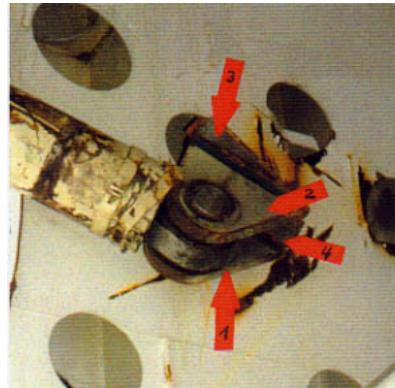
In consequence of this statement the photos showing the damage condition of this foundation have been analysed in detail and the result is outlined below: The foundation of the visor actuators did consist of two strong lugs welded to the B-deck and which were supported by two longitudinal and two transverse stiffeners. The picture below shows the port foundation with actuator still attached to the recovered visor. The arrows indicate the different components.

- arrow 1 = port outer lug plate of actuator foundation
- arrow 2 = port inner lug plate of actuator foundation

- arrow 3 = port inner stiffener (deformed)
- arrow 4 = port outer stiffener

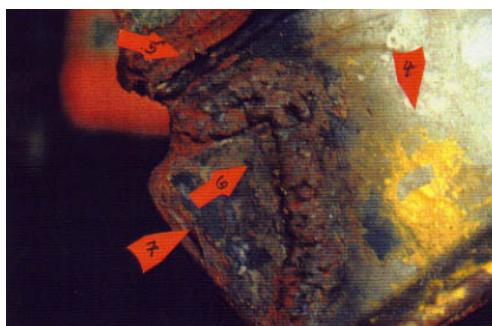
The lug plate (1) was obviously only partly connected to the B-deck as can be seen from the above photo when it was ripped off the B-deck (5) and only a small part connected by the welding seams (green paint) remained with the actuator foundation. The deck as well as the stiffener were pre-damaged - see Subchapter 34.4 - [Enclosure 30.417](#) - which is indicated by the damage repair, but also by the more or less straight cracking of the stiffener forward and aft of the lug plate, as can be seen on the following photograph.

Due to the relatively straight cracks (7) directly below the forward and aft parts of the lug plates, it has to be assumed that the stiffeners in way were affected by fatigue cracks. The cracks had developed during some considerable time before the casualty due to load changes during opening/closing of the visor and did most probably propagate more quickly during the last month before the casualty because of the increasing difficulties with the visor, especially with the port side. See Subchapter 12.4 / 12.5. The following drawing demonstrates the above.

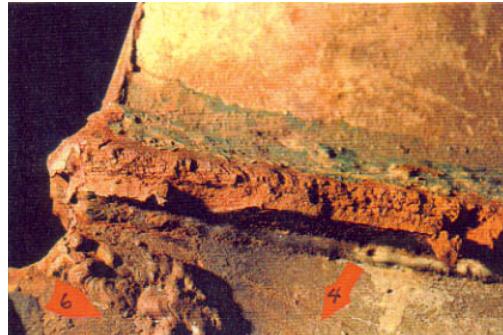
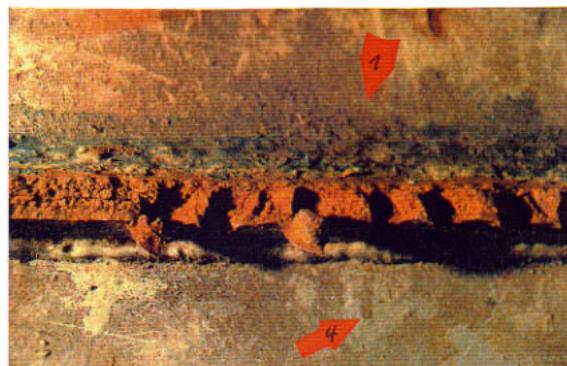
The following photographs indicate the condition of the B-deck in way of the port visor actuator foundation. The reader looks to the port outer lug plate and follows on the next 4 photos the ripped off B-deck remains from forward to aft of the outer lug plate. For easy reference the photographs are marked with the previously used arrow numbers.

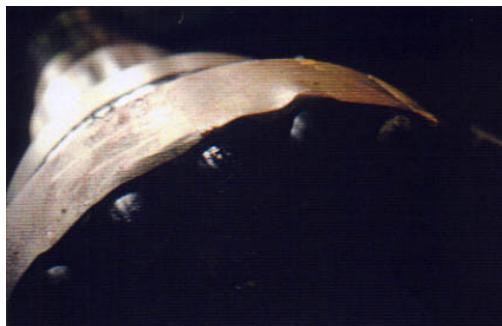
"... it was noticed that there were heavy damages at the distance when the piston rod is about 400 mm open. The damages were on the starboard side of the piston rod. Damages were also noticed on the piston cover's fixing screws. The ends of these hexagon screws were like hammered." (See [Enclosure 29.413](#))

The picture below demonstrates the above.

- The port actuator: Cover and hexagon screws on the piston rod side are severely hammered. The clamping ring is missing. The outside of the actuator shows heavy longitudinal scoring marks. The piston rod shows heavy damage on starboard side at a opening stage of ca. 400 mm.

(5) The piston rod of the port actuator shows severe damage on the starboard side at an opening stage of about 400 mm which indicates that vessel and visor were heeled to starboard when the piston rod was extended by 400 mm.

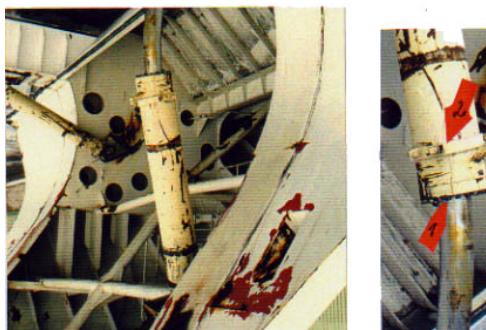
This is different at the starboard actuator as can be seen from the pictures on the next page with close-up of the area of interest. The arrow 1 points to the hexagon screws looking absolutely identical and which are evidently not hammered at all. Arrow 2 points to a clamping ring in apparently undamaged condition which had obviously not been exposed to hammering or otherwise heavy contacts. The differences between the external conditions including the hexagon screws of the port and starboard actuators can be explained as follows:

- The starboard actuator: Cover and hexagon screw on the piston rod side were not affected at all. The clamping ring was still attached to the piston and apparently completely unaffected. The actuator shows only very few external scoring marks - see picture above. The piston rod shows some scoring marks but no particular damage, certainly no heavy damages on the starboard side as can be seen on the piston rod of the port actuator. The scoring marks on the piston rod may have been caused at any time during the long process of separation from the vessel. This does not allow the conclusion that the lifting cylinder had been opened when the actuator was still attached to B-deck, i.e. that the visor opened to some extent, although this has to be assumed because of the unaffected rubber packings around the actuator opening - see above.

(4) Evidently all this was not the case with the starboard actuator, viz. piston cover and hexagon screws show no sign of hammering or any other damage, the clamping ring is in place, the actuator hardly scored. Obviously this piston had not been pulled through the starboard front bulkhead when it was still intact, but when the actuator was pulled through the front bulkhead by the forward moving visor this bulkhead was already open - see Chapter 32 - and therefore the actuator could easily slip through the wide opening - see also Chapter 29 - S 4.

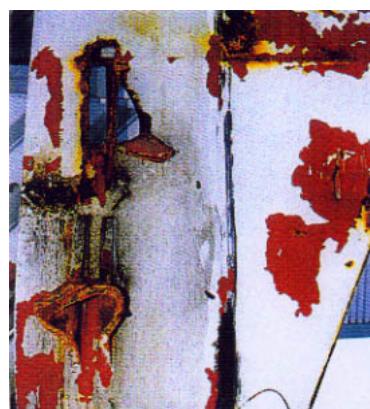
2, 3 - show the area of the missing side lock lug and the considerably bent hooks of the manual side locks from the top and from the side. The side view shows that the area in way of the pushed out steel tongue - see arrow 1 - is bulged outwards indicating pressure from inside to outside, whereas the plating between the hole for the lug and the hooks shows smoke marks, which are explained in Chapter 32. Around the opening for the lug burning/welding marks from the cutting off and the subsequent rewelding of the lug are visible. The following picture has been taken from the JAIC Report and clearly confirms the above.

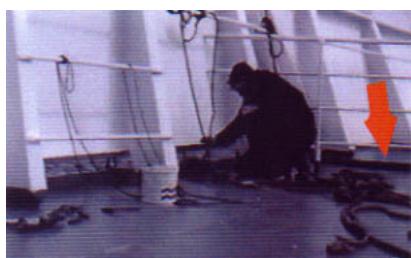
The image following shows the area in question. The arrow indicates where the crewman was hammering.

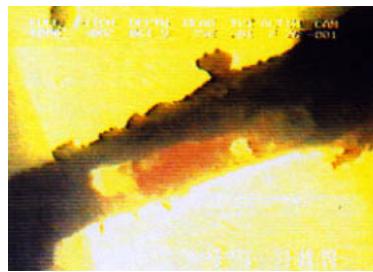
The following image shows the lug attached to the bolt inside the vessel before it was pulled out by the diver. Contrary to the starboard side this lug rested inside the bulkhead as visible, although it was on the high port side.

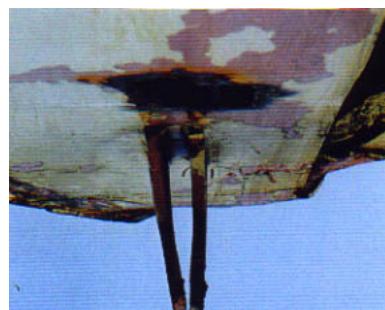
The hooks for the manual side lock were just bent together, as can be seen on the picture on the next page. The area around the lug location shows burning marks obviously from cutting off the lug by flame cutting - see arrow - but no smoke marks as on the starboard side and the plating was not pushed out/distorted.

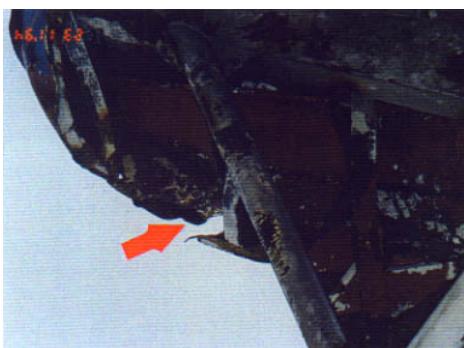
8 - shows the lower aft bulkhead/visor bottom which is only moderately damaged compared to the starboard side - see also the picture below.

The arrow points to a damage to the port aft edge of the visor bottom which apparently occurred when the visor moved transversely from port to starboard. This will be explained in Chapter 31 - The Casualty Scenario. See also picture 5 on the following Sheet 6.

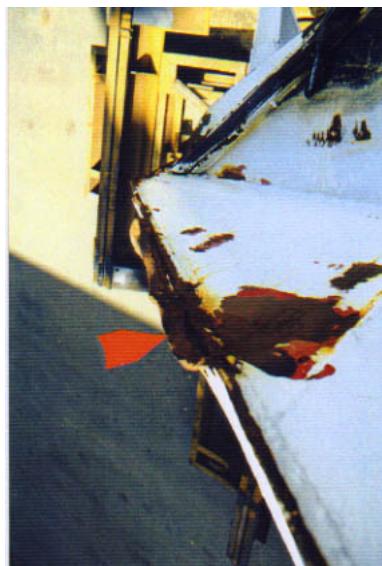
1 - shows the upper part of the aft bulkhead with the moderately affected recess which has already been discussed at the beginning of this item. The picture on the next page shows the recess as enlargement with damage at the edge of the shell plating - see arrow - which obviously occurred when the visor was moving in the transverse, i.e. athwartships, direction. - See also Chapter 31 - The Casualty Scenario.

(7) The recess at the upper part of the port aft bulkhead of the visor was damaged when the visor was moving transversely respectively athwartships.

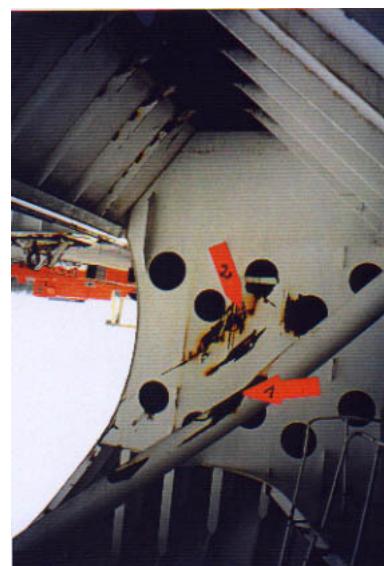
The picture below shows the port inner side of the visor with the slightly damaged frames at the port aft part of the ramp house. The upper part of the longitudinal bulkhead is completely unaffected. The scorings and the deep indentations and deformation (arrow 2) are restricted to the middle part, and, in the foreground, the vertical beam which had been in contact with the upper part of the ramp with the folded flap in between is visible (arrow 1).

1 / 2 - show the completely intact and untouched starboard inner longitudinal bulkhead which - due to the starboard heel - remained obviously unaffected even during final separation of visor and bow ramp which will be explained in Chapter 31 - The Casualty Scenario.

- (1) The upper and the lower parts of the port inner bulkhead of the visor are completely unaffected, the middle part however is very severely scraped, indented and cracked which was caused by the bow ramp when the visor was resting on it.

- (2) The above-mentioned damage was exclusively caused by the bow ramp, the port actuator has not been in contact with the bulkhead plating.
- (3) The opposite starboard inner longitudinal bulkhead is completely unaffected, thus there has been no contact with the bow ramp.

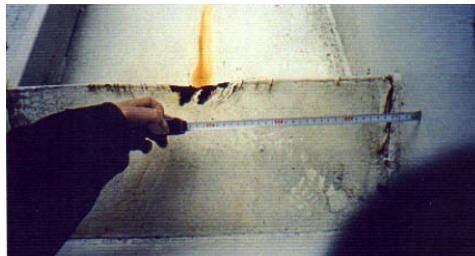
The picture below shows the starboard side with the longer distance to the starboard bulkhead also due to the starboard heel of visor and vessel.

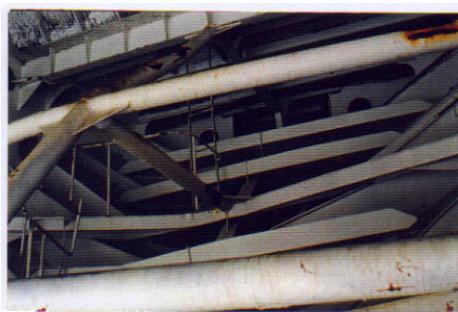
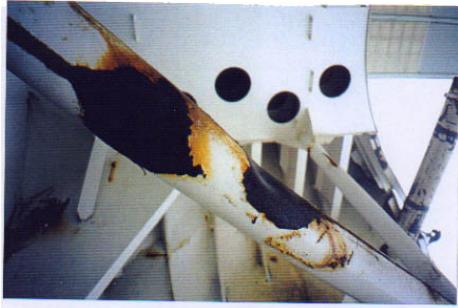
The two pictures below show the damage to the top and port side of the vertical beam.

- (3) The damage to the vertical beam was caused when the ramp was resting inside the visor on this beam with a flap in between. This flap in the centre line of the ramp is heavily damaged.

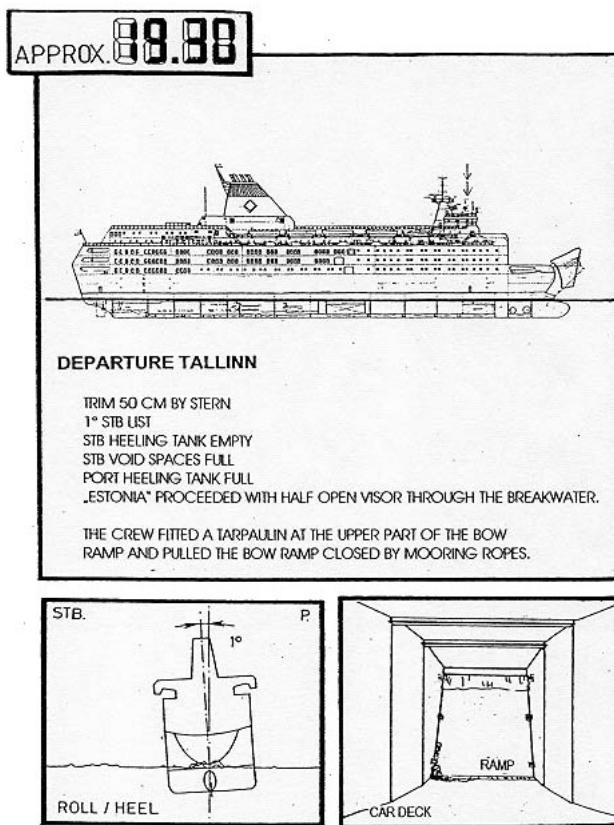
The scenario starts with the condition of the ferry upon departure from Tallinn at about 19.30 hours on the 27th September 1994. The departure condition is demonstrated by drawings and text below.

**Visor Locking Devices:** Atlantic Lock / hydraulic side locks engaged, manual side locks - not engaged  
**Ramp locking devices:** Starboard ramp hook and securing bolts not engaged, Port ramp hook and securing bolts not engaged  
Gaps between ramp/car deck seals by mattresses, blankets, rags.

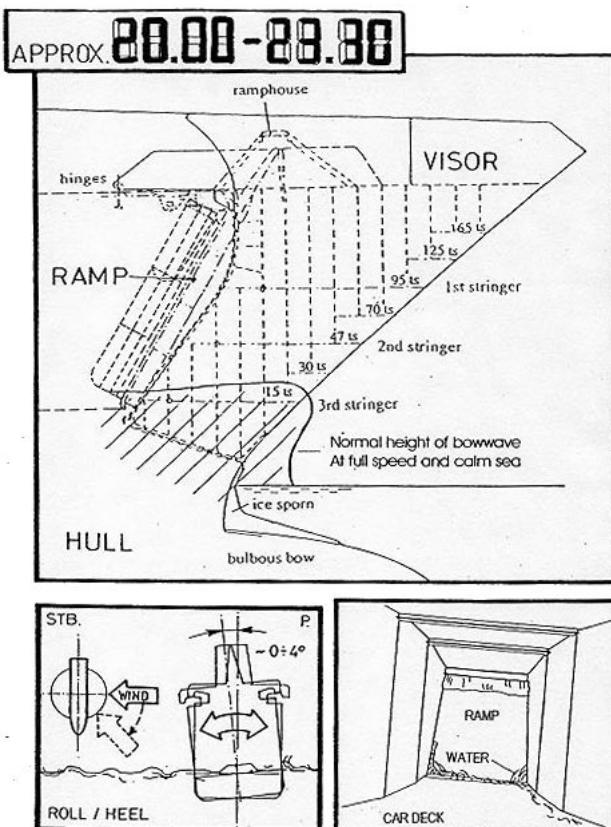
Even with calm sea the water level inside the visor was rising above the 3rd stringer when the vessel was at full speed. The lower side of the bow ramp was below 3rd stringer level, thus even in calm sea the water from the visor was penetrating the gap in the bow ramp and was flooding onto the car deck.

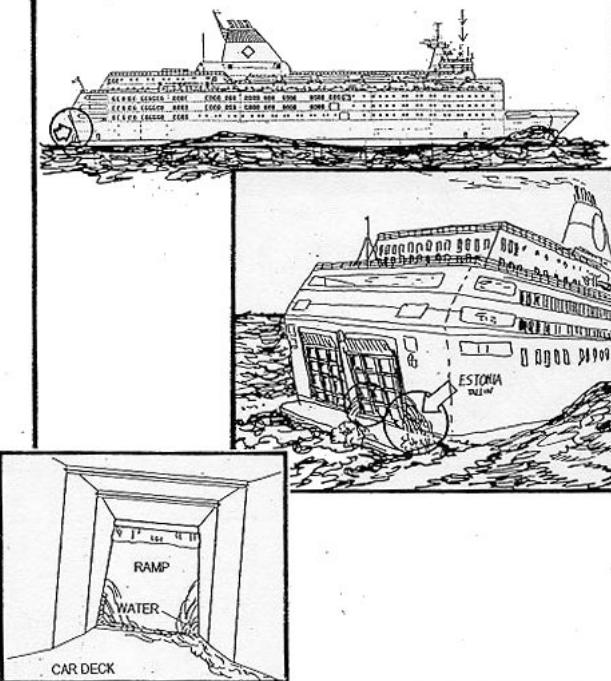
1. At ca. 20.45hrs. the aft hydraulic pumps were started on the STB. stern ramp opened slightly.
2. Due to the stern trim and the STB. heel of the ferry the water penetrating through the improperly closed bow ramp streamed off the car deck through the slightly open STB. stern ramp.
3. The high and very disturbing hydraulic noise was heard throughout the evening.
4. The vessel was pitching very hard in rough head seas.

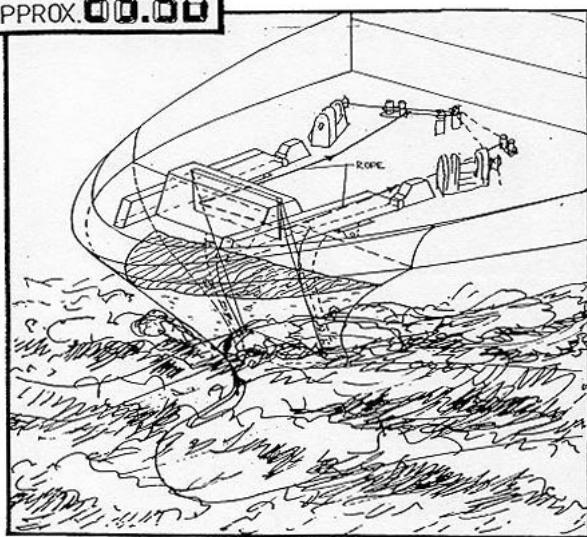
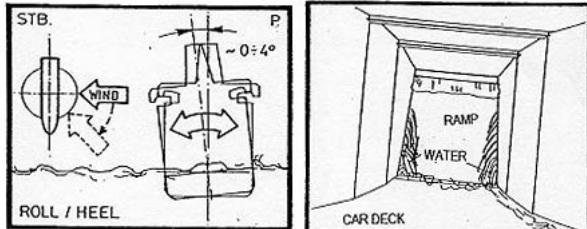
1. Due to increasing wave height and deep pitching of the ferry the water level inside the visor rose higher and the pressure on the "sealing" material
2. Water entered the car deck in increasing quantities.
3. The ferry made very hard pitch movements.
4. The bow ramp was kept more or less closed by the rope and the water pressure from the visor side, however water penetrated at both sides of the ramp
5. This was the condition on board the ESTONIA when she met "AMBER".

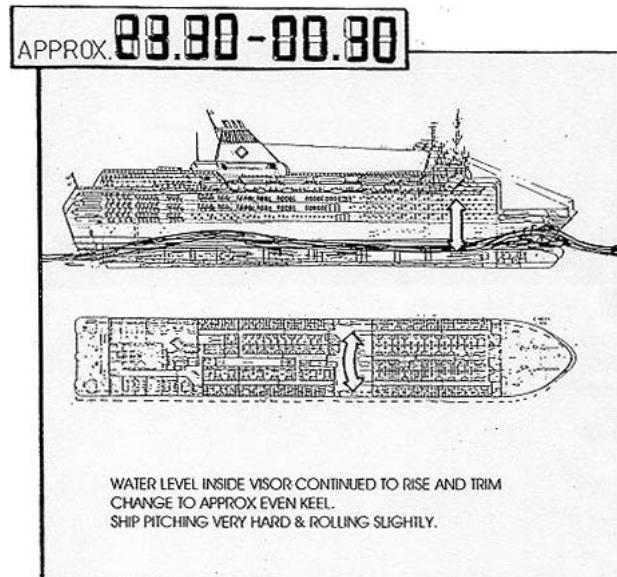
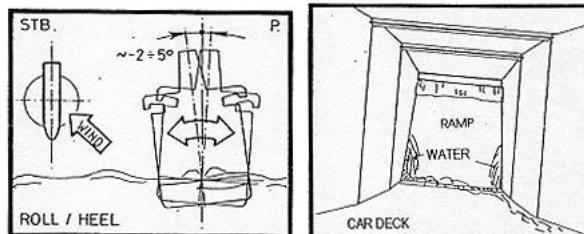
Many passengers heard low metallic banging caused by visor moving within play of locking devices due to misaligned visor, damaged stempost and missing rubber packings.

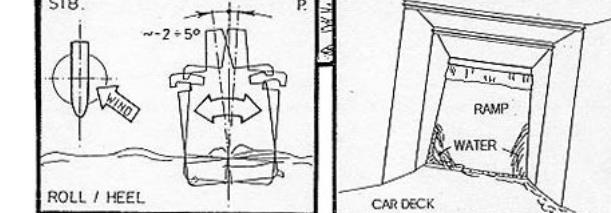
1. Low banging noises continued
2. Port stabiliser fin activated, crew started to work on the starboard fin.
3. The watch A.B. noted a lot of water on the car deck, alarmed the bridge and crew was activated
4. The course was changed to starboard and the ferry began to roll heavily, whereafter the vessel was turned back to port and started to pitch heavily. The speed was reduced.
5. The crew was working on the car deck to control the water ingress which turned out to be impossible.
6. The vessel made deep, slow pitch movements and was slightly rolling, more to starboard, less to port.

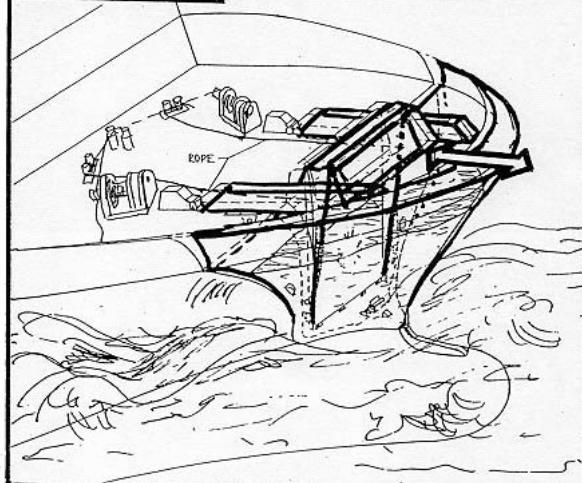
1. Also the port hinges and the port side lock failed and the visor moved forward/aft between the deck beam at frame 159 and the hinge parts on

2. Simultaneously hard scraping noises were caused by the upper flaps of the ramp scraping along the vertical beam inside the visor due to the movements in the sea

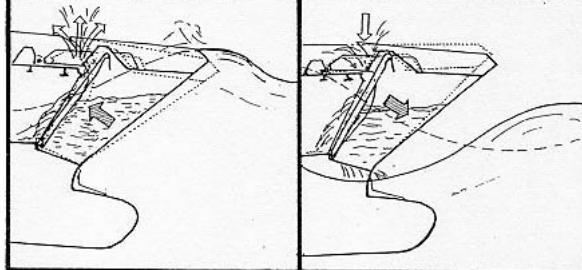
1. Hard metallic banging/knocking and scraping noises.

2. Visor moving forward /aft between the deck beam at the frame 159 and the forecastle deck parts of the hinges, the lugs underneath the visor arms were cutting through the deck beam.

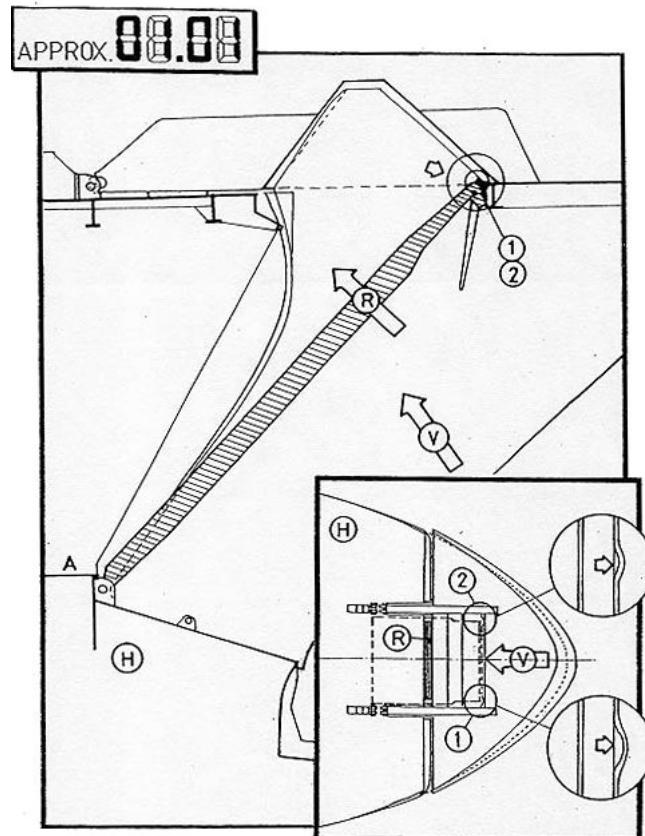
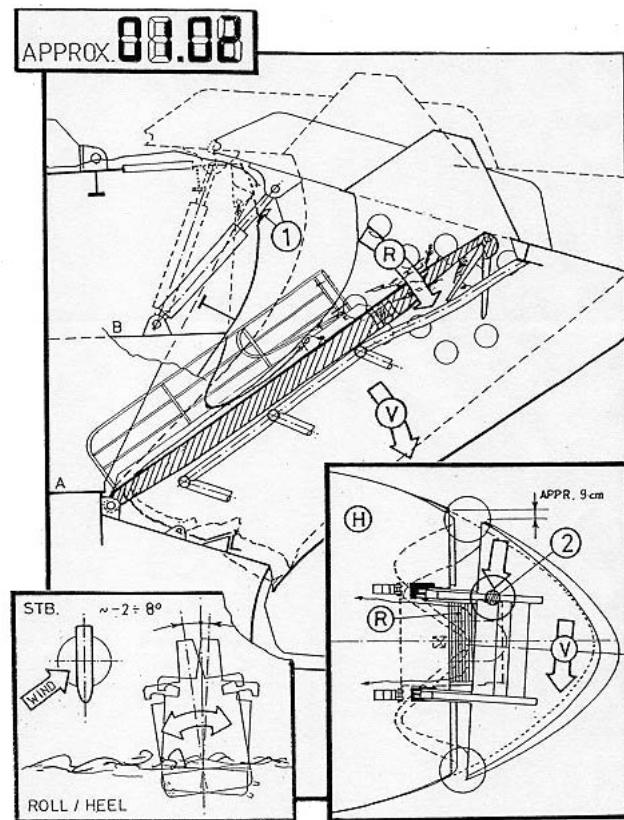
1. Vessel rolling more to starboard/less to port .
2. Visor lugs broke through the front bulkheads and did not support the visor anymore against moving towards the deeper starboard side (1)
3. With a big crash the visor fell abruptly about 10 cm to starboard until the inner port bulkhead was resting on the upper part of the bow ramp (2).
4. The visor was now extending the starboard front bulkhead of the vessel and the port front bulkhead was extending the visor.
5. The atlantic lock failed.

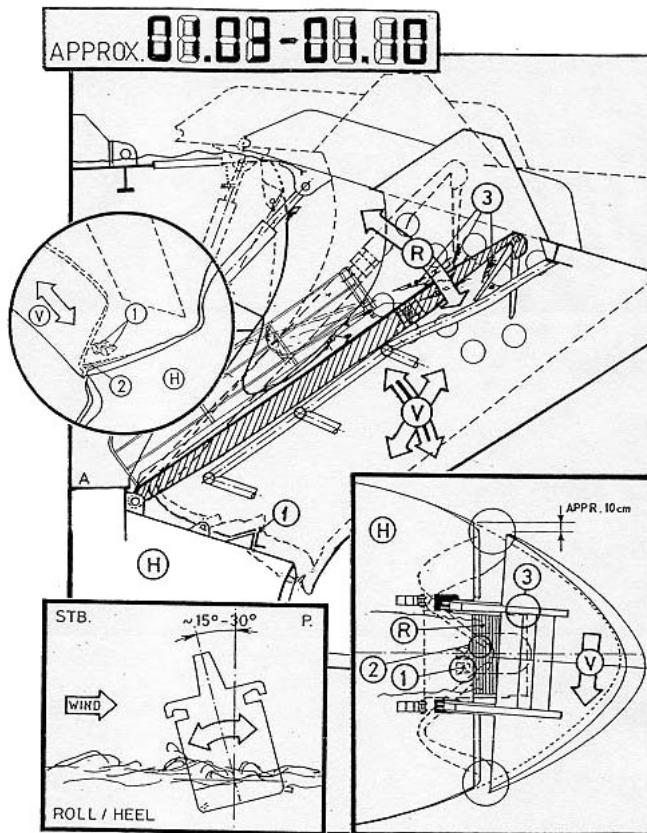
- 1.Approx 01.08-01.10 hrs the main engine shut-down automatically at a stbd heel of ca 30o.
- 2.The visor was held by the bow (3) ramp and by the forepeak deck increasingly penetrating the visor bottom (1)(2).
- 3.The intact starboard actuator was resisting the forward movement of the visor.

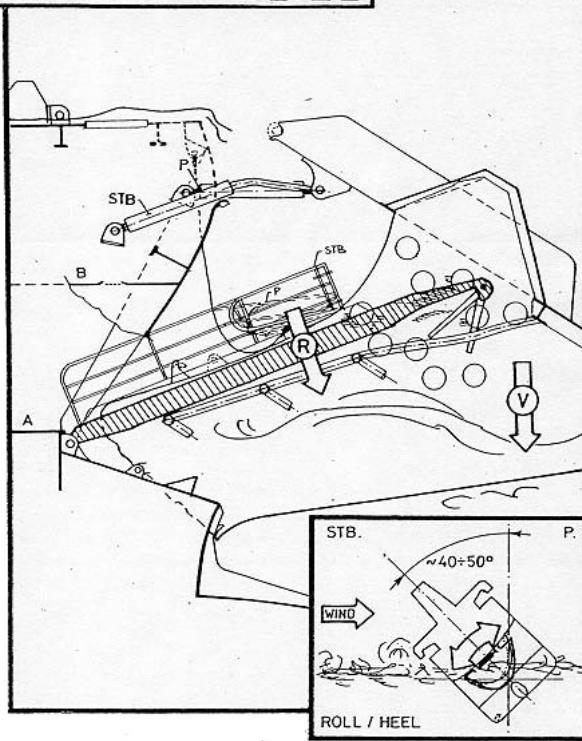
1. After the vessel had stabilised for some time at a heel of about 40o-50o the heeling increased again.
2. The visor moved further forward and downwards and also the starboard actuator was torn off its foundation and broke through the front bulkhead as did the port one.
3. The port actuator was completely retracted while the starboard actuator was fully extended with the piston rod bent.
4. The visor was still hanging on the ramp and was still supported against falling off to starboard by the forepeak deck being pressed into the visor bottom.

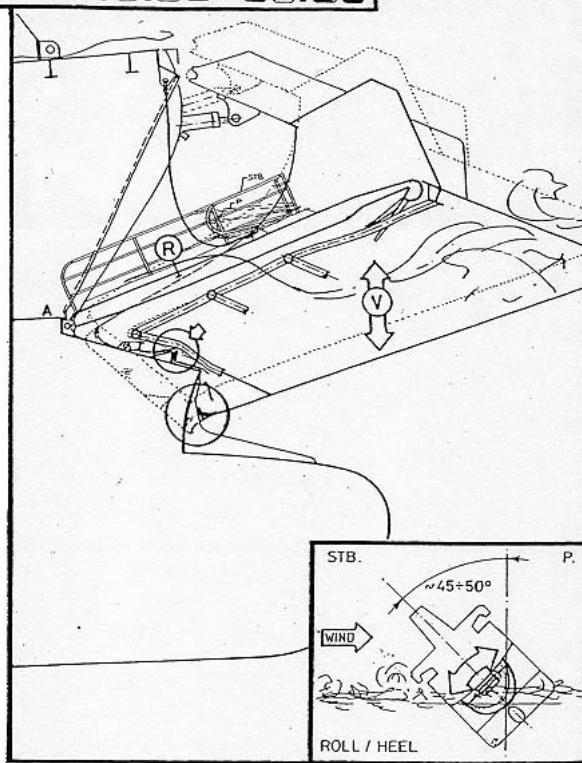
The vessel was still rolling stepwise and the visor with the bow ramp inside was labouring up and down and from port to starboard in the seaway.

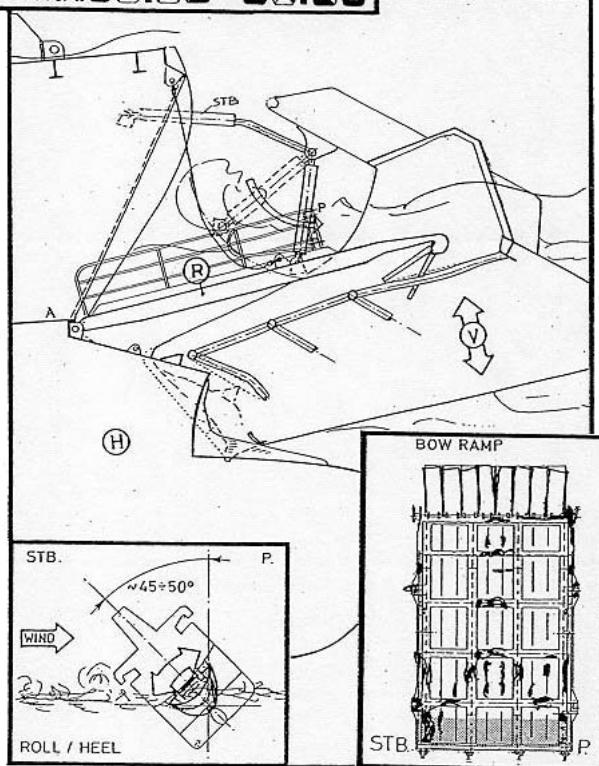
1. The port actuator broke through the front bulkhead, swung forward and got and crashed against the bow ramp
2. The structure of the ramp was continuously and very severely deformed by the heavy and changing weight of the visor.

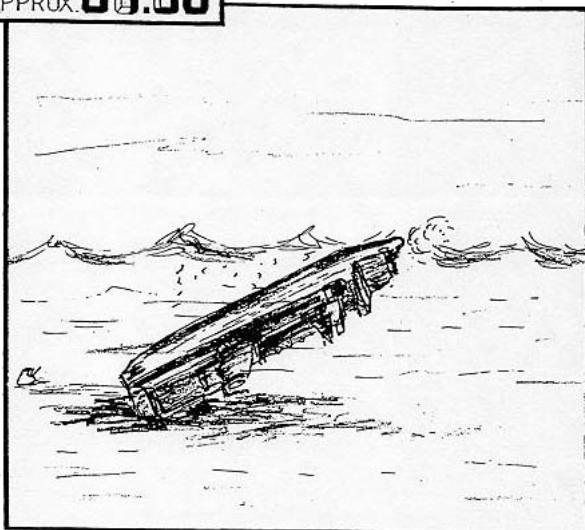
1. The Vessel sank stern first.
2. The bow was still above water when the stern was already on the sea bottom.
3. The visor sank about 1nm west of the wreck upside down.

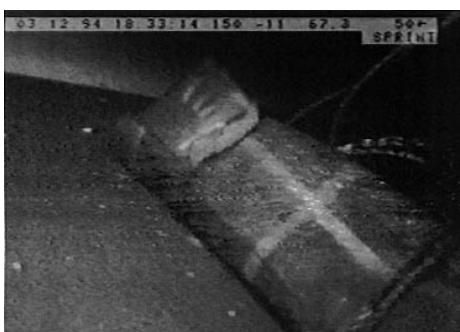
Both identified the package with about 90% certainty to be an explosive charge used underwater.

Evaluation of the footage made by ROV on 02. and 09.10.94 revealed, however, that the package had not been at the identified location on the 5th deck on these dates, thus must have been placed there between the 09.10. and 03.12.94 and therefore could not be casually related.

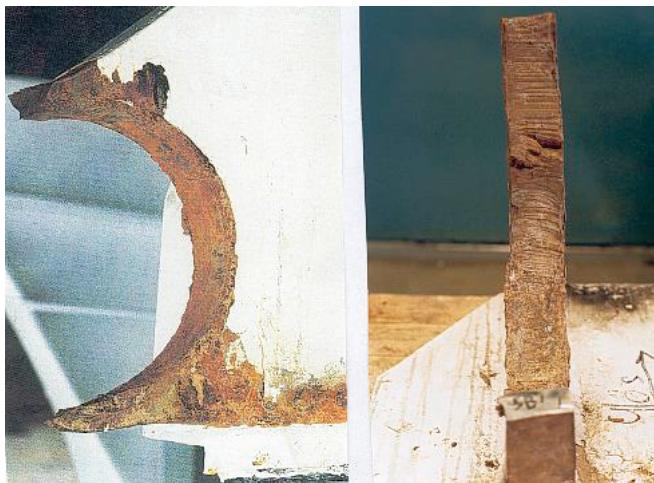
- all four arms do not have identical appearances as it is evident from the two photos below, the left one shows the port outer visor arm and the right one the starboard inner visor arm.

Evidently the starboard visor arm plate looks identical to the test burnt installation part - see the photo above - and the port one is smooth without burning marks at all. A detailed inspection even revealed indications of circumferential drilling marks as initially the holes were drilled at newbuilding - see Subchapter 2.4.6. Therefore this 'Group of Experts' has always taken and still does take the view that the port bushings were still original while the starboard ones were very unprofessionally replaced. How gross negligently this replacement was carried out became fully clear when a passenger video was made available to this 'Group of Experts' in 1996 - see Subchapter 39.2.
