The MV ESTONIA Accident - Second Interim Report of the Joint Accident
Investigation Commission

MV ESTONIA - Probable Sequence of Events as Cause of the Accident

MV ESTONIA - Technical Evaluation of the Probable Sequence of Events and Cause of the Accident

MV ESTONIA - Summary of Technical Findings and Technical Evaluation of the Probable Sequence of Events and Cause of the Accident

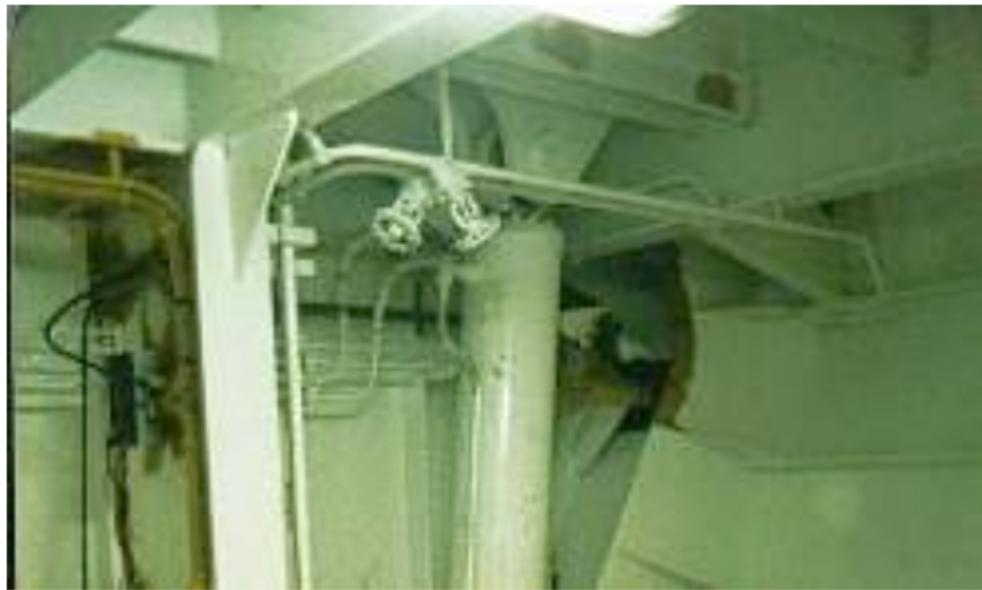
After the failure of the hinges the visor moved forward and the lugs underneath the visor arms were cutting through the 8 mm deck plating, but only for 120 mm, then they hit the rather strong transverse deck-beam. According to the estimate of metallurgists it took any time up to 10 minutes for the lugs to cut through this strong beam. The condition can best be demonstrated by the photo below showing the void space on B-Deck Starboard side with closed visor.

B-Deck starboard side pre-casualty condition When the lugs were working their way through deck and deck beam whilst the visor was moving forward/aft naturally deep scorings were sustained by the lugs. Assuming that the vessel was still in an upright condition - which is part of your scenario - these scoring marks would be more or less of similar intensity at the outer as well as at the inner lug plates. This, however, is not the case as can be clearly seen by the photos below.

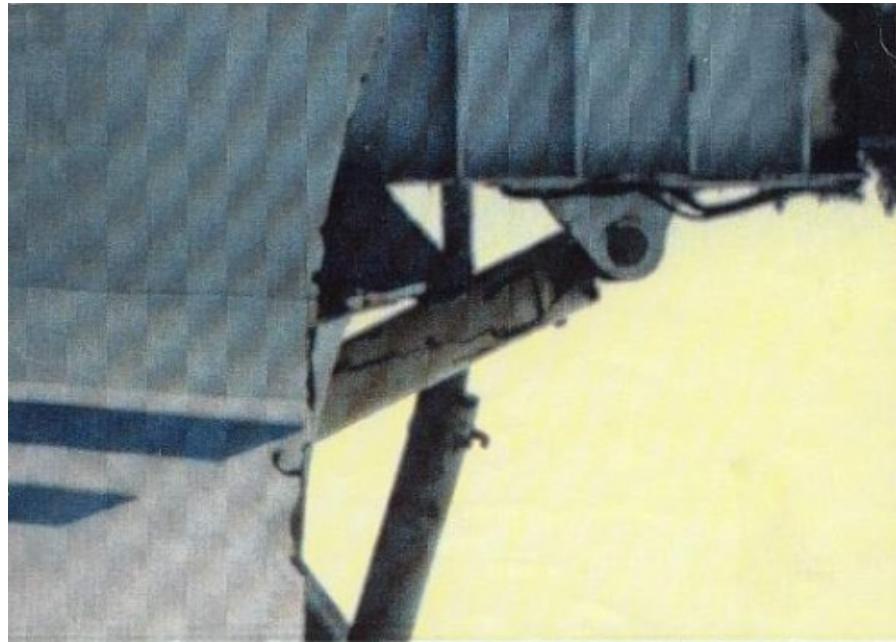
The above photo shows the *outside of the port lug* with evidently no or only minor scratches.

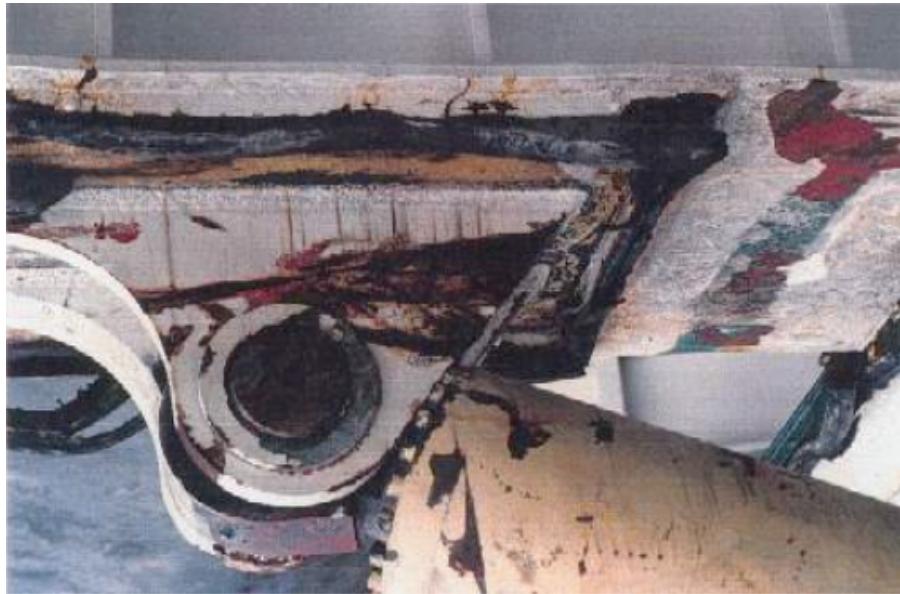
The ***port inner side***, however, which is shown on the above picture, evidently sustained very deep and sharp scorings indicating severe pressure from port to starboard and straight as drawn by a ruler. The following picture shows the ***inner side of the starboard lug*** - practically the counter-part to the port outer side - with some deep scorings at the upper part indicating more of a circular movement.

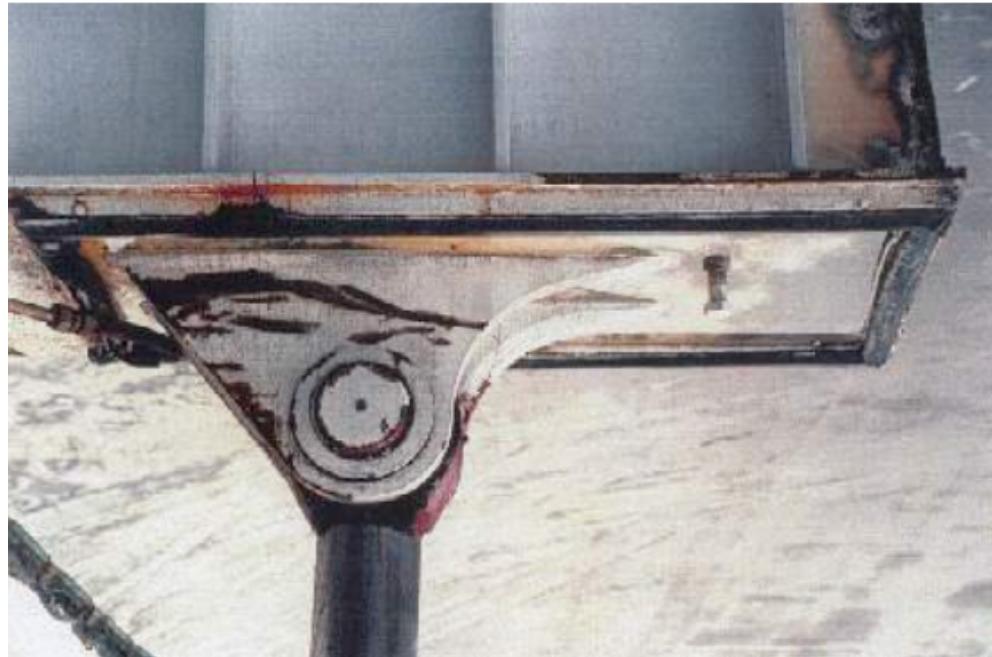
The picture below finally shows the outer side of the starboard lug - practically the counterpart of the severely scored inner side of the port lug - indicating also severe pressure from port to starboard side, though apparently not as heavy as at the port lug inner side. The cut area through the green painted forecastle deck is clearly visible and straight as if drawn with a ruler.

- The scorings at the lugs can only have been caused when the lugs were cutting through deck/deck beams.
- Contact between lugs and deck/deck beams is only possible after the hinges have failed.

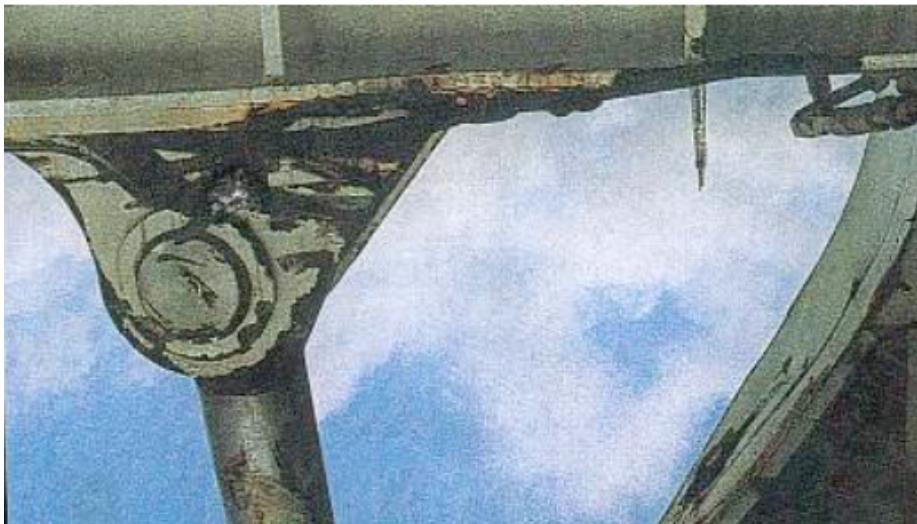
The above pictures lead to the following conclusions:

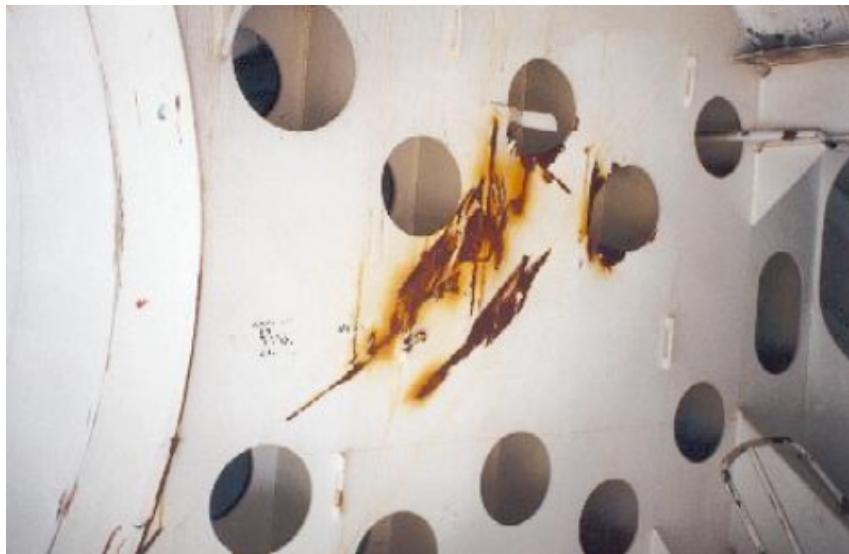
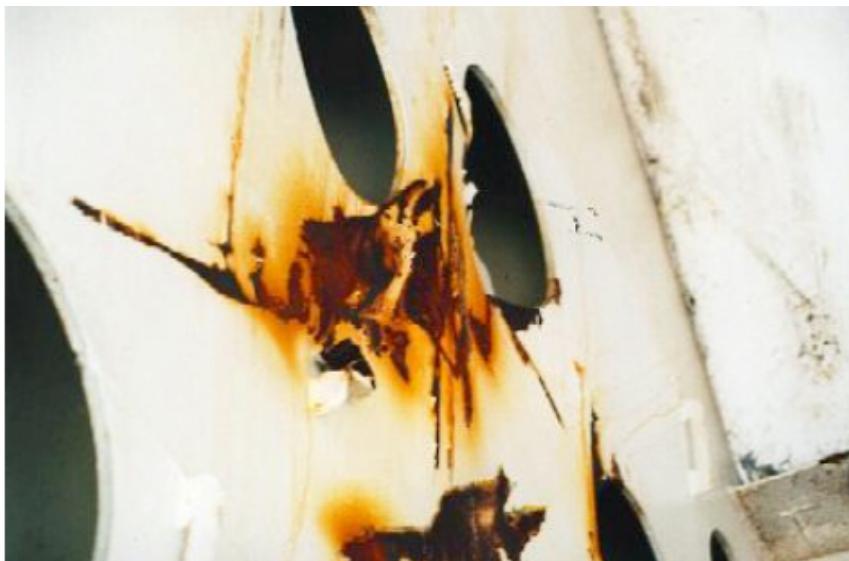
5. Inner Bulkheads

The same as can be observed from the lugs underneath the visor arms is confirmed by the damage/scorings to the port inner bulkhead, whilst the opposite starboard side is completely untouched with absolutely no contact marks. The 2 pictures below show the inner side of the visor bulkhead with deep scorings/indentation and the holes partly torn.
