THE GERMAN GROUP OF EXPERTS

Summary

1 THE CASUALTY

2 THE VESSEL "VIKING SALLY"

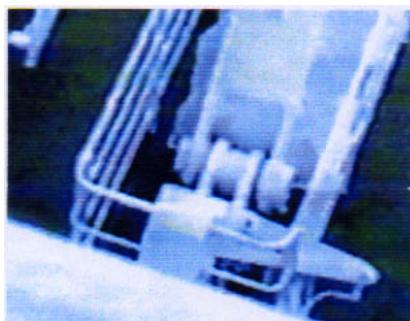
b.) That there was something seriously wrong at least with the starboard hinge arrangement of the visor well before the casualty becomes very obvious when having a close look at the **video film made by a passenger upon departure from Tallinn on 17 September 1994**, i.e. 10 days before ESTONIA's last sailing. He stood on the open forepart of the 8th deck and with his video camera filmed the closing of the visor. Thereby he zoomed in on the starboard hinge arrangement. The subsequent evaluation of the video proved that the starboard visor hinges were totally misaligned with the lower part of the outer bushing as well as the securing plate missing. The video was analysed and evaluated in detail by the Reconnaissance Expert Bryan Roberts of Churchgate/UK and his report is attached as [Enclosure 12.5.180](#).

The print is shown below and the enlargement is attached as [Enclosure 12.5.181](#).

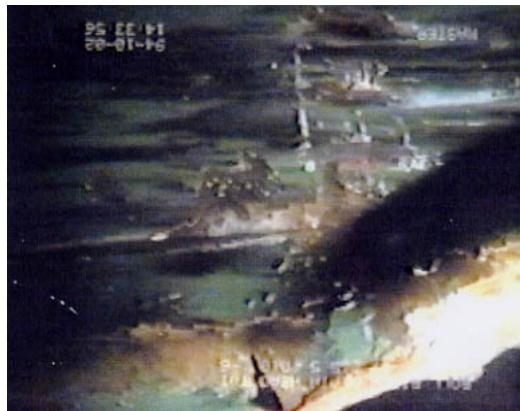
Image No. 1, 2 and 6 show the starboard inner side of the cut through the deck beam at frame 149, which are evidently pressed together, partly cracked and bent up, indicating pressure from port to starboard. The edges of the deck opening aft of the deck beam are not affected at all, same as on the starboard side. This is only indicated on the detail drawing but is clearly shown on the available video footage. The starboard side of the cut through deck beam and the deck plating as well as the rubber marks are shown also on the picture below.

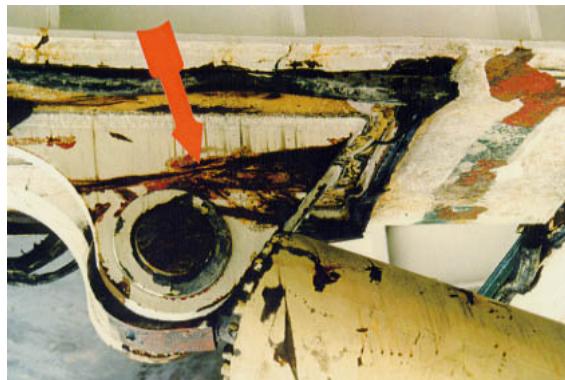
It must have taken some time for the visor lugs to cut through this deck beam while the visor moved forward/aft in the sea state ending when the visor lug plates had finally cut through this strong deck beam. It has to be assumed that during this cutting process at least the paint on both the inner and the outer lug plates should have been destroyed in way of the contact area. This was, however, evidently only the case with the inner lug plate as can be seen on the picture overleaf.

The lug plate has very deep and - at the upside - straight scoring marks, almost engraved, which indicate

- (a) the movements of the visor and
- (b) that the weight of the visor was to some extent resting on this inner lug plate which caused these very deep scraping marks, whilst the opposite side, i.e. the outer lug plate, remained completely unaffected as visible on the next picture.

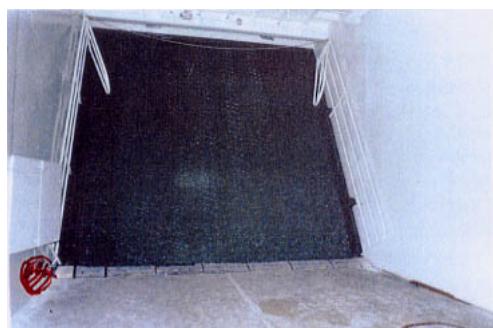
The bow ramp is fitted with two rails on each side as can be seen on the photo below.

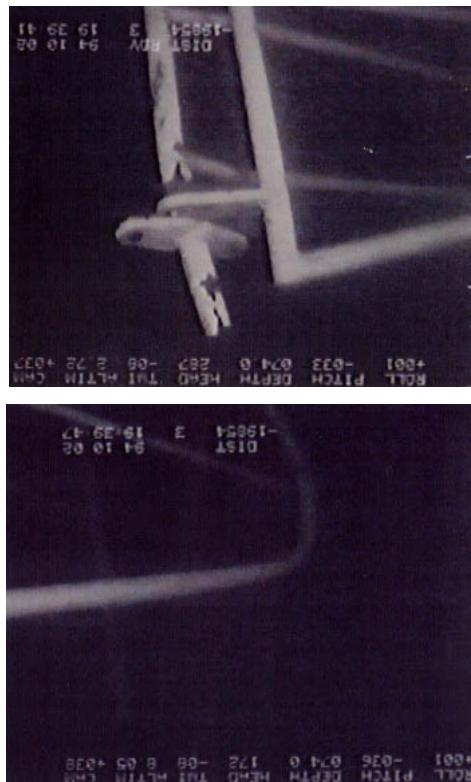
Upon evaluation of the video tapes by Disengage parts of the bow ramp rails were identified on the sea bottom and the images shown below and overleaf were produced.

The two images above made by ROV on 2.10.94 already clearly and without doubt prove that it is the forward section with movable part of the starboard bow ramp rail which is resting on the bottom of the sea.

A reconstruction of the ROV track commencing at the stern of the wreck revealed that these rail parts are located about 250 m to the south of the stern and about 80 m to the south-east of an area where the video was cut three times, each time for about 1 minute.

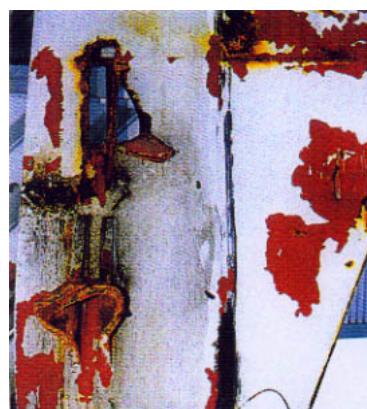
2, 3 - show the area of the missing side lock lug and the considerably bent hooks of the manual side locks from the top and from the side. The side view shows that the area in way of the pushed out steel tongue - see arrow 1 - is bulged outwards indicating pressure from inside to outside, whereas the plating between the hole for the lug and the hooks shows smoke marks, which are explained in Chapter 32. Around the opening for the lug burning/welding marks from the cutting off and the subsequent rewelding of the lug are visible. The following picture has been taken from the JAIC Report and clearly confirms the above.

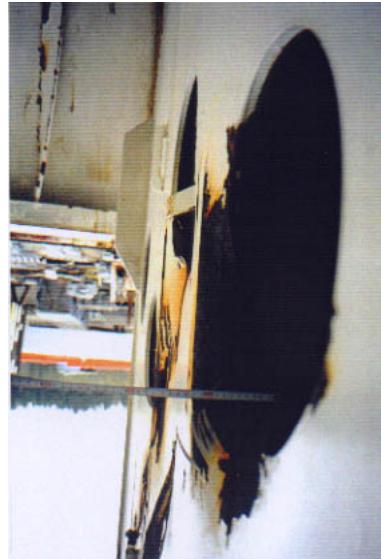
1 / 2 - show the port inner longitudinal bulkhead with scraping/scoring marks at the lower aft part - see arrow 1 - and very deep indentations with the steel plating partly torn - see arrow 2 - and enlargement picture 1.1. The picture below shows that the plating was actually pressed into the bulkhead up to 120 mm.

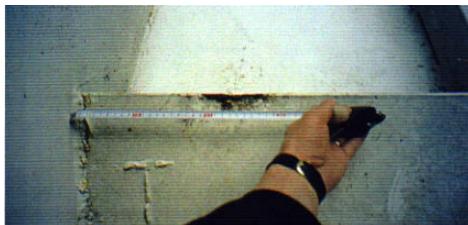
2 - shows the lower inside of the visor with the lower transverse beam in way of the 3rd stringer. This beam was found to be very severely scored and scraped, which was most probably caused during the lifting operation. The picture also demonstrates the very severely set up visor bottom which is underlined by the close-up No. 10 and explained by detail drawing No. 8. There are two further contact marks in way of the deck beam at the lower forward part of the ramp house, viz. in the most port and most starboard frame spaces, which were evidently also caused by the bell cranks of the ramp when the visor moved further forward and downwards and the vessel was already severely heeled to starboard already. See also sheet 2 - The Ramp House. The picture below indicates the short distance to the port bulkhead because of the starboard heel.

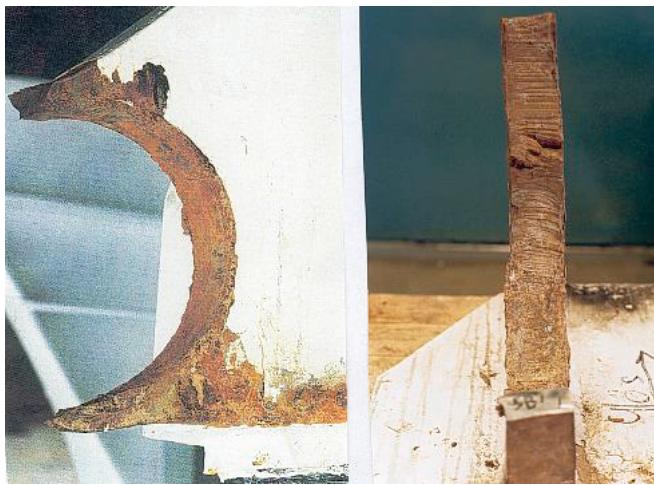
- all four arms do not have identical appearances as it is evident from the two photos below, the left one shows the port outer visor arm and the right one the starboard inner visor arm.

Evidently the starboard visor arm plate looks identical to the test burnt installation part - see the photo above - and the port one is smooth without burning marks at all. A detailed inspection even revealed indications of circumferential drilling marks as initially the holes were drilled at newbuilding - see Subchapter 2.4.6. Therefore this 'Group of Experts' has always taken and still does take the view that the port bushings were still original while the starboard ones were very unprofessionally replaced. How gross negligently this replacement was carried out became fully clear when a passenger video was made available to this 'Group of Experts' in 1996 - see Subchapter 39.2.
