**The German Group of Experts
investigating the sinking of M/V "ESTONIA"**
c/o AHLERS & VOGEL · Schaeffter 1 D-20459 Hamburg · Telephone 49-40-371075

Memo for Dr. Holtappels

re: 2nd Meeting with F.B.N. on 27.10.95

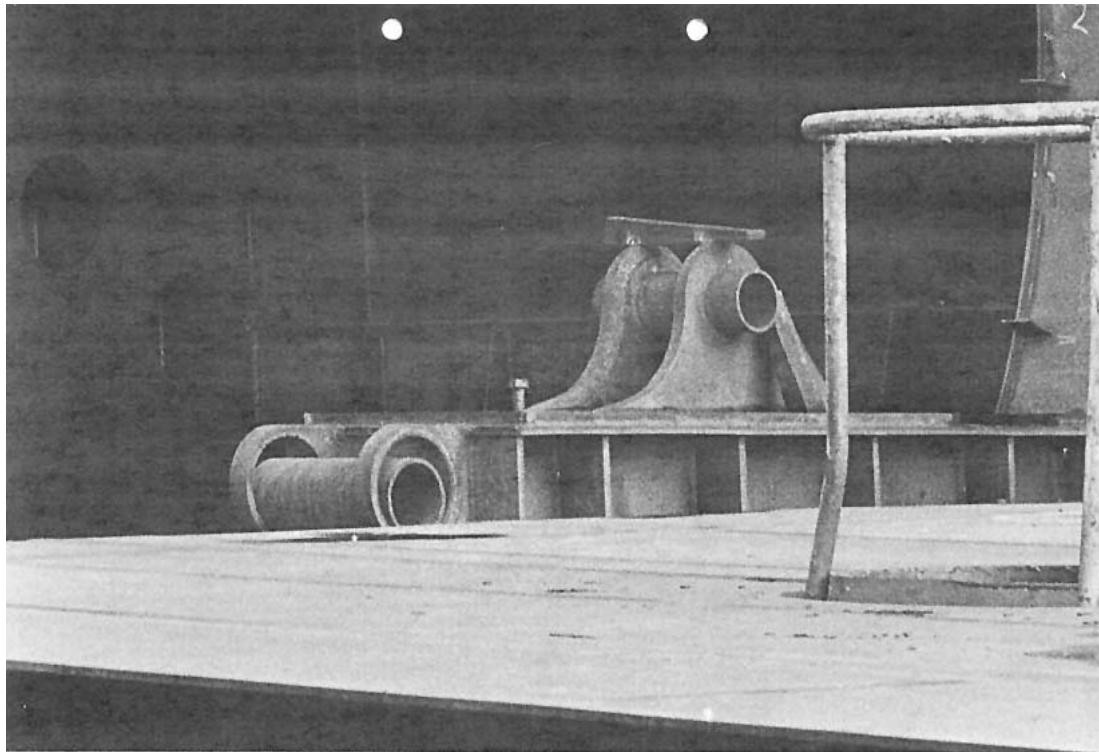
Enclosure 2.4.6.64

Photo showing visor at the vessel without hinge connection

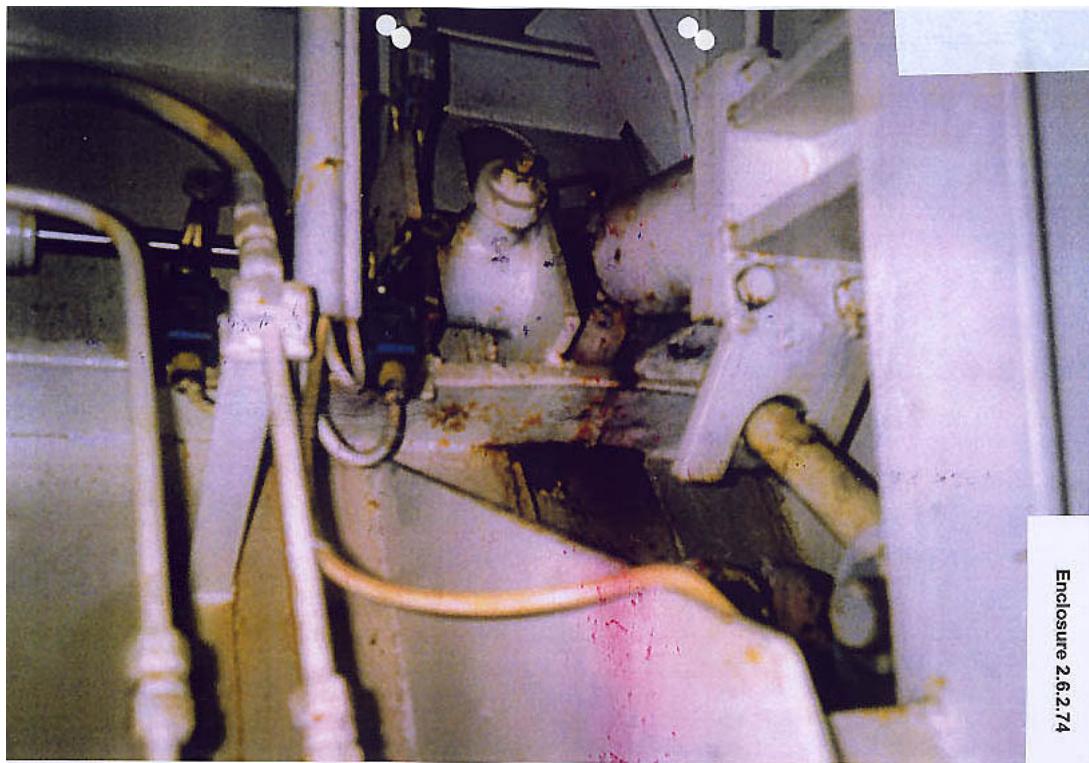
Photo showing hydraulic an manual side locks

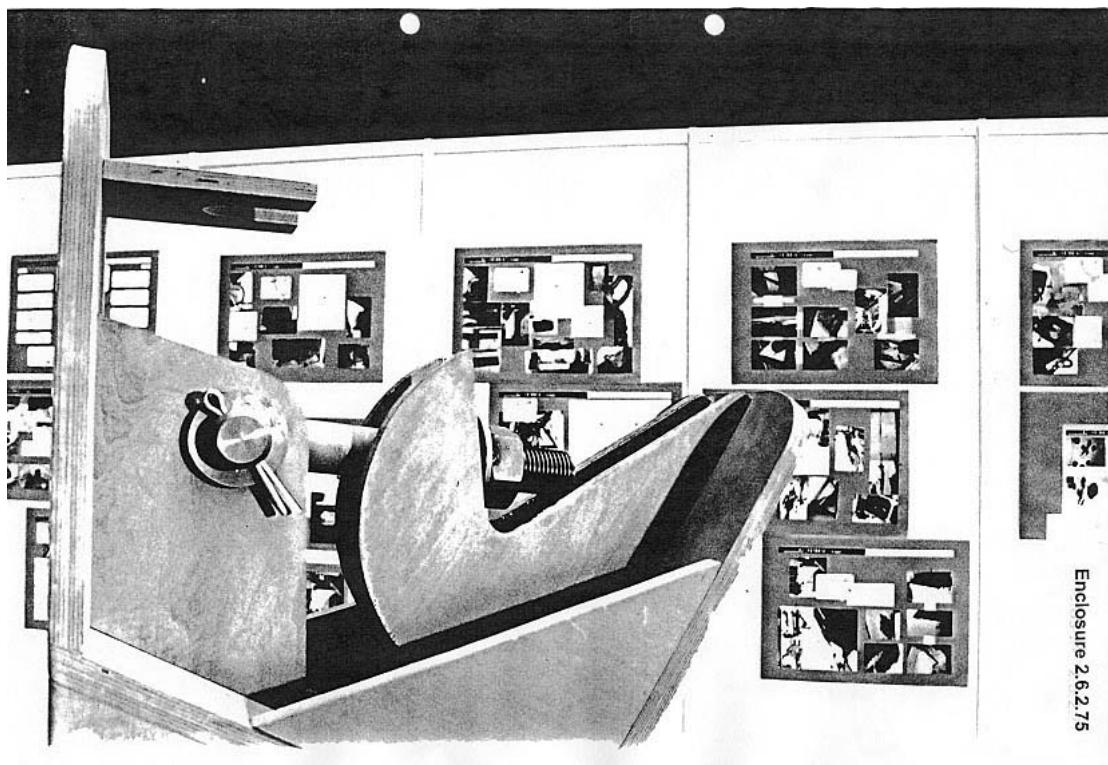
Photo showing mock up of side lock
