FACTUAL INFORMATION

1 THE CASUALTY

2 THE VESSEL "VIKING SALLY"

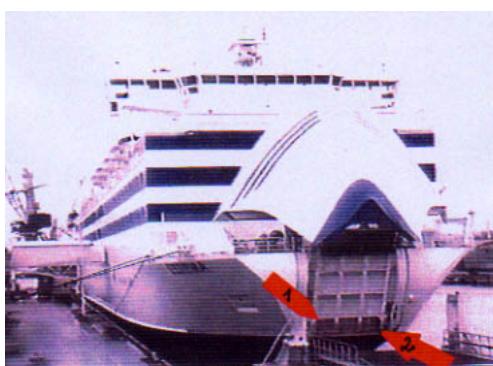
The picture below shows ESTONIA at her berth in Tallinn with open visor and closed bow ramp. The arrow no. 1 points to the oil covered lower part of bow ramp which demonstrates the height of the water level with hydraulic oil floating on top inside of the visor when the vessel was at sea in calm weather. Arrow no. 2 points to the bow ramp hinges which are on car deck level.

- **Charley K. Dahlberg**, engineer, ca. 40 years old, made about 30 trips on the ESTONIA, clearly remembers frequently having heard the splashing of water inside the visor at sea; realised the bad condition of the visor and of the bow ramp as well as the many cracked and re-welded welding seams in way, decided not to use the ESTONIA anymore when going from Stockholm to Tallinn, but to go via Helsinki instead. The complete interview is attached as [Enclosure 12.4.4.158](#).
- **Torsten Sundberg**, skipper of the Sandhamn pilot boat, wrote to the Swedish Commission on 14.02.95 as follows (office translation):

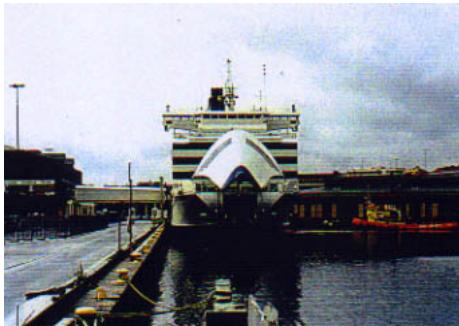
One of the viewers of the 'EFTERLYS' program reported that he saw the ESTONIA in July 1994 at her berth in Stockholm with open visor and open bow ramp, which was categorically denied by N&T, ESCO and the JAIC members.

The following picture proves it. It was made by a German tourist in July 1994.

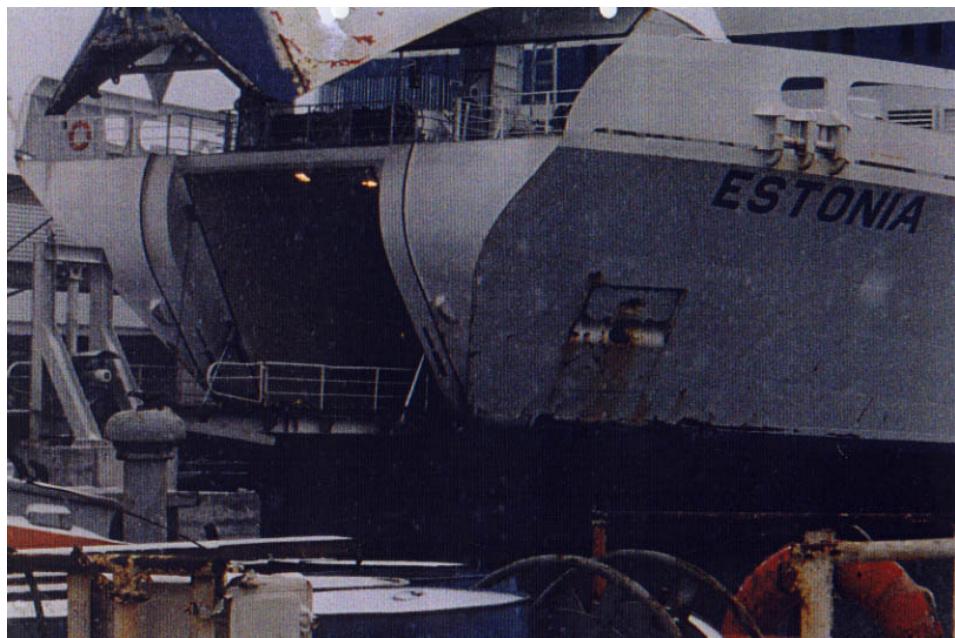
The ice situation is demonstrated on the ice chart of 28.03.94 which is attached as [Enclosure 12.4.2.152](#) and two photos showing the cruise vessel SALLY ALBATROSS sitting aground outside Porkkala (opposite Tallinn) in heavy ice during February/March 1994. The photos attached as [Enclosure 12.4.2.153](#) clearly demonstrate the ice conditions which were prevailing at this time in the Gulf of Finland. The effect these ice conditions had on the visor and foreship of the ESTONIA can be seen on the photo below which was made on 24.03.94.

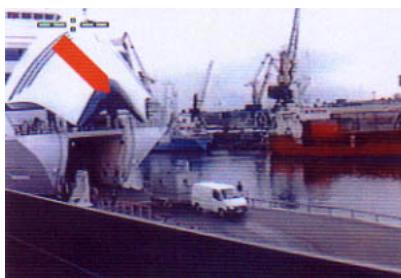
The damage sustained by the visor while proceeding at full speed through ice barriers several meters high and using the vessel as an ice breaker is demonstrated by the preceding photo and can also be seen on the video image below made from a film of 30.03.94.

As a result of the sustained severe structural damages and in combination with the different lifting speeds of the actuators and severely worn out hinge bushings, the visor became increasingly misaligned and out of geometry.

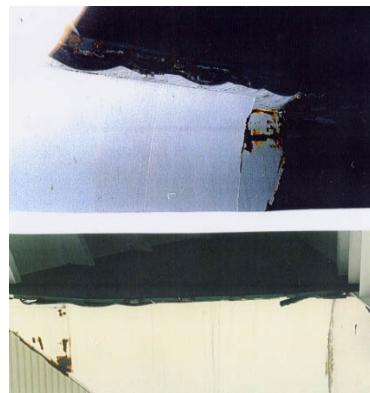
Also the flat bars around the deck opening into which the rubber packings - fitted below the visor arm - should be pressed, when the visor was closed, were missing. The same refers to the flat bars having initially been welded athwartships at the forward part of the forecastle deck into which the rubber packings at the aft part, i.e. below the recess of the visor, should be pressed when the visor was closing (see also item 5 on the detail drawing). This can be seen from the following two pictures, of which the first one shows the starboard aft part of the visor deck with untouched rubber packings, intact and in place and the 2nd is the port side which is evidently in worse condition.

The picture below shows the rubber packing underneath the starboard visor arm which was obviously never pressed into any flat bar and is not affected at all, which confirms the apparent fact that

- a) the flat bars around the deck opening had been removed prior to the casualty and that
- b) the visor was raised to some extent at this side after the hinges were broken since otherwise this rubber packing would have been destroyed as it did happen at port side - see P 3 - Port Side Fore-castle Deck.

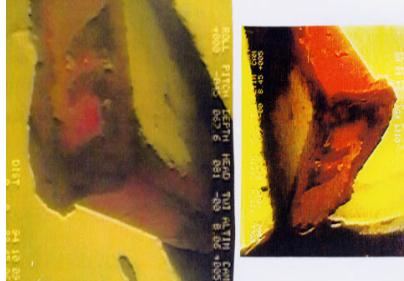
The next images show the lug of the hydraulic side lock which was evidently torn off the visor bulkhead together with the welding seams by which it had been welded to the bulkhead.

Note: It is obvious that these welding seams do not originate from one welding procedure only but from several weldings on top of each other, i. e. after each cutting off the new weld was laid on top of the previous ones without grinding off the remains of the previous welds as required by proper workmanship to assure the required load-carrying capacity of the weld. The required load-carry capacity of these lugs being part of the locking system of the visor did already since sometime before the last departure no more exist and was reduced to a fraction of the initial load-carrying capacity by such unqualified repairs.

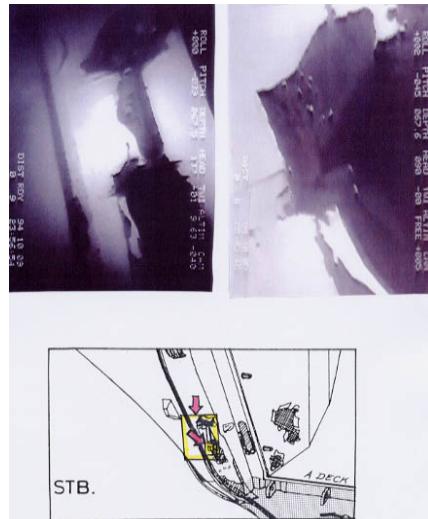
The following pictures show the upper part of the enlarged opening for the manual side lock.
Note the steel bent from inside to outside.

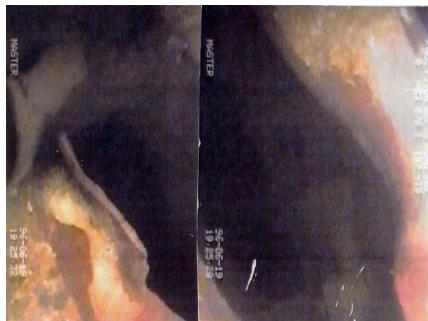
The two pictures below show the enlarged opening for the hooks of the manual side locks with the steel plating bent from inside to outside and the edges cracked.

On the right picture the not engaged mating part of the manual side lock is visible in the background. Furthermore a "soft" indentation can be seen on the inside of the substantially enlarged opening.

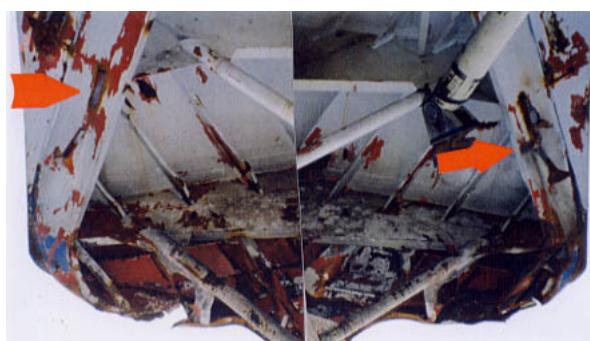
The picture on the right left shows the area of interest on the starboard side, the picture on the left shows the corresponding port side. It shows a completely different damage picture: no smoke marks, no steel tongue torn off the bulk-head and no twisted hooks. Two of the following four pictures on the next page show those areas at the port and starboard aft bulkhead of the visor where the lugs of the side locks had been welded to and the hooks for the manual side locks were fitted. The other two are close-ups of the upper parts of the area where the lugs had been welded. The right side shows the part of the starboard visor bulkhead directly opposite the above explained damage area. The smoke marks are still clearly visible although the visor had been on the sea bottom for 7 weeks. The hooks are distorted in a way which is technically not explainable. The area is dark. The picture on the left shows the corresponding port side as comparison with a complete different damage picture, with no smoke marks, no steel tongue torn out of the bulkhead and no twisted hooks and a generally clean appearance. The two close-ups arranged below the above mentioned photos show the respective upper parts of those openings in the bulkhead. They do illustrate the difference very clearly. While the port side shows normal steel clean of corrosion, the starboard side shows steel which had obviously been exposed to heat and pressure force: The metal is distorted and pushed out, the stiffener is detached from the bulkhead. See also Chapters 30 and 32.

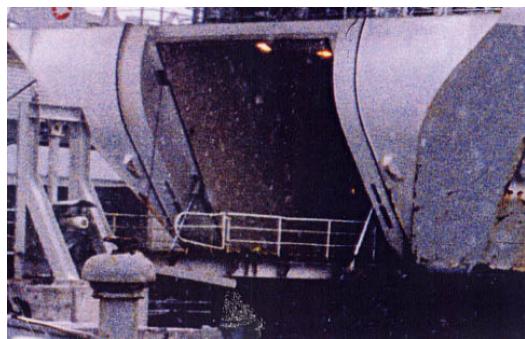
The area under investigation is restricted to the bow ramp and the adjacent plating of forecastle deck and forepeak deck as well as the front bulkheads on both sides, as can be seen on the picture below showing the area in question, (photo was taken on 25.03.94 in Tallinn when it was snowing) and indicated on the overview drawing.

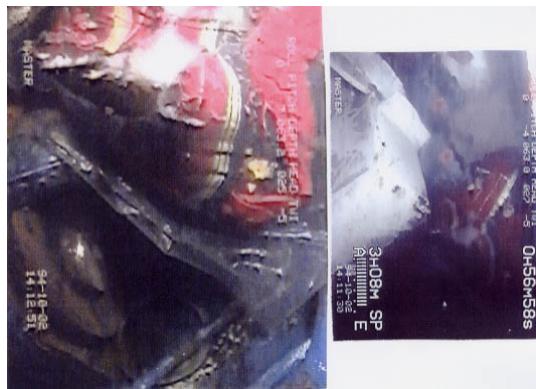
Also the following image shows the same area, but slightly further to starboard. The rubbing marks on the bedding indicate that it had been in place during several openings/closings of the bow ramp.

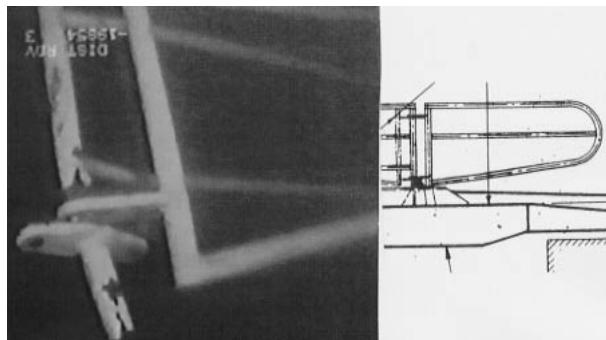
As parts of the starboard rail, the 4th section with the attached 5th moveable section, were found on the seabed already on 02.10.94 by ROV "Jutta II" - see the image on the next page - the available footage has been evaluated for indications of the bow ramp rails.

It is obvious that it is the starboard side because the movable part is always fixed at the inside of the fourth section if the ramp is open, as visible here and it is also obvious that the lower, bent part was the part attached to the ramp. It is further apparent that the vertical stanchion had been bent and finally cracked off by a force acting from port to starboard.

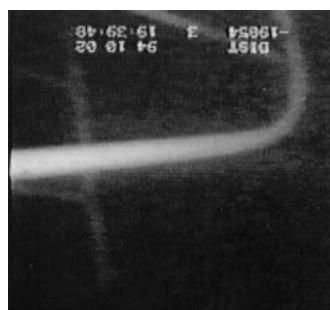
The image below shows the aft lower part of the movable fifth section which confirms the before said.

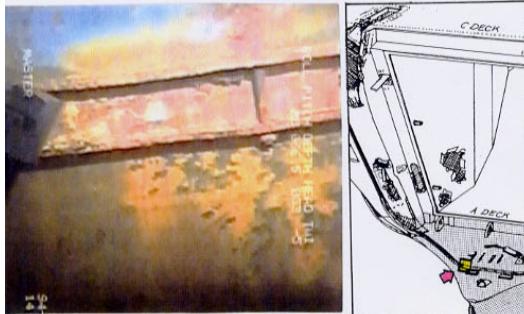
- Nos. 2, 4, 5, 6 show either empty flatbar channels where the rubber packings were supposed to be - which is also confirmed by the image below - or show the rubber packing lying loosely on the flatbars into which they should be fitted and bolted. The evaluation of the video films - of which these 3 pictures are just a small selection - prove that the rubber packings were only in place at the starboard side from forward of the Atlantic lock to the "corner of the mouth" and these were in a rather poor condition. Along the whole port side up into the "corner of the mouth" there were no rubber packings. The diver followed the flatbar - channel for the rubber packings from the top of the starboard front bulkhead via the forepeak deck to the top of the port front bulkhead which is documented on video tape B40c. The two images below are just a confirmation of the findings explained above.

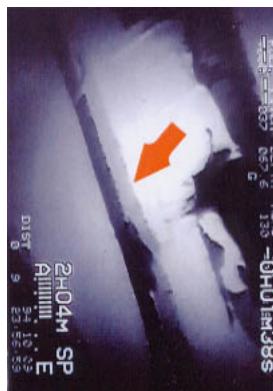
The lower part of the starboard front bulkhead in way of the hydraulic and manual side locks - see also further forward in this chapter, the starboard front bulkhead - is shown on the following images. The first one shows the upper part of the opening for the manual side lock with the rubber packing to the left. Between opening and rubber

packing the bulkhead is visibly bulged - see arrow - i.e. the bulkhead is pushed out around the opening for the manual hook and increasingly deeper down the bulkhead. This can be seen from the next image below - arrow 1. In addition, there is a very deep fold - see arrow 2 - as well as damage in way of the rubber packings - arrow 3.

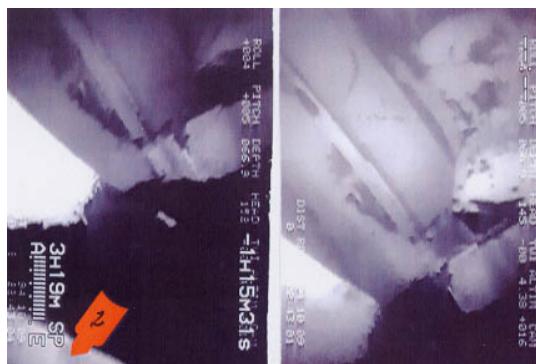
The following two images show the area adjacent to this pushed-out lower part of the front bulkhead, the recess with the torn-off and severely bent lower part of the outer vertical girder of the bow ramp. Apparently the deck/bulkhead is open in way of these severe distortions which also extends downwards.

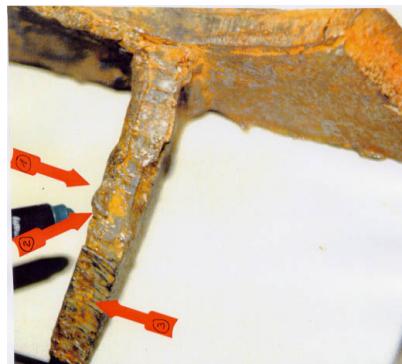
- Next an enlargement of the support bracket attached to the outside of the starboard lug is shown.

- The support bracket at the outer side of the lug (arrow 1) is larger than the original, which is evident because it overlaps the end of the welding seam (arrow 2) which marks the end of the bushing. The support bracket is about 12 mm larger compared to the original one made according to the von Tell drawing No. 49111- 373.

- The oblique end of the bracket is just burnt, not grinded (arrow 3). It is considered impossible that the bracket would have left blacksmith's shop of the Meyer Werft in such a condition - see also Subchapter 2.4.6;

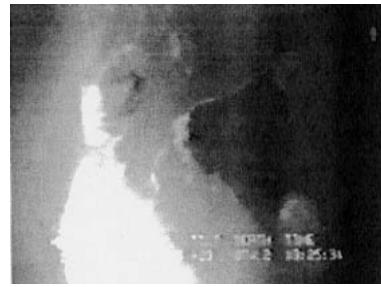
Since the starboard shell plating in way of 0-deck is accessible over the whole length of the wreck - see the 2 drawings on the previous pages - and has been carefully examined by ROV and divers during the mudline surveys, it is certain that respective video material is available. The "official" mudline video is, however, censored, i.e. the relevant parts were deleted - see also the Disengage Report - [Enclosure 34.6.434](#). Nevertheless, careful evaluation of the available mudline video does reveal very substantial damage to the starboard shell plating and bottom plating above and below the bilge keel as demonstrated by the images below.

When looking at the images presented here it is difficult to assume that this vessel had been in drydock only 8 months before, because the starboard side is really in a very bad condition, actually much worse as it is possible to demonstrate by images. Very deep indentations between the frames and deep scoring marks, partly not even corroded, are the rule, however, in some particular areas the plating is even holed as e.g. can be seen from the image below.

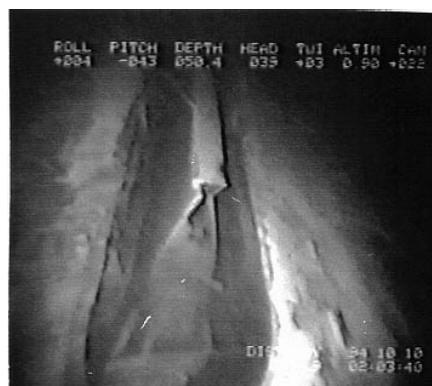
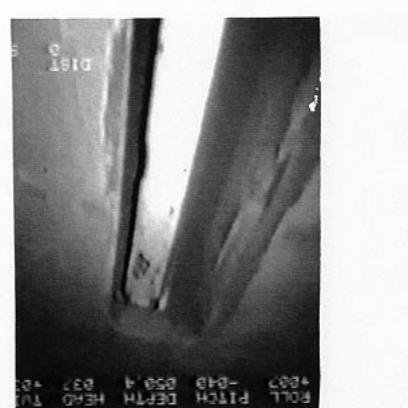
In January 1994 the ESTONIA was fitted with stabilisers of make Brown Brothers which had allegedly been in operation at the time of the casualty. According to 3rd engineer Margus Treu, the fins should retract automatically at speeds below 4 kn, therefore he does not believe that survivors could have seen the port stabiliser still out when the vessel was already almost on the side - see [Enclosure 21.3.271](#) - Protocol of Landvetter meeting on 31.03.95. In all probability Margus Treu is right because only after proper questioning of the survivors Pierre Thiger, Tony Spuhl and Mats Hillerström did it turn out that what they believed to have been the stabiliser was much too much forward to assume it could have been the stabiliser. They saw something big, partly white, partly dark, vertically bigger than transverse, which was moving in/out and/or up/down, very far forward, almost at the bow. They saw it still when the vessel was on the side already. The statement of Pierre Thiger taken on 08.10.99 is attached as Enclosure 29.6.414 and the statement of Tony Spuhl taken on 10.10.99 is attached as Enclosure 29.6.415. The statement of Mats Hillerström is not yet available. The actual stabiliser, however, is installed in a pocket behind the heeling tank on 0-dek level, i.e. about midships. When the witnesses were informed accordingly they categorically denied having seen anything moving in this area. This leads to the conclusion that the survivors had seen the visor, then still hanging on the bow ramp with the bottom attached to the forepeak deck and ice-knife of the bulbous bow. This leaves the trainee mate Einar Kukk who has stated - see [Enclosure 21.2.1.251](#) - that the stern was down to the stabiliser fin level. But he did not say that the fin was out. Therefore, it has to be assumed that the survivors actually meant the visor when they mentioned the stabiliser during the last stage before leaving the vessel. In any event the port stabiliser fin was found to be in its pocket during the ROV inspection on 09/10.10.94 - see the images below.

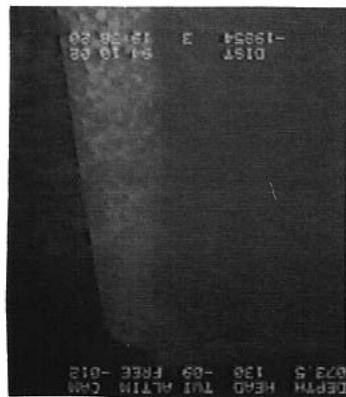
Alternatively the stabiliser fin could have broken off by the object sliding against the vessel's starboard side by which the scraping noises were caused. The noise scenario for Bengt Nilsson would have been the same. Therefore the video footage showing the ROV inspection of the sea bottom was analysed and the following two images were found which could show parts of the stabiliser fin.

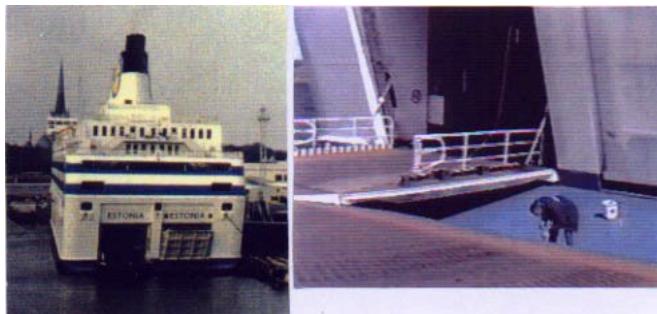
The ROV tape made on 02.10.94 indicates that the starboard stern ramp is slightly open as can be seen on the adjacent image. It shows the upper inner side. The explanation for this slight opening was given already in Subchapter 21.3.3 by the statement of Rolf Sörman - see [Enclosure 21.3.3.335.1](#) - who, as well as his seminar colleagues, were disturbed to such extent by hydraulic noises that they gave up their conference at 21.45 hours ET.

It has to be assumed that the starboard stern ramp was completely unlocked as it otherwise could not be slightly open and that the reason for this slightly open condition is the almost upside down condition of the wreck. It has further to be assumed that the stern ramp has been much more open during casualty sequence-of-events because latest after the shut-down of the auxiliary diesels the hydraulic pumps stopped since not being connected to the emergency generator. This means that subsequently the starboard stern ramp slowly opened completely or more or less completely while the ferry heeled more and more to starboard which led to massive water ingress onto the car deck and through the big lift opening at the aft end of the centre casing also into the large provision area in the aft of deck 1 and so on. This is most probably the explanation for the ferry sinking by the stern.

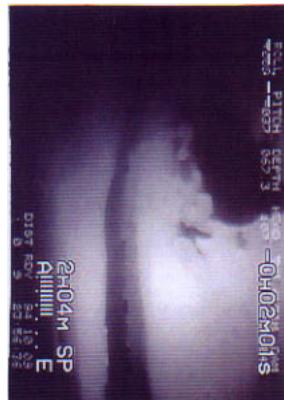
- The front bulkhead plating below the area of the hydraulic side lock was pushed outwards with exception of the rubber packing - see image below. It is clearly visible that the rubber packings, normally extending beyond the bulkhead, are in some sort of fold indicating that the surrounding plating was deformed towards the outside.

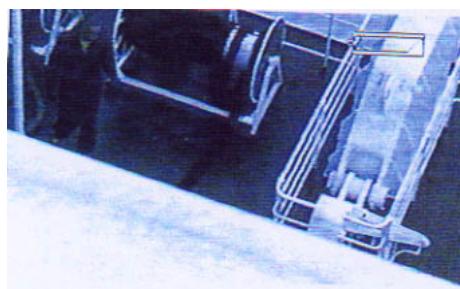
The visor's hinge system design consisted of the starboard and port side hinge arms fabricated from structural platings, with two attached lug plates on each side, carrying support bushings with bronze liners in the respective bore holes. The support bushings were welded to the lug plates with circular fillet welds. The visor hinge lugs were mated by deck hinge fittings, represented by lugs welded to the forecastle deck. The mechanical connection was one bolt on each side. The video image below shows the starboard hinge arm shortly before the accident.

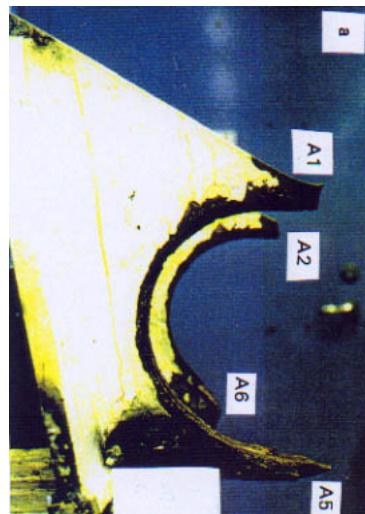
The following picture shows the broken port visor lug plates with the fractures A1, A2, A5 and A6.

The outer port side shows a vertical to slightly horizontal bending to port side at the fracture at the lower part of the remaining bore. The inner port side lug and both starboard lugs - see picture below - did not exhibit significant bending deformations. The picture below shows the broken starboard visor lug plates with fractures A3, A4, A7, A8:

The failure of the visor hinges occurred by fractures A1-A8 of the visor lug plates together with the fillet welds to the support bushings. The bolts had been ripped out of the hinges, together with the bushings.

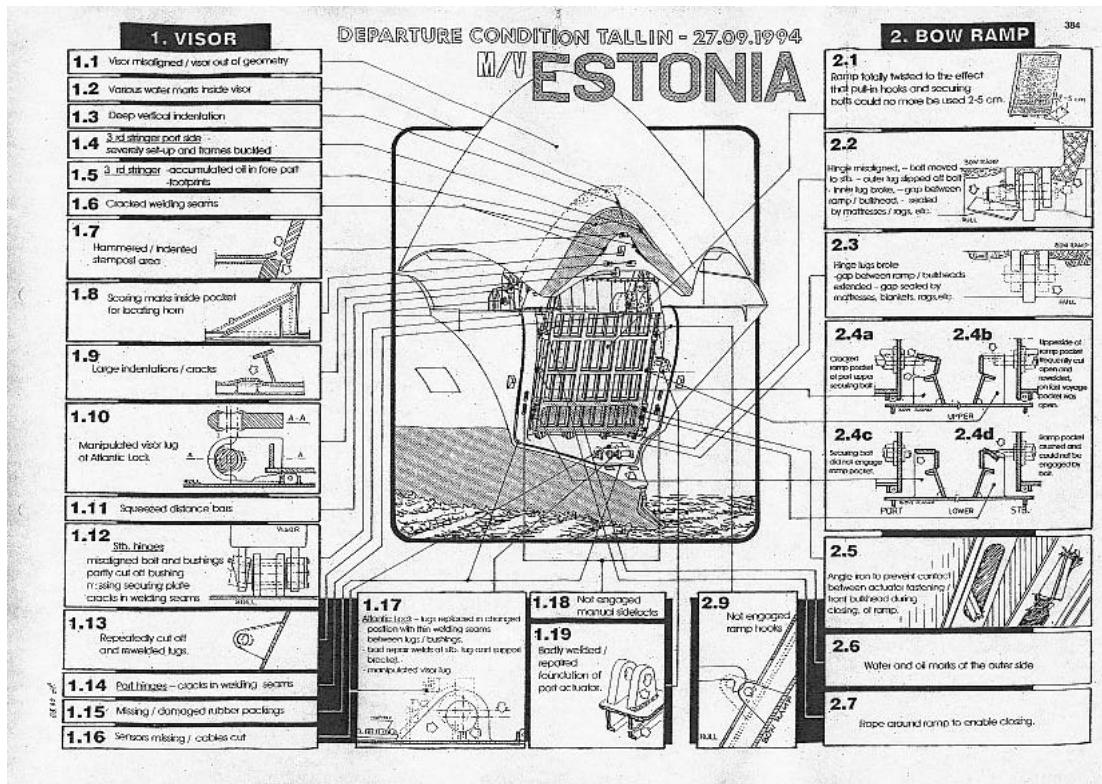
In addition, these deficiencies are shown on a drawing of the foreship with open visor which is integrated into this report and forms the following page.

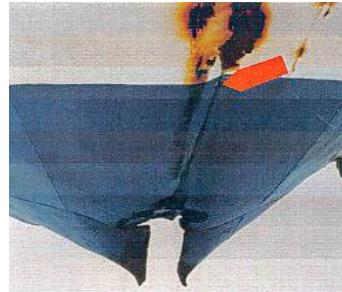
The shell plating as well as the internals are very severely damaged in two places, viz. there is a deep vertical indentation in the bow leading upwards from the stempost for about 2 m, as can be seen on the picture below from the outside,

The arrow points to the deep indentation which is completely painted and the paint does not show contact marks. The following photos showing the inside of the same area do confirm the deep indentation in a very strong part of the visor to be of old origin.

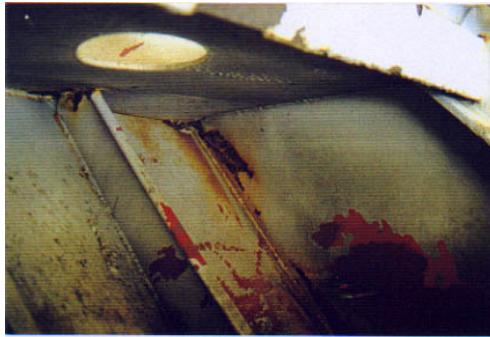
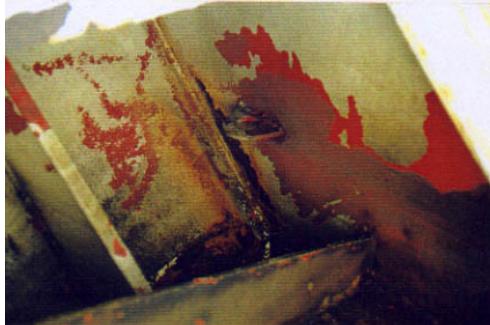
Furthermore, the shell plating as well as the 3rd stringer at the port side are severely indented and set up with the frames buckled which had been sustained already some time before the casualty. - See the pictures above.

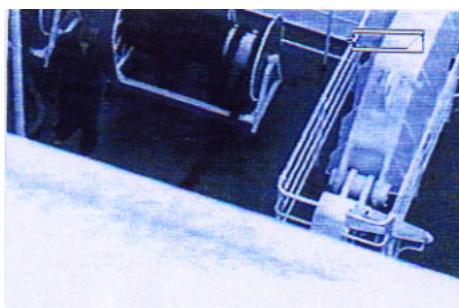
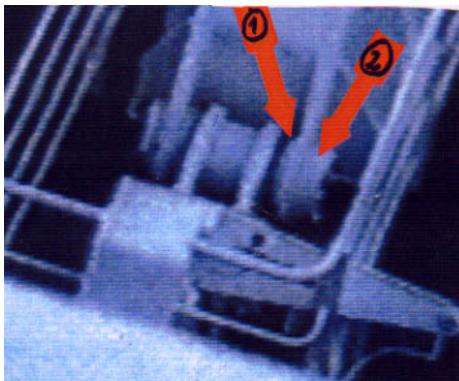
The passenger was standing in front of deck 7 and filmed the closing of the visor, finally zooming in on the starboard hinges. The video-prints below are part of the film. Picture 2 is an enlargement of Picture 1.

On Picture 2 there are obviously several major deficiencies visible, viz.

(a) the gap between the starboard vessel hinge plate and the outer bushing is much too large (arrow 1).

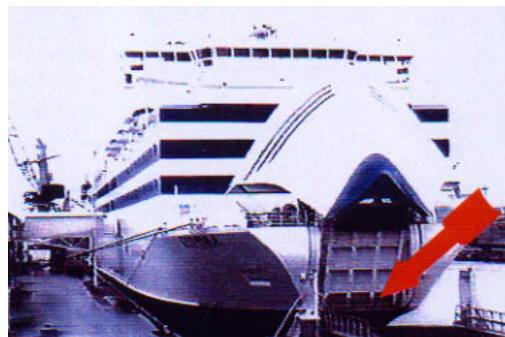
The following picture shows the ESTONIA in Tallinn, with open visor but closed bow ramp so that the otherwise invisible underside of the bow ramp is shown with the lowest section being dark - see arrow. Doubtless this was caused by the water inside the visor with hydraulic oil from the leaking cylinders swimming on top of the water surface. When the vessel reduced speed and the bow wave became smaller and finally disappeared completely when the vessel was alongside, the water streamed out of the visor and the oil settled everywhere inside the visor, also on the bow ramp which forms the aft inside of the visor. The water streaming out of the visor was observed by many passengers when the vessel was alongside in Stockholm with closed visor and, among others, also by the skipper of the Sandhamn pilot boat as well as by several pilots when the ferry was slowing down during the approach to the pilot boat.

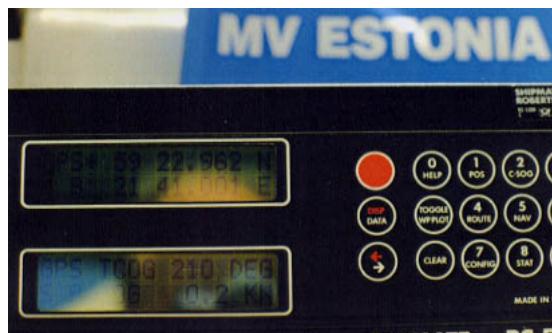
The photo below shows the DGPS position of the wreck taken on board of a tug directly above.

The heading is approximately east and the wreck is lying on her starboard side with a list of about 120°. The water depth above the bow is 85 m and above the stern is 74 m. The highest point of the wreck is the stern with 58 m of water above. The wreck is resting on soft clay on the top with stiff boulder clay below. A side scan sonar survey of the area around the wreck revealed debris in an area of up to 350 m to the south and the west of the wreck.

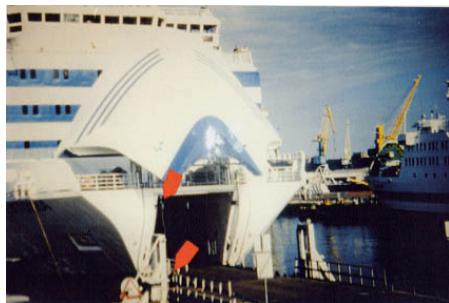
The arrows on the picture above point to the shackles by which the starboard preventer wire is connected to vessel and bow ramp. The system on the port side is identical.

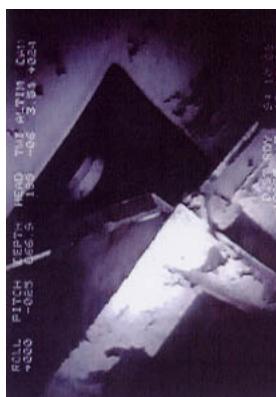
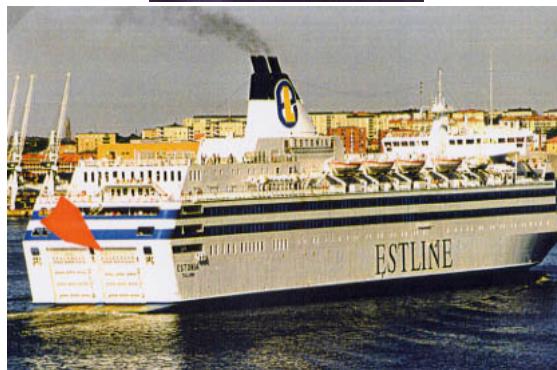
as to (8) The condition of the starboard stern ramp.

The image below shows the inside of the upper starboard stern ramp to be partly open. It was taken from the ROV video dated 09.10.94. The arrow on the picture further down points to the area in question. This fact will be explained in detail in Subchapter 29.7.

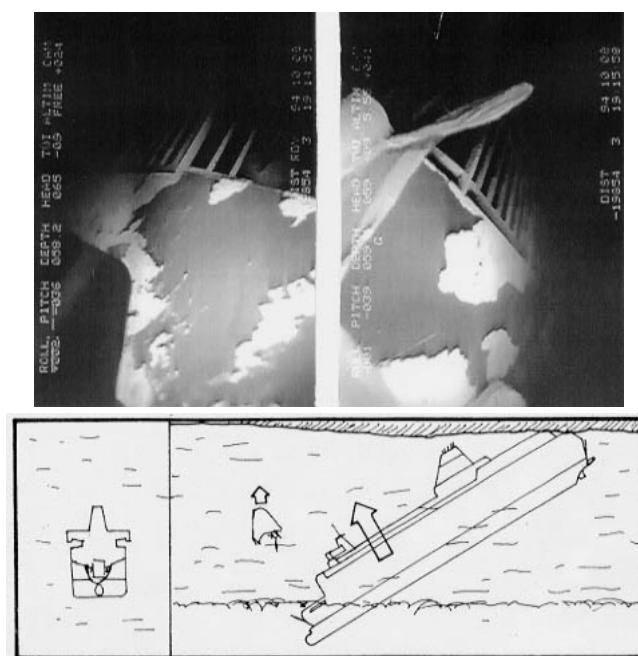
The visor was missing with the remains of the hinges on the forecastle deck broken, both front bulkheads and the bow ramp were noted to be severely damaged, damaged/broken railings and broken davits were found in way of deck 7 and some broken windows/port holes on other decks. Window panels were found to have been pushed out and doors in the aft bulkheads of decks 5 and 7 were missing while the door in the front bulkhead of deck 5 leading down to the forecastle deck was noted to be open.

Note: This door could only be opened by crew members. The aft parts of the superstructures in way of decks 7 and 8 on the port side were found to be partly distorted and buckled. Large flakes of paint were scored off the aft parts of decks 5 and 6 - see the two images below - which was most probably caused when the vessel was in upside down condition with the stern already aground and the bow still above the water. - See the drawing below.

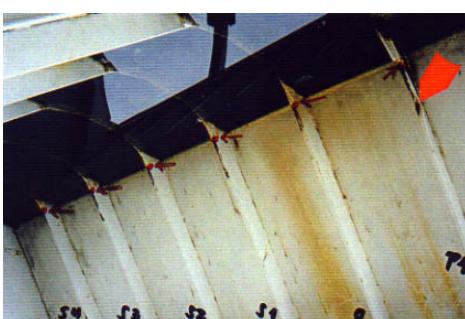
The arrow indicates the point of contact on web 9. The next frame 5, which is the centre line, and the following frames to starboard have no marks at this level.

This means that when web 9 came in contact with the port side of the bow ramp and was pressed together from 160 mm to 20 mm the corresponding web 1 at the starboard side of the ramp house was 360 / .160 = 200 mm away from the starboard side of the bow ramp. Due to the narrow construction, such a misalignment of the visor is not possible as long as the visor lugs move within the forecastle deck area aft of the deck-beam at frame 159 and as long as both actuators are connected to the B-deck. As will be shown on sheet P 4 + S 4 this was no more the case with the foundation of the port actuator. Also visible on the two pictures above are slight scorings inside the ramp house from web 1 through web 9 which could indicate a slight contact at another time, earlier or later (see red arrows on both pictures). The scoring marks are just below the brackets between vertical/horizontal webs which would be the

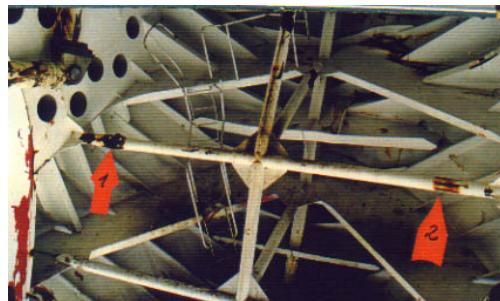
Although the upper transverse crossbar inside the visor shows respective damage - see arrow 1 on the picture below - the corresponding part at the port outer longitudinal girder of the bow ramp does not. This is confirmed by the image further down,

taken from the ROV video made on 09.10.94 which shows the port outer girder underside of the bow ramp in way of the contact area with the above-mentioned crossbar. There is no damage, the paint is completely unaffected (the diagonally running stripe being a wire).

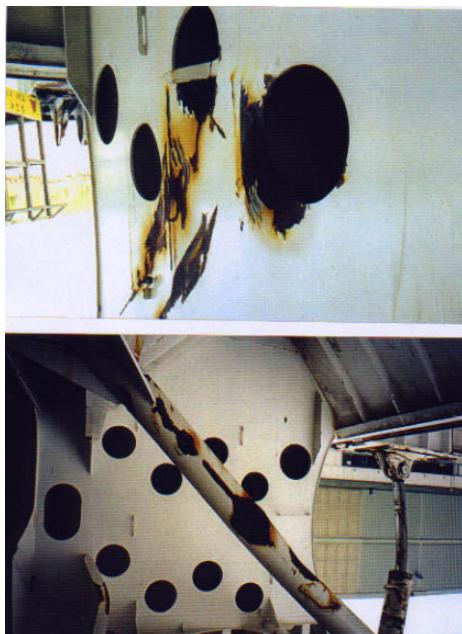
Finally attention has to be drawn to one indentation pushed at each side into the forward deck beam of the visor, i.e. the lower side of the forward part of the ramp house as indicated on the two pictures on the next page. According to drawing on page 956 the port indentation is 240 mm away from the inner bulkhead and the starboard one 325 m. This means that these indentations were most probably caused by the bell cranks being the most upwards extending parts of the bow ramp. This must have occurred at a time when the visor was hanging on the bow ramp already, i.e. the contact area having been the port inner bulkhead. Therefore the distance between bow ramp and port inner bulkhead has as small as possible - 240 mm - while the opposite distance between the bow ramp and the starboard inner bulkhead was as big as possible - 325 mm. This is also the explanation for the apparent fact that the port inner bulkhead was very severely distorted and partly cracked while the starboard inner bulkhead remained completely unaffected even without paint scratches. See also S 4 and P4 - The Inner Bulkheads - further down.

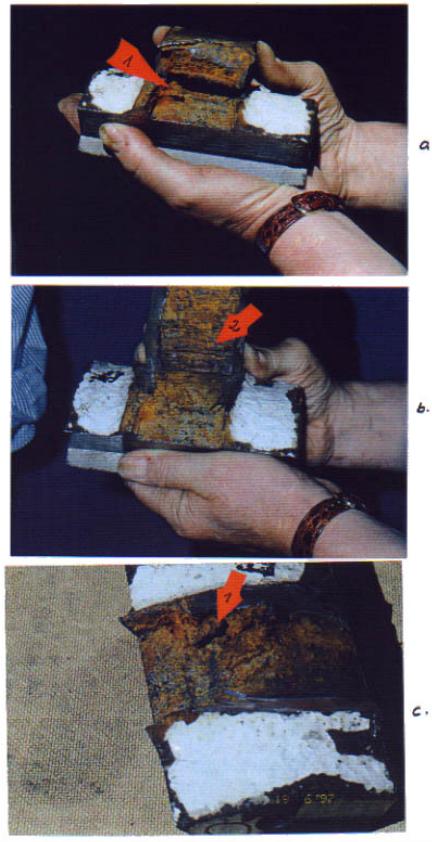
2, 3, 6 - show part of this bushing with part of the fractured visor hinge plate still attached to it. This part is shown in more detail after the hinge-plate part had been cut off on the following page (pictures a - c). The pictures reveal the following:

- The welding seams between bushing and hinge plate are of poor quality and only 7-8 mm thick whereas the originals were about 15 mm thick.
- The same welding seams apparently cracked frequently and it had been attempted to close the cracks by welding which resulted in welding material penetrating through the cracks into the gap between the hinge plate and bushing. See arrows 1 on pictures a and c.
- The surface of the bushing in way of the hinge plate shows corrosion which indicates that the space between bushing/hinge plate, which should be sealed airtight by the welding seams, had not been airtight anymore for some time already obviously due to the crack propagation in the too thin welding seams and/or due to unprofessional welding.

- The inside of the hinge plates were damaged by deep burning marks (see arrow 2 on picture b) from which crack propagation into the material of the hinge plates started and after the cracks had penetrated 50-60% of the material the remaining part of the hinge plate failed in the shear mode.
- The surface of the bushing, corresponding to the inside of the hinge plate with the burning marks explained above, does not show burning marks, therefore it has to be assumed that the original bushing was burned out some time before the casualty and replaced by the present one.
- The gap between bushing and hinge plate in way of the fracture area was about 25 mm indicating that the bushing did not fit into the hole of the hinge plate because the bushing was too small.

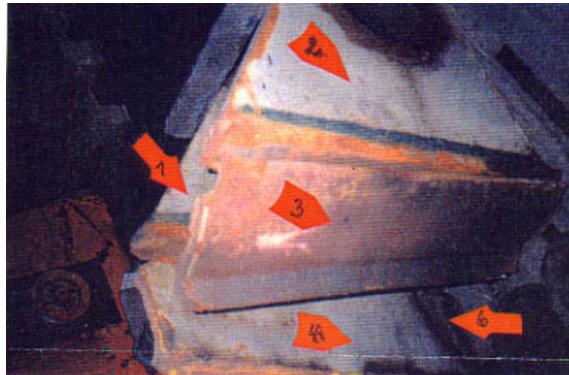
The following photograph shows the actuator foundation after it was removed and taken to the workshop of MacGregor, Turku for examination/testing on behalf of the JAIC. The arrows show the same numbers as used above.

As it is obvious from the close-ups below, the stiffener (3) was hardly spot-welded and thus only slightly connected with the B-deck. As this part of the stiffener is not painted at all - see the next photo to which the reader looks on the port inner lug plate from starboard to port - it is no more original, i.e. has been installed subsequently when the vessel was trading already.

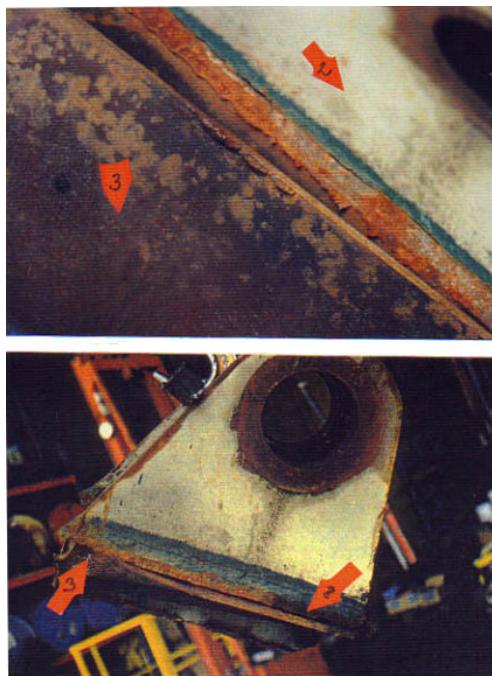
(4) The port inner stiffener was no more the original one since firstly it did not show any protecting coating and secondly was only spot welded to the deck - if at all. All stiffeners were however fully welded to the deck by the shipyard during new-building, as it can still be seen on the starboard actuator foundation.

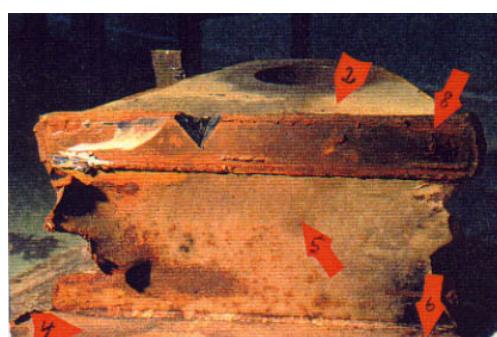
The following photograph shows the port visor actuator foundation after parts had been cut out for testing purposes. The foundation lies on its port outer lug plate. In the front the port outer stiffener (4) is visible, which is fully welded to the B-deck (5). Further at the forward right corner the old temporary repair with the very poor welding seams (6) is visible from inside. For cutting purposes the port inner stiffener (3) had been removed.

The apparent fact that this stiffener (3) had been disconnected from the B-deck (5) respectively since the last repair was never really fitted to it, is further confirmed by a part of the welding seam - see arrow 8 - on the previous two photos - apparently being soaked with oil while the stiffener below is unaffected. This means that this stiffener was not welded to the B-deck.

- (1) The outer stiffener of the port actuator foundation shows an old temporary repair with very poor welding seems in its forward part. Due to the corrosion visible on the previous photos it has to be assumed that this improper repair was carried out already some considerable time before the casualty.
- (2) The stiffeners show relatively straight cracks directly below the forward and the aft ends of the lug plates. Therefore it can be reasonably assumed that the stiffeners were affected by fatigue cracks and thus pre-damaged. The cracks had developed during some considerable time before the casualty due to load changes during the opening and closing of the visor.

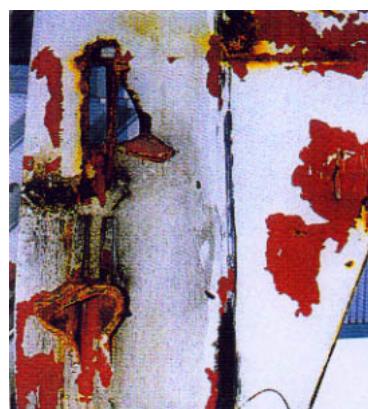
2, 3 - show the area of the missing side lock lug and the considerably bent hooks of the manual side locks from the top and from the side. The side view shows that the area in way of the pushed out steel tongue - see arrow 1 - is bulged outwards indicating pressure from inside to outside, whereas the plating between the hole for the lug and the hooks shows smoke marks, which are explained in Chapter 32. Around the opening for the lug burning/welding marks from the cutting off and the subsequent rewelding of the lug are visible. The following picture has been taken from the JAIC Report and clearly confirms the above.

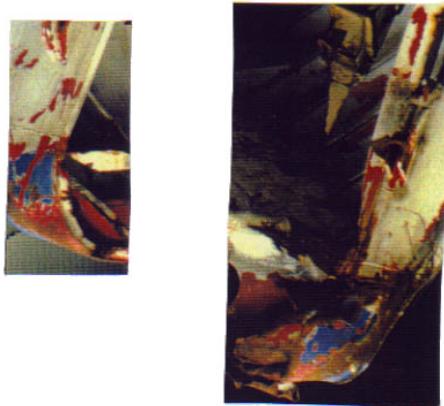
- (6) The hooks were crushed together in such a way which cannot be explained mechanically.
- (7) The bottom end of the aft bulkhead is partly crushed, partly torn and on the outside a deep fold in way of the contact area with the rubber packings of the corresponding front bulkhead of the vessel extends from the area of the lug down to the bottom area. - See the right picture on the next page. The corresponding area on the lower part of the port aft bulkhead of the visor, as can be seen on the left picture on the next page, is apparently undamaged.

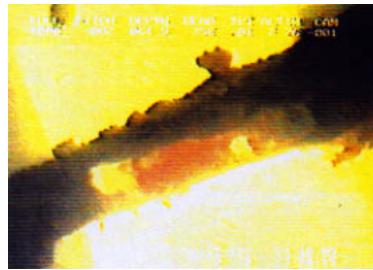
The following image shows the lug attached to the bolt inside the vessel before it was pulled out by the diver. Contrary to the starboard side this lug rested inside the bulkhead as visible, although it was on the high port side.

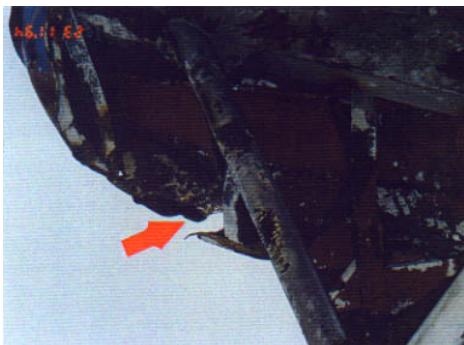
8 - shows the lower aft bulkhead/visor bottom which is only moderately damaged compared to the starboard side - see also the picture below.

The arrow points to a damage to the port aft edge of the visor bottom which apparently occurred when the visor moved transversely from port to starboard. This will be explained in Chapter 31 - The Casualty Scenario. See also picture 5 on the following Sheet 6.

(4) The very sharp damage at the port aft edge of the visor bottom was caused when the visor moved athwartships in the final stage of gliding off the bow ramp, the forepeak deck and finally the bulbous bow to the bottom of the sea.

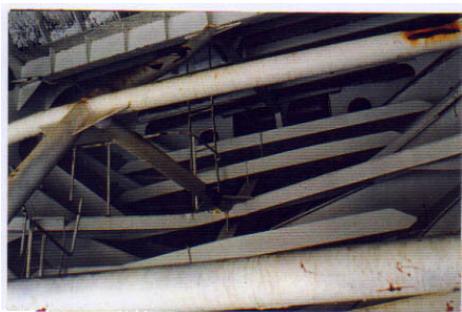
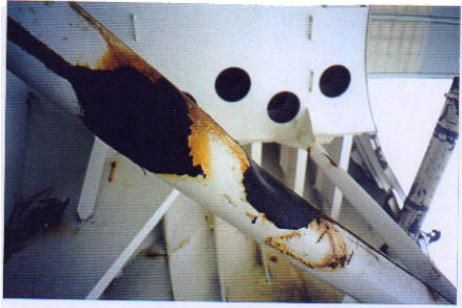
The two pictures below show the damage to the top and port side of the vertical beam.

- (1) The upper cross-beam shows damage at two locations on the port side which cannot have been caused by the bow ramp, because there was no corresponding damage at the ramp.

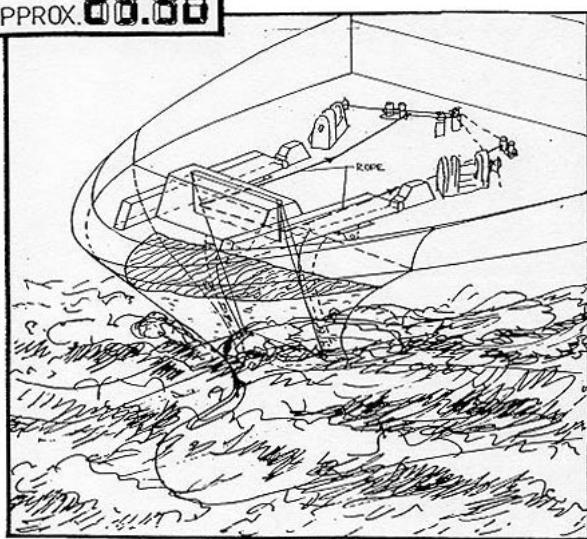
APPROX. 88.88

1. Due to increasing wave height and deep pitching of the ferry the water level inside the visor rose higher and the pressure on the "sealing" material
2. Water entered the car deck in increasing quantities.
3. The ferry made very hard pitch movements.
4. The bow ramp was kept more or less closed by the rope and the water pressure from the visor side, however water penetrated at both sides of the ramp
5. This was the condition on board the ESTONIA when she met "AMBER".

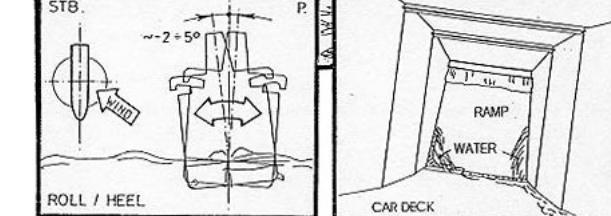
1. Low banging noises continued
2. Port stabiliser fin activated, crew started to work on the starboard fin.
3. The watch A.B. noted alot of water on the car deck, alarmed the bridge and crew was activated
4. The course was changed to starboard and the ferry began to roll heavily, whereafter the vessel was turned back to port and stated to pitch heavily. The speed was reduced.
5. The crew was working on the car deck to control the water ingress which turned out to be impossible.
6. The vessel made deep, slow pitch movements and was slightly rolling, more to starboard, less to port.

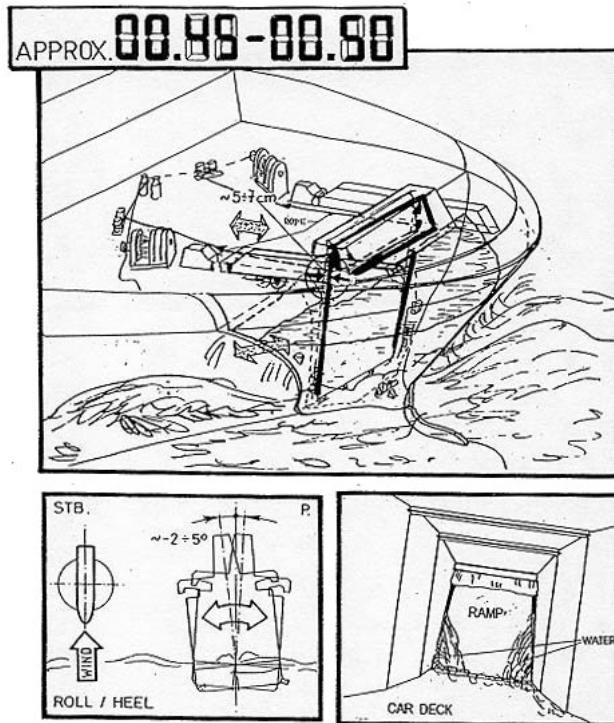
1. The crew members went on the forecastle deck through the door on deck 5 and tried to heave the rope holding the bow ramp which failed probably due to the green water taken on the forecastle deck.
2. The bow was held by the actuators and lowered down inside the visor.
3. The crew somehow managed to start the hydraulic pumps under extremely difficult conditions due to the water on the deck and the moving cars.
4. The substantially pre-damaged STB . Visor hinges failed followed by the equally pre-damaged STB side lock.5. The starboard side of the visor moved forward, the lugs cut through the deck plating and struck against the deck beam aft frame 159, the visor was pushed back when the vessel was diving into the next wave trough causing the broken visor hinge parts to smash against the hinge parts on the forecastle deck.

The starboard side of the visor was 5-7 cm moving forward/aft between the deck beam at frame 159 and the hinge parts on forecastle deck which created the heavy metallic banging noises scaring many passengers. The lug plates underneath the starboard visor arm came in contact with the adjacent plating and sustained scoring marks on the inside and on the outside because the vessel was only slightly heeled to starboard, still pitching in head seas and only slightly rolling. The port visor hinges remained intact for the time being.

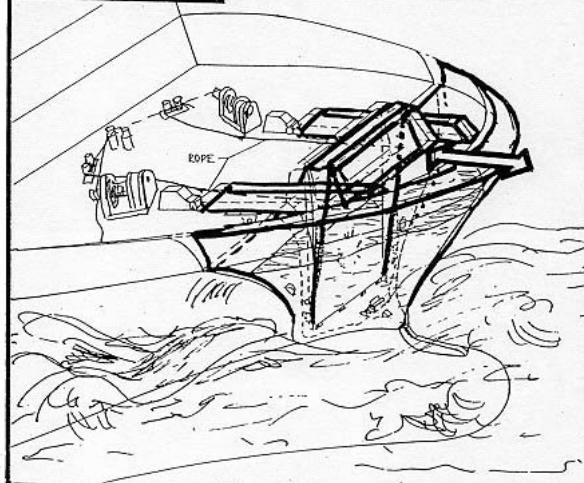
APPROX. **88.88**

1. Also the port hinges and the port side lock failed and the visor moved forward/aft between the deck beam at frame 159 and the hinge parts on

2. Simultaneously hard scraping noises were caused by the upper flaps of the ramp scraping along the vertical beam inside the visor due to the movements in the sea

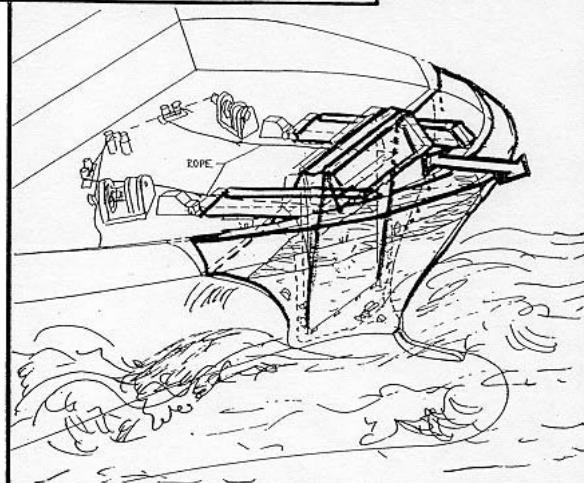
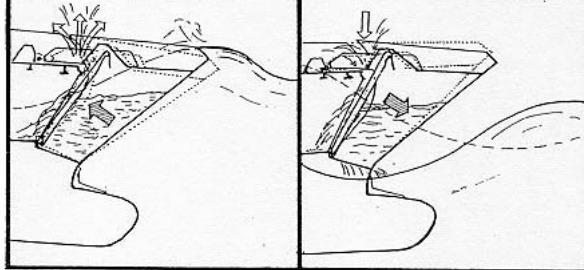
APPROX. **88.88 - 88.88**

1. Hard metallic banging/knocking and scraping noises.

2. Visor moving forward /aft between the deck beam at the frame 159 and the forecastle deck parts of the hinges, the lugs underneath the visor arms were cutting through the deck beam.

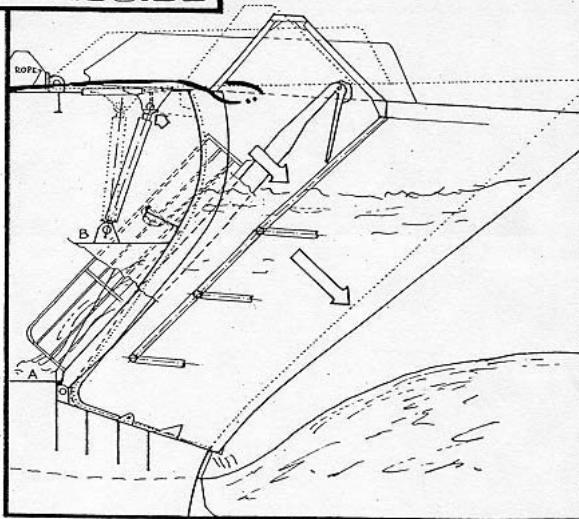
APPROX. 88.88

1. The visor lugs finally cut through the deck beam and the visor moved forward, the forepeak deck penetrated the visor bottom.
2. The vessel was now more rolling than pitching.
3. The ramp was inside the visor while the visor moved forward.

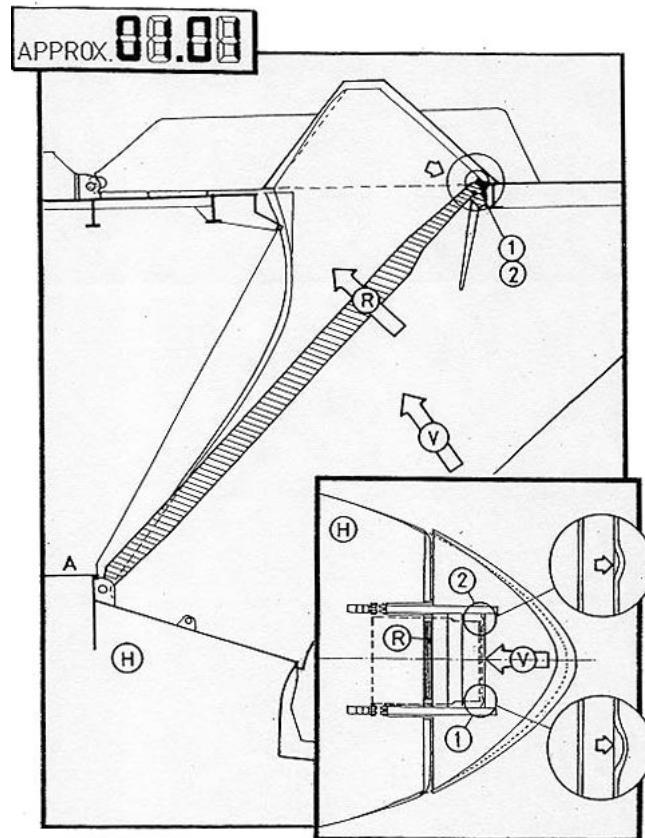
1. Vessel rolling more to starboard/less to port .

2. Visor lugs broke through the front bulkheads and did not support the visor anymore against moving towards the deeper starboard side (1)
3. With a big crash the visor fell abruptly about 10 cm to starboard until the inner port bulkhead was resting on the upper part of the bow ramp (2).
4. The visor was now extending the starboard front bulkhead of the vessel and the port front bulkhead was extending the visor.
5. The atlantic lock failed.

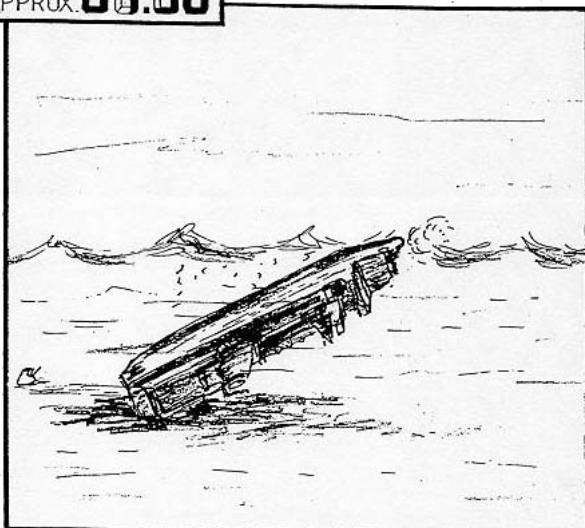
APPROX. **08.90**

1. The Vessel sank stern first.
2. The bow was still above water when the stern was already on the sea bottom.
3. The visor sank about 1nm west of the wreck upside down.
