FACTUAL INFORMATION

1 THE CASUALTY

2 THE VESSEL "VIKING SALLY"

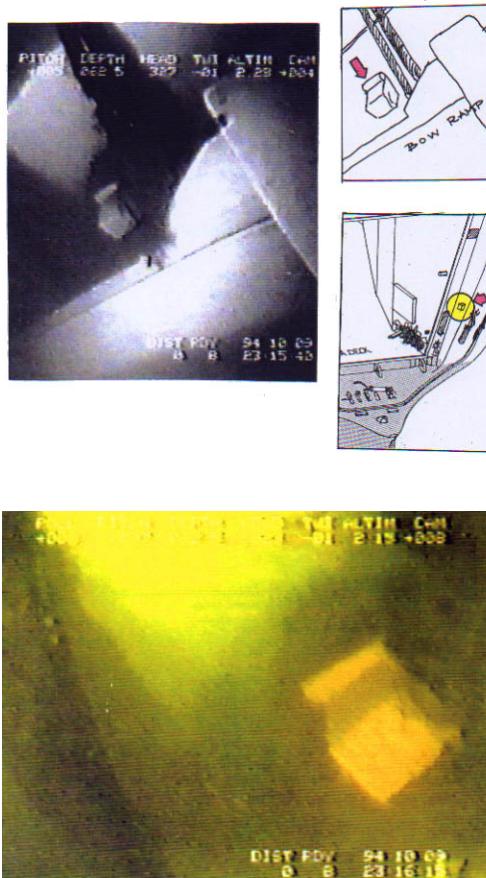
Images were made from the orange coloured cube and identified by all three experts from Sweden, England and Germany with a high degree of probability as an "explosive charge". See the following two images.

As this charge attached in way of a very sensitive area - the port side locking devices of the visor and the fastening of the port bow ramp actuator - obviously did not explode, the corresponding area of the starboard side was analysed for possible explosion damage which was positively identified by the underwater explosive expert Brian Braidwood. This resulted in a further analysis of the available video footage all received from the JAIC. The results are outlined in the following subchapters.
