# Statement Carl overberg

Enclosure 12.4.2.151

Statement

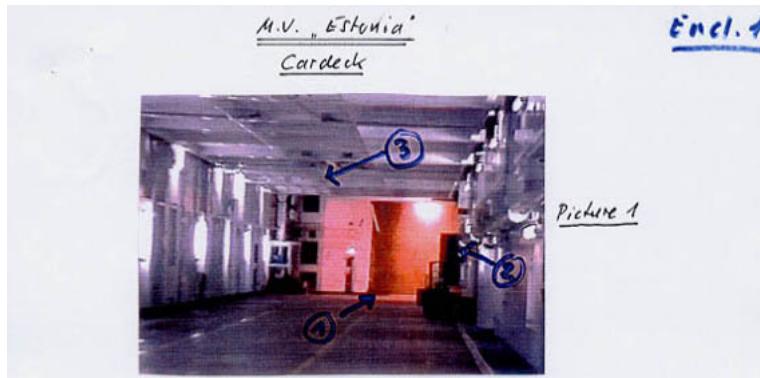
When I was waiting in my car on the car deck on one voyage I noticed that there was a video camera mounted underneath the upper deck at port side forward which was looking aft. The approximate position is indicated by arrow 3 on picture no. 1 on Enclosure no. 1. I am aware that the ferry's car deck

- (c) In front of the centre casing there were always one or two garbage containers standing into which the crew put empty bottles, cartons and the like. In addition, I noticed sometimes these containers also standing at port and starboard sides in the aft part of the car deck. I have drawn the position into a sketch of the car deck attached as Enclosure no. 2. As far as I remember these containers were never secured and very often caused concern to me when my car was standing close to them. The port one is visible on picture 1 of Enclosure no. 1. Arrow 2 is pointing to it.

Port forward part with closed bowramp.  
Arrow 1 indicates the missing flaps between ramp/cardeck, which are pulled to the side when the bowramp is closed.  
Arrow 2 indicates the garbage container.
