The German 'Group of Experts' has now - as far as possible - completed its investigation of the foundering of the M. V. ESTONIA, a disaster that has taken the greatest toll of human life in the Baltic Sea in times of peace. The German 'Group of Experts' has during the past five years performed a difficult investigation in a partly hostile and reluctant environment. The work was carried out during the first two years - 1995/1996 - in close co-operation with the Swedish leader of the Technical Group of the Joint Accident Investigation Commission of Estonia, Finland and Sweden (JAIC), Börje Stenström († February 1997), and also with the Finnish member of the Technical Group, Dr. Tuomo Karppinen and the expert Dr. Klaus Rahka. All the investigation results of this 'Group of Experts' were submitted either verbally in joint meetings with the members and the experts from Estonia, Finland and Sweden attending or in letters with attached photos and/or video film documentation to the JAIC. This documentation and information concerned the design, construction and building of M. V. ESTONIA in general and the locking devices of the bow visor in particular, including the load calculations, the c

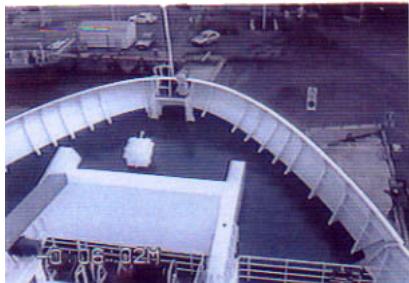
On my last trip to Tallinn before the casualty (I missed one sailing) my car was on the hanging deck at starboard side. Thus I could not see what was going on at the ramp and the visor when being opened. I saw, however, crew members working at the bow ramp before it was lowered down. When I drove down the ramp I saw the equipment for either welding or burning (gas bottles) laying at port side near ramp. We had to wait longer than normal, maybe half an hour or more before the bow ramp opened. I remember this clearly, because I had people waiting for me at the quay who had left before I was from board because it took so long. It could be the time when I saw the visor moving up and down several times before the bow ramp opened combined with banging noises and also hammering.«

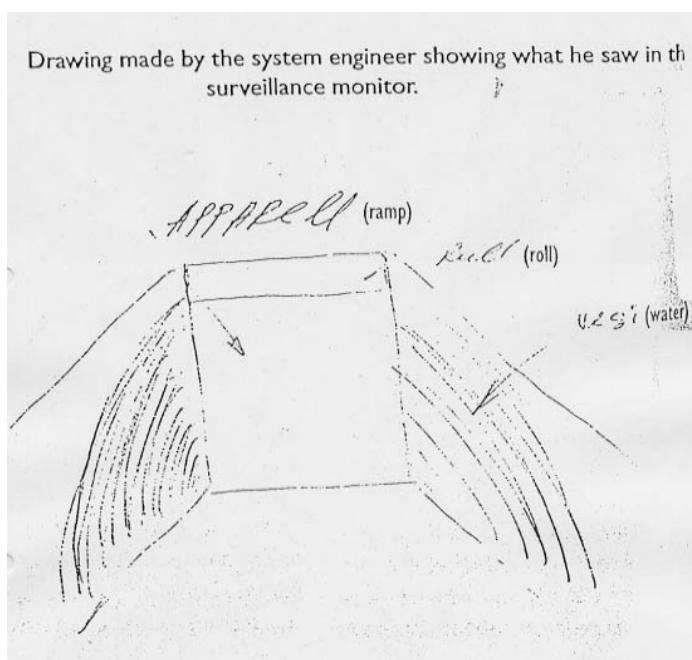
Sillaste has maintained this observation, viz. that the bow ramp was slightly open when he looked at the monitor for the first time in the Engine Control Room (ECR), during all his statements. Although he is expressing himself very carefully and has, after the first three statements taken on 28/29 September 1994 at Turku, obviously been prepared for possible further questioning concerning the visor and its locking devices, however, apparently not in respect of the bow ramp. Also the fact that he was not invited to attend the Landvetter meeting at the end of March 1995 indicates that neither JAIC nor ESCO did consider him to be a key witness. This apparently changed after this 'Group of Experts' had presented his detailed evidence, including the drawing he had made showing the slightly open bow ramp with water pressing through at both sides, to JAIC in the course of the joint meetings held during the second half of 1995.

Already in January 1996 he was again interrogated by the Estonian security police when he made another drawing showing the same condition of the slightly open bow ramp with water pressing through at both sides. Both drawings are shown below.

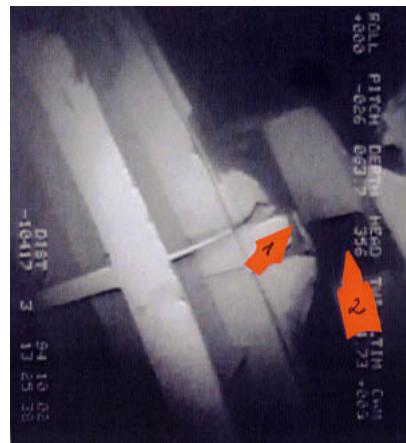
The following picture shows the misalignment between the mating lug at the ramp side and the opening in the front bulkhead out of which the hook would extend, i.e. it was impossible for the hook to engage the mating lug in this condition. This explains the undamaged condition of both hook and mating lug.

Arrow 1 points to the mating lug at the ramp

Arrow 2 points to the location where the hook would reach out of the opening

Note: The 4 inches = 100 cm misalignment between the bolts on the ship's side and the mating pockets on the port side of the bow ramp as reported by the diver must logically exist also between the ramp hook on the ship's side and the mating lug on the bow ramp. This is further evidence that neither the bolts could have engaged the mating boxes nor the ramp hook the mating lug on the port side.

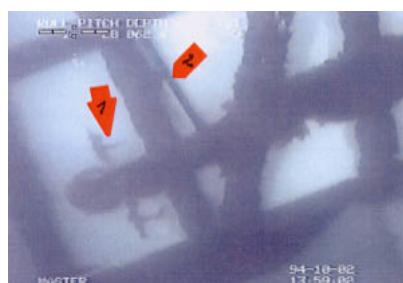
Area No. 3:

The following image shows transverse contact marks above the opening for the hydraulic side lock - see arrow 1 - which presumably resulted from the visor moving forward/aft during the time it took the visor arm lugs to cut through the deck beam.

Arrow 2 on the above image points to a wire running across the front bulkhead and the bow ramp to the starboard side and apparently from the port fair leads of the forecastle deck (there is no other possibility where a wire could come from). The image was made from the video tape produced by ROV on 02.10.94 - see Subchapter 25.1 - because on subsequent videos the wire is no more visible.

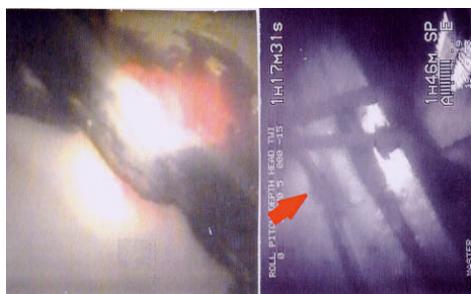
Arrow 2 points to a damage area in way of the rubber packings which is better visible on the right image below made from the 1996 video tape. The double rope was then still there because it is jammed in, though in slightly changed position. The damage area is more clearly visible - see arrow.

The left image above was taken from diver video B40c and is a close up of the same damage area. It shows that the rubber packing including flat bar channel has been pressed flat on a distance of about 200 mm. This could have been caused by a single wire or wire running from the bow ramp around the edge of bulkhead/hull plating up to the fair leads on the forecastle deck and further to one of the winches. Alternatively the damage could have been caused by the port aft edge of the visor bottom in the final stage of the visor separating from the vessel - see Chapter 31 - or it could have been an old damage because the corresponding area on the aft bulkhead of the visor does not show rubbing marks from the rubber packing. See the picture on the next page. A similar damage does not exist at the starboard front bulkhead.

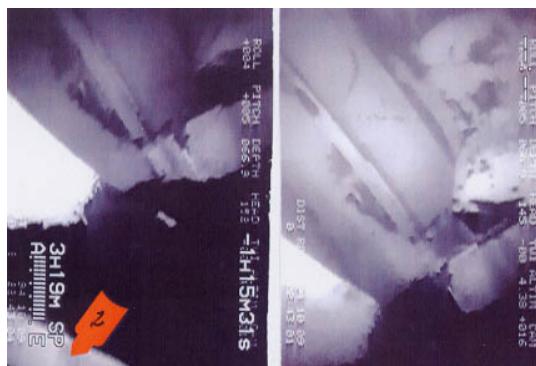
The following two images show the area adjacent to this pushed-out lower part of the front bulkhead, the recess with the torn-off and severely bent lower part of the outer vertical girder of the bow ramp. Apparently the deck/bulkhead is open in way of these severe distortions which also extends downwards.

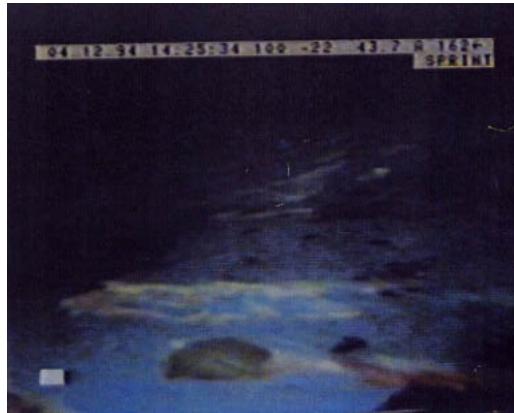
The following image shows white contact marks on the port side of the bulbous bow further aft than the previous one.

The pictures do confirm contact with some object which could have been quite strong considering the very strong construction of the bulbous bow, i.e. a weaker construction might have sustained heavy damage due to contact with the strong bulbous bow as indicated by the above paint and scoring marks.

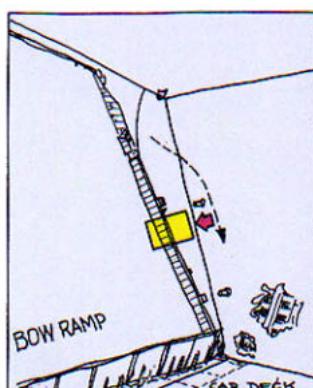
This is the area where the broken piston rod of the actuator was seen from the outside to be jammed in between the ramp and the recess.

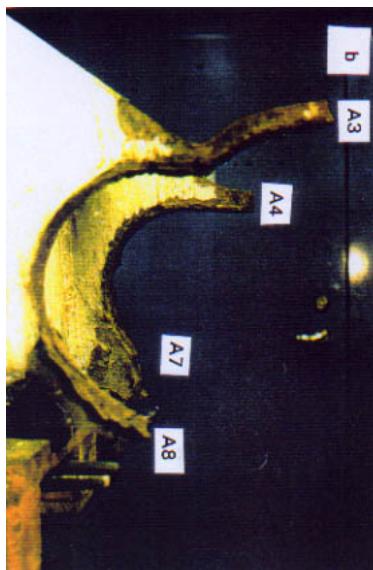
The outer port side shows a vertical to slightly horizontal bending to port side at the fracture at the lower part of the remaining bore. The inner port side lug and both starboard lugs - see picture below - did not exhibit significant bending deformations. The picture below shows the broken starboard visor lug plates with fractures A3, A4, A7, A8:

The fractures A1-A4 of the upper locations of the remaining bores were indicating considerable less necking as compared to the lower fractures A5-A8. In particular, the upper fractures A3,A4 of the starboard lugs exhibited only very small fracture edge contractions, yielding substantially identical cross sections of the fractures and the plates as taken from the design drawing. Fracture A4, shows delaminations originating from longitudinally to rolling direction orientated inclusions.

The lower fractures A6 of both the inner port side and the outer starboard lug A8 were heavily deformed by bending and hammering. As a particular feature, the inner starboard upper fracture A3, was accompanied by numerous secondary cracks. Some of them even penetrated the lug plate in radial direction without significant macroscopic deformation.

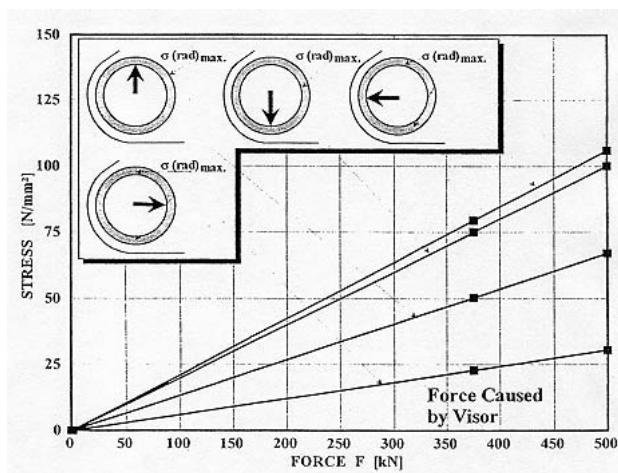
For example, the normal visor opening procedure created a vertical down force of maximum 375 kN on each hinge lug based on nominal visor weight and respective leverages and resulted in maximum radial stress in the fillet weld found at the location as marked by the circle in the drawing below together with the stress distribution in radial direction. Accordingly the opening procedure would thus create a local radial weld joint stress of 75 N/mm².

It is thus obvious that, during opening of the visor, the location of maximum radial fillet weld stress is found in the same region where fatigue cracking of those fillet welds initiated. However, also the other assumed directions of loads on the visor hinges would provide maximum radial stress locations. In particular, a similar stress range as for the opening procedure would result from an assumed afterwards force on the hinges. Such an afterwards load could have created the conditions for crack initiation and failure of the hinge plates, following the failure of the fillet.

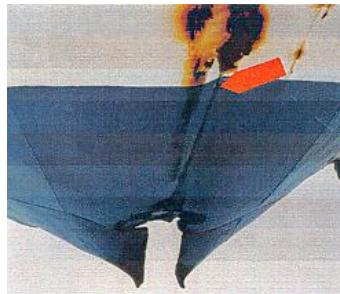
The shell plating as well as the internals are very severely damaged in two places, viz. there is a deep vertical indentation in the bow leading upwards from the stempost for about 2 m, as can be seen on the picture below from the outside,

The arrow points to the deep indentation which is completely painted and the paint does not show contact marks. The following photos showing the inside of the same area do confirm the deep indentation in a very strong part of the visor to be of old origin.

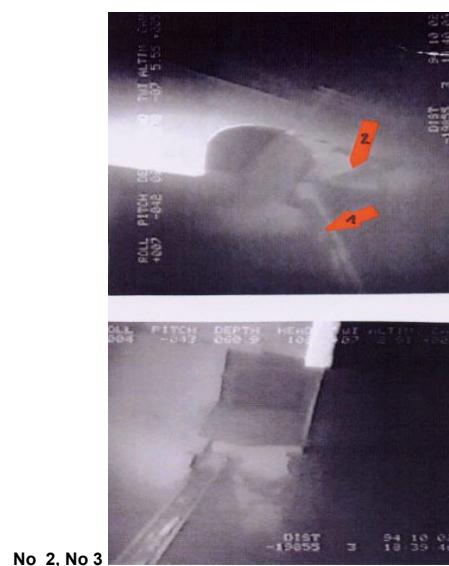
as to (1): The torn and broken open underside of the port bridge wing.

The area in question and the extent of this unusual damage at an unusual location shall be illustrated by a number video images. The first ones were made from footage produced already on 02.10.94, i.e. 4 days after the casualty, and the last ones at the diving investigation between 01-04.12.94. The arrow on the picture below points to the area in question.

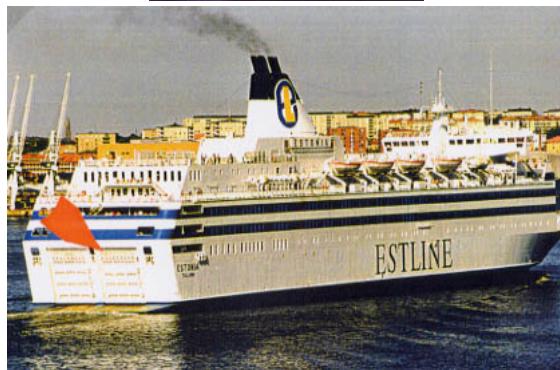
The image below shows the inside of the upper starboard stern ramp to be partly open. It was taken from the ROV video dated 09.10.94. The arrow on the picture further down points to the area in question. This fact will be explained in detail in Subchapter 29.7.

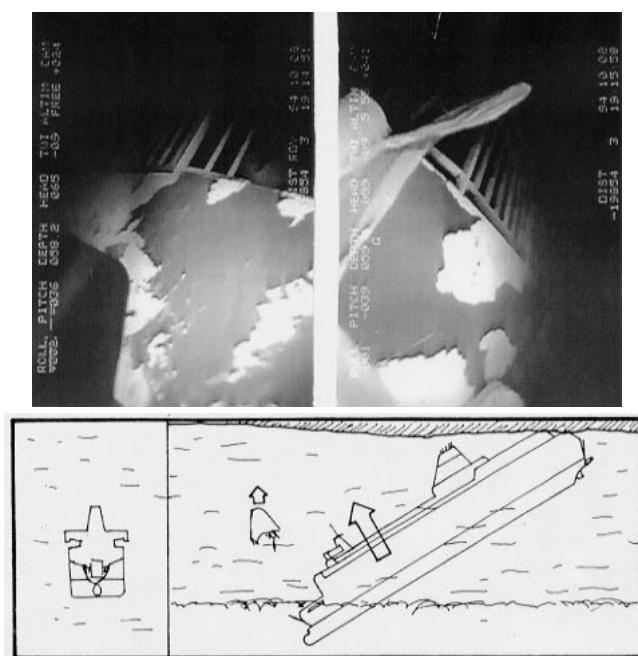
Note: This door could only be opened by crew members. The aft parts of the superstructures in way of decks 7 and 8 on the port side were found to be partly distorted and buckled. Large flakes of paint were scored off the aft parts of decks 5 and 6 - see the two images below - which was most probably caused when the vessel was in upside down condition with the stern already aground and the bow still above the water. - See the drawing below.

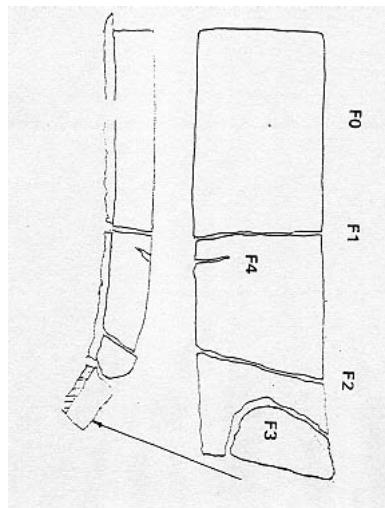
(3) At least 2 fatigue cracks had penetrated the stempost already by about 50% when ice paint was applied the last time which was between 10 and 14 January 1994 in the shipyard at Naantali. During the following nine months up to the casualty the cracks had to propagate further and the lowest one did fully penetrate the stempost which led to the breaking away of part F 3 (see drawing below) and the creation of a corresponding hole in the visor bottom and, consequently, the faster flooding of the visor inside at sea.

The below drawing shows the fatigue cracked stempost from the side and from forward.

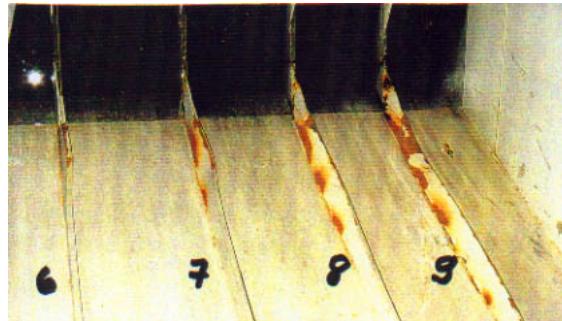
There is no sheet available for this part of the visor. The pictures show the inside of the aft part of the ramp house with 9 vertical webs each at its forward- and aft-parts. The webs are of the hp profile-type and measure 160 x 7 mm. The 4 webs at the port side of the aft part - numbered 6 to 9 - were indented to varying extent as can be seen on the picture below. Web 6 was evidently just slightly touched while web 9 was pushed flat.

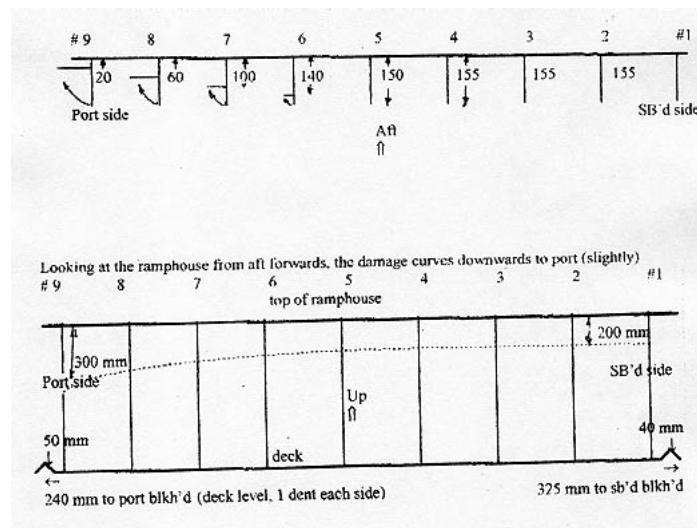
»Undamaged webs are abt. 155 mm high. There are 9 pcs webs in all. Webs # 1 to 4 from the sb side are essentially undamaged, but the paint has been scraped off all of them in a line abt 20 mm down from the ramphouse upper horizontal surface plate (top). Web # 5 is already very slightly deflected towards port and measures at 150 mm (against 155, see above). Web # 6 is deflected so that 140 mm remains, # 7 has 100 mm, # 8 has 60 mm and # 9 has 20 mm standing, while the rest of that web has been deflected to port. The depth of damage (deflection) is thus quite linear between webs 6 and 9. However the point of max damaged paint at # 1 to max deflection at # 9 seems to follow a gentle curve dropping downwards as you look to port. The ramphouse after plate with the damaged webs below.«

The damage configuration revealed by the above measurements indicates that the visor must have been misaligned by 4°-5° in forward/aft direction if the indentations should have occurred by contact with the bow ramp, i.e. the port side of the visor had to be about 300 mm further forward than the starboard side. In other words, the port side of the visor must have moved forward while the starboard side was held back. Before such forward movement of the visor is possible at all and contact between the aft part of the visor's ramp house and the upper part of the bow ramp is possible, several initially built in obstacles have to be overcome as demonstrated by the drawing on the following page.

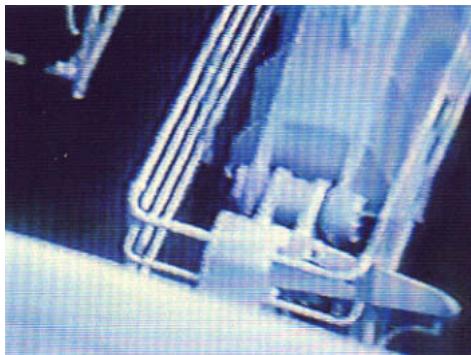
1 - shows the remains of the starboard hinge plates still attached to the visor (they were cut off upon the instructions of the JAIC in January 1995 and were transported to the Royal Technical Institute (KTH) in Stockholm for examination). The very bad condition, especially of the outer hinge plate is obvious. The deep burning marks and the missing metal are striking. All this is confirmed by the video film made by a passenger on 17.09.94 from the open forepart of deck 8 - see also Subchapter 12.5 - i.e. 10 days before the catastrophe. The image below shows a sequence of this video.

It demonstrates that,

- the whole hinge arrangement is severely misaligned;
- the outer bushing is extending too much to the outside and is twisted;
- the lower part of this bushing as well as the securing plate are missing;
- there is a big gap between the inner part of this bushing and the outer hinge plate fitted on the forecastle deck;

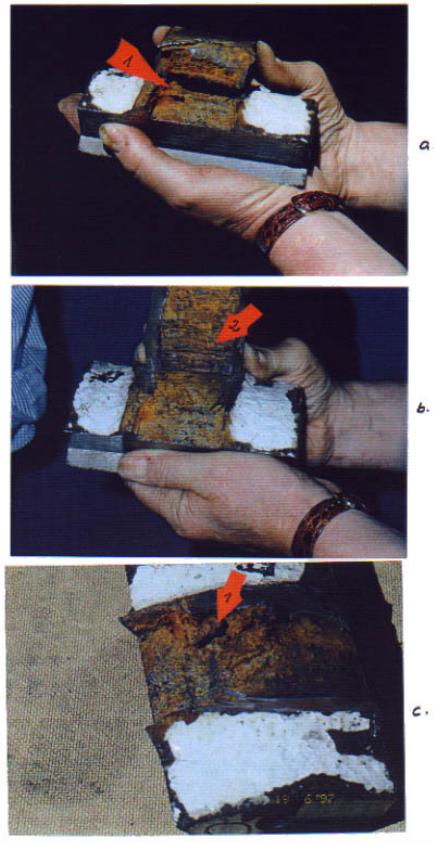
- The inside of the hinge plates were damaged by deep burning marks (see arrow 2 on picture b) from which crack propagation into the material of the hinge plates started and after the cracks had penetrated 50-60% of the material the remaining part of the hinge plate failed in the shear mode.
- The surface of the bushing, corresponding to the inside of the hinge plate with the burning marks explained above, does not show burning marks, therefore it has to be assumed that the original bushing was burned out some time before the casualty and replaced by the present one.
- The gap between bushing and hinge plate in way of the fracture area was about 25 mm indicating that the bushing did not fit into the hole of the hinge plate because the bushing was too small.

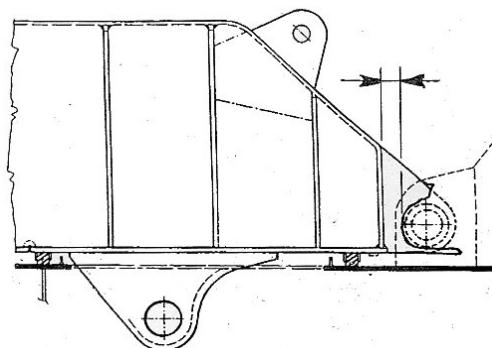
Note: When measuring the distances from the vertical welding seams between face plates and hinge plates and the inside of the bores through the hinge plates it becomes evident that at the starboard hinge plates there is about 15 mm less material than at the port hinge plates. This means that the visor was misaligned at least by this distance of 15 mm in the forward / aft direction. See the drawing below.

This means that the distance between the 2 arrows above was 15 mm smaller at the starboard hinges compared to the port hinges. This was certainly one of the reasons why the starboard hinges broke first and the port hinges were holding for some time longer.

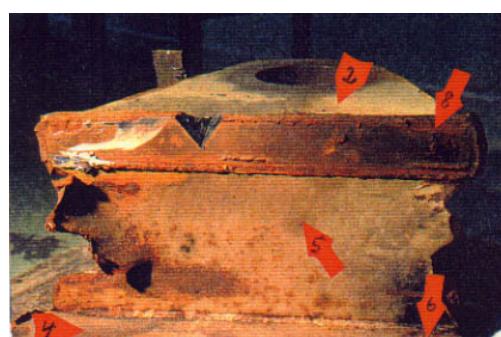
The following photograph shows the port visor actuator foundation after parts had been cut out for testing purposes. The foundation lies on its port outer lug plate. In the front the port outer stiffener (4) is visible, which is fully welded to the B-deck (5). Further at the forward right corner the old temporary repair with the very poor welding seams (6) is visible from inside. For cutting purposes the port inner stiffener (3) had been removed.

The apparent fact that this stiffener (3) had been disconnected from the B-deck (5) respectively since the last repair was never really fitted to it, is further confirmed by a part of the welding seam - see arrow 8 - on the previous two photos - apparently being soaked with oil while the stiffener below is unaffected. This means that this stiffener was not welded to the B-deck.

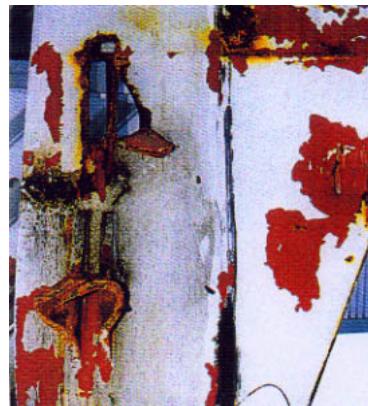
2, 3 - show the area of the missing side lock lug and the considerably bent hooks of the manual side locks from the top and from the side. The side view shows that the area in way of the pushed out steel tongue - see arrow 1 - is bulged outwards indicating pressure from inside to outside, whereas the plating between the hole for the lug and the hooks shows smoke marks, which are explained in Chapter 32. Around the opening for the lug burning/welding marks from the cutting off and the subsequent rewelding of the lug are visible. The following picture has been taken from the JAIC Report and clearly confirms the above.

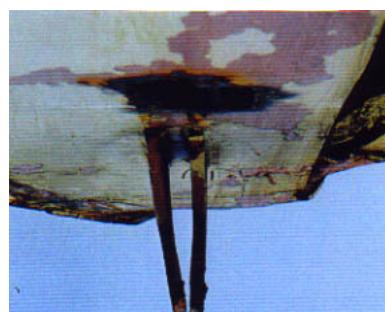
The hooks for the manual side lock were just bent together, as can be seen on the picture on the next page. The area around the lug location shows burning marks obviously from cutting off the lug by flame cutting - see arrow - but no smoke marks as on the starboard side and the plating was not pushed out/distorted.

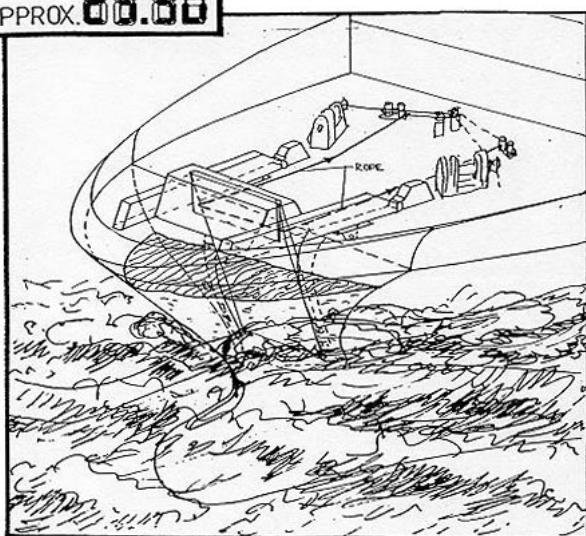
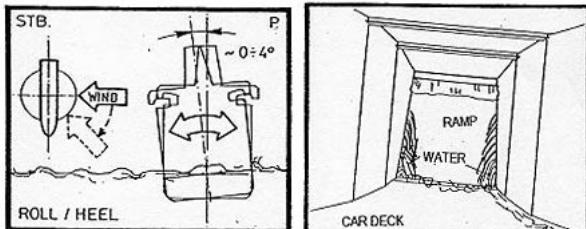
APPROX. 88.88

1. Due to increasing wave height and deep pitching of the ferry the water level inside the visor rose higher and the pressure on the "sealing" material
2. Water entered the car deck in increasing quantities.
3. The ferry made very hard pitch movements.
4. The bow ramp was kept more or less closed by the rope and the water pressure from the visor side, however water penetrated at both sides of the ramp
5. This was the condition on board the ESTONIA when she met "AMBER".

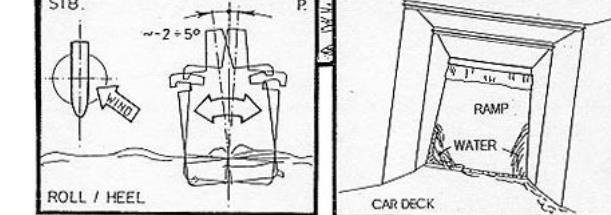
1. Low banging noises continued
2. Port stabiliser fin activated, crew started to work on the starboard fin.
3. The watch A.B. noted alot of water on the car deck, alarmed the bridge and crew was activated
4. The course was changed to starboard and the ferry began to roll heavily, whereafter the vessel was turned back to port and stated to pitch heavily. The speed was reduced.
5. The crew was working on the car deck to control the water ingress which turned out to be impossible.
6. The vessel made deep, slow pitch movements and was slightly rolling, more to starboard, less to port.

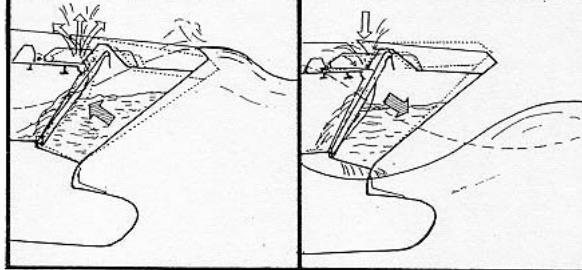
APPROX. **88.88 - 88.88**

1. Hard metallic banging/knocking and scraping noises.

2. Visor moving forward /aft between the deck beam at the frame 159 and the forecastle deck parts of the hinges, the lugs underneath the visor arms were cutting through the deck beam.

4. The crew still working on the car deck.

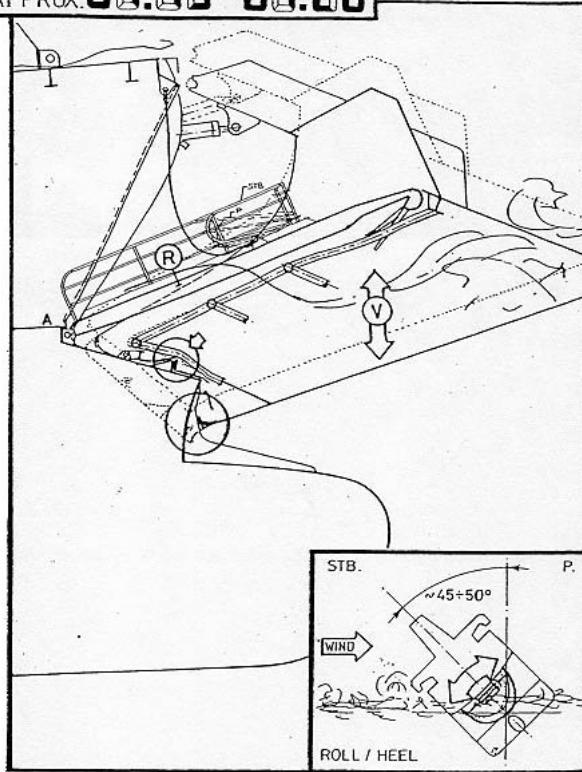
APPROX. 88.88 - 88.88

The vessel was still rolling stepwise and the visor with the bow ramp inside was labouring up and down and from port to starboard in the seaway.

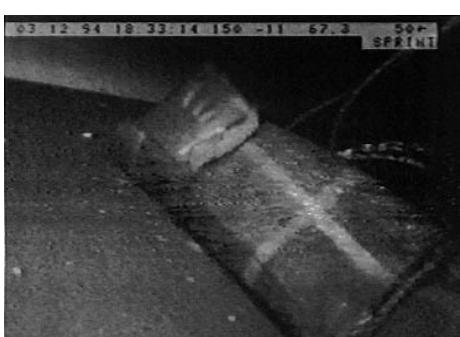
After a relatively silent 1998 when most of the interested people were analysing and subsequently criticising the report of the JAIC a new person appeared in Sweden apparently with sufficient time, and an undisturbed mind, to analyse again all the publicly available video footage and documentation on this subject collected by the JAIC. He found among other things on the video B40b, made by the SPRINT ROV on 03.12.94, a package on the port superstructure in way of the 5th deck which appeared suspicious to him. Video images were made and shown among others also to experts in explosives in Sweden and Germany. See the following image.

Both identified the package with about 90% certainty to be an explosive charge used underwater.

Evaluation of the footage made by ROV on 02. and 09.10.94 revealed, however, that the package had not been at the identified location on the 5th deck on these dates, thus must have been placed there between the 09.10. and 03.12.94 and therefore could not be casually related.

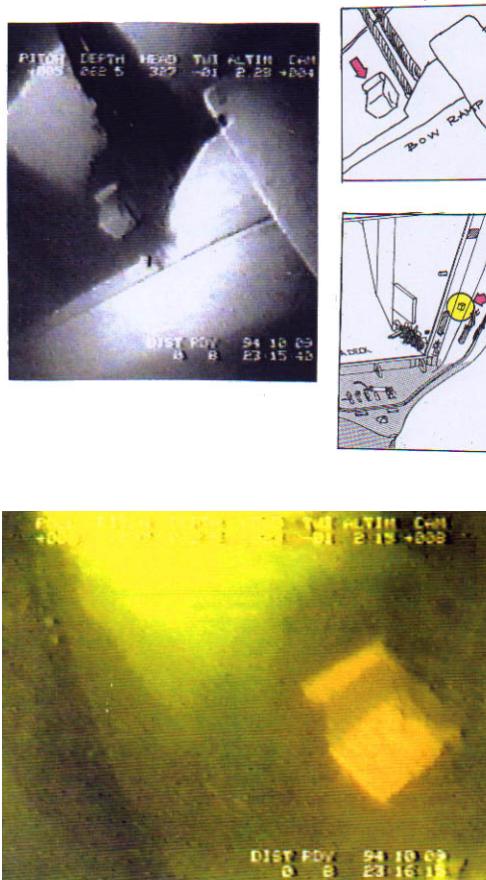
The cube was clearly visible and had been closely looked at by the ROV during the inspection on 09.10.94, it could not, however, be found on the 02.10.94 videos which was possibly due to restricted visibility and was definitely not in this location on the SPRINT ROV made on 03.12.94 respectively on the diver video of the same date.

Images were made from the orange coloured cube and identified by all three experts from Sweden, England and Germany with a high degree of probability as an "explosive charge". See the following two images.

As this charge attached in way of a very sensitive area - the port side locking devices of the visor and the fastening of the port bow ramp actuator - obviously did not explode, the corresponding area of the starboard side was analysed for possible explosion damage which was positively identified by the underwater explosive expert Brian Braidwood. This resulted in a further analysis of the available video footage all received from the JAIC. The results are outlined in the following subchapters.
