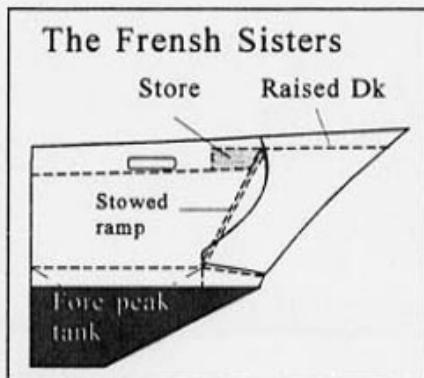
The "French Sisters" Svea Corona, Wellamo and Bore Star had an interesting solution. Instead of the garage a store was arranged on the fore castle deck. The ramp was stowed towards the forward bulkhead of that store. The foremost part of the forecastle deck belonging to the visor was then raised to the same level as the roof of that store. Thus the ramp and the visor was no longer an integrated design.
