The German 'Group of Experts' has now - as far as possible - completed its investigation of the foundering of the M. V. ESTONIA, a disaster that has taken the greatest toll of human life in the Baltic Sea in times of peace. The German 'Group of Experts' has during the past five years performed a difficult investigation in a partly hostile and reluctant environment. The work was carried out during the first two years - 1995/1996 - in close co-operation with the Swedish leader of the Technical Group of the Joint Accident Investigation Commission of Estonia, Finland and Sweden (JAIC), Börje Stenström († February 1997), and also with the Finnish member of the Technical Group, Dr. Tuomo Karppinen and the expert Dr. Klaus Rahka. All the investigation results of this 'Group of Experts' were submitted either verbally in joint meetings with the members and the experts from Estonia, Finland and Sweden attending or in letters with attached photos and/or video film documentation to the JAIC. This documentation and information concerned the design, construction and building of M. V. ESTONIA in general and the locking devices of the bow visor in particular, including the load calculations, the c

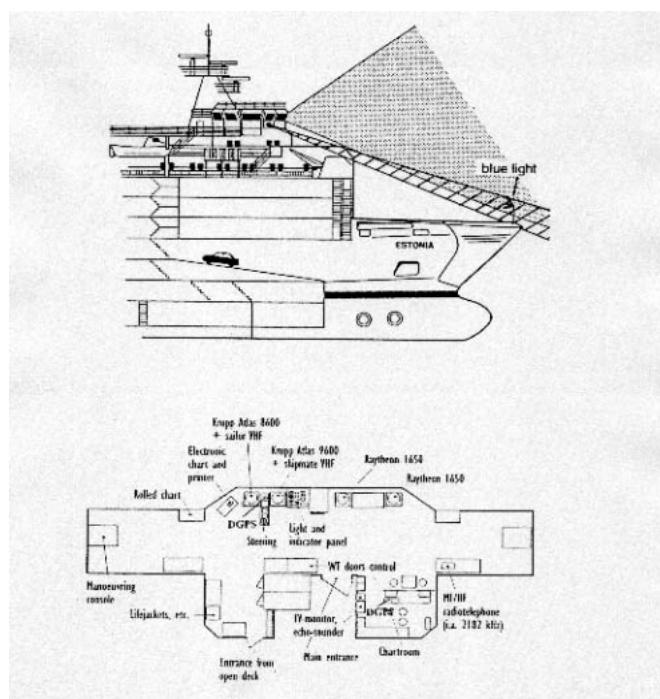
Because of the retracted position of the navigation bridge, only the flag pole on the bow of the vessel was visible from the conning station - see drawing below - whilst the most forward part of the visor could be seen through the two windows on deck level at both sides of the extended central part of the bridge, as can be seen on the drawing below. A monitor, showing among other things, the transmissions from the four car-deck cameras, was placed at the chartroom entrance and could not be seen from the conning station.

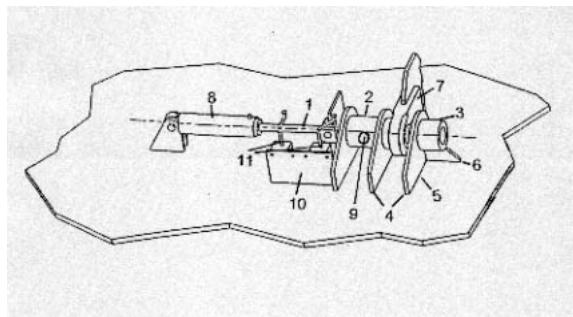
This locking device consisted of a locking bolt (1), movable horizontally in a transverse direction, guided in a bolt housing (2). In extended position the tip of the bolt engaged a support bushing (3). The bolt housing was fixed to the forepeak deck by means of two steel lugs (4) and the bushing was installed in a third similar lug (5), to which a support bracket (6) was fitted. A mating lug (7), attached to the visor itself, was located between the bolt housing and the support bushing when the visor was in the closed position and the extended bolt then engaged the hole in the mating lug.

The bolt was moved in the bolt housing between the retracted position and the extended position by means of an hydraulic actuator (8), operated from the control panel located behind the bow and the ramp on the car deck. A spring-loaded mechanical plunger (9), perpendicular to the bolt, engaged grooves in the bolt in the open and closed position, thereby securing the bolt mechanically in its extreme positions, regardless of hydraulic pressure. The bolt was also locked hydraulically at any time because the hydraulic fluid was trapped in the system, regardless of whether the hydraulic system was under pressure or not.

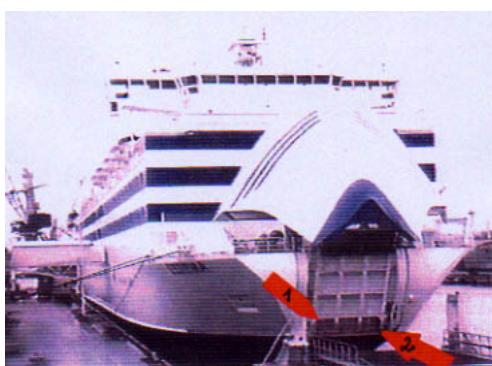
The picture below shows ESTONIA at her berth in Tallinn with open visor and closed bow ramp. The arrow no. 1 points to the oil covered lower part of bow ramp which demonstrates the height of the water level with hydraulic oil floating on top inside of the visor when the vessel was at sea in calm weather. Arrow no. 2 points to the bow ramp hinges which are on car deck level.

- **Charley K. Dahlberg**, engineer, ca. 40 years old, made about 30 trips on the ESTONIA, clearly remembers frequently having heard the splashing of water inside the visor at sea; realised the bad condition of the visor and of the bow ramp as well as the many cracked and re-welded welding seams in way, decided not to use the ESTONIA anymore when going from Stockholm to Tallinn, but to go via Helsinki instead. The complete interview is attached as [Enclosure 12.4.4.158](#).
- **Torsten Sundberg**, skipper of the Sandhamn pilot boat, wrote to the Swedish Commission on 14.02.95 as follows (office translation):

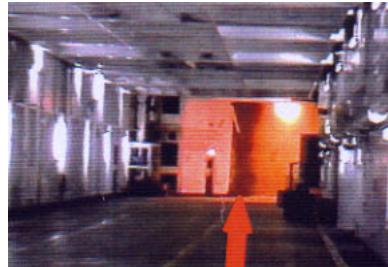
*»When I was sitting in my car in a position close behind the bow ramp waiting for the ramp to open, I remember having frequently seen crew members pulling steel plates across the gap between the open bow ramp and the car deck. I know that this gap is normally closed by steel flaps, but these had been dismounted with certainty at the port side. There were now holes in the flaps on both ends into which crew members were putting hooks by means of which they were pulling the flaps across the gap when the ramp was open and to the side before the ramp was closed.  
The area with missing flaps at the port side of the closed bow ramp can be seen on the following video prints (see arrows).«*

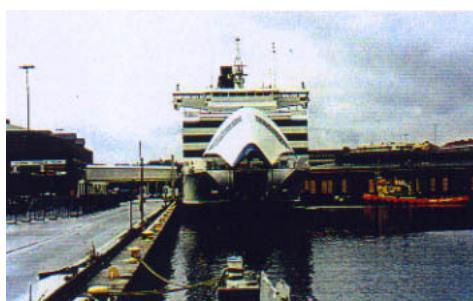
*»I had frequently been on the forward part of the 8th deck upon departure from Stockholm and do remember having quite often seen the visor open.« (See photo below.)*

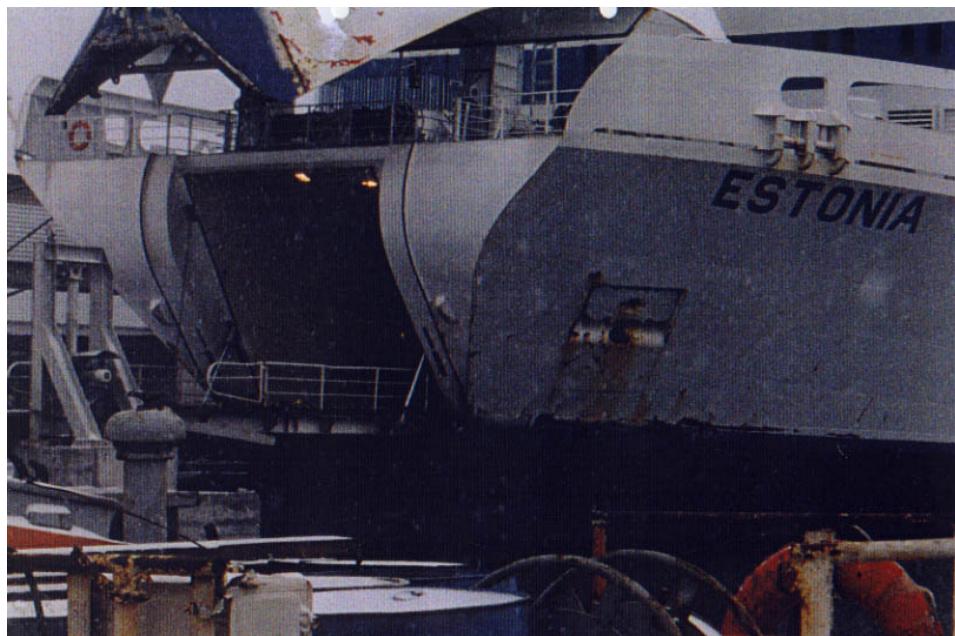
The ice situation is demonstrated on the ice chart of 28.03.94 which is attached as [Enclosure 12.4.2.152](#) and two photos showing the cruise vessel SALLY ALBATROSS sitting aground outside Porkala (opposite Tallinn) in heavy ice during February/March 1994. The photos attached as [Enclosure 12.4.2.153](#) clearly demonstrate the ice conditions which were prevailing at this time in the Gulf of Finland. The effect these ice conditions had on the visor and foreship of the ESTONIA can be seen on the photo below which was made on 24.03.94.

The results of such reckless navigation are clearly visible on the large photo on the previous page which was taken on the following day, 25 March 1994, in Tallinn by the professional photographer Li Samuelson.

The ice damage sustained by the visor during the months of February and March 1994, when the Gulf of Finland and the Northern and Middle Baltic were more or less continuously covered by ice (see Subchapter 12.4.2), were roughly repaired by replacing parts of shell plating and bottom of the visor in Tallinn whilst the vessel remained in service. The renewed parts are still visible on the visor.

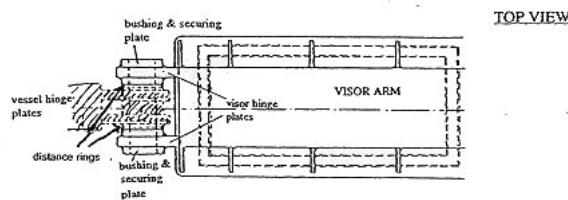
On the other hand, he had told Klaus Rahka during the questioning at Hangö on 24.03.95 that he had painted the visor hinges green and white and - as clearly visible on the video image on the following page showing the starboard hinge bolt - there is quite a lot of green paint on the bolt which could not possibly have got there as long as the hinges were in their original, intact condition because then it was practically a closed system, i.e. paint could not reach the bolt. The intact system has no gap as can be seen from the drawing below showing the intact starboard hinge arrangement.

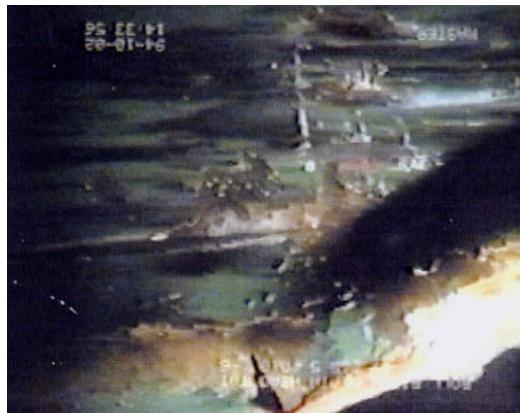
Image No. 1, 2 and 6 show the starboard inner side of the cut through the deck beam at frame 149, which are evidently pressed together, partly cracked and bent up, indicating pressure from port to starboard. The edges of the deck opening aft of the deck beam are not affected at all, same as on the starboard side. This is only indicated on the detail drawing but is clearly shown on the available video footage. The starboard side of the cut through deck beam and the deck plating as well as the rubber marks are shown also on the picture below.

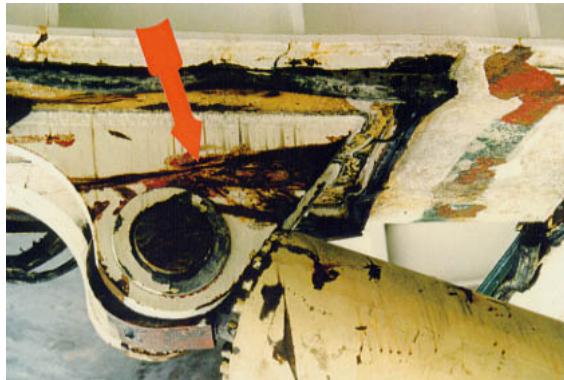
It must have taken some time for the visor lugs to cut through this deck beam while the visor moved forward/aft in the sea state ending when the visor lug plates had finally cut through this strong deck beam. It has to be assumed that during this cutting process at least the paint on both the inner and the outer lug plates should have been destroyed in way of the contact area. This was, however, evidently only the case with the inner lug plate as can be seen on the picture overleaf.

The lug plate has very deep and - at the upside - straight scoring marks, almost engraved, which indicate

- (a) the movements of the visor and
- (b) that the weight of the visor was to some extent resting on this inner lug plate which caused these very deep scraping marks, whilst the opposite side, i.e. the outer lug plate, remained completely unaffected as visible on the next picture.

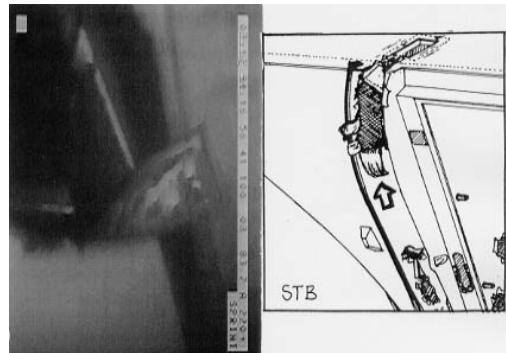
The picture below shows the lowest part of the damage, i.e. an almost horizontal, slightly upwards pointing steel flap.

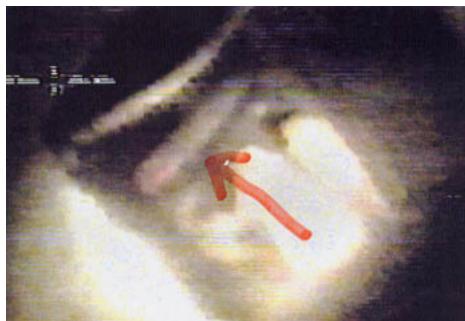
- concerns the opening in the recess of the front bulkhead for the ramp hook. The hook has been identified inside this opening. The red arrow on the image below is pointing to the hook which is obviously intact and in locked condition.

The image above is a view into the opening in the front bulkhead recess inside of which the port ramp hook should have engaged the mating lug at the ramp during the closing procedure which it evidently did not do during the last voyage. This has already been explained under P 3 - Port Forecastle deck.

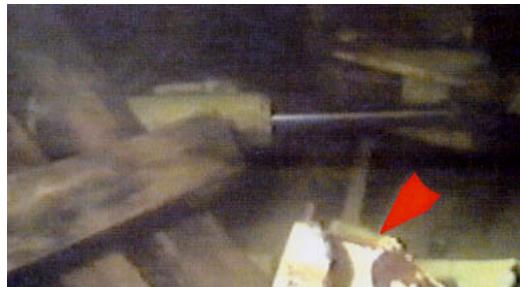
The image below was made when the ROV looked into the opening in the forecastle deck for the port visor actuator. The actuator of the ramp hook with part of the hook arrangement and the remains of the cut through deck beam - see arrow - are clearly visible.

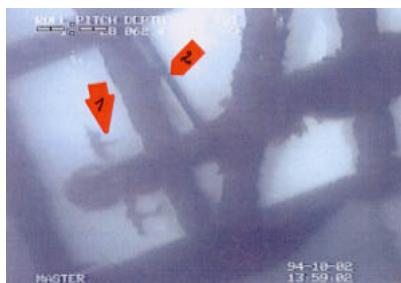
The following image shows transverse contact marks above the opening for the hydraulic side lock - see arrow 1 - which presumably resulted from the visor moving forward/aft during the time it took the visor arm lugs to cut through the deck beam.

Arrow 2 on the above image points to a wire running across the front bulkhead and the bow ramp to the starboard side and apparently from the port fair leads of the forecastle deck (there is no other possibility where a wire could come from). The image was made from the video tape produced by ROV on 02.10.94 - see Subchapter 25.1 - because on subsequent videos the wire is no more visible.

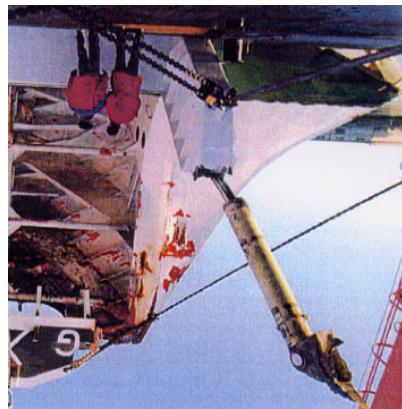
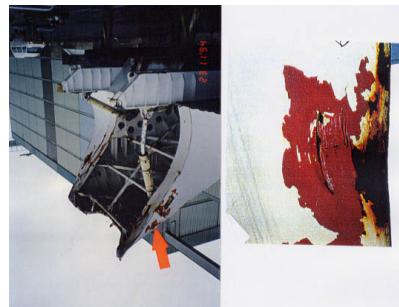
The starboard actuator, to the contrary, was found to be fully extended with the piston rod bent. It had apparently been the last connection between the vessel and the visor except for the bow ramp, the fore-castle deck and bulbous bow.

The area indicated by the arrow and the close up was probably struck by the foundation of the starboard actuator after the actuator had moved out of the front bulkhead of the vessel. - See also Chapter 30 - The Visor.

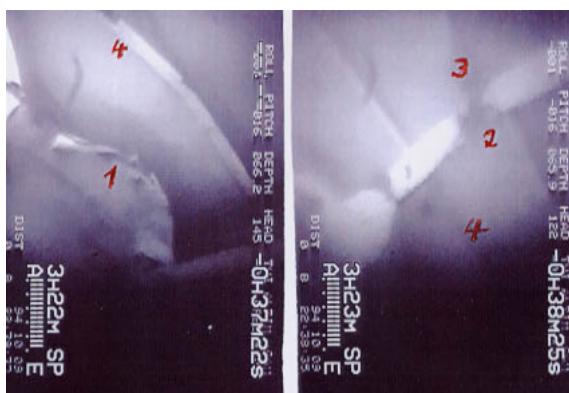
The left picture shows the lower part of the port outer vertical girder, cracked off above and below and twisted up to 70° - damage No. 1 on the drawing as well as damage No. 4. The right picture shows damages Nos. 2, 3, 4.

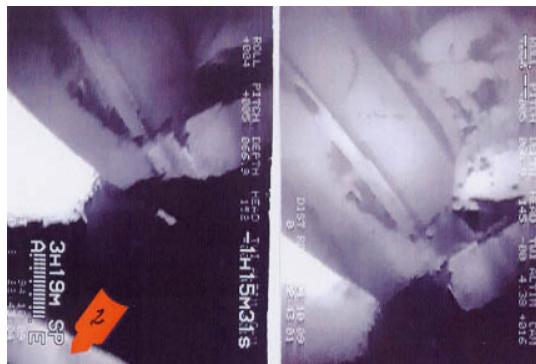
The following two images show the area adjacent to this pushed-out lower part of the front bulkhead, the recess with the torn-off and severely bent lower part of the outer vertical girder of the bow ramp. Apparently the deck/bulkhead is open in way of these severe distortions which also extends downwards.

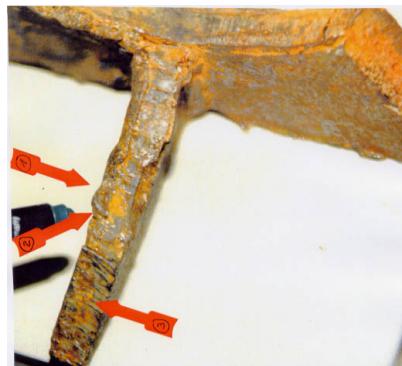
- Next an enlargement of the support bracket attached to the outside of the starboard lug is shown.

- The support bracket at the outer side of the lug (arrow 1) is larger than the original, which is evident because it overlaps the end of the welding seam (arrow 2) which marks the end of the bushing. The support bracket is about 12 mm larger compared to the original one made according to the von Tell drawing No. 49111- 373.

- The oblique end of the bracket is just burnt, not grinded (arrow 3). It is considered impossible that the bracket would have left blacksmith's shop of the Meyer Werft in such a condition - see also Subchapter 2.4.6;

- The welds are thin and interrupted, respectively cracked, because they are so thin, which is demonstrated by the corroded surface of the inner side of the lug normally covered by the bushing. As long as the welding seams are intact the space between bushing/lug is airtight, i.e. without oxygen, which was burnt by the heat of the welding process. This was obviously no more the case since some time before the bushing was torn off, because substantial corrosion was able to develop.

- The forward and aft welding seams between bushing and support bracket are not connected at the outer end (or closed, as the welders say), thus water could penetrate. This confirms the unprofessionalism of the welder who did these repair welds.

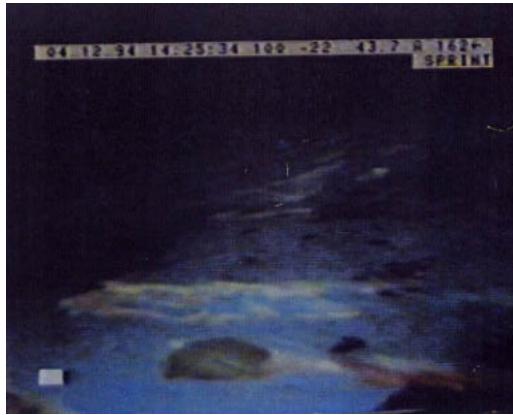
The following image shows white contact marks on the port side of the bulbous bow further aft than the previous one.

The pictures do confirm contact with some object which could have been quite strong considering the very strong construction of the bulbous bow, i.e. a weaker construction might have sustained heavy damage due to contact with the strong bulbous bow as indicated by the above paint and scoring marks.

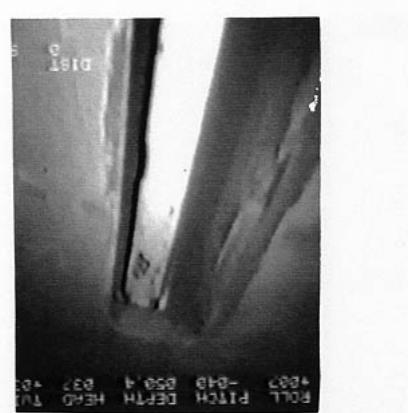
In January 1994 the ESTONIA was fitted with stabilisers of make Brown Brothers which had allegedly been in operation at the time of the casualty. According to 3rd engineer Margus Treu, the fins should retract automatically at speeds below 4 kn, therefore he does not believe that survivors could have seen the port stabiliser still out when the vessel was already almost on the side - see [Enclosure 21.3.271](#) - Protocol of Landvett meeting on 31.03.95. In all probability Margus Treu is right because only after proper questioning of the survivors Pierre Thiger, Tony Spuhl and Mats Hillerström did it turn out that what they believed to have been the stabiliser was much too much forward to assume it could have been the stabiliser. They saw something big, partly white, partly dark, vertically bigger than transverse, which was moving in/out and/or up/down, very far forward, almost at the bow. They saw it still when the vessel was on the side already. The statement of Pierre Thiger taken on 08.10.99 is attached as Enclosure 29.6.414 and the statement of Tony Spuhl taken on 10.10.99 is attached as Enclosure 29.6.415. The statement of Mats Hillerström is not yet available. The actual stabiliser, however, is installed in a pocket behind the heeling tank on 0-dek level, i.e. about midships. When the witnesses were informed accordingly they categorically denied having seen anything moving in this area. This leads to the conclusion that the survivors had seen the visor, then still hanging on the bow ramp with the bottom attached to the forepeak deck and ice-knife of the bulbous bow. This leaves the trainee mate Einar Kukk who has stated - see [Enclosure 21.2.1.251](#) - that the stern was down to the stabiliser fin level. But he did not say that the fin was out. Therefore, it has to be assumed that the survivors actually meant the visor when they mentioned the stabiliser during the last stage before leaving the vessel. In any event the port stabiliser fin was found to be in its pocket during the ROV inspection on 09/10.10.94 - see the images below.

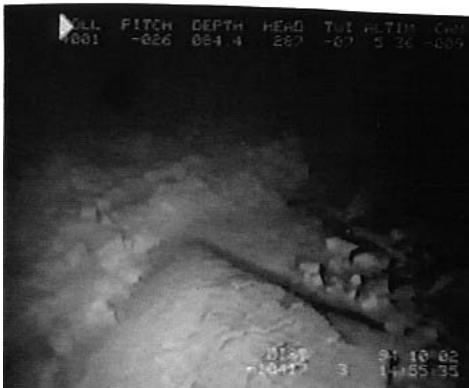
Alternatively the stabiliser fin could have broken off by the object sliding against the vessel's starboard side by which the scraping noises were caused. The noise scenario for Bengt Nilsson would have been the same. Therefore the video footage showing the ROV inspection of the sea bottom was analysed and the following two images were found which could show parts of the stabiliser fin.

As to the **starboard stabiliser** there are strong indications that it broke off or was broken off and is resting on the sea bottom now. In both cases a substantial water ingress into the engine room - at least 2 watertight compartments were affected - would have been the result for which there are also indications, because Henrik Sillaste has testified that the bilge pumps were running and Margus Treu has stated they were trying to pump water out of the ship. As it is not possible to pump water from the car deck they can only have pumped from 1st deck and 0-deck.

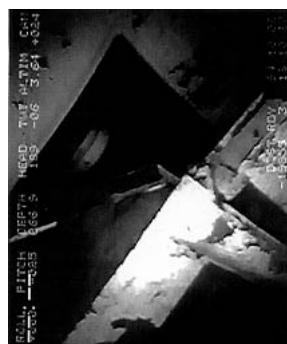
The ROV tape made on 02.10.94 indicates that the starboard stern ramp is slightly open as can be seen on the adjacent image. It shows the upper inner side. The explanation for this slight opening was given already in Subchapter 21.3.3 by the statement of Rolf Sörman - see [Enclosure 21.3.3.335.1](#) - who, as well as his seminar colleagues, were disturbed to such extent by hydraulic noises that they gave up their conference at 21.45 hours ET.

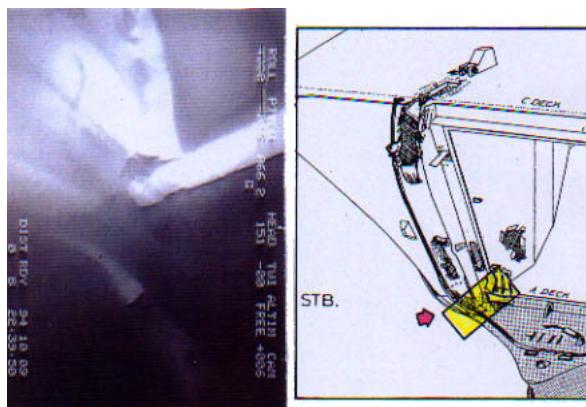
- Next to the cracked open inner bulkhead plating, the lower section of the starboard outer vertical girder of the bow ramp - being immediately next to the cracked plating when the ramp is closed. It is noted to be cracked off both from the upper and the lower transverse girder as well as from the bow ramp plating and extremely deformed and pushed to port. - See the image below with the explanatory drawing and also the extensive photo documentation in Subchapter 29.2.

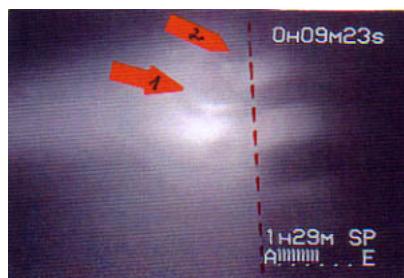
The next image shows the black/yellow painted tire-protection bar edge of the bow ramp to the right with the remains, i.e. the inner part of the fastening, for the starboard ramp actuator - see arrow 1.

It is further visible that the edge of the ramp is bent up - arrow 2 - above the line of the recess bulkhead - see red dotted line.

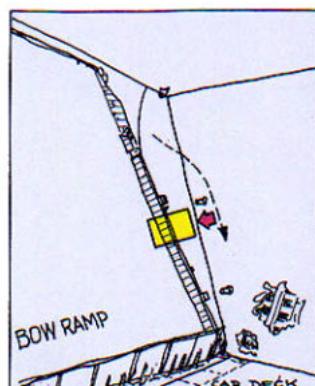
This is the area where the broken piston rod of the actuator was seen from the outside to be jammed in between the ramp and the recess.

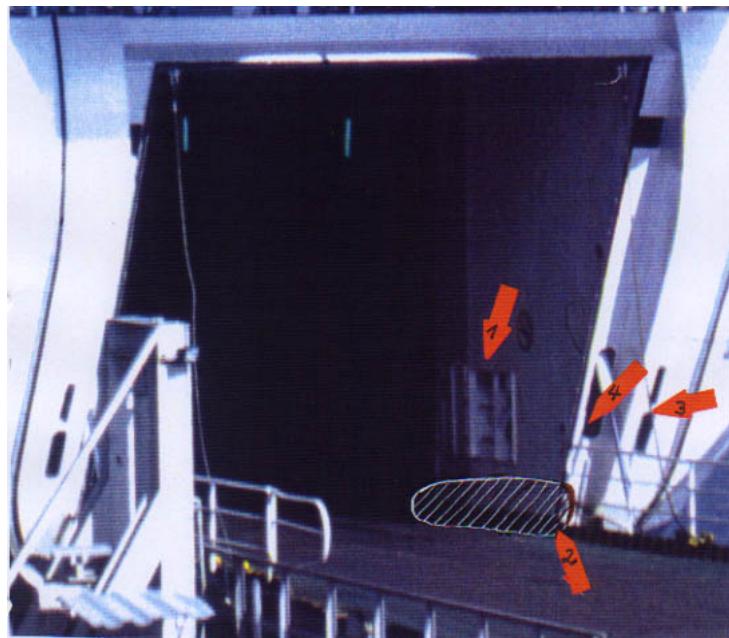
**arrow 1** = control panel

**arrow 2** = bottom end of raised black/yellow ramp edge and first flap from port side

**arrow 4** = opening for ramp actuator - the arrow points to the position of the actual fastening when the ramp was in closed condition.

The red hatched area indicates the damage, whereby the extent into the car deck is unknown because the diver looked only slightly further to the left as can be seen from the following image, which shows even more distortion with two apparently wooden planks sticking out of the torn up bulkhead edge - arrow 1 - and something like a stanchion with two guides or lugs at the top below the plank - see arrow 2.

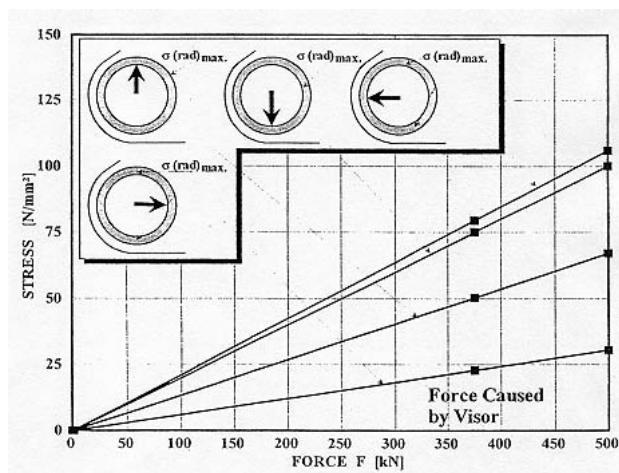
For example, the normal visor opening procedure created a vertical down force of maximum 375 kN on each hinge lug based on nominal visor weight and respective leverages and resulted in maximum radial stress in the fillet weld found at the location as marked by the circle in the drawing below together with the stress distribution in radial direction. Accordingly the opening procedure would thus create a local radial weld joint stress of 75 N/mm<sup>2</sup>.

It is thus obvious that, during opening of the visor, the location of maximum radial fillet weld stress is found in the same region where fatigue cracking of those fillet welds initiated. However, also the other assumed directions of loads on the visor hinges would provide maximum radial stress locations. In particular, a similar stress range as for the opening procedure would result from an assumed afterwards force on the hinges. Such an afterwards load could have created the conditions for crack initiation and failure of the hinge plates, following the failure of the fillet.

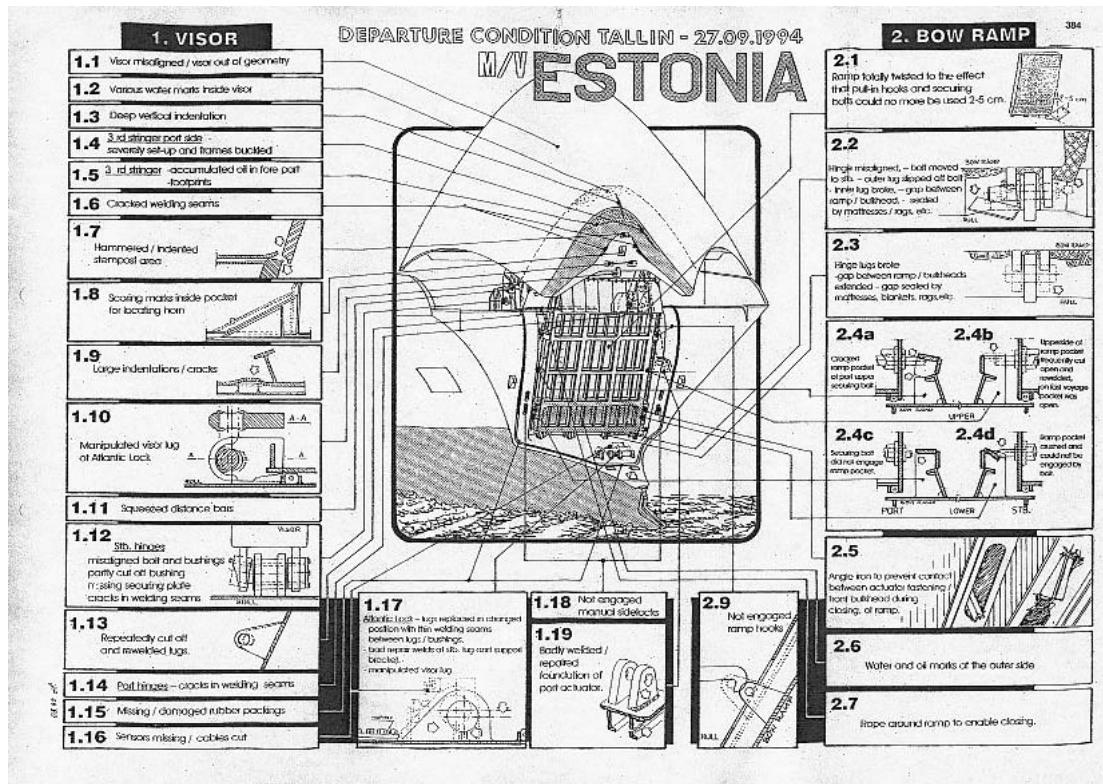
In addition, these deficiencies are shown on a drawing of the foreship with open visor which is integrated into this report and forms the following page.

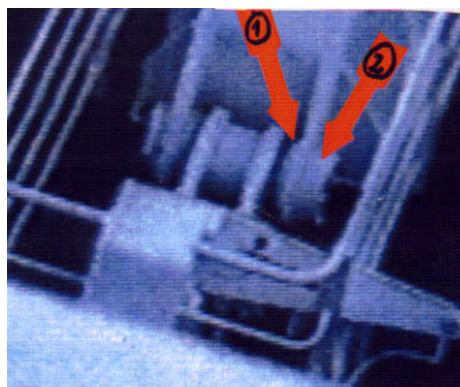
The passenger was standing in front of deck 7 and filmed the closing of the visor, finally zooming in on the starboard hinges. The video-prints below are part of the film. Picture 2 is an enlargement of Picture 1.

On Picture 2 there are obviously several major deficiencies visible, viz.

(a) the gap between the starboard vessel hinge plate and the outer bushing is much too large (arrow 1).

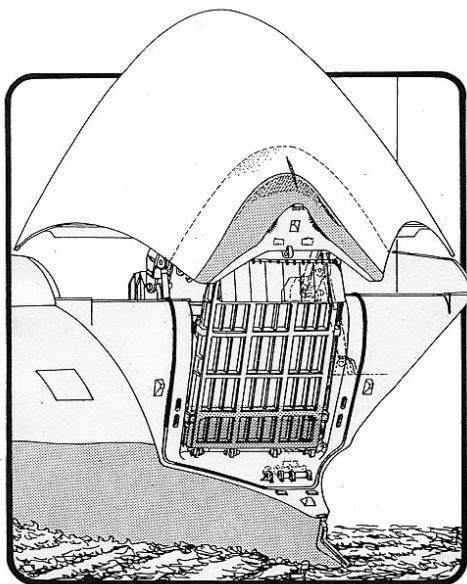
The last Finnish crew had requested the renewal of 15 m of rubber packing in way of the visor for the then planned yard time in January 1993, because the rubber packing had last been renewed in January 1991. This meant a renewal of the entire packing on the forepeak deck plus about 2 m up each front bulkhead as demonstrated by the following drawing.

Since the new technical managers N&T were of the opinion that visors are full of water at sea anyway, the rubber packings were not renewed in January 1993 and also not later. This means that the visor became quickly filled up with water at sea up to the height of the outside water level. In calm sea it was the height of the bow wave which filled the visor up to the 3rd stringer, however, the worse the weather was and the deeper the bow was diving into the waves, the higher the water rose inside the visor.

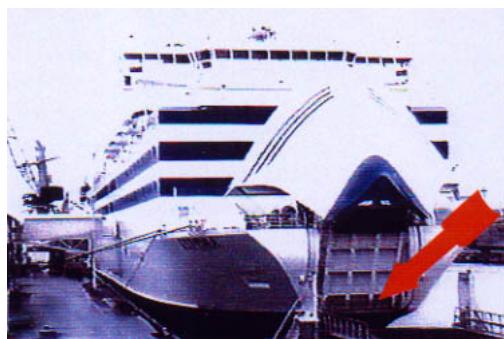
The following picture shows the ESTONIA in Tallinn, with open visor but closed bow ramp so that the otherwise invisible underside of the bow ramp is shown with the lowest section being dark - see arrow. Doubtless this was caused by the water inside the visor with hydraulic oil from the leaking cylinders swimming on top of the water surface. When the vessel reduced speed and the bow wave became smaller and finally disappeared completely when the vessel was alongside, the water streamed out of the visor and the oil settled everywhere inside the visor, also on the bow ramp which forms the aft inside of the visor. The water streaming out of the visor was observed by many passengers when the vessel was alongside in Stockholm with closed visor and, among others, also by the skipper of the Sandhamn pilot boat as well as by several pilots when the ferry was slowing down during the approach to the pilot boat.

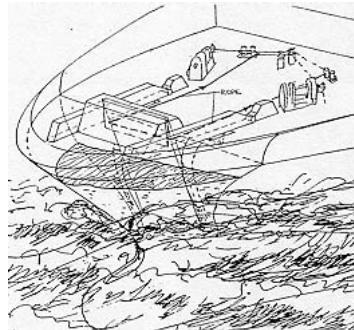
- (a) the port upper pocket was intact and only slightly bent towards the centre-line of the ramp with metal at both sides of the pocket slightly ripped which was probably caused by the bending; the bolt was fully extended and about 100 mm below the pocket;
- (b) the port lower pocket was found to be intact with the bolt only partly extended and about 100 mm below the pocket;
- (c) The starboard upper pocket was noted to be without cover plate which had been burnt off by the crew in the morning of 27 September 1994 after arrival when it turned out to be impossible to open the bolt; the bolt was fully extended; there was apparently no misalignment between bolt and pocket;
- (d) the starboard lower pocket was crushed together to the effect that the bolt - noted to be fully extended - could never have entered the pocket.

Consequently it has not been possible for the crew to secure the bow ramp at all by its four securing bolts. The same refers to the port ramp hook which could not engage its mating lug at the ramp, due to the misalignment of the port ramp side as it was demonstrated already by the distance of ca. 100 mm between the mating pockets and bolts. The obvious fact that the port ramp hook had never engaged its mating lug is further confirmed by the intact hook and the intact, unbroken lug. Both hook and lug are visible among other things on the diver video B40a. - See also Subchapter 34.6.  
The starboard ramp hook, however, is nowhere visible and the location where it should be, is empty. It has thus to be assumed that also this hook had not engaged its mating lug at the ramp, which means that the ramp had just been closed by the actuators - as stated before - to an remaining opening of 4-5 cm. Due to several mooring ropes and two wires found in way of the ramp and respective indications on the ramp - see Chapter 29.2 - it has to be assumed that the crew tried to close the ramp completely by means of mooring ropes and/or wires probably pulled tight by means of the mooring winches on the forecastle deck.

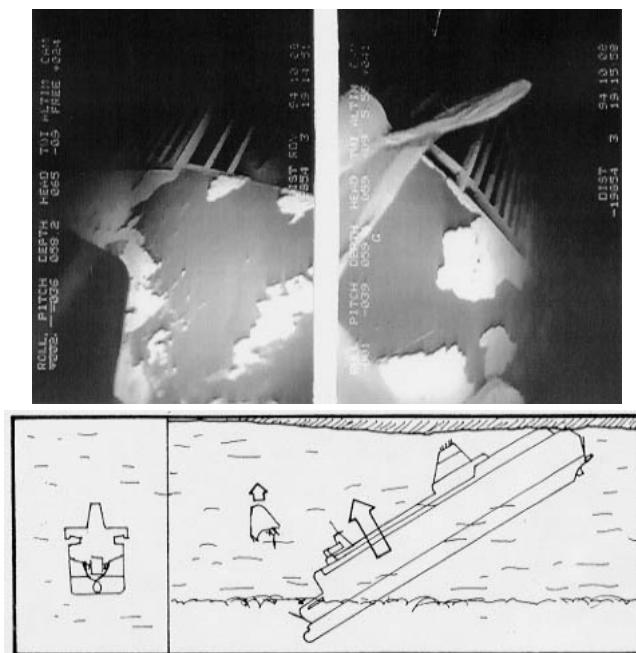
The visor was missing with the remains of the hinges on the forecastle deck broken, both front bulkheads and the bow ramp were noted to be severely damaged, damaged/broken railings and broken davits were found in way of deck 7 and some broken windows/port holes on other decks. Window panels were found to have been pushed out and doors in the aft bulkheads of decks 5 and 7 were missing while the door in the front bulkhead of deck 5 leading down to the forecastle deck was noted to be open.

Note: This door could only be opened by crew members. The aft parts of the superstructures in way of decks 7 and 8 on the port side were found to be partly distorted and buckled. Large flakes of paint were scored off the aft parts of decks 5 and 6 - see the two images below - which was most probably caused when the vessel was in upside down condition with the stern already aground and the bow still above the water. - See the drawing below.

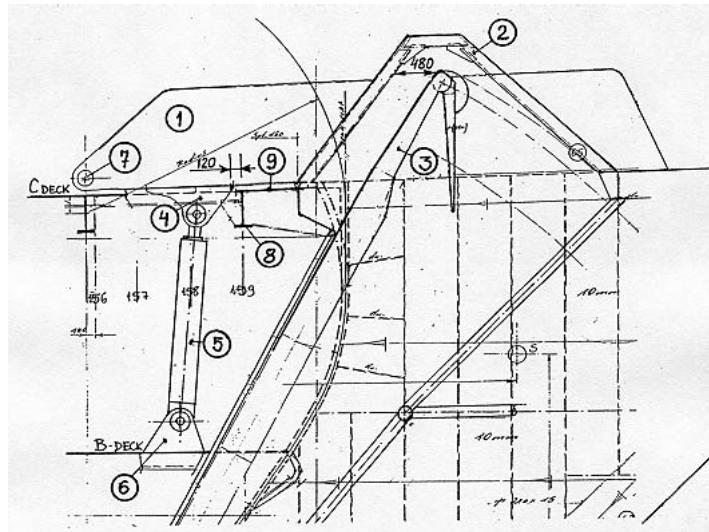
Note: The forces necessary for the lugs to cut through this frame have been calculated by the Technical University Hamburg-Harburg to have been about 200 ts. This means a point load of ca. 100 ts at the port side and a point load of ca. 100 ts at the starboard side. See Subchapter 34.12.

- (d) the visor has to move 360 mm forward before the aft webs of the ramp house (160 x 7 mm) can come in contact with the upper part of the bow ramp;
- (e) the (empty) visor weighing 55 ts, of which the main part is still absorbed by the forepeak deck, will then lean on the properly closed and locked bow ramp;
- (f) as the break-load of the 2 ramp hooks was 42 ts each, i.e. 84 ts, and the break-load of the 4 securing bolts was 25 ts each, i.e. in total the break-load of the bow ramp's locking devices was 184 ts, the visor will lean against the ramp and nothing will happen as it is proven by the MARIELLA incident described in Chapter 33.

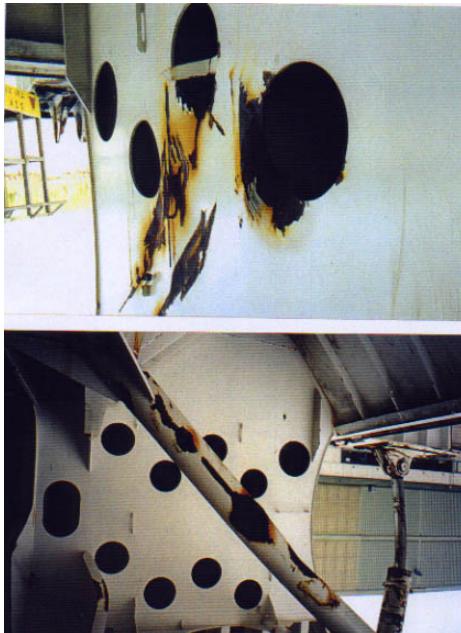
Finally attention has to be drawn to one indentation pushed at each side into the forward deck beam of the visor, i.e. the lower side of the forward part of the ramp house as indicated on the two pictures on the next page. According to drawing on page 956 the port indentation is 240 mm away from the inner bulkhead and the starboard one 325 m. This means that these indentations were most probably caused by the bell cranks being the most upwards extending parts of the bow ramp. This must have occurred at a time when the visor was hanging on the bow ramp already, i.e. the contact area having been the port inner bulkhead. Therefore the distance between bow ramp and port inner bulkhead has as small as possible - 240 mm - while the opposite distance between the bow ramp and the starboard inner bulkhead was as big as possible - 325 mm. This is also the explanation for the apparent fact that the port inner bulkhead was very severely distorted and partly cracked while the starboard inner bulkhead remained completely unaffected even without paint scratches. See also S 4 and P4 - The Inner Bulkheads - further down.

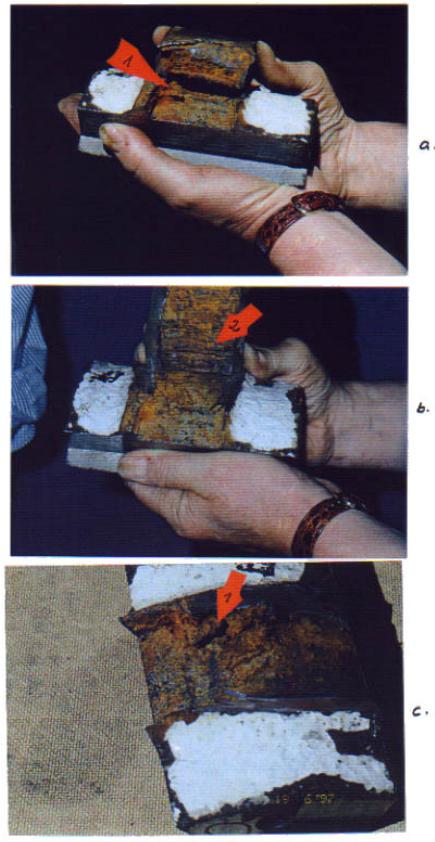
2, 3, 6 - show part of this bushing with part of the fractured visor hinge plate still attached to it. This part is shown in more detail after the hinge-plate part had been cut off on the following page (pictures a - c). The pictures reveal the following:

- The welding seams between bushing and hinge plate are of poor quality and only 7-8 mm thick whereas the originals were about 15 mm thick.
- The same welding seams apparently cracked frequently and it had been attempted to close the cracks by welding which resulted in welding material penetrating through the cracks into the gap between the hinge plate and bushing. See arrows 1 on pictures a and c.
- The surface of the bushing in way of the hinge plate shows corrosion which indicates that the space between bushing/hinge plate, which should be sealed airtight by the welding seams, had not been airtight anymore for some time already obviously due to the crack propagation in the too thin welding seams and/or due to unprofessional welding.

- The inside of the hinge plates were damaged by deep burning marks (see arrow 2 on picture b) from which crack propagation into the material of the hinge plates started and after the cracks had penetrated 50-60% of the material the remaining part of the hinge plate failed in the shear mode.
- The surface of the bushing, corresponding to the inside of the hinge plate with the burning marks explained above, does not show burning marks, therefore it has to be assumed that the original bushing was burned out some time before the casualty and replaced by the present one.
- The gap between bushing and hinge plate in way of the fracture area was about 25 mm indicating that the bushing did not fit into the hole of the hinge plate because the bushing was too small.

Note: At newbuilding the bushings were shrinked into the bores of the visor hinge plates, thus there had been no gap at all. See Subchapters 2.4.3 / 2.4.6 and Enclosure 2.4.2.21.

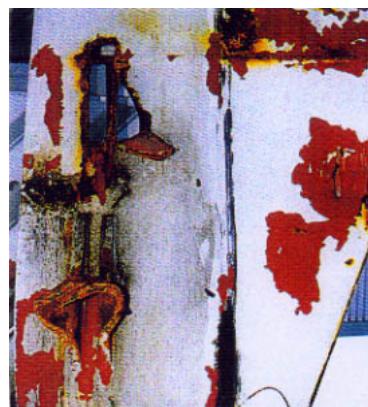
2, 3 - show the area of the missing side lock lug and the considerably bent hooks of the manual side locks from the top and from the side. The side view shows that the area in way of the pushed out steel tongue - see arrow 1 - is bulged outwards indicating pressure from inside to outside, whereas the plating between the hole for the lug and the hooks shows smoke marks, which are explained in Chapter 32. Around the opening for the lug burning/welding marks from the cutting off and the subsequent rewelding of the lug are visible. The following picture has been taken from the JAIC Report and clearly confirms the above.

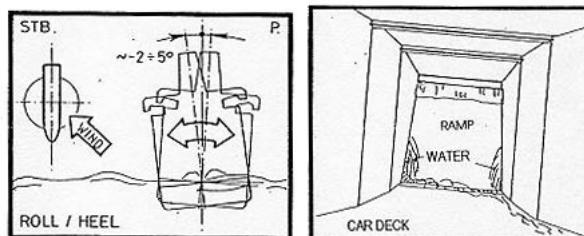
Many passengers heard low metallic banging caused by visor moving within play of locking devices due to misaligned visor, damaged stempost and missing rubber packings.

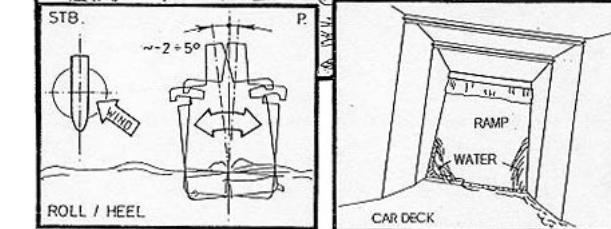
1. Low banging noises continued
2. Port stabiliser fin activated, crew started to work on the starboard fin.
3. The watch A.B. noted a lot of water on the car deck, alarmed the bridge and crew was activated
4. The course was changed to starboard and the ferry began to roll heavily, whereafter the vessel was turned back to port and started to pitch heavily. The speed was reduced.
5. The crew was working on the car deck to control the water ingress which turned out to be impossible.
6. The vessel made deep, slow pitch movements and was slightly rolling, more to starboard, less to port.

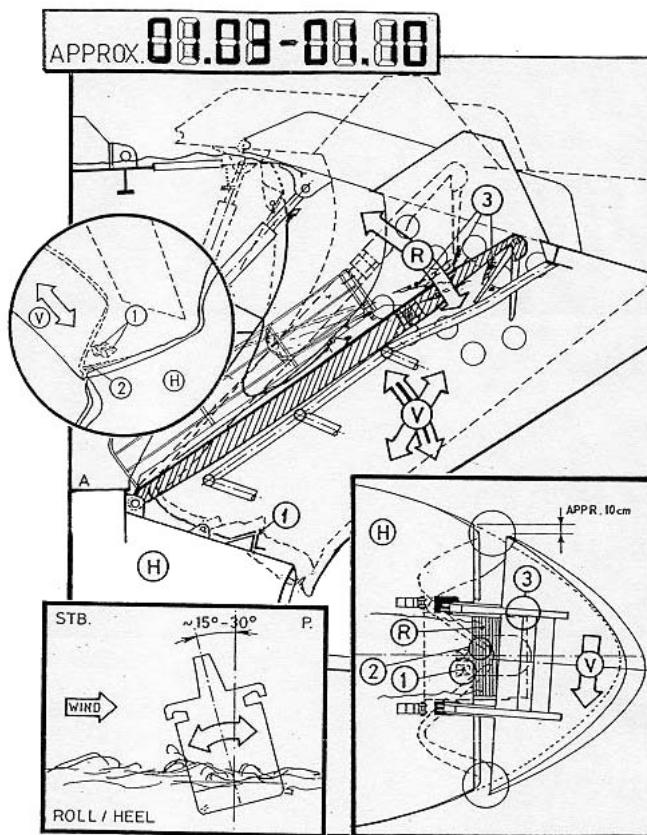
- 1.Approx 01.08-01.10 hrs the main engine shut-down automatically at a stbd heel of ca 30o.
- 2.The visor was held by the bow (3) ramp and by the forepeak deck increasingly penetrating the visor bottom (1)(2).
- 3.The intact starboard actuator was resisting the forward movement of the visor.

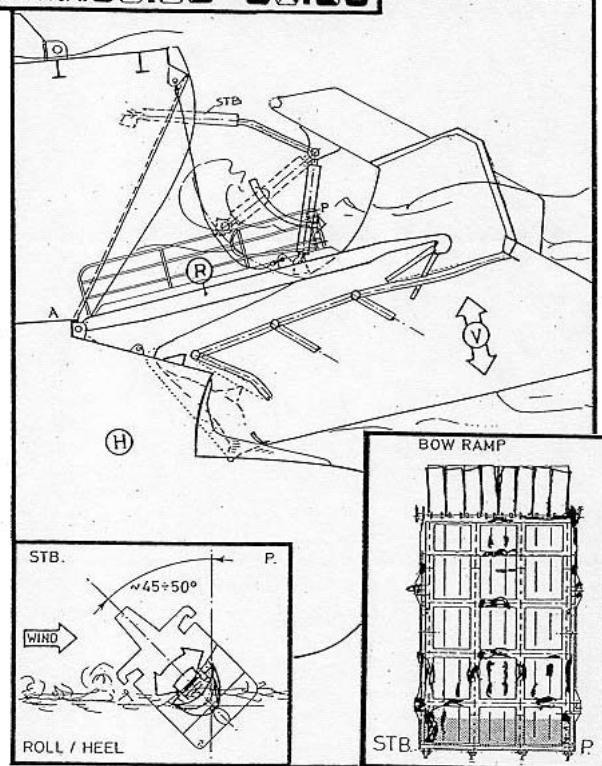
APPROX. 88.88-88.88

1. The port actuator broke through the front bulkhead, swung forward and got and crashed against the bow ramp
2. The structure of the ramp was continuously and very severely deformed by the heavy and changing weight of the visor.

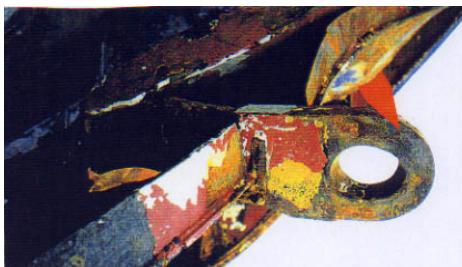
The blue coloured part of the lug - see arrow - looked as if having been exposed to heat which was unusual since this part had been below water. The JAIC was contacted and it turned out that samples had been taken already on 25 November 1994 and had been examined upon request of the Central Criminal Police in Finland and Kari Lethola as chairman of the Finnish part of the JAIC on 30.03.95. The tests were carried out on 30.05.95 by the Criminal Laboratory Technical Division, Helsinki. The "available" documentation was received - already translated into English - from Kari Lethola.
