# Statement Carl overberg

Enclosure 12.4.2.151

Statement

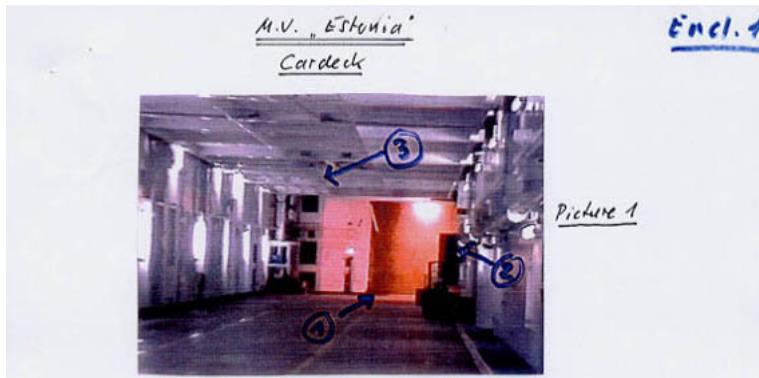
When I was waiting in my car on the car deck on one voyage I noticed that there was a video camera mounted underneath the upper deck at port side forward which was looking aft. The approximate position is indicated by arrow 3 on picture no. 1 on Enclosure no. 1. I am aware that the ferry's car deck

- (c) In front of the centre casing there were always one or two garbage containers standing into which the crew put empty bottles, cartons and the like. In addition, I noticed sometimes these containers also standing at port and starboard sides in the aft part of the car deck. I have drawn the position into a sketch of the car deck attached as Enclosure no. 2. As far as I remember these containers were never secured and very often caused concern to me when my car was standing close to them. The port one is visible on picture 1 of Enclosure no. 1. Arrow 2 is pointing to it.

- (i) When I was sitting in my car in a position close behind the bow ramp waiting for the ramp to open, I remember having frequently seen crew members pulling steel plates across the gap between the open bow ramp and the car deck. I know that this gap is normally closed by steel flaps, as visible on the photo on Enclosure no. 5 (red arrow "flaps"), but these had been dismounted with certainty at the port side. There were now holes in the flaps on both ends into which crew members were putting hooks by means of which they were pulling the flaps across the gap when the ramp was open and to the side before the ramp was closed. The area with missing flaps at the port side of the closed bow ramp can be seen on picture 1 of Enclosure no. 1, where it is indicated by arrow 1.

Port forward part with closed bowramp.  
Arrow 1 indicates the missing flaps between ramp/cardeck, which are pulled to the side when the bowramp is closed.  
Arrow 2 indicates the garbage container.
