THE GERMAN GROUP OF EXPERTS

Summary

1 THE CASUALTY

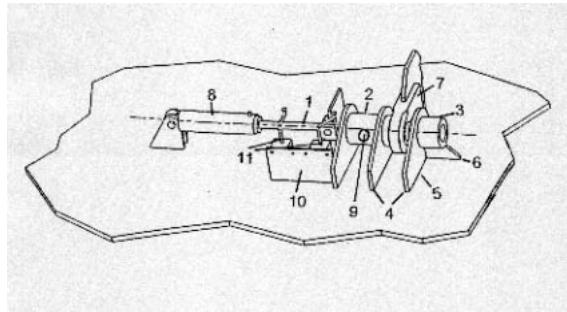
Most important was the Atlantic lock or bottom lock. The arrangement is shown in the sketch below.

This locking device consisted of a locking bolt (1), movable horizontally in a transverse direction, guided in a bolt housing (2). In extended position the tip of the bolt engaged a support bushing (3). The bolt housing was fixed to the forecastle deck by means of two steel lugs (4) and the bushing was installed in a third similar lug (5), to which a support bracket (6) was fitted. A mating lug (7), attached to the visor itself, was located between the bolt housing and the support bushing when the visor was in the closed position and the extended bolt then engaged the hole in the mating lug.

The bolt was moved in the bolt housing between the retracted position and the extended position by means of an hydraulic actuator (8), operated from the control panel located behind the bow and the ramp on the car deck. A spring-loaded mechanical plunger (9), perpendicular to the bolt, engaged grooves in the bolt in the open and closed position, thereby securing the bolt mechanically in its extreme positions, regardless of hydraulic pressure. The bolt was also locked hydraulically at any time because the hydraulic fluid was trapped in the system, regardless of whether the hydraulic system was under pressure or not.

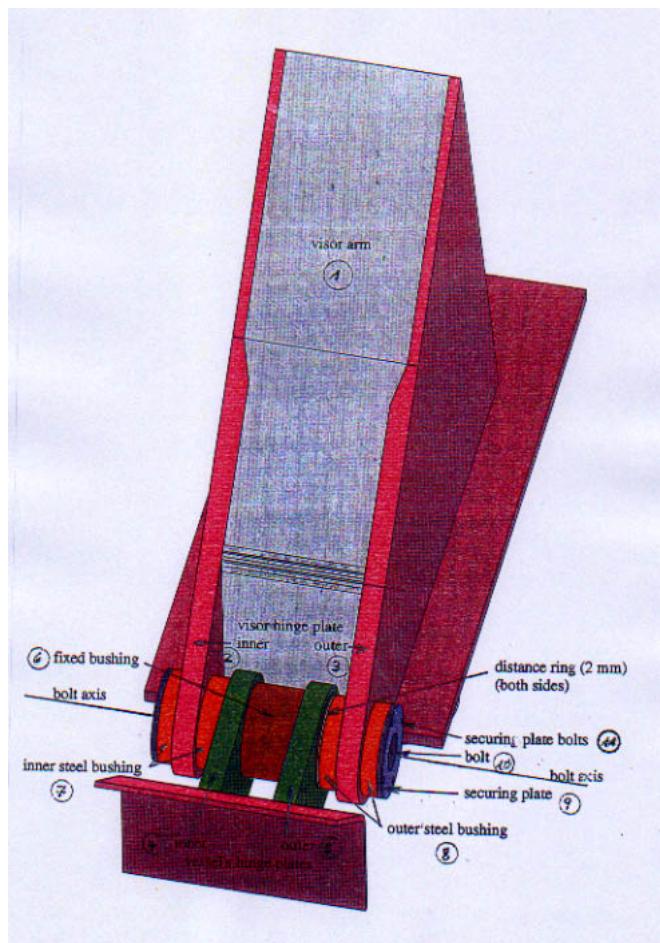
Todsen as well as the Meyer Werft managers and employees have time and again confirmed that the bore holes in the visor arms for the steel bushings had been drilled and not burned and, as a matter of fact, the port outer part of the visor hinge plate still shows circumferential drilling marks. The sketch below shows the hinge arrangements in detail.

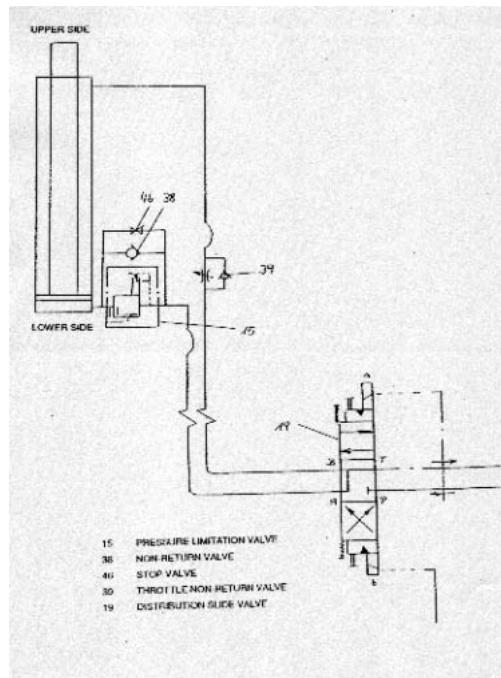
Since the hydraulic system of the actuators of the visor, bow and stern ramps do have some relevance for the casualty scenario, its functioning shall be explained in detail, whereby the figures refer to the sketch below:

- When the distributing slide valves were moved (19) from right to left, oil would flow from the pressure pipes (P) to the piston undersides, the piston rods moved upwards and the visor opened. The oil at the piston rod sides flowed undisturbed through valves 39 into the return pipes (T).

- When the distributing slide valves were moved from left to right the oil flow reached in throttled condition (39) the upper cylinder chambers (piston rod side). The pressure in the upper cylinder chambers pushed the pistons downwards. Also the weight of the visor acted on the pistons. At the underside of the pistons overpressure developed as the stop valves (46) closed, the non-return valve (38) prevented oil flow in this direction and the pressure limitation valves (15) were not yet open. Only if excessive pressure had built up at the lower sides of the pistons would the pressure limitation valves (15) open and the visor move downwards.

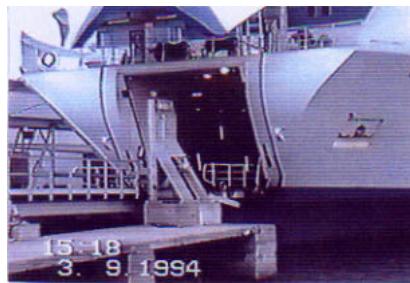
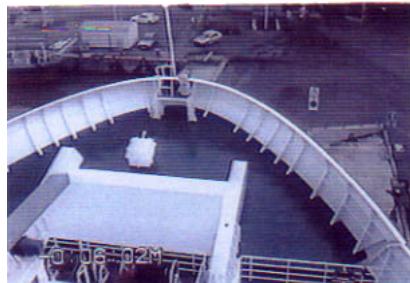
»I have actually seen crew members working at the bow ramp many times by hammering, welding or cutting (burning). I have seen the gas bottles and considered it to be very dangerous. As I am quite familiar with the way the crews from ex Eastern Block countries work, I was, however, not too surprised. It was clearly visible that the bow ramp was severely misaligned respectively bent. In open condition the port side was much lower compared to the starboard side. The bow ramp could not be opened in one go, but had to be raised/lowered several times before it was finally down. Before the ramp was lowered down completely to the quay two crew members jumped on the quay and rolled one or two rope coils underneath the starboard side of the ramp, which was still 30-40 cm above the quay when the port side was already resting on it. I remember also to have seen that wooden pallets were placed underneath the starboard side of the bow ramp instead of the rope coils. I am also of the opinion that, at least during the last months before the catastrophe, the bow ramp could not be closed completely anymore, because several times I observed from my position at the fore part of the car deck that light was falling on to the car deck as soon as the visor began to open, i.e. before the bow ramp itself was even moved. This, in my opinion, is only possible if the bow ramp was already open to a certain extent when the visor opened. The light came in at the upper port side. The whole ramp was badly misaligned, in particular the port side looked very bad, whilst the starboard side looked quite in order. Once I saw a crew member standing on a wooden pallet which was lifted up by a forklift standing behind the closed bow ramp at port side. The man was lifted up to a position just underneath what I believe was the upper bolt. After some hammering to the area where the bolt was located the man was lowered down to the car deck again. I also remember more or less always having seen a large number of wooden pallets on the car deck, which were stowed behind the side houses at both sides. On my last trip to Tallinn before the casualty (I missed one sailing) my car was on the hanging deck at starboard side. Thus I could not see what was going on at the ramp and the visor when being opened. I saw, however, crew members working at the bow ramp before it was lowered down. When I drove down the ramp I saw the equipment for either welding or burning (gas bottles) laying at port side near ramp. We had to wait longer than normal, maybe half an hour or more before the bow ramp opened. I remember this clearly, because I had people waiting for me at the quay who had left before I was from board because it took so long. It could be the time when I saw the visor moving up and down several times before the bow ramp opened combined with banging noises and also hammering.«

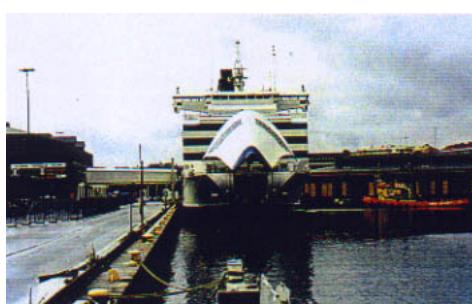
»I had frequently been on the forward part of the 8th deck upon departure from Stockholm and do remember having quite often seen the visor open.« (See photo below.)

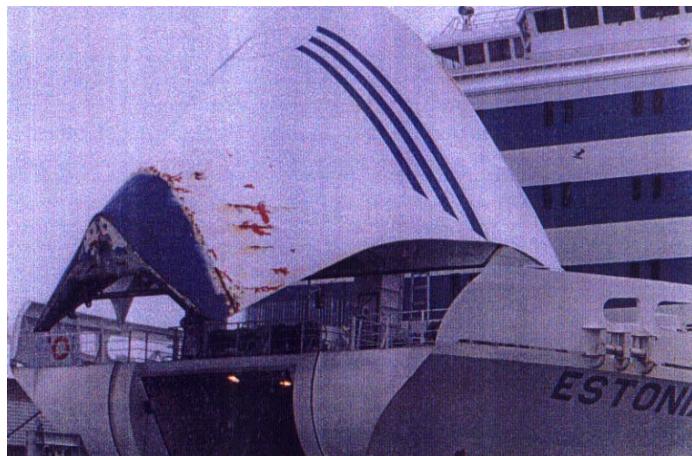
»Observation by Henning Frederiksson on 24.03.94: It was stormy weather and "Estonia" was proceeding in open water at full speed with a following sea when she met pack ice, into which she crashed without any speed reduction. "Estonia" came fast into the pack ice with an enormous crash and had to go backwards and try again. There was 16 m/sec. storm, nevertheless, "Estonia" kept her high speed.«

The results of such reckless navigation are clearly visible on the large photo on the previous page which was taken on the following day, 25 March 1994, in Tallinn by the professional photographer Li Samuelson.

The ice damage sustained by the visor during the months of February and March 1994, when the Gulf of Finland and the Northern and Middle Baltic were more or less continuously covered by ice (see Subchapter 12.4.2), were roughly repaired by replacing parts of shell plating and bottom of the visor in Tallinn whilst the vessel remained in service. The renewed parts are still visible on the visor.

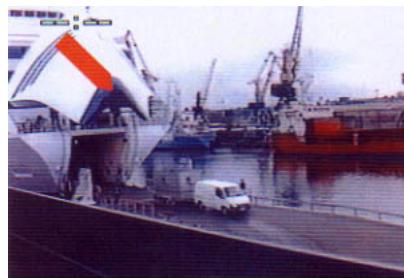
The damage sustained by the visor while proceeding at full speed through ice barriers several meters high and using the vessel as an ice breaker is demonstrated by the preceding photo and can also be seen on the video image below made from a film of 30.03.94.

As a result of the sustained severe structural damages and in combination with the different lifting speeds of the actuators and severely worn out hinge bushings, the visor became increasingly misaligned and out of geometry.

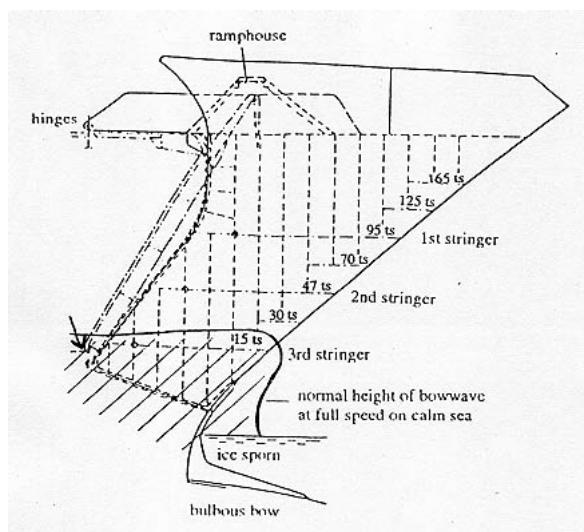
The following drawing clearly demonstrates that already in calm sea the water rose above the 3rd stringer inside the also severely leaking visor due to the height of the bow wave at full speed.

Since the lower part of the deck opening with the missing and/or damaged rubber packings (see arrow on drawing) was below the 3rd stringer level of the closed visor, it is obvious that water penetrated the car deck already in calm sea when the vessel was on full speed (height of bow wave ca. 2.5 m). It is also obvious that the water inside the visor rose when the vessel was pitching in head seas. The height of the water inside the visor depended on the height of the outside water level, i.e. when the ferry was taking green water on the forecastle for a certain time the visor would fill up more or less completely with respective water pressure on the leakage of the bow ramp.

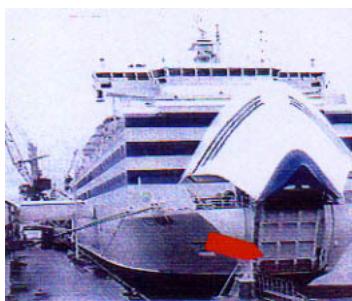
Note: The picture on the next page was taken in October 1993 and shows the lower part of the closed bow ramp severely stained by oil, most probably hydraulic oil, which cannot just be explained by normal leakages.

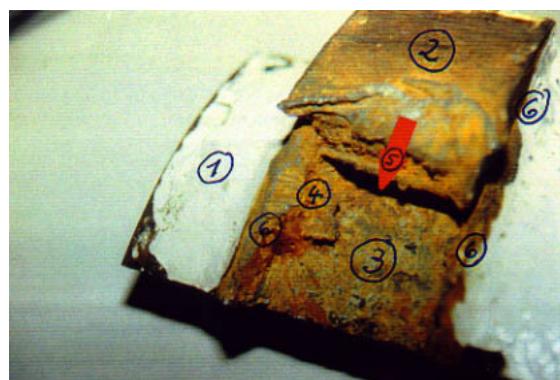
photo of stb. inner bushing recovered by divers

In summary of these three statements it has to be concluded that the welding seams between the bushings and hinge plates of the visor hinges were visibly cracked up to 10 cm at the beginning of August 1994, less than 8 weeks before the casualty.

The photo below shows a part cut out of the bushing recovered by divers from the wreck. It is most probably the starboard inner bushing as will be explained in Chapter 30.

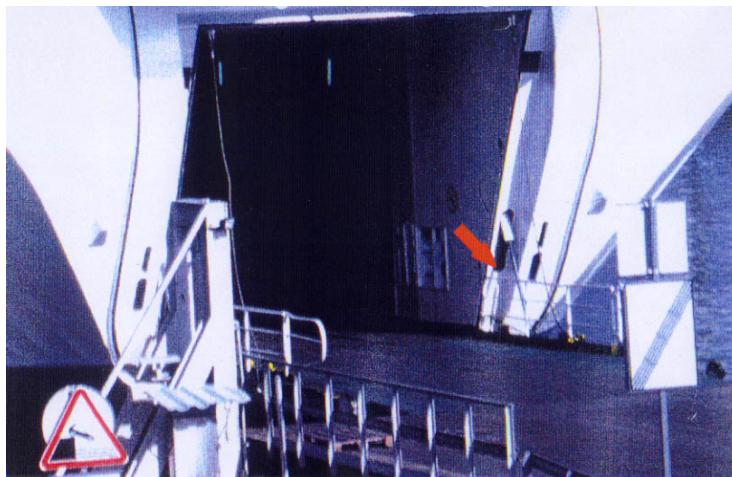
The picture following this demonstrates the conditions that the Swedish inspectors and their trainees found on the open bow ramp. The arrow points to the location where at that time an angle iron was fitted.

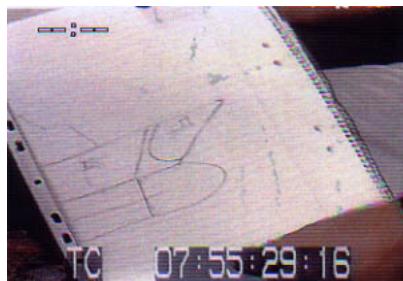
Åke Sjöblom made the following drawing and points to the area which is indicated by the arrow meaning both port and starboard side.

It should be noted that Åke Sjöblom has placed the bow ramp, which is the **upper extension of the collision bulkhead on top of the collision bulkhead** which was not the case on ESTONIA and also not on DIANA II, the near-sister, for which he had then been responsible for about 2 years already with his Malmö inspection office of Sjöfartsverket as the National Maritime Administration.

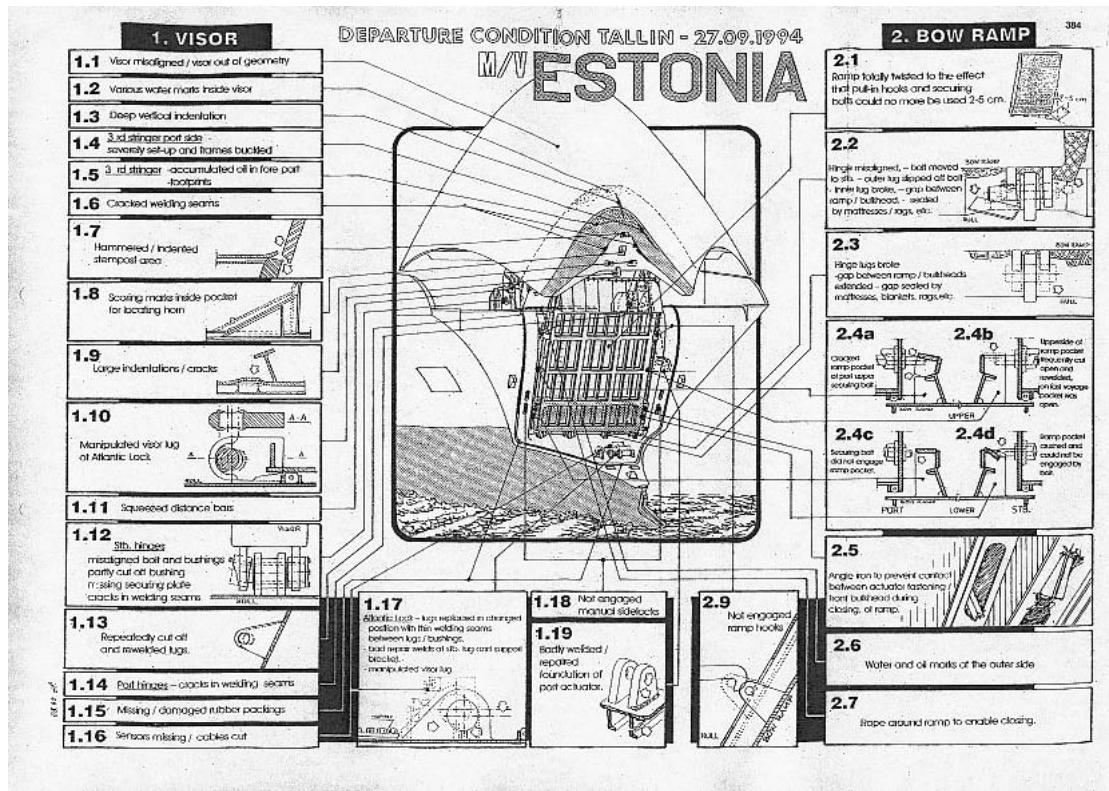
In addition, these deficiencies are shown on a drawing of the foreship with open visor which is integrated into this report and forms the following page.

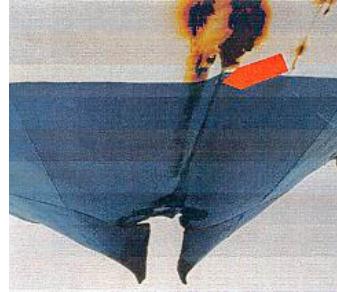
The shell plating as well as the internals are very severely damaged in two places, viz. there is a deep vertical indentation in the bow leading upwards from the stempost for about 2 m, as can be seen on the picture below from the outside,

The arrow points to the deep indentation which is completely painted and the paint does not show contact marks. The following photos showing the inside of the same area do confirm the deep indentation in a very strong part of the visor to be of old origin.

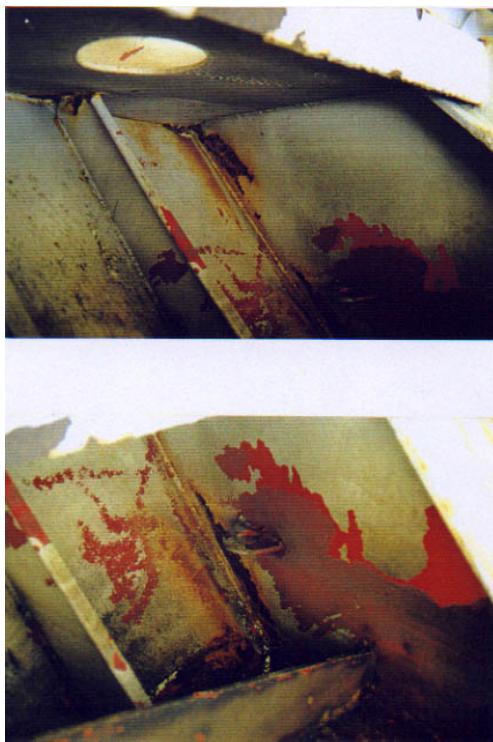
Furthermore, the shell plating as well as the 3rd stringer at the port side are severely indented and set up with the frames buckled which had been sustained already some time before the casualty. - See the pictures above.

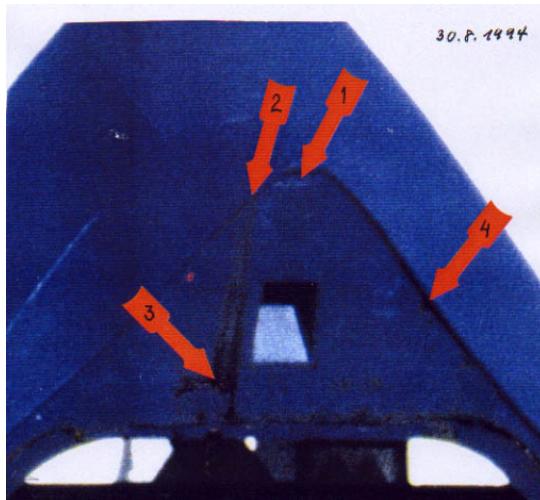
The condition of the visor bottom with stempost is evident from the picture below taken on 30.08.94.

Arrow 1 - Indentation in the foremost part of the visor bottom indicating that the visor's initial position was changed to forward most probably due to misalignment of the whole structure. This led to contact between the visor bottom and the stempost on the forepeak deck. Since the visor bottom in this area is not constructed to take up load, the bottom became indented and cracked.

Arrow 2 - Indicates a cracked welding seam through which water penetrated and created the rust stripes.

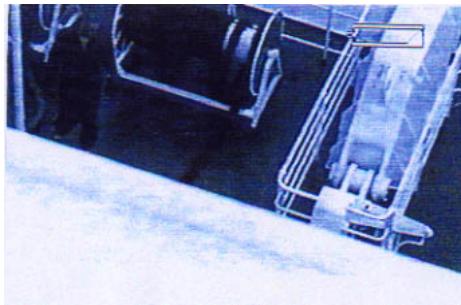
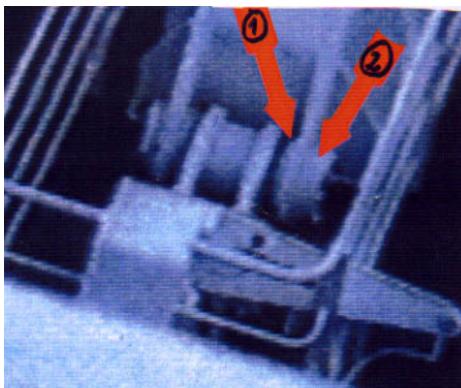
The passenger was standing in front of deck 7 and filmed the closing of the visor, finally zooming in on the starboard hinges. The video-prints below are part of the film. Picture 2 is an enlargement of Picture 1.

On Picture 2 there are obviously several major deficiencies visible, viz.

- (a) the gap between the starboard vessel hinge plate and the outer bushing is much too large (arrow 1).
- (b) the outer bushing is sticking much too far out of the outer visor hinge plate (arrow 2) [which explains the large gap mentioned above].
- (c) the lower part of outer bushing is missing.
- (d) the securing plate is missing and the outer end of the bolt is not visible.
- (e) the outer bushing appears to be twisted anti-clockwise.
- (f) the inner bushing appears to be twisted clockwise.

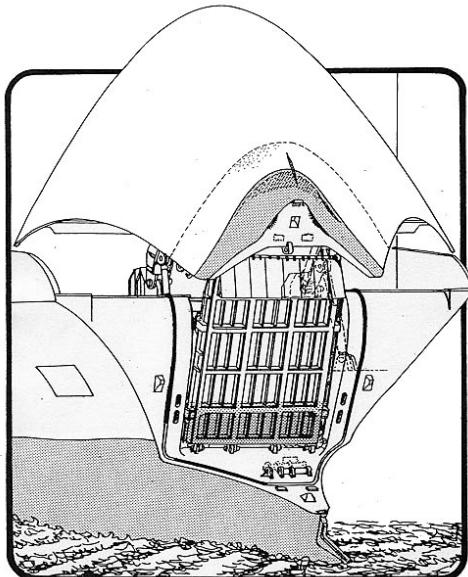
The last Finnish crew had requested the renewal of 15 m of rubber packing in way of the visor for the then planned yard time in January 1993, because the rubber packing had last been renewed in January 1991. This meant a renewal of the entire packing on the forepeak deck plus about 2 m up each front bulkhead as demonstrated by the following drawing.

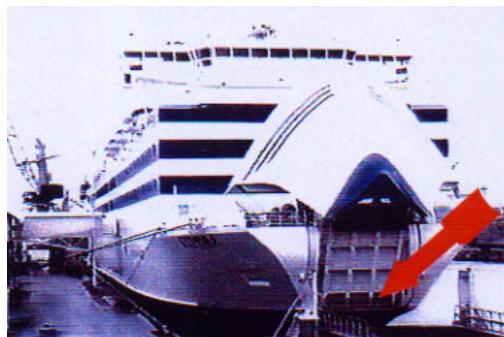
Since the new technical managers N&T were of the opinion that visors are full of water at sea anyway, the rubber packings were not renewed in January 1993 and also not later. This means that the visor became quickly filled up with water at sea up to the height of the outside water level. In calm sea it was the height of the bow wave which filled the visor up to the 3rd stringer, however, the worse the weather was and the deeper the bow was diving into the waves, the higher the water rose inside the visor. The following picture shows the ESTONIA in Tallinn, with open visor but closed bow ramp so that the otherwise invisible underside of the bow ramp is shown with the lowest section being dark - see arrow. Doubtless this was caused by the water inside the visor with hydraulic oil from the leaking cylinders swimming on top of the water surface. When the vessel reduced speed and the bow wave became smaller and finally disappeared completely when the vessel was alongside, the water streamed out of the visor and the oil settled everywhere inside the visor, also on the bow ramp which forms the aft inside of the visor. The water streaming out of the visor was observed by many passengers when the vessel was alongside in Stockholm with closed visor and, among others, also by the skipper of the Sandhamn pilot boat as well as by several pilots when the ferry was slowing down during the approach to the pilot boat.

The bow wave became smaller and the water streamed at once out of the visor. (See Subchapter 12.4.4.) It is obvious that at sea inside the visor the conditions in a partly filled ballast water tank did exist with resultant sloshing effects causing additional loads on hinges and locking devices and vibrations to the whole visor, the consequences of which are described in Subchapter 34.3.

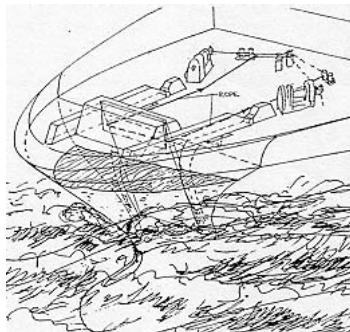
The starboard ramp hook, however, is nowhere visible and the location where it should be, is empty. It has thus to be assumed that also this hook had not engaged its mating lug at the ramp, which means that the ramp had just been closed by the actuators - as stated before - to an remaining opening of 4-5 cm. Due to several mooring ropes and two wires found in way of the ramp and respective indications on the ramp - see Chapter 29.2 - it has to be assumed that the crew tried to close the ramp completely by means of mooring ropes and/or wires probably pulled tight by means of the mooring winches on the forecastle deck.

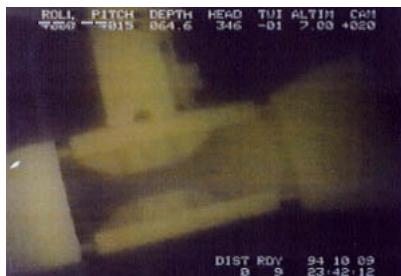
Note: Actually there had to be one red lamp, because at sea the harbour securing of the visor is open, thus the indicator light is red. This would have been the proper reply by Silver Linde, but he had been instructed differently by the security adviser of Estline, Captain Enn Neidre, who obviously was not aware of this respectively not acquainted with the installation. After this 'Group of Experts' had explained in writing to the JAIC the different functions and meanings of the indicator lights, the consultant of the Estonian part of the JAIC, Professor Jaan Metsaveer, tried to correct the already existing impression that the Estonians did not know how their relevant safety installations functioned, by stating at a joint meeting of the JAIC and this 'Group of Experts' that the explanation for "all lights were green" was the fact that the careful boatswain always closed the harbour securing at sea to avoid any lights being red. After

presentation of the video print below, from one of the underwater videos showing the harbour securing open, the professor remained silent for the rest of the meeting.

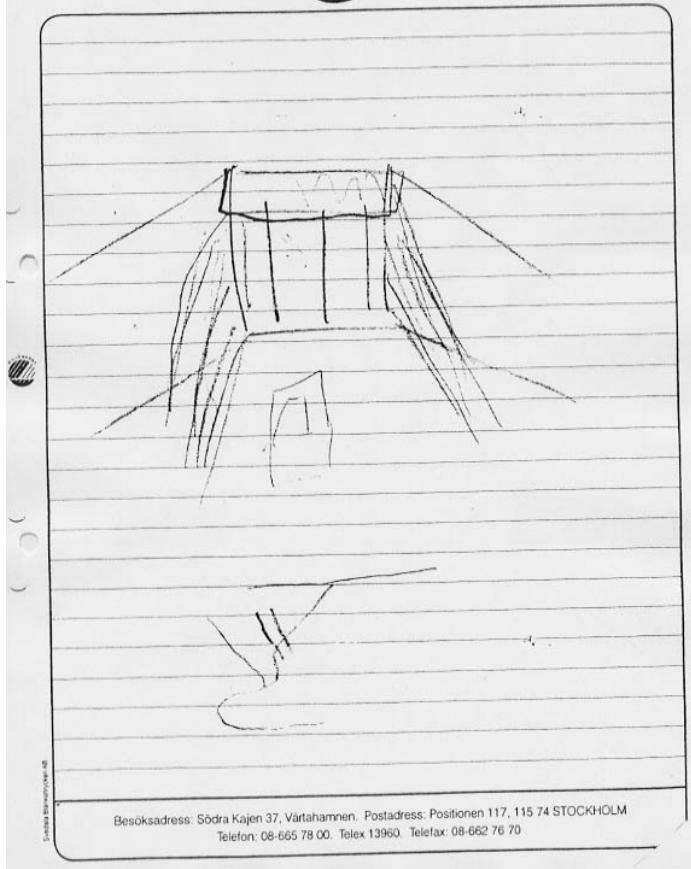
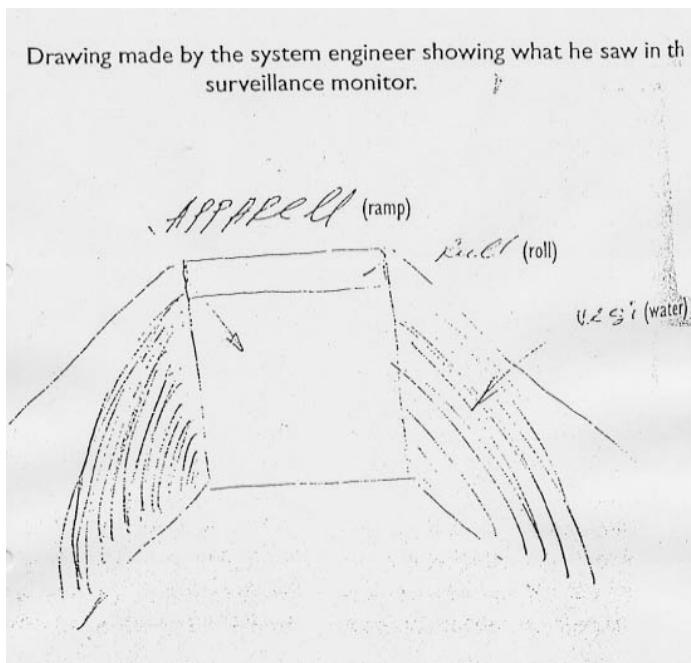
Drawing made by the system engineer showing what he saw in the surveillance monitor.

Sillaste has maintained this observation, viz. that the bow ramp was slightly open when he looked at the monitor for the first time in the Engine Control Room (ECR), during all his statements. Although he is expressing himself very carefully and has, after the first three statements taken on 28/29 September 1994 at Turku, obviously been prepared for possible further questioning concerning the visor and its locking devices, however, apparently not in respect of the bow ramp. Also the fact that he was not invited to attend the Landvetter meeting at the end of March 1995 indicates that neither JAIC nor ESCO did consider him to be a key witness. This apparently changed after this 'Group of Experts' had presented his detailed evidence, including the drawing he had made showing the slightly open bow ramp with water pressing through at both sides, to JAIC in the course of the joint meetings held during the second half of 1995.

Already in January 1996 he was again interrogated by the Estonian security police when he made another drawing showing the same condition of the slightly open bow ramp with water pressing through at both sides. Both drawings are shown below.

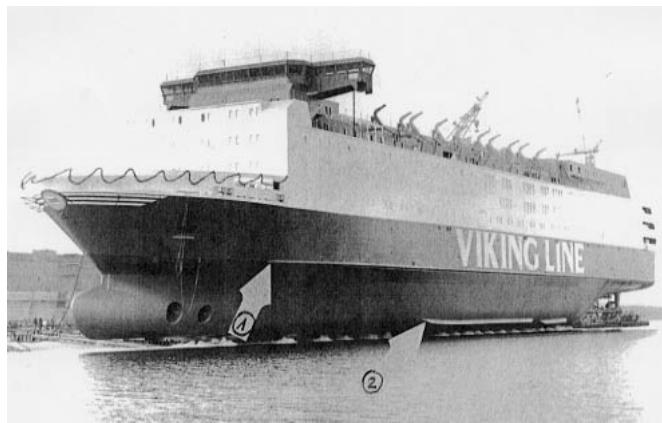
Note: The picture below shows the vessel's port side while still on slip. Arrow 1 indicates the forward end of the fenderbar, arrow 2 the forward end of the bilge keel.

- When he was at the forward part of the fenderbar he saw something like a fin sticking out of the hull, dark like the bottom, maybe 1.5 m or less, looking like a propeller blade of a plane. It was not moving.

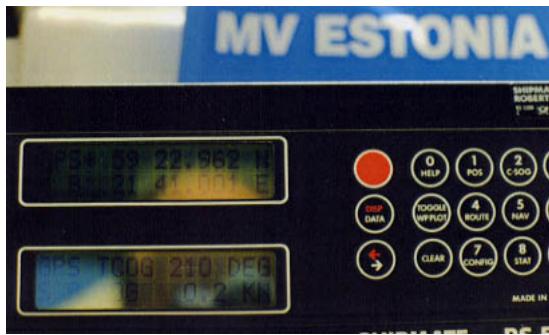
The photo below shows the DGPS position of the wreck taken on board of a tug directly above.

The heading is approximately east and the wreck is lying on her starboard side with a list of about 120°. The water depth above the bow is 85 m and above the stern is 74 m. The highest point of the wreck is the stern with 58 m of water above. The wreck is resting on soft clay on the top with stiff boulder clay below. A side scan sonar survey of the area around the wreck revealed debris in an area of up to 350 m to the south and the west of the wreck.

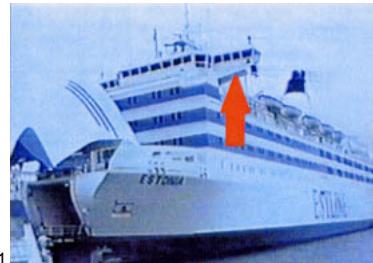
No. 1

as to (1): The torn and broken open underside of the port bridge wing.

The area in question and the extent of this unusual damage at an unusual location shall be illustrated by a number video images. The first ones were made from footage produced already on 02.10.94, i.e. 4 days after the casualty, and the last ones at the diving investigation between 01-04.12.94. The arrow on the picture below points to the area in question.

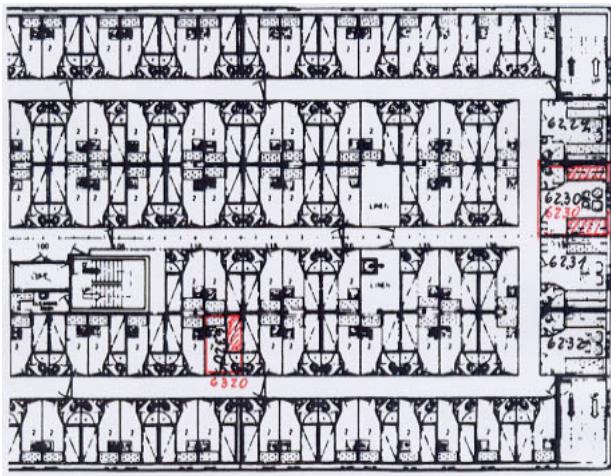
According to video B40a and the video tape log page - attached as [Enclosure 27.411](#) - the diver entered the forward part of deck 6 and tried to enter cabin 6132, which had been occupied by a member of the Stockholm Police ST-Section, but failed, then tried the next cabin 6135 but failed again and then 6134 also without success. The diver returned to the outside for tools and moved in again, broke open cabin 6132 - found a suitcase without name tag and left it behind. He then worked his way to cabin 6230 which was the 2nd cabin from port side of the four luxury cabins in the fore part of deck 6 overlooking the foreship. According to the statement of purser Andres Vihmar of 15.05.96 - see [Enclosure 14.195](#) - this cabin had been assigned to the master of the second crew, Captain Avo Piht. In the alleyway in front of this cabin the diver found a body. The diver, obviously receiving instructions through his second earphone not audible on the available video, broke up the door and headed straight for a suitcase, which was open but - according to the diver - apparently nothing was missing (how could he know?) and the suitcase had a label with the name Alexander Vorodin. The diver carried the suitcase out of the accommodation and it was apparently hoisted up to the diving platform. The diver subsequently broke open or tried to break open the cabins in the vicinity of cabin 6230, all of which had been occupied by members of the ST-Section of the Stockholm Police. The owner of the suitcase, Alexander Vorodin, had been on board together with his uncle and nephew, and all three survived. According to the first and only statement of Alexander Vorodin and to the 2nd statement of his uncle, Vasili Krjutjkov, they had been in cabin 6320. In his 1st statement Vasili Krjutjkov testified, however, that they had been in cabin 6230 - [Enclosure 14.196](#) - which was indirectly confirmed by his young nephew Vassili Vorodin - see his statement [Enclosure 21.3.4.341](#) - who testified that he had been thrown out of his bed to the floor by the big heel and thereafter they had looked out of the window and seen the vessel heeling heavily to starboard. As can be seen from the drawing below showing the forepart of deck 6 - cabin 6320 is an inner cabin without windows and with only 2 beds (1 upper/1 lower) which are arranged athwartships, thus no one would be thrown out of these beds if the vessel suddenly heeled to starboard. Cabin 6230, however, has 2 upper and 2 lower beds which are arranged in longitudinal direction, i.e. if the vessel suddenly heeled to starboard somebody in the port side beds could be thrown to the floor as it happened to Vassili Vorodin. Furthermore this cabin has two windows overlooking the foreship.

Consequently the Vorodins had been in cabin 6230 which is also confirmed by the presence of the suitcase of Alexander Vorodin in this cabin. The question is why did Andres Vihmar testify to the police that it was the cabin of Captain Avo Piht where the suitcase of Alexander Vorodin was found, who had the reputation of being a weapons smuggler, and was therefore so interesting to the criminal police of Stockholm. A transcript with the voice communication during the above explained examinations is attached as Enclosure 27.412.

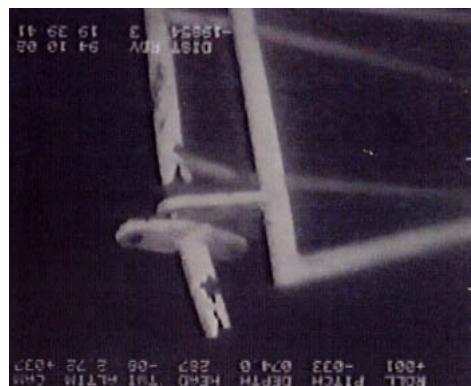
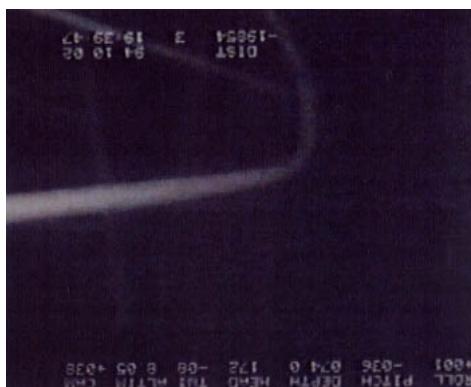
Upon evaluation of the video tapes by Disengage parts of the bow ramp rails were identified on the sea bottom and the images shown below and overleaf were produced.

The two images above made by ROV on 2.10.94 already clearly and without doubt prove that it is the forward section with movable part of the starboard bow ramp rail which is resting on the bottom of the sea.
A reconstruction of the ROV track commencing at the stern of the wreck revealed that these rail parts are located about 250 m to the south of the stern and about 80 m to the south-east of an area where the video was cut three times, each time for about 1 minute.
For further details see Subchapter 29.2 - The Bow Area.

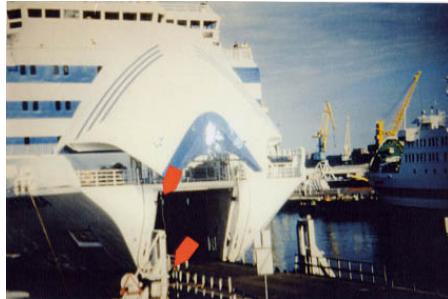
The arrows on the picture above point to the shackles by which the starboard preventer wire is connected to vessel and bow ramp. The system on the port side is identical.

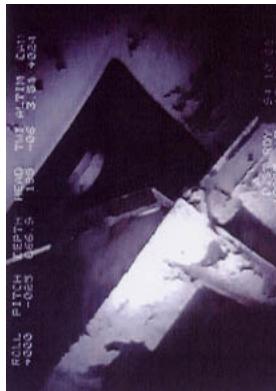
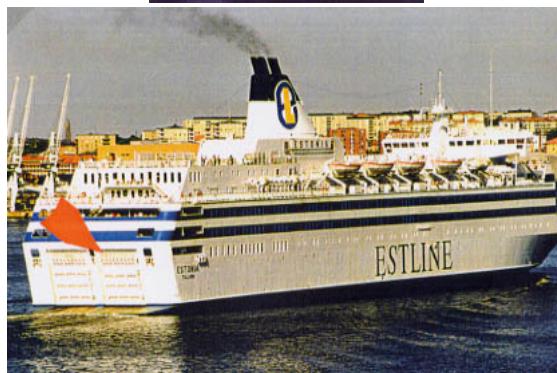
The image below shows the inside of the upper starboard stern ramp to be partly open. It was taken from the ROV video dated 09.10.94. The arrow on the picture further down points to the area in question. This fact will be explained in detail in Subchapter 29.7.

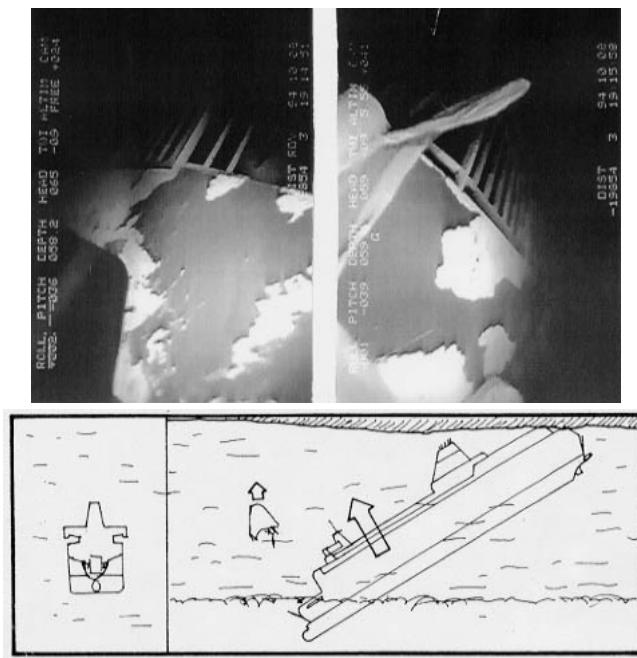
Window panels were found to have been pushed out and doors in the aft bulkheads of decks 5 and 7 were missing while **the door in the front bulkhead of deck 5 leading down to the forecastle deck was noted to be open.**

Note: This door could only be opened by crew members. The aft parts of the superstructures in way of decks 7 and 8 on the port side were found to be partly distorted and buckled. Large flakes of paint were scored off the aft parts of decks 5 and 6 - see the two images below - which was most probably caused when the vessel was in upside down condition with the stern already aground and the bow still above the water. - See the drawing below.

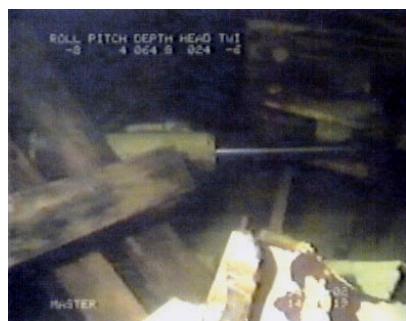
Contrary to the port opening - see sheet P 3 - where the ramp hook arrangement is clearly visible when the ROV looked into the opening - see the image on the next page - the starboard opening is just a big black hole. This can only mean that the starboard ramp hook was not where it was supposed to be.

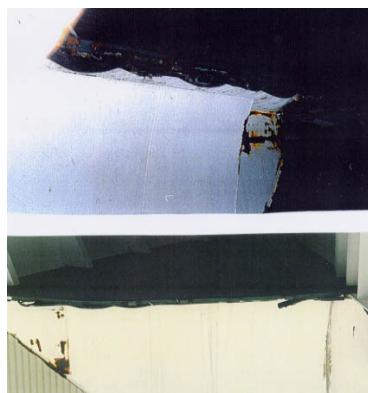
Also the flat bars around the deck opening into which the rubber packings - fitted below the visor arm - should be pressed, when the visor was closed, were missing. The same refers to the flat bars having initially been welded athwartships at the forward part of the forecastle deck into which the rubber packings at the aft part, i.e. below the recess of the visor, should be pressed when the visor was closing (see also item 5 on the detail drawing). This can be seen from the following two pictures, of which the first one shows the starboard aft part of the visor deck with untouched rubber packings, intact and in place and the 2nd is the port side which is evidently in worse condition.

The picture below shows the rubber packing underneath the starboard visor arm which was obviously never pressed into any flat bar and is not affected at all, which confirms the apparent fact that

- a) the flat bars around the deck opening had been removed prior to the casualty and that
- b) the visor was raised to some extent at this side after the hinges were broken since otherwise this rubber packing would have been destroyed as it did happen at port side - see P 3 - Port Side Fore-castle Deck.

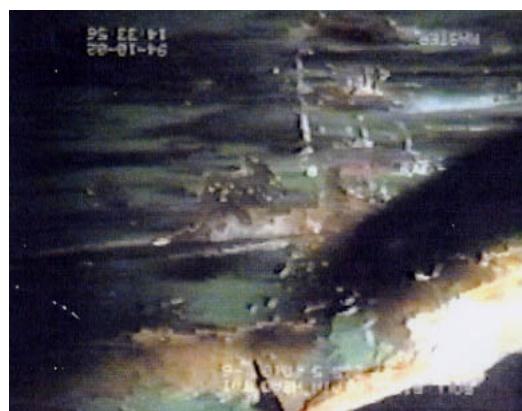
Image No. 1, 2 and 6 show the starboard inner side of the cut through the deck beam at frame 149, which are evidently pressed together, partly cracked and bent up, indicating pressure from port to starboard. The edges of the deck opening aft of the deck beam are not affected at all, same as on the starboard side. This is only indicated on the detail drawing but is clearly shown on the available video footage. The starboard side of the cut through deck beam and the deck plating as well as the rubber marks are shown also on the picture below.

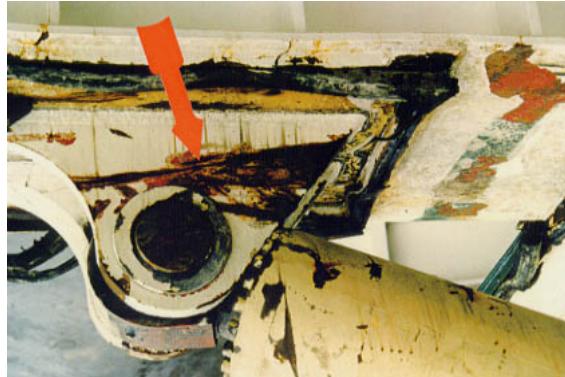
It must have taken some time for the visor lugs to cut through this deck beam while the visor moved forward/aft in the sea state ending when the visor lug plates had finally cut through this strong deck beam. It has to be assumed that during this cutting process at least the paint on both the inner and the outer lug plates should have been destroyed in way of the contact area. This was, however, evidently only the case with the inner lug plate as can be seen on the picture overleaf.

The lug plate has very deep and - at the upside - straight scoring marks, almost engraved, which indicate

- (a) the movements of the visor and
- (b) that the weight of the visor was to some extent resting on this inner lug plate which caused these very deep scraping marks, whilst the opposite side, i.e. the outer lug plate, remained completely unaffected as visible on the next picture.

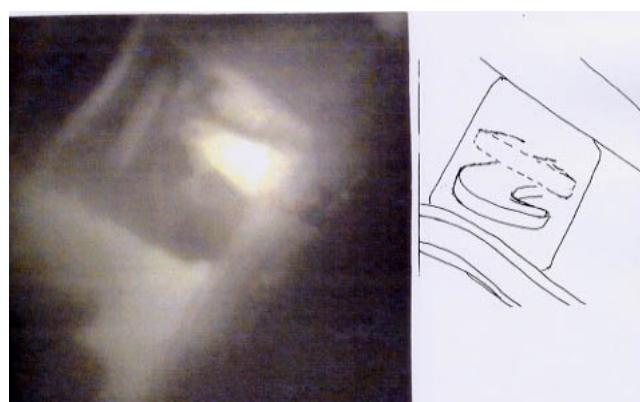
From subsequently obtained video footage - evaluated by Disengage - it was ascertained that the port ramp hook was intact and complete, i.e. neither broken nor bent straight. This means that this hook had not been engaged in its mating lug because this lug is also intact with the bolt undamaged. - See also item 6. The following image shows the intact ramp hook, the adjacent drawing explains the image.

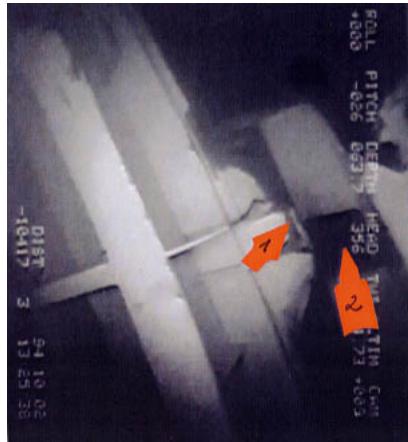
The following picture shows the misalignment between the mating lug at the ramp side and the opening in the front bulkhead out of which the hook would extend, i.e. it was impossible for the hook to engage the mating lug in this condition. This explains the undamaged condition of both hook and mating lug.

Arrow 1 points to the mating lug at the ramp

Arrow 2 points to the location where the hook would reach out of the opening

Note: The 4 inches = 100 cm misalignment between the bolts on the ship's side and the mating pockets on the port side of the bow ramp as reported by the diver must logically exist also between the ramp hook on the ship's side and the mating lug on the bow ramp. This is further evidence that neither the bolts could have engaged the mating boxes nor the ramp hook the mating lug on the port side.

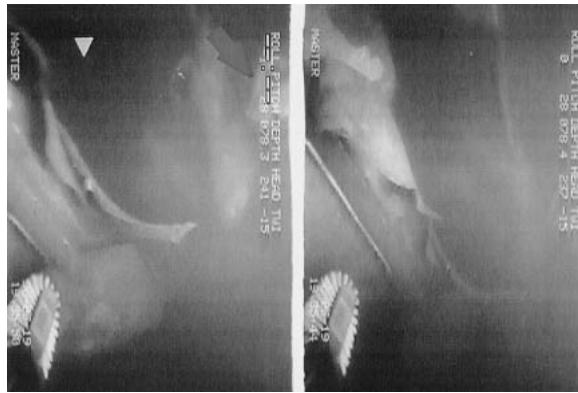
Area No. 2 shows the damage further down the front bulkhead. Note the torn open steel bent to starboard and to port.

The arrow on the left picture points to the severely distorted mating lug for the ramp hook.

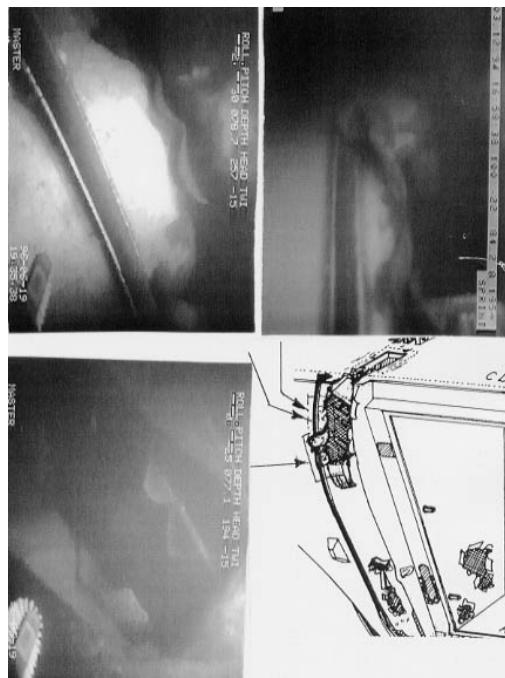
The three images on this page show details of this large damage, in particular the bent and cracked steel parts at the edges.

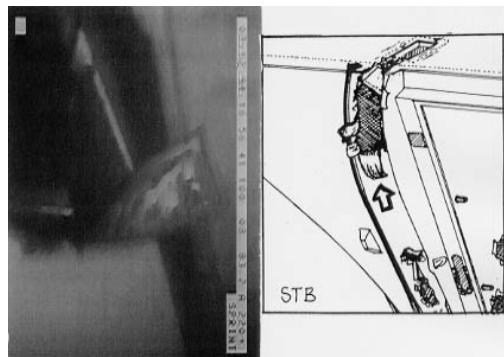
The picture below shows the lowest part of the damage, i.e. an almost horizontal, slightly upwards pointing steel flap.

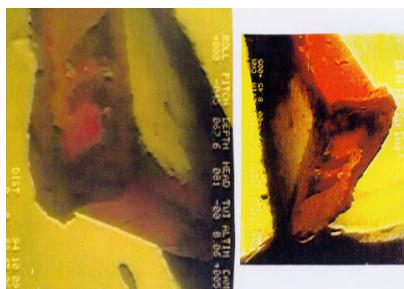
The next images show the lug of the hydraulic side lock which was evidently torn off the visor bulkhead together with the welding seams by which it had been welded to the bulkhead.

Note: It is obvious that these welding seams do not originate from one welding procedure only but from several weldings on top of each other, i. e. after each cutting off the new weld was laid on top of the previous ones without grinding off the remains of the previous welds as required by proper workmanship to assure the required load-carrying capacity of the weld. The required load-carry capacity of these lugs being part of the locking system of the visor did already since sometime before the last departure no more exist and was reduced to a fraction of the initial load-carrying capacity by such unqualified repairs.

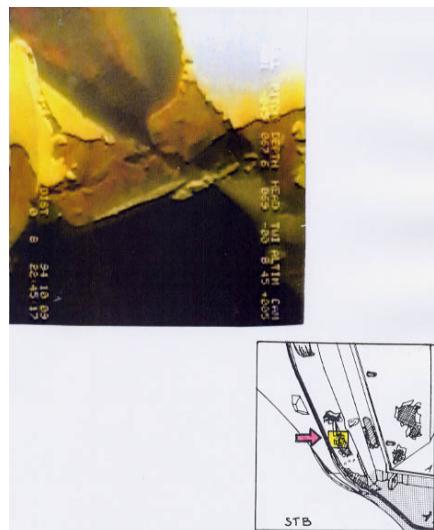
The next image shows the broken bulkhead part between the opening with the lug of the hydraulic side lock and the much enlarged opening for the manual side lock below.

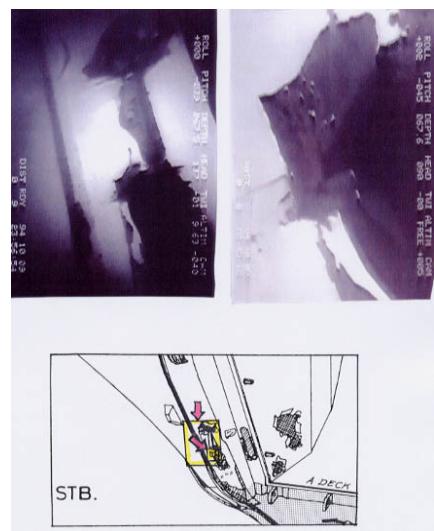
The following pictures show the upper part of the enlarged opening for the manual side lock.
Note the steel bent from inside to outside.

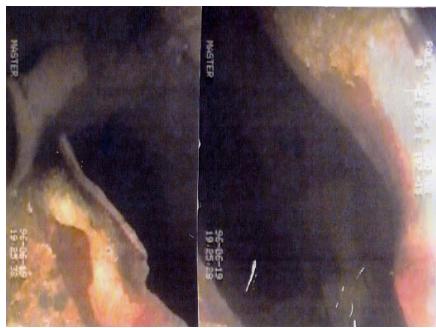
The two pictures below show the enlarged opening for the hooks of the manual side locks with the steel plating bent from inside to outside and the edges cracked.

On the right picture the not engaged mating part of the manual side lock is visible in the background. Furthermore a "soft" indentation can be seen on the inside of the substantially enlarged opening.

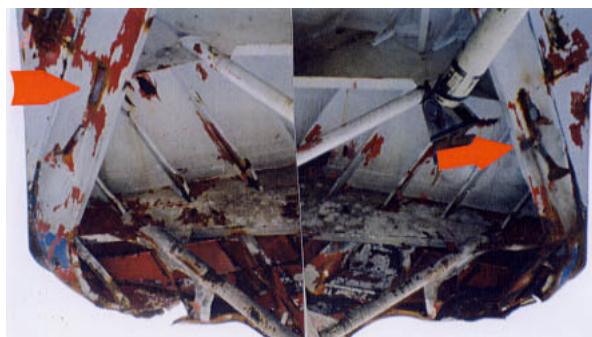
The picture on the right left shows the area of interest on the starboard side, the picture on the left shows the corresponding port side. It shows a completely different damage picture: no smoke marks, no steel tongue torn off the bulk-head and no twisted hooks.

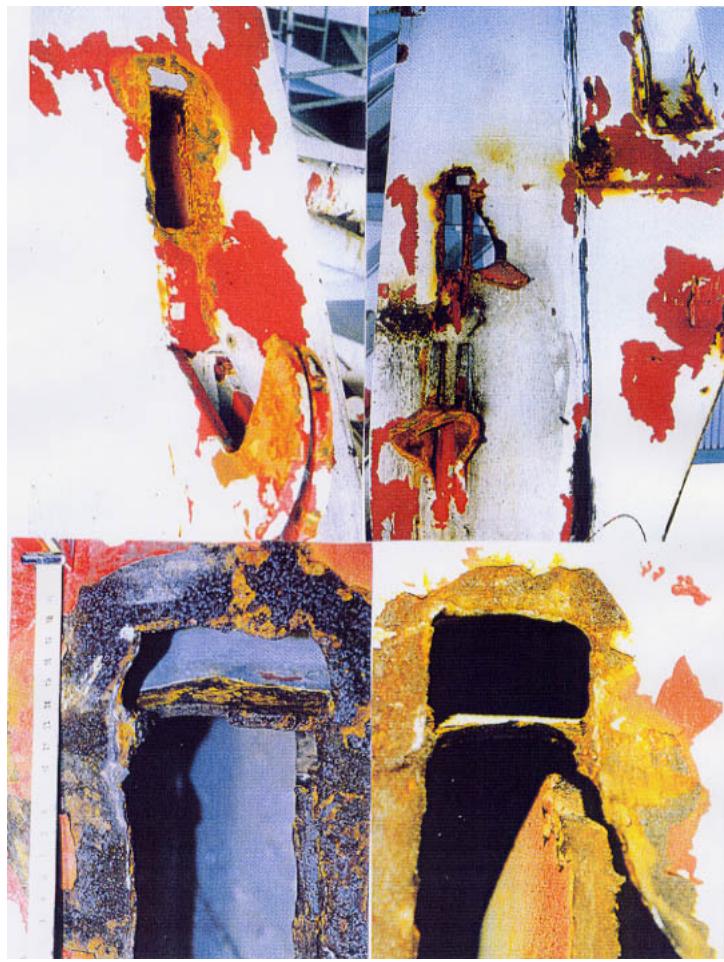
Two of the following four pictures on the next page show those areas at the port and starboard aft bulkhead of the visor where the lugs of the side locks had been welded to and the hooks for the manual side locks were fitted. The other two are close-ups of the upper parts of the area where the lugs had been welded. The right side shows the part of the starboard visor bulkhead directly opposite the above explained damage area. The smoke marks are still clearly visible although the visor had been on the sea bottom for 7 weeks. The hooks are distorted in a way which is technically not explainable. The area is dark. The picture on the left shows the corresponding port side as comparison with a complete different damage picture, with no smoke marks, no steel tongue torn out of the bulkhead and no twisted hooks and a generally clean appearance. The two close-ups arranged below the above mentioned photos show the respective upper parts of those openings in the bulkhead. They do illustrate the difference very clearly. While the port side shows normal steel clean of corrosion, the starboard side shows steel which had obviously been exposed to heat and pressure force: The metal is distorted and pushed out, the stiffener is detached from the bulkhead. See also Chapters 30 and 32.

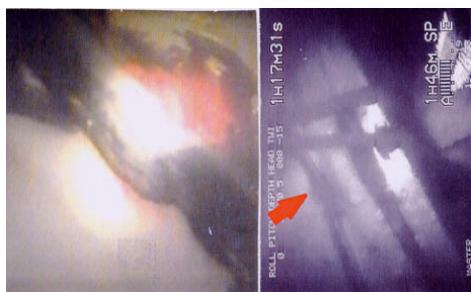
Arrow 2 points to a damage area in way of the rubber packings which is better visible on the right image below made from the 1996 video tape. The double rope was then still there because it is jammed in, though in slightly changed position. The damage area is more clearly visible - see arrow.

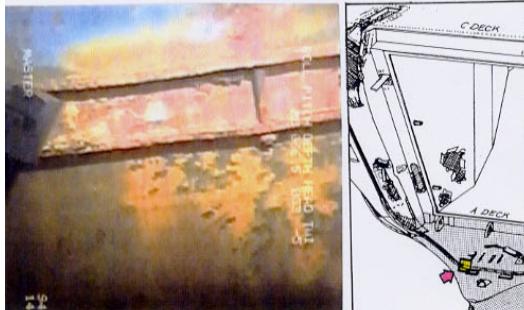
- Nos. 2, 4, 5, 6 show either empty flatbar channels where the rubber packings were supposed to be - which is also confirmed by the image below - or show the rubber packing lying loosely on the flatbars into which they should be fitted and bolted. The evaluation of the video films - of which these 3 pictures are just a small selection - prove that the rubber packings were only in place at the starboard side from forward of the Atlantic lock to the "corner of the mouth" and these were in a rather poor condition. Along the whole port side up into the "corner of the mouth" there were no rubber packings. The diver followed the flatbar - channel for the rubber packings from the top of the starboard front bulkhead via the forepeak deck to the top of the port front bulkhead which is documented on video tape B40c. The two images below are just a confirmation of the findings explained above.

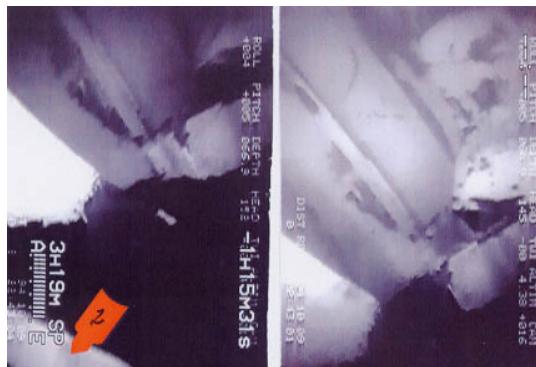
On the right image arrow 1 points to the change over from white to blue paint which should actually continue according to the red-dotted line, however, this is not the case due to the considerable distortion of the complete area which was apparently pushed forward where the visor was at the time.

The following two images show the area adjacent to this pushed-out lower part of the front bulkhead, the recess with the torn-off and severely bent lower part of the outer vertical girder of the bow ramp. Apparently the deck/bulkhead is open in way of these severe distortions which also extends downwards.
