THE GERMAN GROUP OF EXPERTS

Summary

1 THE CASUALTY

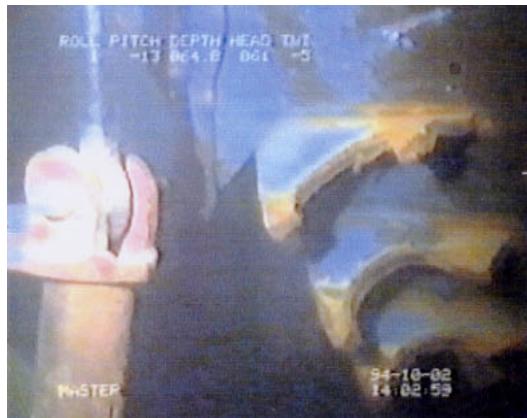
- Image No. 1 shows the starboard and centre logs while images Nos. 2 and 3 show the centre - and the port lugs. The latter one was subsequently destroyed upon instructions of the JAIC for testing purposes.
- The 3 images were taken from the ROV video made on 9 October 1994, i.e. 12 days after the casualty. All fracture surfaces are heavily corroded. This is even more evident from the image below made from the ROV video from 02.10.94, i.e. only 4 days after the sinking, which shows the same corrosion to the fracture surfaces of all 3 lugs.

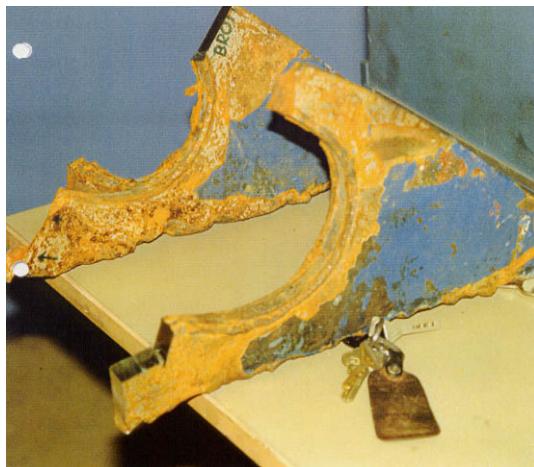
The pictures Nos. 4 and 5 show the starboard and the centre lugs in the Royal Technical University in Stockholm (KTH) in February 1995. They had been cut off the forepeak deck and were recovered by divers on 4th December 1994 and subsequently examined by the KTH. Below a photo of the starboard and centre lugs taken at the KTH, Stockholm in February 1995 is shown in order to illustrate to the reader the actual condition. Particular attention is drawn to the lower fracture area of the starboard lug.

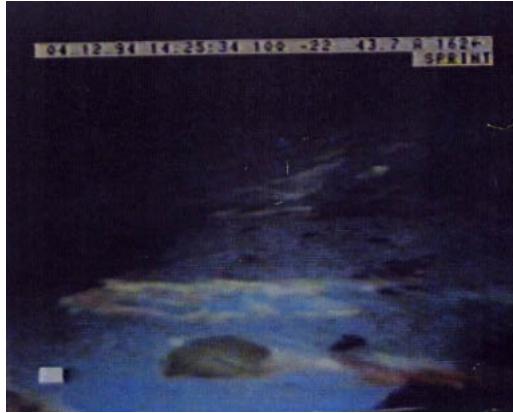
The following image shows white contact marks on the port side of the bulbous bow further aft than the previous one.

The pictures do confirm contact with some object which could have been quite strong considering the very strong construction of the bulbous bow, i.e. a weaker construction might have sustained heavy damage due to contact with the strong bulbous bow as indicated by the above paint and scoring marks.

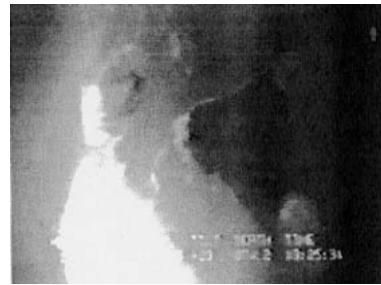
Since the starboard shell plating in way of 0-deck is accessible over the whole length of the wreck - see the 2 drawings on the previous pages - and has been carefully examined by ROV and divers during the mudline surveys, it is certain that respective video material is available. The "official" mudline video is, however, censored, i.e. the relevant parts were deleted - see also the Disengage Report - [Enclosure 34.6.434](#). Nevertheless, careful evaluation of the available mudline video does reveal very substantial damage to the starboard shell plating and bottom plating above and below the bilge keel as demonstrated by the images below.

When looking at the images presented here it is difficult to assume that this vessel had been in drydock only 8 months before, because the starboard side is really in a very bad condition, actually much worse as it is possible to demonstrate by images. Very deep indentations between the frames and deep scoring marks, partly not even corroded, are the rule, however, in some particular areas the plating is even holed as e.g. can be seen from the image below.

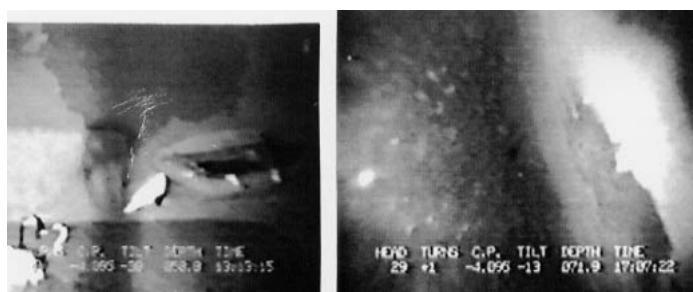
The following two images show an area which is apparently also holed, but not by corrosion because the edges are too sharp.

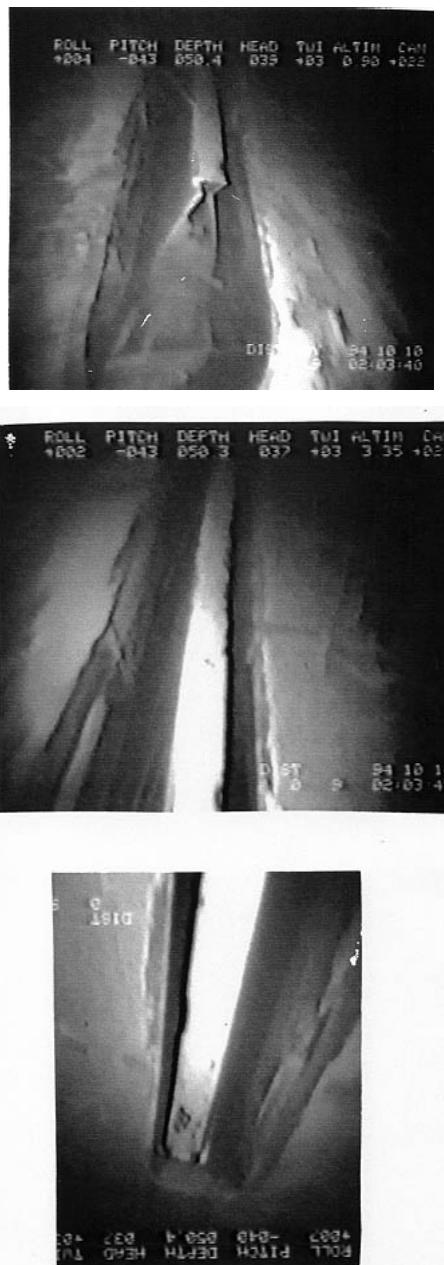
In January 1994 the ESTONIA was fitted with stabilisers of make Brown Brothers which had allegedly been in operation at the time of the casualty. According to 3rd engineer Margus Treu, the fins should retract automatically at speeds below 4 kn, therefore he does not believe that survivors could have seen the port stabiliser still out when the vessel was already almost on the side - see Enclosure 21.3.271 - Protocol of Landvett meeting on 31.03.95. In all probability Margus Treu is right because only after proper questioning of the survivors Pierre Thiger, Tony Spuhl and Mats Hillerström did it turn out that what they believed to have been the stabiliser was much too much forward to assume it could have been the stabiliser. They saw something big, partly white, partly dark, vertically bigger than transverse, which was moving in/out and/or up/down, very far forward, almost at the bow. They saw it still when the vessel was on the side already. The statement of Pierre Thiger taken on 08.10.99 is attached as Enclosure 29.6.414 and the statement of Tony Spuhl taken on 10.10.99 is attached as Enclosure 29.6.415. The statement of Mats Hillerström is not yet available. The actual stabiliser, however, is installed in a pocket behind the heeling tank on 0-dek level, i.e. about midships. When the witnesses were informed accordingly they categorically denied having seen anything moving in this area. This leads to the conclusion that the survivors had seen the visor, then still hanging on the bow ramp with the bottom attached to the forepeak deck and ice-knife of the bulbous bow. This leaves the trainee mate Einar Kukk who has stated - see Enclosure 21.2.1.251 - that the stern was down to the stabiliser fin level. But he did not say that the fin was out. Therefore, it has to be assumed that the survivors actually meant the visor when they mentioned the stabiliser during the last stage before leaving the vessel. In any event the port stabiliser fin was found to be in its pocket during the ROV inspection on 09/10.10.94 - see the images below.

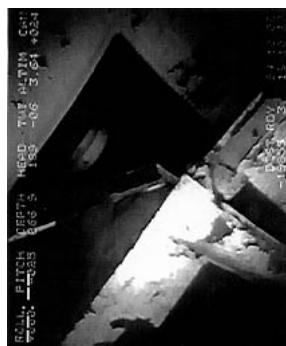
As the superstructure in way of the port side aft part of the 8th and 7th decks were found to be indented and bulged by the divers it has to be assumed that she was somewhat more heeled to port when touching the sea bottom as a result of which the above indentations were caused.

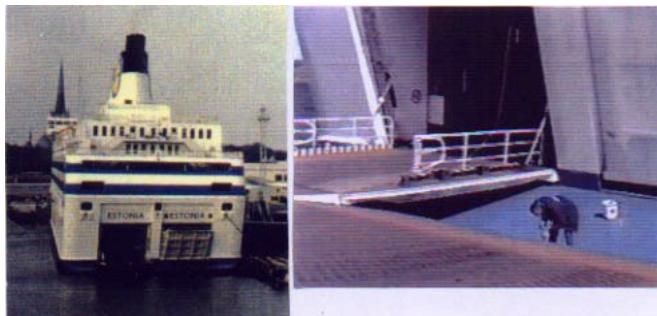
The ROV tape made on 02.10.94 indicates that the starboard stern ramp is slightly open as can be seen on the adjacent image. It shows the upper inner side. The explanation for this slight opening was given already in Subchapter 21.3.3 by the statement of Rolf Sörman - see [Enclosure 21.3.3.335.1](#) - who, as well as his seminar colleagues, were disturbed to such extent by hydraulic noises that they gave up their conference at 21.45 hours ET.

It has to be assumed that the starboard stern ramp was completely unlocked as it otherwise could not be slightly open and that the reason for this slightly open condition is the almost upside down condition of the wreck. It has further to be assumed that the stern ramp has been much more open during casualty sequence-of-events because latest after the shut-down of the auxiliary diesels the hydraulic pumps stopped since not being connected to the emergency generator. This means that subsequently the starboard stern ramp slowly opened completely or more or less completely while the ferry heeled more and more to starboard which led to massive water ingress onto the car deck and through the big lift opening at the aft end of the centre casing also into the large provision area in the aft of deck 1 and so on. This is most probably the explanation for the ferry sinking by the stern.

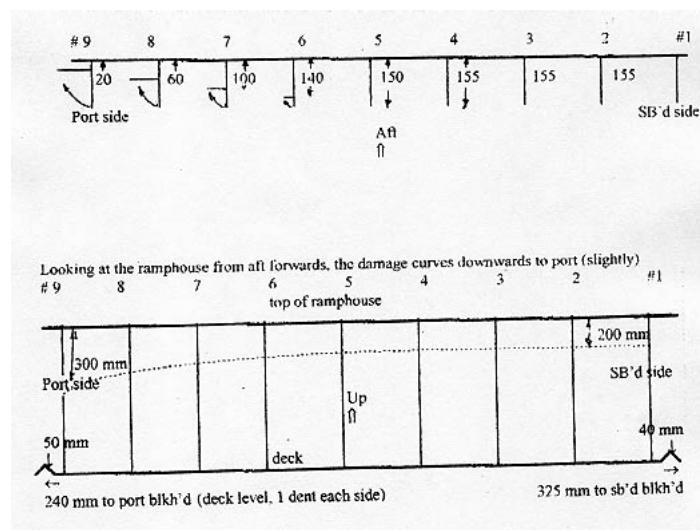
»Undamaged webs are abt. 155 mm high. There are 9 pcs webs in all. Webs # 1 to 4 from the sb side are essentially undamaged, but the paint has been scraped off all of them in a line abt 20 mm down from the ramphouse upper horizontal surface plate (top). Web # 5 is already very slightly deflected towards port and measures at 150 mm (against 155, see above). Web # 6 is deflected so that 140 mm remains, # 7 has 100 mm, # 8 has 60 mm and # 9 has 20 mm standing, while the rest of that web has been deflected to port. The depth of damage (deflection) is thus quite linear between webs 6 and 9. However the point of max damaged paint at # 1 to max deflection at # 9 seems to follow a gentle curve dropping downwards as you look to port. The ramphouse after plate with the damaged webs below.«

The damage configuration revealed by the above measurements indicates that the visor must have been misaligned by 4°-5° in forward/aft direction if the indentations should have occurred by contact with the bow ramp, i.e. the port side of the visor had to be about 300 mm further forward than the starboard side. In other words, the port side of the visor must have moved forward while the starboard side was held back. Before such forward movement of the visor is possible at all and contact between the aft part of the visor's ramp house and the upper part of the bow ramp is possible, several initially built in obstacles have to be overcome as demonstrated by the drawing on the following page.

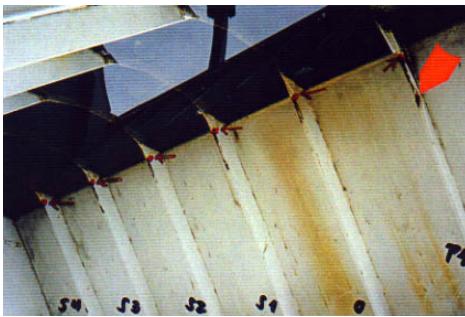
The damage is most extensive at web 9 and then decreasing until web 5 which, as well as the starboard side webs 1 - 4, are not affected at all - see picture below. The visor must have been misaligned by ca. 4-5° in relation to the bow ramp being connected to the vessel.

The arrow indicates the point of contact on web 9. The next frame 5, which is the centre line, and the following frames to starboard have no marks at this level.

This means that when web 9 came in contact with the port side of the bow ramp and was pressed together from 160 mm to 20 mm the corresponding web 1 at the starboard side of the ramp house was 360 / 160 = 200 mm away from the starboard side of the bow ramp. Due to the narrow construction, such a misalignment of the visor is not possible as long as the visor lugs move within the forecastle deck area aft of the deck-beam at frame 159 and as long as both actuators are connected to the B-deck. As will be shown on sheet P 4 + S 4 this was no more the case with the foundation of the port actuator.

Also visible on the two pictures above are slight scorings inside the ramp house from web 1 through web 9 which could indicate a slight contact at another time, earlier or later (see red arrows on both pictures). The scoring marks are just below the brackets between vertical/horizontal webs which would be the areas of contact when visor and bow ramp are in normal condition as on the drawings.

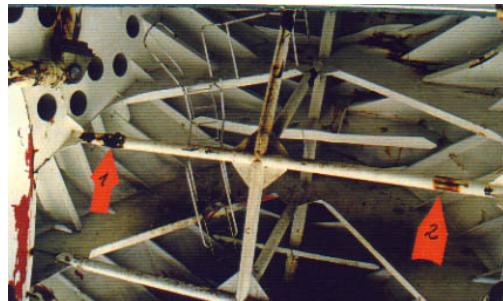
Although the upper transverse crossbar inside the visor shows respective damage - see arrow 1 on the picture below - the corresponding part at the port outer longitudinal girder of the bow ramp does not. This is confirmed by the image further down,

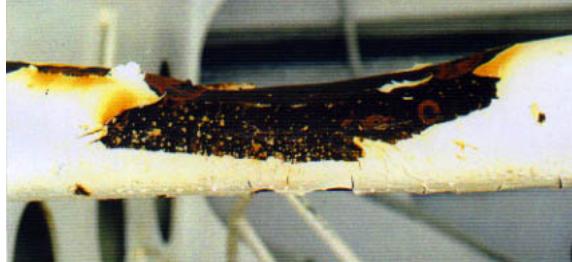
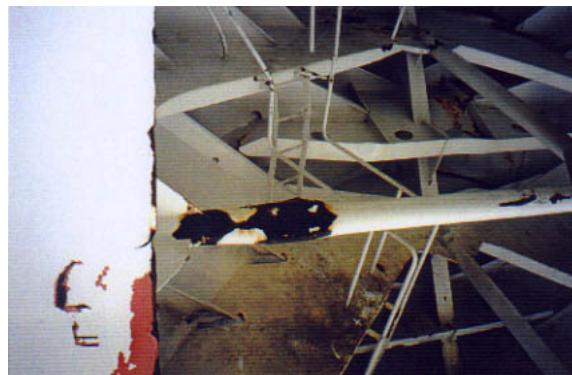
It is obvious that this quite heavy damage shown on the picture on page 961 was caused by impact - see close-up below - and that this impact did not happen too long ago because the cracked paint is still hanging loose. It cannot have been caused by the ramp, at least not at an early stage as explained before. The damage must have been caused when the visor was labouring on the ramp for more than 30 minutes until the heel of the vessel was sufficiently big to let the visor slide off the ramp. During this time, this and other damage to the

port side of the visor was created by heavy contact with the ramp.

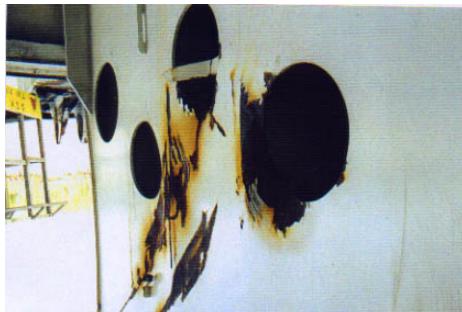
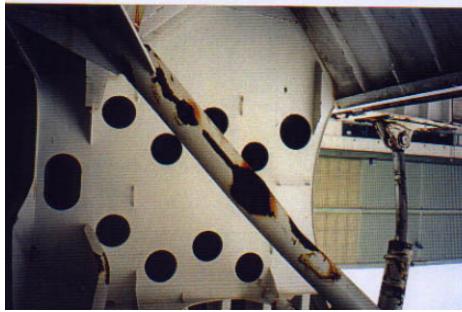
Finally attention has to be drawn to one indentation pushed at each side into the forward deck beam of the visor, i.e. the lower side of the forward part of the ramp house as indicated on the two pictures on the next page. According to drawing on page 956 the port indentation is 240 mm away from the inner bulkhead and the starboard one 325 m. This means that these indentations were most probably caused by the bell cranks being the most upwards extending parts of the bow ramp. This must have occurred at a time when the visor was hanging on the bow ramp already, i.e. the contact area having been the part inner bulkhead. Therefore the distance between bow ramp and port inner bulkhead has as small as possible - 240 mm - while the opposite distance between the bow ramp and the starboard inner bulkhead was as big as possible - 325 mm. This is also the explanation for the apparent fact that the port inner bulkhead was very severely distorted and partly cracked while the starboard inner bulkhead remained completely unaffected even without paint scratches. See also S 4 and P4 - The Inner Bulkheads - further down.

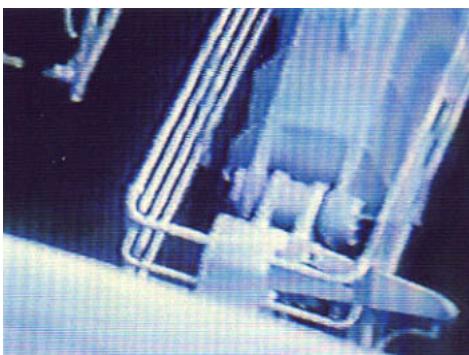
1 - shows the remains of the starboard hinge plates still attached to the visor (they were cut off upon the instructions of the JAIC in January 1995 and were transported to the Royal Technical Institute (KTH) in Stockholm for examination). The very bad condition, especially of the outer hinge plate is obvious. The deep burning marks and the missing metal are striking. All this is confirmed by the video film made by a passenger on 17.09.94 from the open forepart of deck 8 - see also Subchapter 12.5 - i.e. 10 days before the catastrophe. The image below shows a sequence of this video.

It demonstrates that,

- the whole hinge arrangement is severely misaligned;
- the outer bushing is extending too much to the outside and is twisted;
- the lower part of this bushing as well as the securing plate are missing;
- there is a big gap between the inner part of this bushing and the outer hinge plate fitted on the forecastle deck;

just to mention the main and most obvious deficiencies. The video tape was analysed in detail by the British Reconnaissance expert Bryan Roberts and his findings are discussed in Subchapters 12.5 and 34.9 and his report is attached as [Enclosure 12.5.180](#).

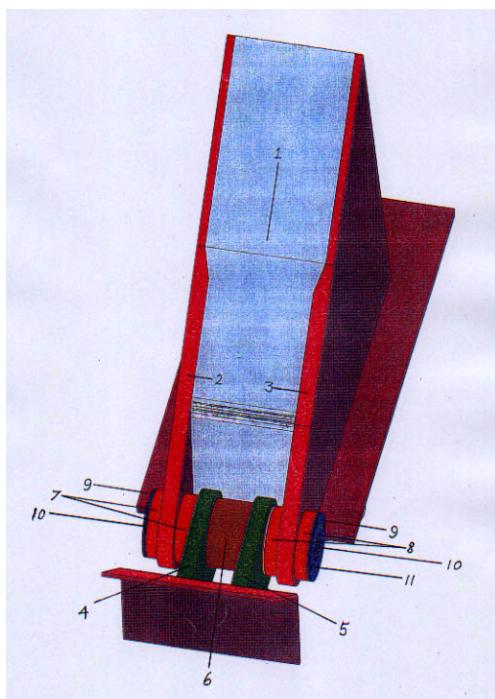
The drawing was taken from the report of Bryan Roberts.

The bushing, obviously having broken out of this inner hinge plate, was recovered by divers and was thus available for examination also by the metallurgical expert on behalf of this 'Group of Experts' and reference is made to the Report of Prof. Dr. Hoffmeister - see Subchapter 34.4 - [Enclosure 30.417](#). Further, the recovered bushing is shown in detail on Sheet 3 and shall be discussed subsequently.

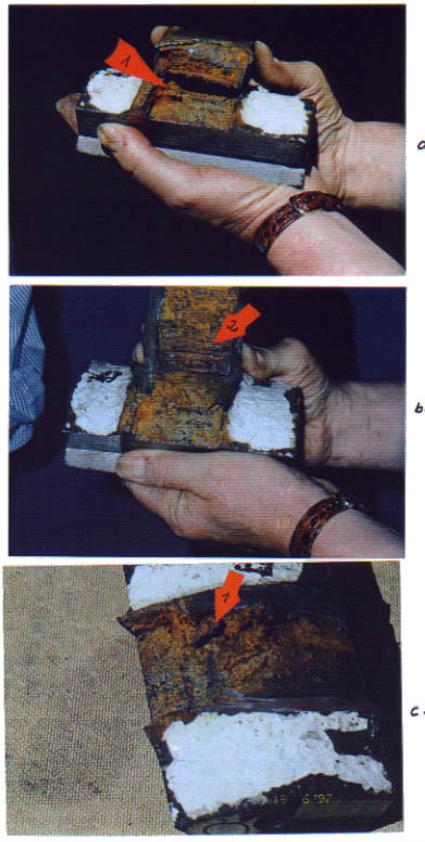
- The inside of the hinge plates were damaged by deep burning marks (see arrow 2 on picture b) from which crack propagation into the material of the hinge plates started and after the cracks had penetrated 50-60% of the material the remaining part of the hinge plate failed in the shear mode.
- The surface of the bushing, corresponding to the inside of the hinge plate with the burning marks explained above, does not show burning marks, therefore it has to be assumed that the original bushing was burned out some time before the casualty and replaced by the present one.
- The gap between bushing and hinge plate in way of the fracture area was about 25 mm indicating that the bushing did not fit into the hole of the hinge plate because the bushing was too small.

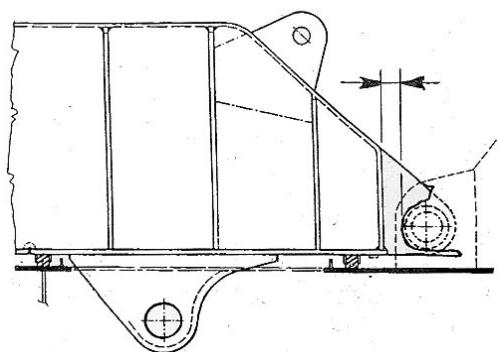
Note: When measuring the distances from the vertical welding seams between face plates and hinge plates and the inside of the bores through the hinge plates it becomes evident that at the starboard hinge plates there is about 15 mm less material than at the port hinge plates. This means that the visor was misaligned at least by this distance of 15 mm in the forward / aft direction. See the drawing below.

This means that the distance between the 2 arrows above was 15 mm smaller at the starboard hinges compared to the port hinges. This was certainly one of the reasons why the starboard hinges broke first and the port hinges were holding for some time longer.

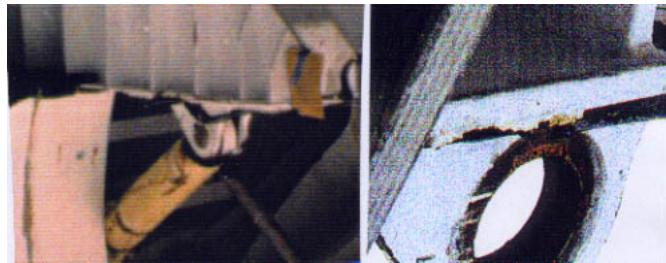
1/2 - show the outer lug plate of the actuator underneath the visor arm which is evidently completely undamaged with the white paint untouched, which is confirmed by the two pictures below.

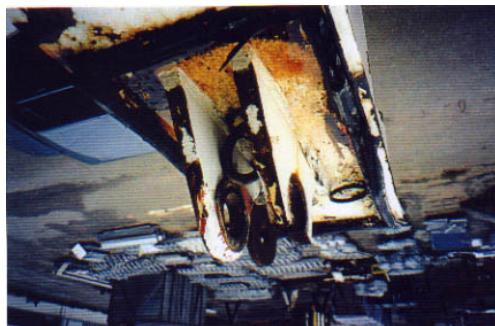
This picture on the next page shows the damaged and torn rubber packing indicating movement of the visor without this side having been raised up.

(1) The outer lug plate is completely untouched while the inner lug plate shows very deeply engraved scraping marks. This means that at the time when the lug plates were cutting through the deck plating and the deck beam the vessel must have heeled already considerably to starboard. Therefore the centre of gravity of the visor had shifted from forward to starboard and the force direction was no more to forward/downwards but starboard/downwards. Thus the weight of the visor in athwartships direction was now carried by the inner port and the outer starboard lug plates because the locating horns gave no more transverse support as the visor had moved too much forward.

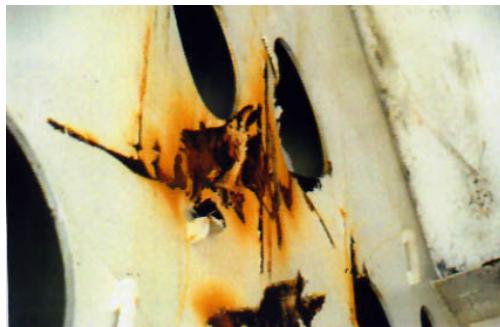
1 - shows the port actuator in jammed condition inside the inner longitudinal bulkhead of the visor. The spherical bearing of the actuator allows a 15° deviation to both sides. The actuator evidently swung into this jammed position after the visor had moved enough forward and after the bow ramp inside the visor was low enough. Thereafter the actuator remained in this position until being dismounted by MacGregor, Turku, in February 1995. The picture below shows the port inner bulkhead after the actuator had been removed.

Measurements revealed and photos confirm that the foundation of the actuator has not been in contact with the plating of the inner longitudinal bulkhead of the visor. Therefore the above visible indentations, scraping and scoring marks have been caused when the visor was hanging on the bow ramp. See also Subchapter 29.2 - The Bow Area - and P 7 further down in this subchapter.

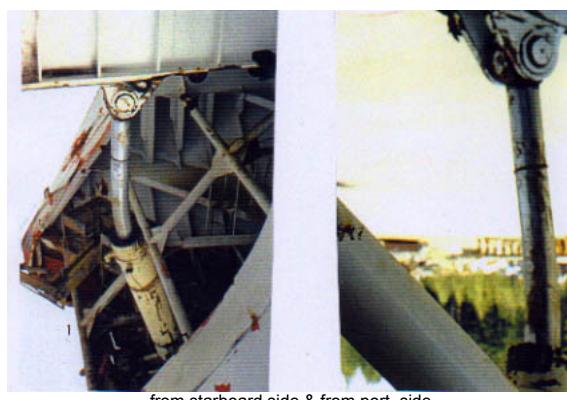
Note: The starboard actuator which the JAIC did not consider worthwhile for examination shows less scoring on the piston rod as can be seen on the pictures below.

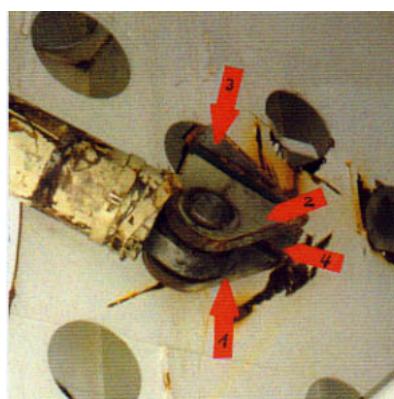
In consequence of this statement the photos showing the damage condition of this foundation have been analysed in detail and the result is outlined below: The foundation of the visor actuators did consist of two strong lugs welded to the B-deck and which were supported by two longitudinal and two transverse stiffeners. The picture below shows the port foundation with actuator still attached to the recovered visor. The arrows indicate the different components.

- arrow 1 = port outer lug plate of actuator foundation
- arrow 2 = port inner lug plate of actuator foundation
- arrow 3 = port inner stiffener (deformed)
- arrow 4 = port outer stiffener

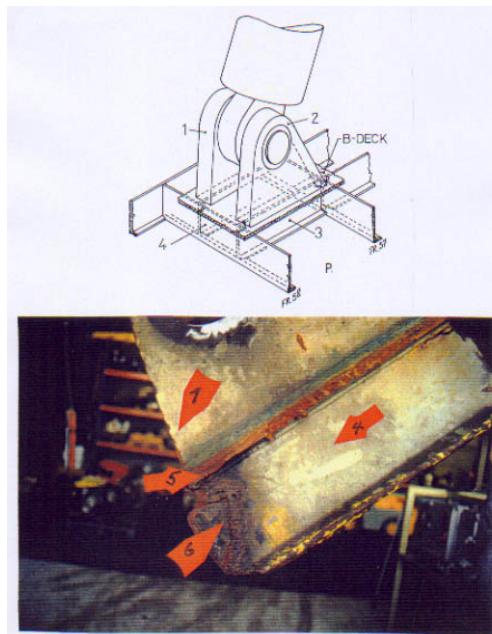
On the above photograph the reader looks on the lower part of the port outer lug plate (arrow 1), i.e. from port to starboard. Arrow 5 points to the remains of the B-deck, to which the port outer stiffener (arrow 4) is still welded. In the forward part of that stiffener an old temporary repair with very poor welding seams is visible (arrow 6). A close-up is shown below.

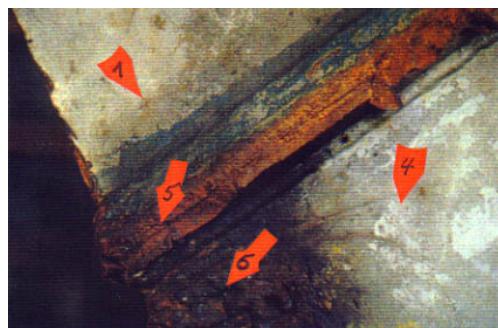
The lug plate (1) was obviously only partly connected to the B-deck as can be seen from the above photo when it was ripped off the B-deck (5) and only a small part connected by the welding seams (green paint) remained with the actuator foundation. The deck as well as the stiffener were pre-damaged - see Subchapter 34.4 - [Enclosure 30.417](#) - which is indicated by the damage repair, but also by the more or less straight cracking of the stiffener forward and aft of the lug plate, as can be seen on the following photograph.

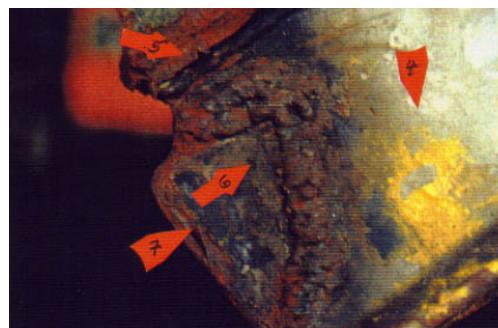
Due to the relatively straight cracks (7) directly below the forward and aft parts of the lug plates, it has to be assumed that the stiffeners in way were affected by fatigue cracks. The cracks had developed during some considerable time before the casualty due to load changes during opening/closing of the visor and did most probably propagate more quickly during the last month before the casualty because of the increasing difficulties with the visor, especially with the port side. See Subchapter 12.4 / 12.5. The following drawing demonstrates the above.

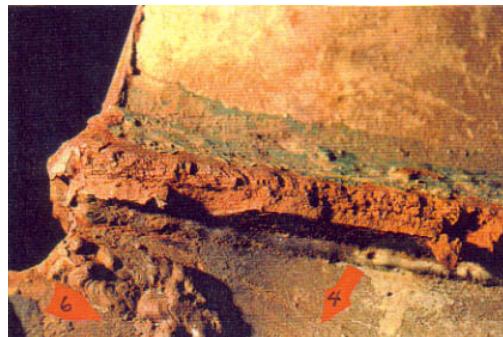
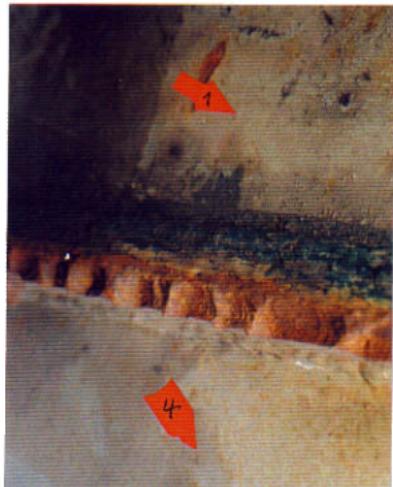
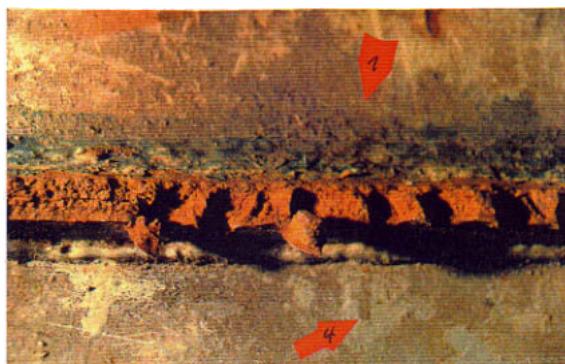
The following photographs indicate the condition of the B-deck in way of the port visor actuator foundation. The reader looks to the port outer lug plate and follows on the next 4 photos the ripped off B-deck remains from forward to aft of the outer lug plate. For easy reference the photographs are marked with the previously used arrow numbers.

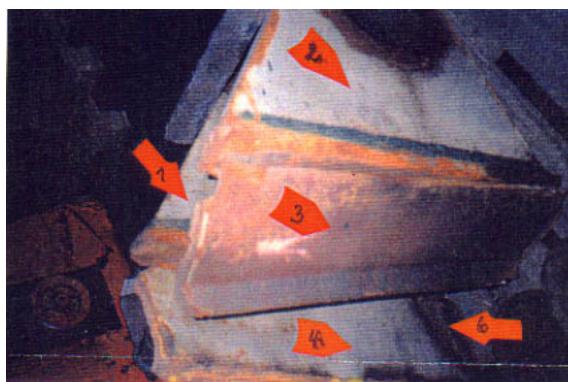
The following photograph shows the actuator foundation after it was removed and taken to the workshop of MacGregor, Turku for examination/testing on behalf of the JAIC. The arrows show the same numbers as used above.

As it is obvious from the close-ups below, the stiffener (3) was hardly spot-welded and thus only slightly connected with the B-deck. As this part of the stiffener is not painted at all - see the next photo to which the reader looks on the port inner lug plate from starboard to port - it is no more original, i.e. has been installed subsequently when the vessel was trading already.

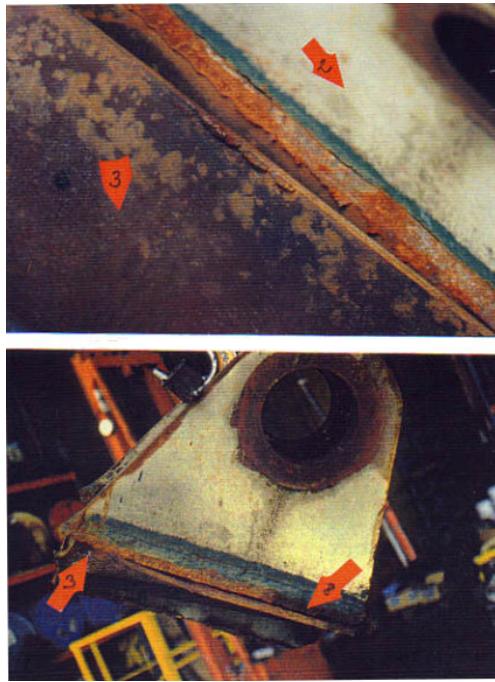
The apparent fact that this stiffener (3) had been disconnected from the B-deck (5) respectively since the last repair was never really fitted to it, is further confirmed by a part of the welding seam - see arrow 8 - on the previous two photos - apparently being soaked with oil while the stiffener below is unaffected. This means that this stiffener was not welded to the B-deck.

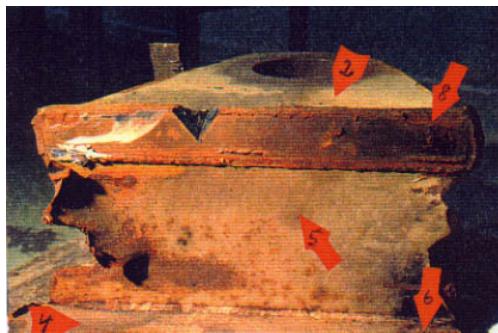
The following photograph shows the port visor actuator foundation after parts had been cut out for testing purposes. The foundation lies on its port outer lug plate. In the front the port outer stiffener (4) is visible, which is fully welded to the B-deck (5). Further at the forward right corner the old temporary repair with the very poor welding seams (6) is visible from inside. For cutting purposes the port inner stiffener (3) had been removed.

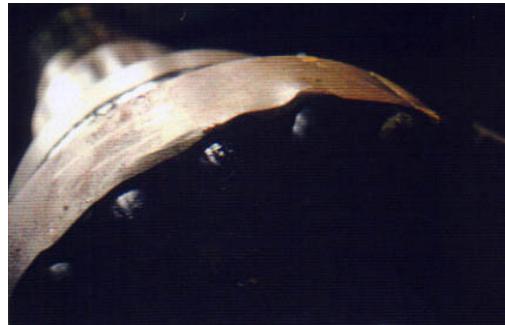
"... it was noticed that there were heavy damages at the distance when the piston rod is about 400 mm open. The damages were on the starboard side of the piston rod. Damages were also noticed on the piston cover's fixing screws. The ends of these hexagon screws were like hammered." (See Enclosure 29.413)

The picture below demonstrates the above.

- The port actuator: Cover and hexagon screws on the piston rod side are severely hammered. The clamping ring is missing. The outside of the actuator shows heavy longitudinal scoring marks. The piston rod shows heavy damage on starboard side at a opening stage of ca. 400 mm.

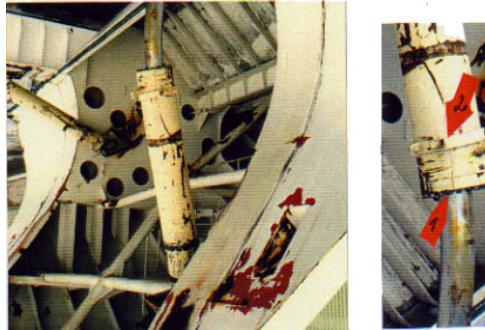
This is different at the starboard actuator as can be seen from the pictures on the next page with close-up of the area of interest. The arrow 1 points to the hexagon screws looking absolutely identical and which are evidently not hammered at all. Arrow 2 points to a clamping ring in apparently undamaged condition which had obviously not been exposed to hammering or otherwise heavy contacts. The differences between the external conditions including the hexagon screws of the port and starboard actuators can be explained as follows:

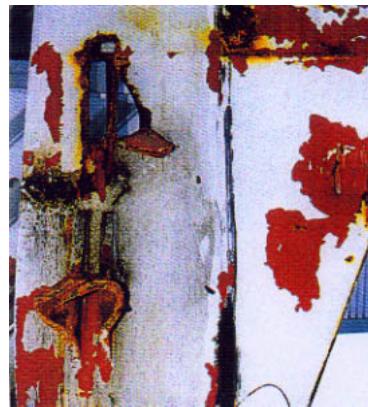
2, 3 - show the area of the missing side lock lug and the considerably bent hooks of the manual side locks from the top and from the side. The side view shows that the area in way of the pushed out steel tongue - see arrow 1 - is bulged outwards indicating pressure from inside to outside, whereas the plating between the hole for the lug and the hooks shows smoke marks, which are explained in Chapter 32. Around the opening for the lug burning/welding marks from the cutting off and the subsequent rewelding of the lug are visible. The following picture has been taken from the JAIC Report and clearly confirms the above.

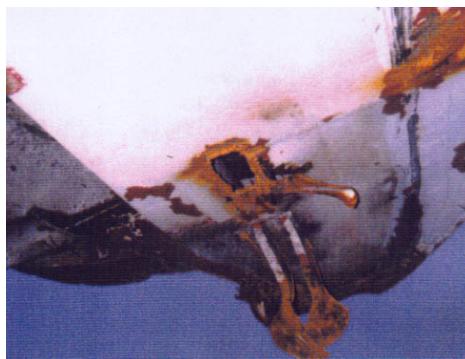
The picture below taken on 23.11.94 shows the lower part of the starboard aft visor bulkhead including the area under discussion looking downwards which is obviously very dark.

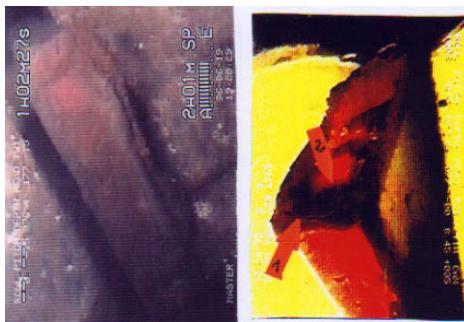
Note: According to the observations of previous passengers, for example truck driver Torbjörn Cederqvist - see [Enclosure 12.4.3.157](#) - Subchapter 12.4 - both lugs had frequently been burned off when the crew was unable to open the side locks hydraulically upon arrival in Tallinn. Obviously they were subsequently rewelded to the same location.

It is also obvious from the condition of the starboard lug as can be seen from the two video images of the corresponding lug still attached to the bolt on the wreck that the lugs had been repeatedly cut off and rewelded.

The very thick welding seam on the lower part - see arrow 1 - is actually a build-up of several welding seams, i.e. weld on top of the previous weld without grinding away of the remnants. It is obvious that the bulkhead part attached to the lug - see arrow 2 - had not been torn out of the bulkhead during the casualty scenario but much earlier because, due to the thickness of the accumulated welding seams, this original part of the visor bulkhead (Viking Line colour) could not come in contact with the adjacent visor plating. Consequently, it has to be assumed that each time the lug was cut off by burning it was just stuck into the respective hole in the bulkhead and welded from both sides, if at all - see also Chapter 29 - S 4.

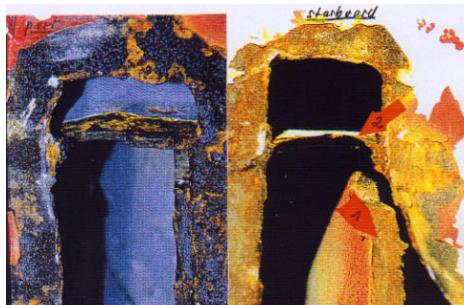
The next pictures - also taken from the JAIC's Report - show the upper parts of the holes in the visor bulkheads where the lugs had been fitted.

The analysis and comparison of both pictures reveal the following:

(1) The plating around **the port** holes is unaffected. Some remains of welding seams are visible at the upper right corner and at the right (inside) there are indications that welding seams could have been there. At the outside (left side) there are no such indications which refers also to the upper hole. Only few spots of corrosion can be seen. In summary it has to be assumed that the lug had not or only to a very limited extent been welded from the outside.

(2) The plating around **the starboard** opening looks completely different because the plating is distorted, the stiffener at the inside is torn off the bulkhead, the plating had apparently been exposed to heat and subsequently became corroded. The steel part between the small hole and the bigger opening was pushed upwards, obviously by the lug then and still attached to the vessel, i.e. the visor made a downward movement in relation to the lug, i.e. the vessel. Thereby the lug was pressed into said steel part. The indication of the remnant of a welding seam is visible at the upper right corner of the big opening. Otherwise there are no indications of welding seams at all.

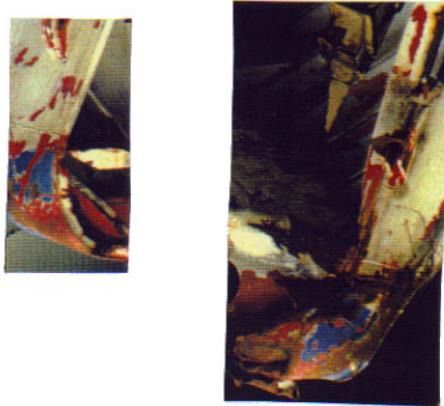
- (6) The hooks were crushed together in such a way which cannot be explained mechanically.
- (7) The bottom end of the aft bulkhead is partly crushed, partly torn and on the outside a deep fold in way of the contact area with the rubber packings of the corresponding front bulkhead of the vessel extends from the area of the lug down to the bottom area. - See the right picture on the next page. The corresponding area on the lower part of the port aft bulkhead of the visor, as can be seen on the left picture on the next page, is apparently undamaged.

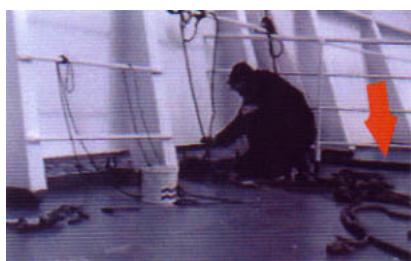
According to the observation of Bo Pettersson the port outer edge of the visor was extending the forecastle deck to such an extent that he could see the water through the gap. He estimated the difference between visor and forecastle deck to have been about 100 mm. Although crew members hammered with sledge hammers on the edge, the condition did not change and they gave up.

The image following shows the area in question. The arrow indicates where the crewman was hammering.

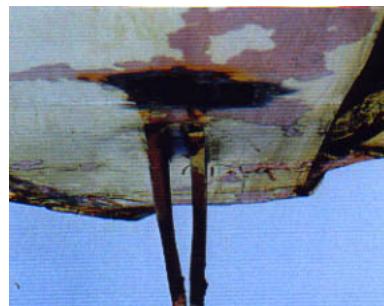
The hooks for the manual side lock were just bent together, as can be seen on the picture on the next page. The area around the lug location shows burning marks obviously from cutting off the lug by flame cutting - see arrow - but no smoke marks as on the starboard side and the plating was not pushed out/distorted.

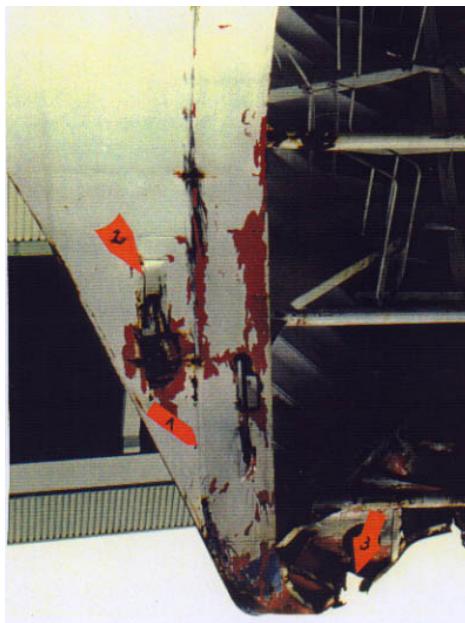
7 - shows the rubbing marks from the rubber packings at the vessel's front bulkhead which are straight in the upper part and slightly irregular in the lower part. The picture on the next page shows the lower port aft bulkhead. It becomes evident that the area below the pocket for the locating horn does not show any rubbing marks - contrary to the starboard side - which leads to the conclusion that the rubber packings at the front bulkhead of the vessel were missing also in this important location - see arrow 1. The pressure mark of the locating horn inside the pocket - see arrow 2 - indicates pressure on the visor from port to starboard, which is a further indication for the severe misalignment of the visor.

Arrow 3 indicates a damage apparently caused when the visor fell off the bow ramp in the final stage when the heel of the vessel was already 120°/130° to starboard. This will be further explained in the following item 6 - **The Visor Bottom**.

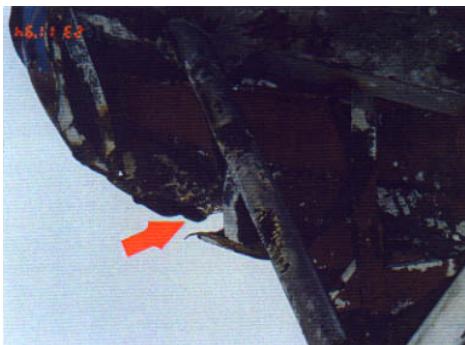
8 - shows the lower aft bulkhead/visor bottom which is only moderately damaged compared to the starboard side - see also the picture below.

The arrow points to a damage to the port aft edge of the visor bottom which apparently occurred when the visor moved transversely from port to starboard. This will be explained in Chapter 31 - The Casualty Scenario. See also picture 5 on the following Sheet 6.

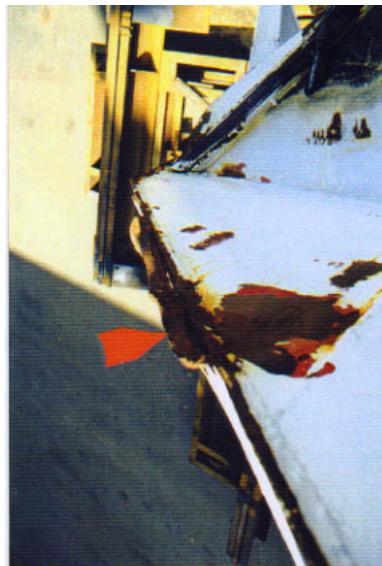
1 - shows the upper part of the aft bulkhead with the moderately affected recess which has already been discussed at the beginning of this item. The picture on the next page shows the recess as enlargement with damage at the edge of the shell plating - see arrow - which obviously occurred when the visor was moving in the transverse, i.e. athwartships, direction. - See also Chapter 31 - The Casualty Scenario.

(7) The recess at the upper part of the port aft bulkhead of the visor was damaged when the visor was moving transversely respectively athwartships.

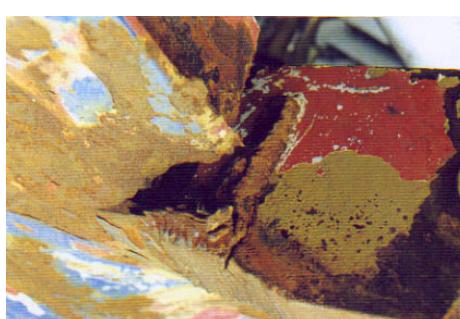
1 - shows the visor lug being part of the Atlantic lock. Arrow 1 points to the previously burnt off part of the lug with cracks propagating from burning marks (arrow 2). The lug apparently became twisted to starboard when the visor moved abruptly to starboard until its port inner bulkhead rested on the port side of the bow ramp. The deep crack in the bottom of the visor to port of the lug confirms this. It further indicates that the visor lug was about to crack off the visor bottom when the lugs on the forepeak deck failed first. This is underlined by the impressive picture below indicating an upwards and to starboard movement of the visor when this big crack propagated and came to a stop when the lugs on the forepeak deck failed.

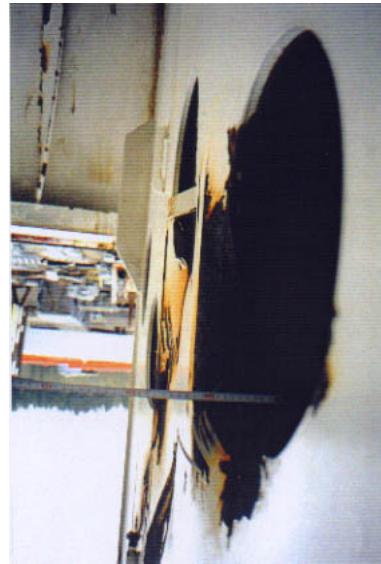
1 / 2 - show the port inner longitudinal bulkhead with scraping/scoring marks at the lower aft part - see arrow 1 - and very deep indentations with the steel plating partly torn - see arrow 2 - and enlargement picture 1.1. The picture below shows that the plating was actually pressed into the bulkhead up to 120 mm.

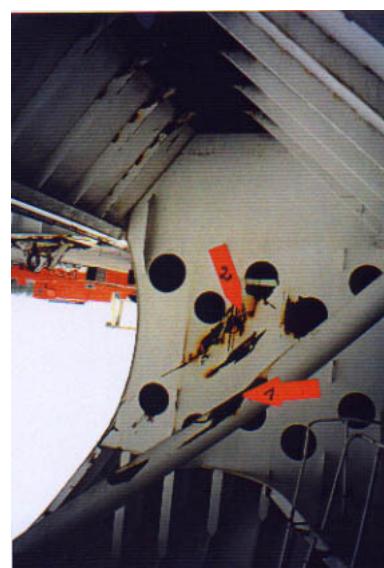
The picture below shows the port inner side of the visor with the slightly damaged frames at the port aft part of the ramp house. The upper part of the longitudinal bulkhead is completely unaffected. The scorings and the deep indentations and deformation (arrow 2) are restricted to the middle part, and, in the foreground, the vertical beam which had been in contact with the upper part of the ramp with the folded flap in between is visible (arrow 1).

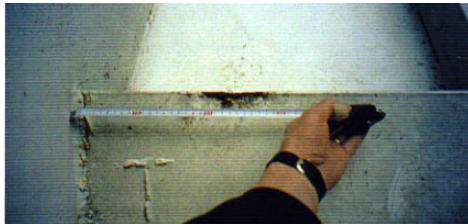
2 - shows the lower inside of the visor with the lower transverse beam in way of the 3rd stringer. This beam was found to be very severely scored and scraped, which was most probably caused during the lifting operation. The picture also demonstrates the very severely set up visor bottom which is underlined by the close-up No. 10 and explained by detail drawing No. 8. There are two further contact marks in way of the deck beam at the lower forward part of the ramp house, viz. in the most port and most starboard frame spaces, which were evidently also caused by the bell cranks of the ramp when the visor moved further forward and downwards and the vessel was already severely heeled to starboard already. See also sheet 2 - The Ramp House. The picture below indicates the short distance to the port bulkhead because of the starboard heel.

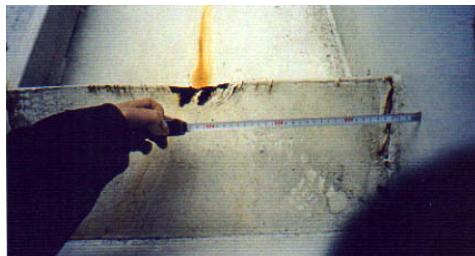
The picture below shows the starboard side with the longer distance to the starboard bulkhead also due to the starboard heel of visor and vessel.

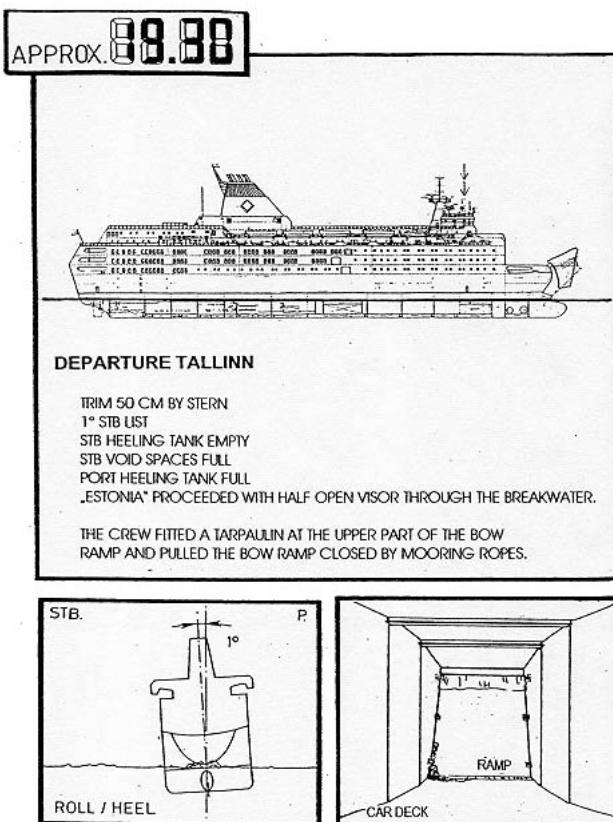
The scenario starts with the condition of the ferry upon departure from Tallinn at about 19.30 hours on the 27th September 1994. The departure condition is demonstrated by drawings and text below.

Visor Locking Devices: Atlantic Lock / hydraulic side locks engaged, manual side locks - not engaged

Ramp locking devices: Starboard ramp hook and securing bolts not engaged, Port ramp hook and securing bolts not engaged

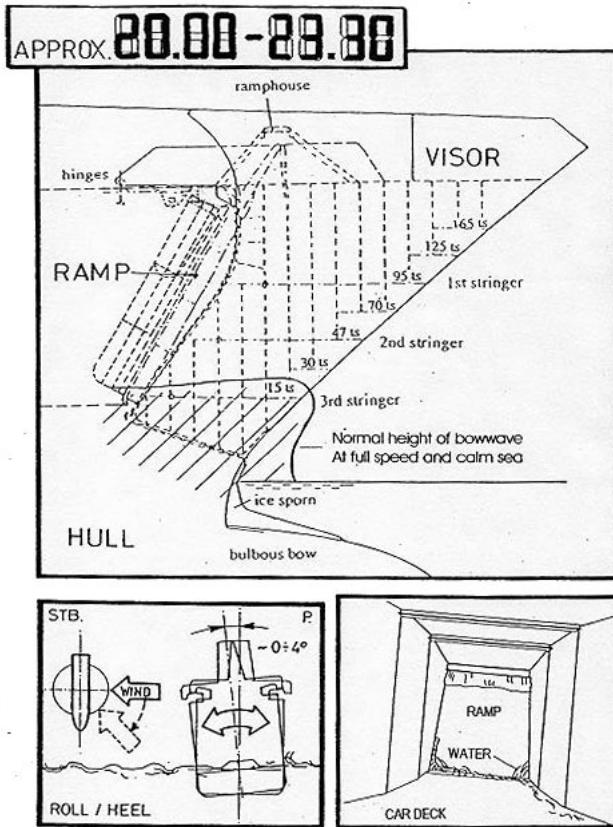
at the port lower side of the bow ramp in spite of the "sealing material" stuffed into the big gap by the crew. - See drawings on the following page 1051. At the end of the TSS off Suurupi Lighthouse the course was changed to 262° and the ferry proceeded with all 4 main engines on full output along the Estonian North coast. Due to the increasing south-westerly gale the ferry heeled 2-4° to starboard and was pitching harder and harder. - See Chapter 30. Passengers started to feel unwell and several became seasick.

Even with calm sea the water level inside the visor was rising above the 3rd stringer when the vessel was at full speed. The lower side of the bow ramp was below 3rd stringer level, thus even in calm sea the water from the visor was penetrating the gap in the bow ramp and was flooding onto the car deck.

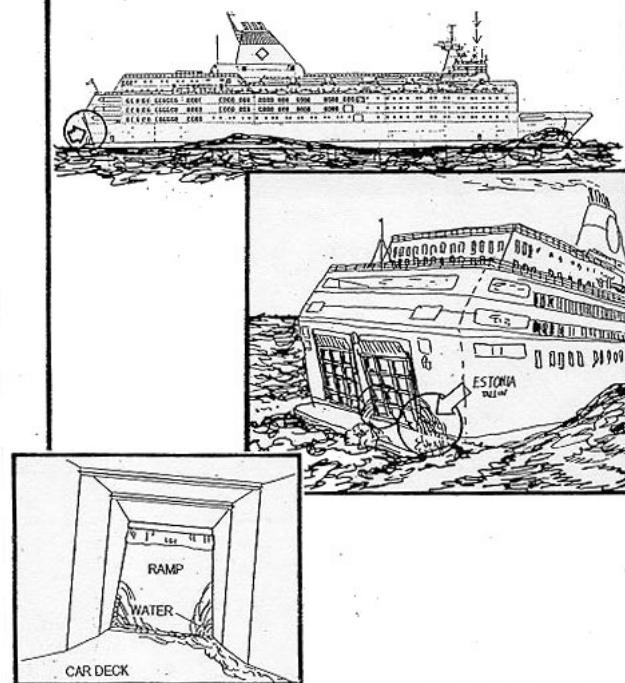
APPROX. 88.88-88.88

1. At ca. 20.45hrs. the aft hydraulic pumps were started on the STB. stern ramp opened slightly.
2. Due to the stern trim and the STB. heel of the ferry the water penetrating through the improperly closed bow ramp streamed off the car deck through the slightly open STB. stern ramp.
3. The high and very disturbing hydraulic noise was heard throughout the evening.
4. The vessel was pitching very hard in rough head seas.

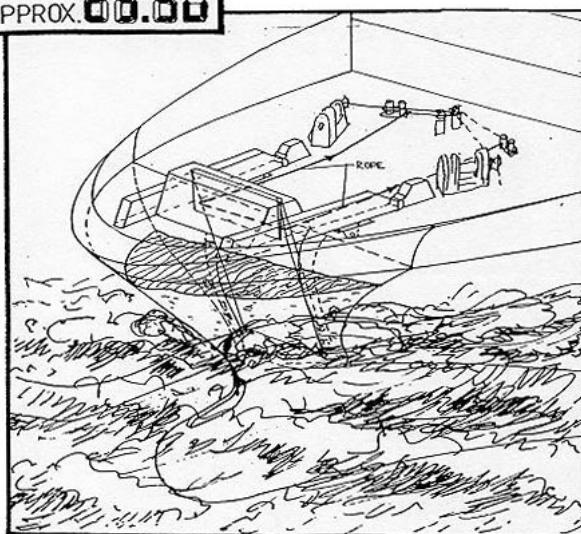
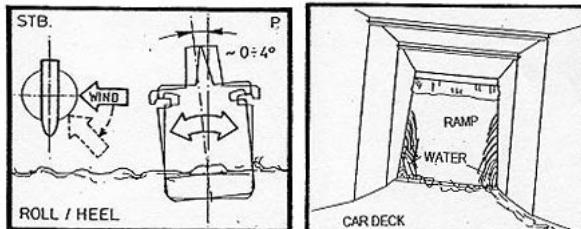
APPROX. 88.88

1. Due to increasing wave height and deep pitching of the ferry the water level inside the visor rose higher and the pressure on the "sealing" material
2. Water entered the car deck in increasing quantities.
3. The ferry made very hard pitch movements.
4. The bow ramp was kept more or less closed by the rope and the water pressure from the visor side, however water penetrated at both sides of the ramp
5. This was the condition on board the ESTONIA when she met "AMBER".

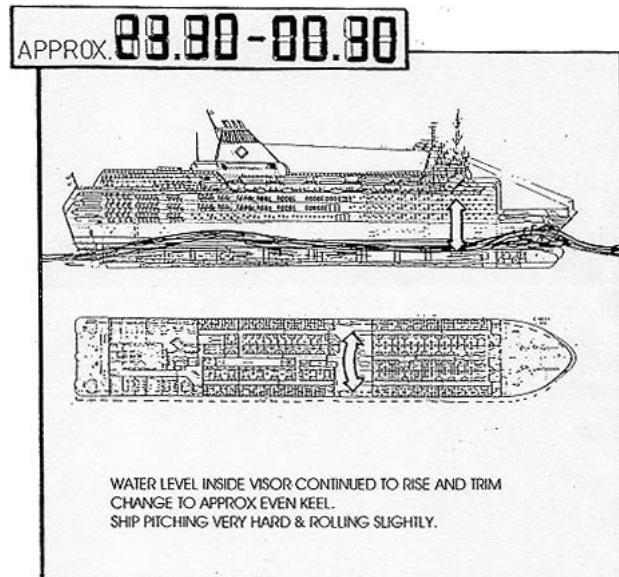
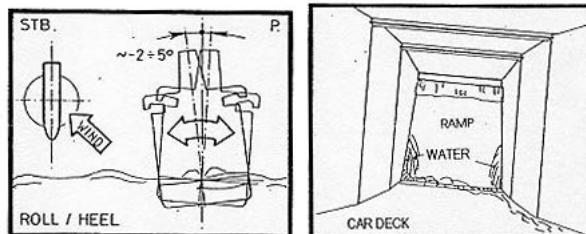
Many passengers heard low metallic banging caused by visor moving within play of locking devices due to misaligned visor, damaged stempost and missing rubber packings.

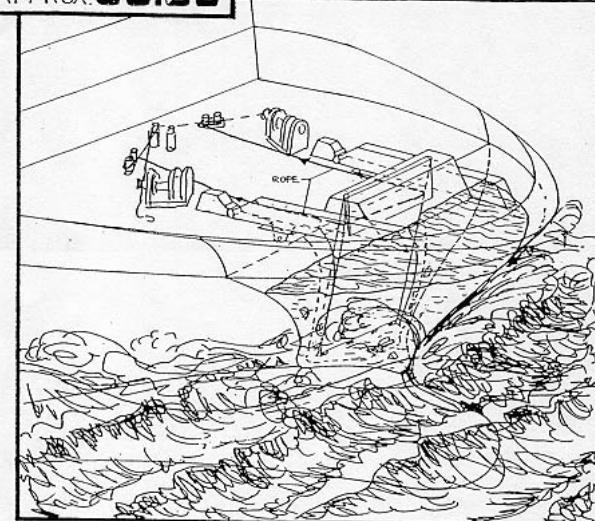
APPROX. 00.80

1. Stabilisers activated and possibly problems with starboard fin.
2. Vessel took green water on forecastle deck due to very heavy pitching movements.
3. Water level inside visor was rising to about 1st stringer level.
4. Water ingress onto car deck had been increasing for some time but, the accumulation of big water quantities on starboard side was avoided by the slightly open starboard stern ramp.
