THE GERMAN GROUP OF EXPERTS

Summary

1 THE CASUALTY

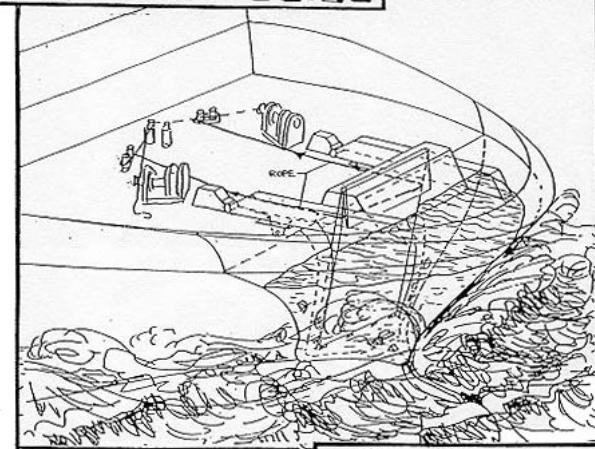
APPROX. 00.80 - 00.95

1. Low banging noises continued
2. Port stabiliser fin activated, crew started to work on the starboard fin.
3. The watch A.B. noted a lot of water on the car deck, alarmed the bridge and crew was activated
4. The course was changed to starboard and the ferry began to roll heavily, whereafter the vessel was turned back to port and started to pitch heavily. The speed was reduced.
5. The crew was working on the car deck to control the water ingress which turned out to be impossible.
6. The vessel made deep, slow pitch movements and was slightly rolling, more to starboard, less to port.

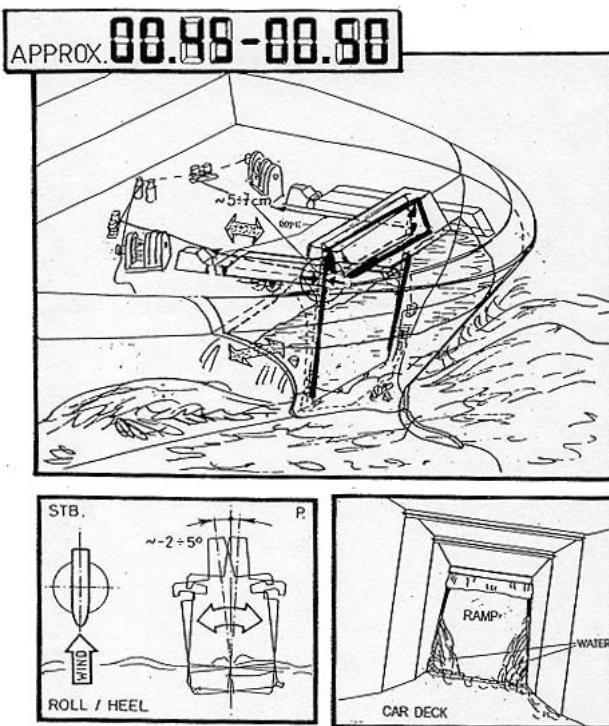
1. The crew members went on the forecastle deck through the door on deck 5 and tried to heave the rope holding the bow ramp which failed probably due to the green water taken on the forecastle deck.
2. The bow was held by the actuators and lowered down inside the visor.
3. The crew somehow managed to start the hydraulic pumps under extremely difficult conditions due to the water on the deck and the moving cars.
4. The substantially pre-damaged STB . Visor hinges failed followed by the equally pre-damaged STB side lock.5. The starboard side of the visor moved forward, the lugs cut through the deck plating and struck against the deck beam aft frame 159, the visor was pushed back when the vessel was diving into the next wave trough causing the broken visor hinge parts to smash against the hinge parts on the forecastle deck.

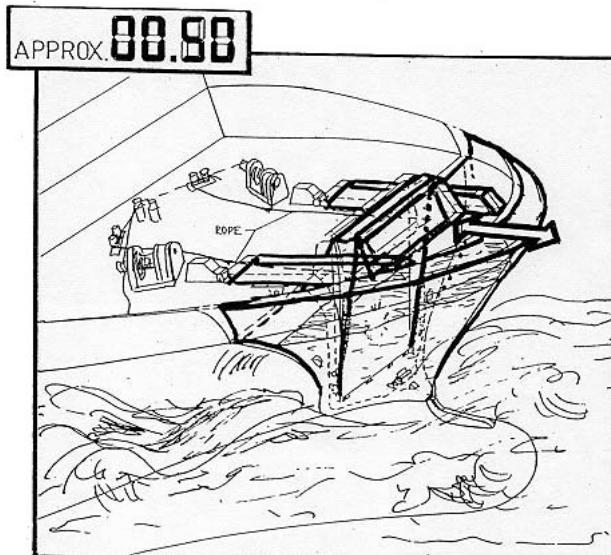
1. Also the port hinges and the port side lock failed and the visor moved forward/aft between the deck beam at frame 159 and the hinge parts on
2. Simultaneously hard scraping noises were caused by the upper flaps of the ramp scraping along the vertical beam inside the visor due to the movements in the sea

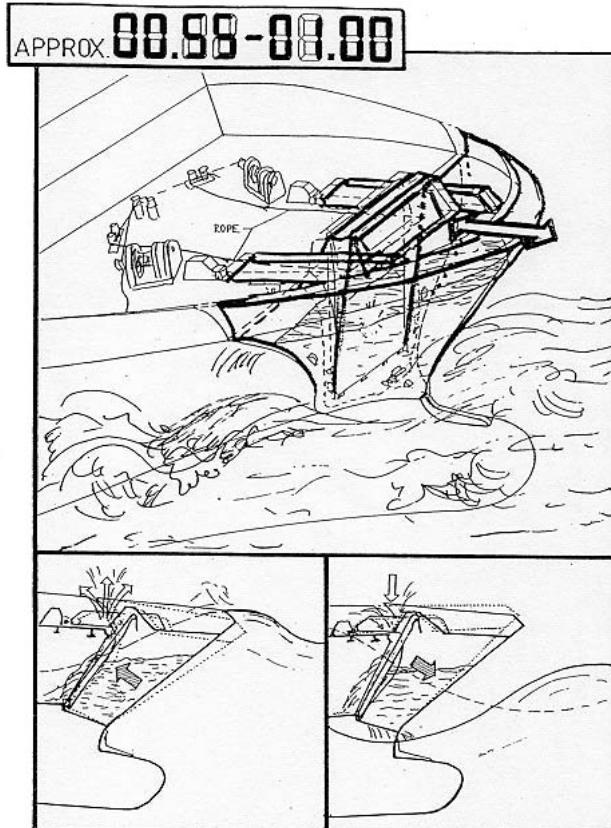
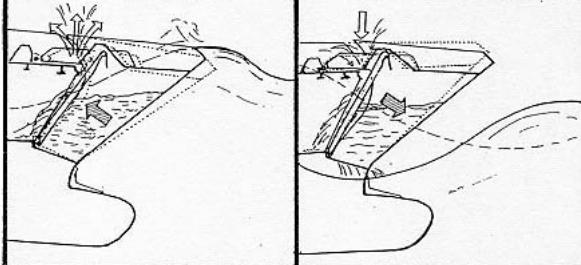
1. Hard metallic banging/knocking and scraping noises.
2. Visor moving forward /aft between the deck beam at the frame 159 and the forecastle deck parts of the hinges, the lugs underneath the visor arms were cutting through the deck beam.
3. The bow was deeply diving into wave troughs and the stern rising high up while the whole vessel was shivering.
4. The crew still working on the car deck.

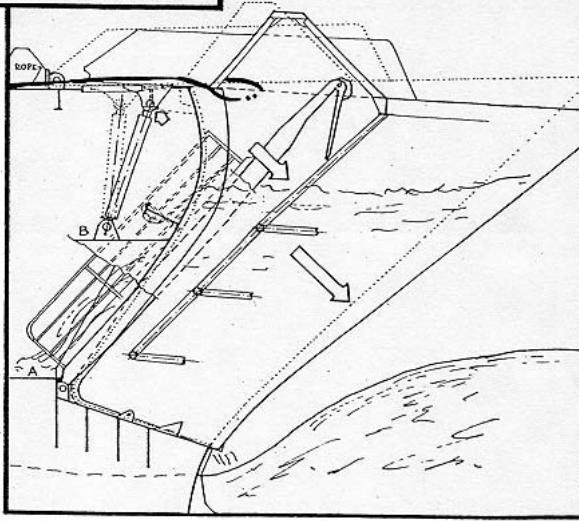
APPROX. 88.88

1. The visor lugs finally cut through the deck beam and the visor moved forward, the forepeak deck penetrated the visor bottom.
2. The vessel was now more rolling than pitching.
3. The ramp was inside the visor while the visor moved forward.

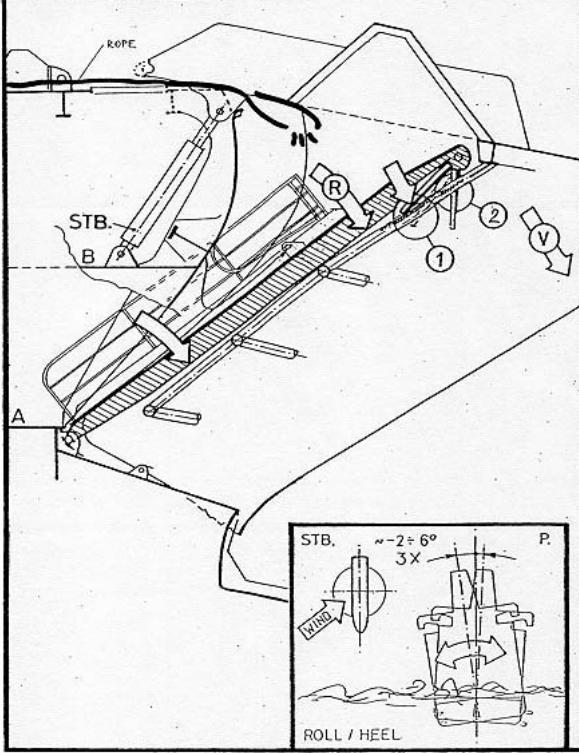
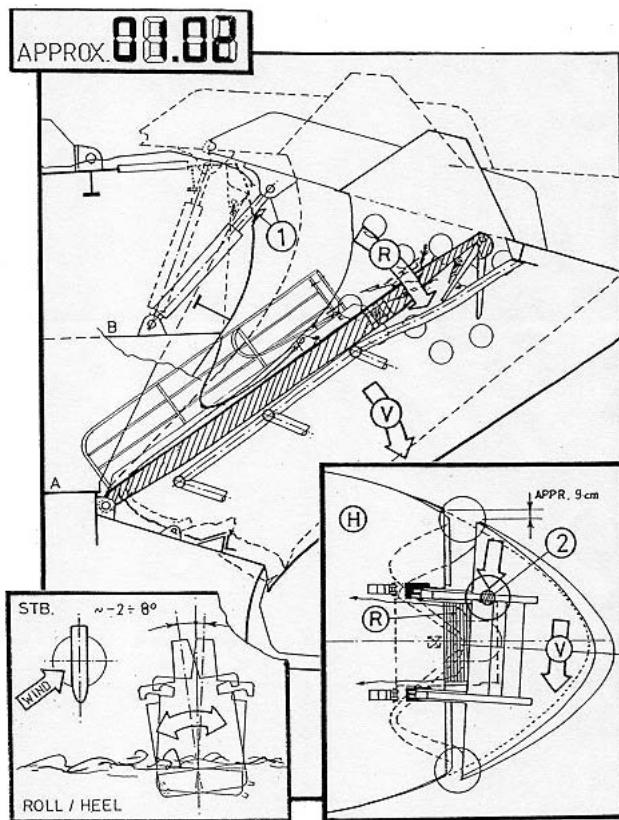
APPROX. 88.88

1. Vessel rolling more to starboard/less to port .
2. Visor lugs broke through the front bulkheads and did not support the visor anymore against moving towards the deeper starboard side (1)
3. With a big crash the visor fell abruptly about 10 cm to starboard until the inner port bulkhead was resting on the upper part of the bow ramp (2).
4. The visor was now extending the starboard front bulkhead of the vessel and the port front bulkhead was extending the visor.
5. The atlantic lock failed.

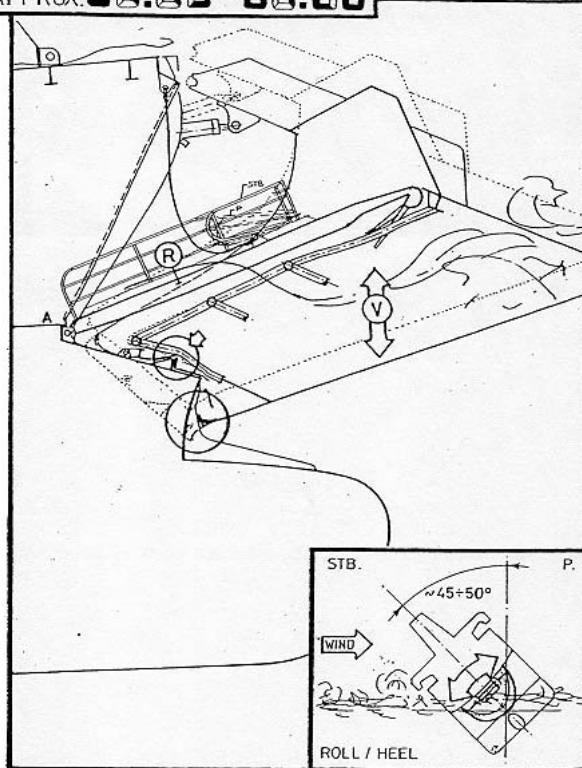
APPROX. 08.08 - 08.20

The vessel was still rolling stepwise and the visor with the bow ramp inside was labouring up and down and from port to starboard in the seaway.

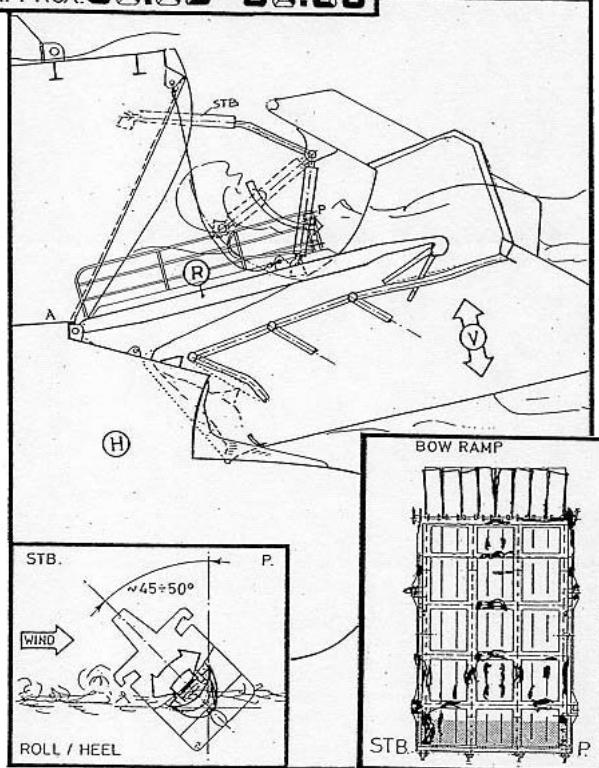
APPROX. 88.88-88.88

1. The port actuator broke through the front bulkhead, swung forward and got and crashed against the bow ramp
2. The structure of the ramp was continuously and very severely deformed by the heavy and changing weight of the visor.

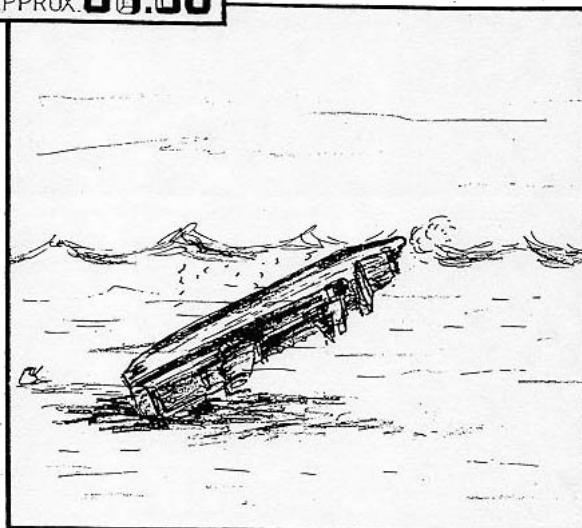
APPROX. 08.80

1. The Vessel sank stern first.
2. The bow was still above water when the stern was already on the sea bottom.
3. The visor sank about 1nm west of the wreck upside down.

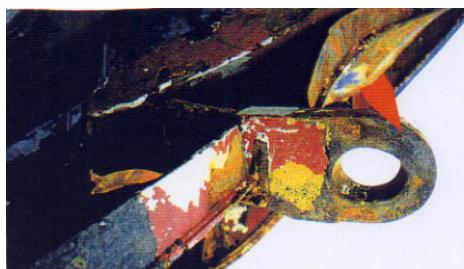
In April 1995 the JAIC published the "PART-Report covering technical issues on the capsizing on 28 September 1994 in the Baltic Sea of the ro-ro passenger vessel MV Estonia" which included also certain picture material, among others the picture below showing the aft part of the visor bottom with the visor lug being part of the Atlantic lock.

The blue coloured part of the lug - see arrow - looked as if having been exposed to heat which was unusual since this part had been below water. The JAIC was contacted and it turned out that samples had been taken already on 25 November 1994 and had been examined upon request of the Central Criminal Police in Finland and Kari Lethola as chairman of the Finnish part of the JAIC on 30.03.95. The tests were carried out on 30.05.95 by the Criminal Laboratory Technical Division, Helsinki. The "available" documentation was received - already translated into English - from Kari Lethola.

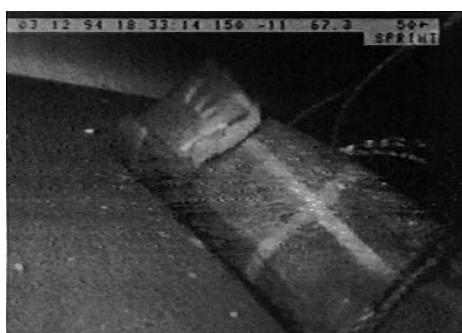
After a relatively silent 1998 when most of the interested people were analysing and subsequently criticising the report of the JAIC a new person appeared in Sweden apparently with sufficient time, and an undisturbed mind, to analyse again all the publicly available video footage and documentation on this subject collected by the JAIC. He found among other things on the video B40b, made by the SPRINT ROV on 03.12.94, a package on the port superstructure in way of the 5th deck which appeared suspicious to him. Video images were made and shown among others also to experts in explosives in Sweden and Germany. See the following image.

Both identified the package with about 90% certainty to be an explosive charge used underwater. Evaluation of the footage made by ROV on 02. and 09.10.94 revealed, however, that the package had not been at the identified location on the 5th deck on these dates, thus must have been placed there between the 09.10. and 03.12.94 and therefore could not be causally related. In any event, the term "explosives", which had always been in the background during the preceding years of the investigation, was suddenly brought back to the attention of the investigators and the video footage available in Hamburg, all obtained from the JAIC, was analysed again also in an attempt to find possible explanations for numerous so far unexplained damage areas. It revealed among other things that an orange coloured cube had been attached to the recess of the port front bulkhead of the wreck in way of the hydraulic and manual side locks and the fastening of the bow ramp actuator.

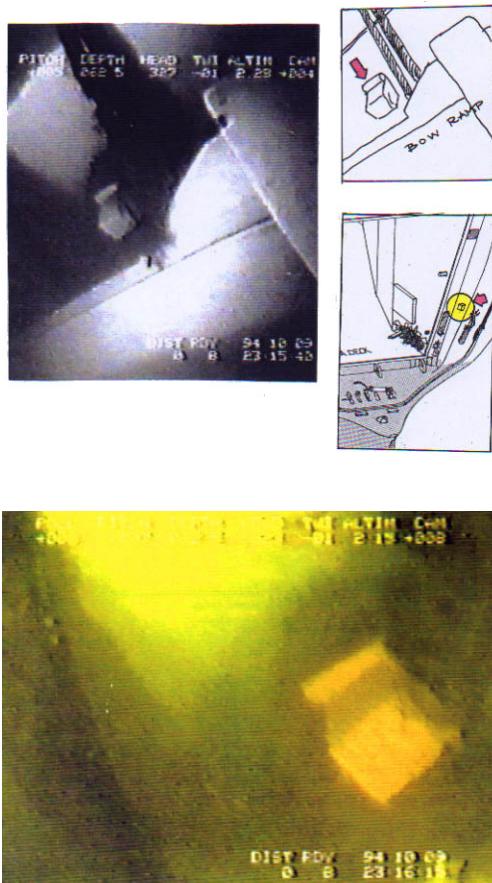
The cube was clearly visible and had been closely looked at by the ROV during the inspection on 09.10.94, it could not, however, be found on the 02.10.94 videos which was possibly due to restricted visibility and was definitely not in this location on the SPRINT ROV made on 03.12.94 respectively on the diver video of the same date. Images were made from the orange coloured cube and identified by all three experts from Sweden, England and Germany with a high degree of probability as an "explosive charge". See the following two images.

As this charge attached in way of a very sensitive area - the port side locking devices of the visor and the fastening of the port bow ramp actuator - obviously did not explode, the corresponding area of the starboard side was analysed for possible explosion damage which was positively identified by the underwater explosive expert Brian Braidwood. This resulted in a further analysis of the available video footage all received from the JAIC. The results are outlined in the following subchapters.

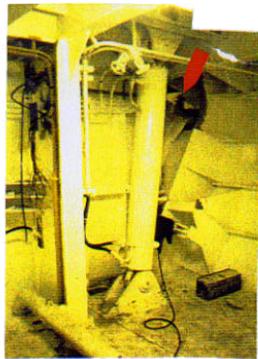
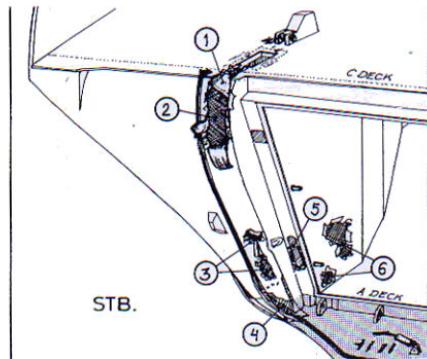
Behind the front bulkhead there is an upper and a lower void space located. In the upper one - actually the B-deck - the visor actuator and the ramp hook arrangement was fitted. The part of the bow ramp with the mating lug for the ramp hook was extending into the void space as can be seen on the picture below. The arrow points to the ramp hook.

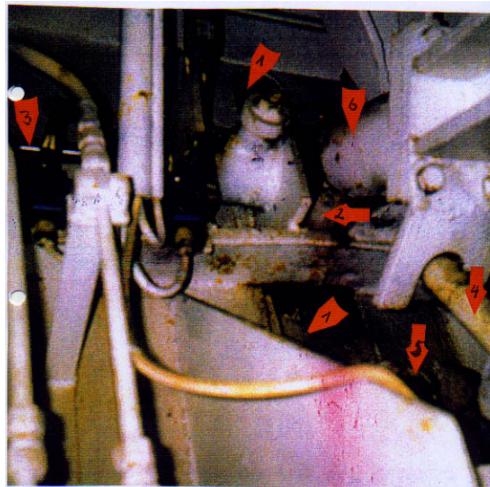
The lower void space - on A-deck - car deck level - was located directly below the upper one - on B-deck - and contained the hydraulic and manual side lock arrangements as can be seen on the picture below which is explained by 6 arrows. The visor is closed.

arrow 1 = opening in front bulkhead with visor plating behind through which the lug of the hydraulic side lock was extending

arrow 2 = lug of hydraulic side lock

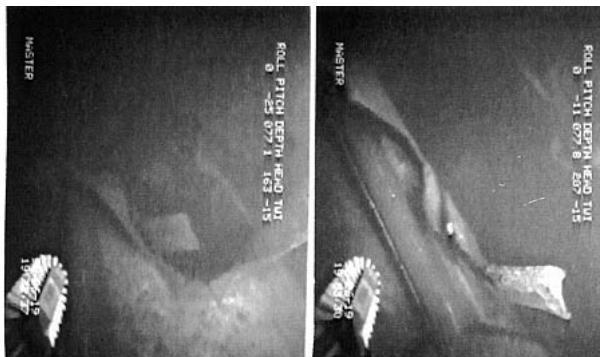
The upper void space behind the starboard front bulkhead shows considerable damage to the bulkhead plating with the plating bent from inside to outside and frequently cracked. This had obviously been possible because the upper part of the visor moved forward after the starboard hinges and side lock had failed and never contacted the front bulkhead again, because at the lower end of the blown open plating a big steel part is extending almost horizontally which otherwise would have been pressed back. The same refers to the steel tongue extending from the visor plating in way which was also not pressed against the bulkhead.

The image below on the left shows the lower part of the damaged upper front bulkhead looking from bottom to top. The image on the right shows the damage further up.

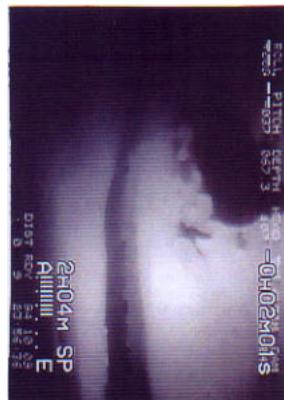
- The front bulkhead plating below the area of the hydraulic side lock was pushed outwards with exception of the rubber packing - see image below. It is clearly visible that the rubber packings, normally extending beyond the bulkhead, are in some sort of fold indicating that the surrounding plating was deformed towards the outside.

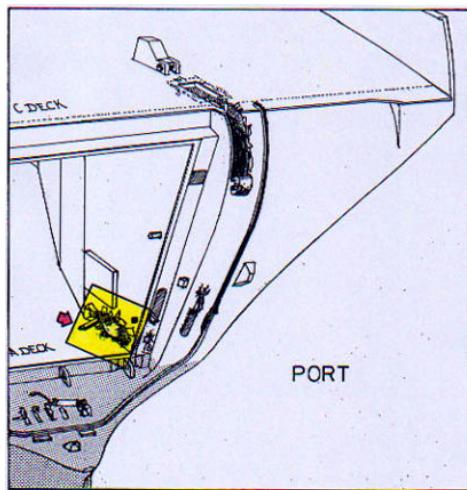
Reference is also made to the drawing following this page showing the port side of the car deck opening without bow ramp.

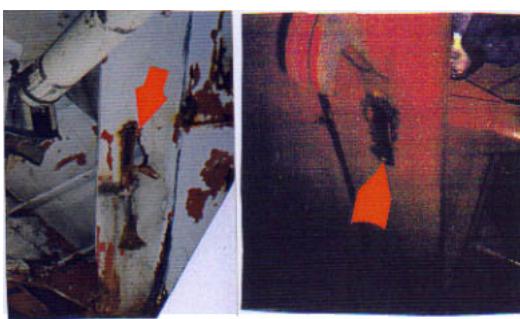
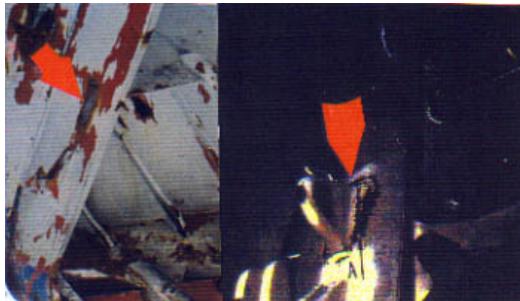
- A comparison of the damage to the side lock lugs of DIANA II / ESTONIA is shown below.

According to the ship's command the torn off starboard lug was lost. This is possible as first the lug hangs on the bolt of the hydraulic locking device and after opening the same it falls into the water. As noticed from the letter of the B.V. lawyer Johnsson, the repairs had already been commenced when the B.V. surveyor boarded the vessel. Thus practically neither the class nor the safety board ever saw the damage in its original condition.

The ship's command was unable to attribute the damage to a special occurrence, such as a hard blow of the sea. Therefore the TR Line inspector Griesmaier is of the opinion that the damage to the locking devices occurred over a longer period. This would be in conformity with among other things the statements of the chief mate Karl Ole Lindroos.

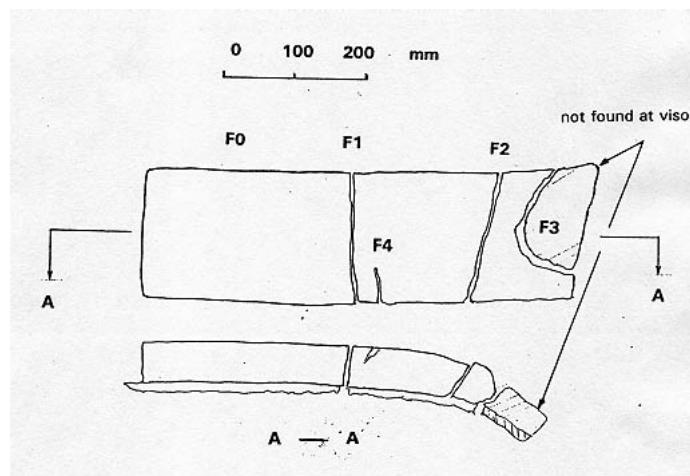
The investigation of fracture F1 - F4 ascertained that all the transverse fracture had started and penetrated from the outside by corrosion assisted fatigue cracking. In addition, fractures F2 and F3 reveal major bending displacements of their flanks, in particular fracture F3 reveals a specific bending angle of about 70° combined with severe bending deformation following the original crack development.

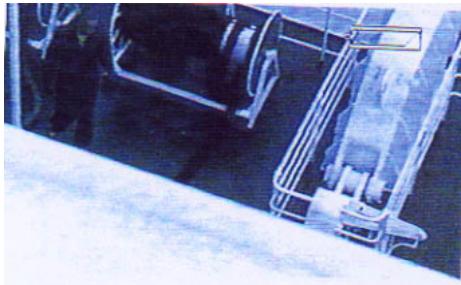
The visor's hinge system design consisted of the starboard and port side hinge arms fabricated from structural platings, with two attached lug plates on each side, carrying support bushings with bronze liners in the respective bore holes. The support bushings were welded to the lug plates with circular fillet welds. The visor hinge lugs were mated by deck hinge fittings, represented by lugs welded to the forecastle deck. The mechanical connection was one bolt on each side. The video image below shows the starboard hinge arm shortly before the accident.

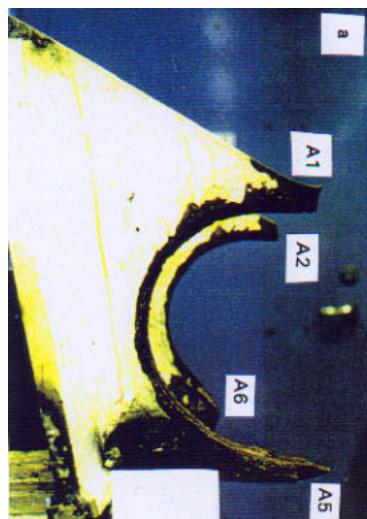
The following picture shows the broken port visor lug plates with the fractures A1, A2, A5 and A6.

The outer port side shows a vertical to slightly horizontal bending to port side at the fracture at the lower part of the remaining bore. The inner port side lug and both starboard lugs - see picture below - did not exhibit significant bending deformations. The picture below shows the broken starboard visor lug plates with fractures A3, A4, A7, A8:

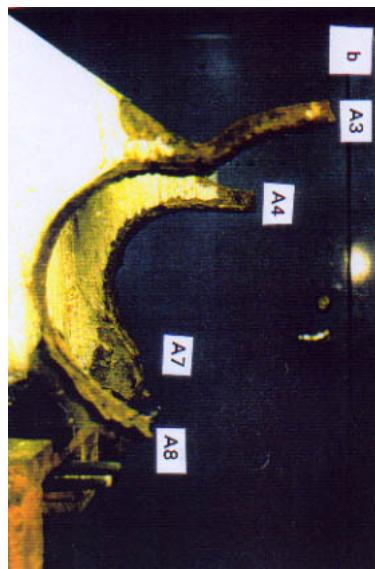
The failure of the visor hinges occurred by fractures A1-A8 of the visor lug plates together with the fillet welds to the support bushings. The bolts had been ripped out of the hinges, together with the bushings.

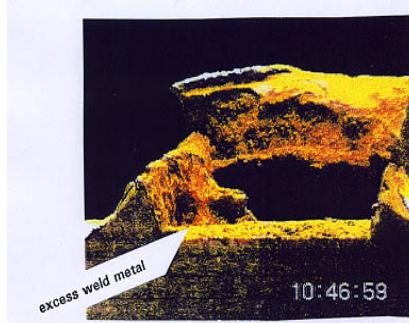
The fracture of the recovered hinge bushing was fitting to the fracture of the inner starboard hinge lug. It exhibits a gap of about 4-6 mm between lug bore and support bushing. This gap is almost entirely filled with corrosion products, presumably magnetite, which is also found in thick layers at a location where both hinge late and fillet weld failure are represented together with some excess weld metal, see arrow on the picture below which may have provided a local notch effect.

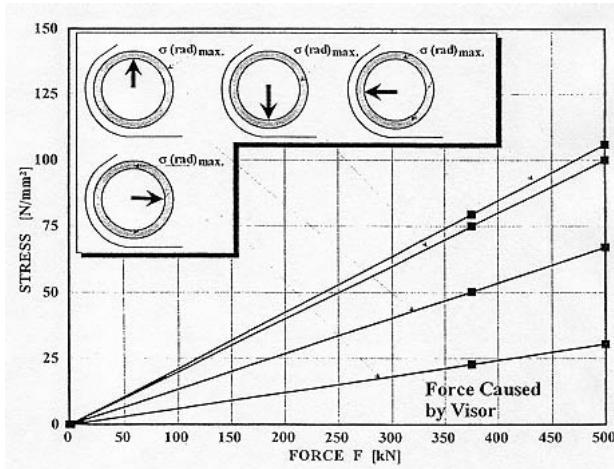
For example, the normal visor opening procedure created a vertical down force of maximum 375 kN on each hinge lug based on nominal visor weight and respective leverages and resulted in maximum radial stress in the fillet weld found at the location as marked by the circle in the drawing below together with the stress distribution in radial direction. Accordingly the opening procedure would thus create a local radial weld joint stress of 75 N/mm².

It is thus obvious that, during opening of the visor, the location of maximum radial fillet weld stress is found in the same region where fatigue cracking of those fillet welds initiated. However, also the other assumed directions of loads on the visor hinges would provide maximum radial stress locations. In particular, a similar stress range as for the opening procedure would result from an assumed afterwards force on the hinges. Such an afterwards load could have created the conditions for crack initiation and failure of the hinge plates, following the failure of the fillet.

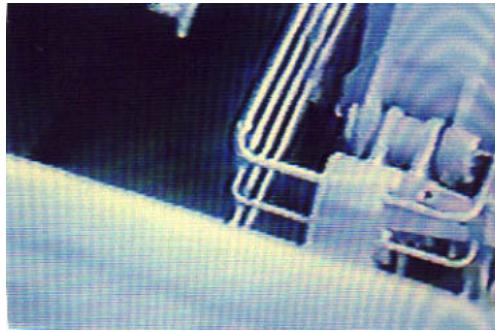
On the evening of 17.09.94, i.e. 10 days before ESTONIA's last departure from Tallinn, a Swedish passenger was standing on the forward open part of deck 7 and filmed the closing of the visor, the handling of the mooring lines by the deck crew and, finally, he zoomed in on the starboard visor hinges. The first copy of the original film was made available to this 'Group of Experts' and a first internal analysis revealed that the starboard visor hinge was in an absolutely disastrous condition as can be seen on the image below.

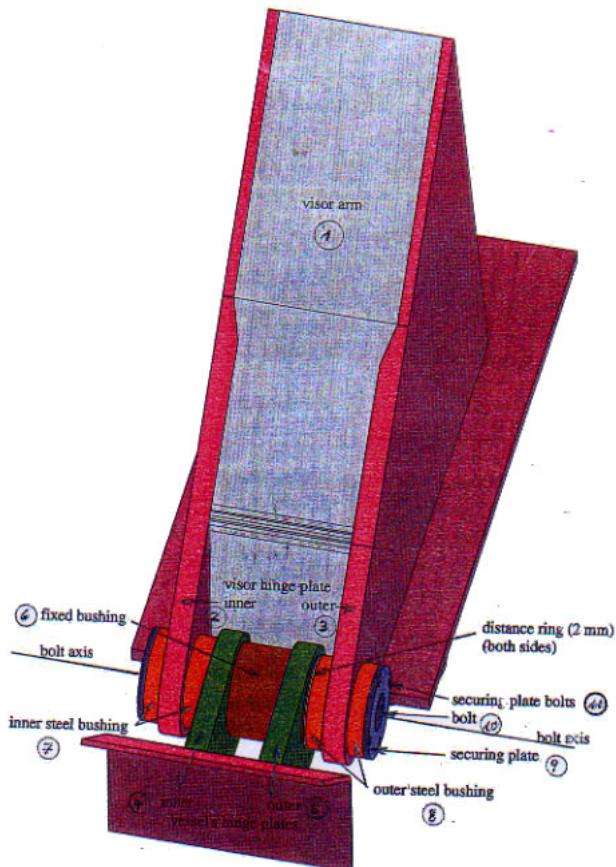
The object of the report was to detect and identify any structural rupture or damage which could have contributed to the loss of the Ro-Ro ferry ESTONIA. For identification of components bracketed numbers, for example (5) in the text refer to annotations on the drawings, on the previous page. A detailed examination of the video tape showed the only damage to be identified limited to the starboard visor hinge. The inner visor hinge plate (2) is correct and straight on its fore and aft axis other than a section of approximately 150 mm between the vertical centre line of bolt (10) and the aft end of the visor arm (1). This section has a clockwise twist which gives a downward inclination to the visor bolt (10) and the inner steel bushing surrounding it (7). This inclination of the bolt assembly (10) and the steel bushing extends from its inner end to the outer face of the vessel hinge plate (5). The video image does not allow a precise calculation of this angle, but the average of a series of measurements show it to be approximately 4 degrees which gives a downward misalignment of the axis at bolt(10) of approximately 25 mm at the starboard face of the vessel's outer hinge plate (5). In addition there are two unexplained dark marks on each side of the inner hinge plate (2) opposite each other at the point it joins the bolt assembly (10). These two marks appear to be joined by a thin line extending across this section of the inner Visor Hinge Plate.

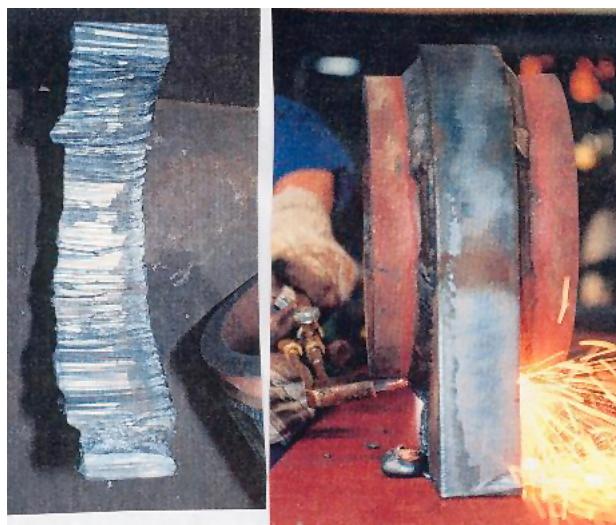
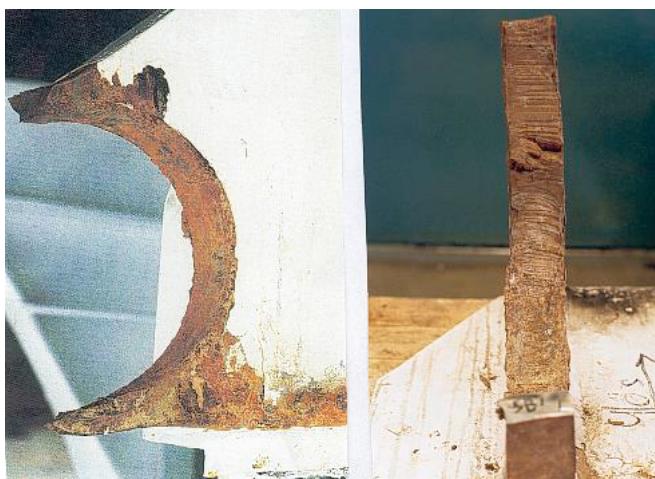
- all four arms do not have identical appearances as it is evident from the two photos below, the left one shows the port outer visor arm and the right one the starboard inner visor arm.
