THE GERMAN 'GROUP OF EXPERTS'

THE GERMAN GROUP OF EXPERTS

16 THE CONDITION OF "ESTONIA" AND THE STATUS OF HER MAIN CLASS AND SAFETY CERTIFICATES BEFORE COMMENCEMENT OF HER LAST VOYAGE

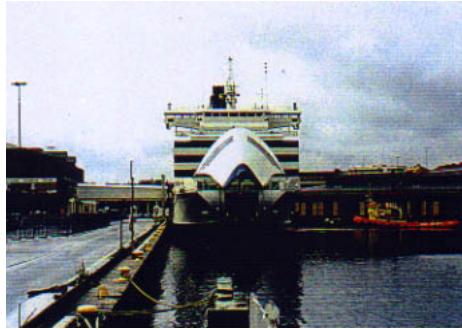
One of the viewers of the 'EFTERLYS' program reported that he saw the ESTONIA in July 1994 at her berth in Stockholm with open visor and open bow ramp, which was categorically denied by N&T, ESCO and the JAIC members.

The following picture proves it. It was made by a German tourist in July 1994.

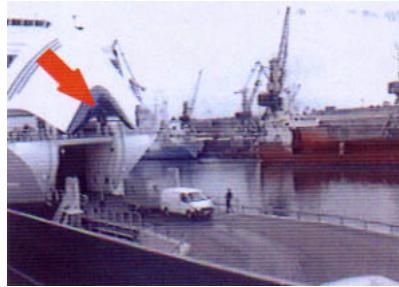
The picture below shows ESTONIA at her berth in Tallinn with open visor and bow ramp on 30.03.94, i.e. more or less at the end of the ice winter which had left visible traces to the visor's structure - see arrow.

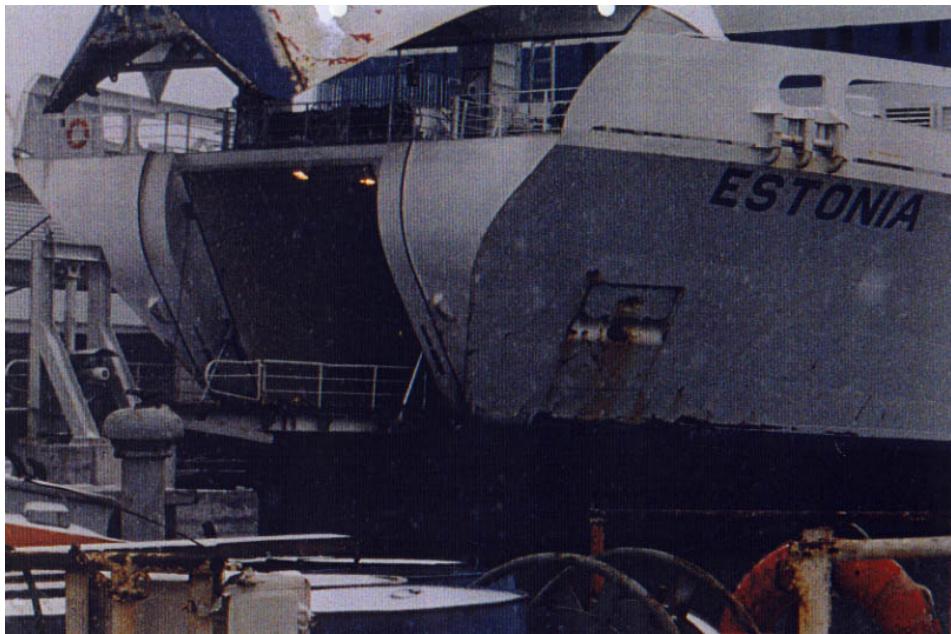
The ice situation is demonstrated on the ice chart of 28.03.94 which is attached as [Enclosure 12.4.2.152](#) and two photos showing the cruise vessel SALLY ALBATROSS sitting aground outside Porkkala (opposite Tallinn) in heavy ice during February/March 1994. The photos attached as [Enclosure 12.4.2.153](#) clearly demonstrate the ice conditions which were prevailing at this time in the Gulf of Finland. The effect these ice conditions had on the visor and foreship of the ESTONIA can be seen on the photo below which was made on 24.03.94.

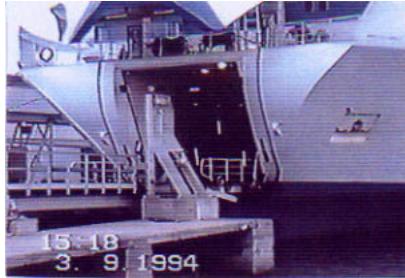
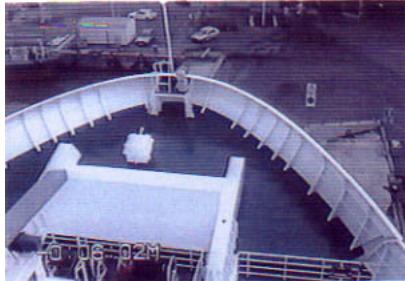
I am also of the opinion that, at least during the last months before the catastrophe, the bow ramp could not be closed completely anymore, because several times I observed from my position at the fore part of the car deck that light was falling on to the car deck as soon as the visor began to open, i.e. before the bow ramp itself was even moved. This, in my opinion, is only possible if the bow ramp was already open to a certain extent when the visor opened. The light came in at the upper port side. The whole ramp was badly misaligned, in particular the port side looked very bad, whilst the starboard side looked quite in order. Once I saw a crew member standing on a wooden pallet which was lifted up by a forklift standing behind the closed bow ramp at port side. The man was lifted up to a position just underneath what I believe was the upper bolt. After some hammering to the area where the bolt was located the man was lowered down to the car deck again.

On my last trip to Tallinn before the casualty (I missed one sailing) my car was on the hanging deck at starboard side. Thus I could not see what was going on at the ramp and the visor when being opened. I saw, however, crew members working at the bow ramp before it was lowered down. When I drove down the ramp I saw the equipment for either welding or burning (gas bottles) laying at port side near ramp. We had to wait longer than normal, maybe half an hour or more before the bow ramp opened. I remember this clearly, because I had people waiting for me at the quay who had left before I was from board because it took so long. It could be the time when I saw the visor moving up and down several times before the bow ramp opened combined with banging noises and also hammering.«

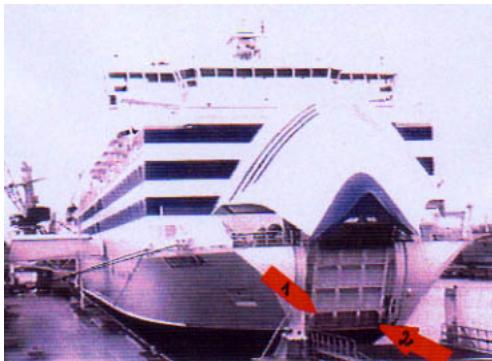
The picture below shows ESTONIA at her berth in Tallinn with open visor and closed bow ramp. The arrow no. 1 points to the oil covered lower part of bow ramp which demonstrates the height of the water level with hydraulic oil floating on top inside of the visor when the vessel was at sea in calm weather. Arrow no. 2 points to the bow ramp hinges which are on car deck level.

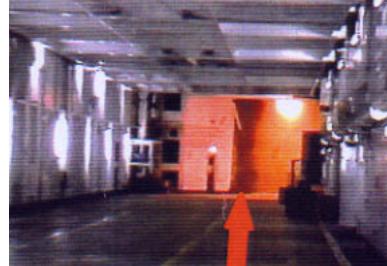
*»When I was sitting in my car in a position close behind the bow ramp waiting for the ramp to open, I remember having frequently seen crew members pulling steel plates across the gap between the open bow ramp and the car deck. I know that this gap is normally closed by steel flaps, but these had been dismounted with certainty at the port side. There were now holes in the flaps on both ends into which crew members were putting hooks by means of which they were pulling the flaps across the gap when the ramp was open and to the side before the ramp was closed.
The area with missing flaps at the port side of the closed bow ramp can be seen on the following video prints (see arrows).«*

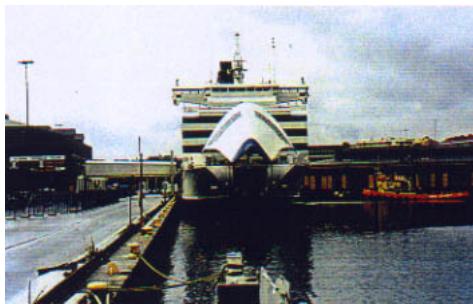
»I had frequently been on the forward part of the 8th deck upon departure from Stockholm and do remember having quite often seen the visor open.« (See photo below.)

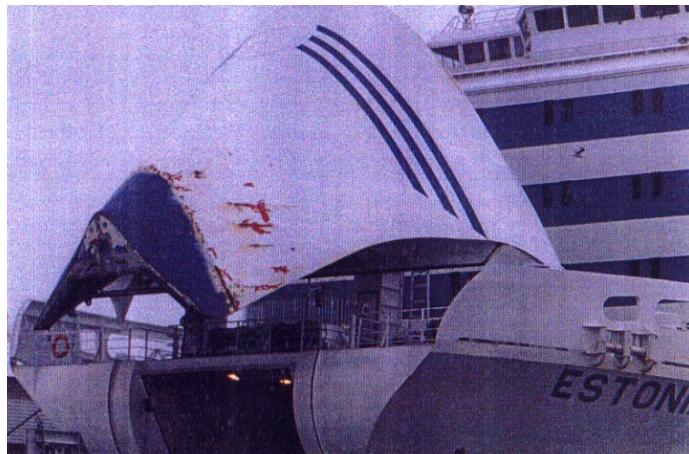
»Observation by Henning Frederiksson on 24.03.94: It was stormy weather and "Estonia" was proceeding in open water at full speed with a following sea when she met pack ice, into which she crashed without any speed reduction. "Estonia" came fast into the pack ice with an enormous crash and had to go backwards and try again. There was 16 m/sec. storm, nevertheless, "Estonia" kept her high speed.«

The results of such reckless navigation are clearly visible on the large photo on the previous page which was taken on the following day, 25 March 1994, in Tallinn by the professional photographer Li Samuelson.

The ice damage sustained by the visor during the months of February and March 1994, when the Gulf of Finland and the Northern and Middle Baltic where more or less continuously covered by ice (see Subchapter 12.4.2), were roughly repaired by replacing parts of shell plating and bottom of the visor in Tallinn whilst the vessel remained in service. The renewed parts are still visible on the visor.

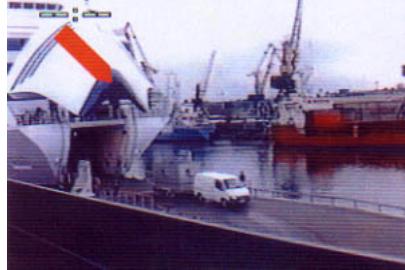
The damage sustained by the visor while proceeding at full speed through ice barriers several meters high and using the vessel as an ice breaker is demonstrated by the preceding photo and can also be seen on the video image below made from a film of 30.03.94.

As a result of the sustained severe structural damages and in combination with the different lifting speeds of the actuators and severely worn out hinge bushings, the visor became increasingly misaligned and out of geometry.

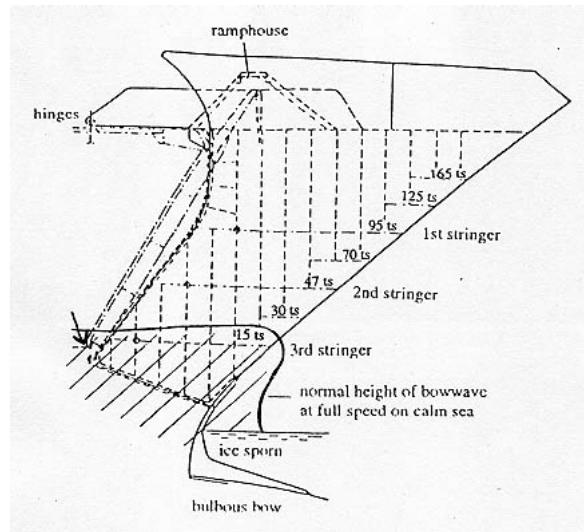
The following drawing clearly demonstrates that already in calm sea the water rose above the 3rd stringer inside the also severely leaking visor due to the height of the bow wave at full speed.

Since the lower part of the deck opening with the missing and/or damaged rubber packings (see arrow on drawing) was below the 3rd stringer level of the closed visor, it is obvious that water penetrated the car deck already in calm sea when the vessel was on full speed (height of bow wave ca. 2.5 m). It is also obvious that the water inside the visor rose when the vessel was pitching in head seas. The height of the water inside the visor depended on the height of the outside water level, i.e. when the ferry was taking green water on the forecastle for a certain time the visor would fill up more or less completely with respective water pressure on the leakage of the bow ramp.

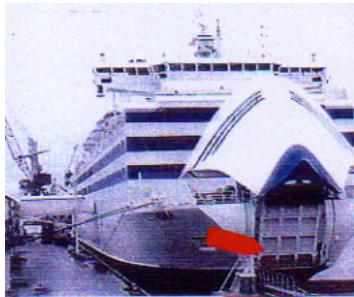
Note: The picture on the next page was taken in October 1993 and shows the lower part of the closed bow ramp severely stained by oil, most probably hydraulic oil, which cannot just be explained by normal leakages.

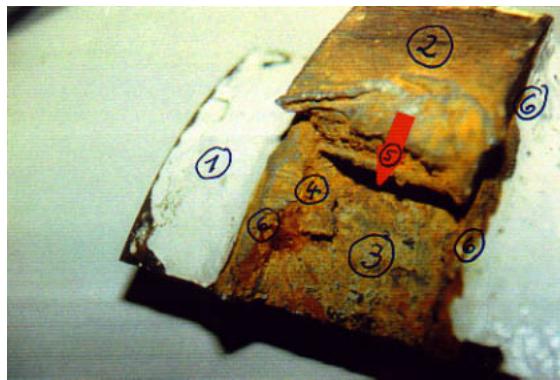
photo of stb. inner bushing recovered by divers

In summary of these three statements it has to be concluded that the welding seams between the bushings and hinge plates of the visor hinges were visibly cracked up to 10 cm at the beginning of August 1994, less than 8 weeks before the casualty.

The photo below shows a part cut out of the bushing recovered from the wreck. It is most probably the starboard inner bushing as will be explained in Chapter 30.

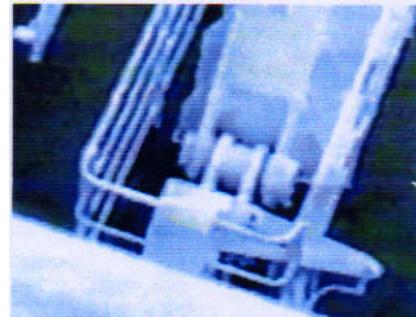
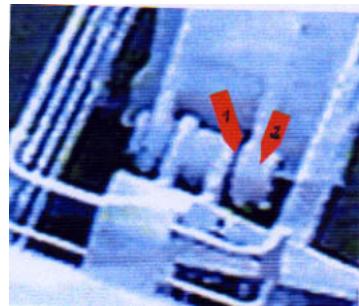
b.) That there was something seriously wrong at least with the starboard hinge arrangement of the visor well before the casualty becomes very obvious when having a close look at the **video film made by a passenger upon departure from Tallinn on 17 September 1994**, i.e. 10 days before *ESTONIA*'s last sailing. He stood on the open forepart of the 8th deck and with his video camera filmed the closing of the visor. Thereby he zoomed in on the starboard hinge arrangement. The subsequent evaluation of the video proved that the starboard visor hinges were totally misaligned with the lower part of the outer bushing as well as the securing plate missing. The video was analysed and evaluated in detail by the Reconnaissance Expert Bryan Roberts of Churchgate/UK and his report is attached as [Enclosure 12.5.180](#).

Although the distortion and misalignment of the starboard hinge is clearly visible to everybody, the Swedish part of JAIC gave a copy of the film to the Military Intelligence Service, who produced the picture attached as [Enclosure 12.5.181.1](#), which evidently shows the same. Nevertheless, the Intelligence people declared the whole film to be unreliable since 5 out of about 800 sequences had been slightly "jumping", which was accepted by the JAIC as well as N&T and the film from then on was ignored by the JAIC and consequently is also not mentioned in their Report. What the film really shows becomes clear on the enlargement below, viz. some major deficiencies:

- the gap between the starboard vessel hinge plate and the outer bushing is much too large (Arrow 1).
- the outer bushing is sticking much too far out of the outer visor hinge plate (Arrow 2) (which explains the large gap mentioned above).
- the lower part of outer bushing is missing.
- the securing plate is missing and the outer end of the bolt is not visible.
- the outer bushing appears to be twisted anti-clockwise.
- the inner bushing appears to be twisted anti-clockwise.

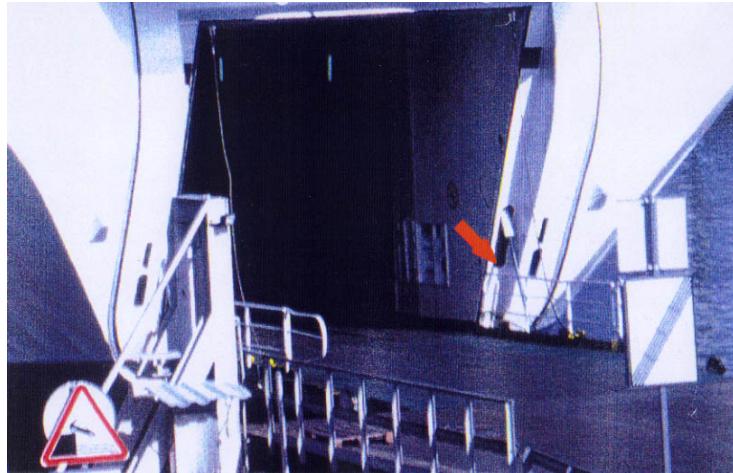
The picture following this demonstrates the conditions that the Swedish inspectors and their trainees found on the open bow ramp. The arrow points to the location where at that time an angle iron was fitted.

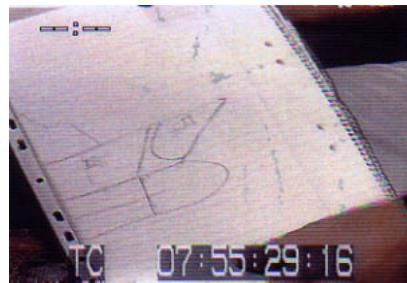
Ake Sjöblom made the following drawing and points to the area which is indicated by the arrow meaning both port and starboard side.

It should be noted that Åke Sjöblom has placed the bow ramp, which is the **upper extension of the collision bulkhead on top of the collision bulkhead** which was not the case on ESTONIA and also not on DIANA II, the near-sister, for which he had then been responsible for about 2 years already with his Malmö inspection office of Sjöfartsverket as the National Maritime Administration.

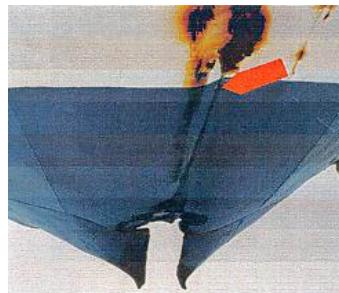
The shell plating as well as the internals are very severely damaged in two places, viz. there is a deep vertical indentation in the bow leading upwards from the stempost for about 2 m, as can be seen on the picture below from the outside,

The arrow points to the deep indentation which is completely painted and the paint does not show contact marks. The following photos showing the inside of the same area do confirm the deep indentation in a very strong part of the visor to be of old origin.

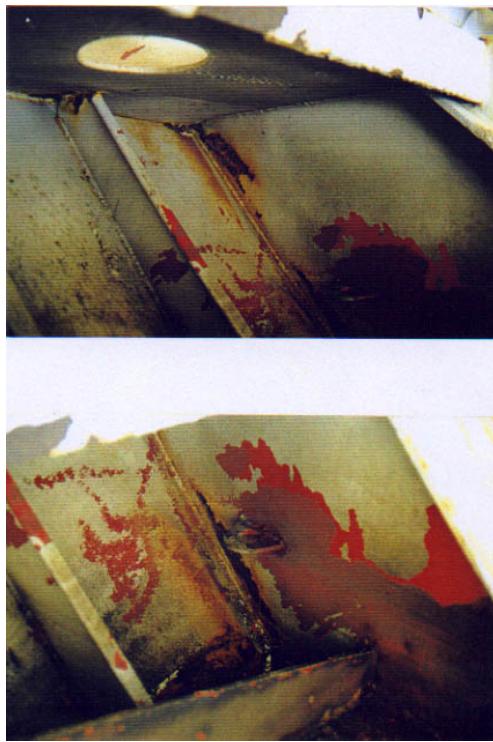
Furthermore, the shell plating as well as the 3rd stringer at the port side are severely indented and set up with the frames buckled which had been sustained already some time before the casualty. - See the pictures above.

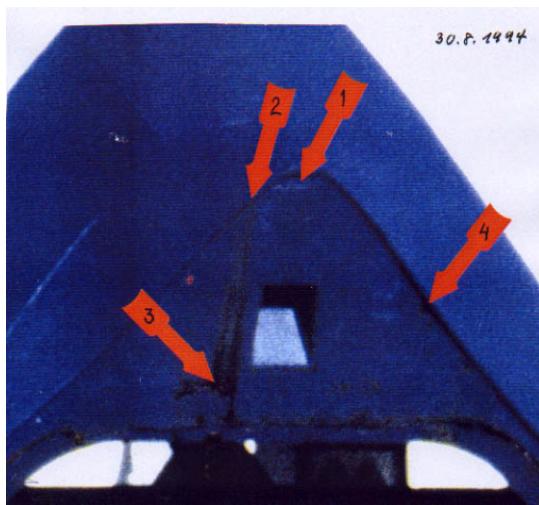
The condition of the visor bottom with stempost is evident from the picture below taken on 30.08.94.

Arrow 1 - Indentation in the foremost part of the visor bottom indicating that the visor's initial position was changed to forward most probably due to misalignment of the whole structure. This led to contact between the visor bottom and the stempost on the forepeak deck. Since the visor bottom in this area is not constructed to take up load, the bottom became indented and cracked.

Arrow 2 - Indicates a cracked welding seam through which water penetrated and created the rust stripes.

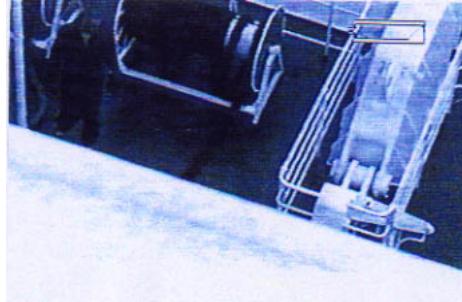
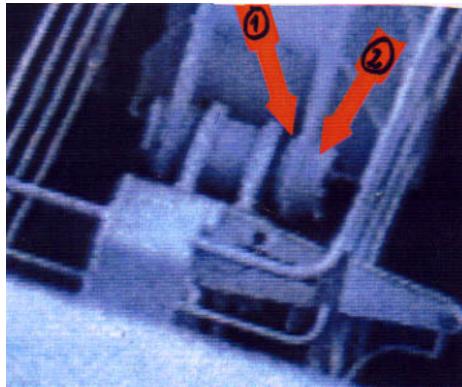
Obviously also the **visor hinges** had become affected because on 17 September 1994, i.e. 10 days before the last departure, a passenger filmed the visor and, in particular, the starboard visor hinges in Tallinn during the closing procedure.

The passenger was standing in front of deck 7 and filmed the closing of the visor, finally zooming in on the starboard hinges. The video-prints below are part of the film. Picture 2 is an enlargement of Picture 1.

On Picture 2 there are obviously several major deficiencies visible, viz.

- (a) the gap between the starboard vessel hinge plate and the outer bushing is much too large (arrow 1).
- (b) the outer bushing is sticking much too far out of the outer visor hinge plate (arrow 2) [which explains the large gap mentioned above].
- (c) the lower part of outer bushing is missing.
- (d) the securing plate is missing and the outer end of the bolt is not visible.
- (e) the outer bushing appears to be twisted anti-clockwise.
- (f) the inner bushing appears to be twisted clockwise.

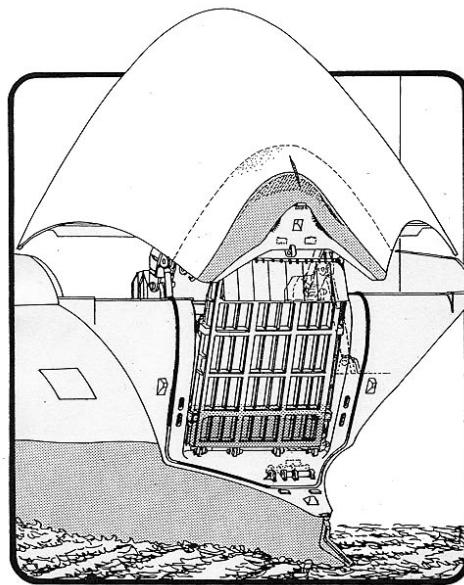
The last Finnish crew had requested the renewal of 15 m of rubber packing in way of the visor for the then planned yard time in January 1993, because the rubber packing had last been renewed in January 1991. This meant a renewal of the entire packing on the forepeak deck plus about 2 m up each front bulkhead as demonstrated by the following drawing.

Since the new technical managers N&T were of the opinion that visors are full of water at sea anyway, the rubber packings were not renewed in January 1993 and also not later. This means that the visor became quickly filled up with water at sea up to the height of the outside water level. In calm sea it was the height of the bow wave which filled the visor up to the 3rd stringer, however, the worse the weather was and the deeper the bow was diving into the waves, the higher the water rose inside the visor.

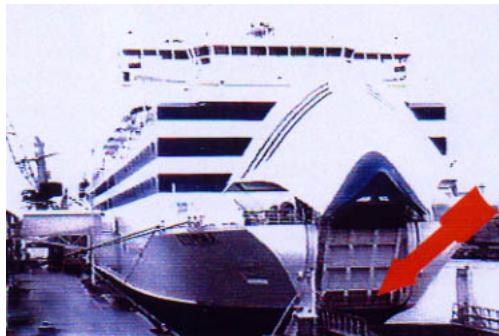
The following picture shows the ESTONIA in Tallinn, with open visor but closed bow ramp so that the otherwise invisible underside of the bow ramp is shown with the lowest section being dark - see arrow. Doubtless this was caused by the water inside the visor with hydraulic oil from the leaking cylinders swimming on top of the water surface. When the vessel reduced speed and the bow wave became smaller and finally disappeared completely when the vessel was alongside, the water streamed out of the visor and the oil settled everywhere inside the visor, also on the bow ramp which forms the aft inside of the visor.

The water streaming out of the visor was observed by many passengers when the vessel was alongside in Stockholm with closed visor and, among others, also by the skipper of the Sandhamn pilot boat as well as by several pilots when the ferry was slowing down during the approach to the pilot boat.

The bow wave became smaller and the water streamed at once out of the visor. (See Subchapter 12.4.4.)

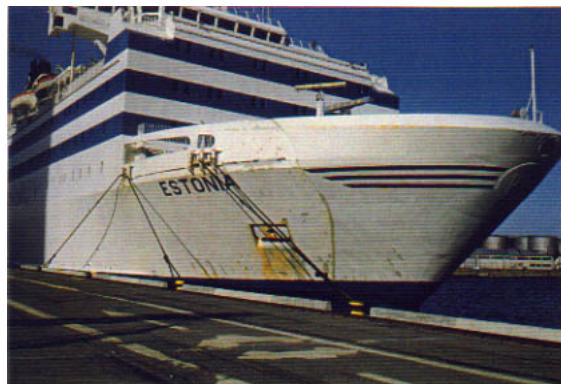
Also the **rubber packings** around the car deck opening, which should be sealed tight by a properly closed and locked bow ramp, apparently did no more seal watertight since

some considerable time already, because the last Finnish crew had ordered **10 m of rubber packing to be renewed** at the next yard time which was planned for January 1993 - see Subchapter 3.4. - as mentioned before. This was more than half of the total length of the rubber packings, but also these packings were never renewed.

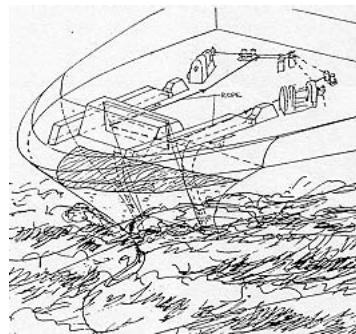
The starboard ramp hook, however, is nowhere visible and the location where it should be, is empty. It has thus to be assumed that also this hook had not engaged its mating lug at the ramp, which means that the ramp had just been closed by the actuators - as stated before - to an remaining opening of 4-5 cm.

Due to several mooring ropes and two wires found in way of the ramp and respective indications on the ramp - see Chapter 29.2 - it has to be assumed that the crew tried to close the ramp completely by means of mooring ropes and/or wires probably pulled tight by means of the mooring winches on the forecastle deck.

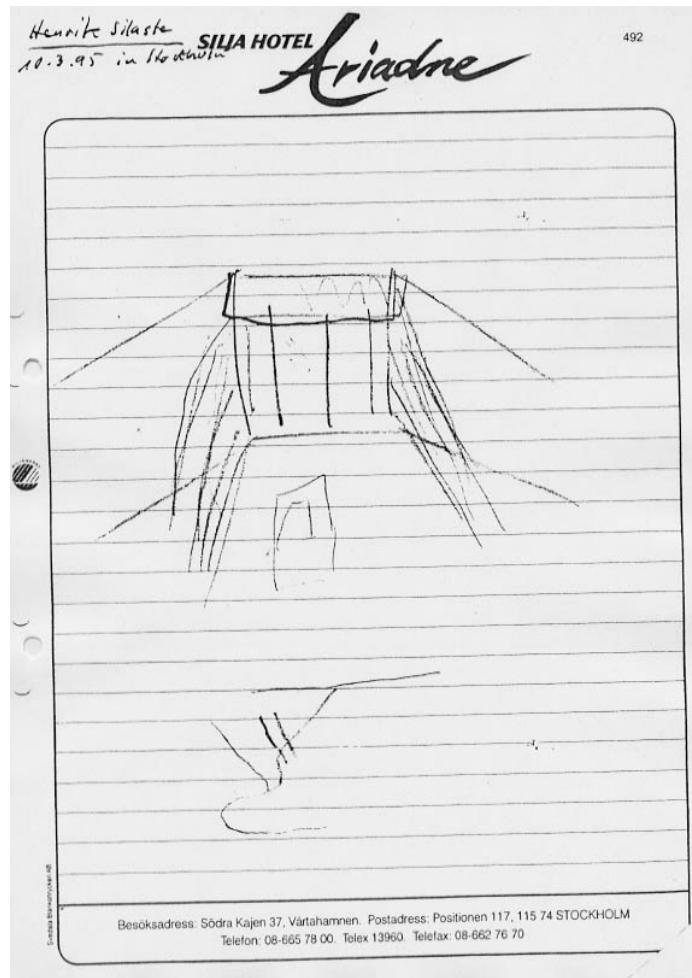
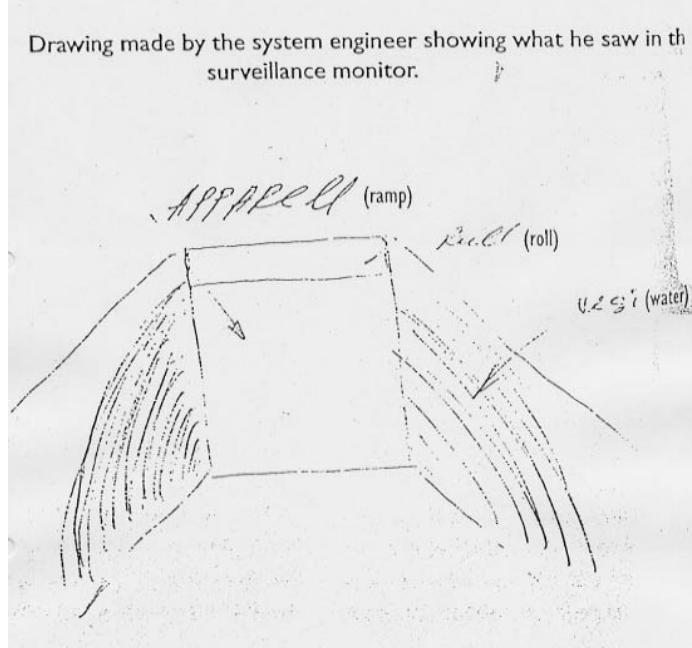
Already in January 1996 he was again interrogated by the Estonian security police when he made another drawing showing the same condition of the slightly open bow ramp with water pressing through at both sides. Both drawings are shown below.

Drawing made by the system engineer showing what he saw in the surveillance monitor.

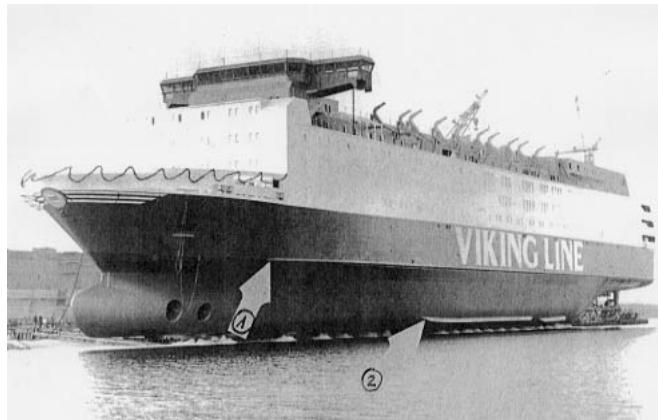
Note: The picture below shows the vessel's port side while still on slip. Arrow 1 indicates the forward end of the fenderbar, arrow 2 the forward end of the bilge keel.

- When he was at the forward part of the fenderbar he saw something like a fin sticking out of the hull, dark like the bottom, maybe 1.5 m or less, looking like a propeller blade of a plane. It was not moving.

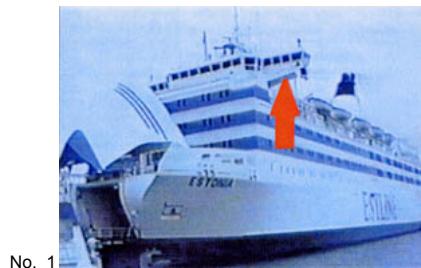
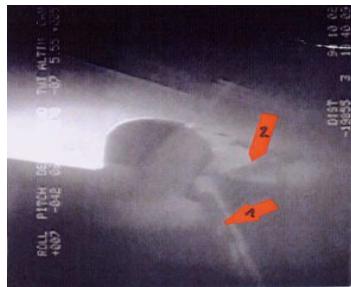
as to (1): The torn and broken open underside of the port bridge wing.

The area in question and the extent of this unusual damage at an unusual location shall be illustrated by a number video images. The first ones were made from footage produced already on 02.10.94, i.e. 4 days after the casualty, and the last ones at the diving investigation between 01-04.12.94. The arrow on the picture below points to the area in question.

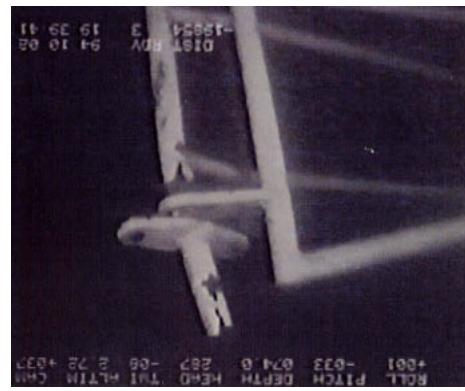
Upon evaluation of the video tapes by Disengage parts of the bow ramp rails were identified on the sea bottom and the images shown below and overleaf were produced.

The two images above made by ROV on 2.10.94 already clearly and without doubt prove that it is the forward section with movable part of the starboard bow ramp rail which is resting on the bottom of the sea.

A reconstruction of the ROV track commencing at the stern of the wreck revealed that these rail parts are located about 250 m to the south of the stern and about 80 m to the south-east of an area where the video was cut three times, each time for about 1 minute.

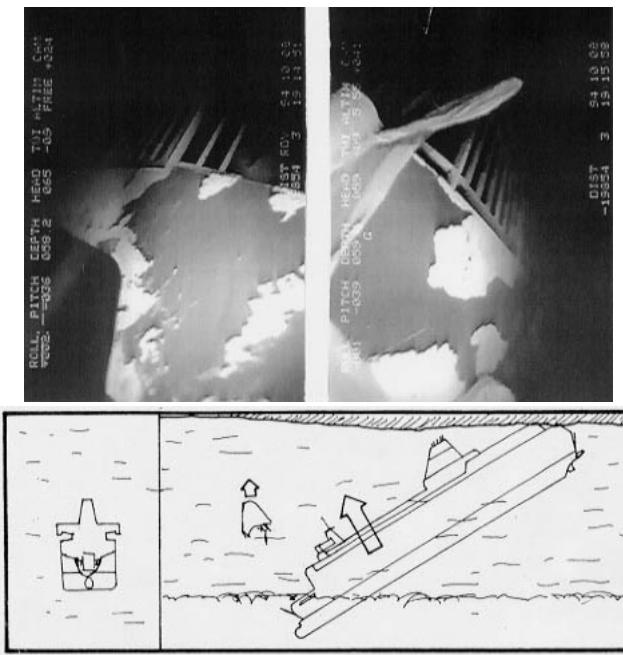
Window panels were found to have been pushed out and doors in the aft bulkheads of decks 5 and 7 were missing while the door in the front bulkhead of deck 5 leading down to the forecastle deck was noted to be open.

Note: This door could only be opened by crew members. The aft parts of the superstructures in way of decks 7 and 8 on the port side were found to be partly distorted and buckled. Large flakes of paint were scored off the aft parts of decks 5 and 6 - see the two images below - which was most probably caused when the vessel was in upside down condition with the stern already aground and the bow still above the water. - See the drawing below.

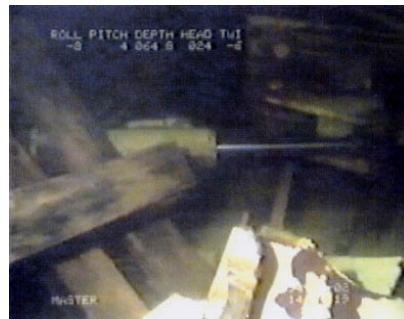
Contrary to the port opening - see sheet P 3 - where the ramp hook arrangement is clearly visible when the ROV looked into the opening - see the image on the next page - the starboard opening is just a big black hole. This can only mean that the starboard ramp hook was not where it was supposed to be.

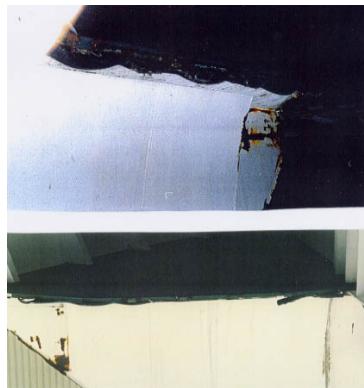
Also the flat bars around the deck opening into which the rubber packings - fitted below the visor arm - should be pressed, when the visor was closed, were missing. The same refers to the flat bars having initially been welded athwartships at the forward part of the forecastle deck into which the rubber packings at the aft part, i.e. below the recess of the visor, should be pressed when the visor was closing (see also item 5 on the detail drawing). This can be seen from the following two pictures, of which the first one shows the starboard aft part of the visor deck with untouched rubber packings, intact and in place and the 2nd is the port side which is evidently in worse condition.

The picture below shows the rubber packing underneath the starboard visor arm which was obviously never pressed into any flat bar and is not affected at all, which confirms the apparent fact that

- a) the flat bars around the deck opening had been removed prior to the casualty and that
- b) the visor was raised to some extent at this side after the hinges were broken since otherwise this rubber packing would have been destroyed as it did happen at port side - see P 3 - Port Side Fore-castle Deck.

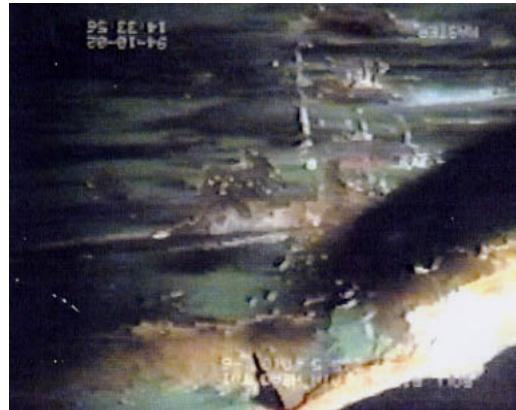
Image No. 1, 2 and 6 show the starboard inner side of the cut through the deck beam at frame 149, which are evidently pressed together, partly cracked and bent up, indicating pressure from port to starboard. The edges of the deck opening aft of the deck beam are not affected at all, same as on the starboard side. This is only indicated on the detail drawing but is clearly shown on the available video footage. The starboard side of the cut through deck beam and the deck plating as well as the rubber marks are shown also on the picture below.

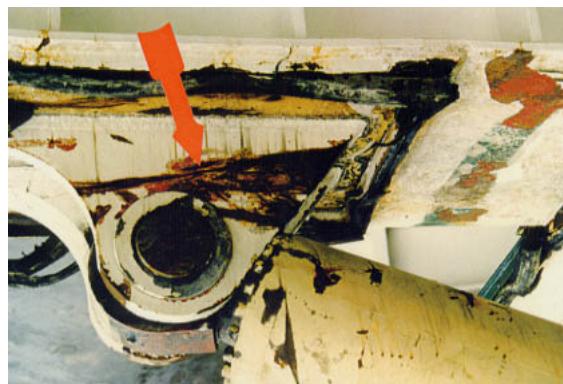
It must have taken some time for the visor lugs to cut through this deck beam while the visor moved forward/aft in the sea state ending when the visor lug plates had finally cut through this strong deck beam. It has to be assumed that during this cutting process at least the paint on both the inner and the outer lug plates should have been destroyed in way of the contact area. This was, however, evidently only the case with the inner lug plate as can be seen on the picture overleaf.

The lug plate has very deep and - at the upside - straight scoring marks, almost engraved, which indicate

- (a) the movements of the visor and
- (b) that the weight of the visor was to some extent resting on this inner lug plate which caused these very deep scraping marks, whilst the opposite side, i.e. the outer lug plate, remained completely unaffected as visible on the next picture.

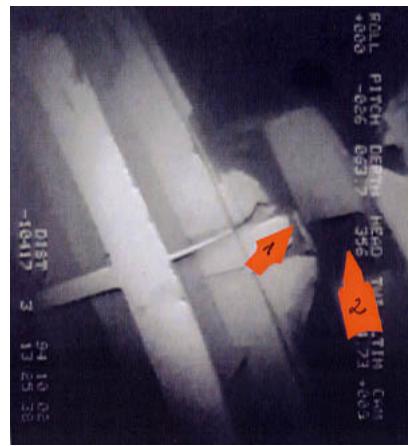
The following picture shows the misalignment between the mating lug at the ramp side and the opening in the front bulkhead out of which the hook would extend, i.e. it was impossible for the hook to engage the mating lug in this condition. This explains the undamaged condition of both hook and mating lug.

Arrow 1 points to the mating lug at the ramp

Arrow 2 points to the location where the hook would reach out of the opening

Note: The 4 inches = 100 cm misalignment between the bolts on the ship's side and the mating pockets on the port side of the bow ramp as reported by the diver must logically exist also between the ramp hook on the ship's side and the mating lug on the bow ramp. This is further evidence that neither the bolts could have engaged the mating boxes nor the ramp hook the mating lug on the port side.

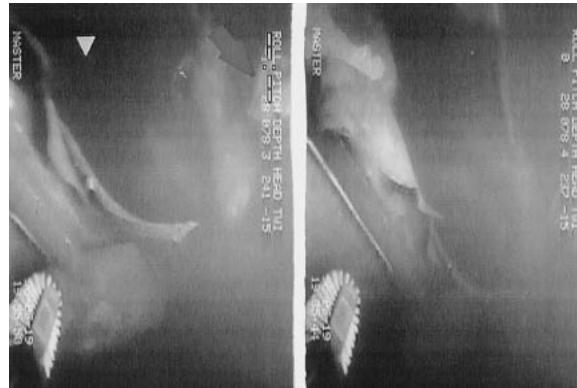
Area No. 2 shows the damage further down the front bulkhead. Note the torn open steel bent to starboard and to port.

The arrow on the left picture points to the severely distorted mating lug for the ramp hook.

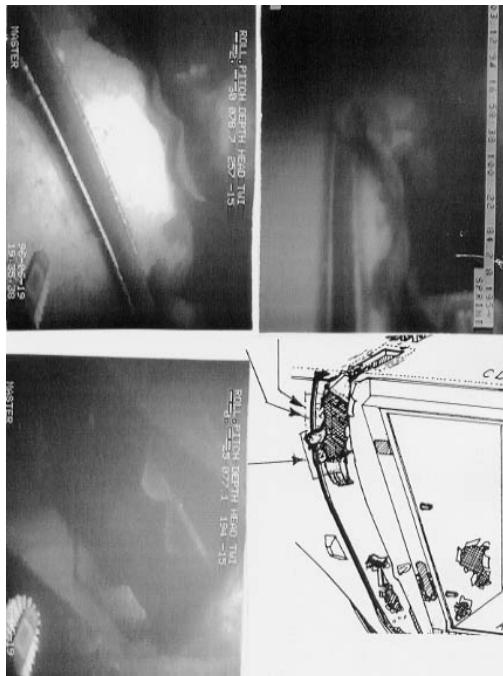
The picture below shows the lowest part of the damage, i.e. an almost horizontal, slightly upwards pointing steel flap.

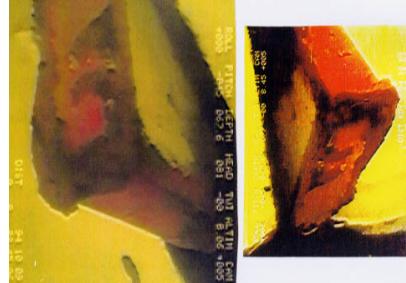
The next images show the lug of the hydraulic side lock which was evidently torn off the visor bulkhead together with the welding seams by which it had been welded to the bulkhead.

Note: It is obvious that these welding seams do not originate from one welding procedure only but from several weldings on top of each other, i. e. after each cutting off the new weld was laid on top of the previous ones without grinding off the remains of the previous welds as required by proper workmanship to assure the required load-carrying capacity of the weld. The required load-carry capacity of these lugs being part of the locking system of the visor did already since sometime before the last departure no more exist and was reduced to a fraction of the initial load-carrying capacity by such unqualified repairs.

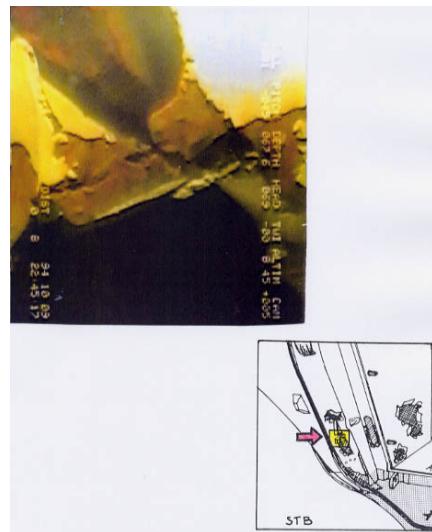
The next image shows the broken bulkhead part between the opening with the lug of the hydraulic side lock and the much enlarged opening for the manual side lock below.

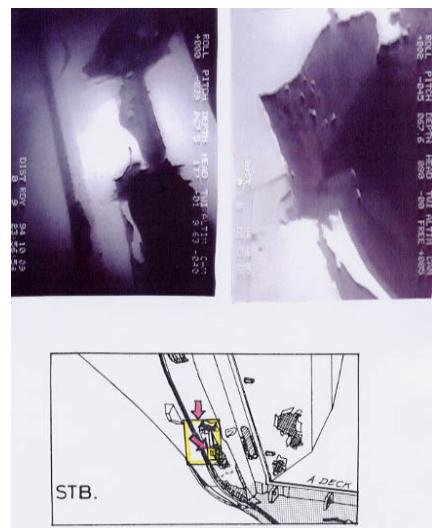
The following pictures show the upper part of the enlarged opening for the manual side lock.
Note the steel bent from inside to outside.

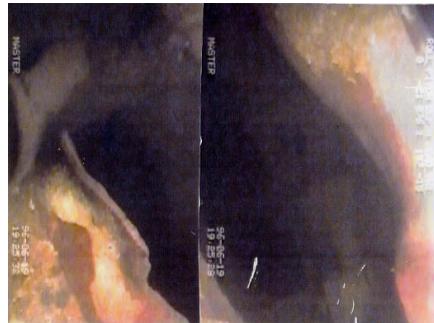
The two pictures below show the enlarged opening for the hooks of the manual side locks with the steel plating bent from inside to outside and the edges cracked.

On the right picture the not engaged mating part of the manual side lock is visible in the background. Furthermore a "soft" indentation can be seen on the inside of the substantially enlarged opening.

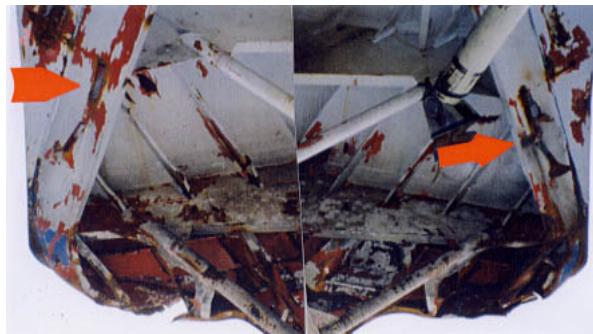
The picture on the right left shows the area of interest on the starboard side, the picture on the left shows the corresponding port side. It shows a completely different damage picture: no smoke marks, no steel tongue torn off the bulk-head and no twisted hooks.

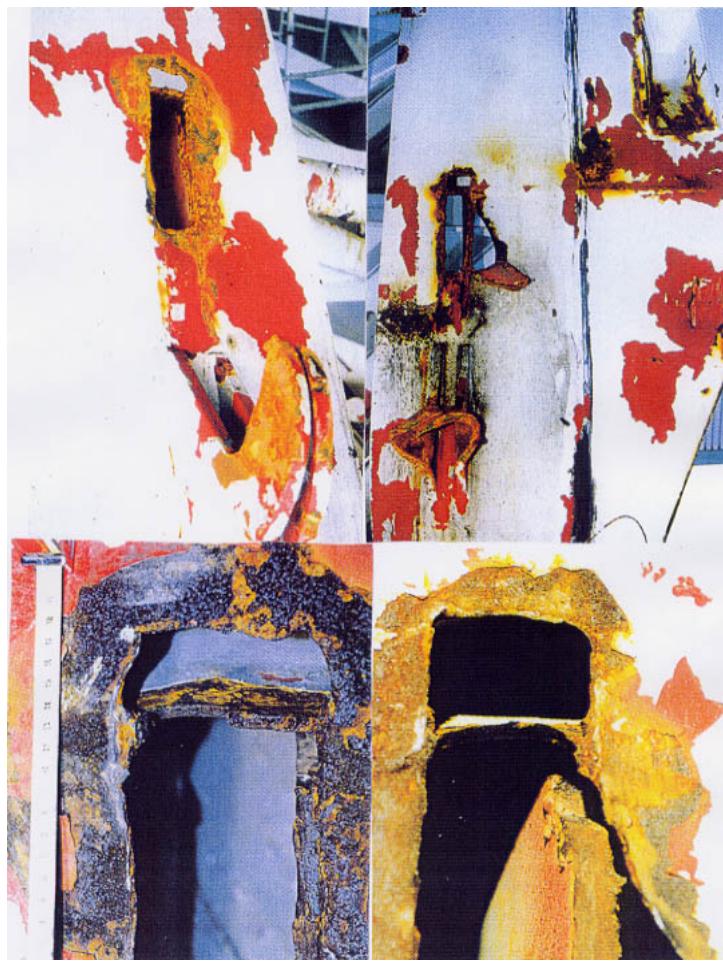
Two of the following four pictures on the next page show those areas at the port and starboard aft bulkhead of the visor where the lugs of the side locks had been welded to and the hooks for the manual side locks were fitted. The other two are close-ups of the upper parts of the area where the lugs had been welded. The right side shows the part of the starboard visor bulkhead directly opposite the above explained damage area. The smoke marks are still clearly visible although the visor had been on the sea bottom for 7 weeks. The hooks are distorted in a way which is technically not explainable. The area is dark. The picture on the left shows the corresponding port side as comparison with a complete different damage picture, with no smoke marks, no steel tongue torn out of the bulkhead and no twisted hooks and a generally clean appearance. The two close-ups arranged below the above mentioned photos show the respective upper parts of those openings in the bulkhead. They do illustrate the difference very clearly. While the port side shows normal steel clean of corrosion, the starboard side shows steel which had obviously been exposed to heat and pressure force: The metal is distorted and pushed out, the stiffener is detached from the bulkhead. See also Chapters 30 and 32.

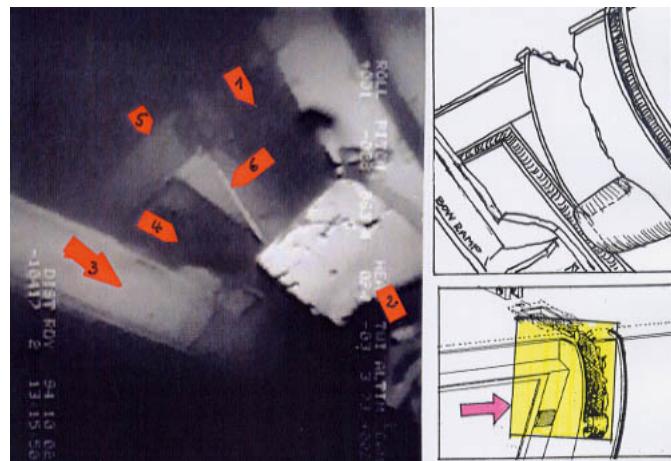
The following picture shows the upper part of the cut in the front bulkhead - arrow 1 - caused by piston rod and lifting cylinder, the lower part and the folded together steel strip torn out of the bulkhead - arrow 2.

Generally the damage appearance is totally different on this side compared to the starboard side. Whereas the cut at port side looks as if having been cleanly made in one go by a large can opener, the damage picture on starboard side demonstrates violent movements, heavy distortion to the starboard side, etc.

Arrow 3 points to the slightly open bow ramp, arrow 4 to the car deck opening and arrow 5 to the forecastle deck.
Arrow 6 points to a wire running from forecastle deck down beside the bow ramp, which was no more there when the divers came.

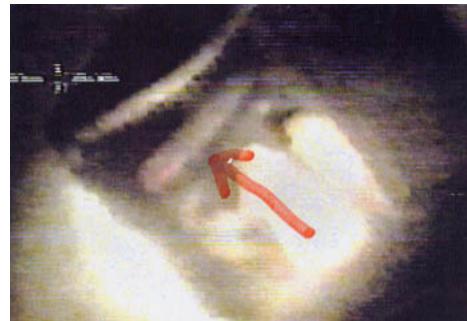
Area No. 2

- concerns the opening in the recess of the front bulkhead for the ramp hook. The hook has been identified inside this opening. The red arrow on the image below is pointing to the hook which is obviously intact and in locked condition.

The image above is a view into the opening in the front bulkhead recess inside of which the port ramp hook should have engaged the mating lug at the ramp during the closing procedure which it evidently did not do during the last voyage. This has already been explained under P 3 - Port Forecastle deck.

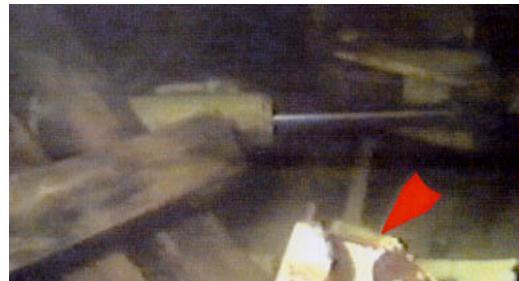
The image below was made when the ROV looked into the opening in the forecastle deck for the port visor actuator. The actuator of the ramp hook with part of the hook arrangement and the remains of the cut through deck beam - see arrow - are clearly visible.

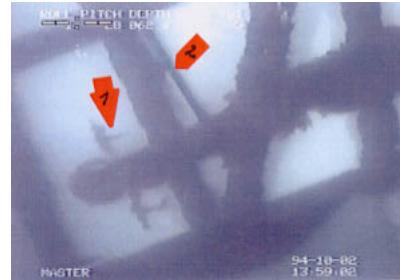
Area No. 3:

The following image shows transverse contact marks above the opening for the hydraulic side lock - see arrow 1 - which presumably resulted from the visor moving forward/aft during the time it took the visor arm lugs to cut through the deck beam.

Arrow 2 on the above image points to a wire running across the front bulkhead and the bow ramp to the starboard side and apparently from the port fair leads of the forecastle deck (there is no other possibility where a wire could come from). The image was made from the video tape produced by ROV on 02.10.94 - see Subchapter 25.1 - because on subsequent videos the wire is no more visible.

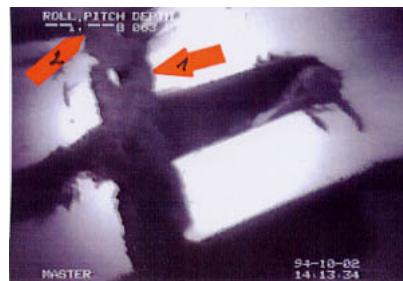
The next image - made from the same video tape - shows the same area, but slightly further down (in normal condition). Arrow 1 points to a double rope coming up from the gap between bulkhead/ramp and rising up due to its floatability.

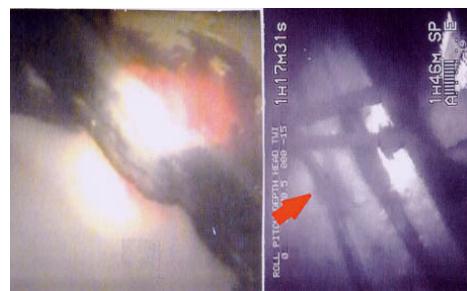
Arrow 2 points to a damage area in way of the rubber packings which is better visible on the right image below made from the 1996 video tape. The double rope was then still there because it is jammed in, though in slightly changed position. The damage area is more clearly visible - see arrow.

The left image above was taken from diver video B40c and is a close up of the same damage area. It shows that the rubber packing including flat bar channel has been pressed flat on a distance of about 200 mm. This could have been caused by a single wire or wire running from the bow ramp around the edge of bulkhead/hull plating up to the fair leads on the forecastle deck and further to one of the winches. Alternatively the damage could have been caused by the port aft edge of the visor bottom in the final stage of the visor separating from the vessel - see Chapter 31 - or it could have been an old damage because the corresponding area on the aft bulkhead of the visor does not show rubbing marks from the rubber packing. See the picture on the next page. A similar damage does not exist at the starboard front bulkhead.

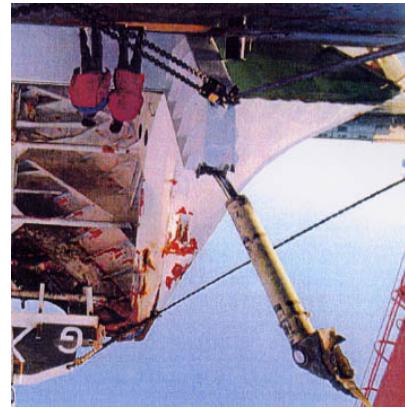
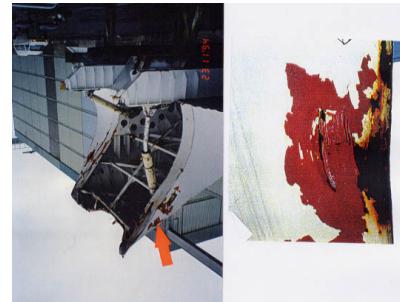
The starboard actuator, to the contrary, was found to be fully extended with the piston rod bent. It had apparently been the last connection between the vessel and the visor except for the bow ramp, the fore-castle deck and bulbous bow.

The area indicated by the arrow and the close up was probably struck by the foundation of the starboard actuator after the actuator had moved out of the front bulkhead of the vessel. - See also Chapter 30 - The Visor.

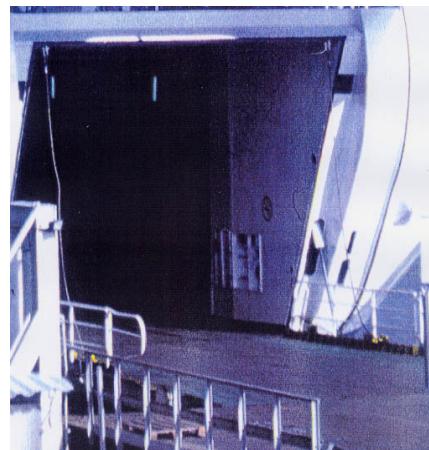
The port actuator and its fastening.

The picture below shows the port actuator extending out of its opening in the recess of the front bulkhead.

Due to the ramp being pressed to starboard the port recess of the front bulkhead is visible with the opening of the actuator.

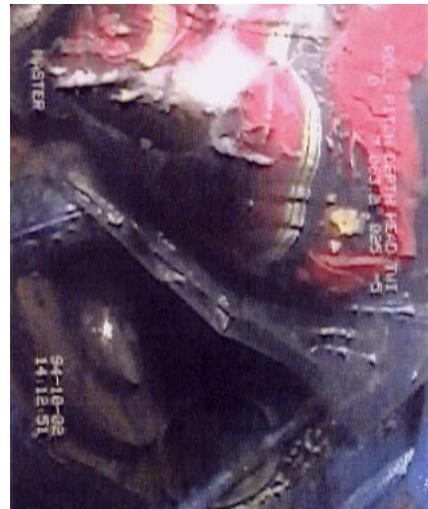
This gap was plugged by mattresses - see the blue transverse one above the hinge remains - the vertical plastic sheet to the right of the blue mattresses, the red/white bedding next to the plastic sheeting. The videos from 02. and 09.10.94 are showing blankets and rags further up in the gap between ramp and bulkhead.

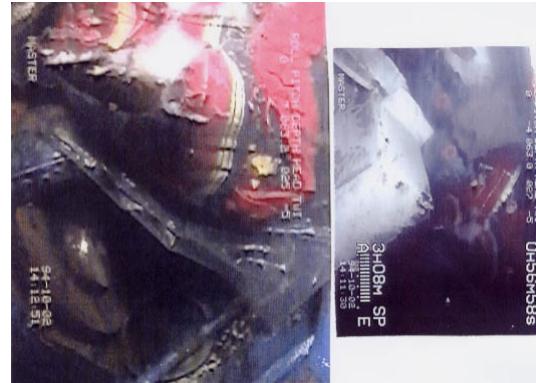
Also the following image shows the same area, but slightly further to starboard. The rubbing marks on the bedding indicate that it had been in place during several openings/closings of the bow ramp.

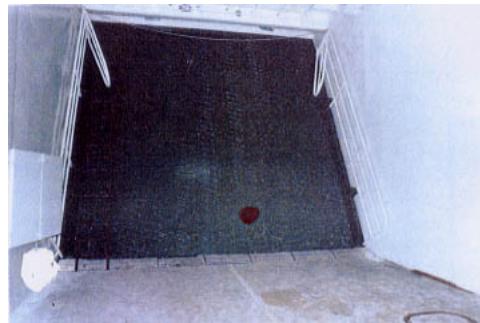
- The lower area is located in the 3rd row of steel profiles, looking from starboard, which are welded to the ramp plating and the 6th or 7th profile from car deck level as indicated on the picture below by the dark spot. The paint of the plating as well as the two flaps below looks reddish/brown. The plating otherwise does not look affected, but the two flaps are bent and distorted and the car deck plating in way appears to be affected.

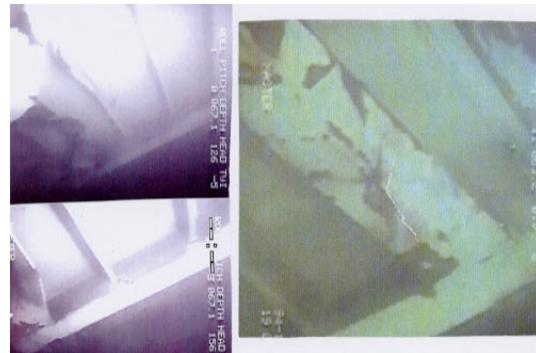
The two images below show on the left side the starboard lower port side with the outer vertical girder cracked off the bottom transverse girder, the ramp plating and the 2nd transverse girder and which is twisted by about 70° - No. 1 on drawing. The image on the right side shows the corresponding port girder with some scorings only and damage further up.

The dramatic damage to the starboard girder cannot have been caused by contact with the forepeak deck, because if the ramp would have smashed onto this deck also the port side should have been damaged. Also the nature and extent of this damage to the starboard girder does exclude that the damage was caused by impact on the forecastle deck.

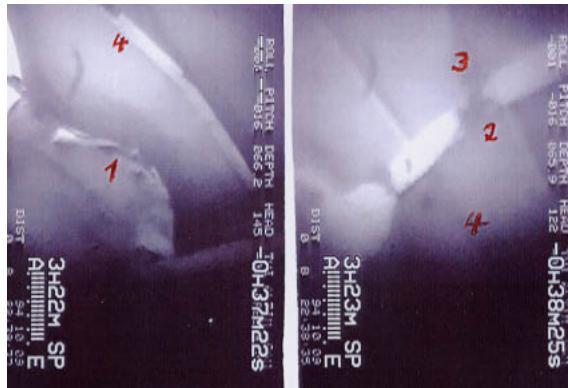
The left picture shows the lower part of the port outer vertical girder, cracked off above and below and twisted up to 70° - damage No. 1 on the drawing as well as damage No. 4. The right picture shows damages Nos. 2, 3, 4.

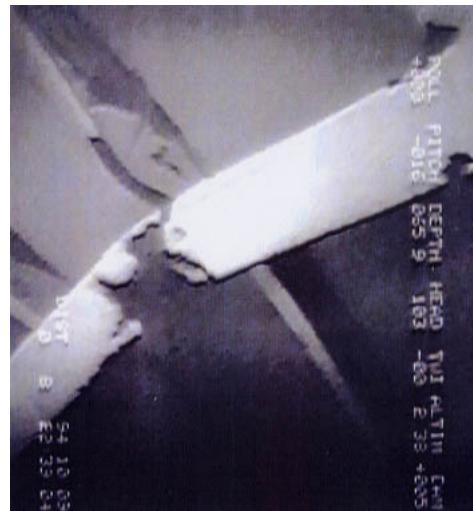
Below is an enlargement of damage No. 2.

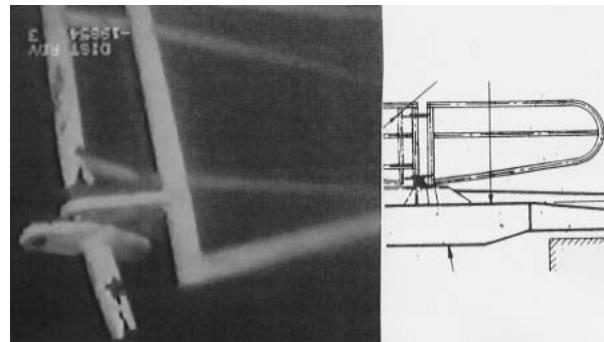
As parts of the starboard rail, the 4th section with the attached 5th moveable section, were found on the seabed already on 02.10.94 by ROV "Jutta II" - see the image on the next page - the available footage has been evaluated for indications of the bow ramp rails.

It is obvious that it is the starboard side because the movable part is always fixed at the inside of the fourth section if the ramp is open, as visible here and it is also obvious that the lower, bent part was the part attached to the ramp. It is further apparent that the vertical stanchion had been bent and finally cracked off by a force acting from port to starboard.

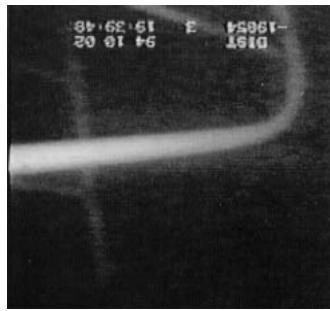
The image below shows the aft lower part of the movable fifth section which confirms the before said.
