THE GERMAN 'GROUP OF EXPERTS'

THE GERMAN GROUP OF EXPERTS

16 THE CONDITION OF "ESTONIA" AND THE STATUS OF HER MAIN CLASS AND SAFETY CERTIFICATES BEFORE COMMENCEMENT OF HER LAST VOYAGE

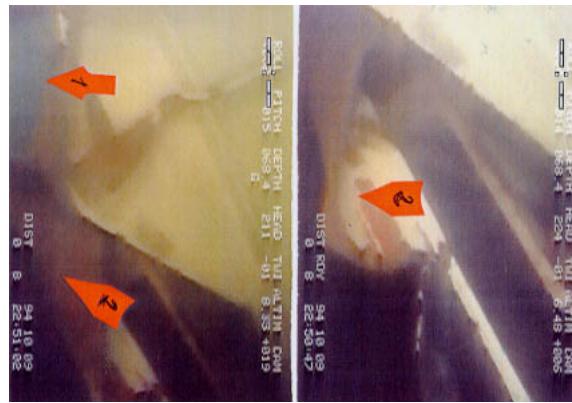
- On the same video tape from 09/10.10.94 two wooden pallets are visibly jammed between the ramp and the recess of the starboard front bulkhead just below (above) the starboard mating lug for the ramp hook. The area is not visible in detail on the 02.10.94 footage, but when the diver inspected the area on 03.12.94 the pallets were definitely no more in place.

The 2 images following show the area in question. Arrow 1 on the left image, points to the landing to which the mating lug for the starboard ramp hook was fastened and which was apparently pushed upwards - see arrows 2 on both images.

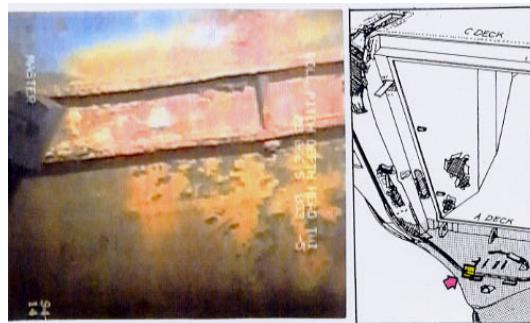
- No. 1 shows the hammered stempost of the wreck
- Nos. 2, 4, 5, 6 show either empty flatbar channels where the rubber packings were supposed to be - which is also confirmed by the image below - or show the rubber packing lying loosely on the flatbars into which they should be fitted and bolted. The evaluation of the video films - of which these 3 pictures are just a small selection - prove that the rubber packings were only in place at the starboard side from forward of the Atlantic lock to the "corner of the mouth" and these were in a rather poor condition. Along the whole port side up into the "corner of the mouth" there were no rubber packings. The diver followed the flatbar - channel for the rubber packings from the top of the starboard front bulkhead via the forepeak deck to the top of the port front bulkhead which is documented on video tape B40c. The two images below are just a confirmation of the findings explained above.

- No. 2 shows the hammered stempost which was evidently not just caused by the contacts with the visor in the course of the casualty sequence, but these quite extensive hammering marks were sustained over a longer period, viz. when the visor moved up and down in the sea state within the play of the locking devices, because the counter-pressure of the missing rubber packings was not existing to avoid such movements. The corresponding stempost of the visor was found to be full of fatigue cracks - see Chapter 30 and Subchapter 34.4.

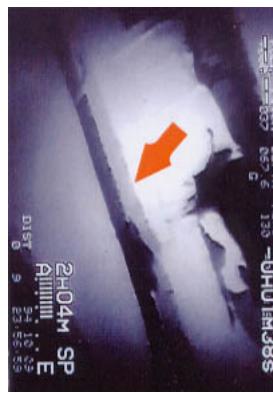
The lower part of the starboard front bulkhead in way of the hydraulic and manual side locks - see also further forward in this chapter, the starboard front bulkhead - is shown on the following images. The first one shows the upper part of the opening for the manual side lock with the rubber packing to the left. Between opening and rubber packing the bulkhead is visibly bulged - see arrow - i.e. the bulkhead is pushed out around the opening for the manual hook and increasingly deeper down the bulkhead. This can be seen from the next image below - arrow 1. In addition, there is a very deep fold - see arrow 2 - as well as damage in way of the rubber packings - arrow 3.

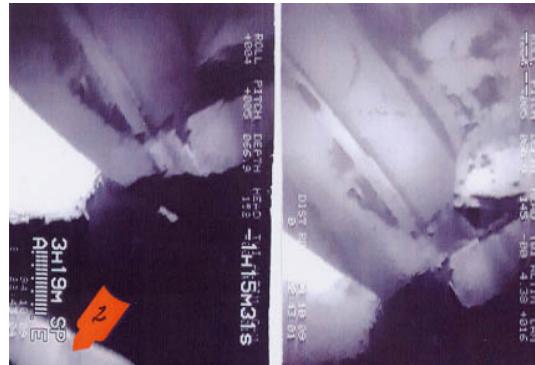
The following two images show the area adjacent to this pushed-out lower part of the front bulkhead, the recess with the torn-off and severely bent lower part of the outer vertical girder of the bow ramp. Apparently the deck/bulkhead is open in way of these severe distortions which also extends downwards.

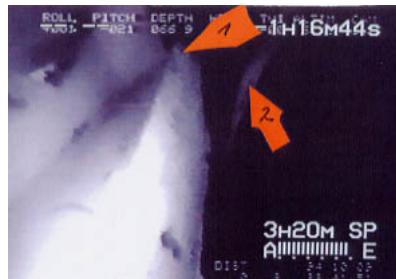
The next image looking from upside down shows the lower part of the front bulkhead twisted to port - see arrow 1 - while the initially lowest part of the bulkhead having been welded to the forepeak deck was cracked off and bent to starboard against the deck edge - see arrow 2 on this and the above image.

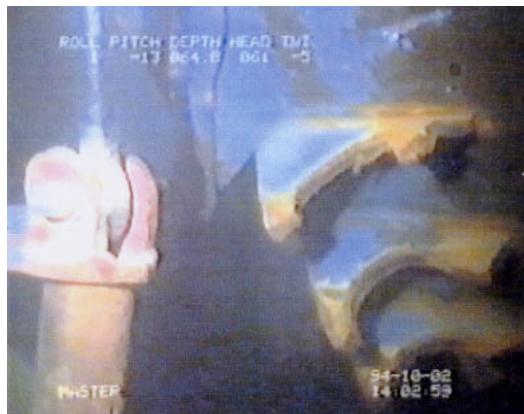
- Image No. 1 shows the starboard and centre logs while images Nos. 2 and 3 show the centre - and the port lugs. The latter one was subsequently destroyed upon instructions of the JAIC for testing purposes.
- The 3 images were taken from the ROV video made on 9 October 1994, i.e. 12 days after the casualty. All fracture surfaces are heavily corroded. This is even more evident from the image below made from the ROV video from 02.10.94, i.e. only 4 days after the sinking, which shows the same corrosion to the fracture surfaces of all 3 lugs.

- the starboard lug lower fracture runs obliquely from the upper point of the fracture towards the lower forward side of the lug and the fracture surface is severely corroded.
- The centre lug lower fracture looks completely different because the fracture runs horizontally from the point of fracture on the inside towards the outside or vice versa. Also this fracture surface is severely corroded.
- according to the available videos the port lug lower fracture has apparently been subject to pounding. The initial condition cannot be determined anymore because the lug was destroyed for testing purposes.

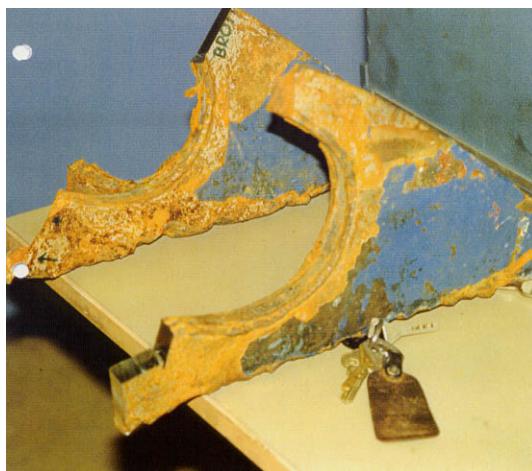
The pictures Nos. 4 and 5 show the starboard and the centre lugs in the Royal Technical University in Stockholm (KTH) in February 1995. They had been cut off the forepeak deck and were recovered by divers on 4th December 1994 and subsequently examined by the KTH. Below a photo of the starboard and centre lugs taken at the KTH, Stockholm in February 1995 is shown in order to illustrate to the reader the actual condition. Particular attention is drawn to the lower fracture area of the starboard lug.

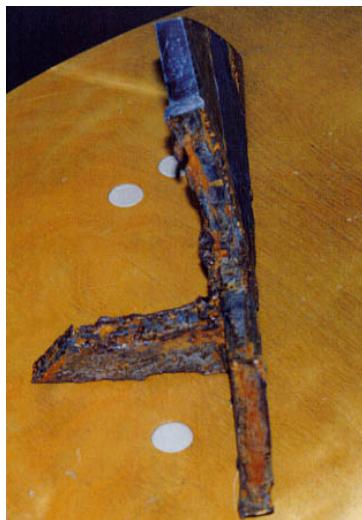
- The photo below shows the starboard lug looking from forward to aft. Attention is drawn to the lower fracture area and the bending of the lug.

- The support bracket at the outer side of the lug (arrow 1) is larger than the original, which is evident because it overlaps the end of the welding seam (arrow 2) which marks the end of the bushing. The support bracket is about 12 mm larger compared to the original one made according to the von Tell drawing No. 49111-373.
- The oblique end of the bracket is just burnt, not grinded (arrow 3). It is considered impossible that the bracket would have left blacksmith's shop of the Meyer Werft in such a condition - see also Subchapter 2.4.6;
- The remains of the welding seams at the outer side of the lug were made very unprofessionally when the lug was upright which allows the conclusion that the lug was fixed to the vessel as otherwise the welder would have laid the lug flat. This would have permitted easier welding and would have produced a qualified welding seam.

- The welds are thin and interrupted, respectively cracked, because they are so thin, which is demonstrated by the corroded surface of the inner side of the lug normally covered by the bushing. As long as the welding seams are intact the space between bushing/lug is airtight, i.e. without oxygen, which was burnt by the heat of the welding process. This was obviously no more the case since some time before the bushing was torn off, because substantial corrosion was able to develop.

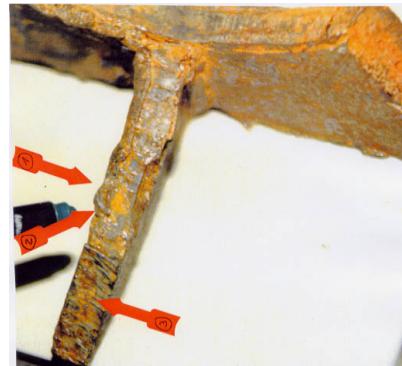
- Next an enlargement of the support bracket attached to the outside of the starboard lug is shown.

- The forward and aft welding seams between bushing and support bracket are not connected at the outer end (or closed, as the welders say), thus water could penetrate. This confirms the unprofessionalism of the welder who did these repair welds.

- The welding seams in way of the outer side of the starboard lug including support bracket/support bushing were poor quality repair welds made when the lug was in upright condition.

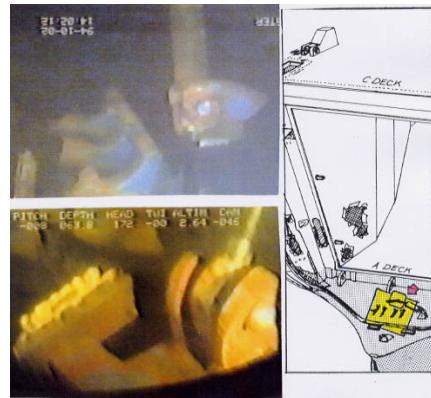
- This was no more the case at the time of the casualty as can be seen from images 13/15 and from the image below made from the ROV videos of 02.10.94 and 09.10.94, because evidently the contact plate was bent from starboard to port when the bolt was in original condition.

- The opening movement of the bolt was from starboard to port and the contact plate was bent from starboard to port. Therefore it has to be assumed that the crew hammered against the contact plate to open the bolt, because there is no other possibility of forcing the bolt open. The hammering marks on the plate are clearly visible. When closing the bolt they hammered directly against the bolt (which is not possible for opening), i.e. against the 2 lugs between which the piston rod of the hydraulic cylinder was fastened by a little bolt.

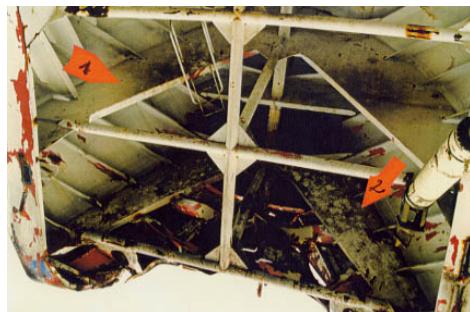
- As the Atlantic lock could no longer be closed hydraulically already since some time before the casualty (probably since the ice winter, March/April 1994) crew members had to go down inside the visor each time before arrival and after departure Tallinn and hammer the bolt open respectively closed through the deformed lugs of the Atlantic lock. Thus they walked from forward to aft and back over the stringers through the freshly settled oil which caused the footprints as can be seen on the next pictures.

- The photograph on the next page was made mid January 1995. It shows a view into the visor with the partly oil stained 2nd stringer (arrow 1) and the completely oil covered stringer 3 (arrow 2).

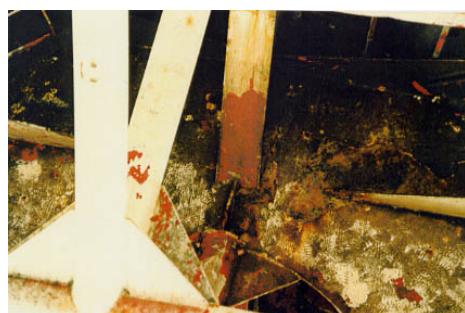
- Also the picture on the next page shows in detail that the footprints were so fresh and clear that even the size of the rubber boots could have been identified. It also demonstrates that there must have been quite some activities down in the visor before the last arrival and after the last departure from Tallinn which cannot just be explained with one or two men going down to hammer the bolt of the Atlantic lock open and closed. There were certainly also other activities going on as will be explained later.

Note: The last time the hydraulic oil settled down on stringer 3 has been before arrival Tallinn in the morning of 27.09.94 when the speed was reduced, the bow wave became small and the water streamed out of the visor. Thereafter the crew entered the visor to hammer open the Atlantic Lock and possibly to carry out other activities. The crew went again inside the visor after departure to hammer the bolt into the Atlantic Lock lugs and to carry out other activities. Subsequently the vessel picked up speed, the bow wave was raising again and the inside of the visor filled within the following hours more or less completely with water, which only left with the lifting of the visor after the casualty. Consequently the fresh footsteps originate from before arrival and after departure on 27.09.94.

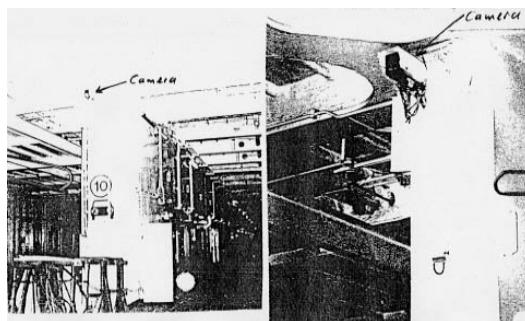
(1) the statement of the watch engineer Margus Treu that a jet of water hit the lens of the video camera transferring pictures from the partly open bow ramp to the monitor in the engine control room (ECR) where he was watching - see his statement dated 29.09.94 Turku - [Enclosure 21.2.3.263](#). Treu believed that this water jet came from the partly open bow ramp, which however is not possible because the camera is fitted at the forward part of the centre casing underneath the ceiling. The distance to the bow ramp is 25 m and the height above car deck is about 5 m - see the pictures below taken on board the near-sister DIANA II where the camera was installed as on ESTONIA.

It can thus be excluded that water penetrating the bow ramp at that relatively early stage could have reached the camera in such high position as much as the car deck between bow ramp and camera was full of trucks and cars.

It is much more likely that the camera lens was hit by a jet of water from the sprinkler installation which had been activated manually in the forward part of the car deck.

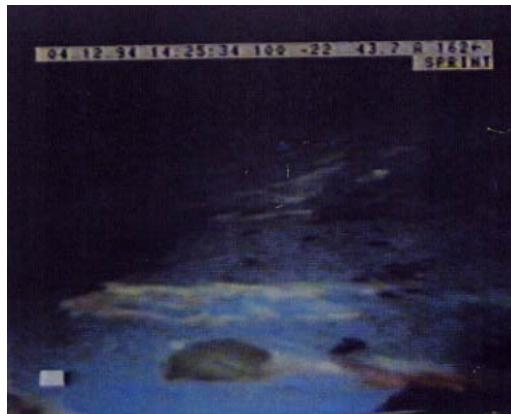
The following image shows white contact marks on the port side of the bulbous bow further aft than the previous one.

The pictures do confirm contact with some object which could have been quite strong considering the very strong construction of the bulbous bow, i.e. a weaker construction might have sustained heavy damage due to contact with the strong bulbous bow as indicated by the above paint and scoring marks.

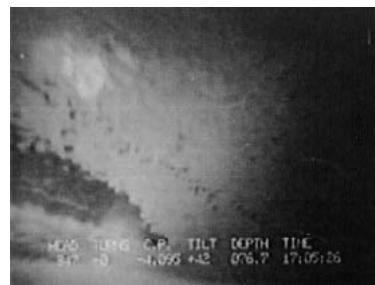
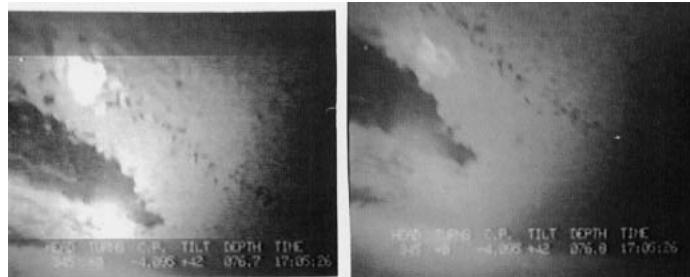
When looking at the images presented here it is difficult to assume that this vessel had been in drydock only 8 months before, because the starboard side is really in a very bad condition, actually much worse as it is possible to demonstrate by images. Very deep indentations between the frames and deep scoring marks, partly not even corroded, are the rule, however, in some particular areas the plating is even holed as e.g. can be seen from the image below.

Enhancement by means of special equipment confirmed indeed that the plating is holed - See the enhancement below.

From the damage appearance it has to be concluded that the plate was severely corroded, i.e. the hole was neither caused by an impact of ex- or implosion but by corrosion. This is easily possible if the coating and/or anode protection of a ballast water tank, e.g. a heeling tank, was not in order.

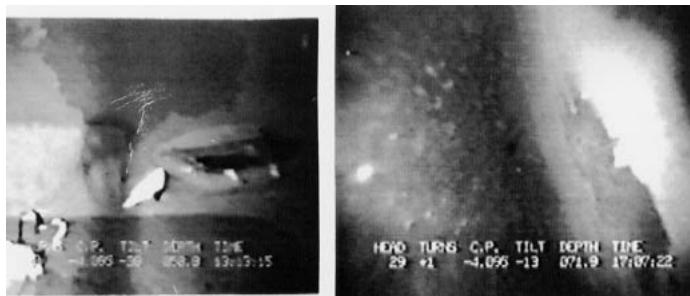
The following two images show an area which is apparently also holed, but not by corrosion because the edges are too sharp.

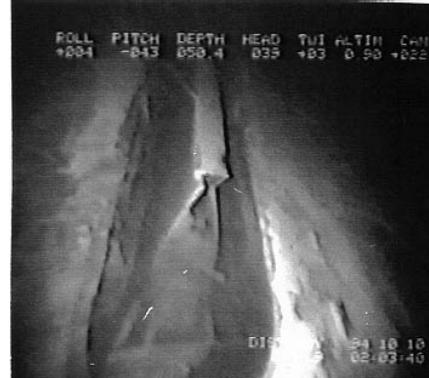
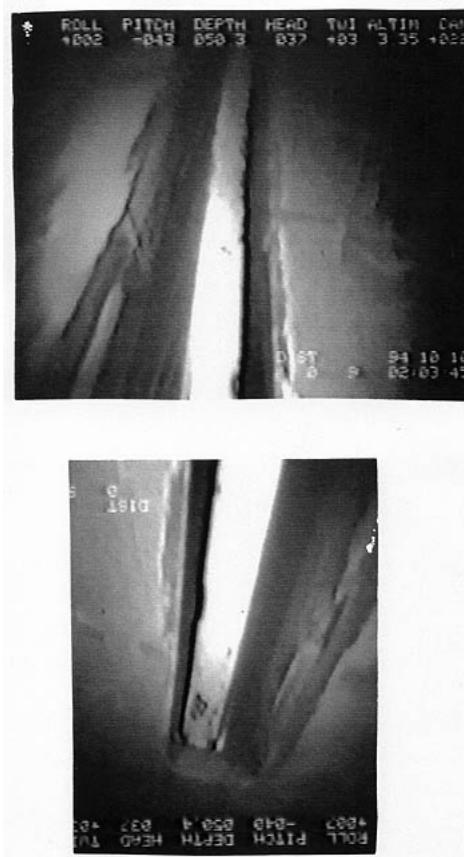
In any event the port stabiliser fin was found to be in its pocket during the ROV inspection on 09/10.10.94 - see the images below.

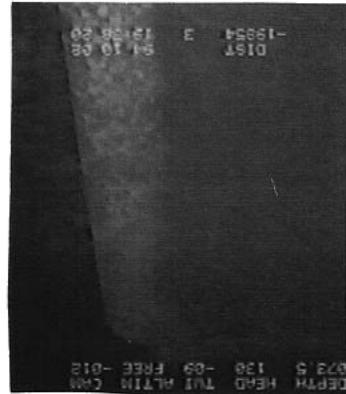
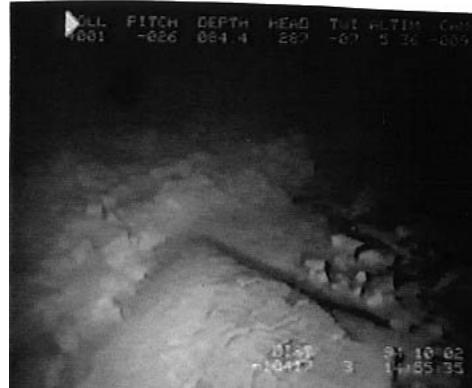
Alternatively the stabiliser fin could have broken off by the object sliding against the vessel's starboard side by which the scraping noises were caused. The noise scenario for Bengt Nilsson would have been the same. Therefore the video footage showing the ROV inspection of the sea bottom was analysed and the following two images were found which could show parts of the stabiliser fin.

As to the **starboard stabiliser** there are strong indications that it broke off or was broken off and is resting on the sea bottom now. In both cases a substantial water ingress into the engine room - at least 2 watertight compartments were affected - would have been the result for which there are also indications, because Henrik Sillaste has testified that the bilge pumps were running and Margus Treu has stated they were trying to pump water out of the ship. As it is not possible to pump water from the car deck they can only have pumped from 1st deck and 0-deck.

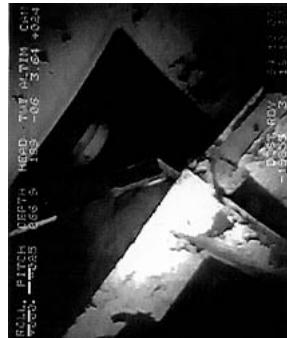
As the superstructure in way of the port side aft part of the 8th and 7th decks were found to be indented and bulged by the divers it has to be assumed that she was somewhat more heeled to port when touching the sea bottom as a result of which the above indentations were caused.

The ROV tape made on 02.10.94 indicates that the starboard stern ramp is slightly open as can be seen on the adjacent image. It shows the upper inner side. The explanation for this slight opening was given already in Subchapter 21.3.3 by the statement of Rolf Sörman - see [Enclosure 21.3.3.335.1](#) - who, as well as his seminar colleagues, were disturbed to such extent by hydraulic noises that they gave up their conference at 21.45 hours ET.

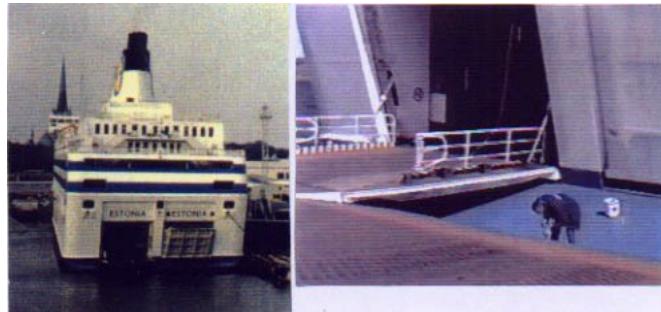
As the 2nd main hydraulic station was located at the starboard side aft on the car deck level directly below the conference area this is the only installation able to produce the explained disturbing noise level. It can furthermore be reasonably assumed that the hydraulic pumps had been started and kept running to open the starboard stern ramp slightly by means of the ice breaking cylinders and keep the ramp in this position by operating the control time and again in the closing mode to press the ramp against the ice breaking cylinders as it would otherwise more open/close due to the very hard pitching of the ferry. The slight opening of the starboard stern ramp allowed the excessive water on the car deck, continuously penetrating through the unclosed bow ramp from the water filled visor, to run out at the stern. This worked, of course, only as long as the ferry had a stern trim and a starboard list. Both was the case until about 23.30 hours when the visor was more or less full and the trim changed to down by head. For further details see Chapter 31 - The Casualty Scenario. The pictures below show the stern ramp arrangements in port.

It has to be assumed that the starboard stern ramp was completely unlocked as it otherwise could not be slightly open and that the reason for this slightly open condition is the almost upside down condition of the wreck. It has further to be assumed that the stern ramp has been much more open during casualty sequence-of-events because latest after the shut-down of the auxiliary diesels the hydraulic pumps stopped since not being connected to the emergency generator. This means that subsequently the starboard stern ramp slowly opened completely or more or less completely while the ferry heeled more and more to starboard which led to massive water ingress onto the car deck and through the big lift opening at the aft end of the centre casing also into the large provision area in the aft of deck 1 and so on. This is most probably the explanation for the ferry sinking by the stern.

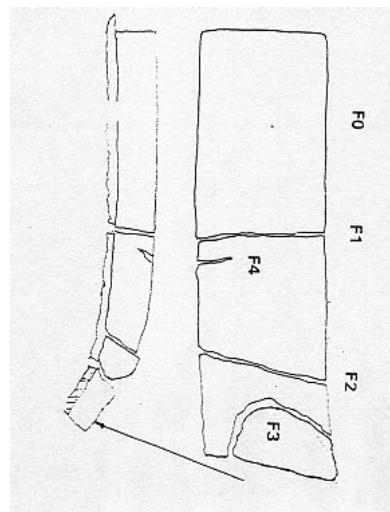
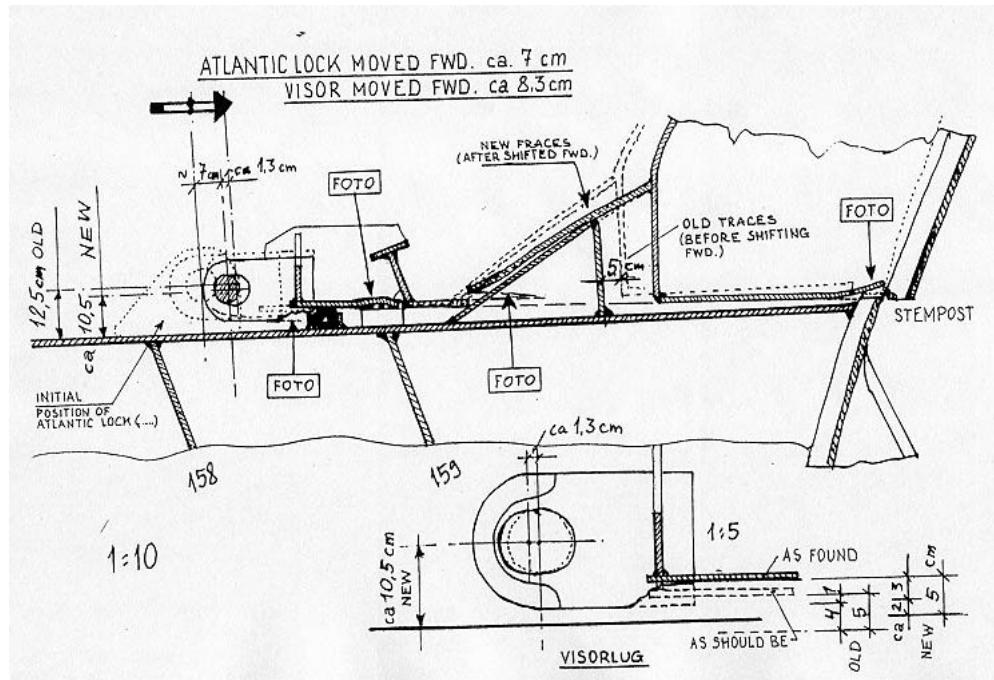
(3) At least 2 fatigue cracks had penetrated the stempost already by about 50% when ice paint was applied the last time which was between 10 and 14 January 1994 in the shipyard at Naantali. During the following nine months up to the casualty the cracks had to propagate further and the lowest one did fully penetrate the stempost which led to the breaking away of part F 3 (see drawing below) and the creation of a corresponding hole in the visor bottom and, consequently, the faster flooding of the visor inside at sea.

The drawing below shows the fatigue cracked stempost from the side and from forward.

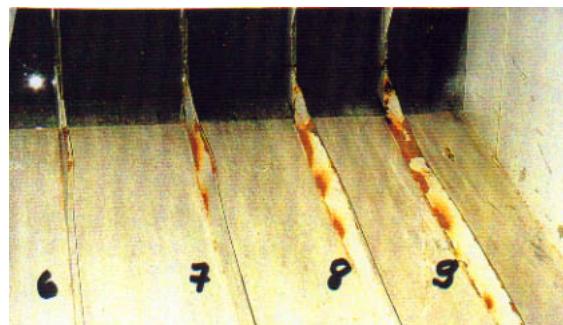
There is no sheet available for this part of the visor. The pictures show the inside of the aft part of the ramp house with 9 vertical webs each at its forward- and aft-parts. The webs are of the hp profile-type and measure 160 x 7 mm. The 4 webs at the port side of the aft part - numbered 6 to 9 - were indented to varying extent as can be seen on the picture below. Web 6 was evidently just slightly touched while web 9 was pushed flat.

»Undamaged webs are abt. 155 mm high. There are 9 pcs webs in all. Webs # 1 to 4 from the sb side are essentially undamaged, but the paint has been scraped off all of them in a line abt 20 mm down from the ramphouse upper horizontal surface plate (top). Web # 5 is already very slightly deflected towards port and measures at 150 mm (against 155, see above). Web # 6 is deflected so that 140 mm remains, # 7 has 100 mm, # 8 has 60 mm and # 9 has 20 mm standing, while the rest of that web has been deflected to port. The depth of damage (deflection) is thus quite linear between webs 6 and 9. However the point of max damaged paint at # 1 to max deflection at # 9 seems to follow a gentle curve dropping downwards as you look to port. The ramphouse after plate with the damaged webs below.«

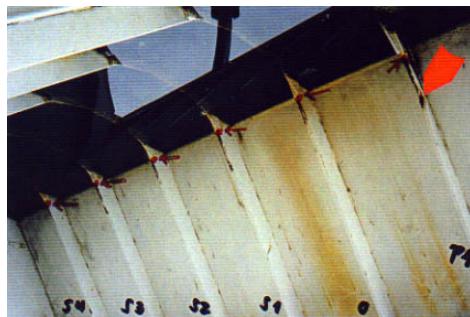
The damage is most extensive at web 9 and then decreasing until web 5 which, as well as the starboard side webs 1 - 4, are not affected at all - see picture below. The visor must have been misaligned by ca. 4-5° in relation to the bow ramp being connected to the vessel.

The arrow indicates the point of contact on web 9. The next frame 5, which is the centre line, and the following frames to starboard have no marks at this level.

This means that when web 9 came in contact with the port side of the bow ramp and was pressed together from 160 mm to 20 mm the corresponding web 1 at the starboard side of the ramp house was 360 ./ 160 = 200 mm away from the starboard side of the bow ramp. Due to the narrow construction, such a misalignment of the visor is not possible as long as the visor lugs move within the forecastle deck area aft of the deck-beam at frame 159 and as long as both actuators are connected to the B-deck. As will be shown on sheet P 4 + S 4 this was no more the case with the foundation of the port actuator.

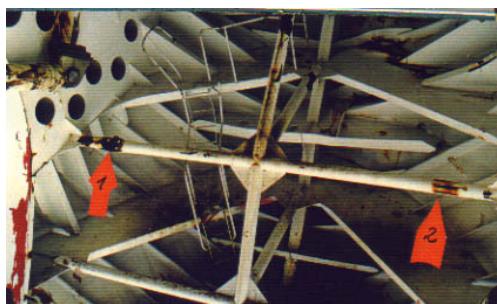
Although the upper transverse crossbar inside the visor shows respective damage - see arrow 1 on the picture below - the corresponding part at the port outer longitudinal girder of the bow ramp does not. This is confirmed by the image further down,

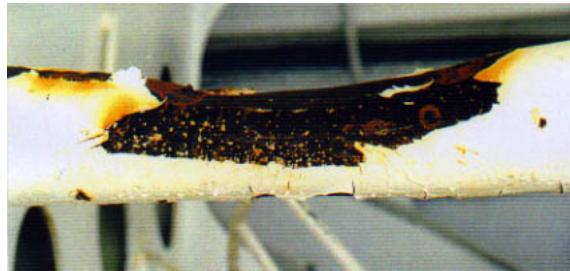
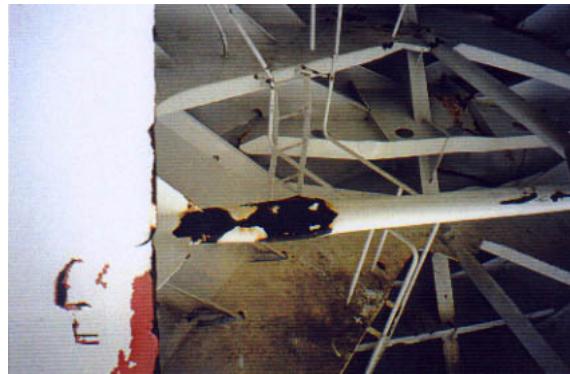
It is obvious that this quite heavy damage shown on the picture on page 961 was caused by impact - see close-up below - and that this impact did not happen too long ago because the cracked paint is still hanging loose. It cannot have been caused by the ramp, at least not at an early stage as explained before. The damage must have been caused when the visor was labouring on the ramp for more than 30 minutes until the heel of the vessel was sufficiently big to let the visor slide off the ramp. During this time, this and other damage to the

port side of the visor was created by heavy contact with the ramp.

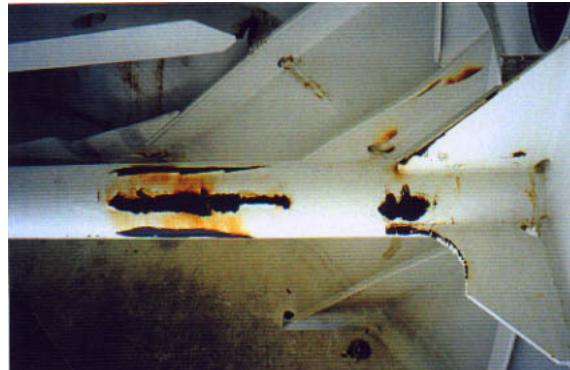
The scoring marks - arrow 1 on the photo on page 961 - at the starboard side of the same crossbeam in way of the first stringer level are not casualty related because except for the middle one the respective areas cannot be reached by the bow ramp. It has to be assumed that these scorings were caused by other means before the casualty.

The indentations/scorings at the vertical beam are discussed in **Item 8 - Internal Structure**.

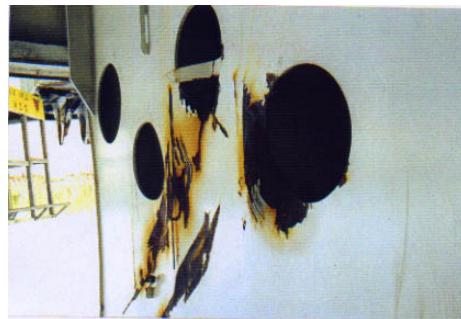
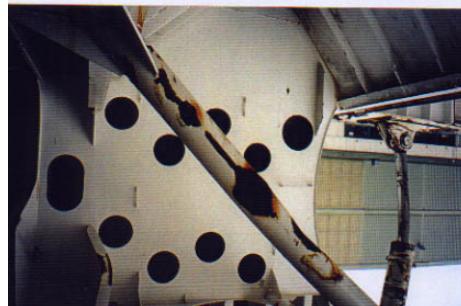
Finally attention has to be drawn to one indentation pushed at each side into the forward deck beam of the visor, i.e. the lower side of the forward part of the ramp house as indicated on the two pictures on the next page. According to drawing on page 956 the port indentation is 240 mm away from the inner bulkhead and the starboard one 325 m. This means that these indentations were most probably caused by the bell cranks being the most upwards extending parts of the bow ramp. This must have occurred at a time when the visor was hanging on the bow ramp already, i.e. the contact area having been the part inner bulkhead. Therefore the distance between bow ramp and port inner bulkhead has as small as possible - 240 mm - while the opposite distance between the bow ramp and the starboard inner bulkhead was as big as possible - 325 mm. This is also the explanation for the apparent fact that the port inner bulkhead was very severely distorted and partly cracked while the starboard inner bulkhead remained completely unaffected even without paint scratches. See also S 4 and P4 - The Inner Bulkheads - further down.

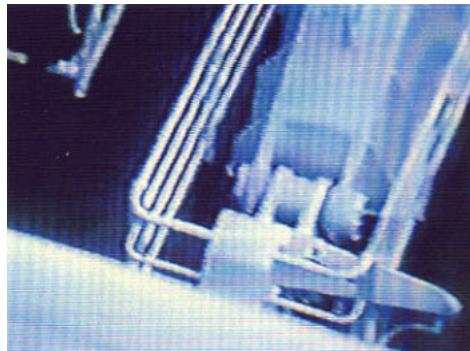
1 - shows the remains of the starboard hinge plates still attached to the visor (they were cut off upon the instructions of the JAIC in January 1995 and were transported to the Royal Technical Institute (KTH) in Stockholm for examination). The very bad condition, especially of the outer hinge plate is obvious. The deep burning marks and the missing metal are striking. All this is confirmed by the video film made by a passenger on 17.09.94 from the open forepart of deck 8 - see also Subchapter 12.5 - i.e. 10 days before the catastrophe. The image below shows a sequence of this video.

It demonstrates that,

- the whole hinge arrangement is severely misaligned;
- the outer bushing is extending too much to the outside and is twisted;
- the lower part of this bushing as well as the securing plate are missing;
- there is a big gap between the inner part of this bushing and the outer hinge plate fitted on the forecastle deck;

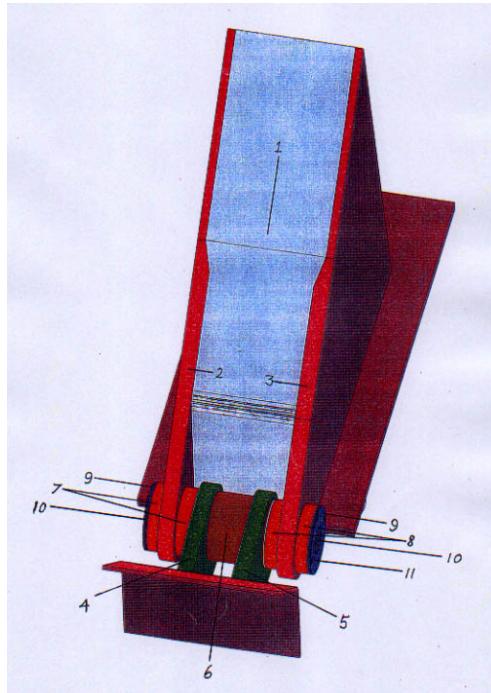
The drawing was taken from the report of Bryan Roberts.

The bushing, obviously having broken out of this inner hinge plate, was recovered by divers and was thus available for examination also by the metallurgical expert on behalf of this 'Group of Experts' and reference is made to the Report of Prof. Dr. Hoffmeister - see Subchapter 34.4 - Enclosure 30.417. Further, the recovered bushing is shown in detail on Sheet 3 and shall be discussed subsequently.

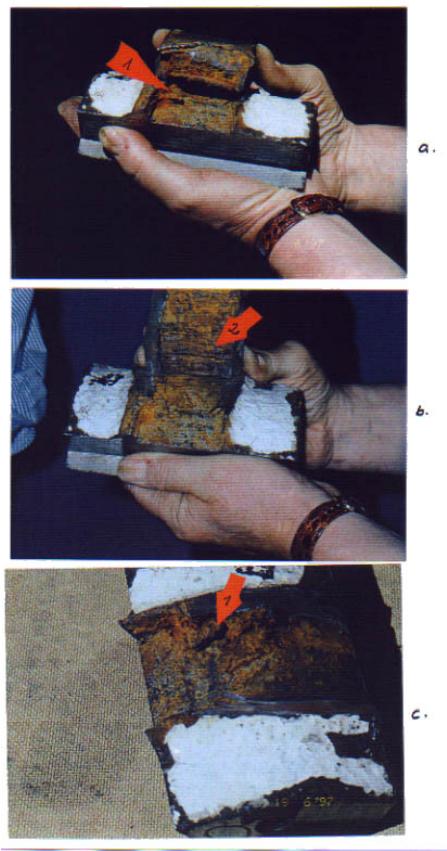
- The inside of the hinge plates were damaged by deep burning marks (see arrow 2 on picture b) from which crack propagation into the material of the hinge plates started and after the cracks had penetrated 50-60% of the material the remaining part of the hinge plate failed in the shear mode.
- The surface of the bushing, corresponding to the inside of the hinge plate with the burning marks explained above, does not show burning marks, therefore it has to be assumed that the original bushing was burned out some time before the casualty and replaced by the present one.
- The gap between bushing and hinge plate in way of the fracture area was about 25 mm indicating that the bushing did not fit into the hole of the hinge plate because the bushing was too small.

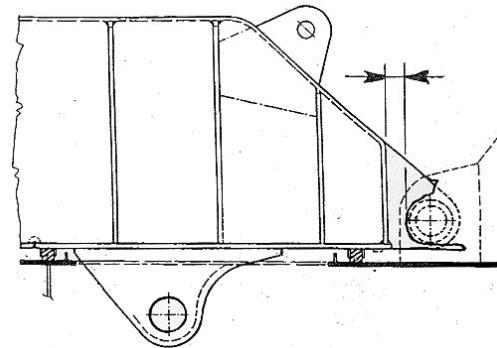
Note: When measuring the distances from the vertical welding seams between face plates and hinge plates and the inside of the bores through the hinge plates it becomes evident that at the starboard hinge plates there is about 15 mm less material than at the port hinge plates. This means that the visor was misaligned at least by this distance of 15 mm in the forward / aft direction. See the drawing below.

This means that the distance between the 2 arrows above was 15 mm smaller at the starboard hinges compared to the port hinges. This was certainly one of the reasons why the starboard hinges broke first and the port hinges were holding for some time longer.

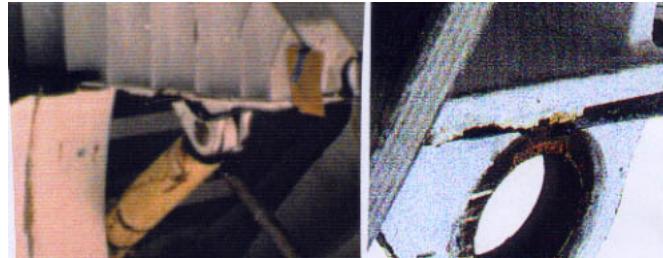
1/2 - show the outer lug plate of the actuator underneath the visor arm which is evidently completely undamaged with the white paint untouched, which is confirmed by the two pictures below.

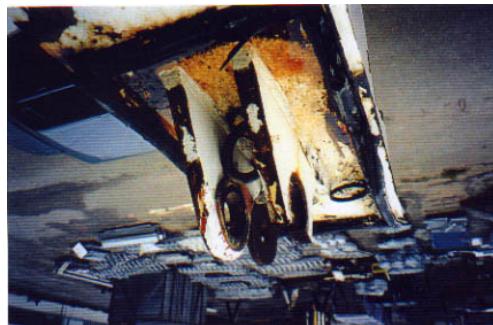
3/4/5 - show the opposite inner lug plate with very deeply engraved scraping marks, furthermore all three pictures show that the rubber packing, which is supposed to seal the opening for the actuator in the forecastle deck, is - contrary to the starboard side - torn and damaged.

This picture on the next page shows the damaged and torn rubber packing indicating movement of the visor without this side having been raised up.

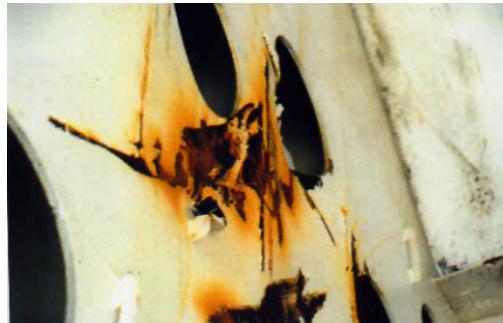
1 - shows the port actuator in jammed condition inside the inner longitudinal bulkhead of the visor. The spherical bearing of the actuator allows a 15° deviation to both sides. The actuator evidently swung into this jammed position after the visor had moved enough forward and after the bow ramp inside the visor was low enough. Thereafter the actuator remained in this position until being dismounted by MacGregor, Turku, in February 1995. The picture below shows the port inner bulkhead after the actuator had been removed.

Measurements revealed and photos confirm that the foundation of the actuator has not been in contact with the plating of the inner longitudinal bulkhead of the visor. Therefore the above visible indentations, scraping and scoring marks have been caused when the visor was hanging on the bow ramp. See also Subchapter 29.2 - The Bow Area - and P 7 further down in this subchapter.

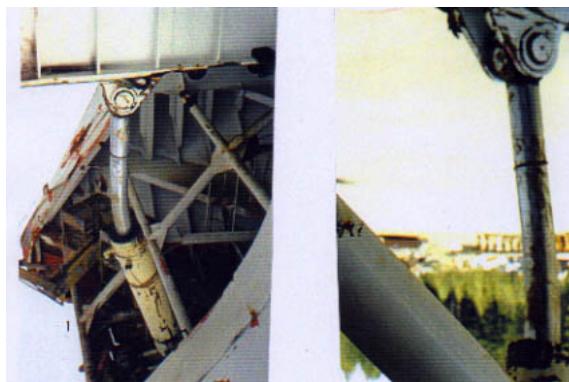
from starboard side & from port side

Note: The starboard actuator which the JAIC did not consider worthwhile for examination shows less scoring on the piston rod as can be seen on the pictures below.

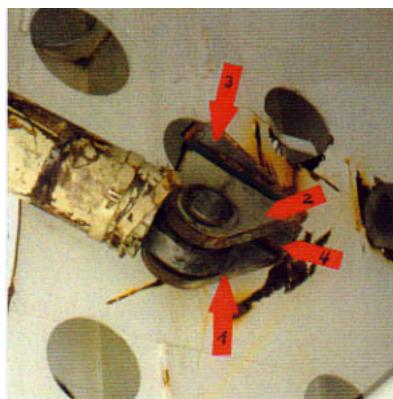
In consequence of this statement the photos showing the damage condition of this foundation have been analysed in detail and the result is outlined below: The foundation of the visor actuators did consist of two strong lugs welded to the B-deck and which were supported by two longitudinal and two transverse stiffeners. The picture below shows the port foundation with actuator still attached to the recovered visor. The arrows indicate the different components.

- arrow 1 = port outer lug plate of actuator foundation
- arrow 2 = port inner lug plate of actuator foundation
- arrow 3 = port inner stiffener (deformed)
- arrow 4 = port outer stiffener

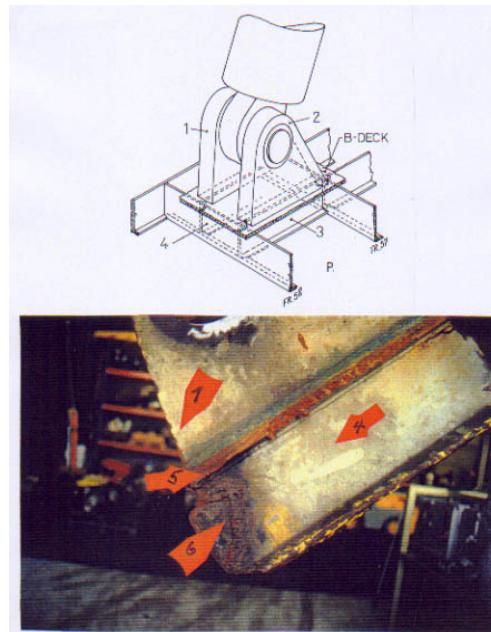
On the above photograph the reader looks on the lower part of the port outer lug plate (arrow 1), i.e. from port to starboard. Arrow 5 points to the remains of the B-deck, to which the port outer stiffener (arrow 4) is still welded. In the forward part of that stiffener an old temporary repair with very poor welding seams is visible (arrow 6). A close-up is shown below.

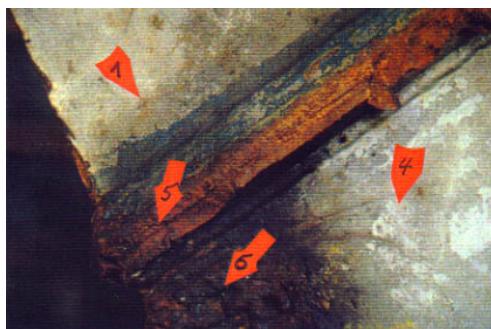
The lug plate (1) was obviously only partly connected to the B-deck as can be seen from the above photo when it was ripped off the B-deck (5) and only a small part connected by the welding seams (green paint) remained with the actuator foundation. The deck as well as the stiffener were pre-damaged - see Subchapter 34.4 - [Enclosure 30.417](#) - which is indicated by the damage repair, but also by the more or less straight cracking of the stiffener forward and aft of the lug plate, as can be seen on the following photograph.

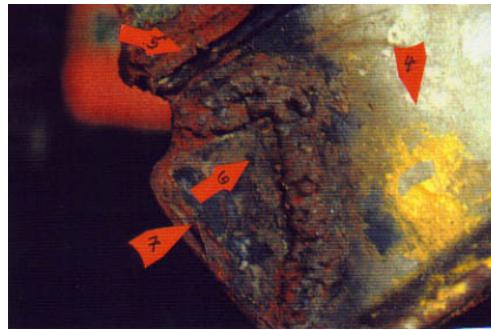
Due to the relatively straight cracks (7) directly below the forward and aft parts of the lug plates, it has to be assumed that the stiffeners in way were affected by fatigue cracks. The cracks had developed during some considerable time before the casualty due to load changes during opening/closing of the visor and did most probably propagate more quickly during the last month before the casualty because of the increasing difficulties with the visor, especially with the port side. See Subchapter 12.4 / 12.5. The following drawing demonstrates the above.

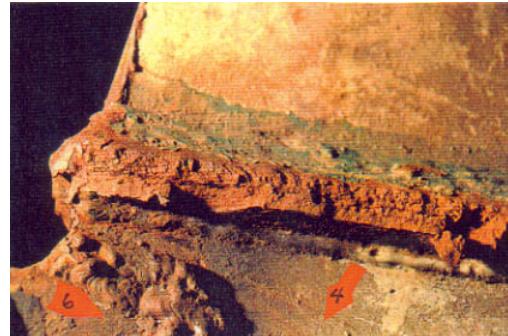
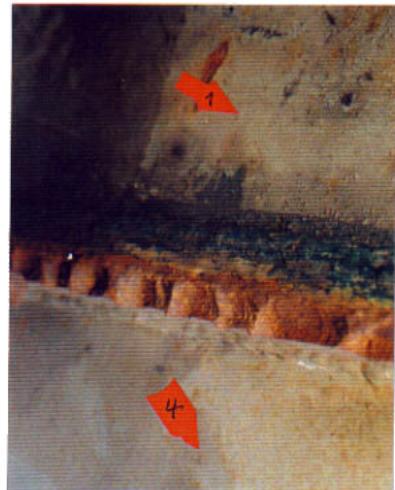
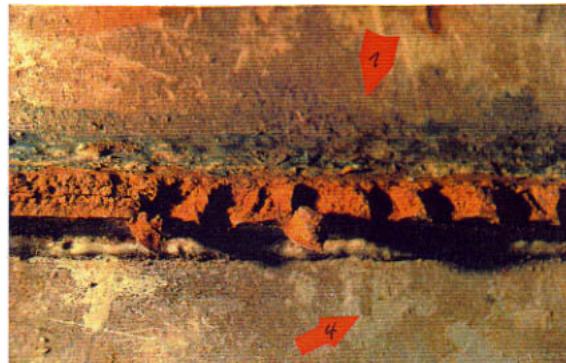
The following photographs indicate the condition of the B-deck in way of the port visor actuator foundation. The reader looks to the port outer lug plate and follows on the next 4 photos the ripped off B-deck remains from forward to aft of the outer lug plate. For easy reference the photographs are marked with the previously used arrow numbers.

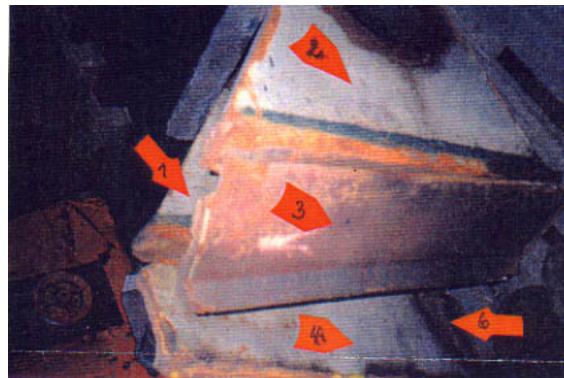
The following photograph shows the actuator foundation after it was removed and taken to the workshop of MacGregor, Turku for examination/testing on behalf of the JAIC. The arrows show the same numbers as used above.

As it is obvious from the close-ups below, the stiffener (3) was hardly spot-welded and thus only slightly connected with the B-deck. As this part of the stiffener is not painted at all - see the next photo to which the reader looks on the port inner lug plate from starboard to port - it is no more original, i.e. has been installed subsequently when the vessel was trading already.

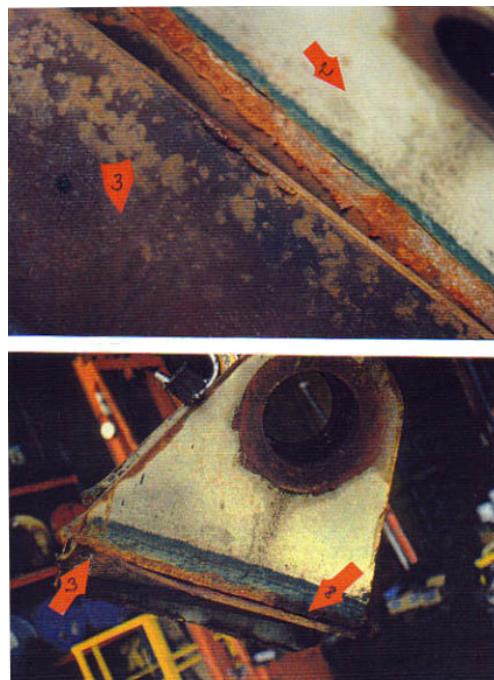
The apparent fact that this stiffener (3) had been disconnected from the B-deck (5) respectively since the last repair was never really fitted to it, is further confirmed by a part of the welding seam - see arrow 8 - on the previous two photos - apparently being soaked with oil while the stiffener below is unaffected. This means that this stiffener was not welded to the B-deck.

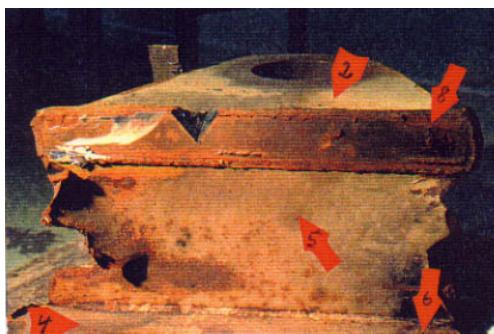
The following photograph shows the port visor actuator foundation after parts had been cut out for testing purposes. The foundation lies on its port outer lug plate. In the front the port outer stiffener (4) is visible, which is fully welded to the B-deck (5). Further at the forward right corner the old temporary repair with the very poor welding seams (6) is visible from inside. For cutting purposes the port inner stiffener (3) had been removed.

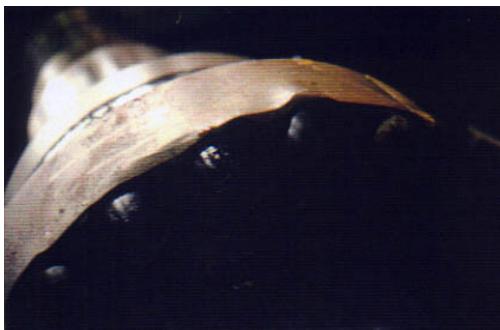
"... it was noticed that there were heavy damages at the distance when the piston rod is about 400 mm open. The damages were on the starboard side of the piston rod. Damages were also noticed on the piston cover's fixing screws. The ends of these hexagon screws were like hammered." (See [Enclosure 29.413](#))

- **The port actuator:** Cover and hexagon screws on the piston rod side are severely hammered. The clamping ring is missing. The outside of the actuator shows heavy longitudinal scoring marks. The piston rod shows heavy damage on starboard side at a opening stage of ca. 400 mm.

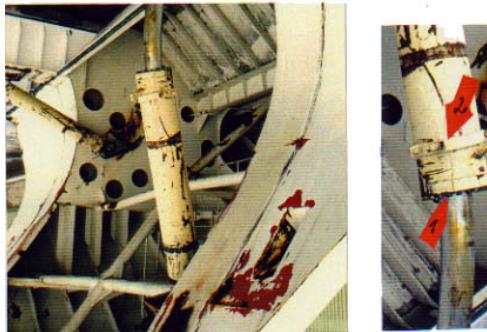
This is different at the starboard actuator as can be seen from the pictures on the next page with close-up of the area of interest. The arrow 1 points to the hexagon screws looking absolutely identical and which are evidently not hammered at all. Arrow 2 points to a clamping ring in apparently undamaged condition which had obviously not been exposed to hammering or otherwise heavy contacts. The differences between the external conditions including the hexagon screws of the port and starboard actuators can be explained as follows:

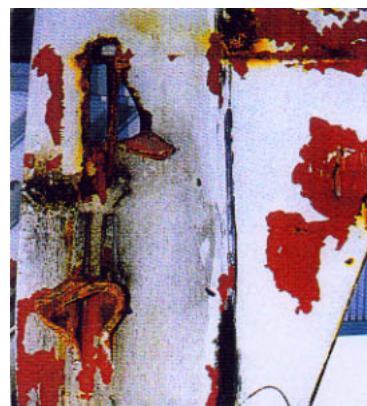
2, 3 - show the area of the missing side lock lug and the considerably bent hooks of the manual side locks from the top and from the side. The side view shows that the area in way of the pushed out steel tongue - see arrow 1 - is bulged outwards indicating pressure from inside to outside, whereas the plating between the hole for the lug and the hooks shows smoke marks, which are explained in Chapter 32. Around the opening for the lug burning/welding marks from the cutting off and the subsequent rewelding of the lug are visible. The following picture has been taken from the JAIC Report and clearly confirms the above.

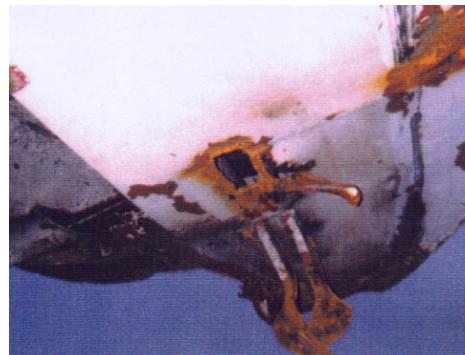
The picture below taken on 23.11.94 shows the lower part of the starboard aft visor bulkhead including the area under discussion looking downwards which is obviously very dark.

Note: According to the observations of previous passengers, for example truck driver Torbjörn Cederqvist - see [Enclosure 12.4.3.157](#) - Subchapter 12.4 - both lugs had frequently been burned off when the crew was unable to open the side locks hydraulically upon arrival in Tallinn. Obviously they were subsequently rewelded to the same location.

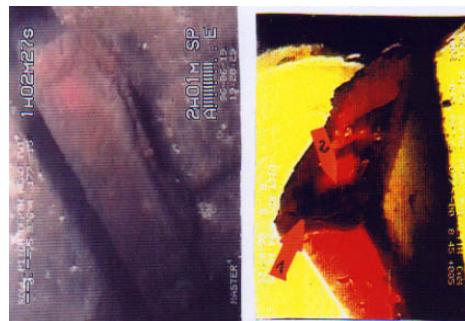
It is also obvious from the condition of the starboard lug as can be seen from the two video images of the corresponding lug still attached to the bolt on the wreck that the lugs had been repeatedly cut off and rewelded.

The very thick welding seam on the lower part - see arrow 1 - is actually a build-up of several welding seams, i.e. weld on top of the previous weld without grinding away of the remnants. It is obvious that the bulkhead part attached to the lug - see arrow 2 - had not been torn out of the bulkhead during the casualty scenario but much earlier because, due to the thickness of the accumulated welding seams, this original part of the visor bulkhead (Viking Line colour) could not come in contact with the adjacent visor plating. Consequently, it has to be assumed that each time the lug was cut off by burning it was just stuck into the respective hole in the bulkhead and welded from both sides, if at all - see also Chapter 29 - S 4.

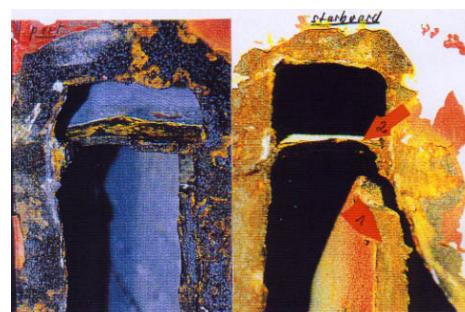
The next pictures - also taken from the JAIC's Report - show the upper parts of the holes in the visor bulkheads where the lugs had been fitted.

The analysis and comparison of both pictures reveal the following:

(1) The plating around **the port** holes is unaffected. Some remains of welding seams are visible at the upper right corner and at the right (inside) there are indications that welding seams could have been there. At the outside (left side) there are no such indications which refers also to the upper hole. Only few spots of corrosion can be seen. In summary it has to be assumed that the lug had not or only to a very limited extent been welded from the outside.

(2) The plating around **the starboard** opening looks completely different because the plating is distorted, the stiffener at the inside is torn off the bulkhead, the plating had apparently been exposed to heat and subsequently became corroded. The steel part between the small hole and the bigger opening was pushed upwards, obviously by the lug then and still attached to the vessel, i.e. the visor made a downward movement in relation to the lug, i.e. the vessel. Thereby the lug was pressed into said steel part. The indication of the remnant of a welding seam is visible at the upper right corner of the big opening. Otherwise there are no indications of welding seams at all.

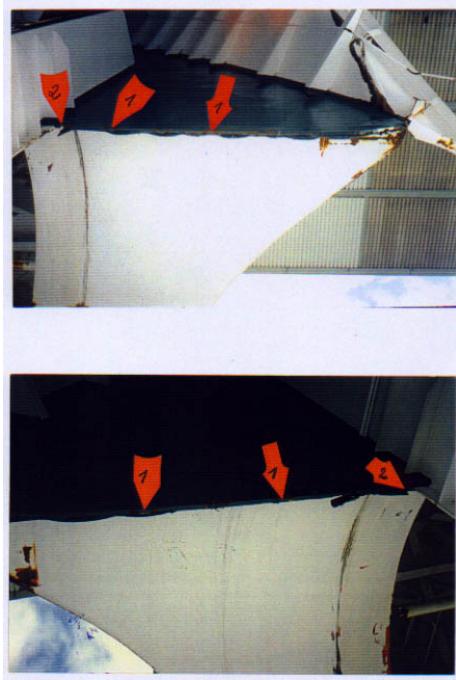
In addition, attention has to be drawn to both aft parts of the visor deck shown on the two pictures overleaf. The corroded areas indicated by arrow 1 on both sides have been the spots where the visor had been welded to the vessel at the time when the bushings of the starboard visor hinges were renewed. This was the time when ESTONIA berthed in Tallinn stern first - see the statement of Torbjörn Cederqvist - Enclosure 12.4.3.157 and Subchapter 12.4.3 - the cars left the ferry via the stern ramps instead of the bow ramp as it is normally the case in Tallinn.

Arrows 2 on both sides indicate the corner between visor deck/aft bulkhead and visor arms along which the rope was running by which the bow ramp was kept close as tight as possible. The drawing below show the forecastle deck with the two winch drums by which the rope was heaved tight and the two fairleads around which the rope was running.

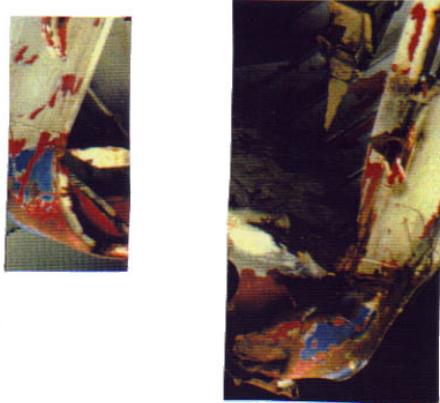
- (6) The hooks were crushed together in such a way which cannot be explained mechanically.
- (7) The bottom end of the aft bulkhead is partly crushed, partly torn and on the outside a deep fold in way of the contact area with the rubber packings of the corresponding front bulkhead of the vessel extends from the area of the lug down to the bottom area. - See the right picture on the next page. The corresponding area on the lower part of the port aft bulkhead of the visor, as can be seen on the left picture on the next page, is apparently undamaged.

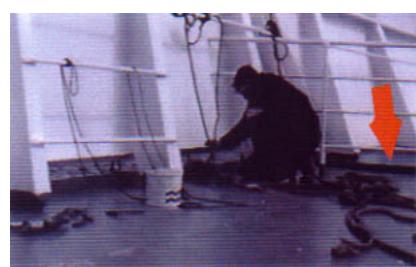
According to the observation of Bo Pettersson the port outer edge of the visor was extending the forecastle deck to such an extent that he could see the water through the gap. He estimated the difference between visor and forecastle deck to have been about 100 mm. Although crew members hammered with sledge hammers on the edge, the condition did not change and they gave up.

The image following shows the area in question. The arrow indicates where the crewman was hammering.
