THE GERMAN 'GROUP OF EXPERTS'

THE GERMAN GROUP OF EXPERTS

16 THE CONDITION OF "ESTONIA" AND THE STATUS OF HER MAIN CLASS AND SAFETY CERTIFICATES BEFORE COMMENCEMENT OF HER LAST VOYAGE

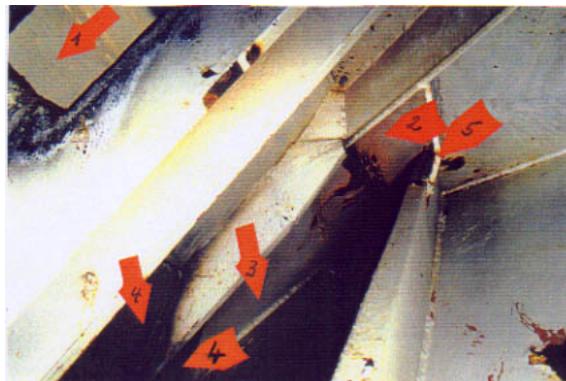
(a) The locating horn does not reach its pocket anymore and caused damage to the plating below - see picture 4 - which was tried to be rectified by welding doubler plates - see picture 5 - below the holed plating and the picture below.

arrow 1 = opening cut around the holes where the lug had been located
 arrow 2, 3, 4 = doublers fitted
 arrow 5 = buckled bracket

The fitted doublers and the buckled bracket points to an area exposed to high stresses and apparently also to damage which has certainly to be seen in connection with the severe misalignment of the visor.

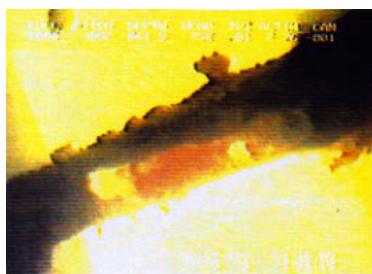
The following image shows the lug attached to the bolt inside the vessel before it was pulled out by the diver. Contrary to the starboard side this lug rested inside the bulkhead as visible, although it was on the high port side.

The next image shows the same lug after having been pulled out by the diver. Arrow 1 indicates the very thick accumulation of welding seams and arrow 2 indicates the bulkhead part torn or cut out at some time before the casualty.

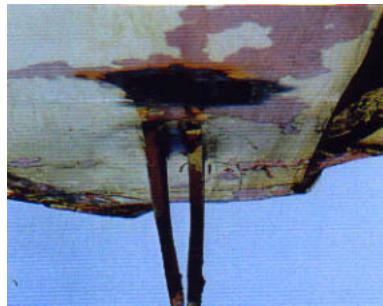
The hooks for the manual side lock were just bent together, as can be seen on the picture on the next page. The area around the lug location shows burning marks obviously from cutting off the lug by flame cutting - see arrow - but no smoke marks as on the starboard side and the plating was not pushed out/distorted.

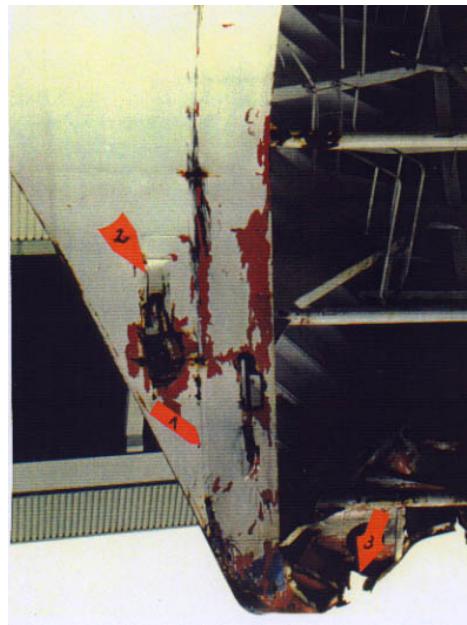
7 - shows the rubbing marks from the rubber packings at the vessel's front bulkhead which are straight in the upper part and slightly irregular in the lower part. The picture on the next page shows the lower port aft bulkhead. It becomes evident that the area below the pocket for the locating horn does not show any rubbing marks - contrary to the starboard side - which leads to the conclusion that the rubber packings at the front bulkhead of the vessel were missing also in this important location - see arrow 1.

The pressure mark of the locating horn inside the pocket - see arrow 2 - indicates pressure on the visor from port to starboard, which is a further indication for the severe misalignment of the visor.

Arrow 3 indicates a damage apparently caused when the visor fell off the bow ramp in the final stage when the heel of the vessel was already 120°/130° to starboard. This will be further explained in the following item 6 - The Visor Bottom.

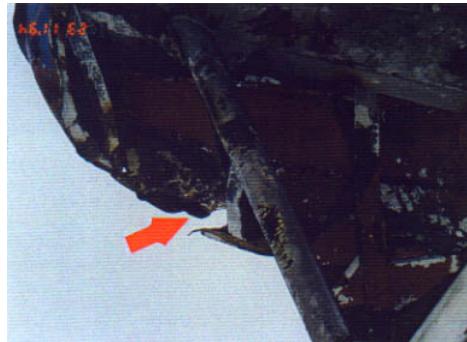
8 - shows the lower aft bulkhead/visor bottom which is only moderately damaged compared to the starboard side - see also the picture below.

The arrow points to a damage to the port aft edge of the visor bottom which apparently occurred when the visor moved transversely from port to starboard. This will be explained in Chapter 31 - The Casualty Scenario. See also picture 5 on the following Sheet 6.

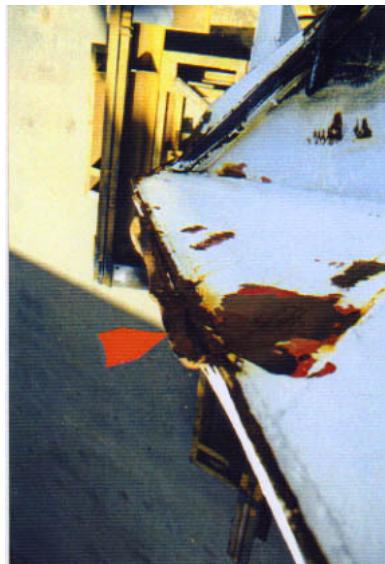
1 - shows the upper part of the aft bulkhead with the moderately affected recess which has already been discussed at the beginning of this item. The picture on the next page shows the recess as enlargement with damage at the edge of the shell plating - see arrow - which obviously occurred when the visor was moving in the transverse, i.e. athwartships, direction. - See also Chapter 31 - The Casualty Scenario.

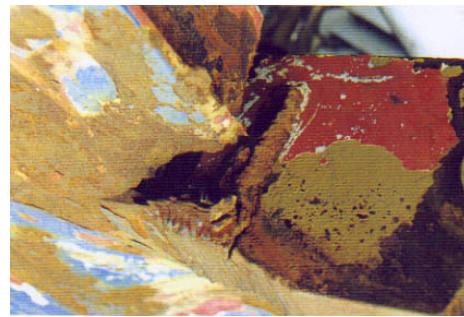
1 - shows the visor lug being part of the Atlantic lock. Arrow 1 points to the previously burnt off part of the lug with cracks propagating from burning marks (arrow 2). The lug apparently became twisted to starboard when the visor moved abruptly to starboard until its port inner bulkhead rested on the port side of the bow ramp. The deep crack in the bottom of the visor to port of the lug confirms this. It further indicates that the visor lug was about to crack off the visor bottom when the lugs on the forepeak deck failed first. This is underlined by the impressive picture below indicating an upwards and to starboard movement of the visor when this big crack propagated and came to a stop when the lugs on the forepeak deck failed.

2 - demonstrates the elongation of the lug which is partly due to wear over 141/2 years and partly due to manipulation by Christer Koivisto already in 1982 - see Chapter 12.4.

3 - shows the yellow basic primer - see arrow - used in the whole forepeak area by the Yard during newbuilding.

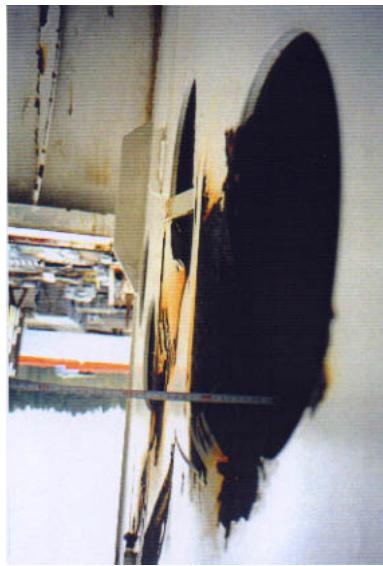
1 / 2 - show the port inner longitudinal bulkhead with scraping/scoring marks at the lower aft part - see arrow 1 - and very deep indentations with the steel plating partly torn - see arrow 2 - and enlargement picture 1.1. The picture below shows that the plating was actually pressed into the bulkhead up to 120 mm.

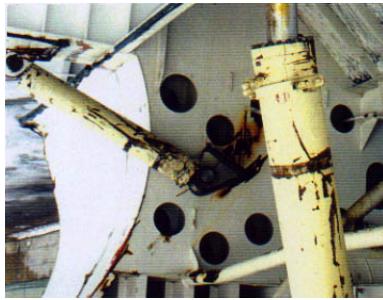
It is quite obvious that these deep indentations cannot have been caused when the port actuator was swinging inside the longitudinal inner bulkhead (due to the existing starboard list of visor and vessel) and got jammed there, as evident from the picture below.

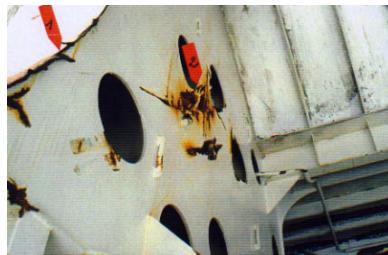
After the actuator had been dismounted by MacGregor, Turku in February 1995 the area looked as it is shown by the following picture. Arrow 1 indicates the area at the edge of aft and inner bulkheads where the aft bulkhead is slightly extending the inner bulkhead and where metal parts were torn off when the actuator moved into its jammed positions. A detailed evaluation of this and other pictures did reveal that neither the actuator nor its foundation had come in contact with the bulkhead which is due to the angle between the fastening point at the lugs below the visor arm and the bulkhead edge. The actuator was able to swing into this position because of its spherical bearings which allow deviation of up to 15° to each side.

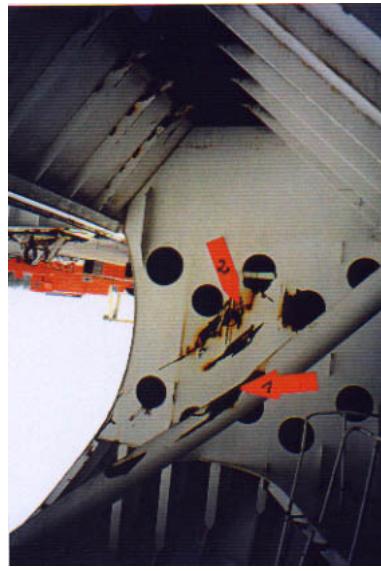
The picture below shows the port inner side of the visor with the slightly damaged frames at the port aft part of the ramp house. The upper part of the longitudinal bulkhead is completely unaffected. The scorings and the deep indentations and deformation (arrow 2) are restricted to the middle part, and, in the foreground, the vertical beam which had been in contact with the upper part of the ramp with the folded flap in between is visible (arrow 1).

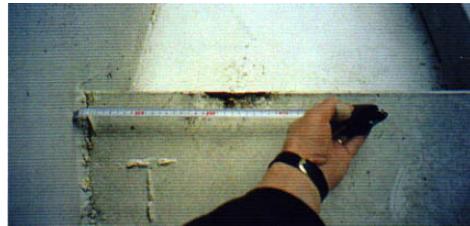
2 - shows the lower inside of the visor with the lower transverse beam in way of the 3rd stringer. This beam was found to be very severely scored and scraped, which was most probably caused during the lifting operation. The picture also demonstrates the very severely set up visor bottom which is underlined by the close-up No. 10 and explained by detail drawing No. 8. There are two further contact marks in way of the deck beam at the lower forward part of the ramp house, viz. in the most port and most starboard frame spaces, which were evidently also caused by the bell cranks of the ramp when the visor moved further forward and downwards and the vessel was already severely heeled to starboard already. See also sheet 2 - The Ramp House. The picture below indicates the short distance to the port bulkhead because of the starboard heel.

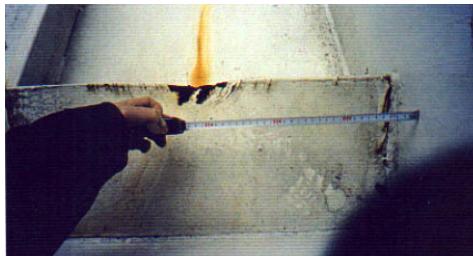
The picture below shows the starboard side with the longer distance to the starboard bulkhead also due to the starboard heel of visor and vessel.

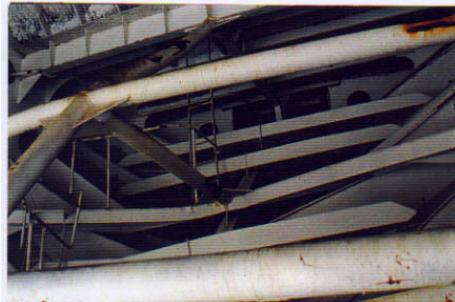
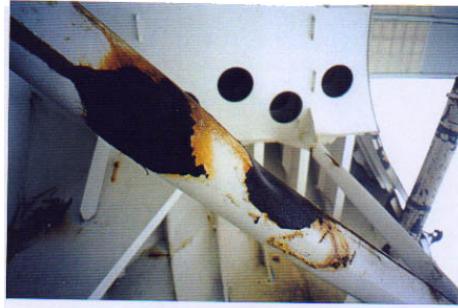
The two pictures below show the damage to the top and port side of the vertical beam.

- (1) The upper cross-beam shows damage at two locations on the port side which cannot have been caused by the bow ramp, because there was no corresponding damage at the ramp.

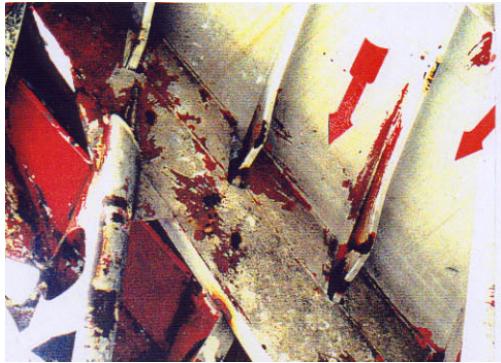
- (3) The visor had always been full of water to the outside level when the vessel was at sea. See the photo below.
- (4) The hydraulic cylinders/pipes were leaking which caused hydraulic oil to swim on the water surface inside the visor which settled down once the water left the visor.

- (5) People had been very active inside the visor, in particular on the 3rd stringer. The majority of the footprints are fresh and not covered by oil, thus originate from the time before arrival and after departure Tallinn on September 27, 1994.

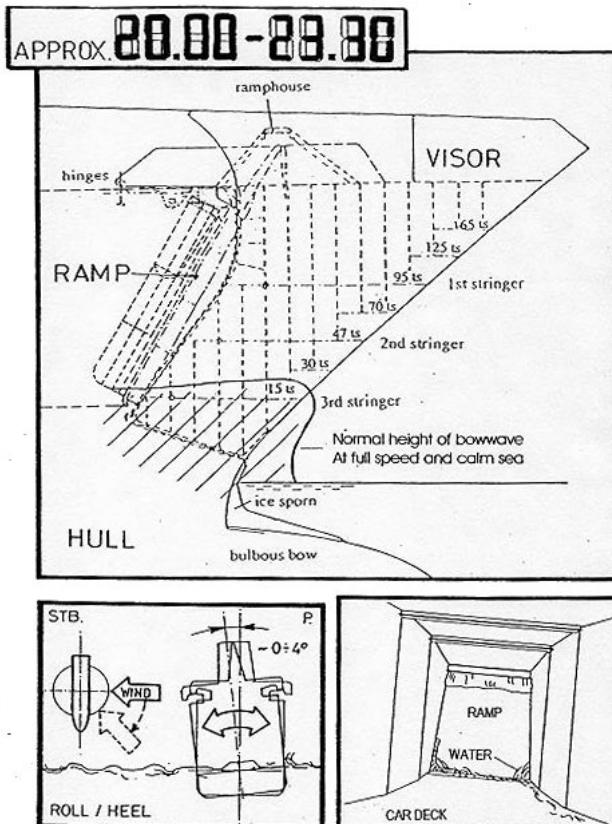
Even with calm sea the water level inside the visor was rising above the 3rd stringer when the vessel was at full speed. The lower side of the bow ramp was below 3rd stringer level, thus even in calm sea the water from the visor was penetrating the gap in the bow ramp and was flooding onto the car deck.

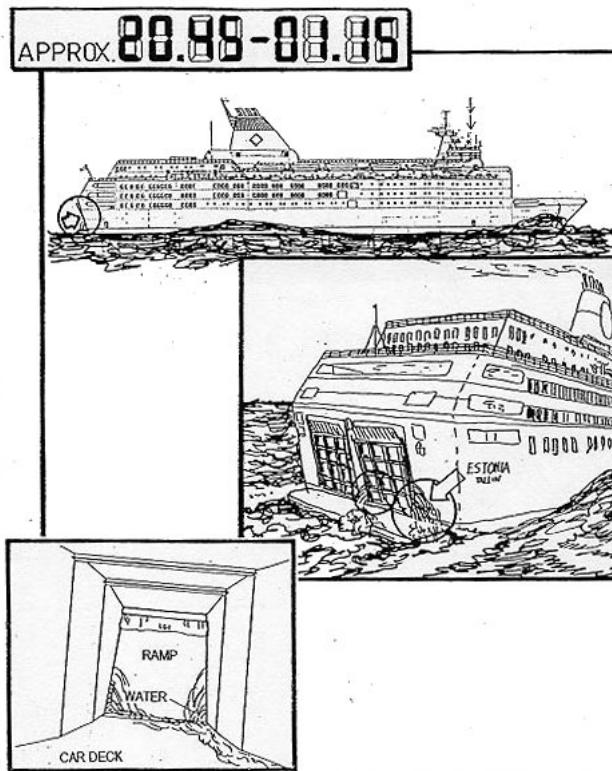
1. At ca. 20.45hrs. the aft hydraulic pumps were started on the STB. stern ramp opened slightly.
2. Due to the stern trim and the STB. heel of the ferry the water penetrating through the improperly closed bow ramp streamed off the car deck through the slightly open STB. stern ramp.
3. The high and very disturbing hydraulic noise was heard throughout the evening.
4. The vessel was pitching very hard in rough head seas.

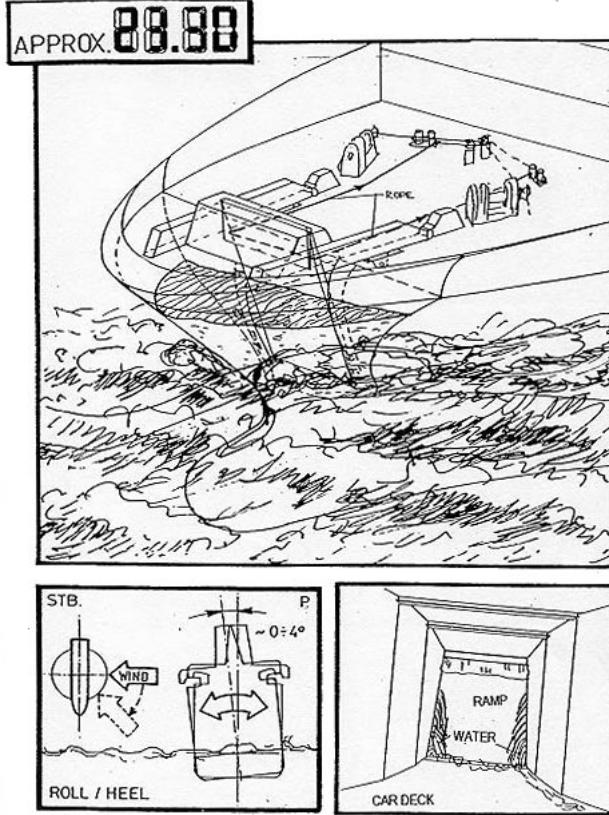
1. Due to increasing wave height and deep pitching of the ferry the water level inside the visor rose higher and the pressure on the "sealing" material
2. Water entered the car deck in increasing quantities.
3. The ferry made very hard pitch movements.
4. The bow ramp was kept more or less closed by the rope and the water pressure from the visor side, however water penetrated at both sides of the ramp
5. This was the condition on board the ESTONIA when she met "AMBER".

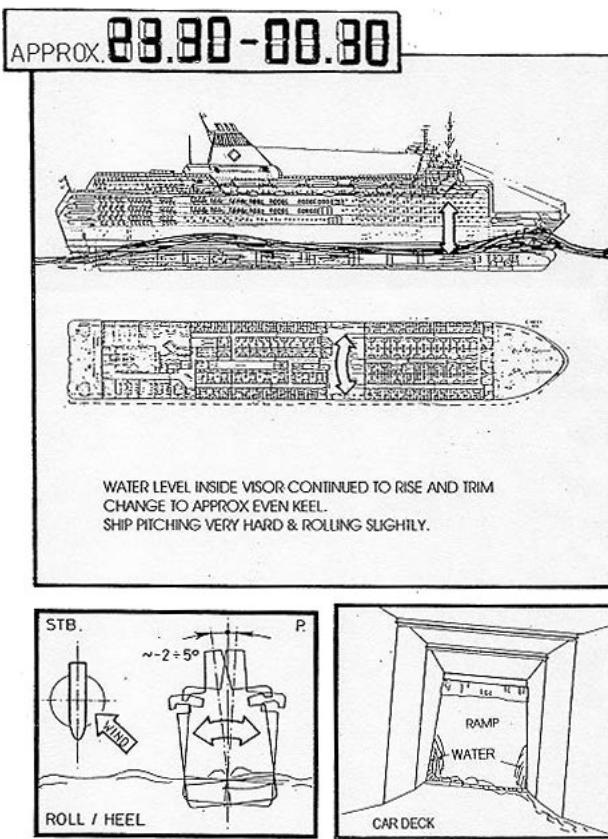
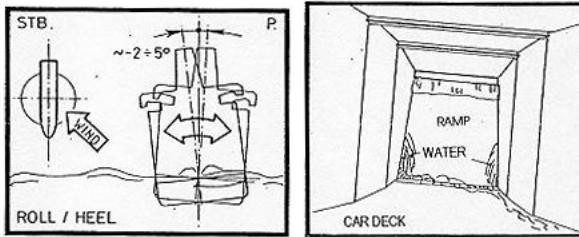
Many passengers heard low metallic banging caused by visor moving within play of locking devices due to misaligned visor, damaged stempost and missing rubber packings.

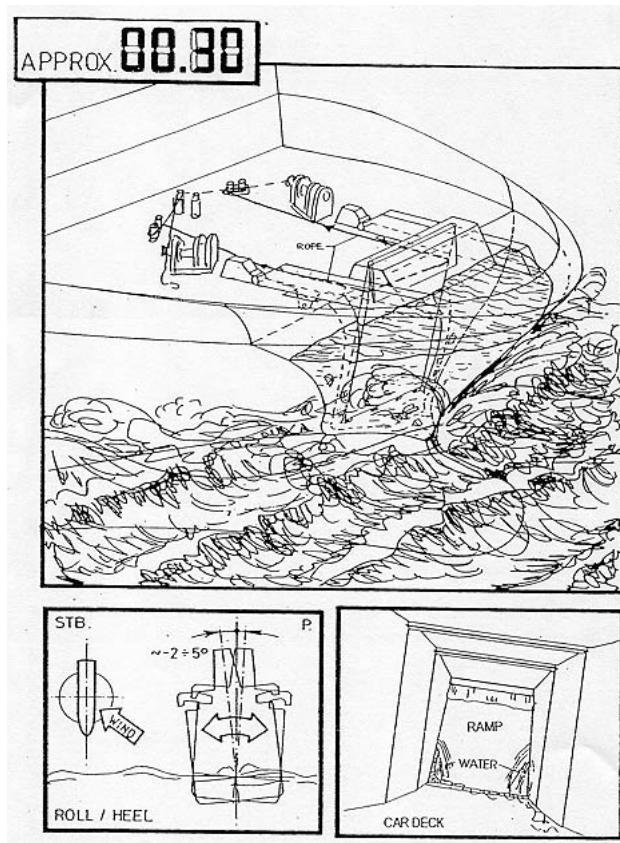
1. Stabilisers activated and possibly problems with starboard fin.
2. Vessel took green water on forecastle deck due to very heavy pitching movements.
3. Water level inside visor was rising to about 1st stringer level.
4. Water ingress onto car deck had been increasing for some time but, the accumulation of big water quantities on starboard side was avoided by the slightly open starboard stern ramp.

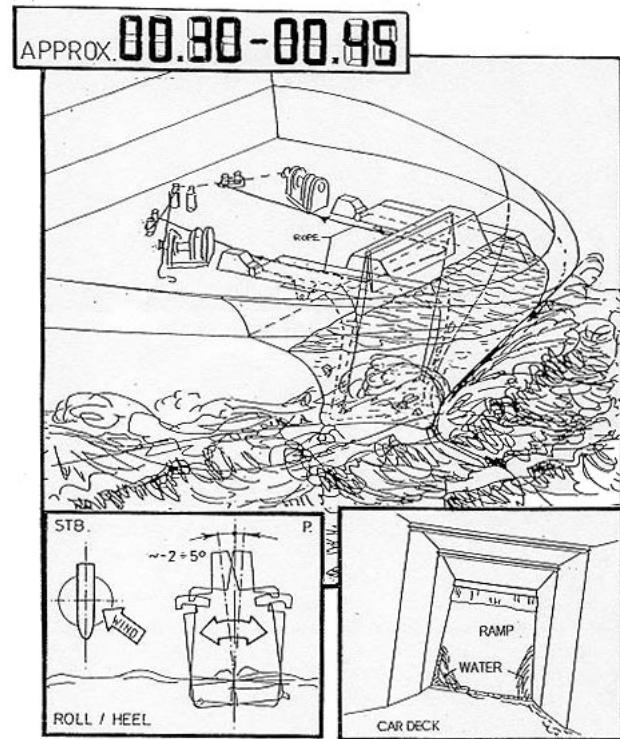
1. Low banging noises continued
2. Port stabiliser fin activated, crew started to work on the starboard fin.
3. The watch A.B. noted a lot of water on the car deck, alarmed the bridge and crew was activated
4. The course was changed to starboard and the ferry began to roll heavily, whereafter the vessel was turned back to port and started to pitch heavily. The speed was reduced.
5. The crew was working on the car deck to control the water ingress which turned out to be impossible.
6. The vessel made deep, slow pitch movements and was slightly rolling, more to starboard, less to port.

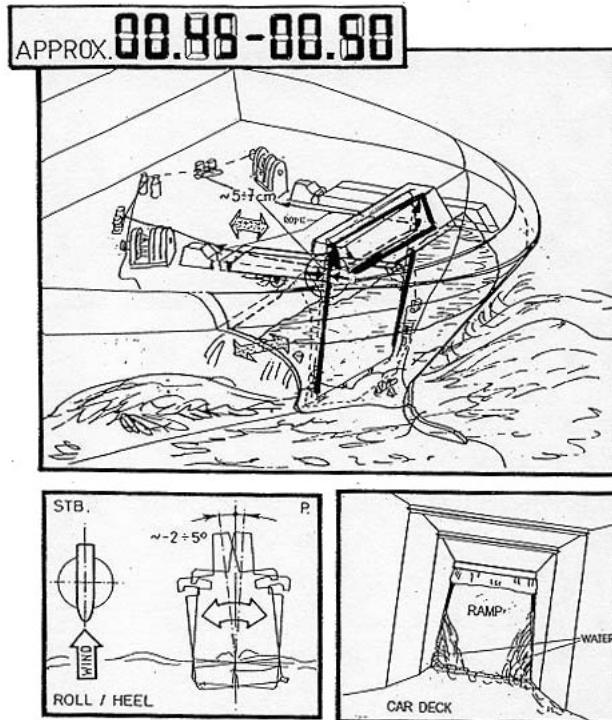
1. The crew members went on the forecastle deck through the door on deck 5 and tried to heave the rope holding the bow ramp which failed probably due to the green water taken on the forecastle deck.

2. The bow was held by the actuators and lowered down inside the visor.

3. The crew somehow managed to start the hydraulic pumps under extremely difficult conditions due to the water on the deck and the moving cars.

4. The substantially pre-damaged STB. Visor hinges failed followed by the equally pre-damaged STB side lock.5. The starboard side of the visor moved forward, the lugs cut through the deck plating and struck against the deck beam aft frame 159, the visor was pushed back when the vessel was diving into the next wave trough causing the broken visor hinge parts to smash against the hinge parts on the forecastle deck.

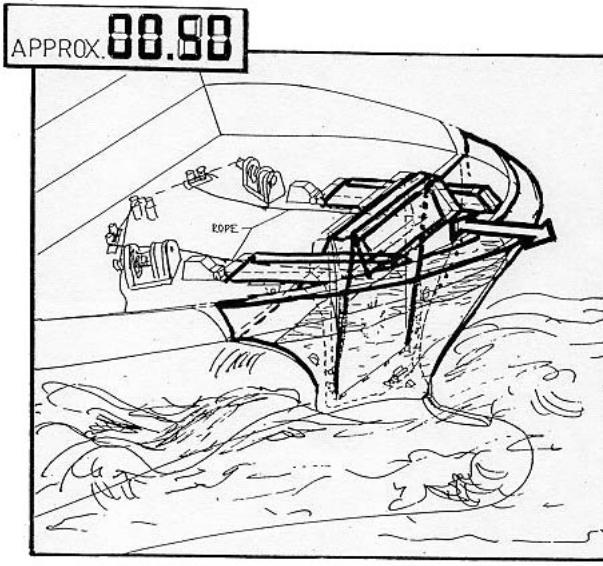
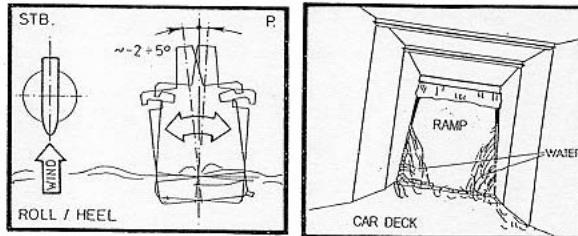
1. Also the port hinges and the port side lock failed and the visor moved forward/aft between the deck beam at frame 159 and the hinge parts on
2. Simultaneously hard scraping noises were caused by the upper flaps of the ramp scraping along the vertical beam inside the visor due to the movements in the sea

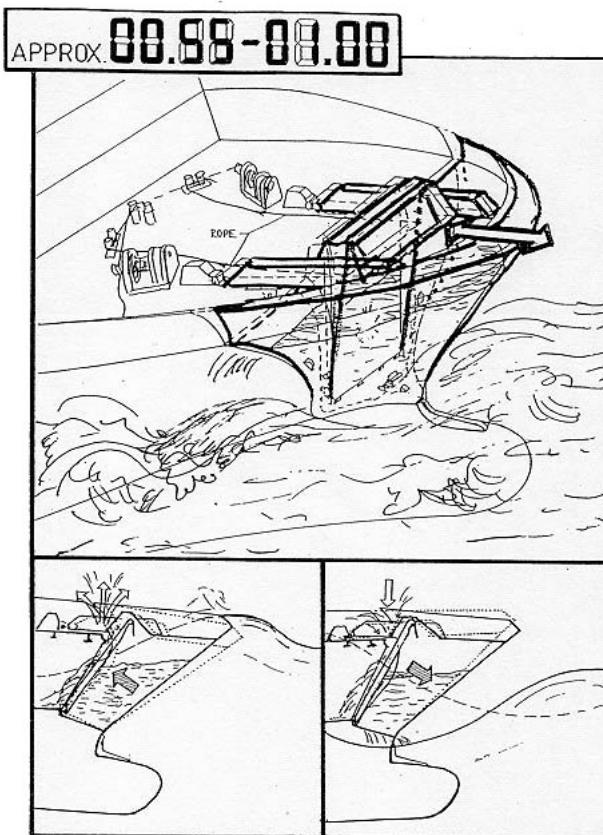
1. Hard metallic banging/knocking and scraping noises.
2. Visor moving forward /aft between the deck beam at the frame 159 and the forecastle deck parts of the hinges, the lugs underneath the visor arms were cutting through the deck beam.
3. The bow was deeply diving into wave troughs and the stern rising high up while the whole vessel was shivering.
4. The crew still working on the car deck.

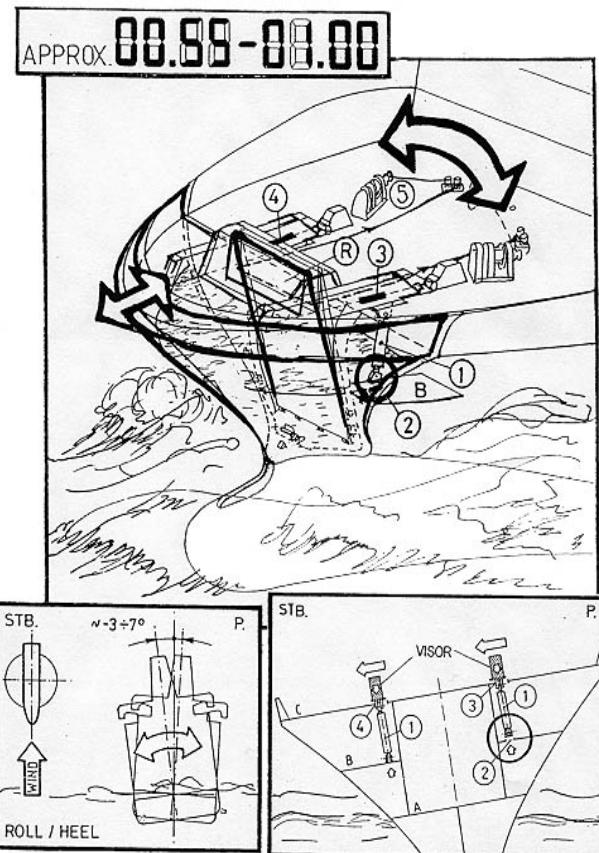
1. Hard metallic banging/knocking and scraping noises.
2. Crew tried to hold the visor by means of the hydraulic actuators (1) and the bow ramp by ropes (5)
3. The port actuator was torn off its foundation on B-deck.(2)
4. Deep contact marks occurred on the visor lug plates port inside/ starboard inside and outside. (3+4)
5. The vessel was slowly turned further to port and started to pitch and to roll.
6. The crew abandoned the attempts to hold the visor close to the bow ramp and rushed up to deck. 7. The ropes remained around the bow ramp and on the winch drums on the forecastle deck.

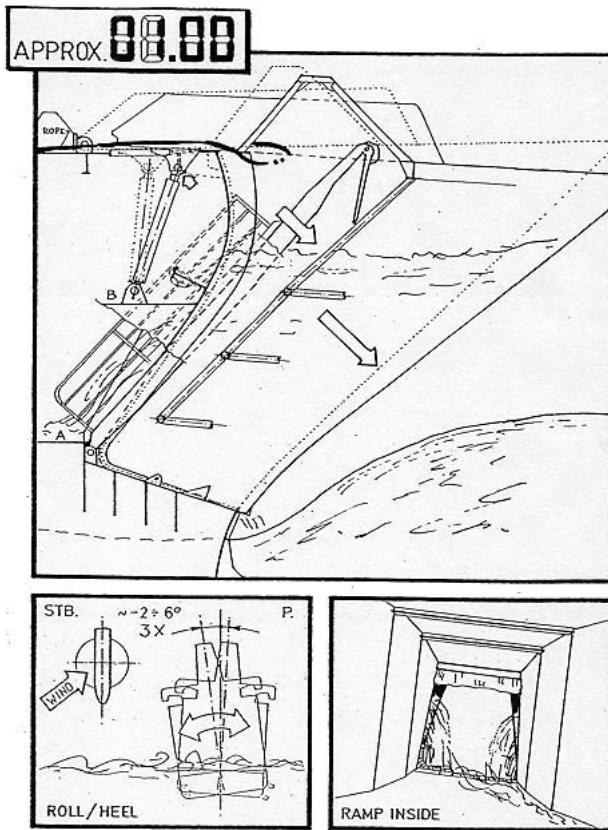
1. The visor lugs finally cut through the deck beam and the visor moved forward, the forepeak deck penetrated the visor bottom.
2. The vessel was now more rolling than pitching.
3. The ramp was inside the visor while the visor moved forward.

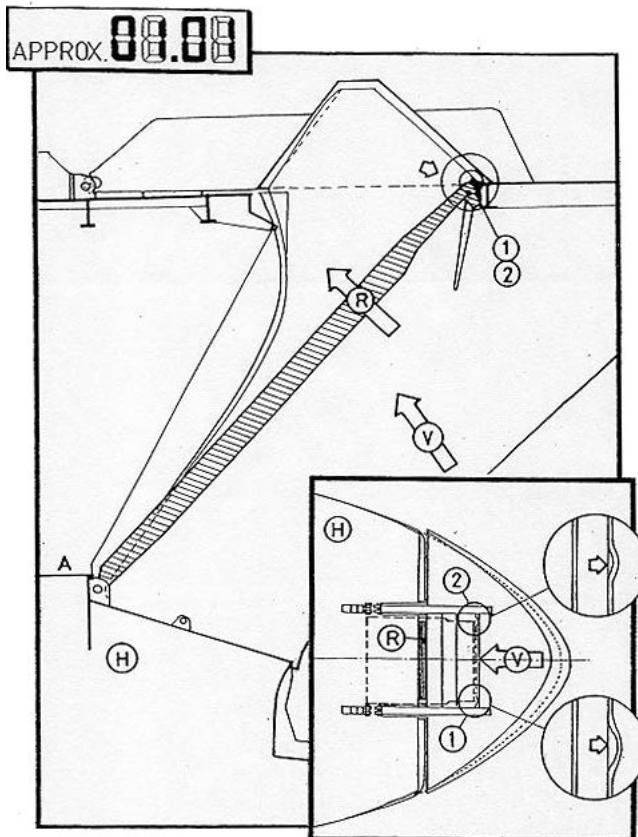
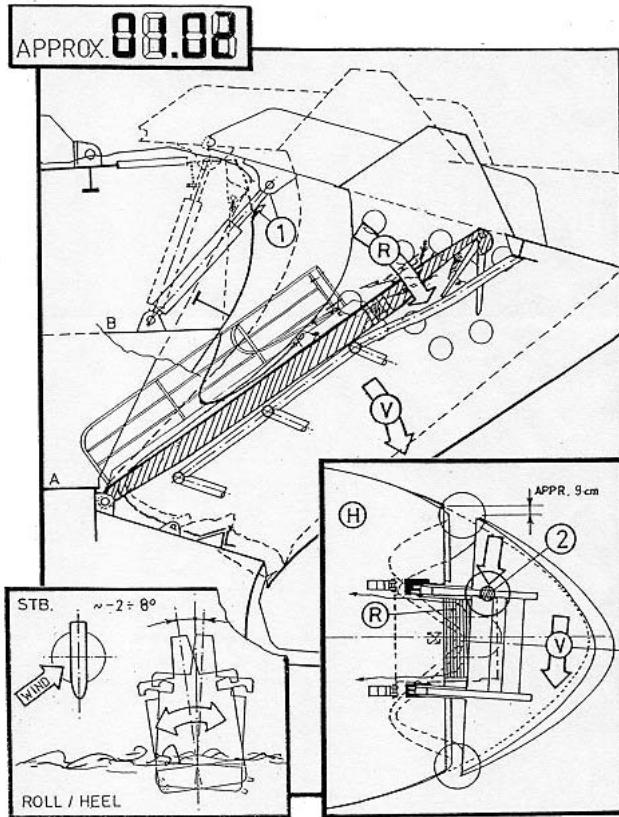
1. Vessel rolling more to starboard/less to port .
2. Visor lugs broke through the front bulkheads and did not support the visor anymore against moving towards the deeper starboard side (1)
3. With a big crash the visor fell abruptly about 10 cm to starboard until the inner port bulkhead was resting on the upper part of the bow ramp (2).
4. The visor was now extending the starboard front bulkhead of the vessel and the port front bulkhead was extending the visor.
5. The atlantic lock failed.

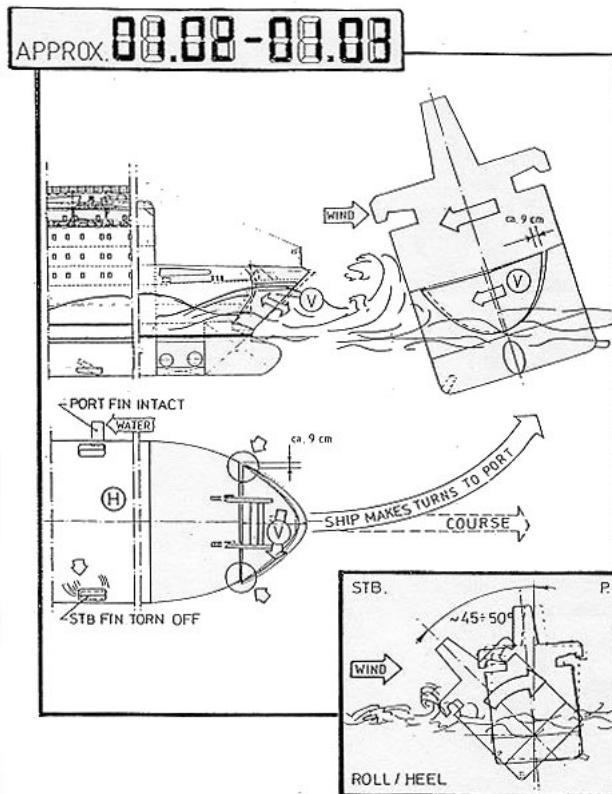
1. The vessel stopped abruptly. Water penetrated from O-deck under pressure.
2. The slow port turning increased rapidly while the vessel heeled wide over to starboard -ca. 450-500°, and came back to ca. 10° STB heel after the turning had stopped. The wind and waves now came from starboard abeam.
3. The heeling to STB increased stepwise with roll movements.

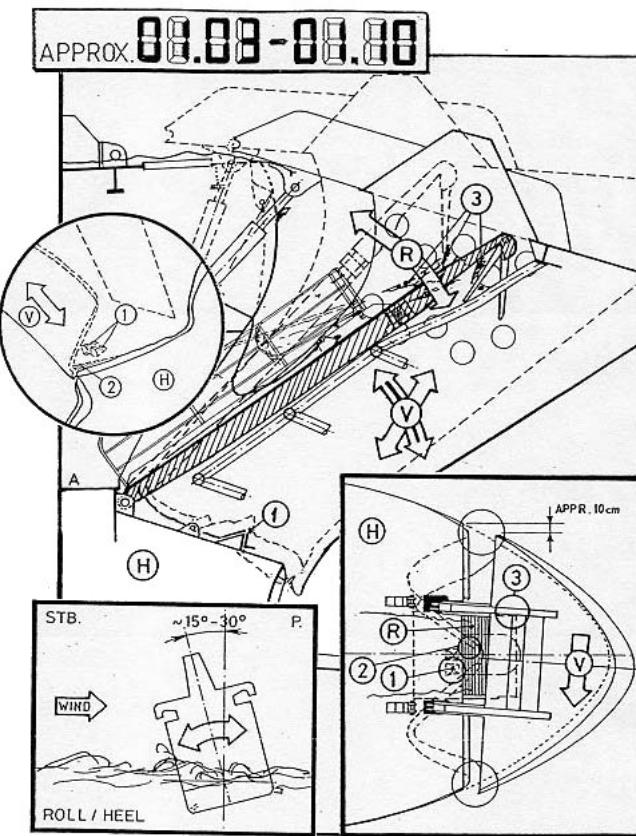
1. Approx 01.08-01.10 hrs the main engine shut-down automatically at a stoboard heel of ca 30°.
2. The visor was held by the bow (3) ramp and by the forepeak deck increasingly penetrating the visor bottom (1)(2).
3. The intact starboard actuator was resisting the forward movement of the visor.

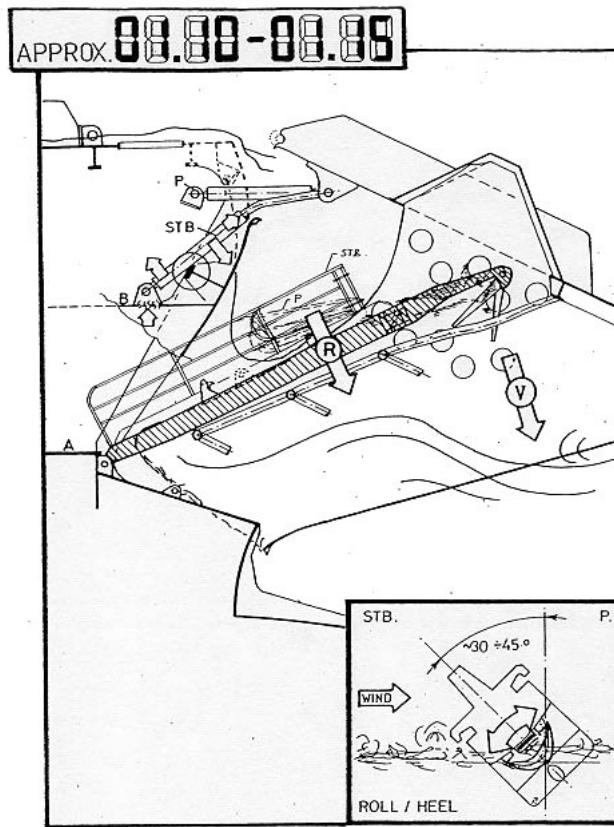
The visor moved further forward with the starboard actuator extending and the forepeak deck pressing into the visor bottom.
The strong ice plates supported the visor further from falling off to the starboard and the further the visor moved forward the deeper the forepeak deck pressed into the visor bottom .

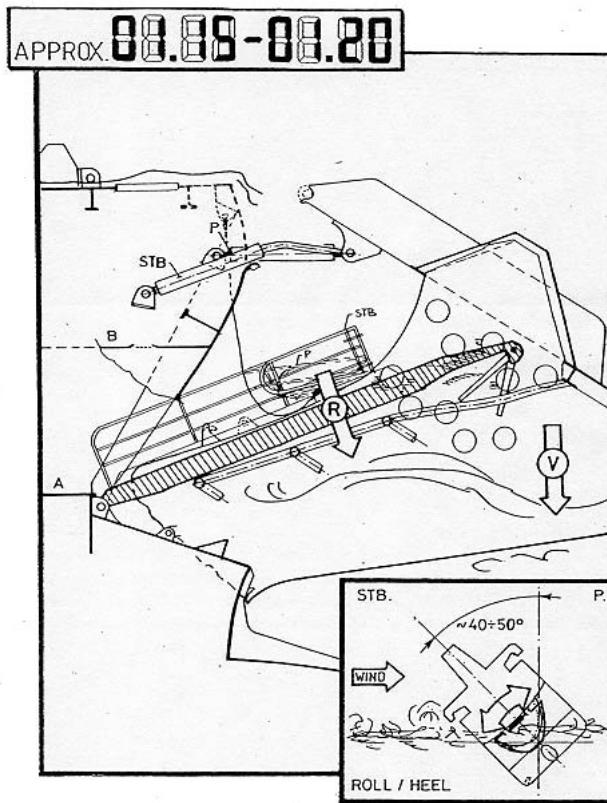
1. After the vessel had stabilised for some time at a heel of about 40o-50o the heeling increased again.
2. The visor moved further forward and downwards and also the starboard actuator was torn off its foundation and broke through the front bulkhead as did the port one.
3. The port actuator was completely retracted while the starboard actuator was fully extended with the piston rod bent.
4. The visor was still hanging on the ramp and was still supported against falling off to starboard by the forepeak deck being pressed into the visor bottom.

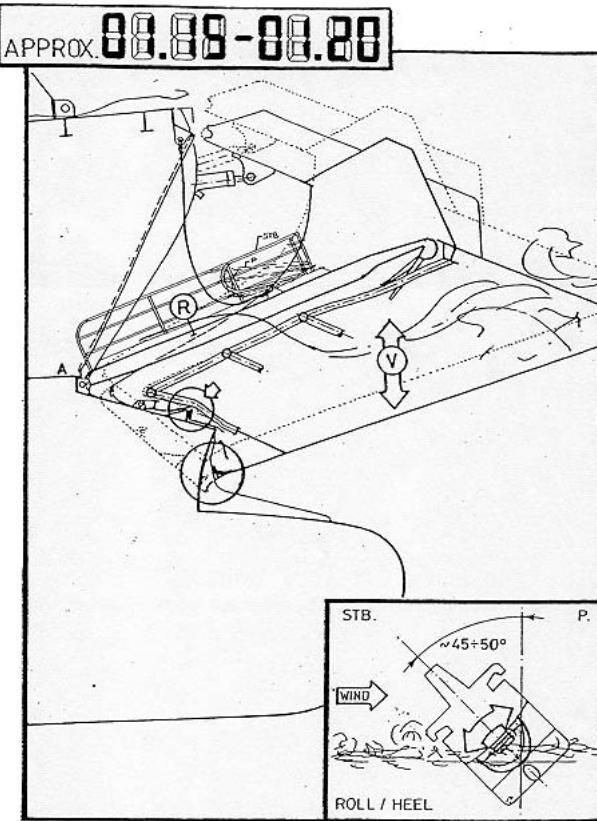
The vessel was still rolling stepwise and the visor with the bow ramp inside was labouring up and down and from port to starboard in the seaway.

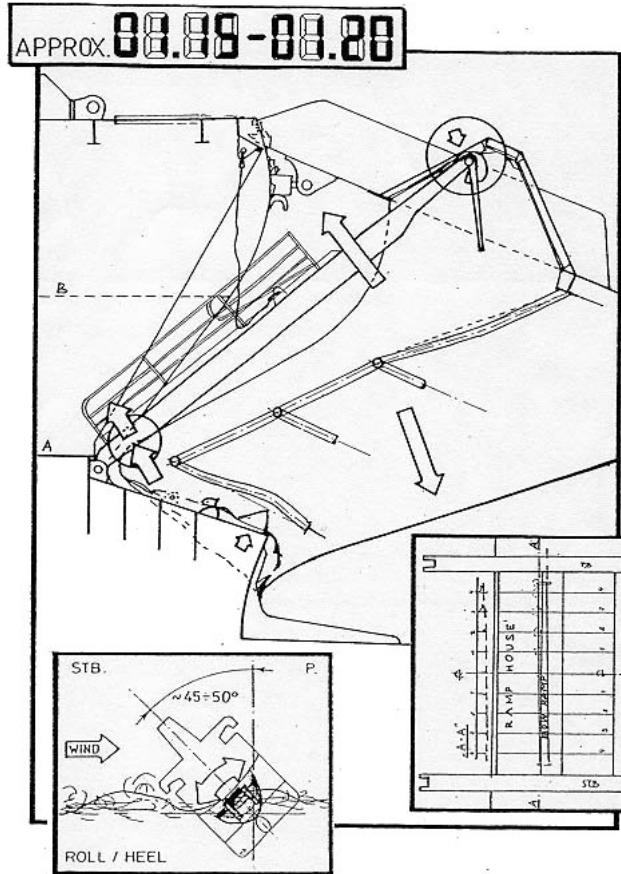
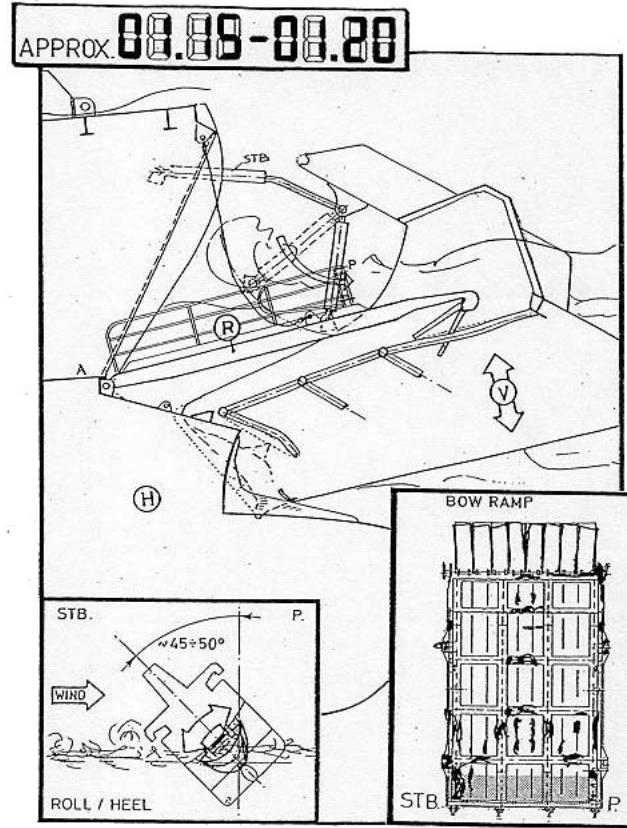
1. The port actuator broke through the front bulkhead, swung forward and got and crashed against the bow ramp.
2. The structure of the ramp was continuously and very severely deformed by the heavy and changing weight of the visor.

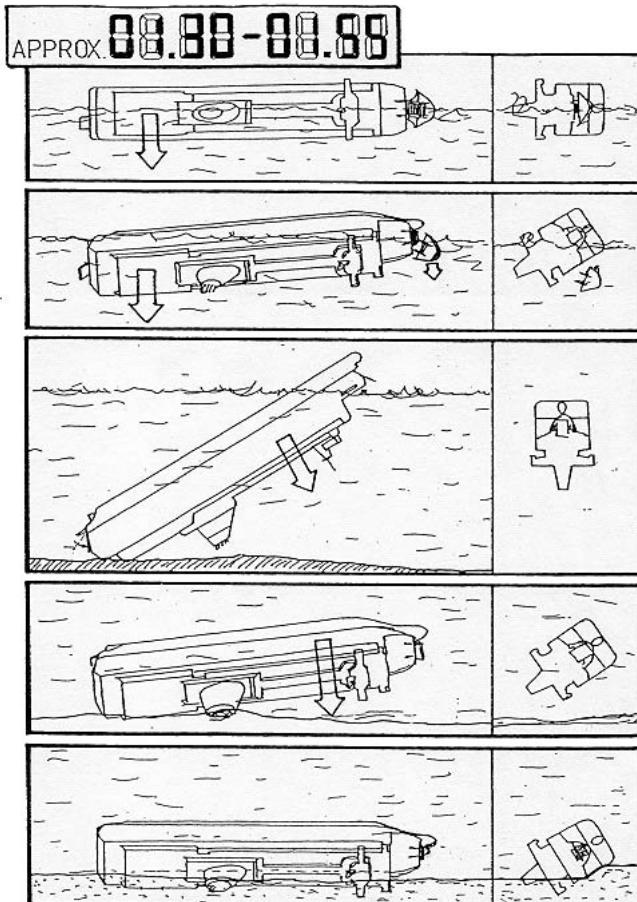
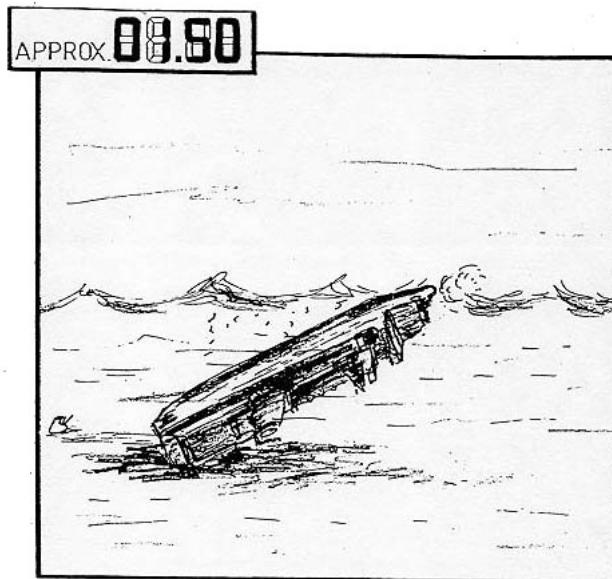
1. The Vessel sank stern first.
2. The bow was still above water when the stern was already on the sea bottom.
3. The visor sank about 1nm west of the wreck upside down.

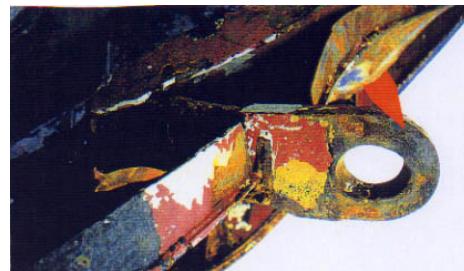
The blue coloured part of the lug - see arrow - looked as if having been exposed to heat which was unusual since this part had been below water. The JAIC was contacted and it turned out that samples had been taken already on 25 November 1994 and had been examined upon request of the Central Criminal Police in Finland and Kari Lethola as chairman of the Finnish part of the JAIC on 30.03.95. The tests were carried out on 30.05.95 by the Criminal Laboratory Technical Division, Helsinki. The "available" documentation was received - already translated into English - from Kari Lethola.

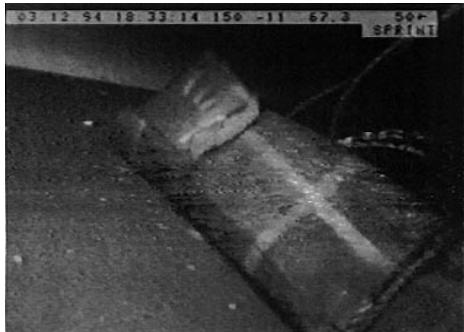
Both identified the package with about 90% certainty to be an explosive charge used underwater.

Evaluation of the footage made by ROV on 02. and 09.10.94 revealed, however, that the package had not been at the identified location on the 5th deck on these dates, thus must have been placed there between the 09.10. and 03.12.94 and therefore could not be casualty related.

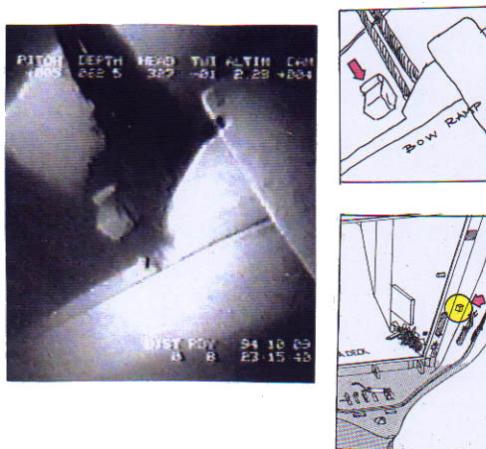
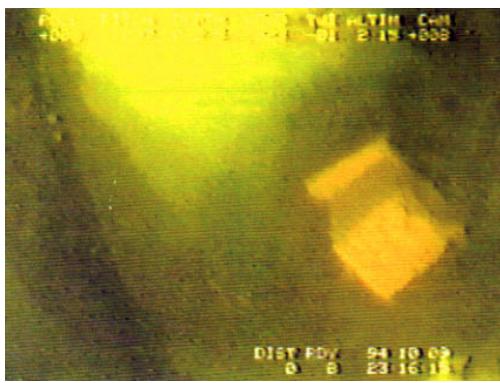
The cube was clearly visible and had been closely looked at by the ROV during the inspection on 09.10.94, it could not, however, be found on the 02.10.94 videos which was possibly due to restricted visibility and was definitely not in this location on the SPRINT ROV made on 03.12.94 respectively on the diver video of the same date.

Images were made from the orange coloured cube and identified by all three experts from Sweden, England and Germany with a high degree of probability as an **"explosive charge"**. See the following two images.

As this charge attached in way of a very sensitive area - the port side locking devices of the visor and the fastening of the port bow ramp actuator - obviously did not explode, the corresponding area of the starboard side was analysed for possible explosion damage which was positively identified by the underwater explosive expert Brian Braidwood. This resulted in a further analysis of the available video footage all received from the JAIC. The results are outlined in the following subchapters.

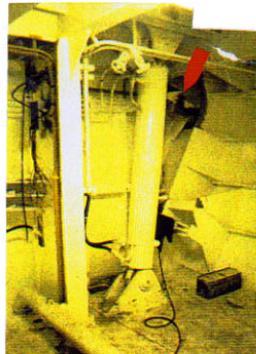
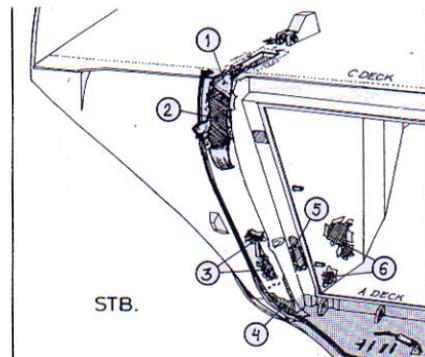
Behind the front bulkhead there is an upper and a lower void space located. In the upper one - actually the B-deck - the visor actuator and the ramp hook arrangement was fitted. The part of the bow ramp with the mating lug for the ramp hook was extending into the void space as can be seen on the picture below. The arrow points to the ramp hook.

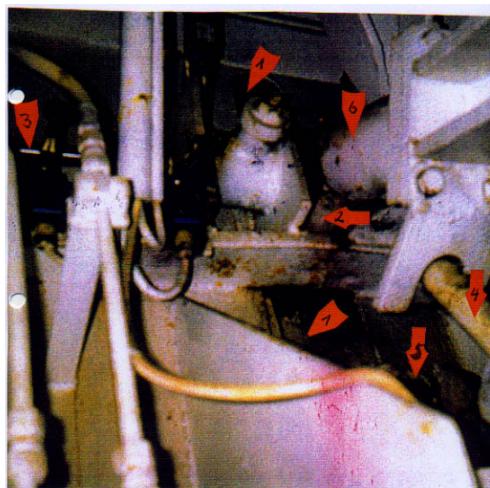
The lower void space - on A-deck - car deck level - was located directly below the upper one - on B-deck - and contained the hydraulic and manual side lock arrangements as can be seen on the picture below which is explained by 6 arrows. The visor is closed.

arrow 1 = opening in front bulkhead with visor plating behind through which the lug of the hydraulic side lock was extending
arrow 2 = lug of hydraulic side lock

arrow3 = cylinder and piston rod of hydraulic side lock

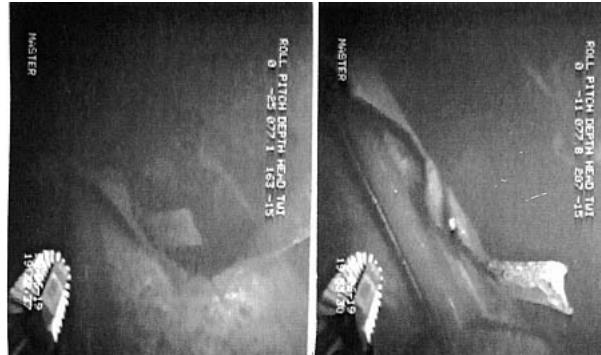
The upper void space behind the starboard front bulkhead shows considerable damage to the bulkhead plating with the plating bent from inside to outside and frequently cracked. This had obviously been possible because the upper part of the visor moved forward after the starboard hinges and side lock had failed and never contacted the front bulkhead again, because at the lower end of the blown open plating a big steel part is extending almost horizontally which otherwise would have been pressed back. The same refers to the steel tongue extending from the visor plating in way which was also not pressed against the bulkhead.

The image below on the left shows the lower part of the damaged upper front bulkhead looking from bottom to top. The image on the right shows the damage further up.

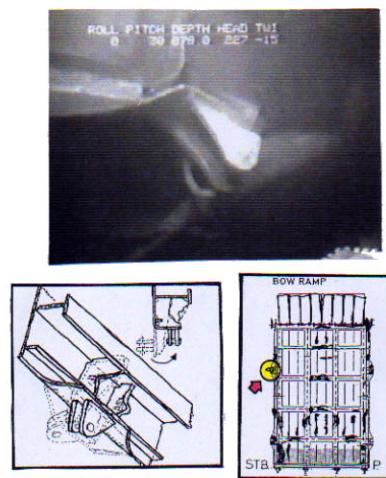
The following image shows the upper part of the same damage with the severely distorted and upwards bent mating lug for the starboard ramp hook.

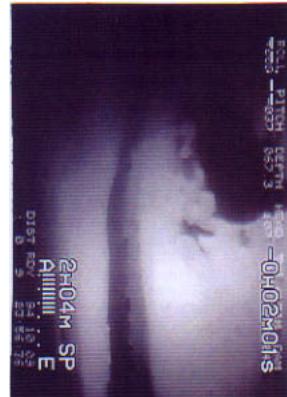
The lower void space behind the starboard front bulkhead shows very considerable damage in way of the openings for the lug and hooks of the hydraulic and manual side locks but, in particular, further down the bulkhead was apparently completely cracked off the forepeak deck and pushed upwards.

- The front bulkhead plating below the area of the hydraulic side lock was pushed outwards with exception of the rubber packing - see image below. It is clearly visible that the rubber packings, normally extending beyond the bulkhead, are in some sort of fold indicating that the surrounding plating was deformed towards the outside.

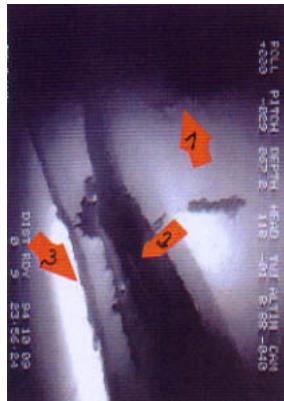
- The next image shows the area further down the bulkhead. Arrow 1 points to the lower edge of the opening for the hook, arrow 2 to the rubber packing and arrow 3 to the deep, sharp fold to starboard of the rubber packing, which extends from forepeak deck level up to the side becoming narrower the further up it runs. It is obvious that the surrounding bulkhead plating was deformed towards the outside of both sides of this fold and also between the rubber packing and the inner bulkhead edge.

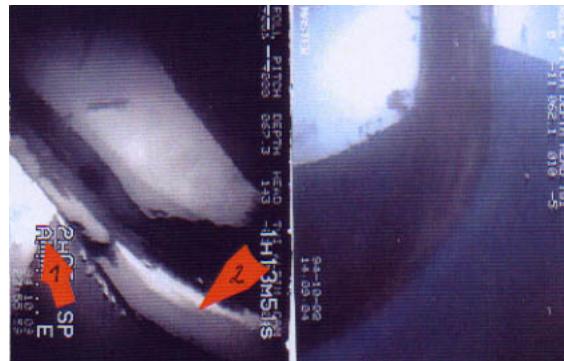
- Further down the front bulkhead in the so-called "corner of the mouth", the area to the outside of the rubber packing is cracked open over some 300 mm - see left image below. The bottom part of the front bulkhead is severely deformed and apparently cracked off the forepeak deck as well as cracked off the inner bulkhead plating and probably also off the outer shell plating as can be seen from the left image below.

In explanation of the left image the following has to be noted:

- arrow 1** = change over from blue to white paint. On the image below the arrow points to the respective area on the opposite port side.
- arrow 2** = points to the torn off and dislocated lower parts of the front bulkhead. The right image shows the corresponding intact port side.

Note: As the visor was resting against this area when a possible explosion occurred, the bulkhead could not burst open to forward and the pressure obviously escaped downwards and to the sides. Thereby the complete lower part of the front bulkhead was torn off the recess on the inside, off the shell plating on the outside and off the fore-peak deck on the lower side. Actually the area indicated by arrow 2 should be blue as can be seen from the image beside it showing the respective port side.

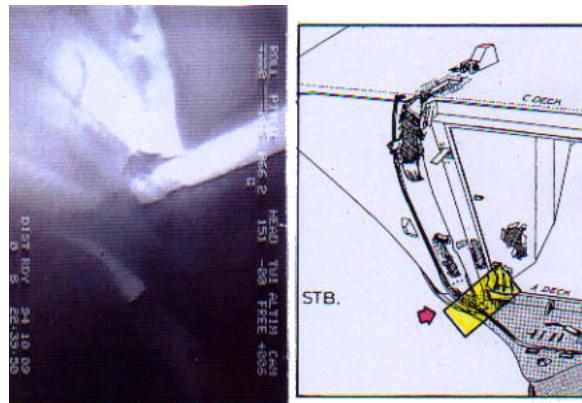
- Next to the cracked open inner bulkhead plating, the lower section of the starboard outer vertical girder of the bow ramp - being immediately next to the cracked plating when the ramp is closed. It is noted to be cracked off both from the upper and the lower transverse girder as well as from the bow ramp plating and extremely deformed and pushed to port. - See the image below with the explanatory drawing and also the extensive photo documentation in Subchapter 29.2.

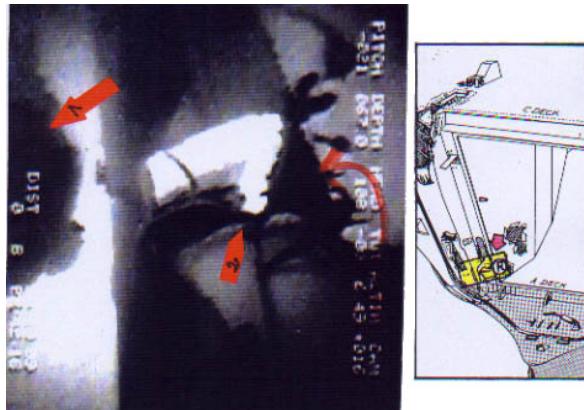
- Slightly further up, the landing of the fastening of the starboard bow ramp actuator was noted to have been cracked open, severely deformed, with the fastenings of the actuator missing and the actuator broken twice. See the following image.

Arrow 1 points to the enlarged opening in the front bulkhead for the manual hook and arrow 2 points to the burst open landing to which the starboard bow ramp actuator had been attached.
