THE GERMAN 'GROUP OF EXPERTS'

THE GERMAN GROUP OF EXPERTS

16 THE CONDITION OF "ESTONIA" AND THE STATUS OF HER MAIN CLASS AND SAFETY CERTIFICATES BEFORE COMMENCEMENT OF HER LAST VOYAGE

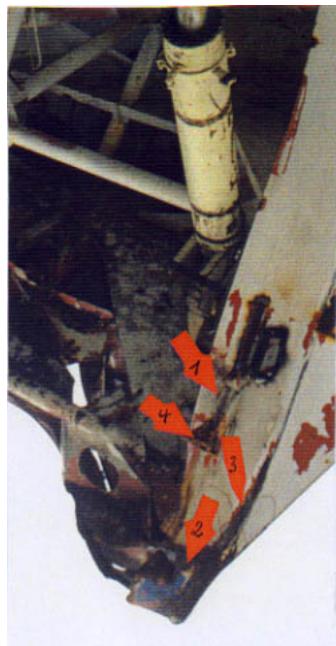
Due to the extent of this damage it has to be assumed that additional areas were affected, e.g. the bottom part of this and the adjacent void spaces, and the bulkhead towards the car deck. The appearance of the corresponding parts of the starboard lower aft bulkhead of the visor do confirm that the damage existing in way of the lower starboard front bulkhead of the vessel and the adjacent area was most probably caused by the same occurrence, viz.:

- the area between the lug and the hook shows intense smoke marks and had obviously been exposed to heat (arrow 1).
- the bulkhead plating at the change-over from white to blue and deeper is cracked at least twice with the plating severely distorted and plating parts torn out (which excludes pounding) - (arrow 2).
- a deep fold in way of the contact area with the flatbars housing the rubber packing of the vessel runs up the aft bulkhead from visor bottom to the hooks (arrow 3).
- the way the two hooks were crushed together (arrow 4).

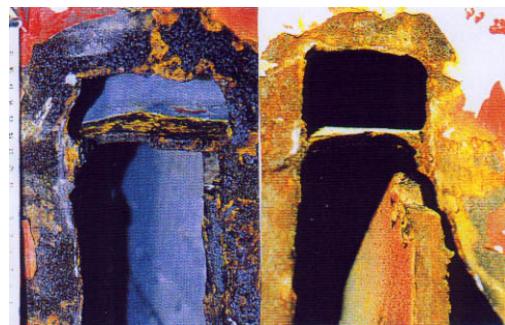
The two pictures below were taken from page 168 of the JAIC Report. The left picture shows the port aft bulkhead of the visor and the right one the starboard one, both in way of the initial location of the lugs for the hydraulic side locks. See also Chapter 30.

It is most likely that the starboard side had been exposed to considerable heat which is indicated by the corroded surface as a result of the changed metal structure. It is also most likely that the starboard side had been exposed to pressure from inside to outside which is indicated by the distortions and the cracked off stiffener, indicating a possible explosion in way. - See also Subchapter 37.7.

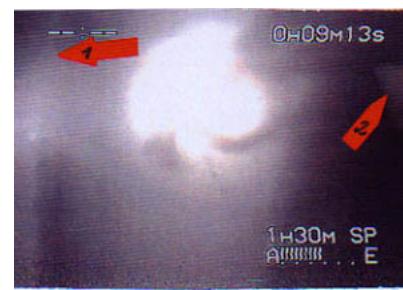
The image on below shows the area of the recess bulkhead between the lug for the preventer wire and the upper mating box. Arrow 1 points to the rubber packing of the bow ramp and arrow 2 points to the edge of the bow ramp. Between the arrows a metal flap is visible which is apparently part of the recess. Transferred to the front bulkhead around the corner this is the area of the big damage above the lug of the hydraulic lock. See also the above drawing.

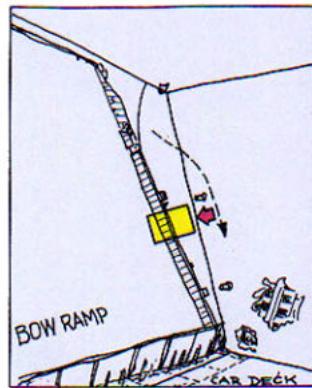
This is the area where the broken piston rod of the actuator was seen from the outside to be jammed in between the ramp and the recess.

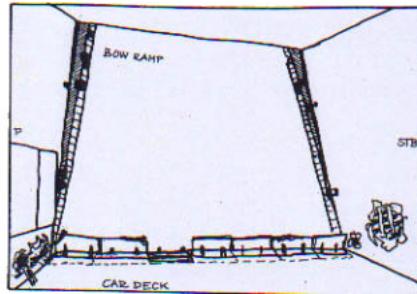
The eight flaps of the bow ramp covering the gap between the car deck and the open ramp were found to be in different condition: some were well painted, green and intact, while others - in the middle - were brownish/red and partly damaged. See the two images below.

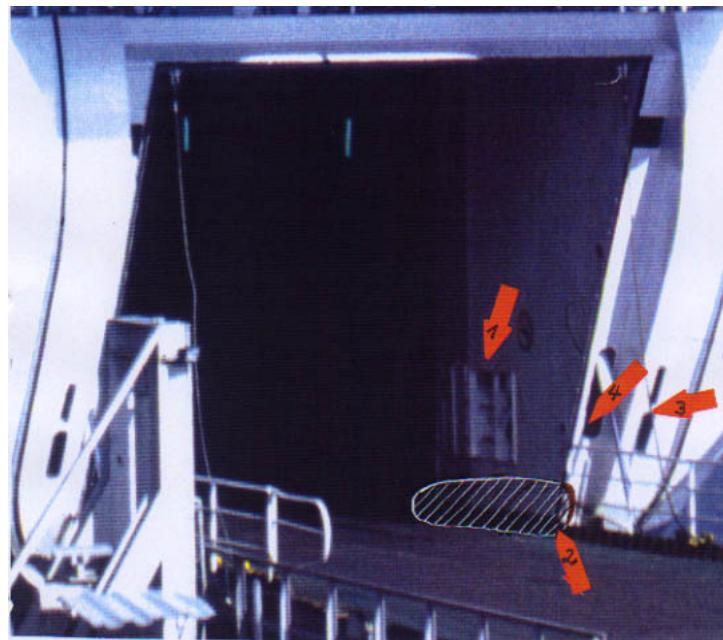
The diver continued to look further along the apparently torn open bulkhead with all sorts of things sticking out of it - see the image below apparently showing some rubber tire (used as fenders on the ferry) - arrow - together with other debris. This should be the area below the control panel as can be seen from the following image showing the entrance to the car deck with the open bow ramp.

arrow 1 = control panel

arrow 2 = bottom end of raised black/yellow ramp edge and first flap from port side

arrow 4 = opening for ramp actuator - the arrow points to the position of the actual fastening when the ramp was in closed condition.

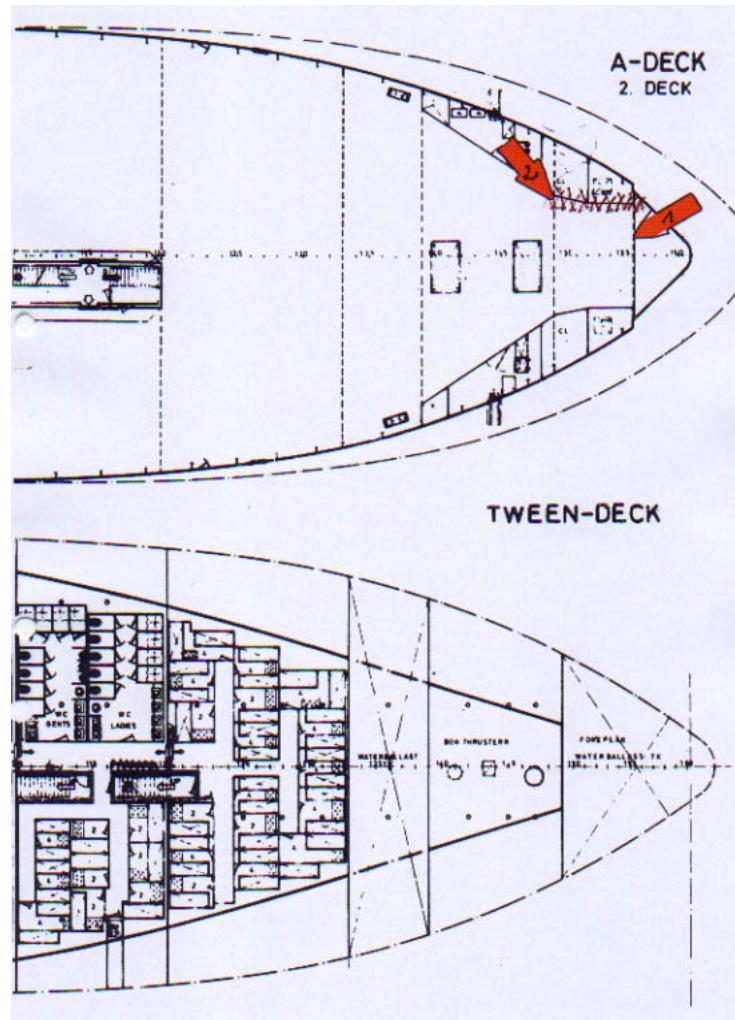
The drawing below is a part of the general arrangement plan of the vessel which shows the forward part of A-deck = car deck and the area directly below on tween deck = 1st deck. The red hatched area shows the damage area which can be seen on the images explained on the previous pages. The distance from the bow ramp - arrow 1 - to the corner of the bulkhead - arrow 2 - is about 4 m. Below the dotted line the bow thruster space begins, before that space the full forepeak was located.

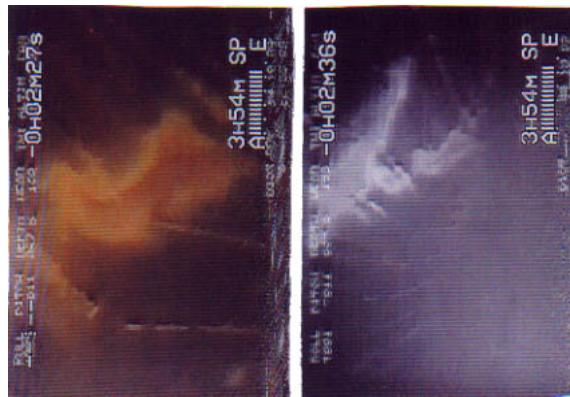
The respective inside of the bow ramp shows severe deformation and a burnt area in way. See the images below.

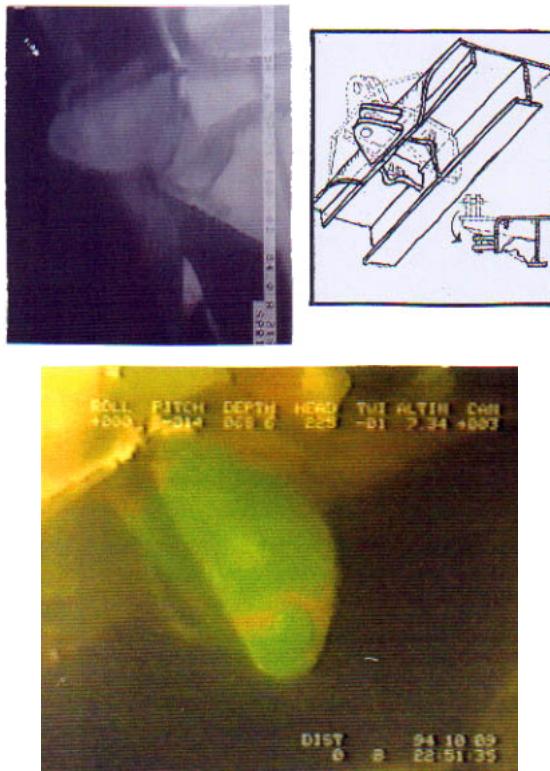
- The pushed up landing of the mating lug for the starboard ramp hook. See images below and on page 1106.

The landing with the apparently unaffected lug was pushed to starboard and upwards which has now also been verified by the expert Brian Braidwood and the results are confirmed in his "Supplementary Report" - see Subchapter 34.7.1. - [Enclosure 34.7.1.435.1](#). In summary of the before explained items (1) to (4) it has to be assumed that the damages shown on the drawing behind the next page had been caused by explosion.

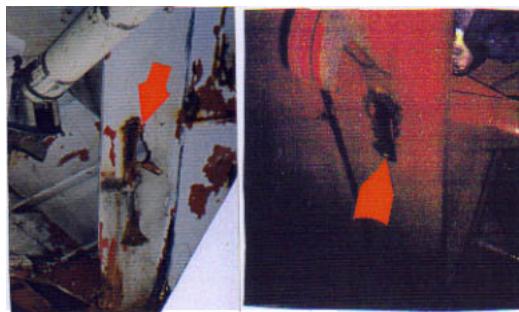
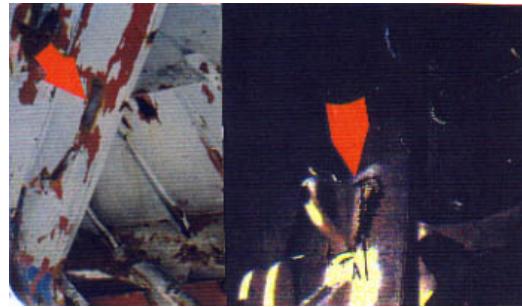
- A comparison of the damage to the side lock lugs of DIANA II / ESTONIA is shown below.

According to the ship's command the torn off starboard lug was lost. This is possible as first the lug hangs on the bolt of the hydraulic locking device and after opening the same it falls into the water. As noticed from the letter of the B.V. lawyer Johnsson, the repairs had already been commenced when the B.V. surveyor boarded the vessel. Thus practically neither the class nor the safety board ever saw the damage in its original condition.

The ship's command was unable to attribute the damage to a special occurrence, such as a hard blow of the sea. Therefore the TR Line inspector Griesmaier is of the opinion that the damage to the locking devices occurred over a longer period. This would be in conformity with among other things the statements of the chief mate Karl Ole Lindroos.

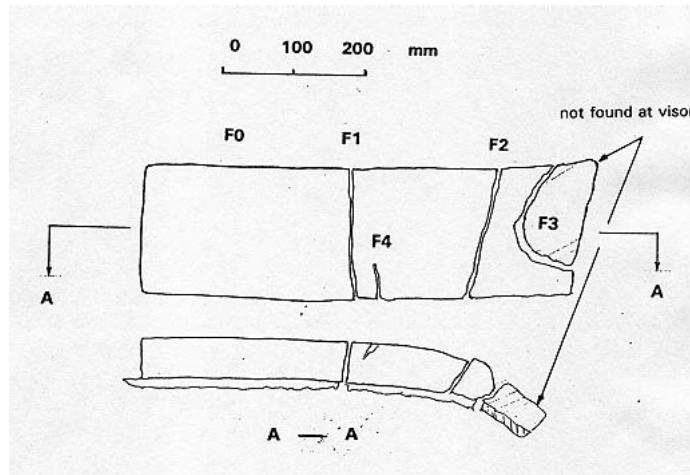
The welds between stempost and shell plating of the visor had failed already during normal service by a spectrum of cyclic loading providing tensile stress at the crack initiation points together with long term corrosive action of seawater after opening of the welds. As a consequence the stempost had not only been separated from the shell plating during normal service but the stempost being a vital part in its load-carrying function was in itself found to be split up into four parts by crack development well before the casualty. The drawing on the next page shows the cracks F1 - F4 of which F1 had penetrated the thickness of the stempost to about 40% and blue paint was found inside the crack. It could be verified that these traces of blue paint originated from penetration of the outside paint into the crack opening at the time the crack had penetrated the stempost already to the extent of about 40% of its thickness.

The investigation of fracture F1 - F4 ascertained that all the transverse fracture had started and penetrated from the outside by corrosion assisted fatigue cracking. In addition, fractures F2 and F3 reveal major bending displacements of their flanks, in particular fracture F3 reveals a specific bending angle of about 70° combined with severe bending deformation following the original crack development.

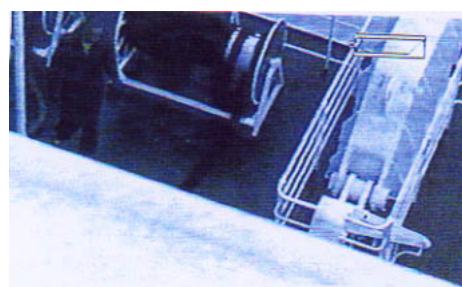
The visor's hinge system design consisted of the starboard and port side hinge arms fabricated from structural platings, with two attached lug plates on each side, carrying support bushings with bronze liners in the respective bore holes. The support bushings were welded to the lug plates with circular fillet welds. The visor hinge lugs were mated by deck hinge fittings, represented by lugs welded to the forecastle deck. The mechanical connection was one bolt on each side. The video image below shows the starboard hinge arm shortly before the accident.

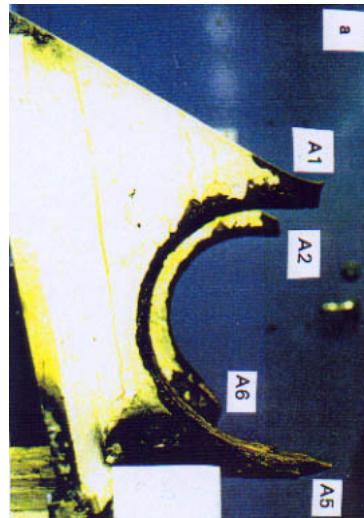
The following picture shows the broken port visor lug plates with the fractures A1, A2, A5 and A6.

The outer port side shows a vertical to slightly horizontal bending to port side at the fracture at the lower part of the remaining bore. The inner port side lug and both starboard lugs - see picture below - did not exhibit significant bending deformations. The picture below shows the broken starboard visor lug plates with fractures A3, A4, A7, A8:

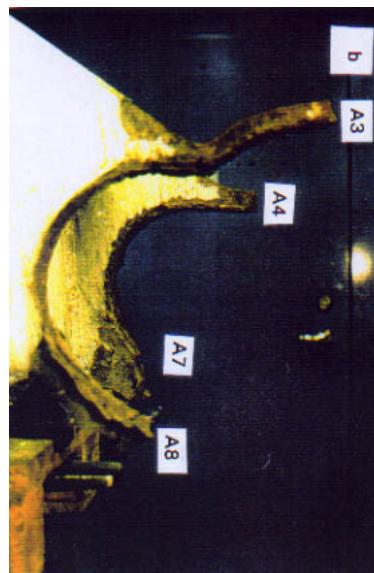
The failure of the visor hinges occurred by fractures A1-A8 of the visor lug plates together with the fillet welds to the support bushings. The bolts had been ripped out of the hinges, together with the bushings.

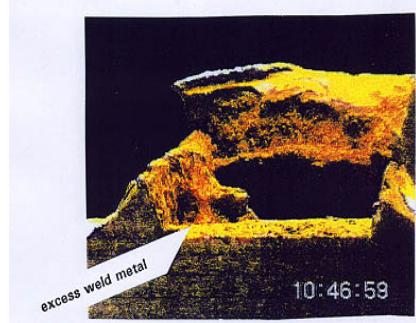
The fracture of the recovered hinge bushing was fitting to the fracture of the inner starboard hinge lug. It exhibits a gap of about 4-6 mm between lug bore and support bushing. This gap is almost entirely filled with corrosion products, presumably magnetite, which is also found in thick layers at a location where both hinge late and fillet weld failure are represented together with some excess weld metal, see arrow on the picture below which may have provided a local notch effect.

In another cross section, also severe corrosion inside the gap is identified and the surface of the hinge bore and the bushing exhibit a considerable misalignment, which, during welding of the left fillet weld, was overcome by a buffering layer. The misalignment corresponds to asymmetric burning marks, for example of the inner starboard hinge. For closer investigation only a small part of an adhering fillet weld of the support bushing was available. It included both a full crack of the hinge plate material and a secondary crack close to the weld metal and showed also the flame cut surface of the hinge plate bore hole. While the full crack revealed plastic shear at its flanks, the secondary crack had started from the heat affected flame cut surface and propagated close to the heat affected zone of the weld in radial direction.

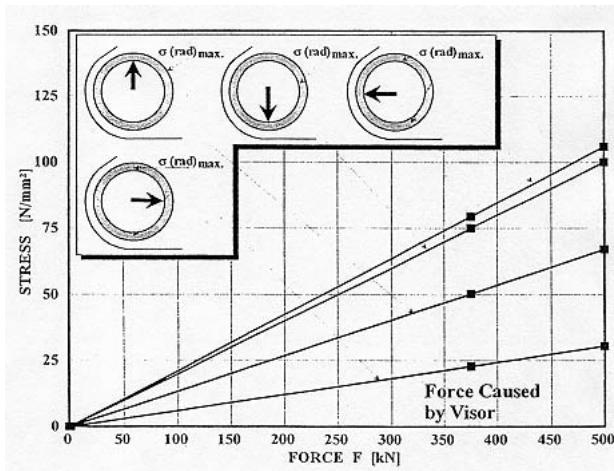
For example, the normal visor opening procedure created a vertical down force of maximum 375 kN on each hinge lug based on nominal visor weight and respective leverages and resulted in maximum radial stress in the fillet weld found at the location as marked by the circle in the drawing below together with the stress distribution in radial direction. Accordingly the opening procedure would thus create a local radial weld joint stress of 75 N/mm².

It is thus obvious that, during opening of the visor, the location of maximum radial fillet weld stress is found in the same region where fatigue cracking of those fillet welds initiated. However, also the other assumed directions of loads on the visor hinges would provide maximum radial stress locations. In particular, a similar stress range as for the opening procedure would result from an assumed afterwards force on the hinges. Such an afterwards load could have created the conditions for crack initiation and failure of the hinge plates, following the failure of the fillet.

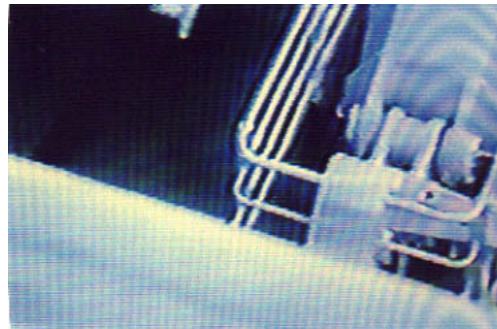
On the evening of 17.09.94, i.e. 10 days before ESTONIA's last departure from Tallinn, a Swedish passenger was standing on the forward open part of deck 7 and filmed the closing of the visor, the handling of the mooring lines by the deck crew and, finally, he zoomed in on the starboard visor hinges. The first copy of the original film was made available to this 'Group of Experts' and a first internal analysis revealed that the starboard visor hinge was in an absolutely disastrous condition as can be seen on the image below.

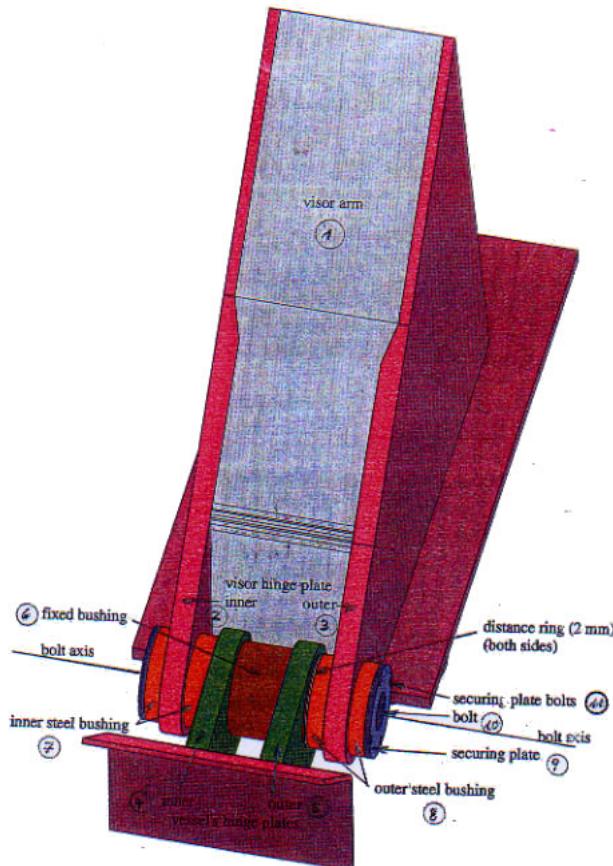
For explanation purposes a computer drawing of the hinge arrangement was made and the figures 1 - 12 point to the relevant components as outlined below:

The object of the report was to detect and identify any structural rupture or damage which could have contributed to the loss of the Ro-Ro ferry ESTONIA. For identification of components bracketed numbers, for example (5) in the text refer to annotations on the drawings, on the previous page. A detailed examination of the video tape showed the only damage to be identified limited to the starboard visor hinge.

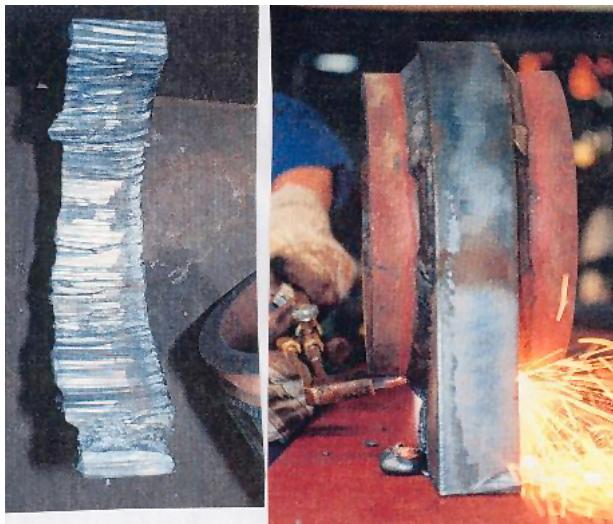
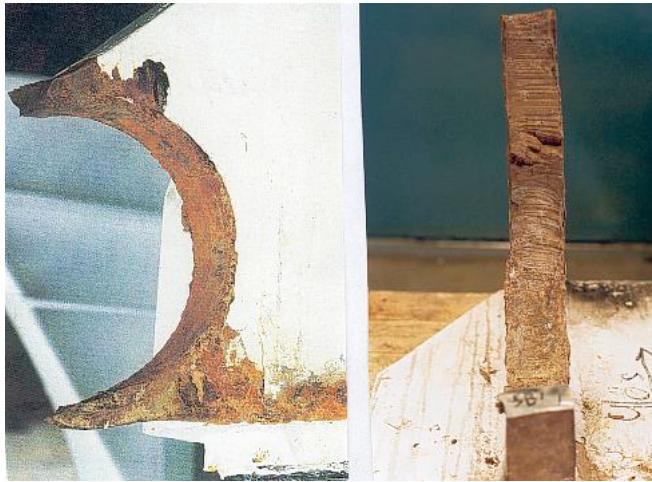
- all four arms do not have identical appearances as it is evident from the two photos below, the left one shows the port outer visor arm and the right one the starboard inner visor arm.
