1 THE CASUALTY

The German 'Group of Experts' has now - as far as possible - completed its investigation of the foundering of the M. V. ESTONIA, a disaster that has taken the greatest toll of human life in the Baltic Sea in times of peace. The German 'Group of Experts' has during the past five years performed a difficult investigation in a partly hostile and reluctant environment. The work was carried out during the first two years - 1995/1996 - in close co-operation with the Swedish leader of the Technical Group of the Joint Accident Investigation Commission of Estonia, Finland and Sweden (JAIC), Börje Stenström († February 1997), and also with the Finnish member of the Technical Group, Dr. Tuomo Karppinen and the expert Dr. Klaus Rahka. All the investigation results of this 'Group of Experts' were submitted either verbally in joint meetings with the members and the experts from Estonia, Finland and Sweden attending or in letters with attached photos and/or video film documentation to the JAIC. This documentation and information concerned the design, construction and building of M. V. ESTONIA in general and the locking devices of the bow visor in particular, including the load cal

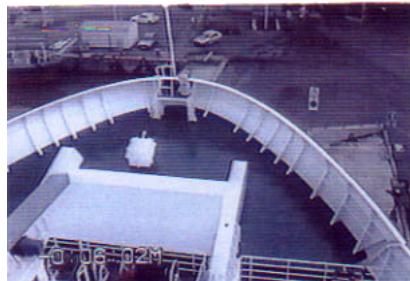
On my last trip to Tallinn before the casualty (I missed one sailing) my car was on the hanging deck at starboard side. Thus I could not see what was going on at the ramp and the visor when being opened. I saw, however, crew members working at the bow ramp before it was lowered down. When I drove down the ramp I saw the equipment for either welding or burning (gas bottles) laying at port side near ramp. We had to wait longer than normal, maybe half an hour or more before the bow ramp opened. I remember this clearly, because I had people waiting for me at the quay who had left before I was from board because it took so long. It could be the time when I saw the visor moving up and down several times before the bow ramp opened combined with banging noises and also hammering.«

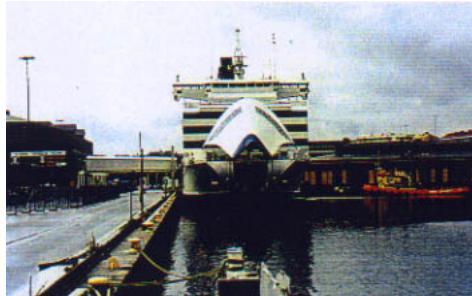
»I had frequently been on the forward part of the 8th deck upon departure from Stockholm and do remember having quite often seen the visor open.« (See photo below.)

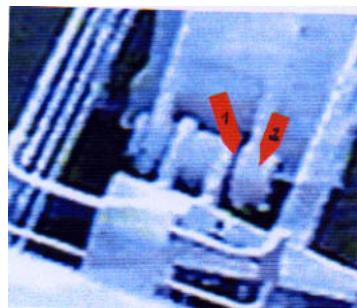
Although the distortion and misalignment of the starboard hinge is clearly visible to everybody, the Swedish part of JAIC gave a copy of the film to the Military Intelligence Service, who produced the picture attached as [Enclosure 12.5.181.1](#), which evidently shows the same. Nevertheless, the Intelligence people declared the whole film to be unreliable since 5 out of about 800 sequences had been slightly "jumping", which was accepted by the JAIC as well as N&T and the film from then on was ignored by the JAIC and consequently is also not mentioned in their Report. What the film really shows becomes clear on the enlargement below, viz. some major deficiencies:

- the gap between the starboard vessel hinge plate and the outer bushing is much too large (Arrow 1).
 - the outer bushing is sticking much too far out of the outer visor hinge plate (Arrow 2) (which explains the large gap mentioned above).
 - the lower part of outer bushing is missing.
 - the securing plate is missing and the outer end of the bolt is not visible.
 - the outer bushing appears to be twisted anti-clockwise.
 - the inner bushing appears to be twisted anti-clockwise.

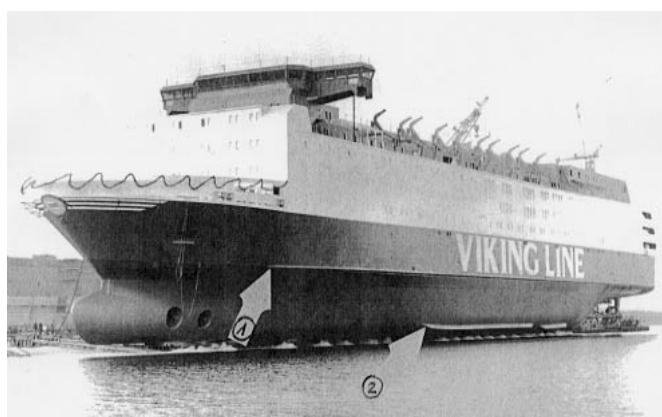
Note: The picture below shows the vessel's port side while still on slip. Arrow 1 indicates the forward end of the fenderbar, arrow 2 the forward end of the bilge keel.

- When he was at the forward part of the fenderbar he saw something like a fin sticking out of the hull, dark like the bottom, maybe 1.5 m or less, looking like a propeller blade of a plane. It was not moving.

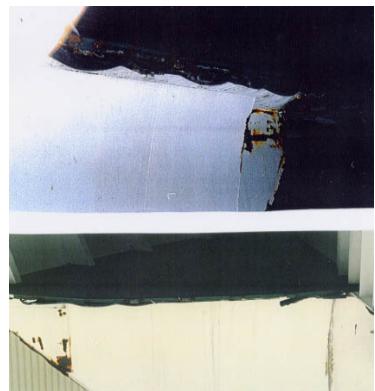
Also the flat bars around the deck opening into which the rubber packings - fitted below the visor arm - should be pressed, when the visor was closed, were missing. The same refers to the flat bars having initially been welded athwartships at the forward part of the forecastle deck into which the rubber packings at the aft part, i.e. below the recess of the visor, should be pressed when the visor was closing (see also item 5 on the detail drawing). This can be seen from the following two pictures, of which the first one shows the starboard aft part of the visor deck with untouched rubber packings, intact and in place and the 2nd is the port side which is evidently in worse condition.

The picture below shows the rubber packing underneath the starboard visor arm which was obviously never pressed into any flat bar and is not affected at all, which confirms the apparent fact that

- a) the flat bars around the deck opening had been removed prior to the casualty and that
- b) the visor was raised to some extent at this side after the hinges were broken since otherwise this rubber packing would have been destroyed as it did happen at port side - see P 3 - Port Side Fore-castle Deck.

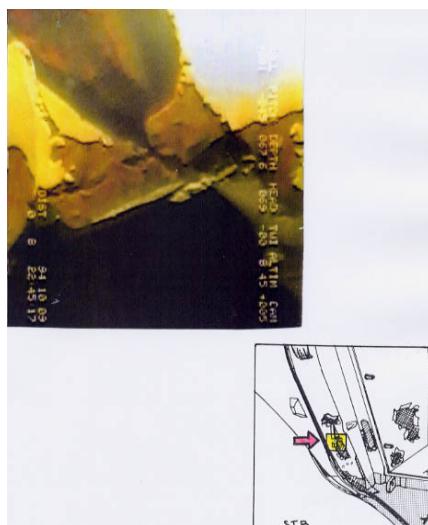
The next image shows the broken bulkhead part between the opening with the lug of the hydraulic side lock and the much enlarged opening for the manual side lock below.

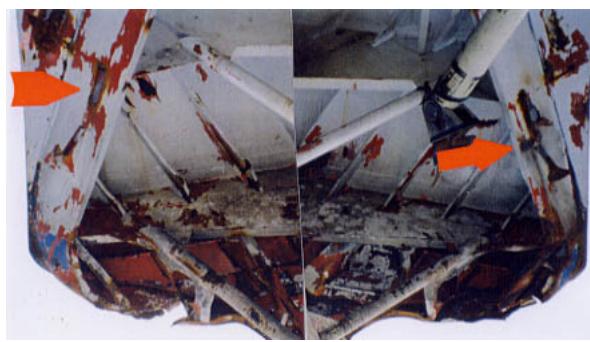
Next pictures follow which show the starboard lower aft bulkhead of the visor having been directly opposite to the corresponding parts of the starboard front bulkhead of the wreck. In comparison also the port lower aft bulkhead is shown.

The picture on the right left shows the area of interest on the starboard side, the picture on the left shows the corresponding port side. It shows a completely different damage picture: no smoke marks, no steel tongue torn off the bulk-head and no twisted hooks. Two of the following four pictures on the next page show those areas at the port and starboard aft bulkhead of the visor where the lugs of the side locks had been welded to and the hooks for the manual side locks were fitted. The other two are close-ups of the upper parts of the area where the lugs had been welded. The right side shows the part of the starboard visor bulkhead directly opposite the above explained damage area. The smoke marks are still clearly visible although the visor had been on the sea bottom for 7 weeks. The hooks are distorted in a way which is technically not explainable. The area is dark. The picture on the left shows the corresponding port side as comparison with a complete different damage picture, with no smoke marks, no steel tongue torn out of the bulkhead and no twisted hooks and a generally clean appearance. The two close-ups arranged below the above mentioned photos show the respective upper parts of those openings in the bulkhead. They do illustrate the difference very clearly. While the port side shows normal steel clean of corrosion, the starboard side shows steel which had obviously been exposed to heat and pressure force: The metal is distorted and pushed out, the stiffener is detached from the bulkhead. See also Chapters 30 and 32.

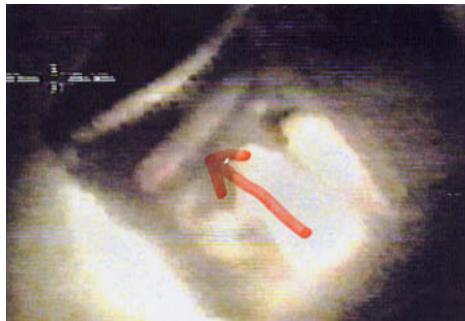
- concerns the opening in the recess of the front bulkhead for the ramp hook. The hook has been identified inside this opening. The red arrow on the image below is pointing to the hook which is obviously intact and in locked condition.

The image above is a view into the opening in the front bulkhead recess inside of which the port ramp hook should have engaged the mating lug at the ramp during the closing procedure which it evidently did not do during the last voyage. This has already been explained under P 3 - Port Forecastle deck.

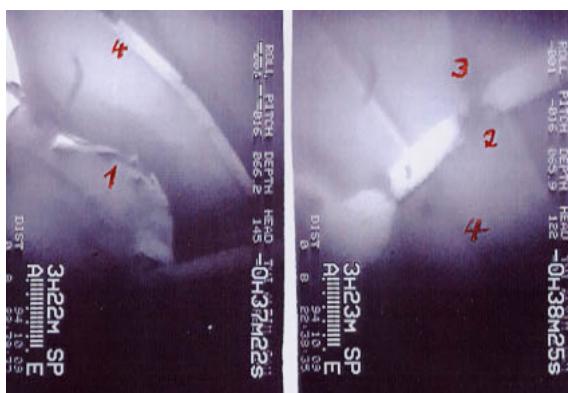
Also damage No. 5 is dubious because the area has obviously been damaged twice, viz.

- (1) at first horizontally (the black looking area) and
- (2) secondly diagonally.

The left picture shows the lower part of the port outer vertical girder, cracked off above and below and twisted up to 70° - damage No. 1 on the drawing as well as damage No. 4. The right picture shows damages Nos. 2, 3, 4.

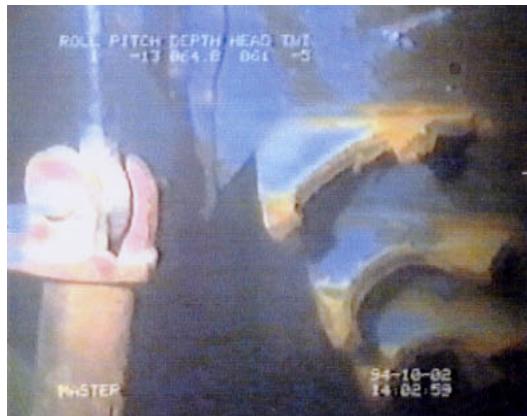
- Image No. 1 shows the starboard and centre logs while images Nos. 2 and 3 show the centre - and the port lugs. The latter one was subsequently destroyed upon instructions of the JAIC for testing purposes.
- The 3 images were taken from the ROV video made on 9 October 1994, i.e. 12 days after the casualty. All fracture surfaces are heavily corroded. This is even more evident from the image below made from the ROV video from 02.10.94, i.e. only 4 days after the sinking, which shows the same corrosion to the fracture surfaces of all 3 lugs.

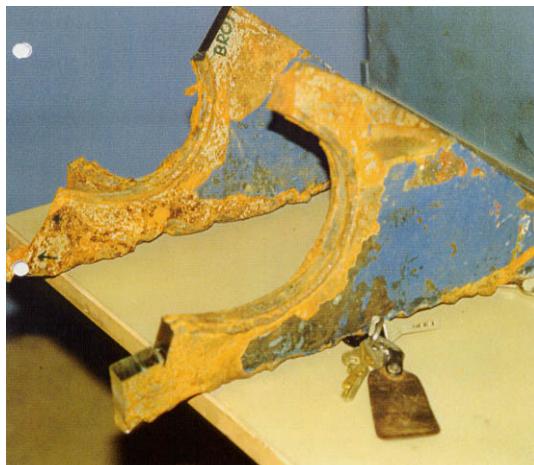
The pictures Nos. 4 and 5 show the starboard and the centre lugs in the Royal Technical University in Stockholm (KTH) in February 1995. They had been cut off the forepeak deck and were recovered by divers on 4th December 1994 and subsequently examined by the KTH. Below a photo of the starboard and centre lugs taken at the KTH, Stockholm in February 1995 is shown in order to illustrate to the reader the actual condition. Particular attention is drawn to the lower fracture area of the starboard lug.

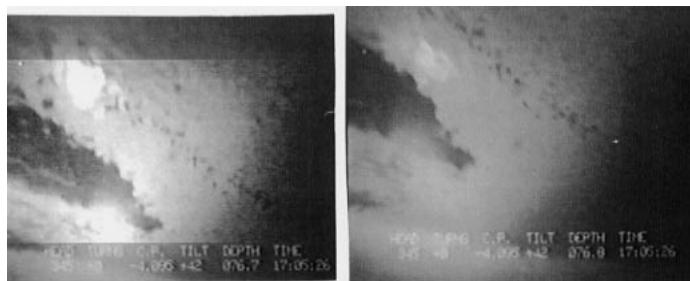
Enhancement by means of special equipment confirmed indeed that the plating is holed - See the enhancement below.

From the damage appearance it has to be concluded that the plate was severely corroded, i.e. the hole was neither caused by an impact of ex- or implosion but by corrosion. This is easily possible if the coating and/or anode protection of a ballast water tank, e.g. a heeling tank, was not in order.

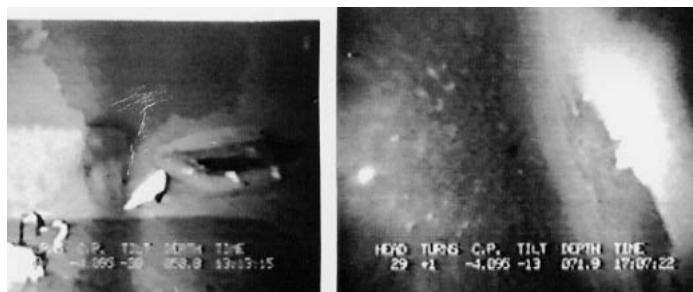
The following two images show an area which is apparently also holed, but not by corrosion because the edges are too sharp.

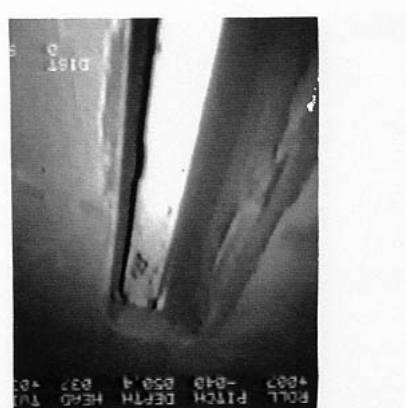
In January 1994 the ESTONIA was fitted with stabilisers of make Brown Brothers which had allegedly been in operation at the time of the casualty. According to 3rd engineer Margus Treu, the fins should retract automatically at speeds below 4 kn, therefore he does not believe that survivors could have seen the port stabiliser still out when the vessel was already almost on the side - see Enclosure 21.3.271 - Protocol of Landvetter meeting on 31.03.95. In all probability Margus Treu is right because only after proper questioning of the survivors Pierre Thiger, Tony Spuhl and Mats Hillerström did it turn out that what they believed to have been the stabiliser was much too much forward to assume it could have been the stabiliser. They saw something big, partly white, partly dark, vertically bigger than transverse, which was moving in/out and/or up/down, very far forward, almost at the bow. They saw it still when the vessel was on the side already. The statement of Pierre Thiger taken on 08.10.99 is attached as Enclosure 29.6.414 and the statement of Tony Spuhl taken on 10.10.99 is attached as Enclosure 29.6.415. The statement of Mats Hillerström is not yet available. The actual stabiliser, however, is installed in a pocket behind the heeling tank on 0-dek level, i.e. about midships. When the witnesses were informed accordingly they categorically denied having seen anything moving in this area. This leads to the conclusion that the survivors had seen the visor, then still hanging on the bow ramp with the bottom attached to the forepeak deck and ice-knife of the bulbous bow. This leaves the trainee mate Einar Kukk who has stated - see Enclosure 21.2.1.251 - that the stern was down to the stabiliser fin level. But he did not say that the fin was out. Therefore, it has to be assumed that the survivors actually meant the visor when they mentioned the stabiliser during the last stage before leaving the vessel. In any event the port stabiliser fin was found to be in its pocket during the ROV inspection on 09/10.10.94 - see the images below.

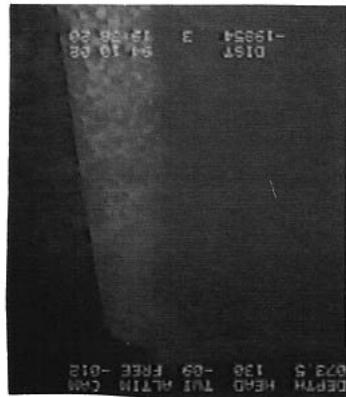
Alternatively the stabiliser fin could have broken off by the object sliding against the vessel's starboard side by which the scraping noises were caused. The noise scenario for Bengt Nilsson would have been the same. Therefore the video footage showing the ROV inspection of the sea bottom was analysed and the following two images were found which show parts of the stabiliser fin.

As to the **starboard stabiliser** there are strong indications that it broke off or was broken off and is resting on the sea bottom now. In both cases a substantial water ingress into the engine room - at least 2 watertight compartments were affected - would have been the result for which there are also indications, because Henrik Sillaste has testified that the bilge pumps were running and Margus Treu has stated they were trying to pump water out of the ship. As it is not possible to pump water from the car deck they can only have pumped from 1st deck and 0-deck.

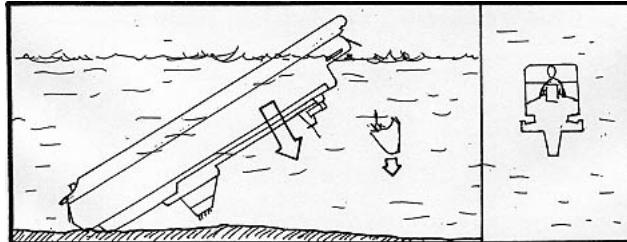
While the ferry was sinking in completely upside down condition the stern area had the first contact with the sea bottom. The bow was still above sea level at this time with the bulbous bow being the highest point. See the drawing below.

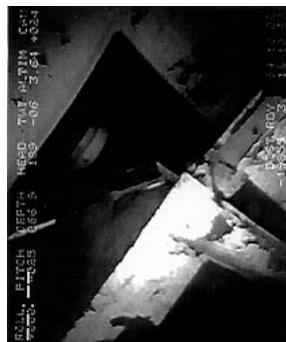
The ROV tape made on 02.10.94 indicates that the starboard stern ramp is slightly open as can be seen on the adjacent image. It shows the upper inner side. The explanation for this slight opening was given already in Subchapter 21.3.3 by the statement of Rolf Sörman - see [Enclosure 21.3.3.335.1](#) - who, as well as his seminar colleagues, were disturbed to such extent by hydraulic noises that they gave up their conference at 21.45 hours ET.

It has to be assumed that the starboard stern ramp was completely unlocked as it otherwise could not be slightly open and that the reason for this slightly open condition is the almost upside down condition of the wreck. It has further to be assumed that the stern ramp has been much more open during casualty sequence-of-events because latest after the shut-down of the auxiliary diesels the hydraulic pumps stopped since not being connected to the emergency generator. This means that subsequently the starboard stern ramp slowly opened completely or more or less completely while the ferry heeled more and more to starboard which led to massive water ingress onto the car deck and through the big lift opening at the aft end of the centre casing also into the large provision area in the aft of deck 1 and so on. This is most probably the explanation for the ferry sinking by the stern.

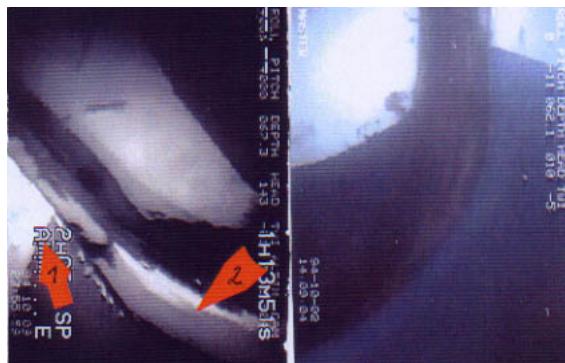
- Further down the front bulkhead in the so-called "corner of the mouth", the area to the outside of the rubber packing is cracked open over some 300 mm - see left image below. The bottom part of the front bulkhead is severely deformed and apparently cracked off the forepeak deck as well as cracked off the inner bulkhead plating and probably also off the outer shell plating as can be seen from the left image below.

arrow 1 = change over from blue to white paint. On the image below the arrow points to the respective area on the opposite port side.
arrow 2 = points to the torn off and dislocated lower parts of the front bulkhead. The right image shows the corresponding intact port side.

Note: As the visor was resting against this area when a possible explosion occurred, the bulkhead could not burst open to forward and the pressure obviously escaped downwards and to the sides. Thereby the complete lower part of the front bulkhead was torn off the recess on the inside, off the shell plating on the outside, and off the forepeak deck on the lower side. Actually the area indicated by arrow 2 should be blue as can be seen from the image beside it showing the respective port side.

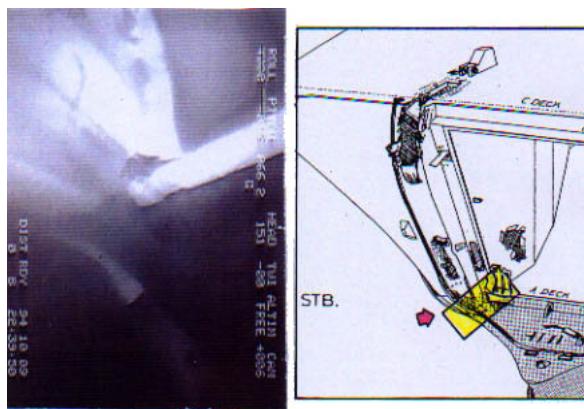
- Next to the cracked open inner bulkhead plating, the lower section of the starboard outer vertical girder of the bow ramp - being immediately next to the cracked plating when the ramp is closed. It is noted to be cracked off both from the upper and the lower transverse girder as well as from the bow ramp plating and extremely deformed and pushed to port. - See the image below with the explanatory drawing and also the extensive photo documentation in Subchapter 29.2.

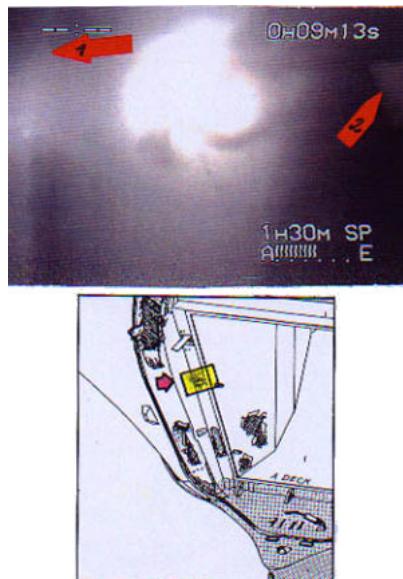
The image on below shows the area of the recess bulkhead between the lug for the preventer wire and the upper mating box. Arrow 1 points to the rubber packing of the bow ramp and arrow 2 points to the edge of the bow ramp. Between the arrows a metal flap is visible which is apparently part of the recess. Transferred to the front bulkhead around the corner this is the area of the big damage above the lug of the hydraulic lock. See also the above drawing.

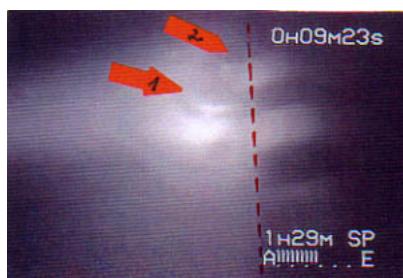
The next image shows the black/yellow painted tire-protection bar edge of the bow ramp to the right with the remains, i.e. the inner part of the fastening, for the starboard ramp actuator - see arrow 1.

It is further visible that the edge of the ramp is bent up - arrow 2 - above the line of the recess bulkhead - see red dotted line.

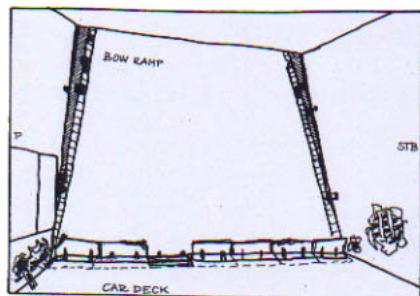
The eight flaps of the bow ramp covering the gap between the car deck and the open ramp were found to be in different condition: some were well painted, green and intact, while others - in the middle - were brownish/red and partly damaged. See the two images below.

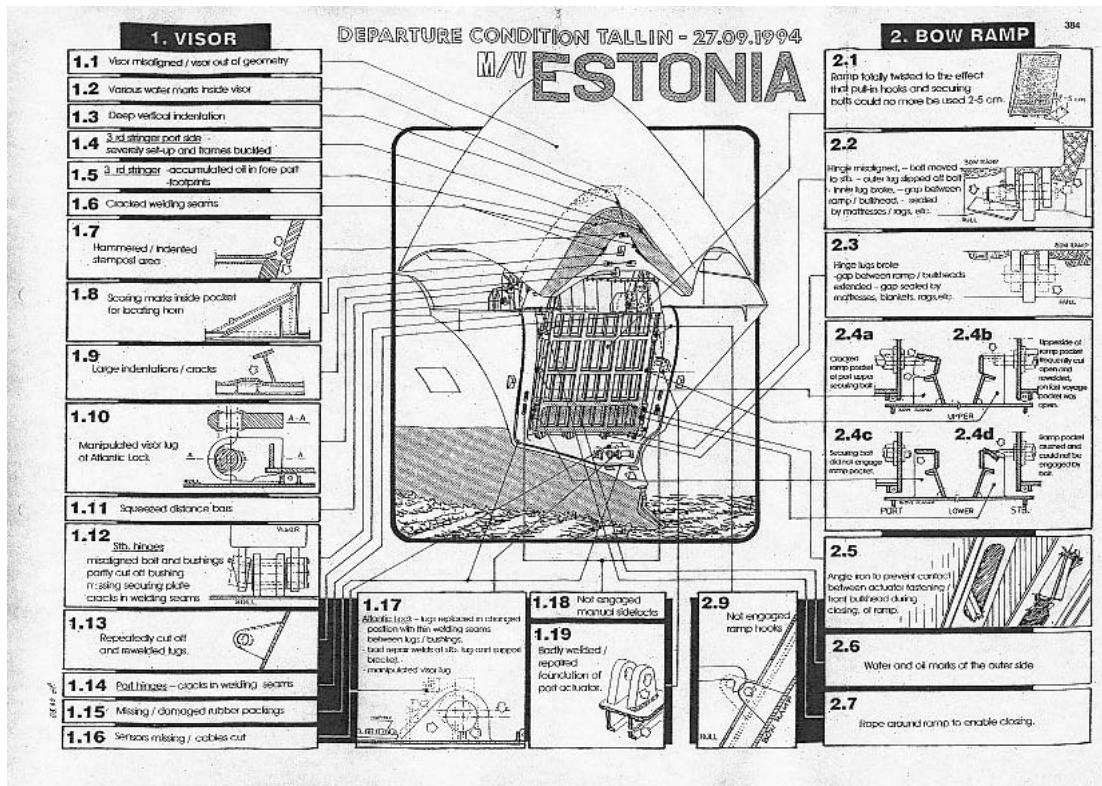
In addition, these deficiencies are shown on a drawing of the foreship with open visor which is integrated into this report and forms the following page.

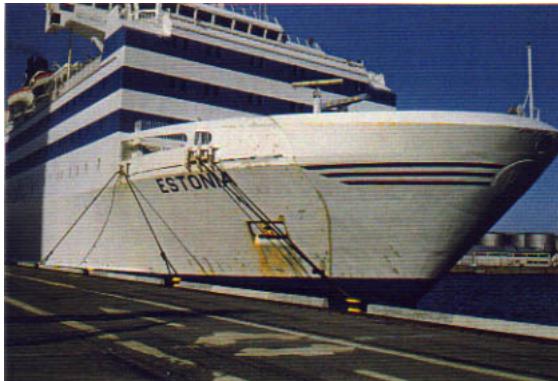
The crew had severe problems to lift up the ramp at all which was only possible after some temporary measurements had been carried out. Ever since, the misalignment of the ramp increased visibly and the problems were growing daily.

Also the rubber packings around the car deck opening, which should be sealed tight by a properly closed and locked bow ramp, apparently did no more seal watertight since some considerable time already, because the last Finnish crew had ordered 10 m of rubber packing to be renewed at the next yard time which was planned for January 1993 - see Subchapter 3.4. - as mentioned before. This was more than half of the total length of the rubber packings, but also these packings were never renewed.

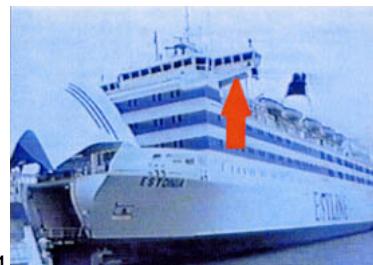
No 4, No 5

as to (1): The torn and broken open underside of the port bridge wing.

The area in question and the extent of this unusual damage at an unusual location shall be illustrated by a number video images. The first ones were made from footage produced already on 02.10.94, i.e. 4 days after the casualty, and the last ones at the diving investigation between 01-04.12.94. The arrow on the picture below points to the area in question.

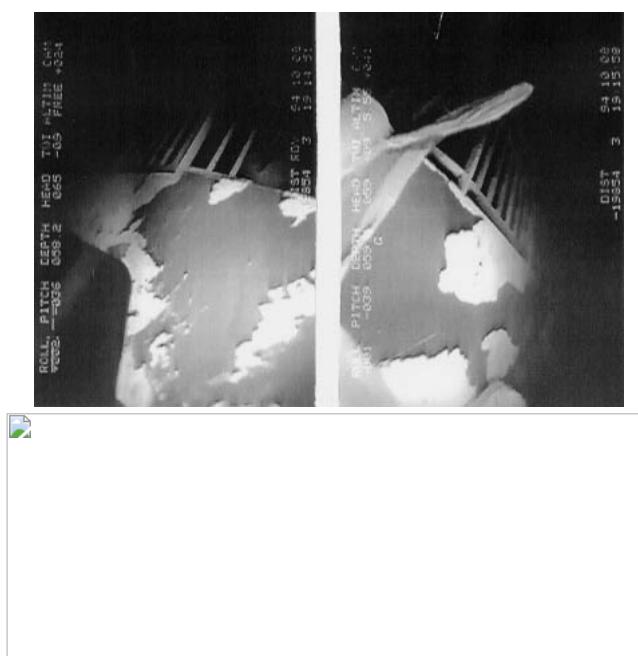
Note: This door could only be opened by crew members. The aft parts of the superstructures in way of decks 7 and 8 on the port side were found to be partly distorted and buckled. Large flakes of paint were scored off the aft parts of decks 5 and 6 - see the two images below - which was most probably caused when the vessel was in upside down condition with the stern already aground and the bow still above the water. - See the drawing below.

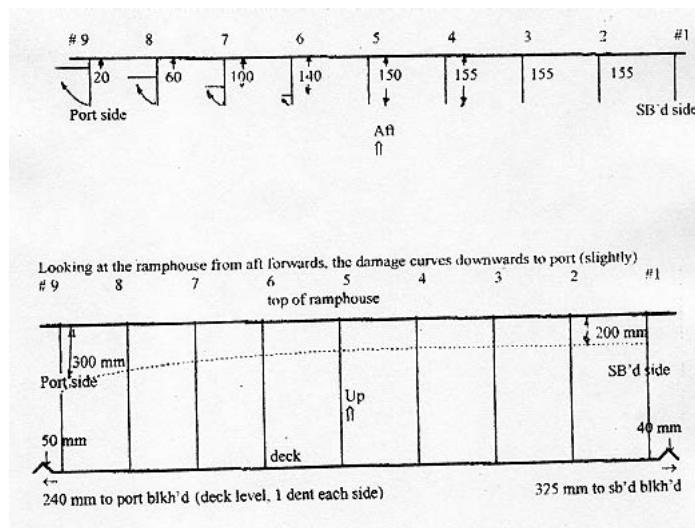
»Undamaged webs are abt. 155 mm high. There are 9 pcs webs in all. Webs # 1 to 4 from the sb side are essentially undamaged, but the paint has been scraped off all of them in a line abt 20 mm down from the ramphouse upper horizontal surface plate (top). Web # 5 is already very slightly deflected towards port and measures at 150 mm (against 155, see above). Web # 6 is deflected so that 140 mm remains, # 7 has 100 mm, # 8 has 60 mm and # 9 has 20 mm standing, while the rest of that web has been deflected to port. The depth of damage (deflection) is thus quite linear between webs 6 and 9. However the point of max damaged paint at # 1 to max deflection at # 9 seems to follow a gentle curve dropping downwards as you look to port. The ramphouse after plate with the damaged webs below.«

The damage configuration revealed by the above measurements indicates that the visor must have been misaligned by 4°-5° in forward/aft direction if the indentations should have occurred by contact with the bow ramp, i.e. the port side of the visor had to be about 300 mm further forward than the starboard side. In other words, the port side of the visor must have moved forward while the starboard side was held back. Before such forward movement of the visor is possible at all and contact between the aft part of the visor's ramp house and the upper part of the bow ramp is possible, several initially built in obstacles have to be overcome as demonstrated by the drawing on the following page.

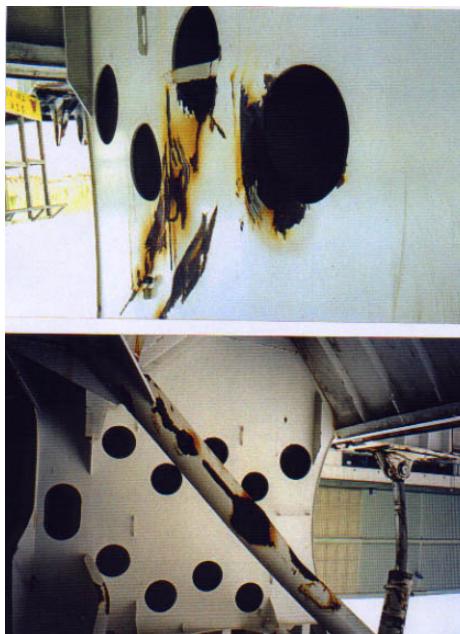
Finally attention has to be drawn to one indentation pushed at each side into the forward deck beam of the visor, i.e. the lower side of the forward part of the ramp house as indicated on the two pictures on the next page. According to drawing on page 956 the port indentation is 240 mm away from the inner bulkhead and the starboard one 325 m. This means that these indentations were most probably caused by the bell cranks being the most upwards extending parts of the bow ramp. This must have occurred at a time when the visor was hanging on the bow ramp already, i.e. the contact area having been the port inner bulkhead. Therefore the distance between bow ramp and port inner bulkhead has as small as possible - 240 mm - while the opposite distance between the bow ramp and the starboard inner bulkhead was as big as possible - 325 mm. This is also the explanation for the apparent fact that the port inner bulkhead was very severely distorted and partly cracked while the starboard inner bulkhead remained completely unaffected even without paint scratches. See also S 4 and P4 - The Inner Bulkheads - further down.

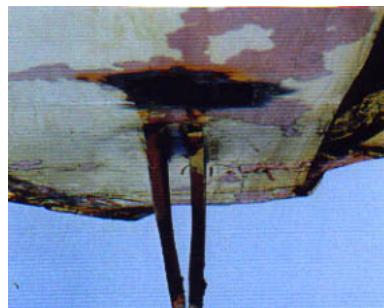
The hooks for the manual side lock were just bent together, as can be seen on the picture on the next page. The area around the lug location shows burning marks obviously from cutting off the lug by flame cutting - see arrow - but no smoke marks as on the starboard side and the plating was not pushed out/distorted.

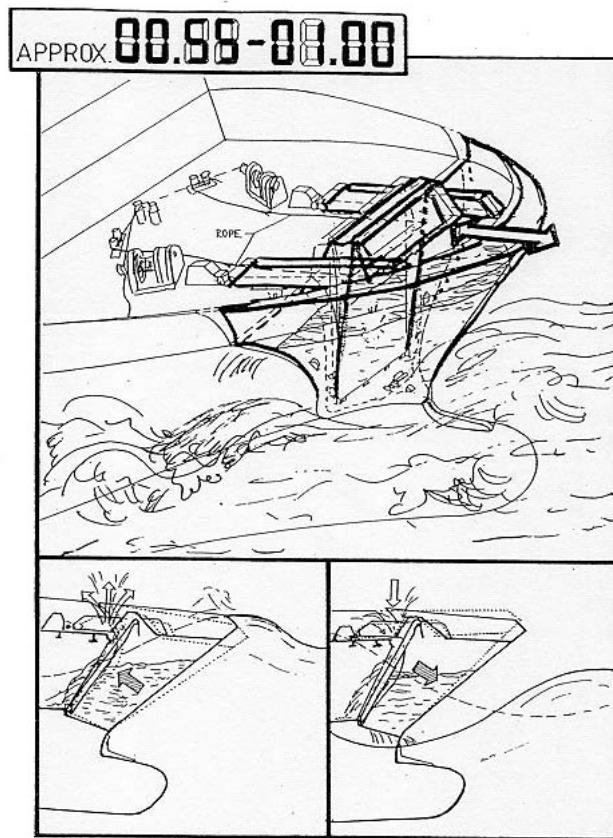
1. Hard metallic banging/knocking and scraping noises.

2. Visor moving forward /aft between the deck beam at the frame 159 and the forecastle deck parts of the hinges, the lugs underneath the visor arms were cutting through the deck beam.

3. The bow was deeply diving into wave troughs and the stern rising high up while the whole vessel was shivering.
4. The crew still working on the car deck.

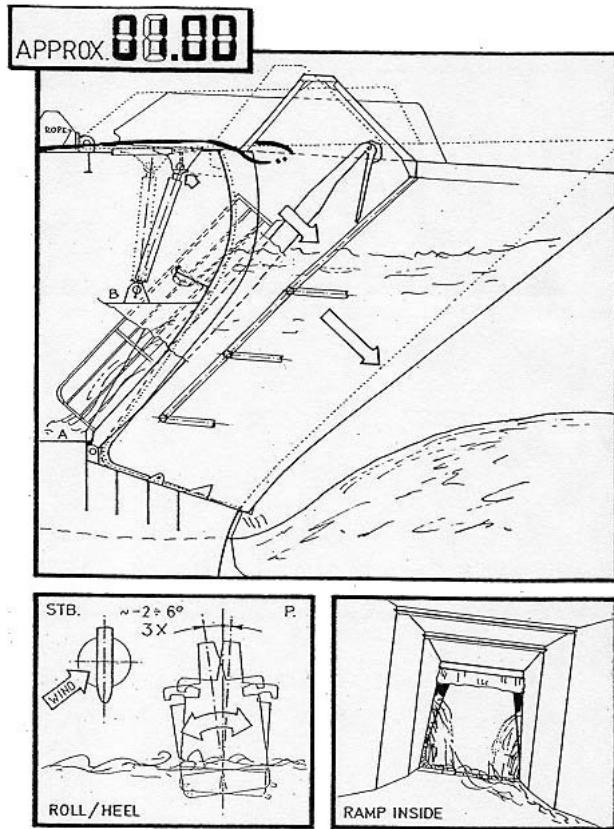
1. The visor lugs finally cut through the deck beam and the visor moved forward, the forepeak deck penetrated the visor bottom.
2. The vessel was now more rolling than pitching.
3. The ramp was inside the visor while the visor moved forward.

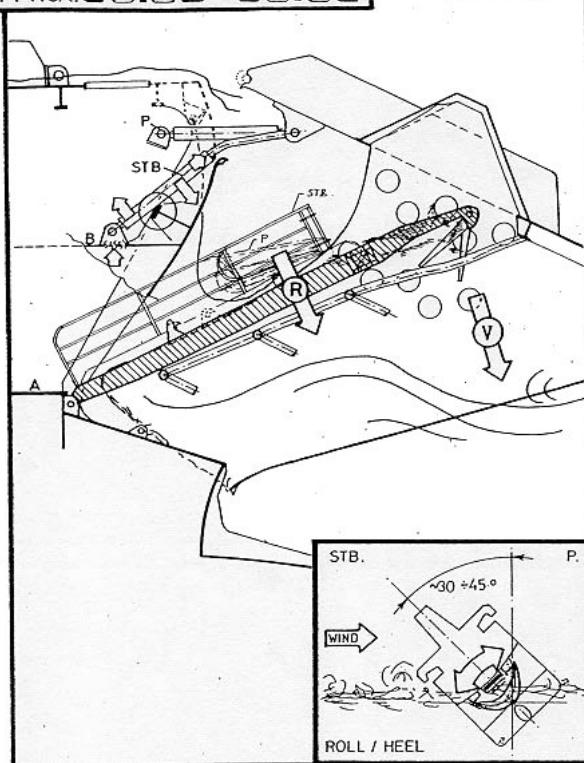
The visor moved further forward with the starboard actuator extending and the forepeak deck pressing into the visor bottom. The strong ice plates supported the visor further from falling off to the starboard and the further the visor moved forward the deeper the forepeak deck pressed into the visor bottom .
