THE GERMAN 'GROUP OF EXPERTS'

1 THE CASUALTY

2 THE VESSEL "VIKING SALLY"

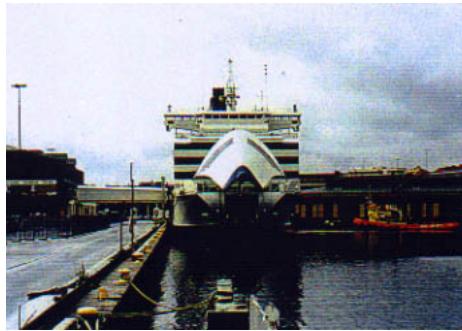
One of the viewers of the 'EFTERLYS' program reported that he saw the ESTONIA in July 1994 at her berth in Stockholm with open visor and open bow ramp, which was categorically denied by N&T, ESCO and the JAIC members.

The following picture proves it. It was made by a German tourist in July 1994.

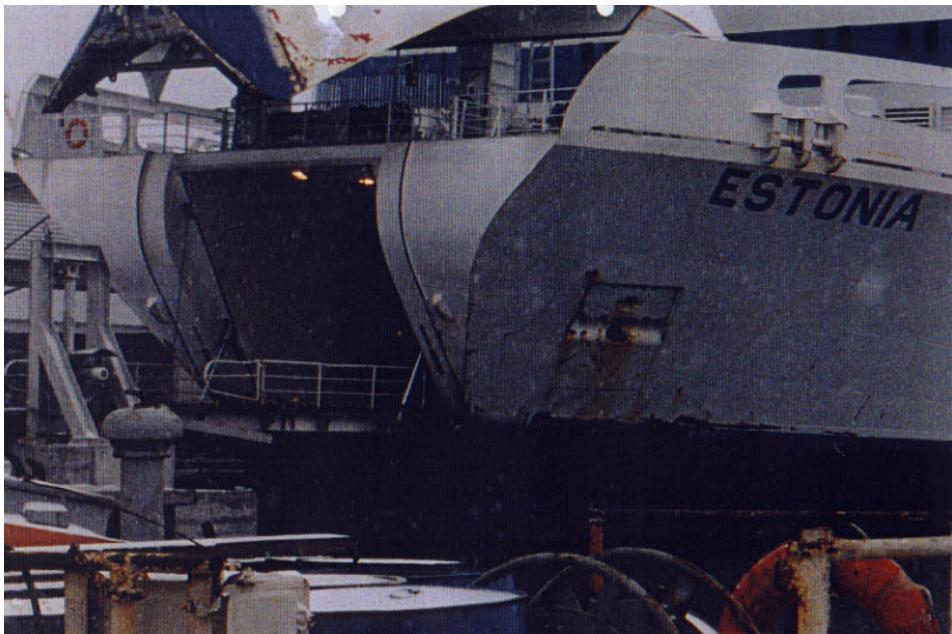
The ice situation is demonstrated on the ice chart of 28.03.94 which is attached as [Enclosure 12.4.2.152](#) and two photos showing the cruise vessel SALLY ALBATROSS sitting aground outside Porkkala (opposite Tallinn) in heavy ice during February/March 1994. The photos attached as [Enclosure 12.4.2.153](#) clearly demonstrate the ice conditions which were prevailing at this time in the Gulf of Finland. The effect these ice conditions had on the visor and foreship of the ESTONIA can be seen on the photo below which was made on 24.03.94.

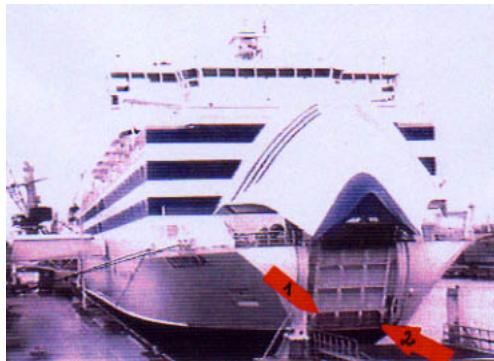
The picture below shows ESTONIA at her berth in Tallinn with open visor and closed bow ramp. The arrow no. 1 points to the oil covered lower part of bow ramp which demonstrates the height of the water level with hydraulic oil floating on top inside of the visor when the vessel was at sea in calm weather. Arrow no. 2 points to the bow ramp hinges which are on car deck level.

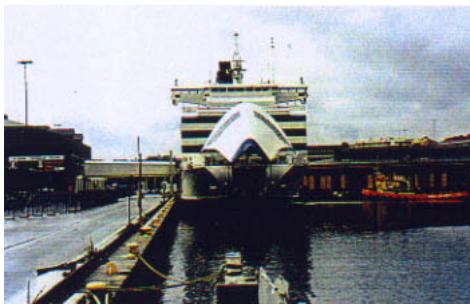
»I had frequently been on the forward part of the 8th deck upon departure from Stockholm and do remember having quite often seen the visor open.« (See photo below.)

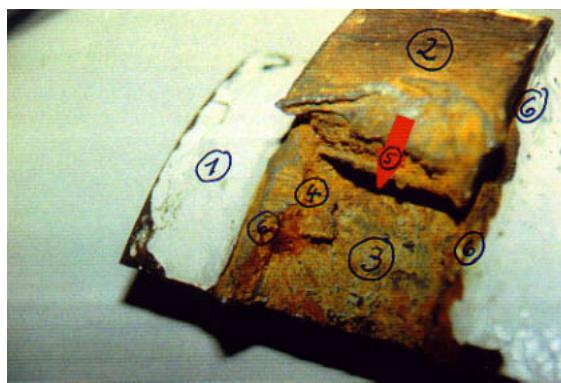
photo of stb. inner bushing recovered by divers

In summary of these three statements it has to be concluded that the welding seams between the bushings and hinge plates of the visor hinges were visibly cracked up to 10 cm at the beginning of August 1994, less than 8 weeks before the casualty.

The photo below shows a part cut out of the bushing recovered from the wreck. It is most probably the starboard inner bushing as will be explained in Chapter 30.

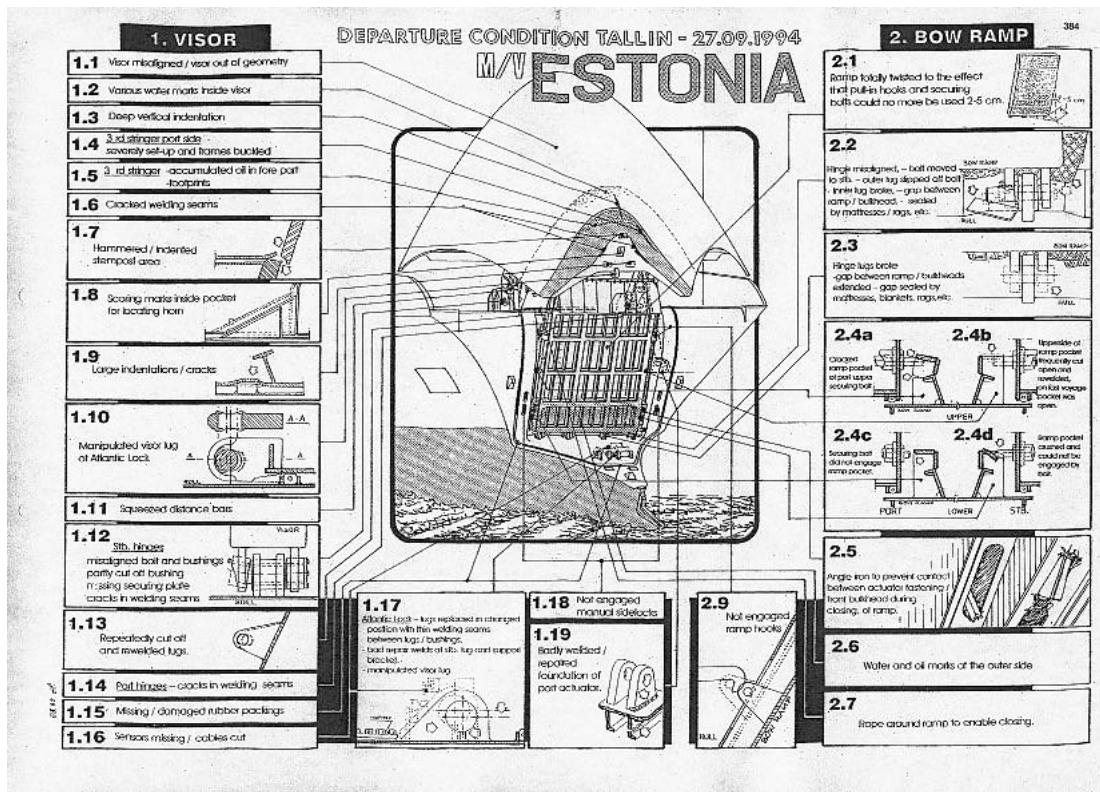
In addition, these deficiencies are shown on a drawing of the foreship with open visor which is integrated into this report and forms the following page.

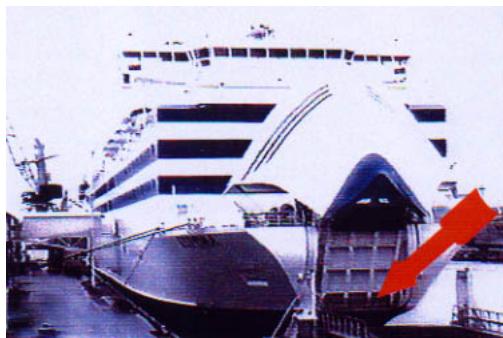
The following picture shows the ESTONIA in Tallinn, with open visor but closed bow ramp so that the otherwise invisible underside of the bow ramp is shown with the lowest section being dark - see arrow. Doubtless this was caused by the water inside the visor with hydraulic oil from the leaking cylinders swimming on top of the water surface. When the vessel reduced speed and the bow wave became smaller and finally disappeared completely when the vessel was alongside, the water streamed out of the visor and the oil settled everywhere inside the visor, also on the bow ramp which forms the aft inside of the visor.

The water streaming out of the visor was observed by many passengers when the vessel was alongside in Stockholm with closed visor and, among others, also by the skipper of the Sandhamn pilot boat as well as by several pilots when the ferry was slowing down during the approach to the pilot boat.

The bow wave became smaller and the water streamed at once out of the visor. (See Subchapter 12.4.4.)

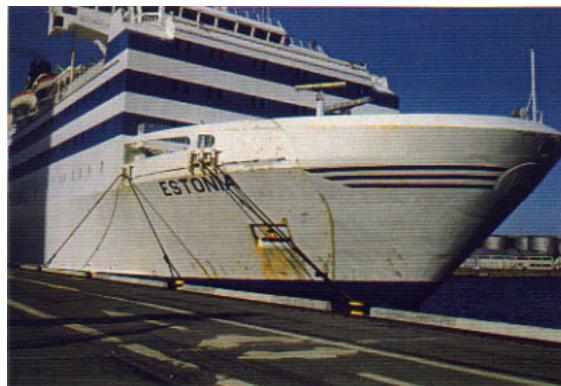
Also the **rubber packings** around the car deck opening, which should be sealed tight by a properly closed and locked bow ramp, apparently did no more seal watertight since

some considerable time already, because the last Finnish crew had ordered **10 m of rubber packing to be renewed** at the next yard time which was planned for January 1993 - see Subchapter 3.4. - as mentioned before. This was more than half of the total length of the rubber packings, but also these packings were never renewed.

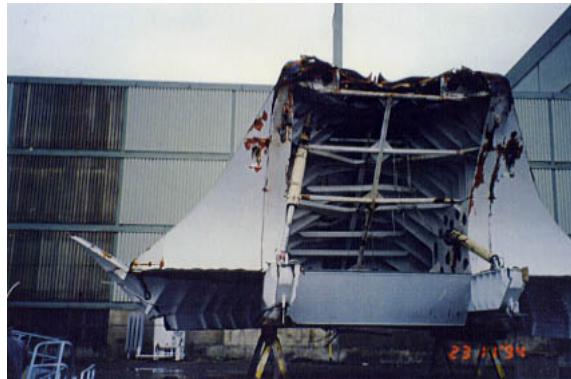
During the time from 16-18 November 1994 the visor was lifted by the Finnish multi-purpose ice breaker NORDICA - assisted by the Swedish mine hunter FURUSUND - and brought to Hangö - see Enclosure 24.408.1 - where it was lifted ashore and placed on the premises of Levator Oy, still in upside down condition. It was left in the open air, totally unprotected, but still in remarkably good condition until 20.11.99. On this day the visor was picked-up by the Swedish navy and transported to Sweden.

The picture below was taken on 23.11.94.

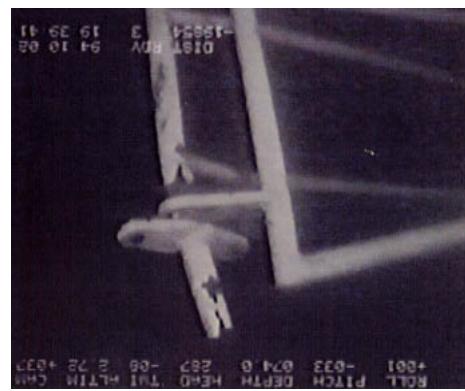
Upon evaluation of the video tapes by Disengage parts of the bow ramp rails were identified on the sea bottom and the images shown below and overleaf were produced.

The two images above made by ROV on 2.10.94 already clearly and without doubt prove that it is the forward section with movable part of the starboard bow ramp rail which is resting on the bottom of the sea.

A reconstruction of the ROV track commencing at the stern of the wreck revealed that these rail parts are located about 250 m to the south of the stern and about 80 m to the south-east of an area where the video was cut three times, each time for about 1 minute.

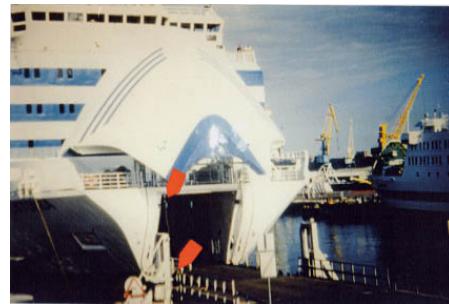
The preventer wires attached at both sides of the bow ramp and the car deck opening were installed to prevent the bow ramp's falling down onto the forepeak deck in case of the failure of the ramp actuators, i.e. wires, shackles, lugs were dimensioned to catch the falling ramp without breaking.

The arrows on the picture above point to the shackles by which the starboard preventer wire is connected to vessel and bow ramp. The system on the port side is identical.

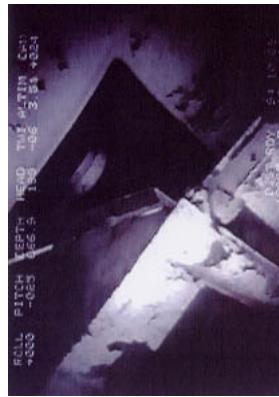
as to (8) The condition of the starboard stern ramp.

The image below shows the inside of the upper starboard stern ramp to be partly open. It was taken from the ROV video dated 09.10.94. The arrow on the picture further down points to the area in question. This fact will be explained in detail in Subchapter 29.7.

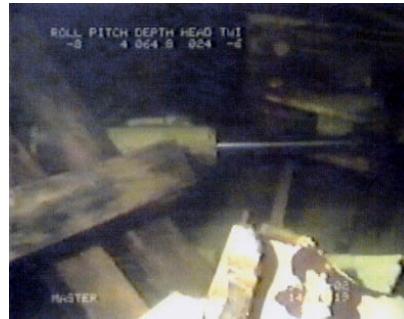
Contrary to the port opening - see sheet P 3 - where the ramp hook arrangement is clearly visible when the ROV looked into the opening - see the image on the next page - the starboard opening is just a big black hole. This can only mean that the starboard ramp hook was not where it was supposed to be.

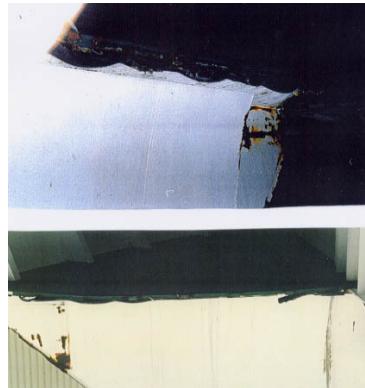
Also the flat bars around the deck opening into which the rubber packings - fitted below the visor arm - should be pressed, when the visor was closed, were missing. The same refers to the flat bars having initially been welded athwartships at the forward part of the forecastle deck into which the rubber packings at the aft part, i.e. below the recess of the visor, should be pressed when the visor was closing (see also item 5 on the detail drawing). This can be seen from the following two pictures, of which the first one shows the starboard aft part of the visor deck with untouched rubber packings, intact and in place and the 2nd is the port side which is evidently in worse condition.

The picture below shows the rubber packing underneath the starboard visor arm which was obviously never pressed into any flat bar and is not affected at all, which confirms the apparent fact that

- a) the flat bars around the deck opening had been removed prior to the casualty and that
- b) the visor was raised to some extent at this side after the hinges were broken since otherwise this rubber packing would have been destroyed as it did happen at port side - see P 3 - Port Side Fore-castle Deck.

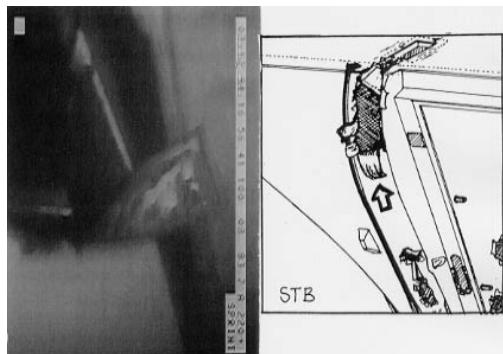
The picture below shows the lowest part of the damage, i.e. an almost horizontal, slightly upwards pointing steel flap.

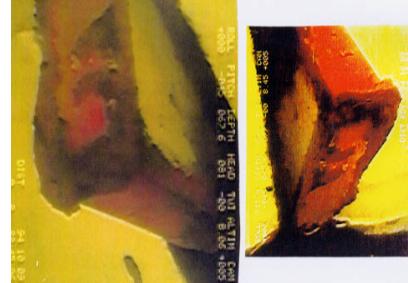
The next images show the lug of the hydraulic side lock which was evidently torn off the visor bulkhead together with the welding seams by which it had been welded to the bulkhead.

Note: It is obvious that these welding seams do not originate from one welding procedure only but from several weldings on top of each other, i. e. after each cutting off the new weld was laid on top of the previous ones without grinding off the remains of the previous welds as required by proper workmanship to assure the required load-carrying capacity of the weld. The required load-carry capacity of these lugs being part of the locking system of the visor did already since sometime before the last departure no more exist and was reduced to a fraction of the initial load-carrying capacity by such unqualified repairs.

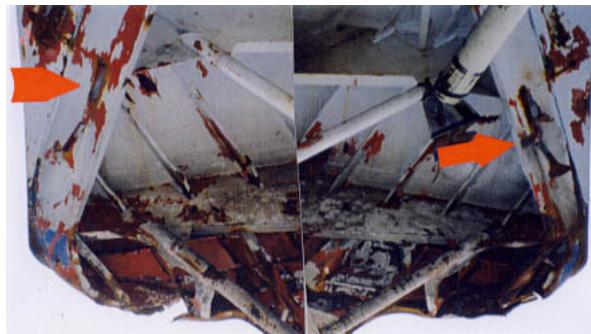
The picture on the right left shows the area of interest on the starboard side, the picture on the left shows the corresponding port side. It shows a completely different damage picture: no smoke marks, no steel tongue torn off the bulk-head and no twisted hooks.

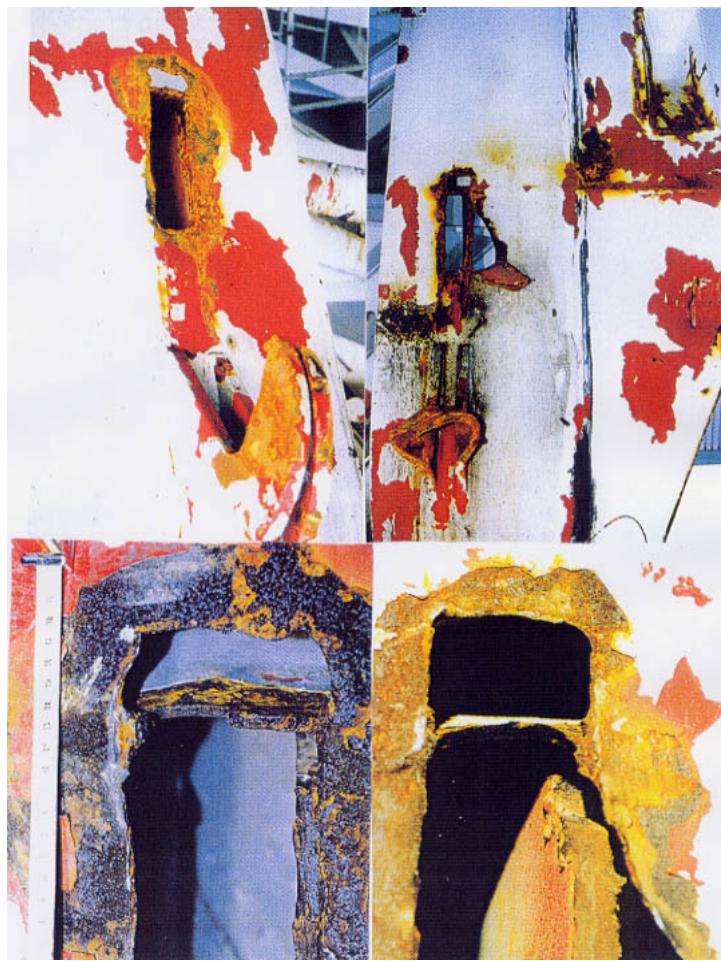
Two of the following four pictures on the next page show those areas at the port and starboard aft bulkhead of the visor where the lugs of the side locks had been welded to and the hooks for the manual side locks were fitted. The other two are close-ups of the upper parts of the area where the lugs had been welded. The right side shows the part of the starboard visor bulkhead directly opposite the above explained damage area. The smoke marks are still clearly visible although the visor had been on the sea bottom for 7 weeks. The hooks are distorted in a way which is technically not explainable. The area is dark. The picture on the left shows the corresponding port side as comparison with a complete different damage picture, with no smoke marks, no steel tongue torn out of the bulkhead and no twisted hooks and a generally clean appearance. The two close-ups arranged below the above mentioned photos show the respective upper parts of those openings in the bulkhead. They do illustrate the difference very clearly. While the port side shows normal steel clean of corrosion, the starboard side shows steel which had obviously been exposed to heat and pressure force: The metal is distorted and pushed out, the stiffener is detached from the bulkhead. See also Chapters 30 and 32.

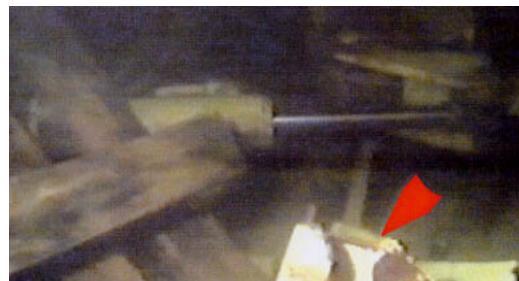
The image below was made when the ROV looked into the opening in the forecastle deck for the port visor actuator. The actuator of the ramp hook with part of the hook arrangement and the remains of the cut through deck beam - see arrow - are clearly visible.

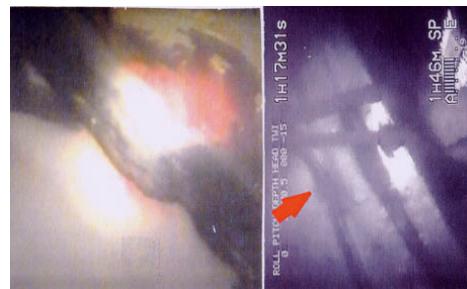
Arrow 2 points to a damage area in way of the rubber packings which is better visible on the right image below made from the 1996 video tape. The double rope was then still there because it is jammed in, though in slightly changed position. The damage area is more clearly visible - see arrow.

The left image above was taken from diver video B40c and is a close up of the same damage area. It shows that the rubber packing including flat bar channel has been pressed flat on a distance of about 200 mm. This could have been caused by a single wire or wire running from the bow ramp around the edge of bulkhead/hull plating up to the fair leads on the forecastle deck and further to one of the winches. Alternatively the damage could have been caused by the port aft edge of the visor bottom in the final stage of the visor separating from the vessel - see Chapter 31 - or it could have been an old damage because the corresponding area on the aft bulkhead of the visor does not show rubbing marks from the rubber packing. See the picture on the next page. A similar damage does not exist at the starboard front bulkhead.

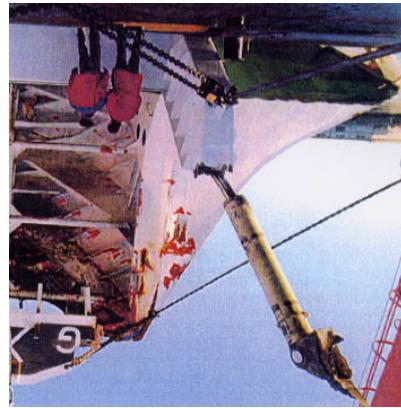
The starboard actuator, to the contrary, was found to be fully extended with the piston rod bent. It had apparently been the last connection between the vessel and the visor except for the bow ramp, the fore-castle deck and bulbous bow.

The area indicated by the arrow and the close up was probably struck by the foundation of the starboard actuator after the actuator had moved out of the front bulkhead of the vessel. - See also Chapter 30 - The Visor.

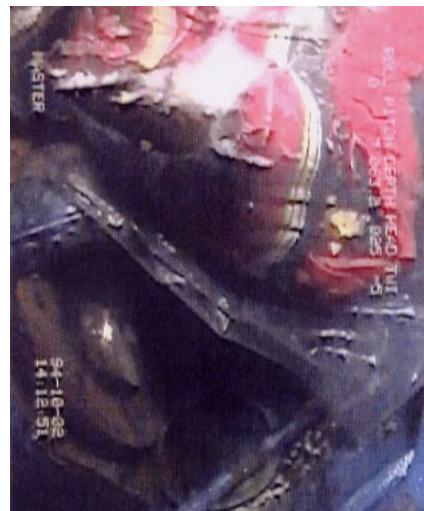
This gap was plugged by mattresses - see the blue transverse one above the hinge remains - the vertical plastic sheet to the right of the blue mattresses, the red/white bedding next to the plastic sheeting. The videos from 02. and 09.10.94 are showing blankets and rags further up in the gap between ramp and bulkhead.

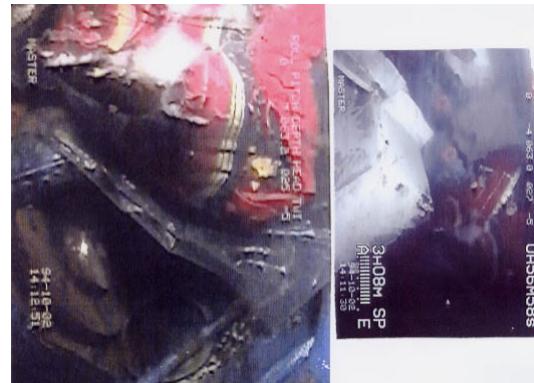
Also the following image shows the same area, but slightly further to starboard. The rubbing marks on the bedding indicate that it had been in place during several openings/closings of the bow ramp.

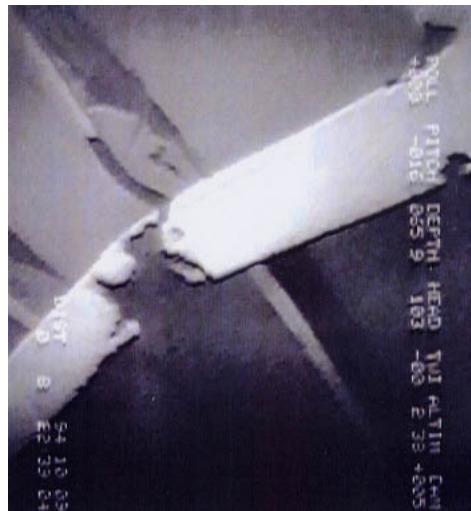
Below is an enlargement of damage No. 2.

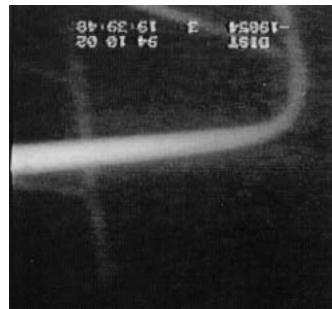
The image below shows the aft lower part of the movable fifth section which confirms the before said.

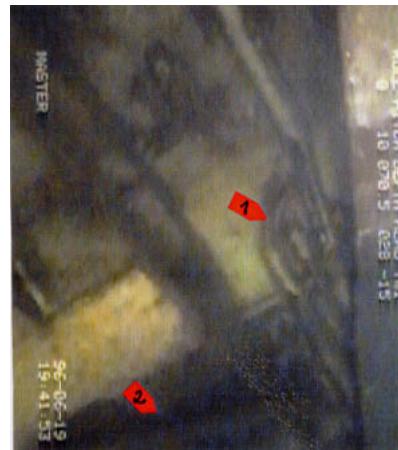
- When diver 1 (David) inspected the outside of the ramp on 03.12.94 he found a running wristwatch in the lower part of the ramp, i.e. in one compartment above the broken starboard hinges. It turned out that the watch belonged to diver 2 (Mark) indicating that he must have been there before apparently engaged in other activities not shown on the available video footage. See the ramp drawing on page 869.

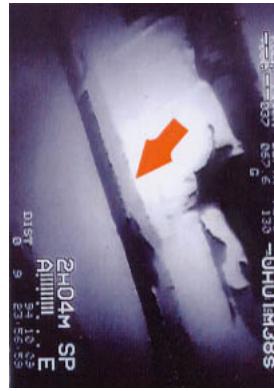
The lower part of the starboard front bulkhead in way of the hydraulic and manual side locks - see also further forward in this chapter, the starboard front bulkhead - is shown on the following images. The first one shows the upper part of the opening for the manual side lock with the rubber packing to the left. Between opening and rubber packing the bulkhead is visibly bulged - see arrow - i.e. the bulkhead is pushed out around the opening for the manual hook and increasingly deeper down the bulkhead. This can be seen from the next image below - arrow 1. In addition, there is a very deep fold - see arrow 2 - as well as damage in way of the rubber packings - arrow 3.

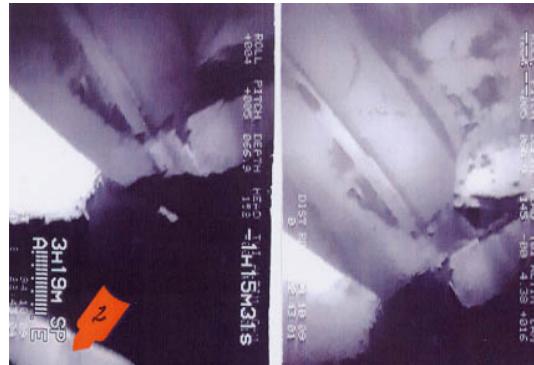
The following two images show the area adjacent to this pushed-out lower part of the front bulkhead, the recess with the torn-off and severely bent lower part of the outer vertical girder of the bow ramp. Apparently the deck/bulkhead is open in way of these severe distortions which also extends downwards.

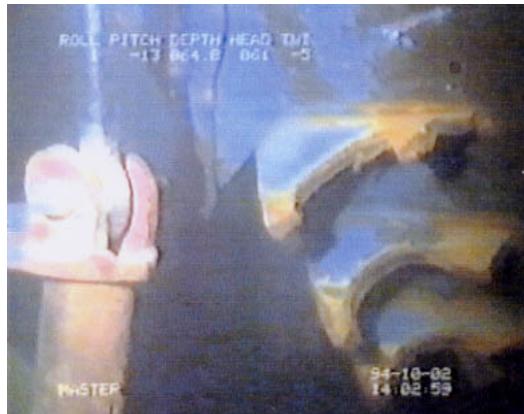
- Image No. 1 shows the starboard and centre logs while images Nos. 2 and 3 show the centre - and the port lugs. The latter one was subsequently destroyed upon instructions of the JAIC for testing purposes.
- The 3 images were taken from the ROV video made on 9 October 1994, i.e. 12 days after the casualty. All fracture surfaces are heavily corroded. This is even more evident from the image below made from the ROV video from 02.10.94, i.e. only 4 days after the sinking, which shows the same corrosion to the fracture surfaces of all 3 lugs.

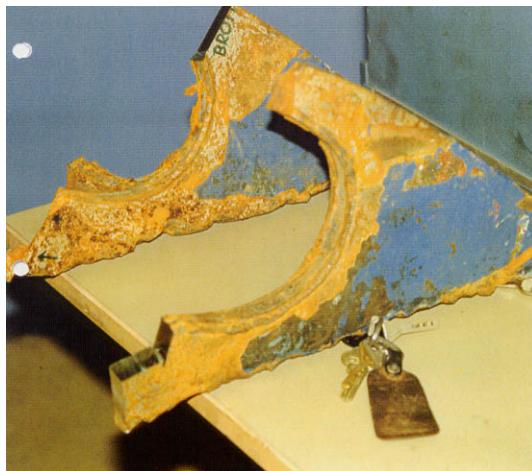
The pictures Nos. 4 and 5 show the starboard and the centre lugs in the Royal Technical University in Stockholm (KTH) in February 1995. They had been cut off the forepeak deck and were recovered by divers on 4th December 1994 and subsequently examined by the KTH. Below a photo of the starboard and centre lugs taken at the KTH, Stockholm in February 1995 is shown in order to illustrate to the reader the actual condition. Particular attention is drawn to the lower fracture area of the starboard lug.

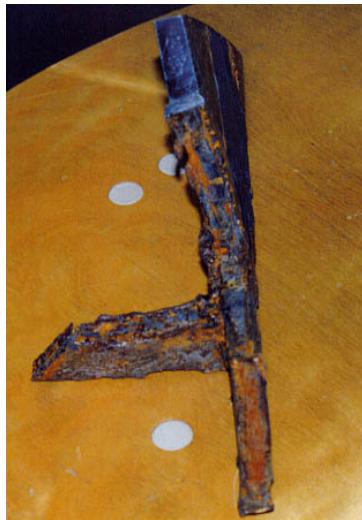
- The photo below shows the starboard lug looking from forward to aft. Attention is drawn to the lower fracture area and the bending of the lug.

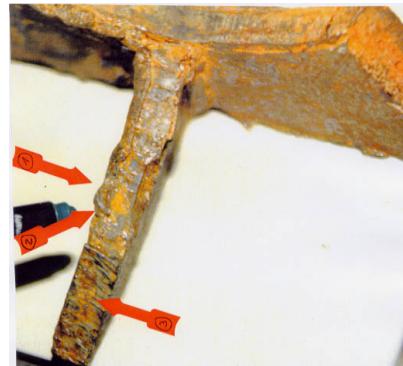
- Next an enlargement of the support bracket attached to the outside of the starboard lug is shown.

- The support bracket at the outer side of the lug (arrow 1) is larger than the original, which is evident because it overlaps the end of the welding seam (arrow 2) which marks the end of the bushing. The support bracket is about 12 mm larger compared to the original one made according to the von Tell drawing No. 49111-373.
- The oblique end of the bracket is just burnt, not grinded (arrow 3). It is considered impossible that the bracket would have left blacksmith's shop of the Meyer Werft in such a condition - see also Subchapter 2.4.6;
- The remains of the welding seams at the outer side of the lug were made very unprofessionally when the lug was upright which allows the conclusion that the lug was fixed to the vessel as otherwise the welder would have laid the lug flat. This would have permitted easier welding and would have produced a qualified welding seam.

- The welds are thin and interrupted, respectively cracked, because they are so thin, which is demonstrated by the corroded surface of the inner side of the lug normally covered by the bushing. As long as the welding seams are intact the space between bushing/lug is airtight, i.e. without oxygen, which was burnt by the heat of the welding process. This was obviously no more the case since some time before the bushing was torn off, because substantial corrosion was able to develop.

- The forward and aft welding seams between bushing and support bracket are not connected at the outer end (or closed, as the welders say), thus water could penetrate. This confirms the unprofessionalism of the welder who did these repair welds.

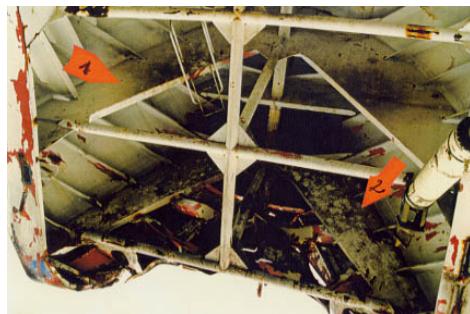
- The photograph on the next page was made mid January 1995. It shows a view into the visor with the partly oil stained 2nd stringer (arrow 1) and the completely oil covered stringer 3 (arrow 2).

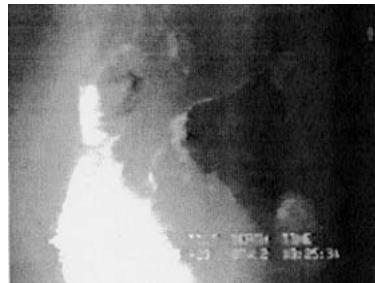
Since the starboard shell plating in way of 0-deck is accessible over the whole length of the wreck - see the 2 drawings on the previous pages - and has been carefully examined by ROV and divers during the mudline surveys, it is certain that respective video material is available. The "official" mudline video is, however, censored, i.e. the relevant parts were deleted - see also the Disengage Report - [Enclosure 34.6.434](#). Nevertheless, careful evaluation of the available mudline video does reveal very substantial damage to the starboard shell plating and bottom plating above and below the bilge keel as demonstrated by the images below.

When looking at the images presented here it is difficult to assume that this vessel had been in drydock only 8 months before, because the starboard side is really in a very bad condition, actually much worse as it is possible to demonstrate by images. Very deep indentations between the frames and deep scoring marks, partly not even corroded, are the rule, however, in some particular areas the plating is even holed as e.g. can be seen from the image below.

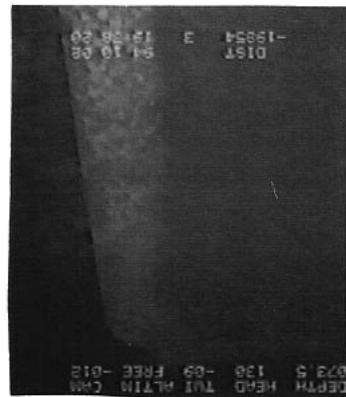
Alternatively the stabiliser fin could have broken off by the object sliding against the vessel's starboard side by which the scraping noises were caused. The noise scenario for Bengt Nilsson would have been the same. Therefore the video footage showing the ROV inspection of the sea bottom was analysed and the following two images were found which could show parts of the stabiliser fin.

As to the **starboard stabiliser** there are strong indications that it broke off or was broken off and is resting on the sea bottom now. In both cases a substantial water ingress into the engine room - at least 2 watertight compartments were affected - would have been the result for which there are also indications, because Henrik Sillaste has testified that the bilge pumps were running and Margus Treu has stated they were trying to pump water out of the ship. As it is not possible to pump water from the car deck they can only have pumped from 1st deck and 0-deck.

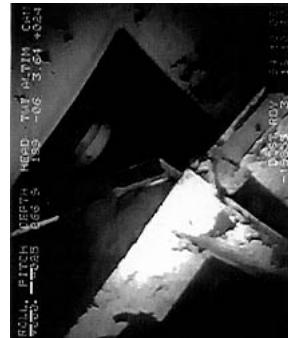
The ROV tape made on 02.10.94 indicates that the starboard stern ramp is slightly open as can be seen on the adjacent image. It shows the upper inner side. The explanation for this slight opening was given already in Subchapter 21.3.3 by the statement of Rolf Sörman - see [Enclosure 21.3.3.335.1](#) - who, as well as his seminar colleagues, were disturbed to such extent by hydraulic noises that they gave up their conference at 21.45 hours ET.

It has to be assumed that the starboard stern ramp was completely unlocked as it otherwise could not be slightly open and that the reason for this slightly open condition is the almost upside down condition of the wreck. It has further to be assumed that the stern ramp has been much more open during casualty sequence-of-events because latest after the shut-down of the auxiliary diesels the hydraulic pumps stopped since not being connected to the emergency generator. This means that subsequently the starboard stern ramp slowly opened completely or more or less completely while the ferry heeled more and more to starboard which led to massive water ingress onto the car deck and through the big lift opening at the aft end of the centre casing also into the large provision area in the aft of deck 1 and so on. This is most probably the explanation for the ferry sinking by the stern.

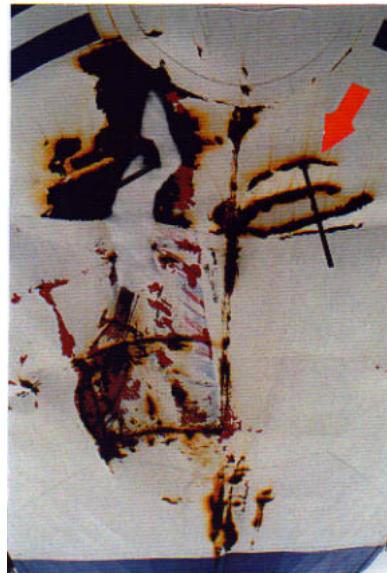
(2) The large damage to the starboard shell plating was apparently sustained in two stages, viz. at first the corroded upper part occurred and subsequently the larger lower part, which extends into the upper part, occurred. Since it is already rather unlikely that the upper part of the damage did occur during the final stage of the casualty sequence-of-events by contact with the bulbous bow, it can be excluded that the 3 sharp and deep transverse indentations to the port side of the centre line were caused by contact with any part of the bulbous bow because there is no corresponding counter-piece. The picture below shows all the indentations in the forepart of the visor. The arrow indicates the 3 horizontal indentations of which the upper and lower ones are rather deep. It has thus to be assumed that the visor had been in contact with some other object either before the casualty scenario began or after it had ended, possibly during the attempts to raise the visor.

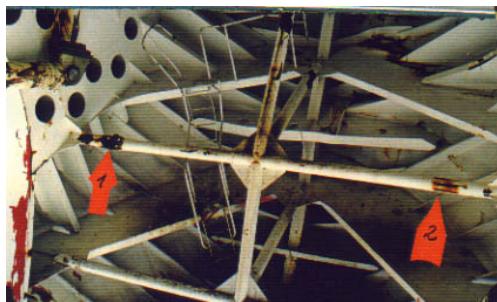
Although the upper transverse crossbar inside the visor shows respective damage - see arrow 1 on the picture below - the corresponding part at the port outer longitudinal girder of the bow ramp does not. This is confirmed by the image further down,

taken from the ROV video made on 09.10.94 which shows the port outer girder underside of the bow ramp in way of the contact area with the above-mentioned crossbar. There is no damage, the paint is completely unaffected (the diagonally running stripe being a wire).

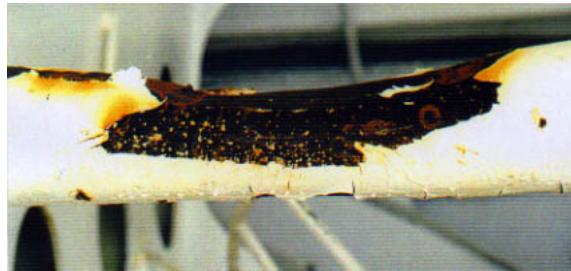
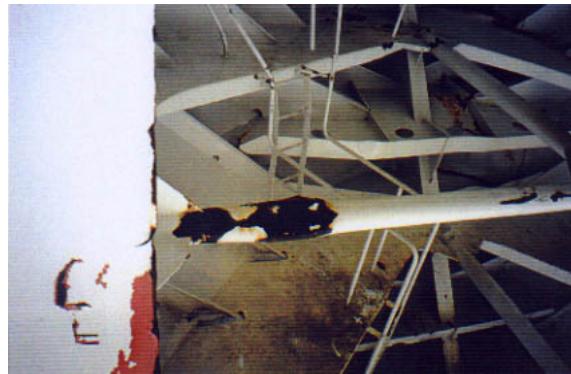
It is obvious that this quite heavy damage shown on the picture on page 961 was caused by impact - see close-up below - and that this impact did not happen too long ago because the cracked paint is still hanging loose. It cannot have been caused by the ramp, at least not at an early stage as explained before. The damage must have been caused when the visor was labouring on the ramp for more than 30 minutes until the heel of the vessel was sufficiently big to let the visor slide off the ramp. During this time, this and other damage to the

port side of the visor was created by heavy contact with the ramp.

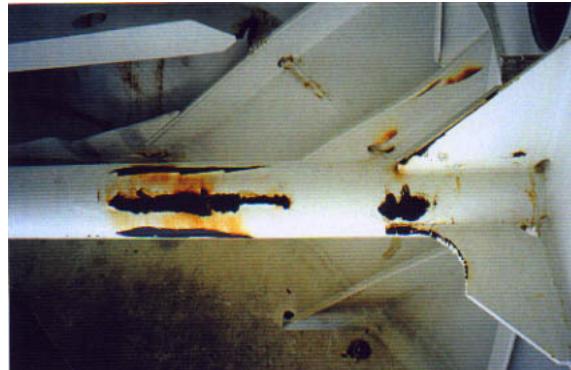
The scoring marks - arrow 1 on the photo on page 961 - at the starboard side of the same crossbeam in way of the first stringer level are not casualty related because except for the middle one the respective areas cannot be reached by the bow ramp. It has to be assumed that these scorings were caused by other means before the casualty.

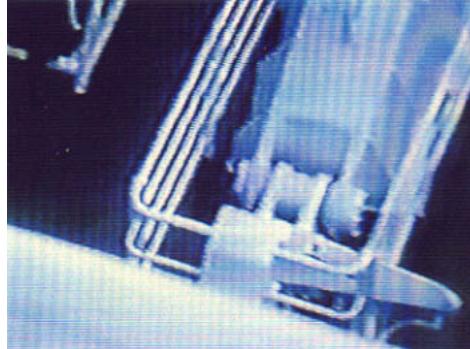
It demonstrates that,

- the whole hinge arrangement is severely misaligned;
- the outer bushing is extending too much to the outside and is twisted;
- the lower part of this bushing as well as the securing plate are missing;
- there is a big gap between the inner part of this bushing and the outer hinge plate fitted on the forecastle deck;

just to mention the main and most obvious deficiencies. The video tape was analysed in detail by the British Reconnaissance expert Bryan Roberts and his findings are discussed in Subchapters 12.5 and 34.9 and his report is attached as [Enclosure 12.5.180](#).

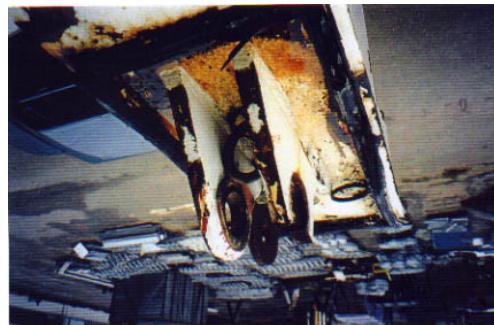
This picture on the next page shows the damaged and torn rubber packing indicating movement of the visor without this side having been raised up.

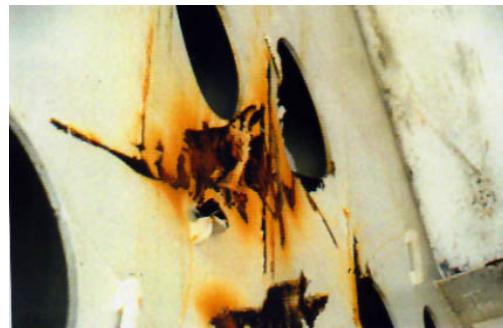
1 - shows the port actuator in jammed condition inside the inner longitudinal bulkhead of the visor. The spherical bearing of the actuator allows a 15° deviation to both sides. The actuator evidently swung into this jammed position after the visor had moved enough forward and after the bow ramp inside the visor was low enough. Thereafter the actuator remained in this position until being dismounted by MacGregor, Turku, in February 1995. The picture below shows the port inner bulkhead after the actuator had been removed.

Measurements revealed and photos confirm that the foundation of the actuator has not been in contact with the plating of the inner longitudinal bulkhead of the visor. Therefore the above visible indentations, scraping and scoring marks have been caused when the visor was hanging on the bow ramp. See also Subchapter 29.2 - The Bow Area - and P 7 further down in this subchapter.

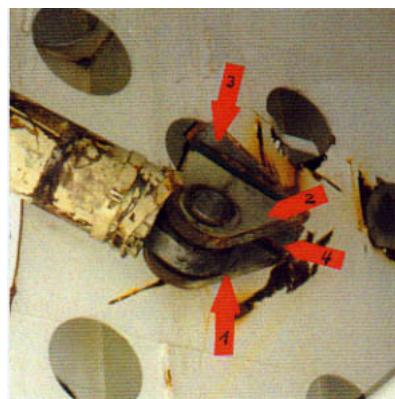
In consequence of this statement the photos showing the damage condition of this foundation have been analysed in detail and the result is outlined below: The foundation of the visor actuators did consist of two strong lugs welded to the B-deck and which were supported by two longitudinal and two transverse stiffeners. The picture below shows the port foundation with actuator still attached to the recovered visor. The arrows indicate the different components.

- arrow 1 = port outer lug plate of actuator foundation
- arrow 2 = port inner lug plate of actuator foundation
- arrow 3 = port inner stiffener (deformed)
- arrow 4 = port outer stiffener

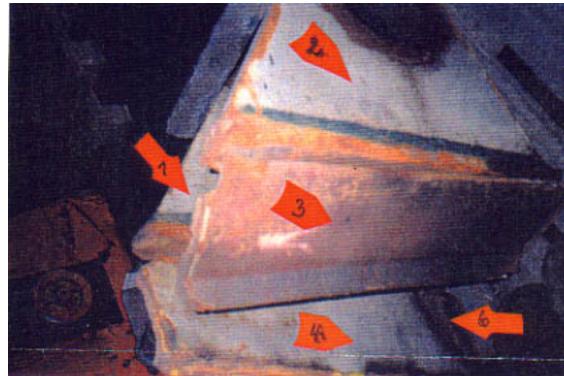
The following photograph shows the actuator foundation after it was removed and taken to the workshop of MacGregor, Turku for examination/testing on behalf of the JAIC. The arrows show the same numbers as used above.

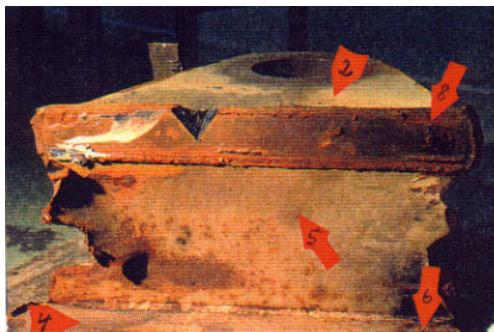
The following photograph shows the port visor actuator foundation after parts had been cut out for testing purposes. The foundation lies on its port outer lug plate. In the front the port outer stiffener (4) is visible, which is fully welded to the B-deck (5). Further at the forward right corner the old temporary repair with the very poor welding seams (6) is visible from inside. For cutting purposes the port inner stiffener (3) had been removed.

The apparent fact that this stiffener (3) had been disconnected from the B-deck (5) respectively since the last repair was never really fitted to it, is further confirmed by a part of the welding seam - see arrow 8 - on the previous two photos - apparently being soaked with oil while the stiffener below is unaffected. This means that this stiffener was not welded to the B-deck.

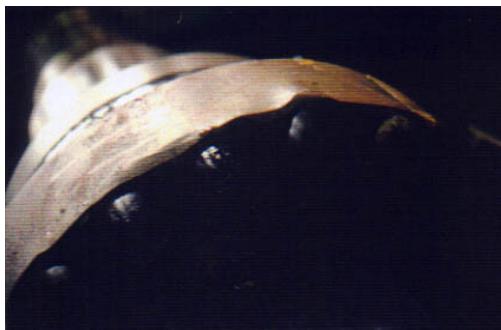
"... it was noticed that there were heavy damages at the distance when the piston rod is about 400 mm open. The damages were on the starboard side of the piston rod. Damages were also noticed on the piston cover's fixing screws. The ends of these hexagon screws were like hammered." (See [Enclosure 29.413](#))

- **The port actuator:** Cover and hexagon screws on the piston rod side are severely hammered. The clamping ring is missing. The outside of the actuator shows heavy longitudinal scoring marks. The piston rod shows heavy damage on starboard side at a opening stage of ca. 400 mm.

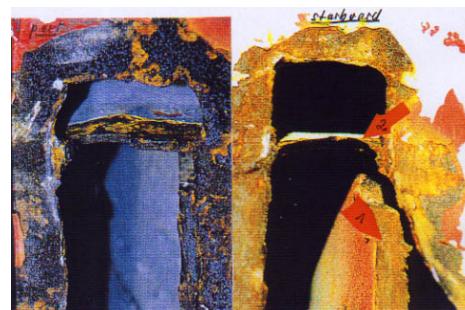
The next pictures - also taken from the JAIC's Report - show the upper parts of the holes in the visor bulkheads where the lugs had been fitted.

The analysis and comparison of both pictures reveal the following:

(1) The plating around **the port** holes is unaffected. Some remains of welding seams are visible at the upper right corner and at the right (inside) there are indications that welding seams could have been there. At the outside (left side) there are no such indications which refers also to the upper hole. Only few spots of corrosion can be seen. In summary it has to be assumed that the lug had not or only to a very limited extent been welded from the outside.

(2) The plating around **the starboard** opening looks completely different because the plating is distorted, the stiffener at the inside is torn off the bulkhead, the plating had apparently been exposed to heat and subsequently became corroded. The steel part between the small hole and the bigger opening was pushed upwards, obviously by the lug then and still attached to the vessel, i.e. the visor made a downward movement in relation to the lug, i.e. the vessel. Thereby the lug was pressed into said steel part. The indication of the remnant of a welding seam is visible at the upper right corner of the big opening. Otherwise there are no indications of welding seams at all.

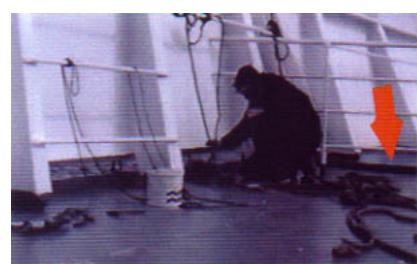
According to the observation of Bo Pettersson the port outer edge of the visor was extending the forecastle deck to such an extent that he could see the water through the gap. He estimated the difference between visor and forecastle deck to have been about 100 mm. Although crew members hammered with sledge hammers on the edge, the condition did not change and they gave up.

The image following shows the area in question. The arrow indicates where the crewman was hammering.

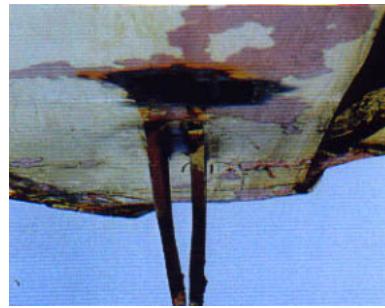
The hooks for the manual side lock were just bent together, as can be seen on the picture on the next page. The area around the lug location shows burning marks obviously from cutting off the lug by flame cutting - see arrow - but no smoke marks as on the starboard side and the plating was not pushed out/distorted.

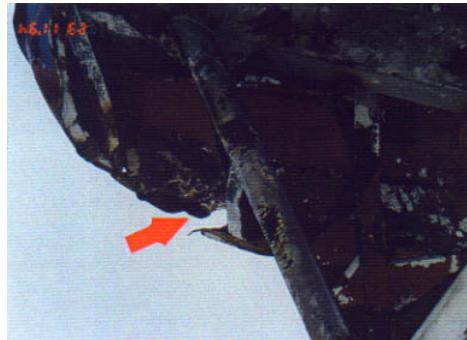
8 - shows the lower aft bulkhead/visor bottom which is only moderately damaged compared to the starboard side - see also the picture below.

The arrow points to a damage to the port aft edge of the visor bottom which apparently occurred when the visor moved transversely from port to starboard. This will be explained in Chapter 31 - The Casualty Scenario. See also picture 5 on the following Sheet 6.

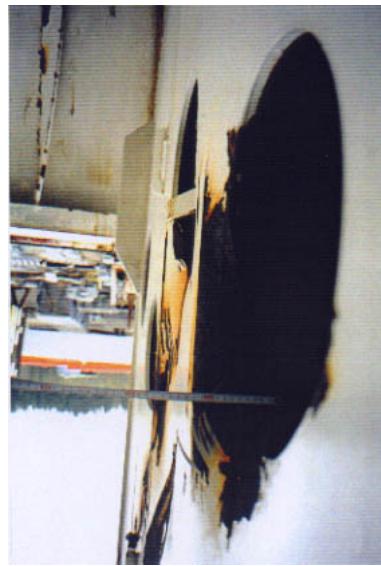
1 / 2 - show the port inner longitudinal bulkhead with scraping/scoring marks at the lower aft part - see arrow 1 - and very deep indentations with the steel plating partly torn - see arrow 2 - and enlargement picture 1.1. The picture below shows that the plating was actually pressed into the bulkhead up to 120 mm.

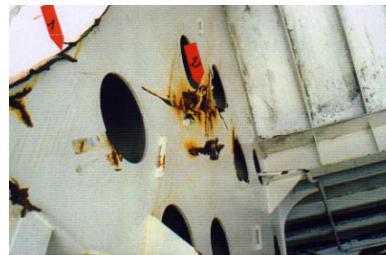
After the actuator had been dismounted by MacGregor, Turku in February 1995 the area looked as it is shown by the following picture. Arrow 1 indicates the area at the edge of aft and inner bulkheads where the aft bulkhead is slightly extending the inner bulkhead and where metal parts were torn off when the actuator moved into its jammed positions. A detailed evaluation of this and other pictures did reveal that neither the actuator nor its foundation had come in contact with the bulkhead which is due to the angle between the fastening point at the lugs below the visor arm and the bulkhead edge. The actuator was able to swing into this position because of its spherical bearings which allow deviation of up to 15° to each side.

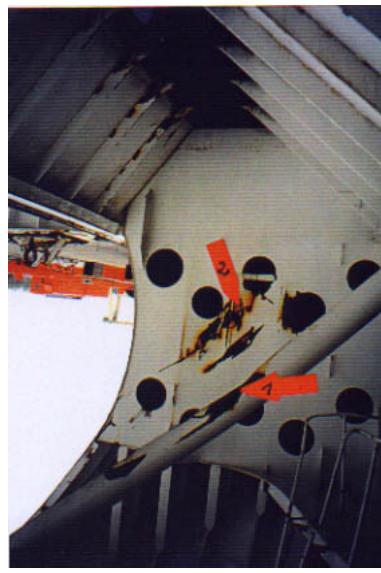
The picture below shows the port inner side of the visor with the slightly damaged frames at the port aft part of the ramp house. The upper part of the longitudinal bulkhead is completely unaffected. The scorings and the deep indentations and deformation (arrow 2) are restricted to the middle part, and, in the foreground, the vertical beam which had been in contact with the upper part of the ramp with the folded flap in between is visible (arrow 1).

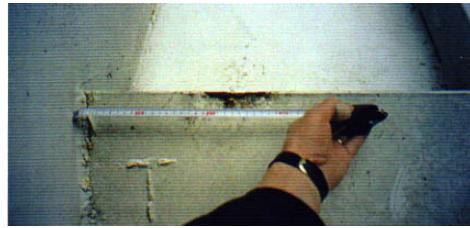
2 - shows the lower inside of the visor with the lower transverse beam in way of the 3rd stringer. This beam was found to be very severely scored and scraped, which was most probably caused during the lifting operation. The picture also demonstrate the very severely set up visor bottom which is underlined by the close-up No. 10 and explained by detail drawing No. 8. There are two further contact marks in way of the deck beam at the lower forward part of the ramp house, viz. in the most port and most starboard frame spaces, which were evidently also caused by the bell cranks of the ramp when the visor moved further forward and downwards and the vessel was already severely heeled to starboard already. See also sheet 2 - The Ramp House. The picture below indicates the short distance to the port bulkhead because of the starboard heel.

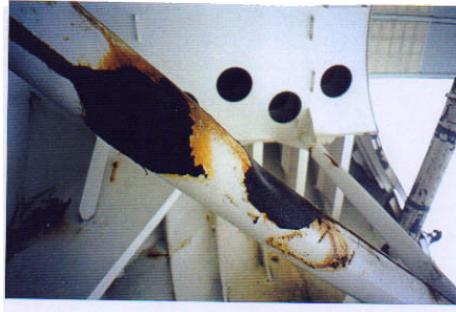
The two pictures below show the damage to the top and port side of the vertical beam.

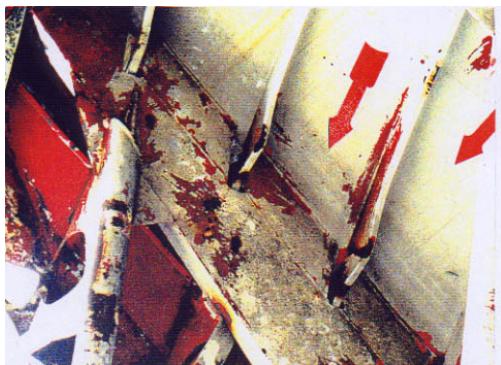
- (3) The visor had always been full of water to the outside level when the vessel was at sea. See the photo below.
- (4) The hydraulic cylinders/pipes were leaking which caused hydraulic oil to swim on the water surface inside the visor which settled down once the water left the visor.

- (5) People had been very active inside the visor, in particular on the 3rd stringer. The majority of the footprints are fresh and not covered by oil, thus originate from the time before arrival and after departure Tallinn on September 27, 1994.

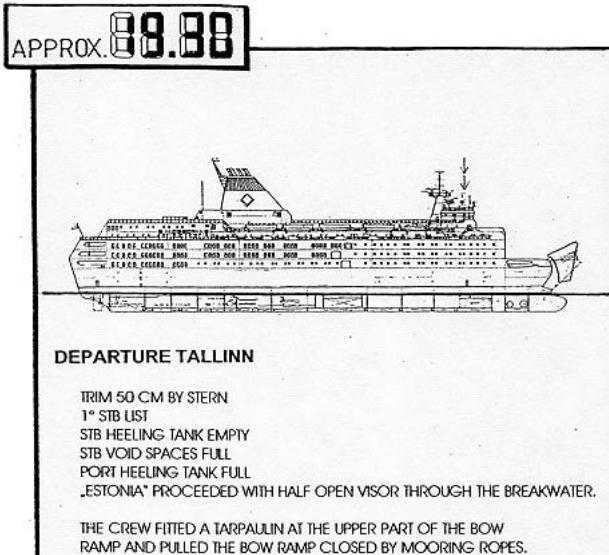
The scenario starts with the condition of the ferry upon departure from Tallinn at about 19.30 hours on the 27th September 1994. The departure condition is demonstrated by drawings and text below.

Visor Locking Devices: Atlantic Lock / hydraulic side locks engaged, manual side locks - not engaged

Ramp locking devices: Starboard ramp hook and securing bolts not engaged, Port ramp hook and securing bolts not engaged

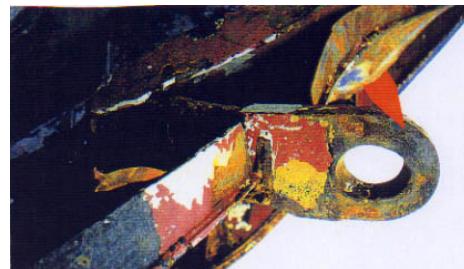
The blue coloured part of the lug - see arrow - looked as if having been exposed to heat which was unusual since this part had been below water. The JAIC was contacted and it turned out that samples had been taken already on 25 November 1994 and had been examined upon request of the Central Criminal Police in Finland and Kari Lethola as chairman of the Finnish part of the JAIC on 30.03.95. The tests were carried out on 30.05.95 by the Criminal Laboratory Technical Division, Helsinki. The "available" documentation was received - already translated into English - from Kari Lethola.

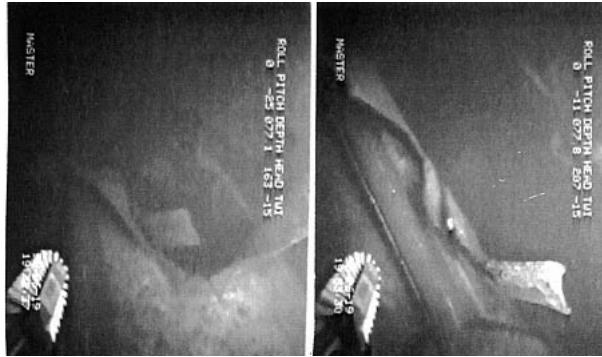
The upper void space behind the starboard front bulkhead shows considerable damage to the bulkhead plating with the plating bent from inside to outside and frequently cracked. This had obviously been possible because the upper part of the visor moved forward after the starboard hinges and side lock had failed and never contacted the front bulkhead again, because at the lower end of the blown open plating a big steel part is extending almost horizontally which otherwise would have been pressed back. The same refers to the steel tongue extending from the visor plating in way which was also not pressed against the bulkhead.

The image below on the left shows the lower part of the damaged upper front bulkhead looking from bottom to top. The image on the right shows the damage further up.

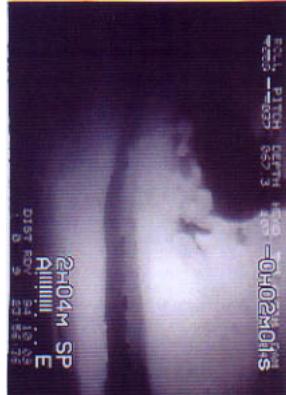
- The front bulkhead plating below the area of the hydraulic side lock was pushed outwards with exception of the rubber packing - see image below. It is clearly visible that the rubber packings, normally extending beyond the bulkhead, are in some sort of fold indicating that the surrounding plating was deformed towards the outside.

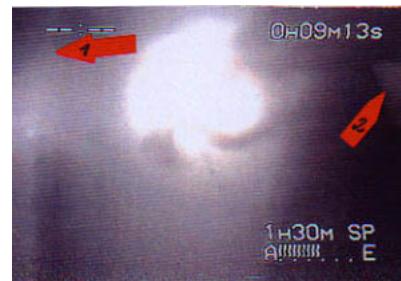
The image on below shows the area of the recess bulkhead between the lug for the preventer wire and the upper mating box. Arrow 1 points to the rubber packing of the bow ramp and arrow 2 points to the edge of the bow ramp. Between the arrows a metal flap is visible which is apparently part of the recess. Transferred to the front bulkhead around the corner this is the area of the big damage above the lug of the hydraulic lock. See also the above drawing.
