THE GERMAN 'GROUP OF EXPERTS'

1 THE CASUALTY

2 THE VESSEL "VIKING SALLY"

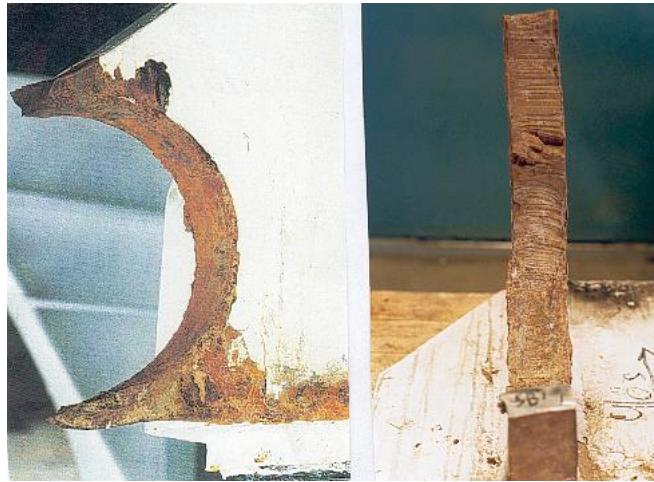
- all four arms do not have identical appearances as it is evident from the two photos below, the left one shows the port outer visor arm and the right one the starboard inner visor arm.

Evidently the starboard visor arm plate looks identical to the test burnt installation part - see the photo above - and the port one is smooth without burning marks at all. A detailed inspection even revealed indications of circumferential drilling marks as initially the holes were drilled at newbuilding - see [Subchapter 2.4.6](#). Therefore this 'Group of Experts' has always taken and still does take the view that the port bushings were still original while the starboard ones were very unprofessionally replaced. How gross negligently this replacement was carried out became fully clear when a passenger video was made available to this 'Group of Experts' in 1996 - see Subchapter 39.2.
