Enclosure 3.4.101

Summary of pre -entry condition survey

for
The Joint Accident Investigation Commission
of Estonia, Finland and Sweden

THE PASSENGER/RORO CARGO/FERRY - M/S ESTONIA

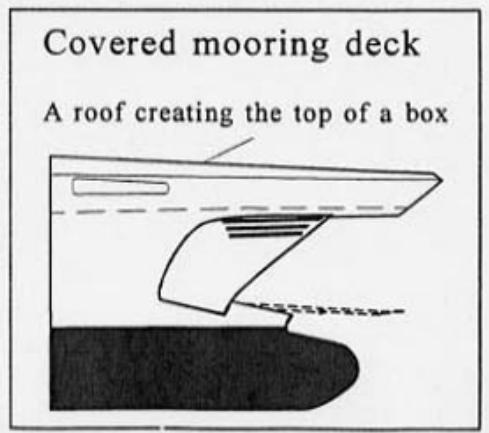
Most bigger relatively new Passenger/ RoRo cargo/ Ferries have bow doors. In some cases the impact forces from sea have been underestimated and the supporting structures have not been strong enough. Consequently when such doors have been overloaded the construction has jammed making the doors difficult to open. This is an example of how a failure didn't result in an unsafe situation.
