Summary

1 THE CASUALTY

16 THE CONDITION OF "ESTONIA" AND THE STATUS OF HER MAIN CLASS AND SAFETY CERTIFICATES BEFORE COMMENCEMENT OF HER LAST VOYAGE

30. THE CONDITION OF THE VISOR

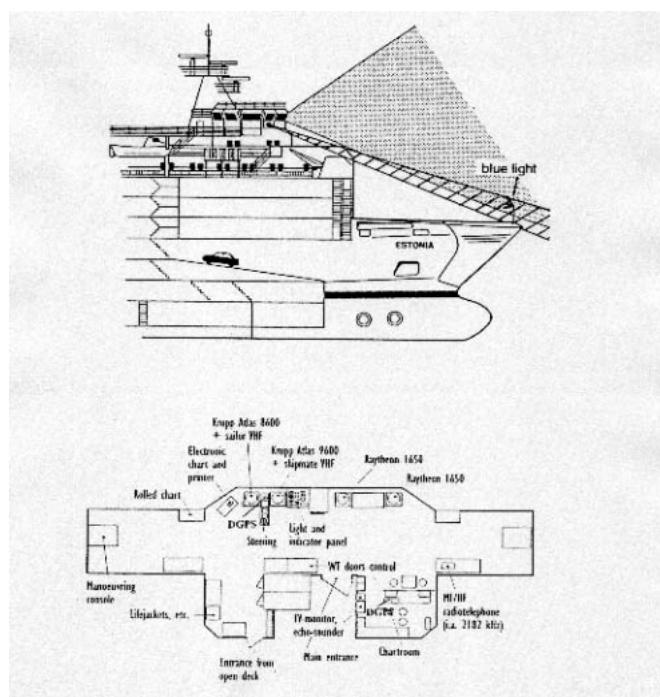
Because of the retracted position of the navigation bridge, only the flag pole on the bow of the vessel was visible from the conning station - see drawing below - whilst the most forward part of the visor could be seen through the two windows on deck level at both sides of the extended central part of the bridge, as can be seen on the drawing below. A monitor, showing among other things, the transmissions from the four car-deck cameras, was placed at the chartroom entrance and could not be seen from the conning station.

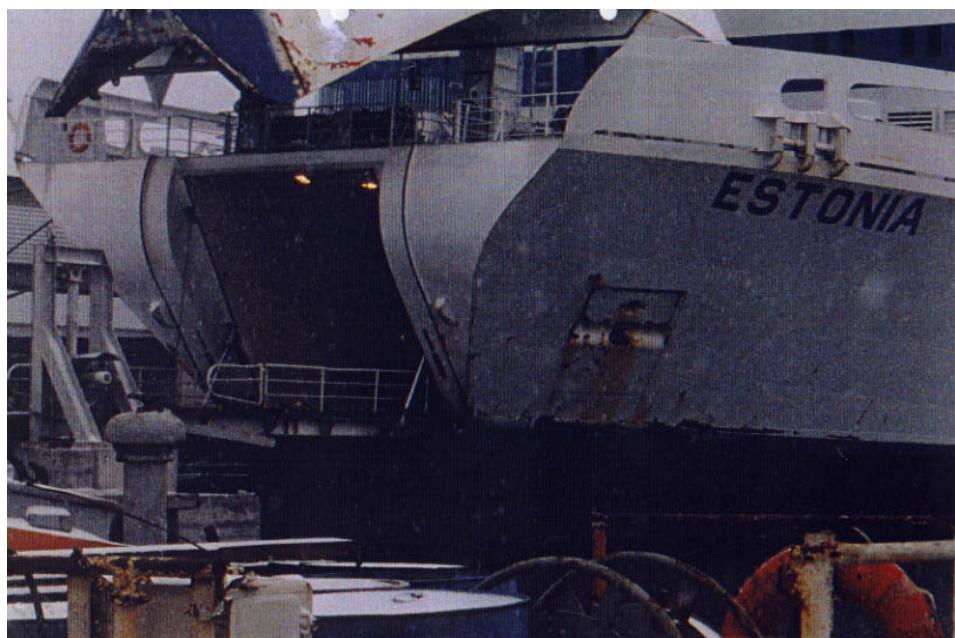
The ice situation is demonstrated on the ice chart of 28.03.94 which is attached as [Enclosure 12.4.2.152](#) and two photos showing the cruise vessel SALLY ALBATROSS sitting aground outside Porkkala (opposite Tallinn) in heavy ice during February/March 1994. The photos attached as [Enclosure 12.4.2.153](#) clearly demonstrate the ice conditions which were prevailing at this time in the Gulf of Finland. The effect these ice conditions had on the visor and foreship of the ESTONIA can be seen on the photo below which was made on 24.03.94.

The results of such reckless navigation are clearly visible on the large photo on the previous page which was taken on the following day, 25 March 1994, in Tallinn by the professional photographer Li Samuelson.

The ice damage sustained by the visor during the months of February and March 1994, when the Gulf of Finland and the Northern and Middle Baltic were more or less continuously covered by ice (see Subchapter 12.4.2), were roughly repaired by replacing parts of shell plating and bottom of the visor in Tallinn whilst the vessel remained in service. The renewed parts are still visible on the visor.

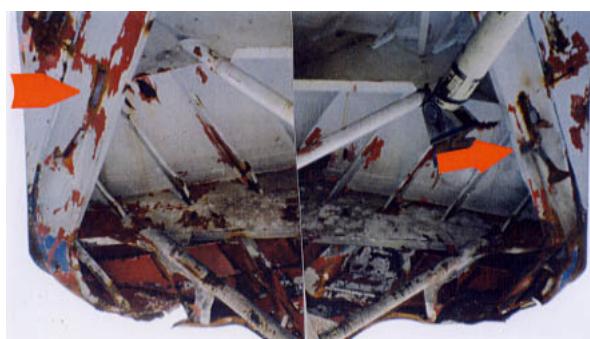
Next pictures follow which show the starboard lower aft bulkhead of the visor having been directly opposite to the corresponding parts of the starboard front bulkhead of the wreck. In comparison also the port lower aft bulkhead is shown.

The picture on the right left shows the area of interest on the starboard side, the picture on the left shows the corresponding port side. It shows a completely different damage picture: no smoke marks, no steel tongue torn off the bulk-head and no twisted hooks. Two of the following four pictures on the next page show those areas at the port and starboard aft bulkhead of the visor where the lugs of the side locks had been welded to and the hooks for the manual side locks were fitted. The other two are close-ups of the upper parts of the area where the lugs had been welded. The right side shows the part of the starboard visor bulkhead directly opposite the above explained damage area. The smoke marks are still clearly visible although the visor had been on the sea bottom for 7 weeks. The hooks are distorted in a way which is technically not explainable. The area is dark. The picture on the left shows the corresponding port side as comparison with a complete different damage picture, with no smoke marks, no steel tongue torn out of the bulkhead and no twisted hooks and a generally clean appearance. The two close-ups arranged below the above mentioned photos show the respective upper parts of those openings in the bulkhead. They do illustrate the difference very clearly. While the port side shows normal steel clean of corrosion, the starboard side shows steel which had obviously been exposed to heat and pressure force: The metal is distorted and pushed out, the stiffener is detached from the bulkhead. See also Chapters 30 and 32.

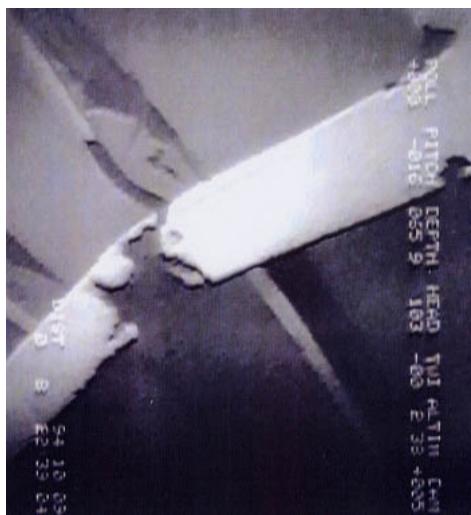
Below is an enlargement of damage No. 2.

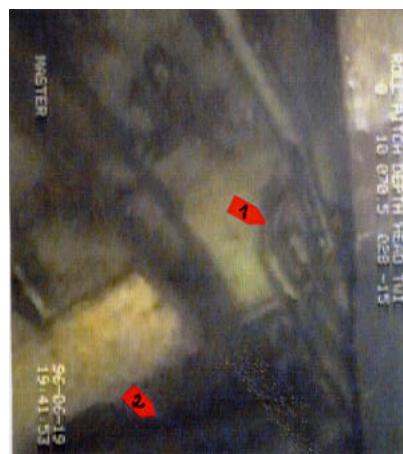
- When diver 1 (David) inspected the outside of the ramp on 03.12.94 he found a running wristwatch in the lower part of the ramp, i.e. in one compartment above the broken starboard hinges. It turned out that the watch belonged to diver 2 (Mark) indicating that he must have been there before apparently engaged in other activities not shown on the available video footage. See the ramp drawing on page 869.

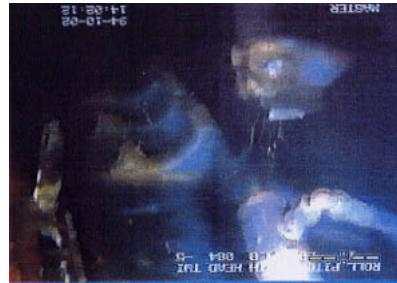
- Whilst the bending of the lugs is doubtless due to the powerful hammering by crew members when trying to force the bolt through the deformed lugs of the Atlantic lock, it is evident from the hammering marks on the contact plate, as visible on the next image, that they sometimes also hammered against this plate when trying to open the bolt. The following image, taken from the Part-Report of the JAIC, shows these lugs to be full of hammering marks, which are shining like new, without any traces of corrosion, although the fracture surfaces of the broken lugs are heavily corroded.

It appears strange that hammering marks, undoubtedly originating from hammering about 6 hours before the casualty, appear without any corrosion as can be seen on the above image, whilst fracture surfaces, which are said to originate from fracturing at the time of the casualty, i.e. were exposed to seawater only about 6 hours later, are severely corroded as can also be seen on the same image. This raises doubt whether the lugs of the Atlantic Lock really fractured only during the casualty or much earlier already.

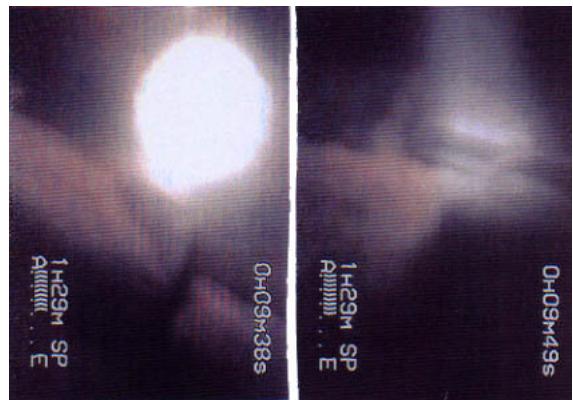
The eight flaps of the bow ramp covering the gap between the car deck and the open ramp were found to be in different condition: some were well painted, green and intact, while others - in the middle - were brownish/red and partly damaged. See the two images below.

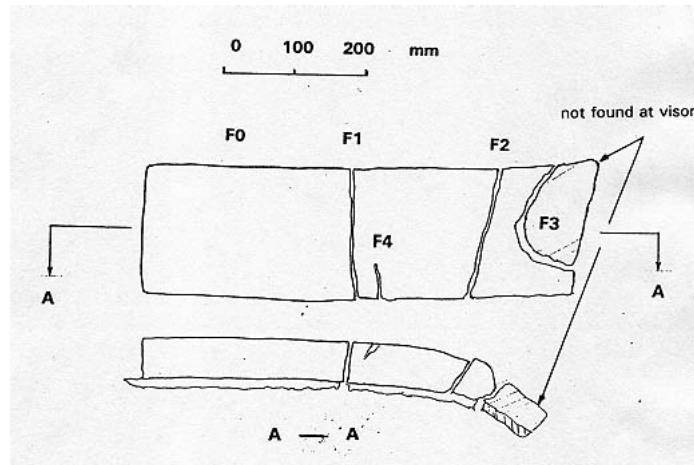
The investigation of fracture F1 - F4 ascertained that all the transverse fracture had started and penetrated from the outside by corrosion assisted fatigue cracking. In addition, fractures F2 and F3 reveal major bending displacements of their flanks, in particular fracture F3 reveals a specific bending angle of about 70° combined with severe bending deformation following the original crack development.

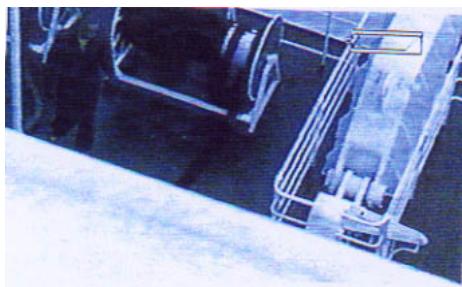
The visor's hinge system design consisted of the starboard and port side hinge arms fabricated from structural platings, with two attached lug plates on each side, carrying support bushings with bronze liners in the respective bore holes. The support bushings were welded to the lug plates with circular fillet welds. The visor hinge lugs were mated by deck hinge fittings, represented by lugs welded to the forecastle deck. The mechanical connection was one bolt on each side. The video image below shows the starboard hinge arm shortly before the accident.

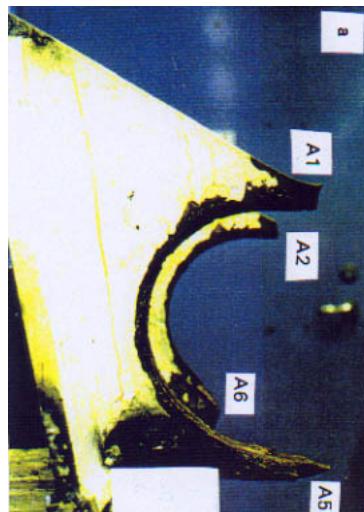
The following picture shows the broken port visor lug plates with the fractures A1, A2, A5 and A6.

The outer port side shows a vertical to slightly horizontal bending to port side at the fracture at the lower part of the remaining bore. The inner port side lug and both starboard lugs - see picture below - did not exhibit significant bending deformations. The picture below shows the broken starboard visor lug plates with fractures A3, A4, A7, A8:

The failure of the visor hinges occurred by fractures A1-A8 of the visor lug plates together with the fillet welds to the support bushings. The bolts had been ripped out of the hinges, together with the bushings.

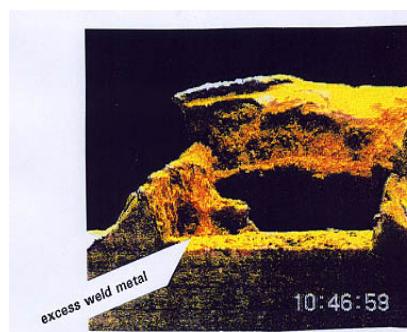
The fracture of the recovered hinge bushing was fitting to the fracture of the inner starboard hinge lug. It exhibits a gap of about 4-6 mm between lug bore and support bushing. This gap is almost entirely filled with corrosion products, presumably magnetite, which is also found in thick layers at a location where both hinge late and fillet weld failure are represented together with some excess weld metal, see arrow on the picture below which may have provided a local notch effect.

In another cross section, also severe corrosion inside the gap is identified and the surface of the hinge bore and the bushing exhibit a considerable misalignment, which, during welding of the left fillet weld, was overcome by a buffering layer. The misalignment corresponds to asymmetric burning marks, for example of the inner starboard hinge.

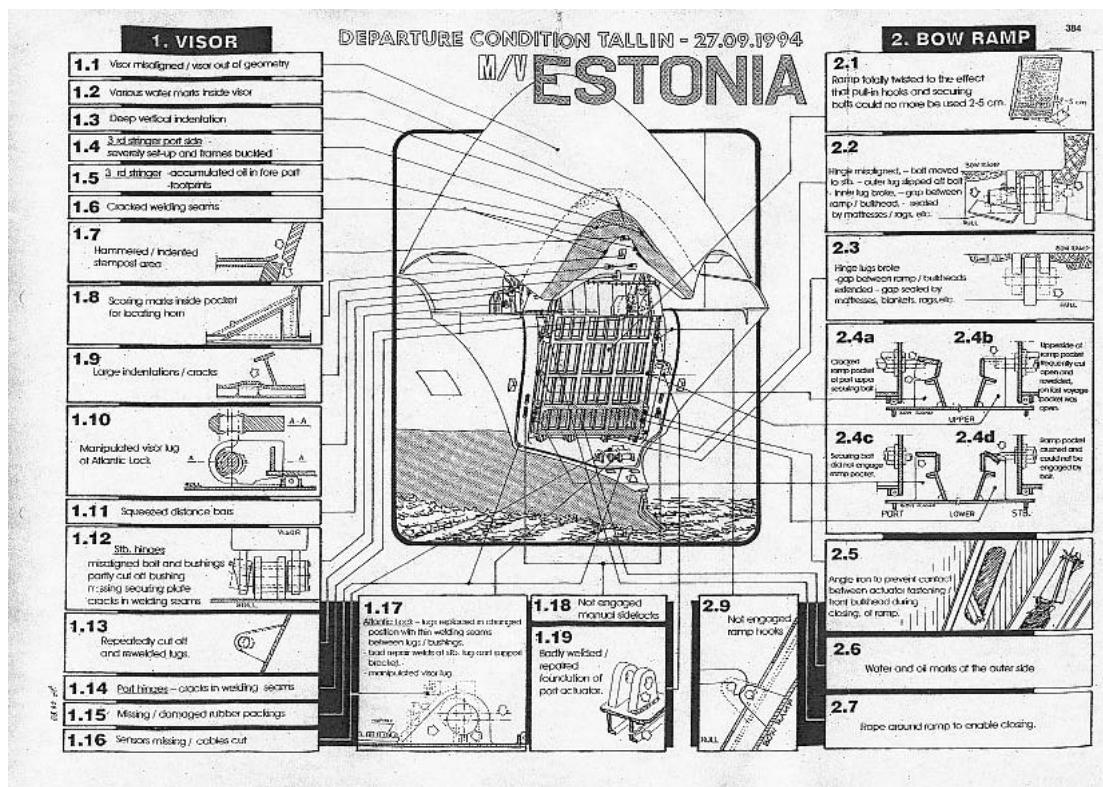
In addition, these deficiencies are shown on a drawing of the foreship with open visor which is integrated into this report and forms the following page.

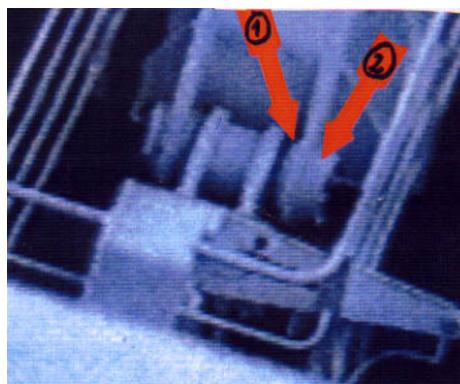
The passenger was standing in front of deck 7 and filmed the closing of the visor, finally zooming in on the starboard hinges. The video-prints below are part of the film. Picture 2 is an enlargement of Picture 1.

On Picture 2 there are obviously several major deficiencies visible, viz.

(a) the gap between the starboard vessel hinge plate and the outer bushing is much too large (arrow 1).

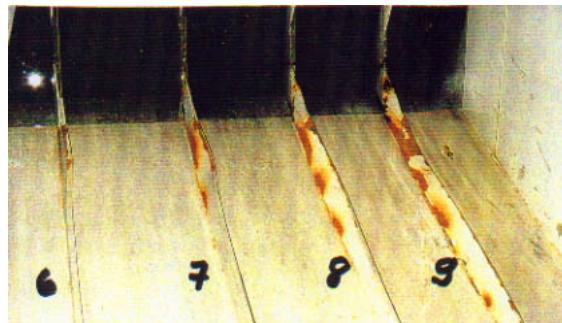
2 - Ramp House

There is no sheet available for this part of the visor. The pictures show the inside of the aft part of the ramp house with 9 vertical webs each at its forward- and aft-parts. The webs are of the hp profile-type and measure 160 x 7 mm. The 4 webs at the port side of the aft part - numbered 6 to 9 - were indented to varying extent as can be seen on the picture below. Web 6 was evidently just slightly touched while web 9 was pushed flat.

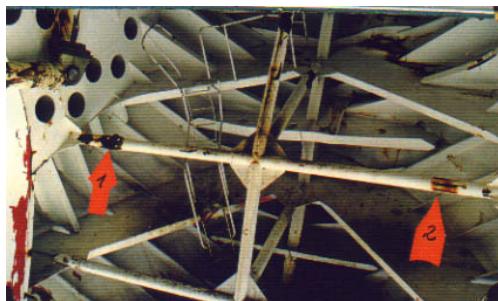
Although the upper transverse crossbar inside the visor shows respective damage - see arrow 1 on the picture below - the corresponding part at the port outer longitudinal girder of the bow ramp does not. This is confirmed by the image further down,

taken from the ROV video made on 09.10.94 which shows the port outer girder underside of the bow ramp in way of the contact area with the above-mentioned crossbar. There is no damage, the paint is completely unaffected (the diagonally running stripe being a wire).

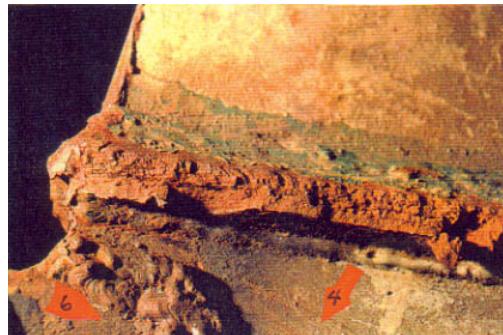
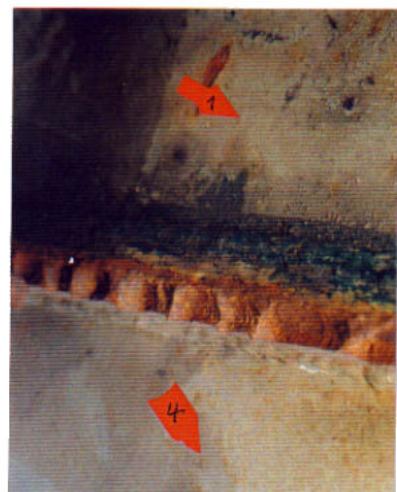
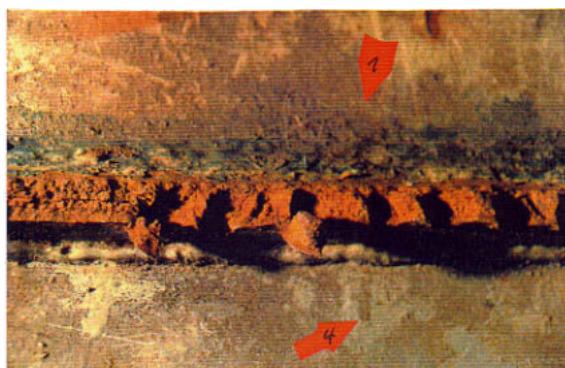
The following photographs indicate the condition of the B-deck in way of the port visor actuator foundation. The reader looks to the port outer lug plate and follows on the next 4 photos the ripped off B-deck remains from forward to aft of the outer lug plate. For easy reference the photographs are marked with the previously used arrow numbers.

(3) The B-deck was also affected by fatigue as already explained for the stiffeners. This fact is indicated by the condition of the ripped off deck remains.

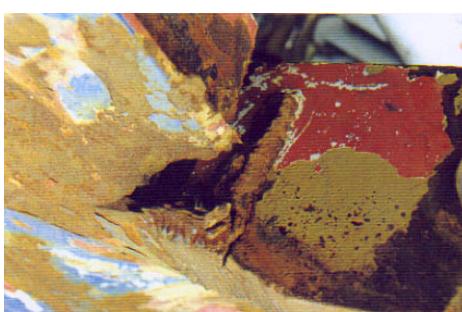
1 - shows the visor lug being part of the Atlantic lock. Arrow 1 points to the previously burnt off part of the lug with cracks propagating from burning marks (arrow 2). The lug apparently became twisted to starboard when the visor moved abruptly to starboard until its port inner bulkhead rested on the port side of the bow ramp. The deep crack in the bottom of the visor to port of the lug confirms this. It further indicates that the visor lug was about to crack off the visor bottom when the lugs on the forepeak deck failed first. This is underlined by the impressive picture below indicating an upwards and to starboard movement of the visor when this big crack propagated and came to a stop when the lugs on the forepeak deck failed.

2 - demonstrates the elongation of the lug which is partly due to wear over 141/2 years and partly due to manipulation by Christer Koivisto already in 1982 - see Chapter 12.4.

3 - shows the yellow basic primer - see arrow - used in the whole foreship area by the Yard during newbuilding.

(5) The visor lug of the Atlantic lock almost cracked off at the bottom when the visor moved forwards and to starboard, however, then the lugs of the forepeak deck broke first and the crack propagation stopped.

(6) The visor lug was considerably elongated due to wear in 141/2 years of exposure to changing loads and the manipulations by Christer Koivisto.

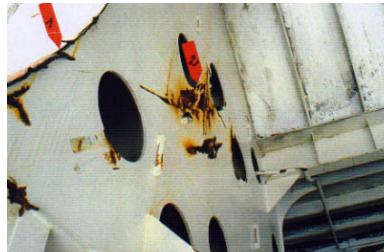
After the actuator had been dismounted by MacGregor, Turku in February 1995 the area looked as it is shown by the following picture. Arrow 1 indicates the area at the edge of aft and inner bulkheads where the aft bulkhead is slightly extending the inner bulkhead and where metal parts were torn off when the actuator moved into its jammed positions. A detailed evaluation of this and other pictures did reveal that neither the actuator nor its foundation had come in contact with the bulkhead which is due to the angle between the fastening point at the lugs below the visor arm and the bulkhead edge. The actuator was able to swing into this position because of its spherical bearings which allow deviation of up to 15° to each side.

It is thus proven with sufficient certainty that the severe damage as well as the scraping and scoring marks were only caused by the bow ramp then lying inside the visor on the beam structure and the visor resting on the bow ramp in way of the damage area under discussion. This shall be explained in more detail in Chapter 31 - The Casualty Scenario.

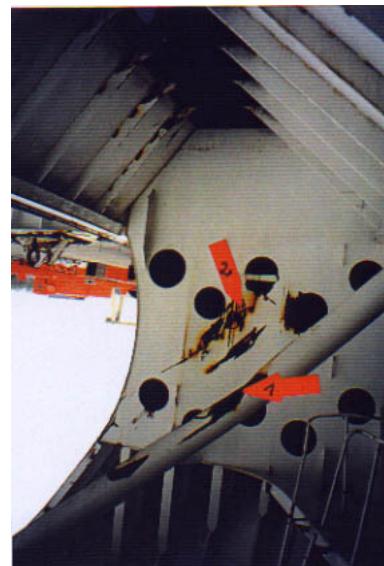
The picture below shows the port inner side of the visor with the slightly damaged frames at the port aft part of the ramp house. The upper part of the longitudinal bulkhead is completely unaffected. The scorings and the deep indentations and deformation (arrow 2) are restricted to the middle part, and, in the foreground, the vertical beam which had been in contact with the upper part of the ramp with the folded flap in between is visible (arrow 1).

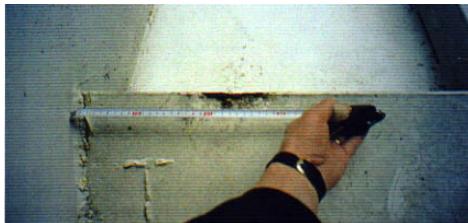
2 - shows the lower inside of the visor with the lower transverse beam in way of the 3rd stringer. This beam was found to be very severely scored and scraped, which was most probably caused during the lifting operation. The picture also demonstrates the very severely set up visor bottom which is underlined by the close-up No. 10 and explained by detail drawing No. 8. There are two further contact marks in way of the deck beam at the lower forward part of the ramp house, viz. in the most port and most starboard frame spaces, which were evidently also caused by the bell cranks of the ramp when the visor moved further forward and downwards and the vessel was already severely heeled to starboard already. See also sheet 2 - The Ramp House. The picture below indicates the short distance to the port bulkhead because of the starboard heel.

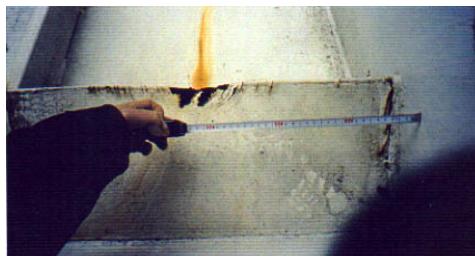
The picture below shows the starboard side with the longer distance to the starboard bulkhead also due to the starboard heel of visor and vessel.

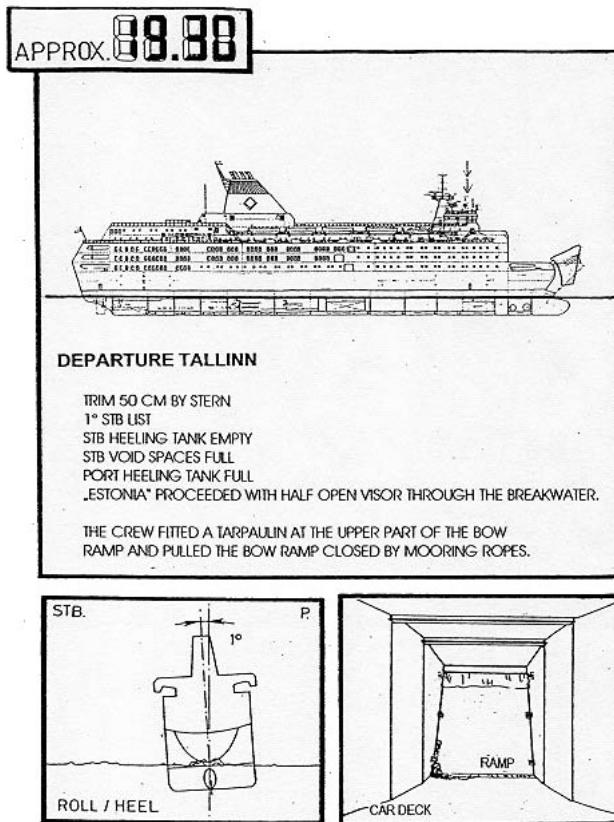
Visor Locking Devices: Atlantic Lock / hydraulic side locks engaged, manual side locks - not engaged
Ramp locking devices: Starboard ramp hook and securing bolts not engaged, Port ramp hook and securing bolts not engaged
Gaps between ramp/car deck seals by mattresses, blankets, rags.

After the bow ramp had been closed as tight as possible by means of a tarpaulin at the top and a mooring rope in the winch drums - see Chapters 16/19 - and further, after the bolt of the Atlantic lock had been hammered by crewmembers through the 3 bent and misaligned lugs on the forepeak deck - see the footprints in the visor on Sheet 9 - Chapter 30 - the ferry quickly picked up speed when she followed the westbound lane in the TSS between the island Naissaar and the mainland. Due to the missing and/or defect rubber packings on the forepeak deck - see Sheet 7 in Chapter 29.2 - the inside of the visor quickly filled with water

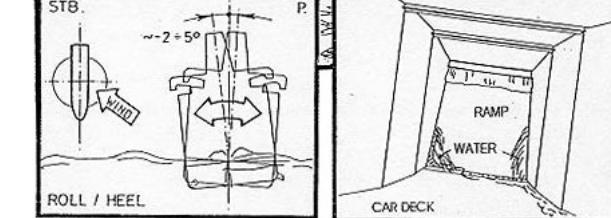
1. Low banging noises continued
2. Port stabiliser fin activated, crew started to work on the starboard fin.
3. The watch A.B. noted a lot of water on the car deck, alarmed the bridge and crew was activated
4. The course was changed to starboard and the ferry began to roll heavily, whereafter the vessel was turned back to port and started to pitch heavily. The speed was reduced.
5. The crew was working on the car deck to control the water ingress which turned out to be impossible.
6. The vessel made deep, slow pitch movements and was slightly rolling, more to starboard, less to port.

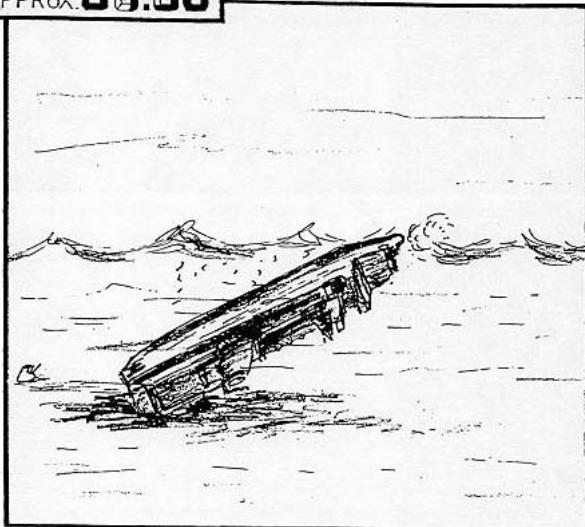
APPROX. **08.90**

1. The Vessel sank stern first.
2. The bow was still above water when the stern was already on the sea bottom.
3. The visor sank about 1nm west of the wreck upside down.
