**The German Group of Experts
investigating the sinking of M/V "ESTONIA"**
c/o AHLERS & VOGEL · Schaeffter 1 D-2045 Hamburg · Telephone 49-40-371075

Memo for Dr. Holtappels

re: 2nd Meeting with F.B.N. on 27.10.95

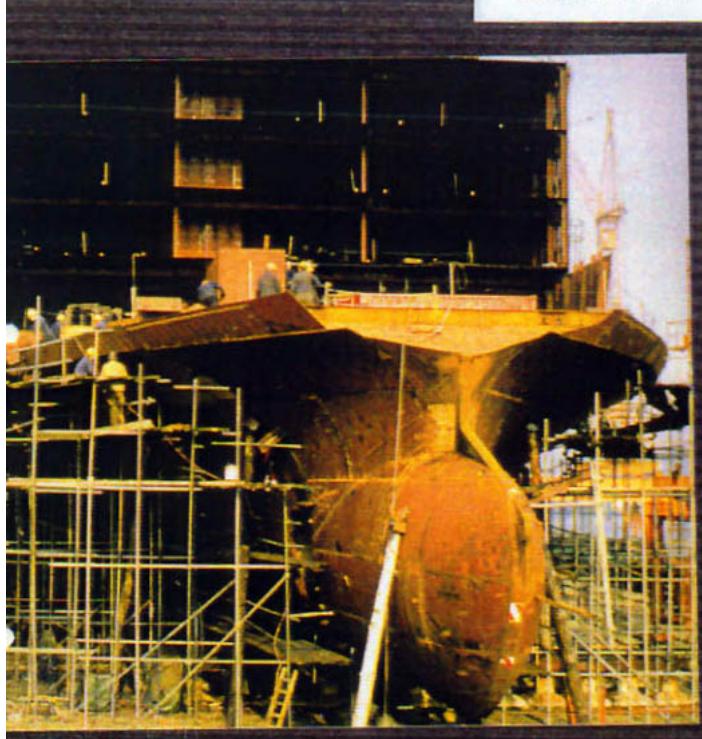
Enclosure 2.4.6.63

Photos showing fore ship area

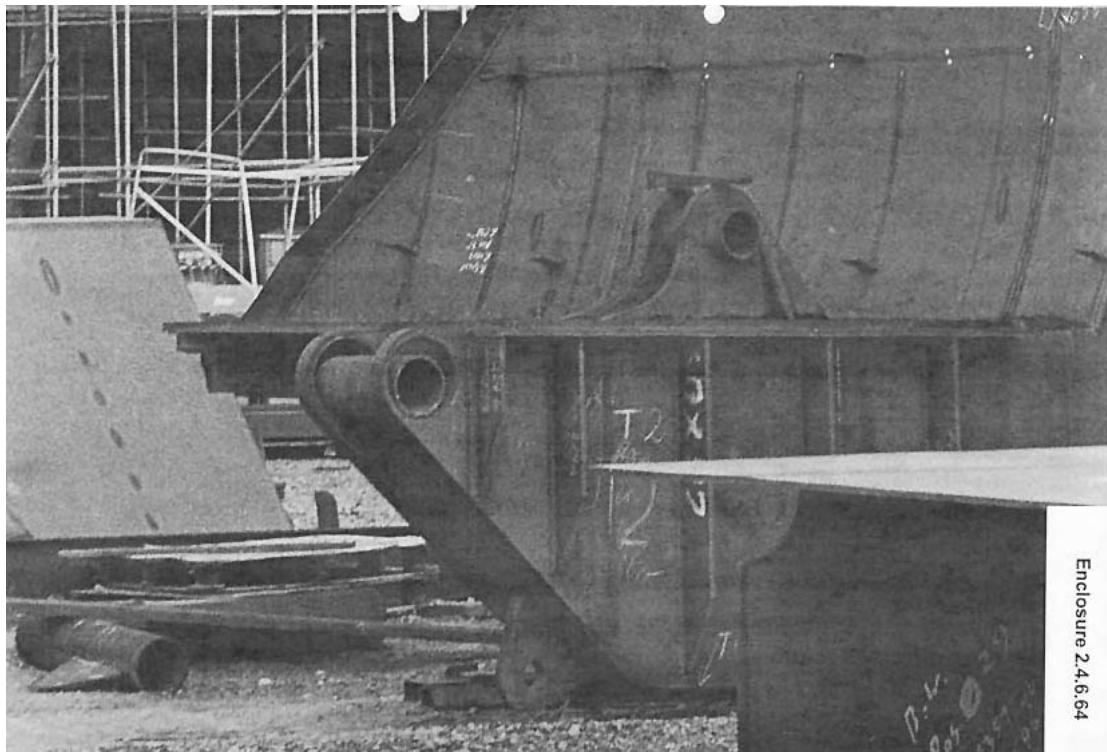
Enclosure 2.4.6.64

Detail photo of the starboard visor hinge plate

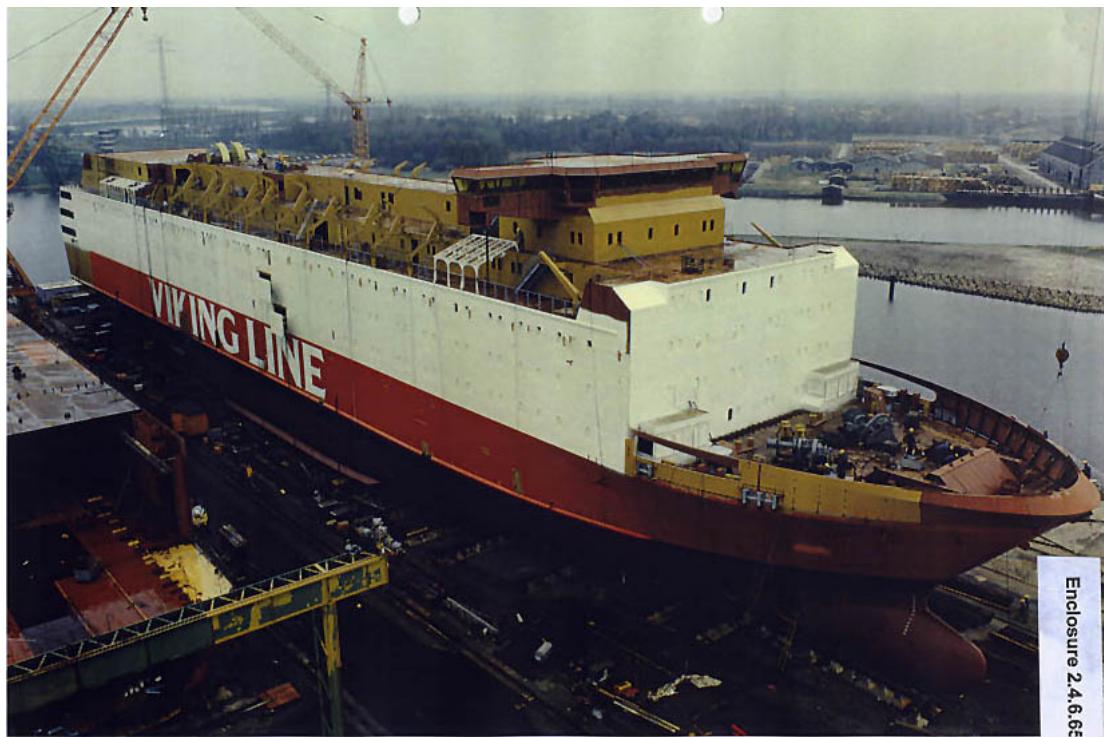
Enclosure 2.4.6.6E

Photo showing visor at the vessel without hinge connection

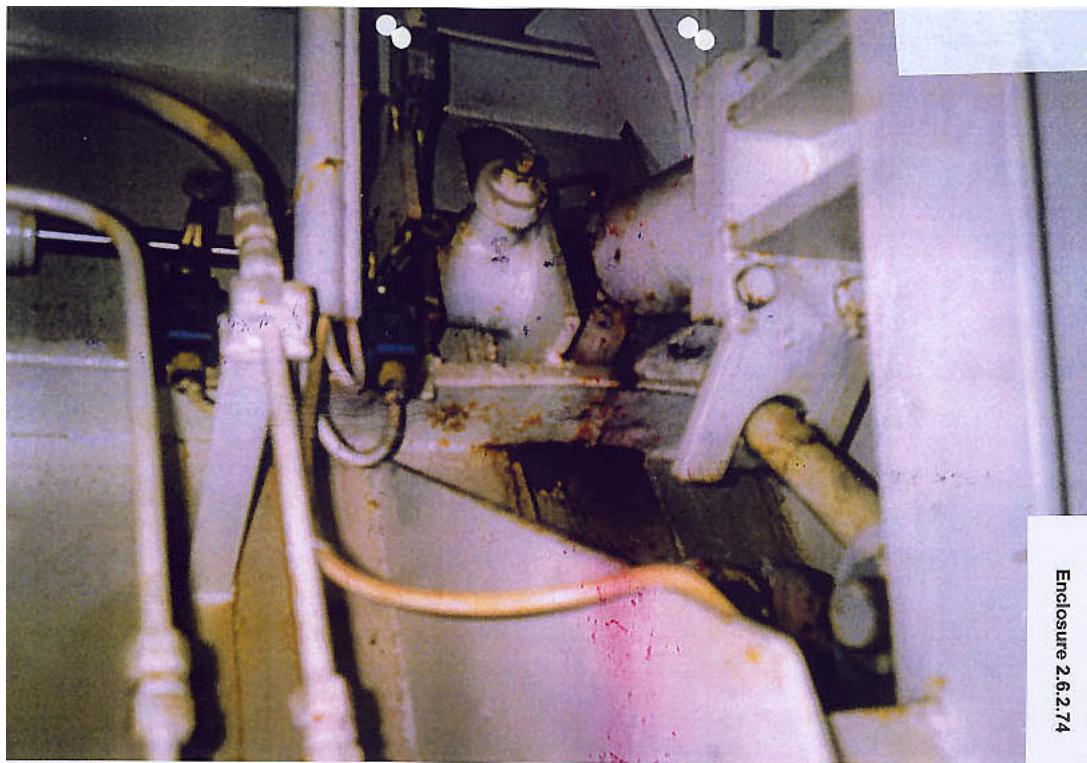
Enclosure 2.6.2.74

Photo showing hydraulic an manual side locks

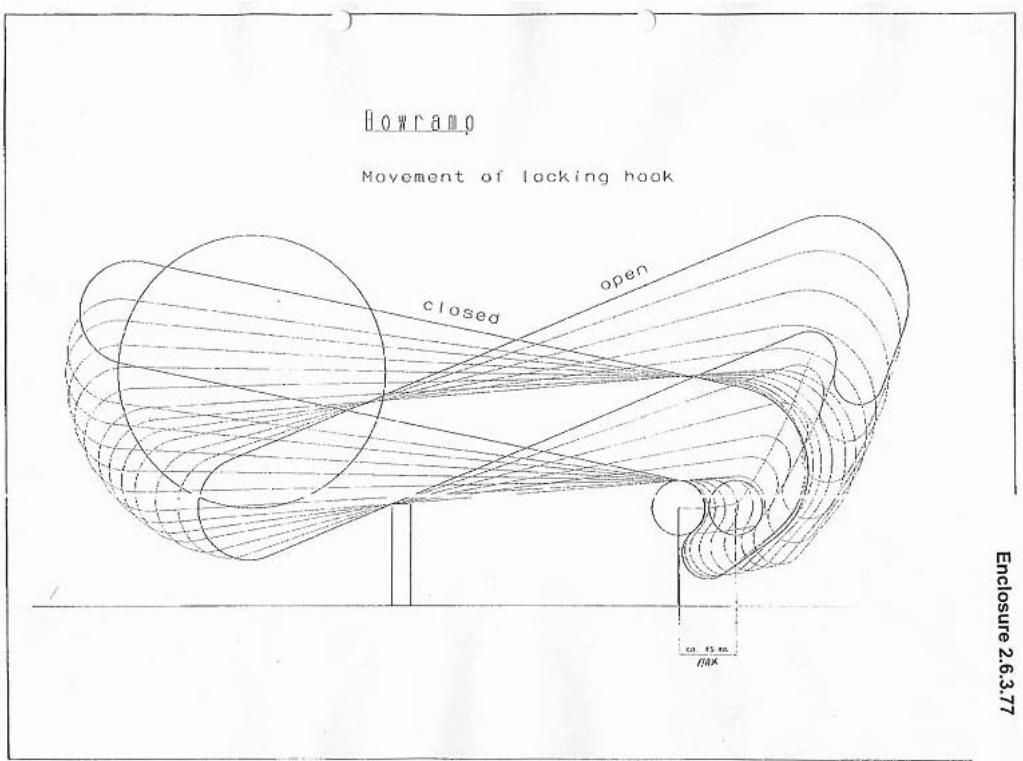
Enclosure 2.6.3.77

Drawing showing moving range of locking hook
