THE GERMAN 'GROUP OF EXPERTS'

The German 'Group of Experts' has now - as far as possible - completed its investigation of the foundering of the M. V. ESTONIA, a disaster that has taken the greatest toll of human life in the Baltic Sea in times of peace. The German 'Group of Experts' has during the past five years performed a difficult investigation in a partly hostile and reluctant environment. The work was carried out during the first two years - 1995/1996 - in close co-operation with the Swedish leader of the Technical Group of the Joint Accident Investigation Commission of Estonia, Finland and Sweden (JAIC), Börje Stenström († February 1997), and also with the Finnish member of the Technical Group, Dr. Tuomo Karppinen and the expert Dr. Klaus Rahka. All the investigation results of this 'Group of Experts' were submitted either verbally in joint meetings with the members and the experts from Estonia, Finland and Sweden attending or in letters with attached photos and/or video film documentation to the JAIC. This documentation and information concerned the design, construction and building of M. V. ESTONIA in general and the locking devices of the bow visor in particular, includi

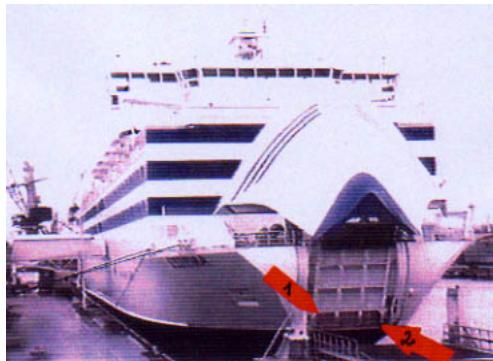
The picture below shows ESTONIA at her berth in Tallinn with open visor and closed bow ramp. The arrow no. 1 points to the oil covered lower part of bow ramp which demonstrates the height of the water level with hydraulic oil floating on top inside of the visor when the vessel was at sea in calm weather. Arrow no. 2 points to the bow ramp hinges which are on car deck level.

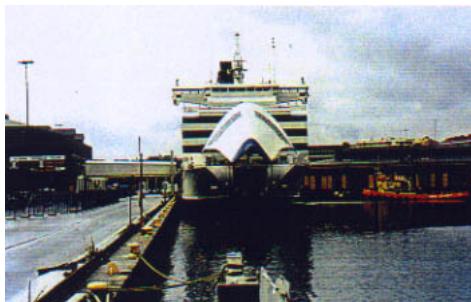
*»I had frequently been on the forward part of the 8th deck upon departure from Stockholm and do remember having quite often seen the visor open.« (See photo below.)*

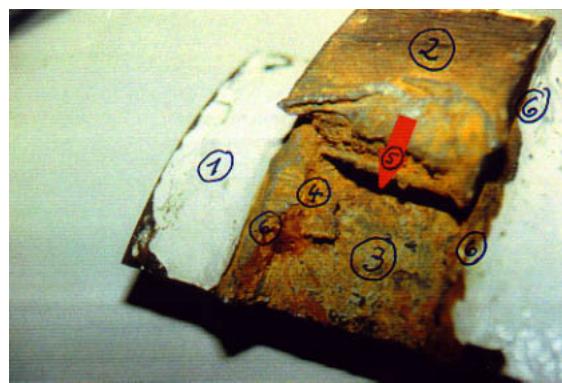
photo of stb. inner bushing recovered by divers

In summary of these three statements it has to be concluded that the welding seams between the bushings and hinge plates of the visor hinges were visibly cracked up to 10 cm at the beginning of August 1994, less than 8 weeks before the casualty.

The photo below shows a part cut out of the bushing recovered from the wreck. It is most probably the starboard inner bushing as will be explained in Chapter 30.

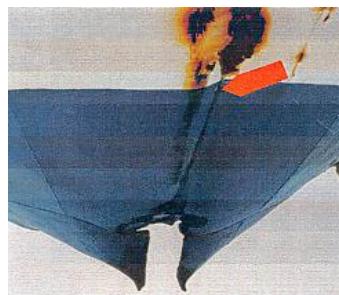
The shell plating as well as the internals are very severely damaged in two places, viz. there is a deep vertical indentation in the bow leading upwards from the stempost for about 2 m, as can be seen on the picture below from the outside,

The arrow points to the deep indentation which is completely painted and the paint does not show contact marks. The following photos showing the inside of the same area do confirm the deep indentation in a very strong part of the visor to be of old origin.

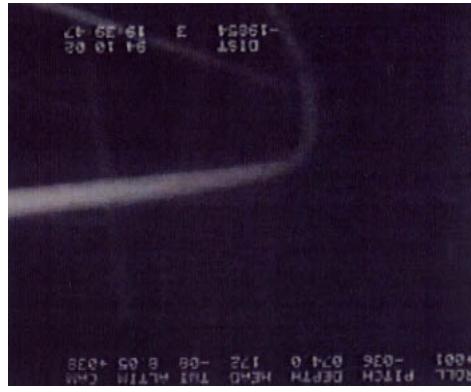
The two images above made by ROV on 2.10.94 already clearly and without doubt prove that it is the forward section with movable part of the starboard bow ramp rail which is resting on the bottom of the sea.

A reconstruction of the ROV track commencing at the stern of the wreck revealed that these rail parts are located about 250 m to the south of the stern and about 80 m to the south-east of an area where the video was cut three times, each time for about 1 minute.

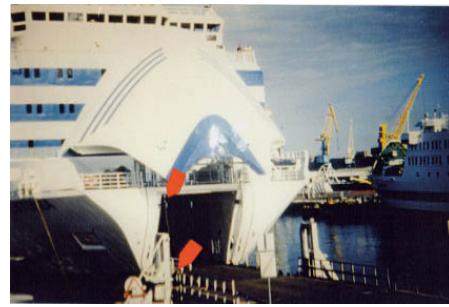
The arrows on the picture above point to the shackles by which the starboard preventer wire is connected to vessel and bow ramp. The system on the port side is identical.

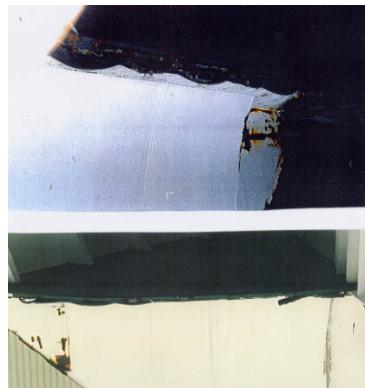
Also the flat bars around the deck opening into which the rubber packings - fitted below the visor arm - should be pressed, when the visor was closed, were missing. The same refers to the flat bars having initially been welded athwartships at the forward part of the forecastle deck into which the rubber packings at the aft part, i.e. below the recess of the visor, should be pressed when the visor was closing (see also item 5 on the detail drawing). This can be seen from the following two pictures, of which the first one shows the starboard aft part of the visor deck with untouched rubber packings, intact and in place and the 2nd is the port side which is evidently in worse condition.

The picture below shows the rubber packing underneath the starboard visor arm which was obviously never pressed into any flat bar and is not affected at all, which confirms the apparent fact that

- a) the flat bars around the deck opening had been removed prior to the casualty and that
- b) the visor was raised to some extent at this side after the hinges were broken since otherwise this rubber packing would have been destroyed as it did happen at port side - see P 3 - Port Side Fore-castle Deck.

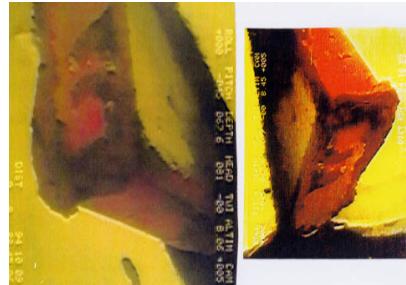
The next images show the lug of the hydraulic side lock which was evidently torn off the visor bulkhead together with the welding seams by which it had been welded to the bulkhead.

**Note:** It is obvious that these welding seams do not originate from one welding procedure only but from several weldings on top of each other, i. e. after each cutting off the new weld was laid on top of the previous ones without grinding off the remains of the previous welds as required by proper workmanship to assure the required load-carrying capacity of the weld. The required load-carry capacity of these lugs being part of the locking system of the visor did already since sometime before the last departure no more exist and was reduced to a fraction of the initial load-carrying capacity by such unqualified repairs.

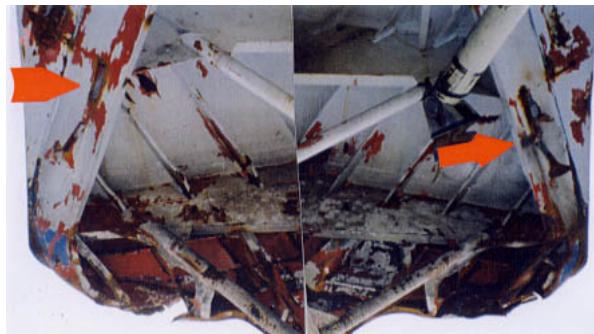
The picture on the right left shows the area of interest on the starboard side, the picture on the left shows the corresponding port side. It shows a completely different damage picture: no smoke marks, no steel tongue torn off the bulk-head and no twisted hooks.

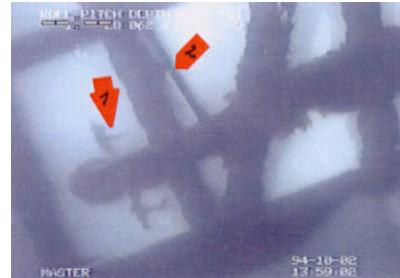
#### Area No. 3:

The following image shows transverse contact marks above the opening for the hydraulic side lock - see arrow 1 - which presumably resulted from the visor moving forward/aft during the time it took the visor arm lugs to cut through the deck beam.

Arrow 2 on the above image points to a wire running across the front bulkhead and the bow ramp to the starboard side and apparently from the port fair leads of the forecastle deck (there is no other possibility where a wire could come from). The image was made from the video tape produced by ROV on 02.10.94 - see Subchapter 25.1 - because on subsequent videos the wire is no more visible.

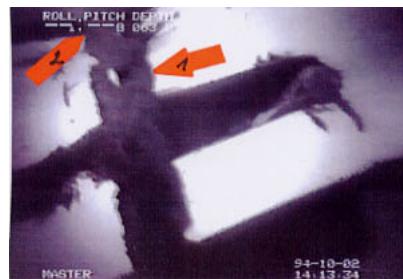
The next image - made from the same video tape - shows the same area, but slightly further down (in normal condition). Arrow 1 points to a double rope coming up from the gap between bulkhead/ramp and rising up due to its floatability.

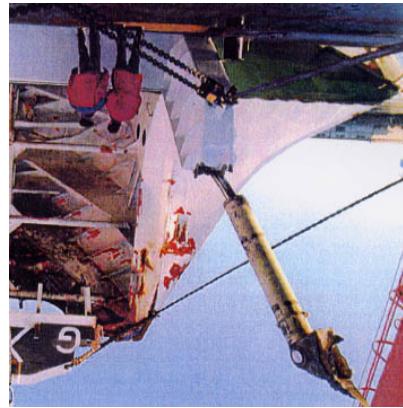
The starboard actuator, to the contrary, was found to be fully extended with the piston rod bent. It had apparently been the last connection between the vessel and the visor except for the bow ramp, the fore-castle deck and bulbous bow.

The area indicated by the arrow and the close up was probably struck by the foundation of the starboard actuator after the actuator had moved out of the front bulkhead of the vessel. - See also Chapter 30 - The Visor.

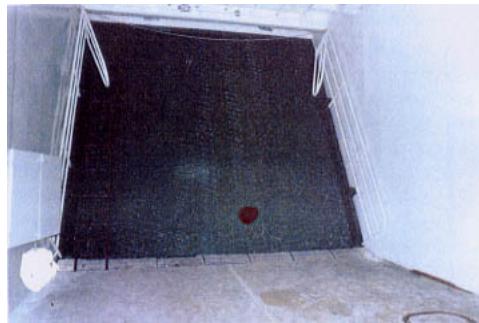
- The lower area is located in the 3rd row of steel profiles, looking from starboard, which are welded to the ramp plating and the 6th or 7th profile from car deck level as indicated on the picture below by the dark spot. The paint of the plating as well as the two flaps below looks reddish/brown. The plating otherwise does not look affected, but the two flaps are bent and distorted and the car deck plating in way appears to be affected.

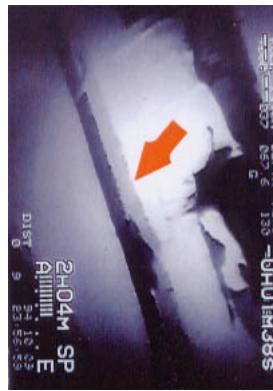
The lower part of the starboard front bulkhead in way of the hydraulic and manual side locks - see also further forward in this chapter, the starboard front bulkhead - is shown on the following images. The first one shows the upper part of the opening for the manual side lock with the rubber packing to the left. Between opening and rubber packing the bulkhead is visibly bulged - see arrow - i.e. the bulkhead is pushed out around the opening for the manual hook and increasingly deeper down the bulkhead. This can be seen from the next image below - arrow 1. In addition, there is a very deep fold - see arrow 2 - as well as damage in way of the rubber packings - arrow 3.

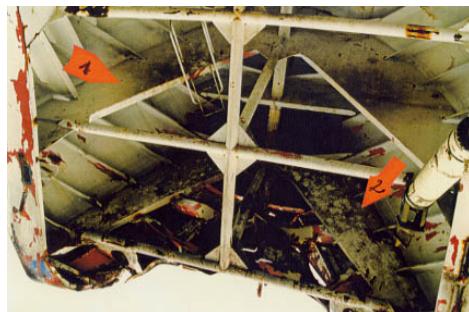
- As the Atlantic lock could no longer be closed hydraulically already since some time before the casualty (probably since the ice winter, March/April 1994) crew members had to go down inside the visor each time before arrival and after departure Tallinn and hammer the bolt open respectively closed through the deformed lugs of the Atlantic lock. Thus they walked from forward to aft and back over the stringers through the freshly settled oil which caused the footprints as can be seen on the next pictures.

- The photograph on the next page was made mid January 1995. It shows a view into the visor with the partly oil stained 2nd stringer (arrow 1) and the completely oil covered stringer 3 (arrow 2).

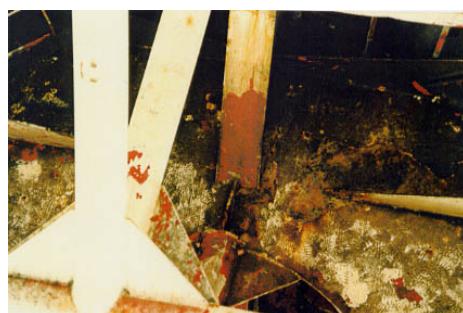
- Also the picture on the next page shows in detail that the footprints were so fresh and clear that even the size of the rubber boots could have been identified. It also demonstrates that there must have been quite some activities down in the visor before the last arrival and after the last departure from Tallinn which cannot just be explained with one or two men going down to hammer the bolt of the Atlantic lock open and closed. There were certainly also other activities going on as will be explained later.

**Note:** The last time the hydraulic oil settled down on stringer 3 has been before arrival Tallinn in the morning of 27.09.94 when the speed was reduced, the bow wave became small and the water streamed out of the visor. Thereafter the crew entered the visor to hammer open the Atlantic Lock and possibly to carry out other activities. The crew went again inside the visor after departure to hammer the bolt into the Atlantic Lock lugs and to carry out other activities. Subsequently the vessel picked up speed, the bow wave was raising again and the inside of the visor filled within the following hours more or less completely with water, which only left with the lifting of the visor after the casualty. Consequently the fresh footsteps originate from before arrival and after departure on 27.09.94.

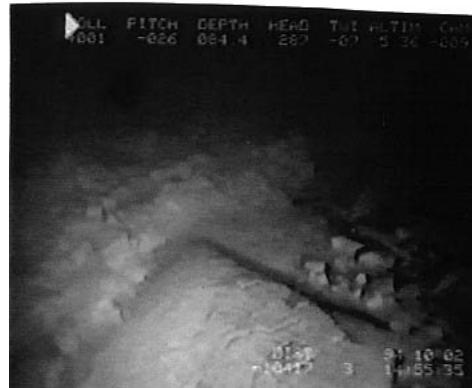
Alternatively the stabiliser fin could have broken off by the object sliding against the vessel's starboard side by which the scraping noises were caused. The noise scenario for Bengt Nilsson would have been the same. Therefore the video footage showing the ROV inspection of the sea bottom was analysed and the following two images were found which could show parts of the stabiliser fin.

As to the **starboard stabiliser** there are strong indications that it broke off or was broken off and is resting on the sea bottom now. In both cases a substantial water ingress into the engine room - at least 2 watertight compartments were affected - would have been the result for which there are also indications, because Henrik Sillaste has testified that the bilge pumps were running and Margus Treu has stated they were trying to pump water out of the ship. As it is not possible to pump water from the car deck they can only have pumped from 1st deck and 0-deck.

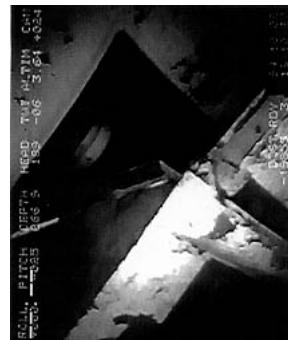
As the superstructure in way of the port side aft part of the 8th and 7th decks were found to be indented and bulged by the divers it has to be assumed that she was somewhat more heeled to port when touching the sea bottom as a result of which the above indentations were caused.

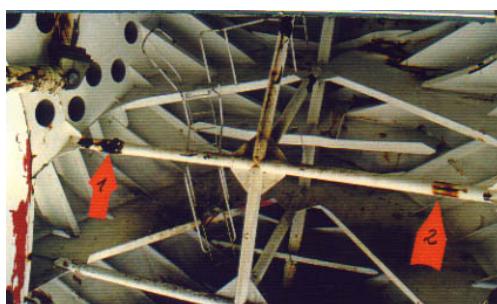
Although the upper transverse crossbar inside the visor shows respective damage - see arrow 1 on the picture below - the corresponding part at the port outer longitudinal girder of the bow ramp does not. This is confirmed by the image further down,

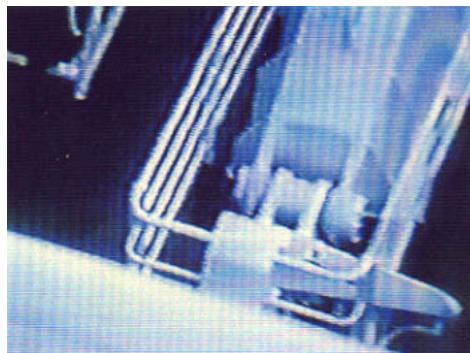
1 - shows the remains of the starboard hinge plates still attached to the visor (they were cut off upon the instructions of the JAIC in January 1995 and were transported to the Royal Technical Institute (KTH) in Stockholm for examination). The very bad condition, especially of the outer hinge plate is obvious. The deep burning marks and the missing metal are striking. All this is confirmed by the video film made by a passenger on 17.09.94 from the open forepart of deck 8 - see also Subchapter 12.5 - i.e. 10 days before the catastrophe. The image below shows a sequence of this video.

It demonstrates that,

- the whole hinge arrangement is severely misaligned;
- the outer bushing is extending too much to the outside and is twisted;
- the lower part of this bushing as well as the securing plate are missing;
- there is a big gap between the inner part of this bushing and the outer hinge plate fitted on the forecastle deck;

just to mention the main and most obvious deficiencies. The video tape was analysed in detail by the British Reconnaissance expert Bryan Roberts and his findings are discussed in Subchapters 12.5 and 34.9 and his report is attached as [Enclosure 12.5.180](#).

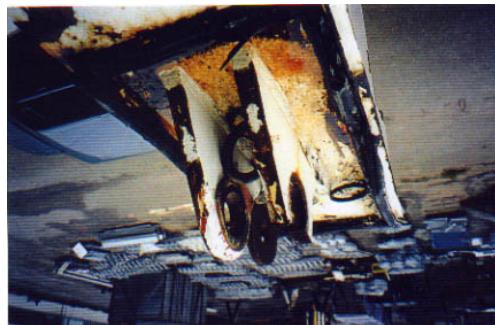
This picture on the next page shows the damaged and torn rubber packing indicating movement of the visor without this side having been raised up.

(1) The outer lug plate is completely untouched while the inner lug plate shows very deeply engraved scraping marks. This means that at the time when the lug plates were cutting through the deck plating and the deck beam the vessel must have heeled already considerably to starboard. Therefore the centre of gravity of the visor had shifted from forward to starboard and the force direction was no more to forward/downwards but starboard/downwards. Thus the weight of the visor in athwartships direction was now carried by the inner port and the outer starboard lug plates because the locating horns gave no more transverse support as the visor had moved too much forward.

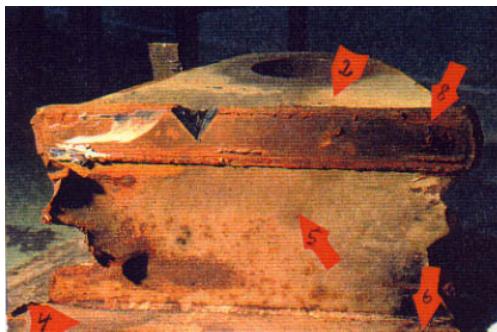
The following photograph shows the port visor actuator foundation after parts had been cut out for testing purposes. The foundation lies on its port outer lug plate. In the front the port outer stiffener (4) is visible, which is fully welded to the B-deck (5). Further at the forward right corner the old temporary repair with the very poor welding seams (6) is visible from inside. For cutting purposes the port inner stiffener (3) had been removed.

The apparent fact that this stiffener (3) had been disconnected from the B-deck (5) respectively since the last repair was never really fitted to it, is further confirmed by a part of the welding seam - see arrow 8 - on the previous two photos - apparently being soaked with oil while the stiffener below is unaffected. This means that this stiffener was not welded to the B-deck.

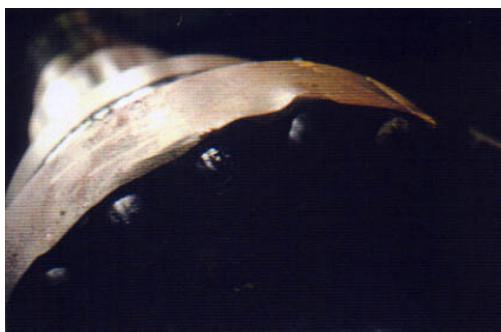
*"... it was noticed that there were heavy damages at the distance when the piston rod is about 400 mm open. The damages were on the starboard side of the piston rod. Damages were also noticed on the piston cover's fixing screws. The ends of these hexagon screws were like hammered." (See [Enclosure 29.413](#))*

The picture below demonstrates the above.

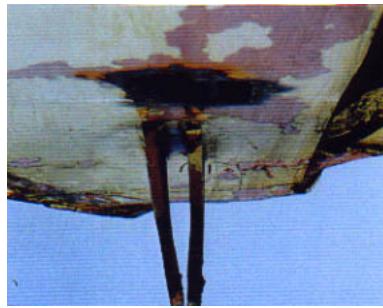
The hooks for the manual side lock were just bent together, as can be seen on the picture on the next page. The area around the lug location shows burning marks obviously from cutting off the lug by flame cutting - see arrow - but no smoke marks as on the starboard side and the plating was not pushed out/distorted.

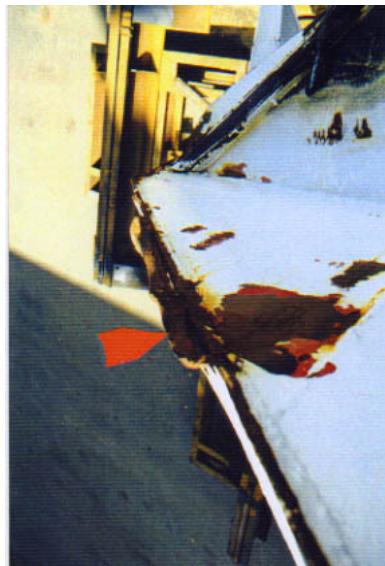
1 - shows the upper part of the aft bulkhead with the moderately affected recess which has already been discussed at the beginning of this item. The picture on the next page shows the recess as enlargement with damage at the edge of the shell plating - see arrow - which obviously occurred when the visor was moving in the transverse, i.e. athwartships, direction. - See also Chapter 31 - The Casualty Scenario.

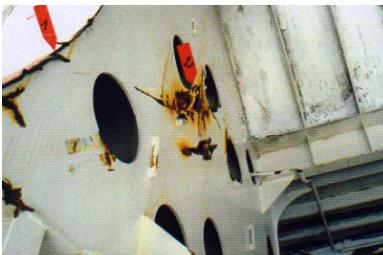
After the actuator had been dismounted by MacGregor, Turku in February 1995 the area looked as it is shown by the following picture. Arrow 1 indicates the area at the edge of aft and inner bulkheads where the aft bulkhead is slightly extending the inner bulkhead and where metal parts were torn off when the actuator moved into its jammed positions. A detailed evaluation of this and other pictures did reveal that neither the actuator nor its foundation had come in contact with the bulkhead which is due to the angle between the fastening point at the lugs below the visor arm and the bulkhead edge. The actuator was able to swing into this position because of its spherical bearings which allow deviation of up to 15° to each side.

It is thus proven with sufficient certainty that the severe damage as well as the scraping and scoring marks were only caused by the bow ramp then lying inside the visor on the beam structure and the visor resting on the bow ramp in way of the damage area under discussion. This shall be explained in more detail in Chapter 31 - The Casualty Scenario.

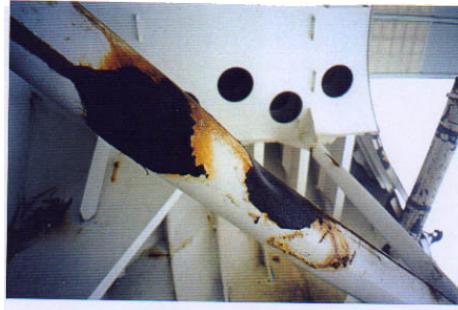
The two pictures below show the damage to the top and port side of the vertical beam.

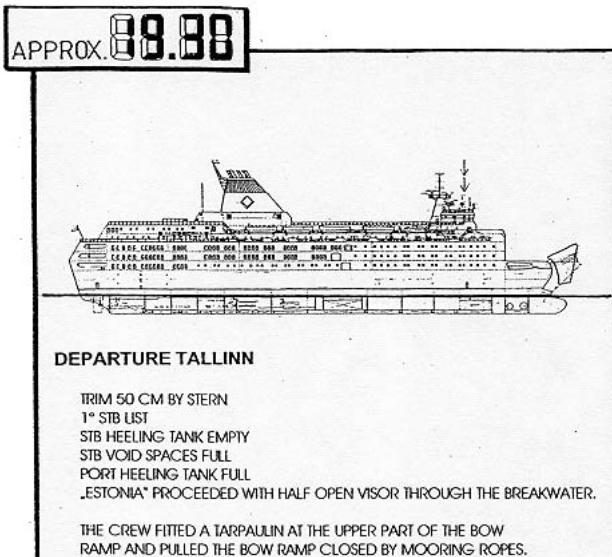
The scenario starts with the condition of the ferry upon departure from Tallinn at about 19.30 hours on the 27th September 1994. The departure condition is demonstrated by drawings and text below.

**Visor Locking Devices:** Atlantic Lock / hydraulic side locks engaged, manual side locks - not engaged

**Ramp locking devices:** Starboard ramp hook and securing bolts not engaged, Port ramp hook and securing bolts not engaged

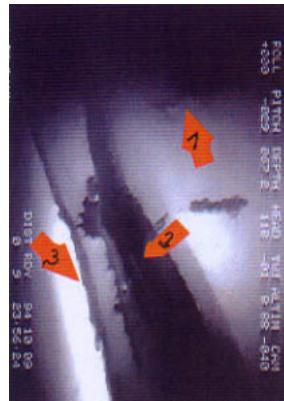
- The next image shows the area further down the bulkhead. Arrow 1 points to the lower edge of the opening for the hook, arrow 2 to the rubber packing and arrow 3 to the deep, sharp fold to starboard of the rubber packing, which extends from forepeak deck level up to the side becoming narrower the further up it runs. It is obvious that the surrounding bulkhead plating was deformed towards the outside of both sides of this fold and also between the rubber packing and the inner bulkhead edge.
