I UNDER FINNISH FLAG

2 THE VESSEL "VIKING SALLY"

The German 'Group of Experts' has now - as far as possible - completed its investigation of the foundering of the M. V. ESTONIA, a disaster that has taken the greatest toll of human life in the Baltic Sea in times of peace. The German 'Group of Experts' has during the past five years performed a difficult investigation in a partly hostile and reluctant environment. The work was carried out during the first two years - 1995/1996 - in close co-operation with the Swedish leader of the Technical Group of the Joint Accident Investigation Commission of Estonia, Finland and Sweden (JAIC), Börje Stenström († February 1997), and also with the Finnish member of the Technical Group, Dr. Tuomo Karppinen and the expert Dr. Klaus Rahka. All the investigation results of this 'Group of Experts' were submitted either verbally in joint meetings with the members and the experts from Estonia, Finland and Sweden attending or in letters with attached photos and/or video film documentation to the JAIC. This documentation and information concerned the design, construction and building of M. V. ESTONIA in general and the locking devices of the bow visor in

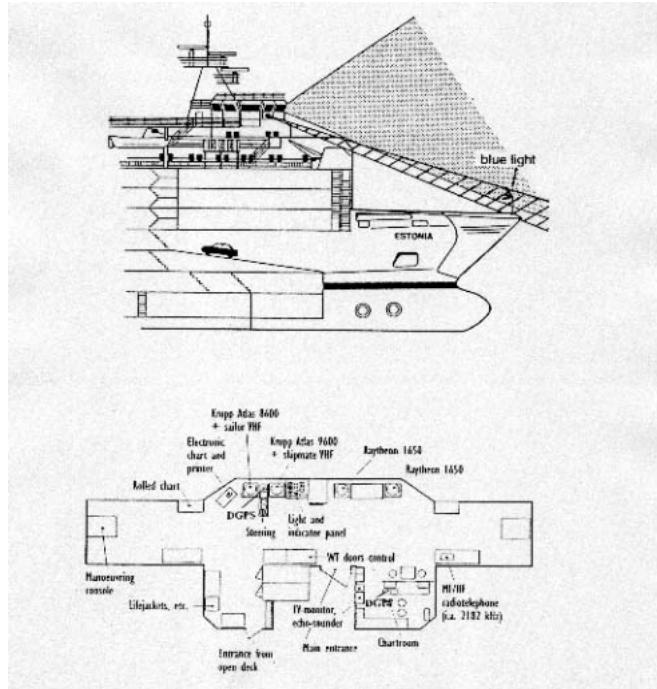
Because of the retracted position of the navigation bridge, only the flag pole on the bow of the vessel was visible from the conning station - see drawing below - whilst the most forward part of the visor could be seen through the two windows on deck level at both sides of the extended central part of the bridge, as can be seen on the drawing below. A monitor, showing among other things, the transmissions from the four car-deck cameras, was placed at the chartroom entrance and could not be seen from the conning station.

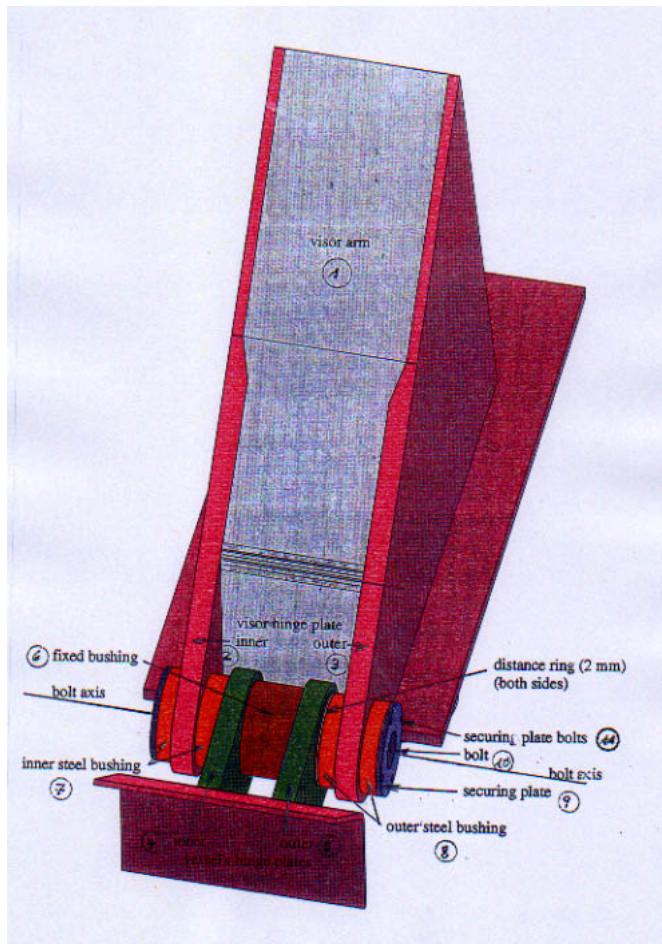
Todsen as well as the Meyer Werft managers and employees have time and again confirmed that the bore holes in the visor arms for the steel bushings had been drilled and not burned and, as a matter of fact, the port outer part of the visor hinge plate still shows circumferential drilling marks. The sketch below shows the hinge arrangements in detail.

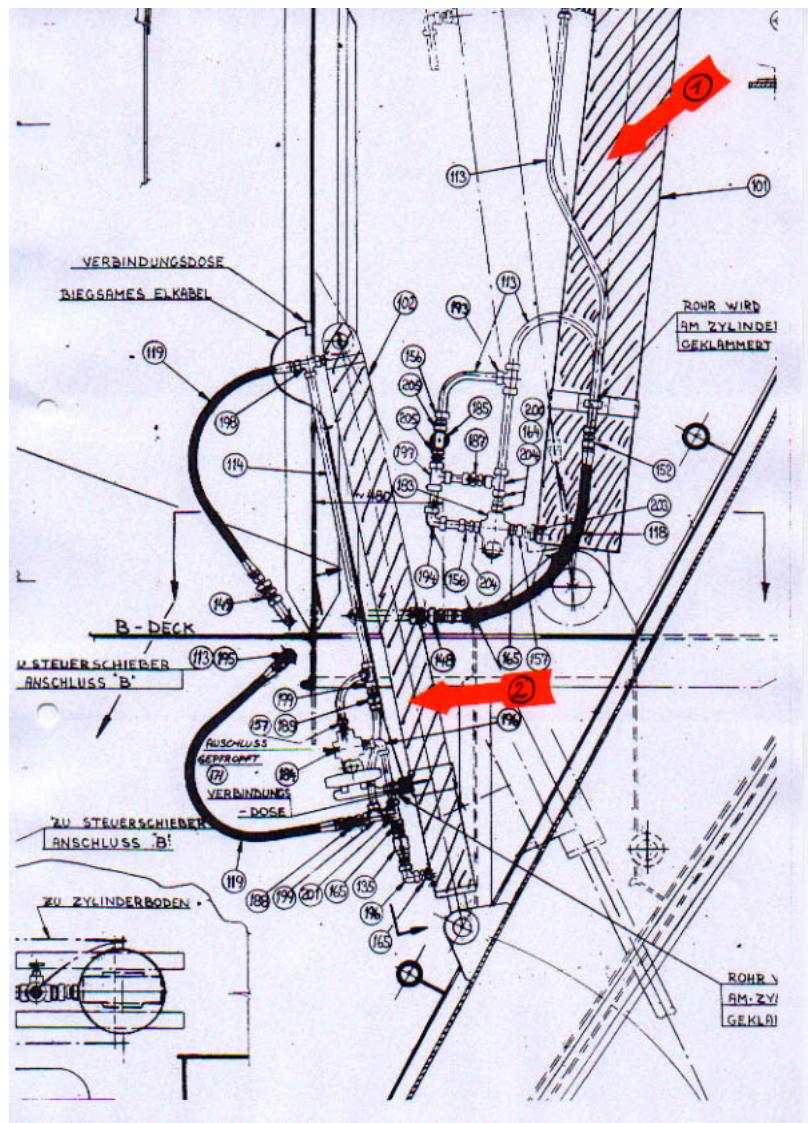
The following diagram shows part of the von Tell drawing 49111-387 with the visor actuator - arrow 1 - and the bow ramp actuator - arrow 2 - with the respective hydraulic systems, as explained on the previous pages, fitted to the cylinders.

As these installations were located in the void spaces above and below B-deck as it is visible from the drawing on the next page, they were accessible for the crew. This means that it has been possible to manipulate the valves at the visor and bow ramp actuators from inside the side-houses without having to touch the control panel on the car deck. By means of the above explained "cross-over" effected at the aft hydraulic station - see Enclosure 2.4.2.31 - it has also been possible to put pressure on the cylinders of visor and bow ramp by means of the aft hydraulic station. In summary it can thus be concluded that it was possible to put pressure on the actuators of visor and bow ramp, i.e. to keep them closed by hydraulic pressure, without having to use the control panel on the car deck.

It can further be concluded that it was possible to keep visor, bow and stern ramps in a semi-open/closed condition which, however, required the running of at least one hydraulic pump under continuous load changes (on/off). The visor actuators were connected to the vessel's B-deck by 2 lugs for each cylinder (see Enclosure 2.6.4.79 - photo showing B-deck).

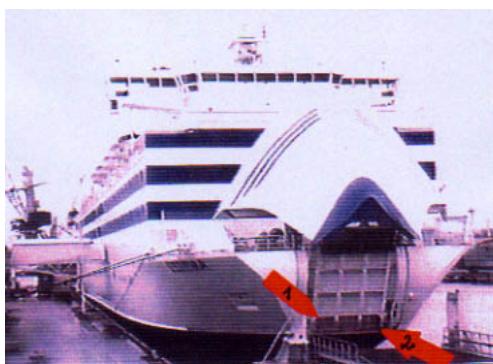
The picture below shows ESTONIA at her berth in Tallinn with open visor and closed bow ramp. The arrow no. 1 points to the oil covered lower part of bow ramp which demonstrates the height of the water level with hydraulic oil floating on top inside of the visor when the vessel was at sea in calm weather. Arrow no. 2 points to the bow ramp hinges which are on car deck level.

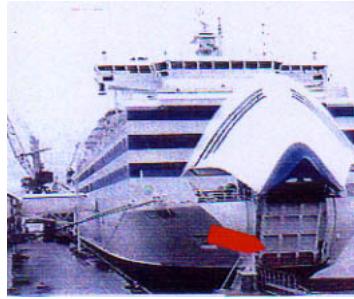
Note: The picture on the next page was taken in October 1993 and shows the lower part of the closed bow ramp severely stained by oil, most probably hydraulic oil, which cannot just be explained by normal leakages.

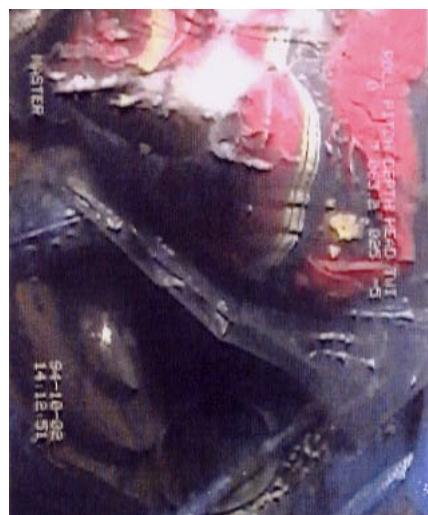
The following image taken from the 02.10.94 video shows the location of the port outer hinge which slipped off, intact outer lug some distance away from its original position because evidently a gap had opened and the ramp became detached from the vessel in this area and through this gap between forepeak deck and bottom of ramp water could freely penetrate on to the car deck from the visor which was always water-filled at sea. This gap was plugged by mattresses - see the blue transverse one above the hinge remains - the vertical plastic sheet to the right of the blue mattresses, the red/white bedding next to the plastic sheeting. The videos from 02. and 09.10.94 are showing blankets and rags further up in the gap between ramp and bulkhead.

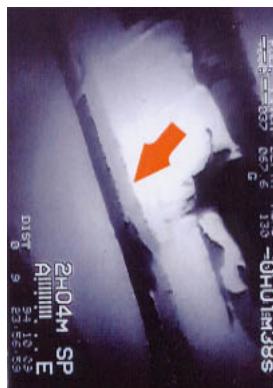
The lower part of the starboard front bulkhead in way of the hydraulic and manual side locks - see also further forward in this chapter, the starboard front bulkhead - is shown on the following images. The first one shows the upper part of the opening for the manual side lock with the rubber packing to the left. Between opening and rubber

packing the bulkhead is visibly bulged - see arrow - i.e. the bulkhead is pushed out around the opening for the manual hook and increasingly deeper down the bulkhead. This can be seen from the next image below - arrow 1. In addition, there is a very deep fold - see arrow 2 - as well as damage in way of the rubber packings - arrow 3.

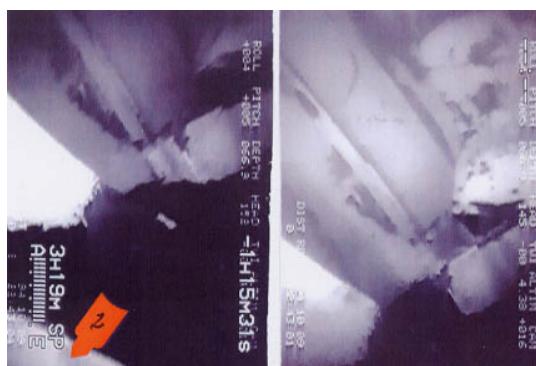
The following two images show the area adjacent to this pushed-out lower part of the front bulkhead, the recess with the torn-off and severely bent lower part of the outer vertical girder of the bow ramp. Apparently the deck/bulkhead is open in way of these severe distortions which also extends downwards.

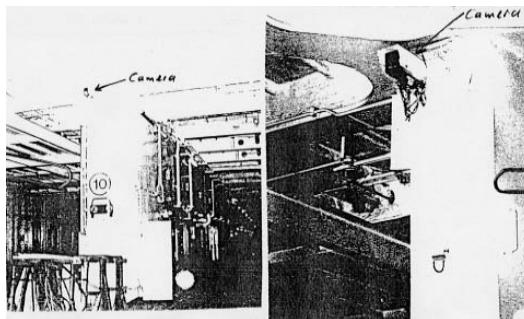
(1) the statement of the watch engineer Margus Treu that a jet of water hit the lens of the video camera transferring pictures from the partly open bow ramp to the monitor in the engine control room (ECR) where he was watching - see his statement dated 29.09.94 Turku - [Enclosure 21.2.3.263](#). Treu believed that this water jet came from the partly open bow ramp, which however is not possible because the camera is fitted at the forward part of the centre casing underneath the ceiling. The distance to the bow ramp is 25 m and the height above car deck is about 5 m - see the pictures below taken on board the near-sister DIANA II where the camera was installed as on ESTONIA.

It can thus be excluded that water penetrating the bow ramp at that relatively early stage could have reached the camera in such high position as much as the car deck between bow ramp and camera was full of trucks and cars.

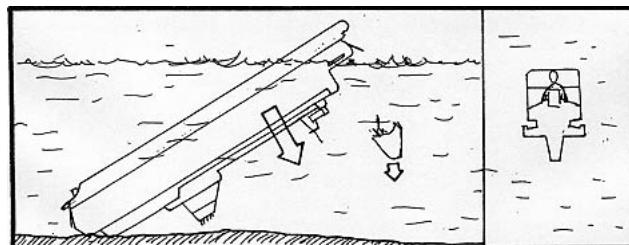
While the ferry was sinking in completely upside down condition the stern area had the first contact with the sea bottom. The bow was still above sea level at this time with the bulbous bow being the highest point. See the drawing below.

As the superstructure in way of the port side aft part of the 8th and 7th decks were found to be indented and bulged by the divers it has to be assumed that she was somewhat more heeled to port when touching the sea bottom as a result of which the above indentations were caused.

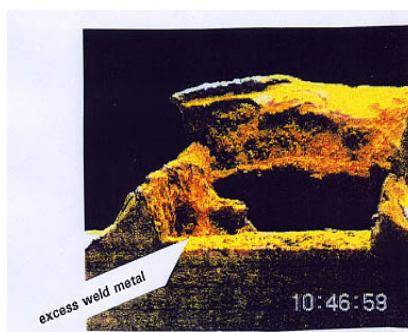
The fracture of the recovered hinge bushing was fitting to the fracture of the inner starboard hinge lug. It exhibits a gap of about 4-6 mm between lug bore and support bushing. This gap is almost entirely filled with corrosion products, presumably magnetite, which is also found in thick layers at a location where both hinge late and fillet weld failure are represented together with some excess weld metal, see arrow on the picture below which may have provided a local notch effect.

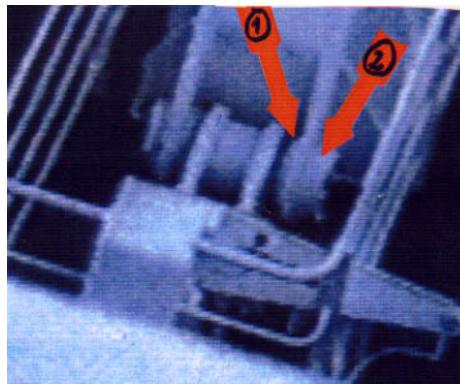
The passenger was standing in front of deck 7 and filmed the closing of the visor, finally zooming in on the starboard hinges. The video-prints below are part of the film. Picture 2 is an enlargement of Picture 1.

On Picture 2 there are obviously several major deficiencies visible, viz.

(a) the gap between the starboard vessel hinge plate and the outer bushing is much too large (arrow 1).

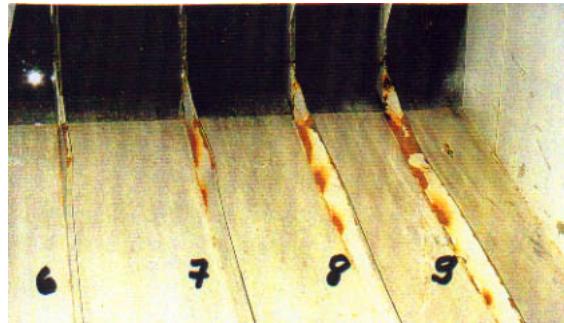
2 - Ramp House

There is no sheet available for this part of the visor. The pictures show the inside of the aft part of the ramp house with 9 vertical webs each at its forward- and aft-parts. The webs are of the hp profile-type and measure 160 x 7 mm. The 4 webs at the port side of the aft part - numbered 6 to 9 - were indented to varying extent as can be seen on the picture below. Web 6 was evidently just slightly touched while web 9 was pushed flat.

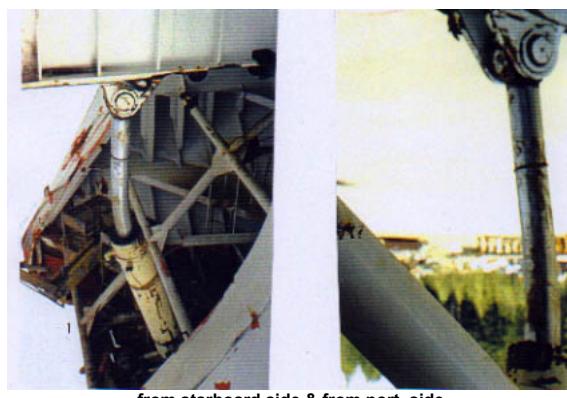
Note: The starboard actuator which the JAIC did not consider worthwhile for examination shows less scoring on the piston rod as can be seen on the pictures below.

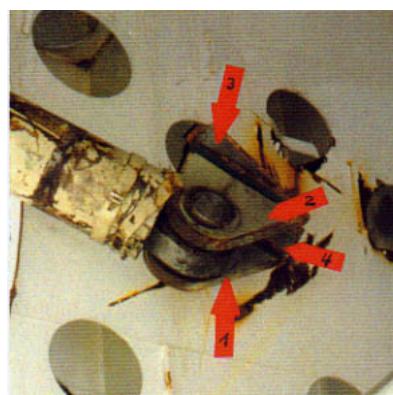
In consequence of this statement the photos showing the damage condition of this foundation have been analysed in detail and the result is outlined below: The foundation of the visor actuators did consist of two strong lugs welded to the B-deck and which were supported by two longitudinal and two transverse stiffeners. The picture below shows the port foundation with actuator still attached to the recovered visor. The arrows indicate the different components.

- arrow 1 = port outer lug plate of actuator foundation
- arrow 2 = port inner lug plate of actuator foundation

- arrow 3 = port inner stiffener (deformed)
- arrow 4 = port outer stiffener

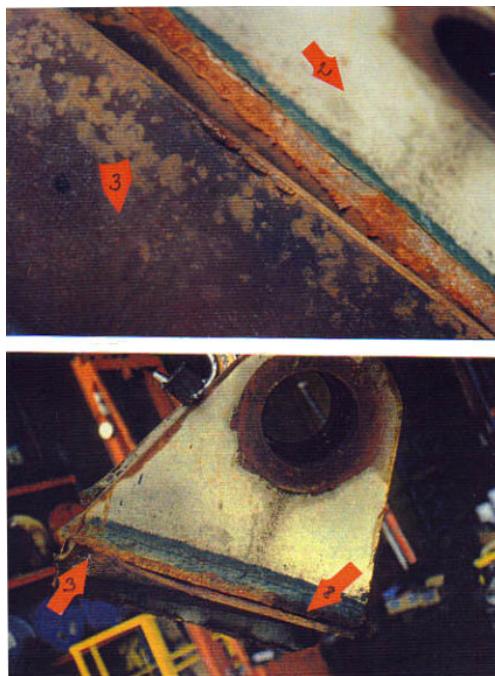
The following photograph shows the port visor actuator foundation after parts had been cut out for testing purposes. The foundation lies on its port outer lug plate. In the front the port outer stiffener (4) is visible, which is fully welded to the B-deck (5). Further at the forward right corner the old temporary repair with the very poor welding seams (6) is visible from inside. For cutting purposes the port inner stiffener (3) had been removed.

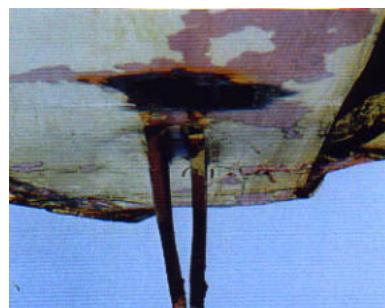
The hooks for the manual side lock were just bent together, as can be seen on the picture on the next page. The area around the lug location shows burning marks obviously from cutting off the lug by flame cutting - see arrow - but no smoke marks as on the starboard side and the plating was not pushed out/distorted.

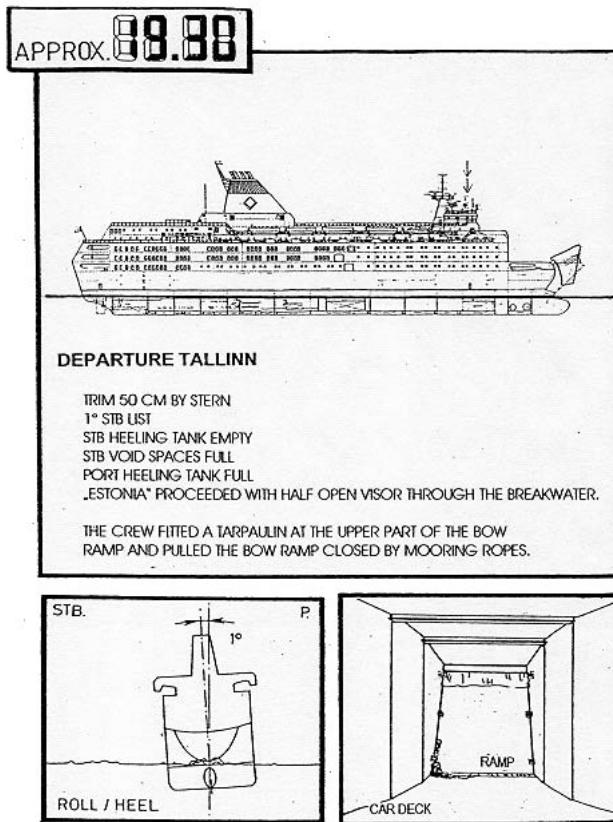
The scenario starts with the condition of the ferry upon departure from Tallinn at about 19.30 hours on the 27th September 1994. The departure condition is demonstrated by drawings and text below.

Visor Locking Devices: Atlantic Lock / hydraulic side locks engaged, manual side locks - not engaged
Ramp locking devices: Starboard ramp hook and securing bolts not engaged, Port ramp hook and securing bolts not engaged
Gaps between ramp/car deck seals by mattresses, blankets, rags.

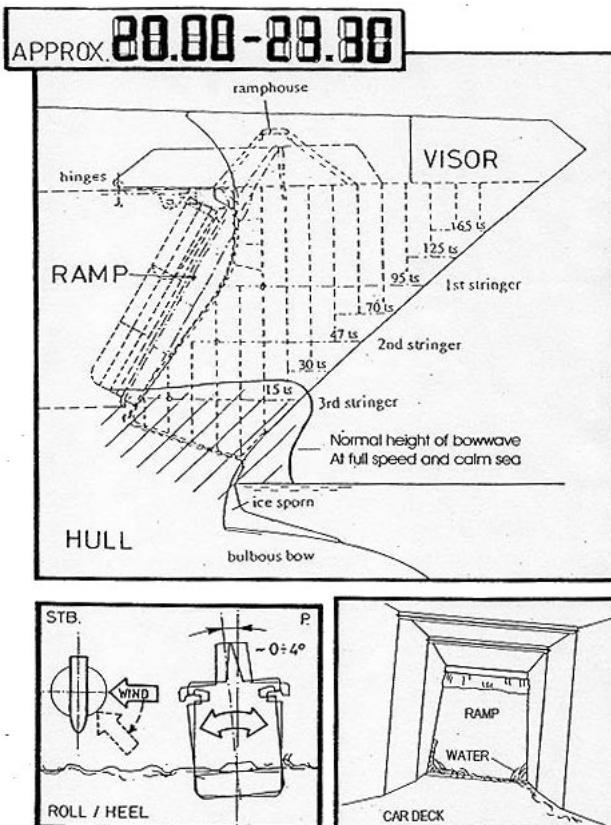
Even with calm sea the water level inside the visor was rising above the 3rd stringer when the vessel was at full speed. The lower side of the bow ramp was below 3rd stringer level, thus even in calm sea the water from the visor was penetrating the gap in the bow ramp and was flooding onto the car deck.

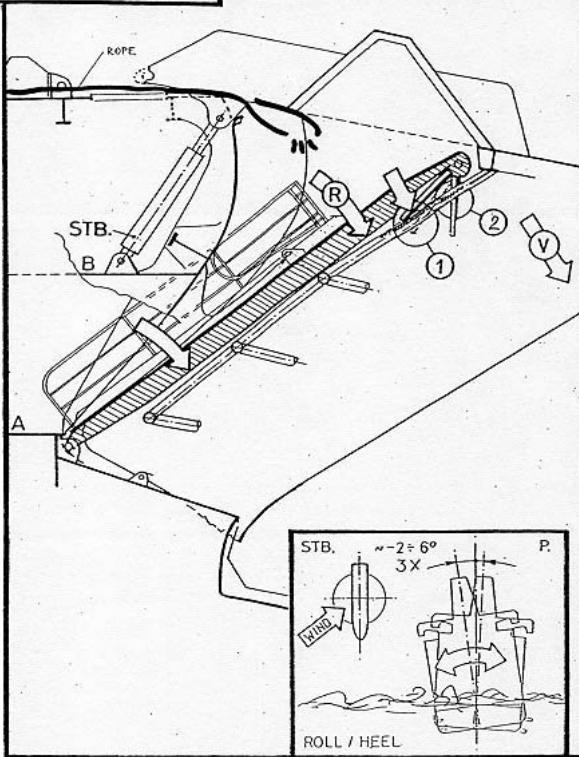
APPROX. 88.88

1. Vessel rolling more to starboard/less to port .
2. Visor lugs broke through the front bulkheads and did not support the visor anymore against moving towards the deeper starboard side (1)
3. With a big crash the visor fell abruptly about 10 cm to starboard until the inner port bulkhead was resting on the upper part of the bow ramp (2).
4. The visor was now extending the starboard front bulkhead of the vessel and the port front bulkhead was extending the visor.
5. The atlantic lock failed.

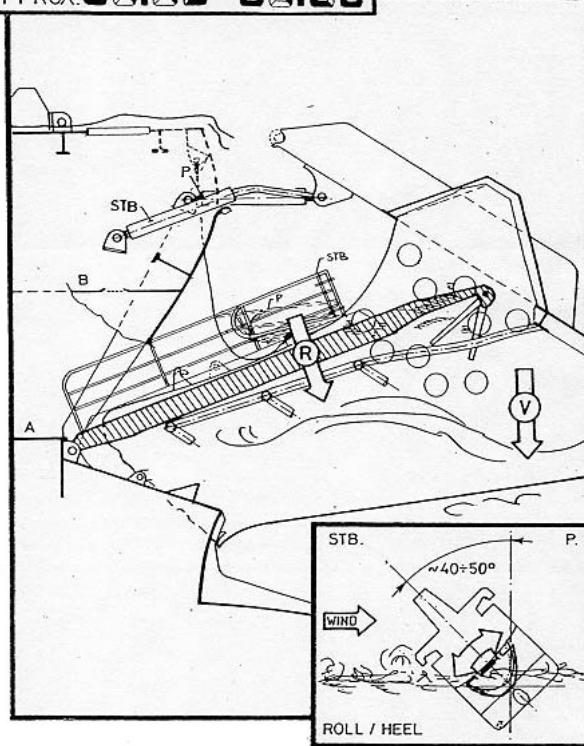
APPROX. 88.88 - 88.88

1. After the vessel had stabilised for some time at a heel of about 40o-50o the heeling increased again.
2. The visor moved further forward and downwards and also the starboard actuator was torn off its foundation and broke through the front bulkhead as did the port one.
3. The port actuator was completely retracted while the starboard actuator was fully extended with the piston rod bent.
4. The visor was still hanging on the ramp and was still supported against falling off to starboard by the forepeak deck being pressed into the visor bottom.

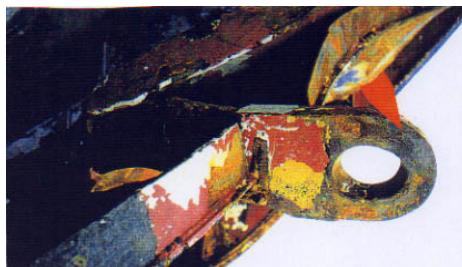
In April 1995 the JAIC published the "PART-Report covering technical issues on the capsizing on 28 September 1994 in the Baltic Sea of the ro-ro passenger vessel MV Estonia" which included also certain picture material, among others the picture below showing the aft part of the visor bottom with the visor lug being part of the Atlantic lock.

The blue coloured part of the lug - see arrow - looked as if having been exposed to heat which was unusual since this part had been below water. The JAIC was contacted and it turned out that samples had been taken already on 25 November 1994 and had been examined upon request of the Central Criminal Police in Finland and Kari Lethola as chairman of the Finnish part of the JAIC on 30.03.95. The tests were carried out on 30.05.95 by the Criminal Laboratory Technical Division, Helsinki. The "available" documentation was received - already translated into English - from Kari Lethola.
