# Statement stig lindstrom

Enclosure 3.4.101

**ANTECKNINGAR:** Brott: Utredning av sjöolycka  
Anmälarnr: 7020/S/10964/94

An historical overview  
made by

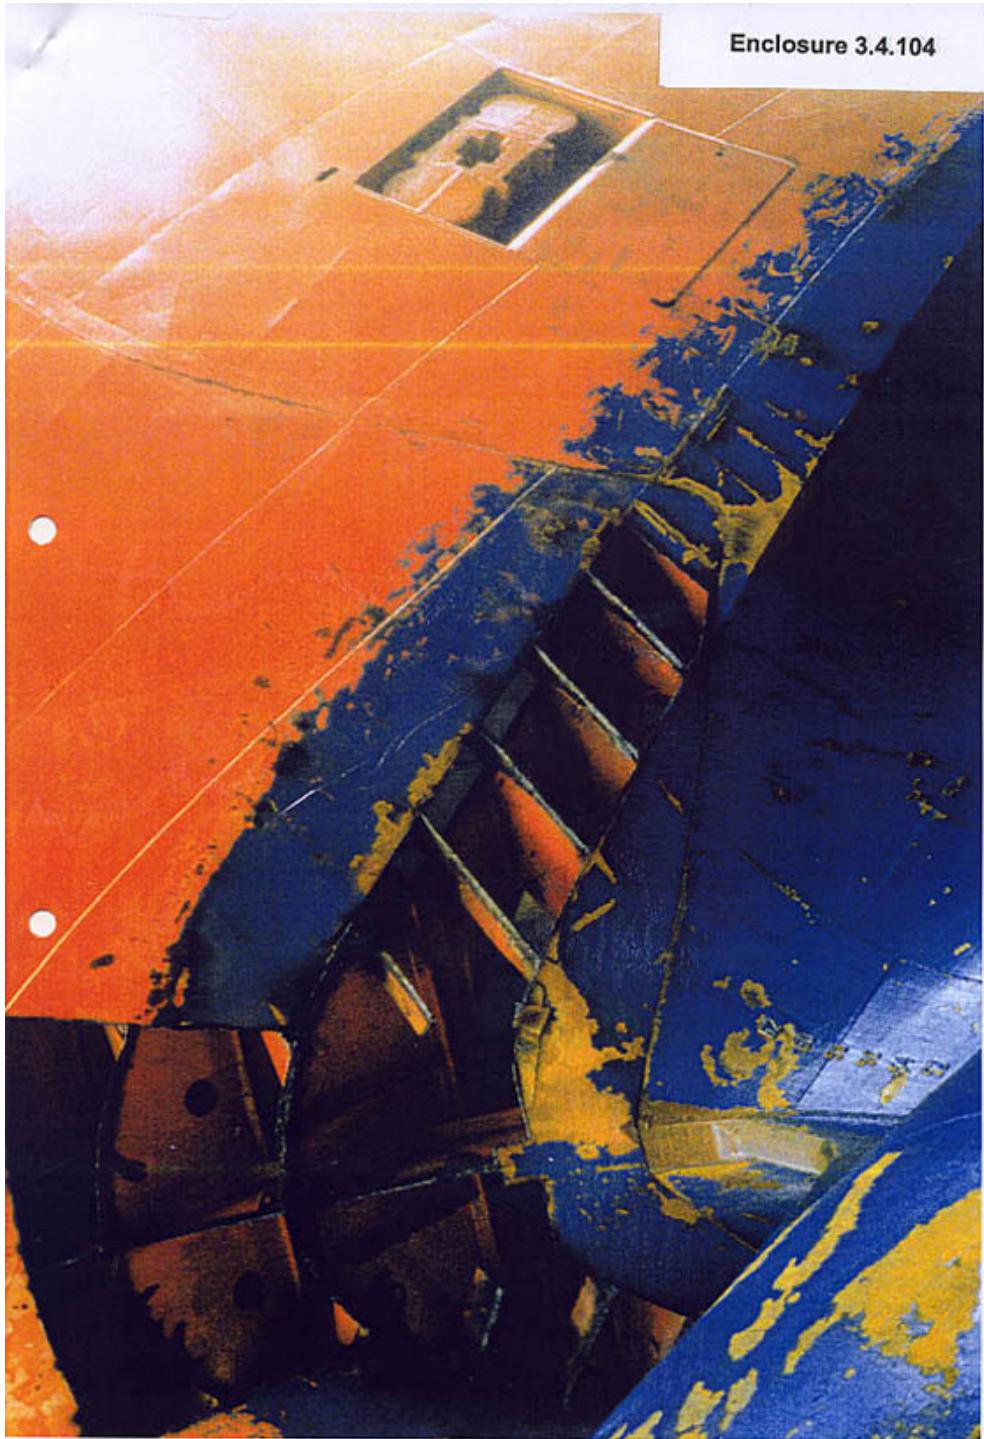
Enclosure 3.4.104

## Photo showing damaged visor plating

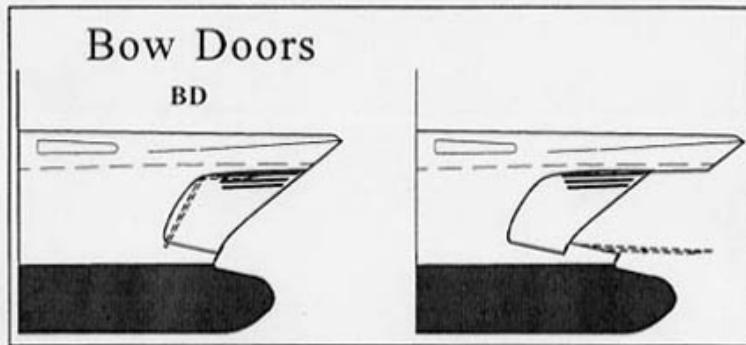
- **Bow doors** are normally hinged on heavy arms. The doors are opened by hydraulic cylinders moving the doors outside along the ship's sides. There are also some old designs where the doors are swinging. In closed position, pressure forces acting on the doors are transferred to the ship's hull via reinforced supports. Though the framework along the contours of the doors absorb some forces, the primary function is to keep the sea away from the space between the ramp and the doors. The primary function of locking devices is to prevent the doors from falling out from the ship.

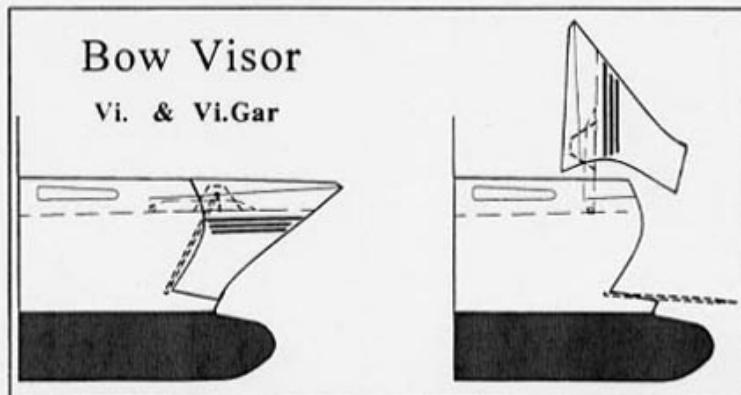
- A **bow visor** forms the bow on a ship. The visor is normally hinged on the forecastle deck and is opened upwards by hydraulic cylinders. The visor's supporting structures in the hull doesn't prevent the visor from opening. Only the locking devices have that function. The space between the visor and the ramp is sealed to the sea along the visor's contouring frame. Depending on the geometry of that frame and the elasticity of the visor the frame may absorb some of the forces acting on the visor.
