# Statement stig lindstrom

Enclosure 3.4.101

ANTECKNINGAR: Brott: Utredning av sjöolycka  
Anmälarnr: 7020/S/10964/94

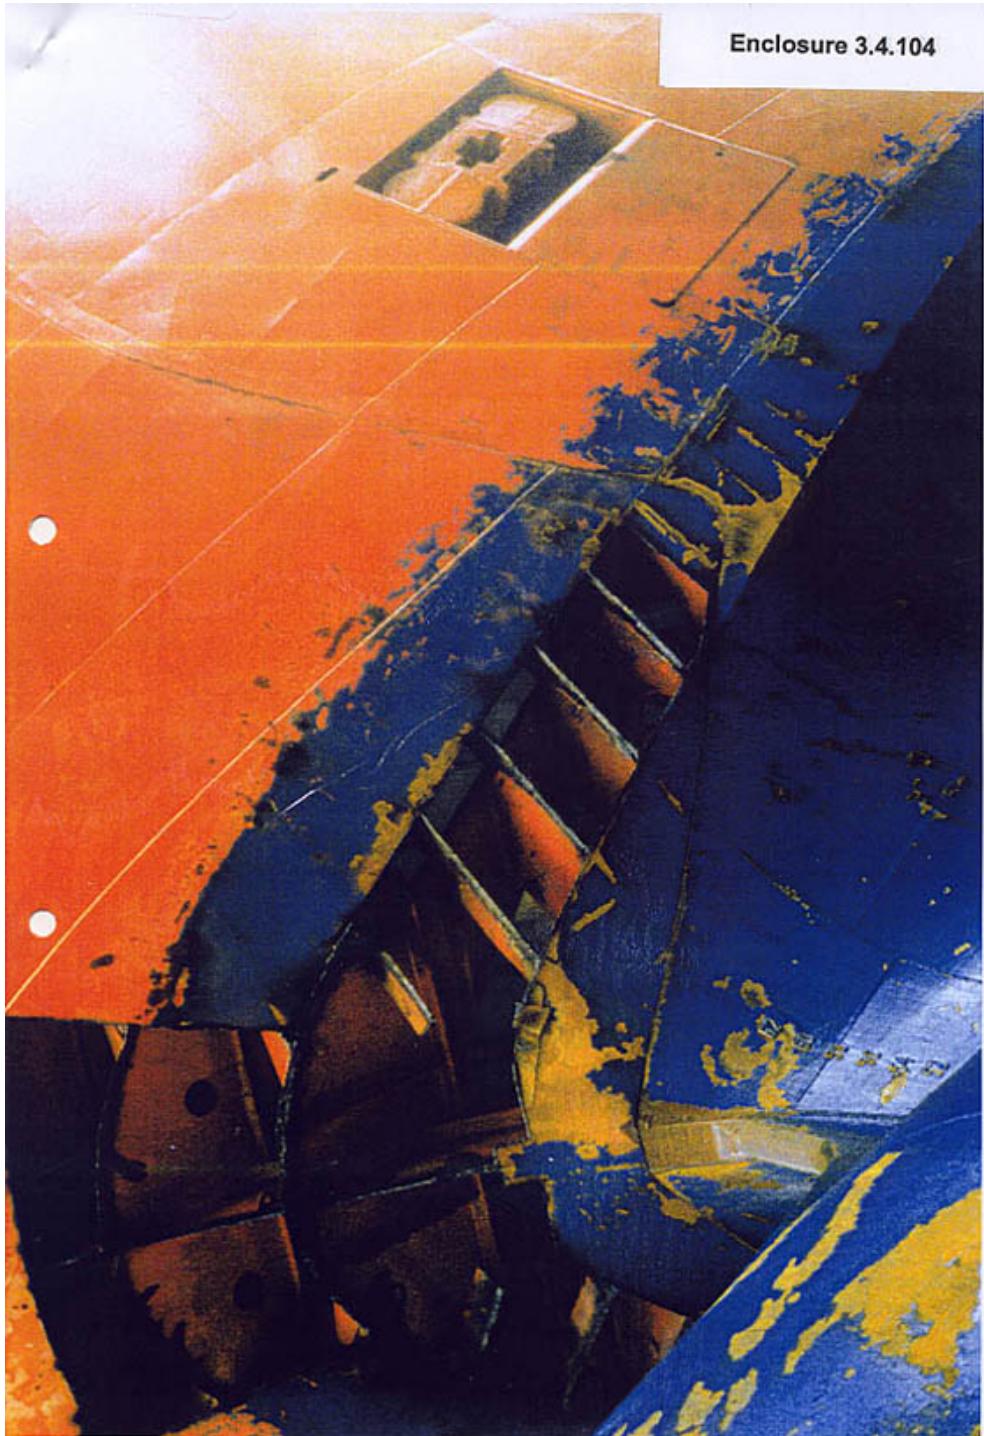
Enclosure 3.4.104

## Photo showing damaged visor plating

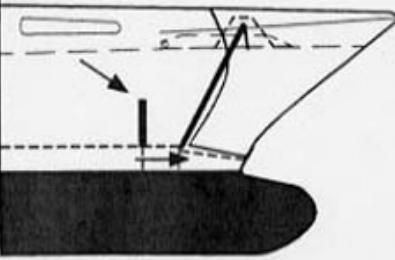
## Protecting barrier

M/S Estonia had a garage built on the visor to accommodate the upper part of the ramp. The ramp was moved forward and therefore did not fulfill the rules as an extension of the collision bulkhead. The arrangement could have complied with the rules of SOLAS if an additional barrier had been arranged.

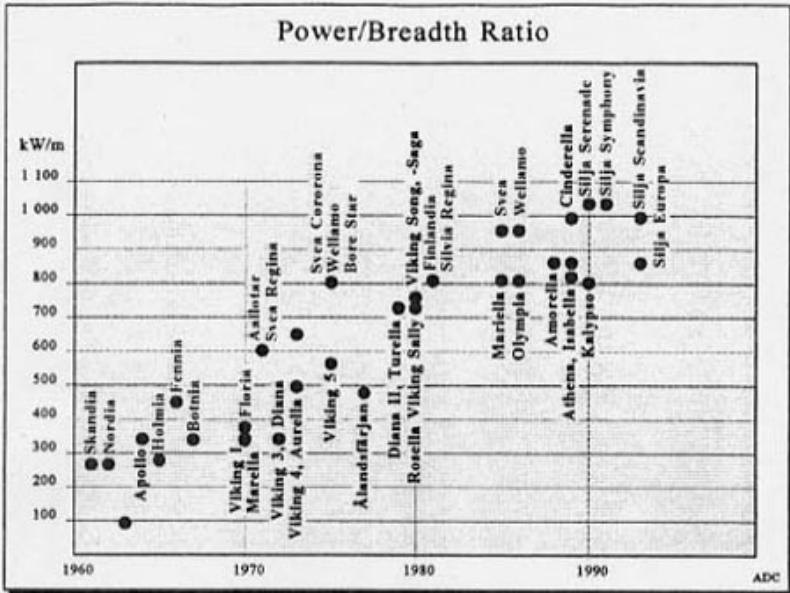
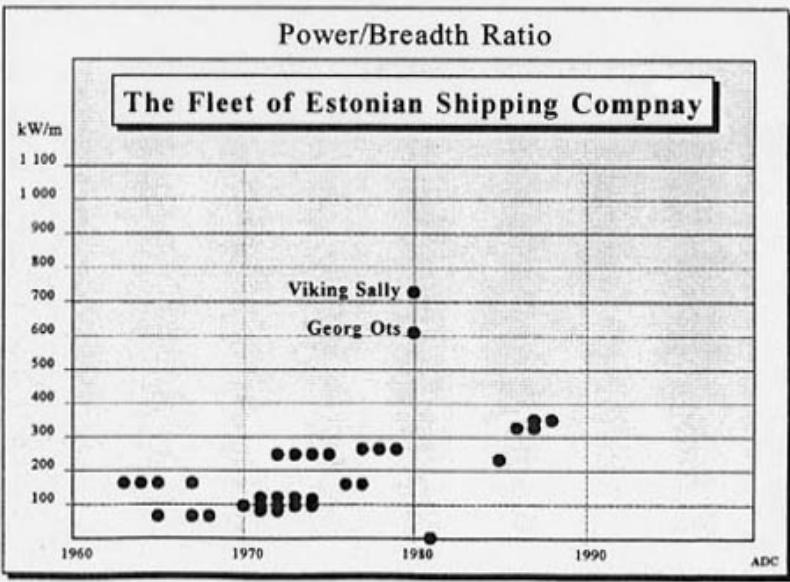
Consequently most Owners in the West also learnt that the engine power of "modern" ships could endanger the ship if the power resource was not handled gently. The diagram below shows the ratio of ship power to breadth over the years, in this traffic. The ratio just mirrors the potential a ship has to maintain speed through rough sea. Since also other factors are influencing on the ships performance in rough sea the plotting in the diagrams shall just be regarded as indications.

The crew of M/S Estonia (M/S Viking Sally) was recruited from Estonian Shipping Company (ESCO). The diagram shows the corresponding power/breadth ratio of the ESCO fleet in early 1993.
