## Case report: wall box with DLB-A1 controller

Charging current exceeds the wall box current limit, overload protection trips, no automatic resume after a DLB pause

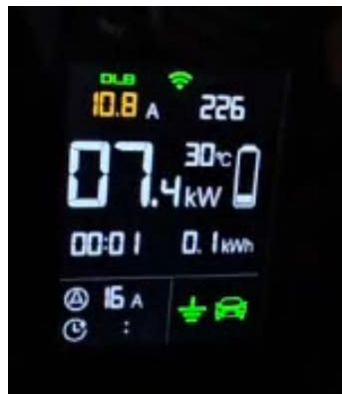
- 1** Charging at **DLB 10.8 A**, 7.4 kW, 226 V, limit 16 A.
- 2** A kettle is connected to simulate additional load on the installation. The DLB works as it should and reduces the wall box current; it falls below 6 A and the wall box **correctly stops charging**. Display: DLB 0.0 A, 0.0 kW, 228 V, limit 16 A, vehicle still connected.
- 3** The kettle is disconnected. **The wall box does not start charging again**. The installers waited 5 minutes – still no charging.
- 4** Only after the vehicle is **unplugged and plugged in again** does charging resume.

**1** charging at DLB 10.8 A, 7.4 kW, limit 16 A

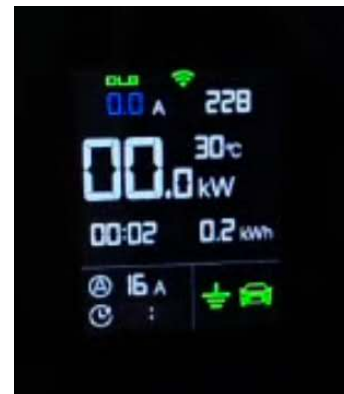
**2** stopped after the kettle was connected: DLB 0.0 A, 0.0 kW, vehicle connected — and it stays like this

| Time | Event |
|---|---|
| 12:37:53 | 工作状态 = <b>200</b> (vehicle connected, not charging) — the pause |
| 12:37:53 – 12:44:21 | No charging state and no current reported; the wall box stays in state 200 |

The DLB-A1 Quick User Manual (section 6.2, *Paused*) states: “Recovery is automatic when headroom returns.” This does not happen.

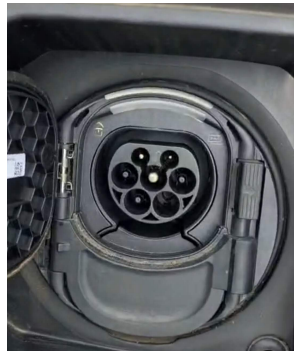
Vehicle A – two-phase  
on-board charger

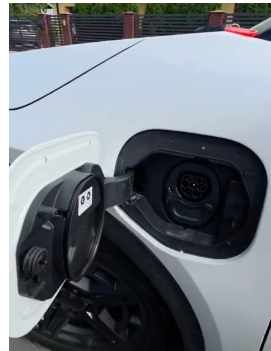
Vehicle B – three-phase  
on-board charger
