## Case report: wall box with DLB-A1 controller

Charging current exceeds the wall box current limit, overload protection trips, no automatic resume after a DLB pause

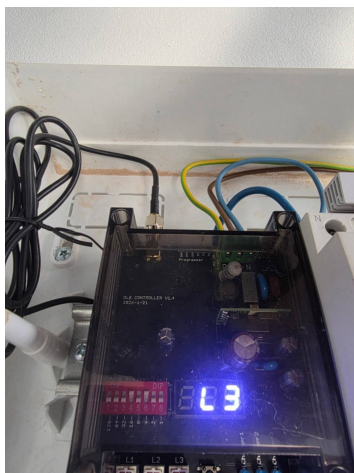
| Item | Details |
|---|---|
| DLB controller | DLB-A1, board marking “DLB CONTROLLER V1.4 2026-1-21”. Three current transformers on L1/L2/L3 of the incoming supply, 433 MHz antenna with magnetic base on top of the distribution board (Fig. 1). <b>Two independent kits</b> (controller with accessories) were tested — the behaviour was identical with both. |

DLB-A1 controller in the distribution board, board marking DLB CONTROLLER V1.4, 2026-1-21

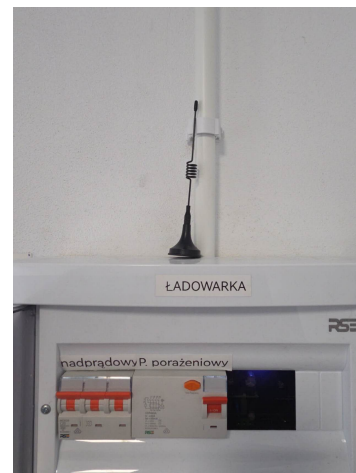
433 MHz antenna with magnetic base on top of the distribution board; wall box breakers below

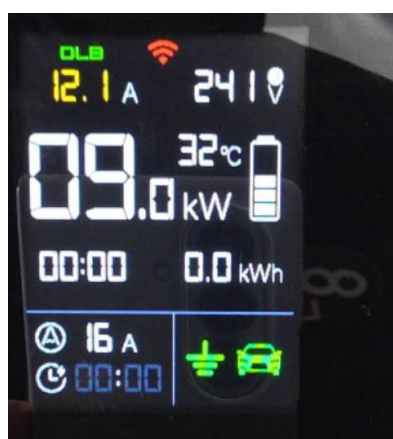
Normal charging with the DLB: DLB 12.1 A, 9.0 kW, limit 16 A — the DLB field shows the DLB-measured current

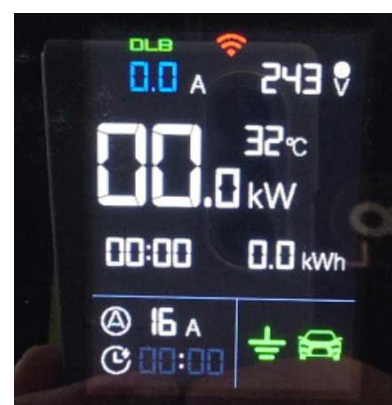
Idle, DLB paired (green icon): DLB 0.0 A, 243 V, limit 16 A

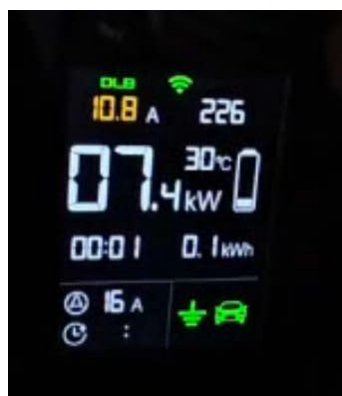
1. **1** Charging at **DLB 10.8 A**, 7.4 kW, 226 V, limit 16 A (log 12:36:13–12:37:34: 10.5–10.8 / 10.7–11.0 / 11.1–11.6 A, 7.4 kW).
2. **2** A kettle is switched on as additional household load. The DLB reduces the allocation below 6 A and the wall box **pauses charging** — **this is correct**. Display: DLB 0.0 A, 0.0 kW, 228 V, limit 16 A, vehicle still connected (log 12:37:53: 工作状态 = 200, vehicle connected, not charging).
3. **3** The kettle is switched off. **The wall box does not resume charging**. The installers waited 5 minutes — still paused. In the log the wall box stayed in state 200 from 12:37:53 until it went offline at 12:44:21; no charging was recorded.
4. **4** Only after the vehicle is **unplugged and plugged in again** does charging restart.

**1** charging at DLB 10.8 A, 7.4 kW, limit 16 A

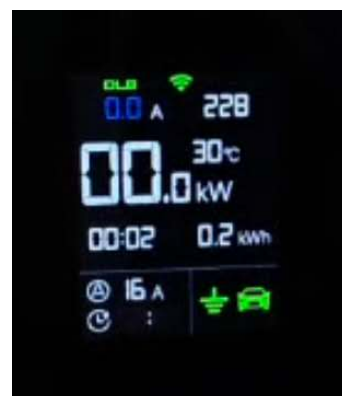
**2** paused after the kettle was switched on: DLB 0.0 A, 0.0 kW, vehicle connected — and it stays like this

The DLB-A1 manual (section 6.2, *Paused*) states: “Recovery is automatic when headroom returns.” This does not happen.

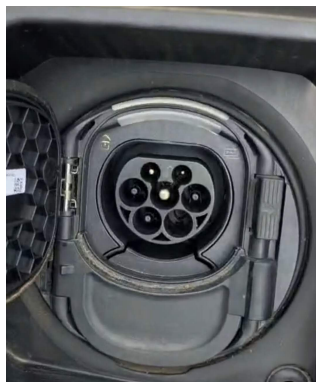
Vehicle A (two-phase). Settings: DLB Configured Supply Limit **18 A** (DLB display 018, Fig. 2), wall box limit **16 A**.

Vehicle A – two-phase  
on-board charger

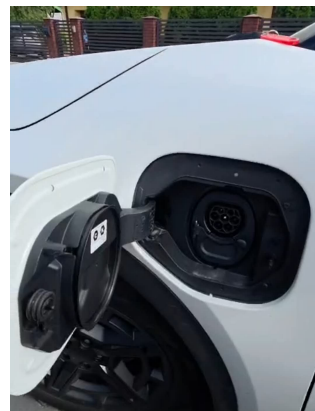
- The on-board charger of that vehicle failed. The vehicle was unresponsive and had to be restored by a mechanic.

The vehicle drew 19.1 A per phase on an installation with a 20 A main breaker and with a wall box rated 16 A. Any additional household load would trip the main breaker. The on-board charger of the three-phase vehicle has already failed.

Vehicle B – three-phase  
11 kW on-board charger
