Influence of soil liquefaction on the structural performance of bridges during earthquakes: Showa Bridge as a case study

International Journal of Engineering & Technology, 7 (4.20) (2018) 146-152

Influence of Soil Liquefaction on the Structural Performance of Bridges During Earthquakes: Showa Bridge as A Case Study

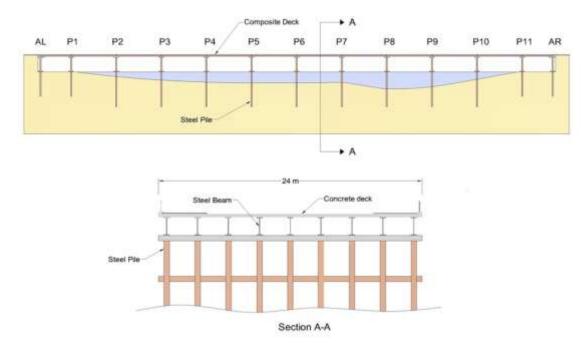
Fig. 2: Collapse of Showa Bridge [16]

In 1964, a 7.6 magnitude earthquakes stroke the city of Nagata, Japan. The earthquake led to catastrophic failures in the infrastructure including the Showa bridge, which was located about 55 km from the epicenter. A photograph of the failure is shown as Fig. 2, while a schematic of the failure is illustrated in Fig. 3. Both figures show that piers P_5 and P_6 have completely fell into the river. In addition, the movable ends (roller supported ends) of girders between piers $P_2 - P_3$ and $P_3 - P_4$ have dropped into the river, while the fix ends have remained on the top of the piers.

Although no consensus has been reached about the cause of the collapse, however, and based on the testimony of a reliable eyewitness, the bridge failed about 1-2 minutes after the earthquake, which rules out the collapse due to the inertia during the shaking of the earthquake [19,20]. Furthermore, preliminary site investigations have shown that the loose sandy soil beneath the bridge liquefied up to a depth of 10 m, which is the maximum depth for liquefaction to occur [6], see Fig 4. The figure shows that the liquefaction depth near the left bank was deeper than that near the right bank.

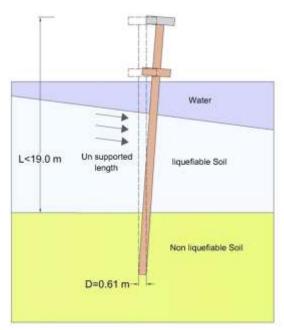
Fig. 5: Effect of lateral spreading during liquefaction.

As stated earlier, when soil liquefies, the particles float and lose contact with each other. And thus, for grounds with shallow slopes, the soil is expected to flow latterly downslope. In the case of Showa bridge, and given the concave shape of the river bed, reports from

literature have confirmed that the soil has spread latterly heading towards the center of the river, thus pushing the piles sideway and causing bending stresses. This failure hypothesis has been adopted by a number of researchers such as Fukuoka [16], Hamada and O'Rourke, [22] and Yasuda and Berrill [23] amongst others as the main failure mechanism.

However, and since the collapse occurred in piers P_5 and P_6 , which were located near the center of the bridge, where the lateral spreading is minimal, and didn't occur in piers near the abutment particularly P_2 and P_3 , where the lateral spreading is expected to be high. Thus, this hypothesis can be considered as inaccurate, still, it can explain the falling of girders between piers $P_2 - P_3$ and $P_3 - P_4$ into the river. Fig. 5 shows that the lateral pressure exerted by the soil might have bent the pile sideways, and since the girder is supported by a roller support from one side and restrained against horizontal movement by a hinge from the other side, the movement of the pier may have stripped the girder from its support. According to Fukuoka [16] it only takes a horizontal movement of around 30 cm to dislodge the girder from its support, see Fig.6. As for piers P_5 and P_6 , a different failure mechanism is proposed later
