# **FOUNDATION FAILURES AND REPAIR: HIGH-RISE AND HEAVY CONSTRUCTION**

DOV KAMINETZKY

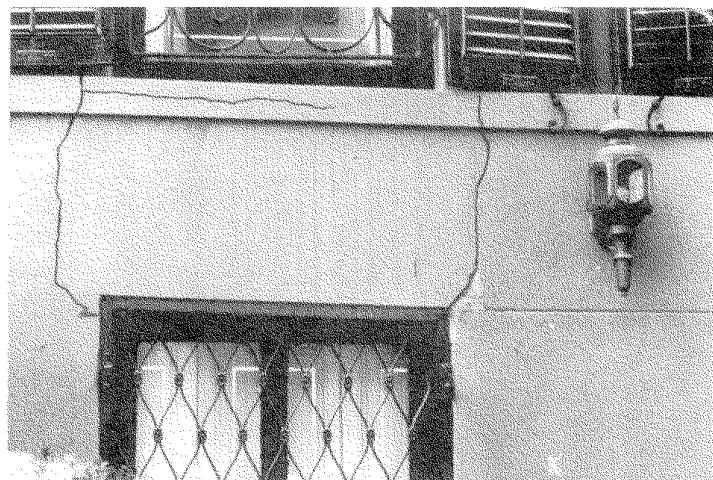
**FIGURE 7.5** Structural damage caused by adjacent excavation.

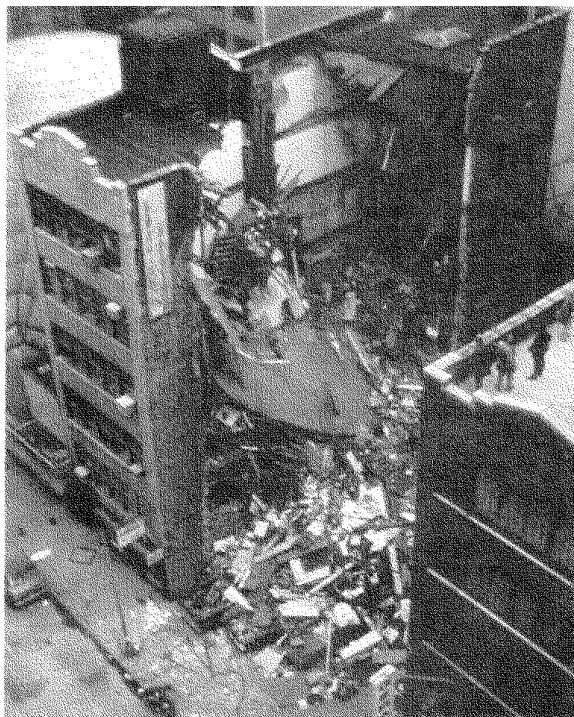
**FIGURE 7.6** Building collapse caused by adjacent excavation.

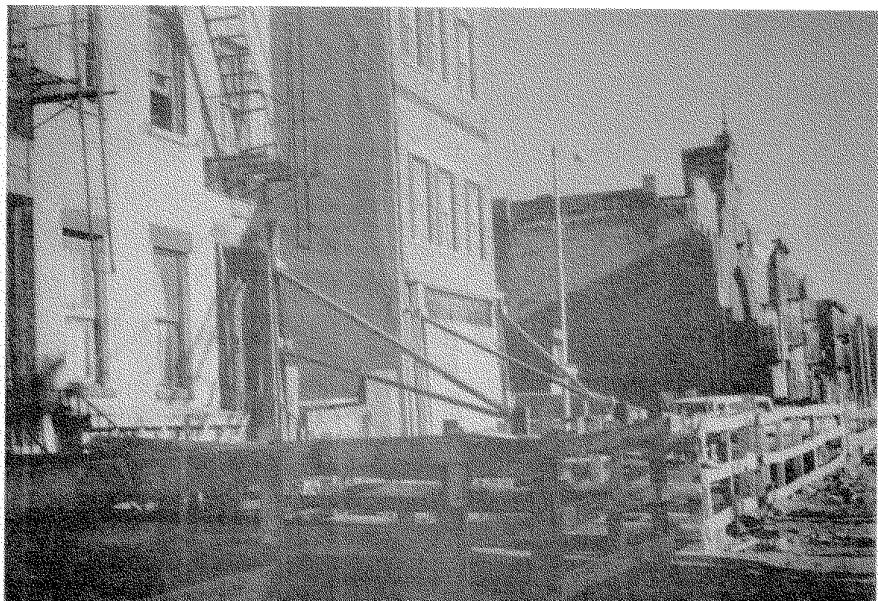
Construction for a new sewer main project in Brooklyn required the excavation of deep cuts adjacent to existing old residential buildings. The sewer lines were designed to run too close to existing footings. Not only were the new cuts within the influence lines of existing footings, but the contractor used vibratory pile drivers to install the piles. There was no monitoring of the vibration levels during pile driving. As a result, many nearby buildings settled, cracked, tilted, and shifted laterally. After the damage occurred, diagonal braces were added for lateral support (Figure 8.8).

**FIGURE 8.8** Bracing structures for lateral support.

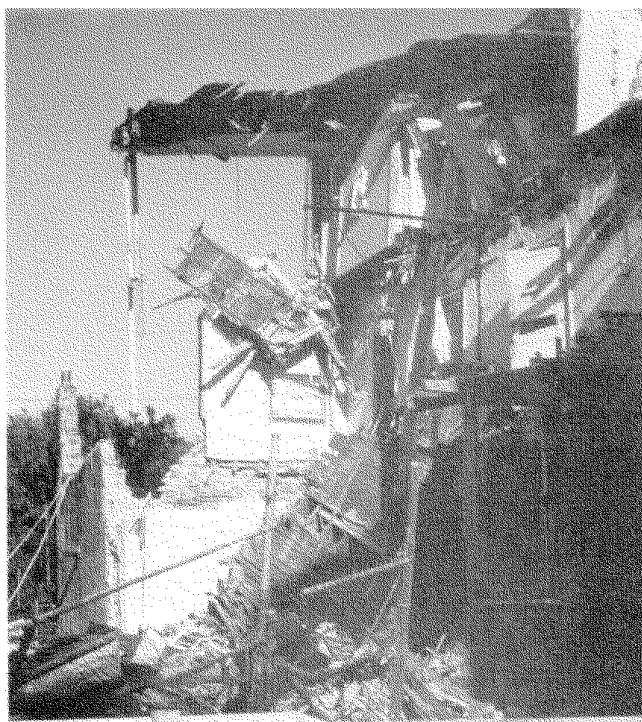
One building collapsed, killing one of the tenants (Figure 8.9). The investigation revealed that the building was constructed using timber footings, a construction method common at the turn of century. The footings were found to be in good condition but had been disturbed by the sewer activity. Once the excavation was within the influence line, vertical support was lost, causing footing set-

**FIGURE 8.9** Building collapse—ineffective bracing.

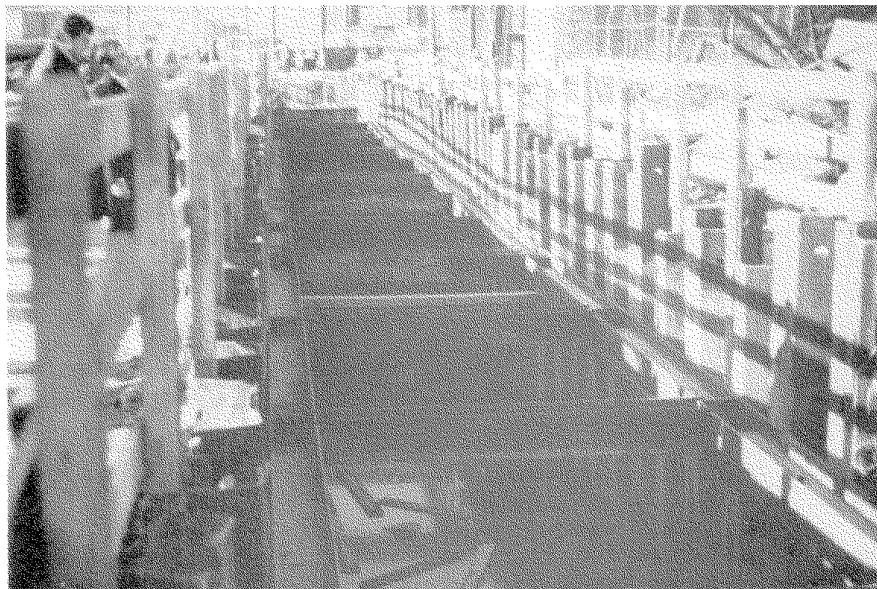
tlements. The high-grade steel bracing system (Figure 8.10) could not save this building, because soil support was lost *below* the footing level.

**FIGURE 8.10** Bracing excavation cut.

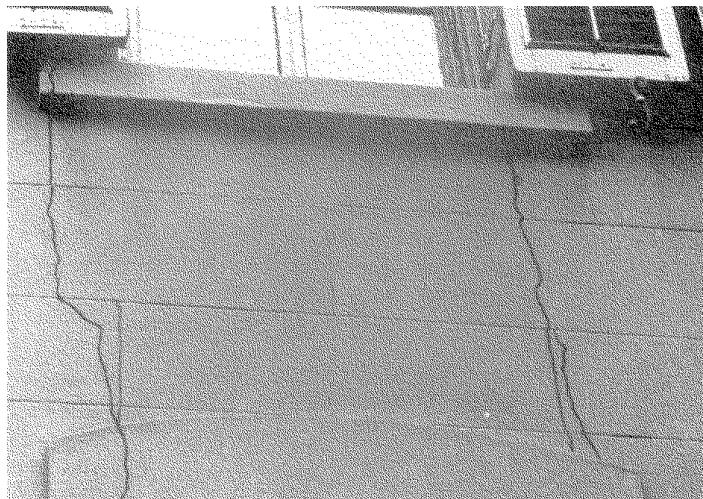
**FIGURE 8.18** Damage resulting from excavation.

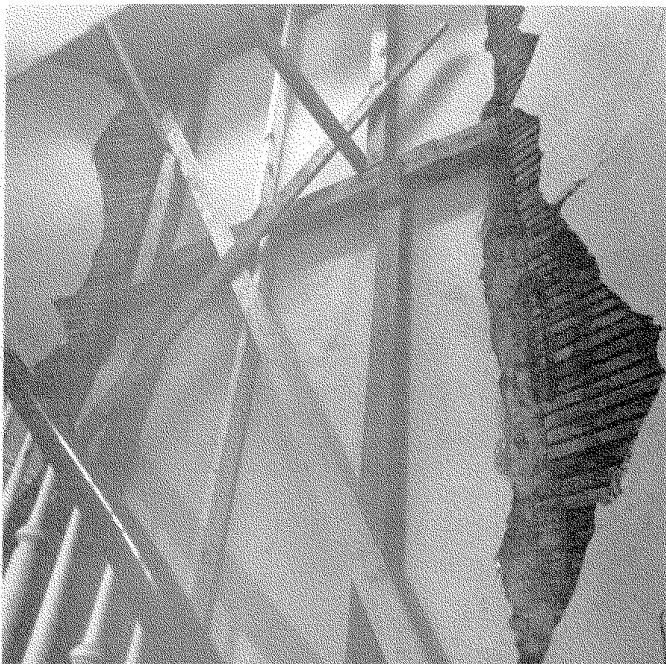
**FIGURE 8.19** Cracking of partition wall and settlement of stairs due to footing movement.

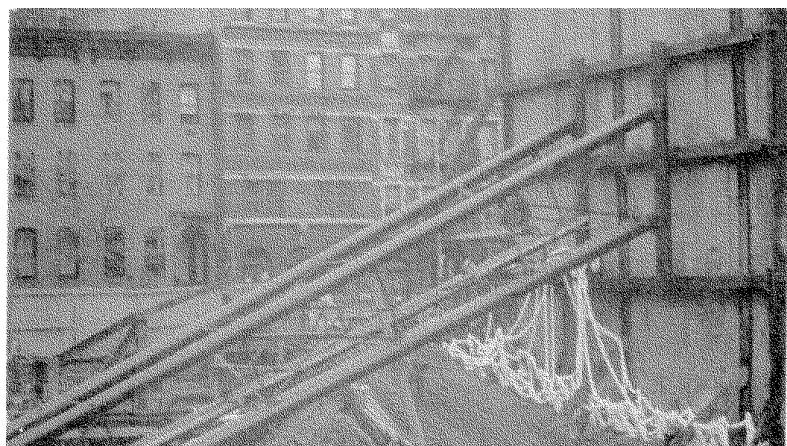
**FIGURE 8.22** Cross-view of Figure 8.21.

proved to be a total success, as practically all movements within the adjacent “ailing” structure stopped. Once the soil under the building was consolidated, the original conventional underpinning design was implemented. Just prior to freezing the soil, a cross-lot bracing system was installed (Figure 8.22). The purpose of this system was to eliminate any further movement in the building on the east and to stabilize it during the subsequent construction operations. The giant cross-lot braces that spanned the entire lot permitted construction to proceed without interruption. After completion of the underpinning, the adjacent buildings were restored.

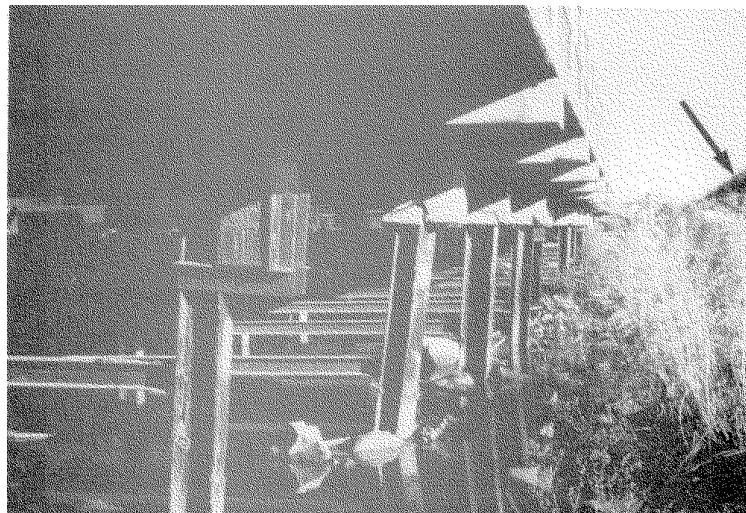
**FIGURE 8.27** Lateral soil shift causes pile failure.

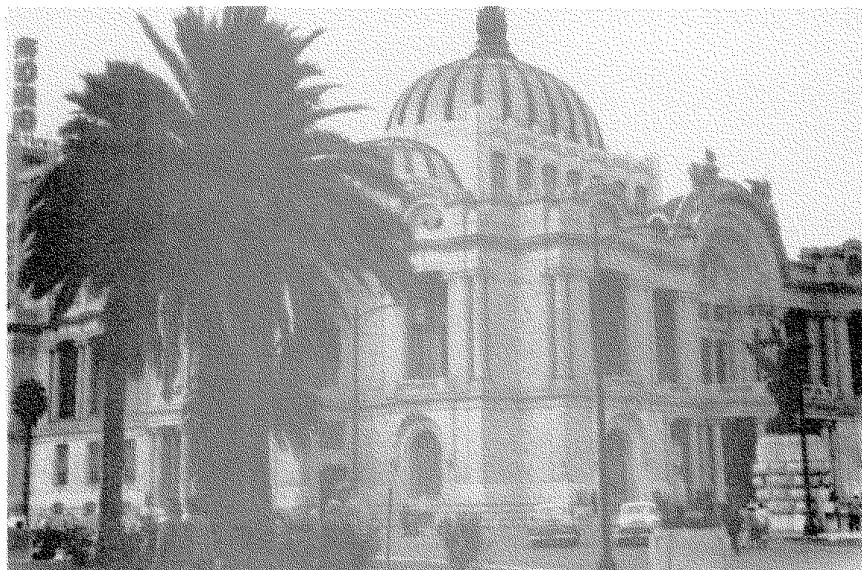
There are many classical examples of tilting buildings as a result of unequal settlements. The Tower of Pisa is probably the best known and researched example and is still in use, as is the Palace of Fine Arts in Mexico City (Figure 8.33) with its settlements measured in meters. The Guadalupe Shrine and Cathedral, also in Mexico City (Figure 8.34), is so distressed, cracked, and tilted that it makes visiting tourists nervous.

**FIGURE 8.33** Settlement of the Palace of Fine Arts, Mexico City.

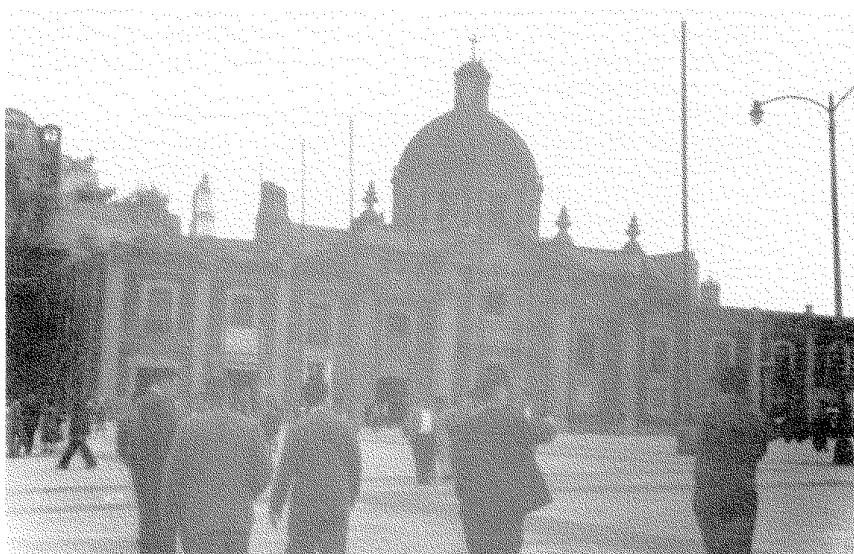
**FIGURE 8.34** Foundation failure of Guadalupe shrine.

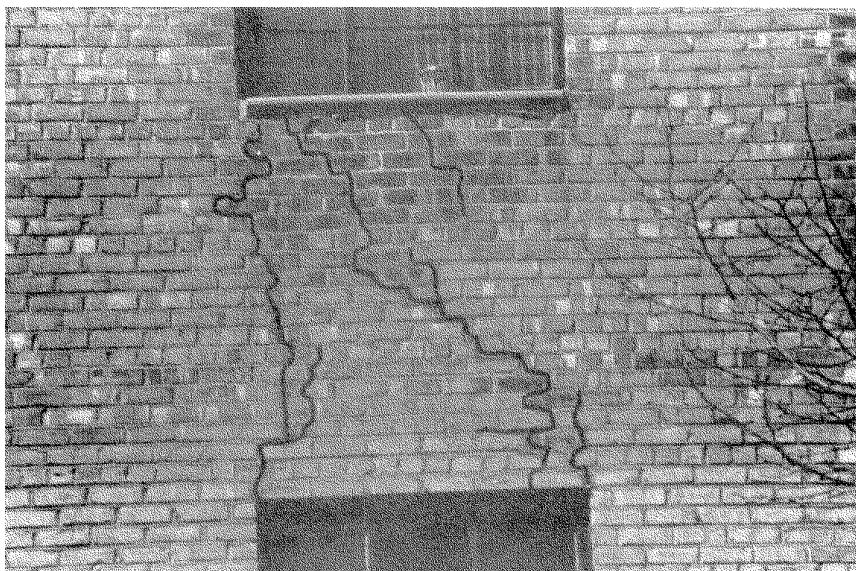
**FIGURE 8.37** Masonry cracks due to settlement.

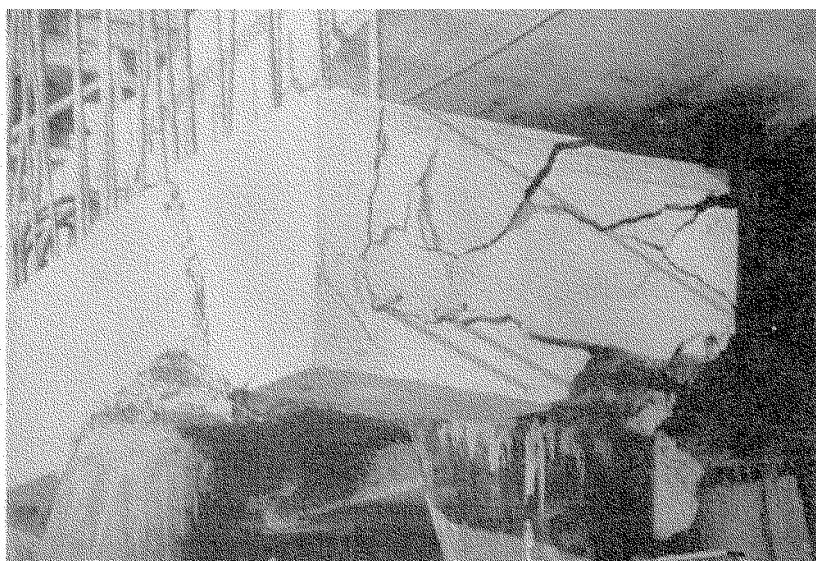
**FIGURE 8.48** Failure of concrete pile caps due to ice action.

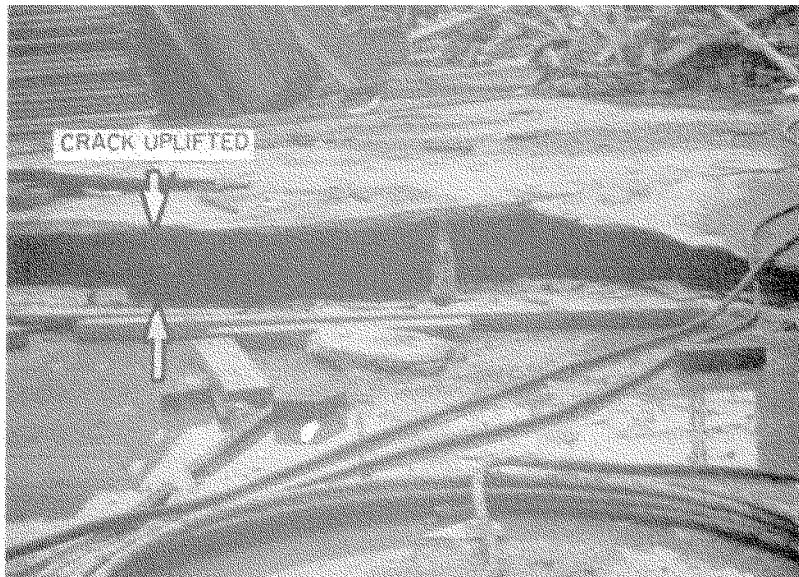
**FIGURE 8.50** Prestress loads cause slab uplift.

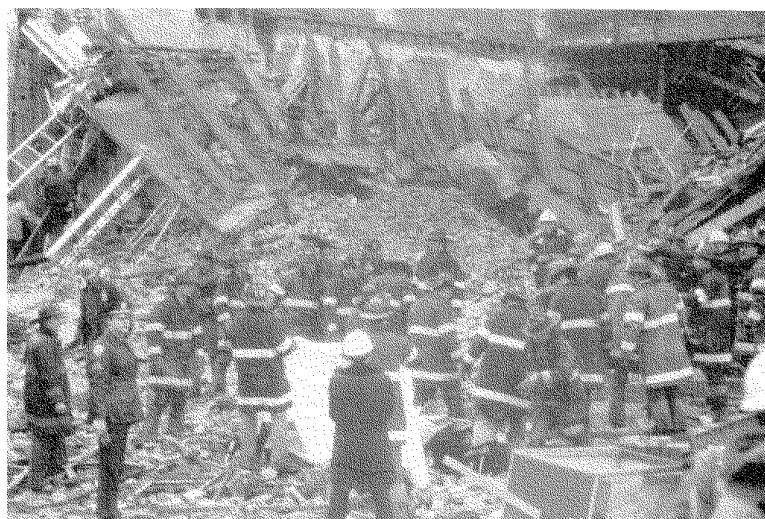
The structural analysis indicated that the bearing capacity of these footings was considerably reduced. Using the actual loads computed to be present at the time of collapse, we estimated that even using the optimum possible bearing capacity of these footings, they would have been loaded at 25% over ultimate capacity and had to fail. See Figures 8.57 and 8.58 for footing diagrams and load table.

FIGURE 8.55 Collapse of structure.

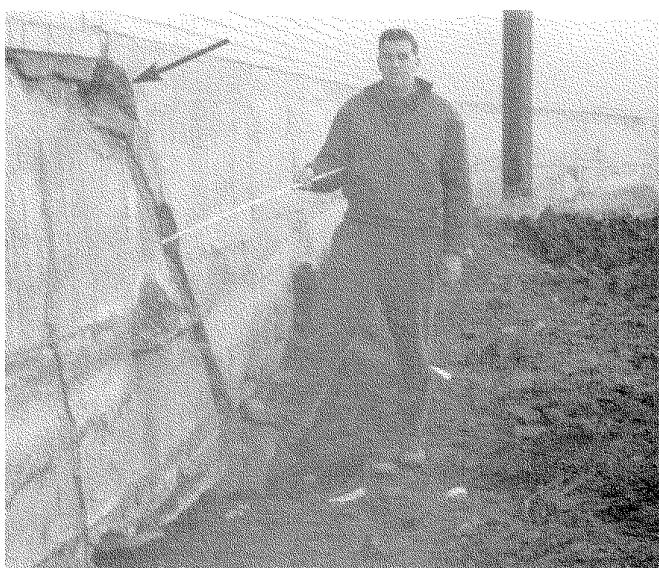
**FIGURE 8.65** Foundation wall failure during construction.

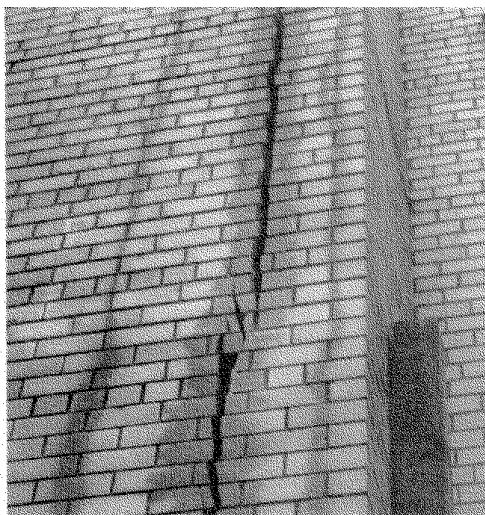
**FIGURE 8.66** Vertical stress crack, hospital.
