REPORT OF MARINE SURVEY

"ALMOST AWESOME"

Report file number: 08-0917-1Martin.

Manufacturer/ Year Built/Model Formula 2006 400 Super Sport, Thunderbird Products Decatur, IN.

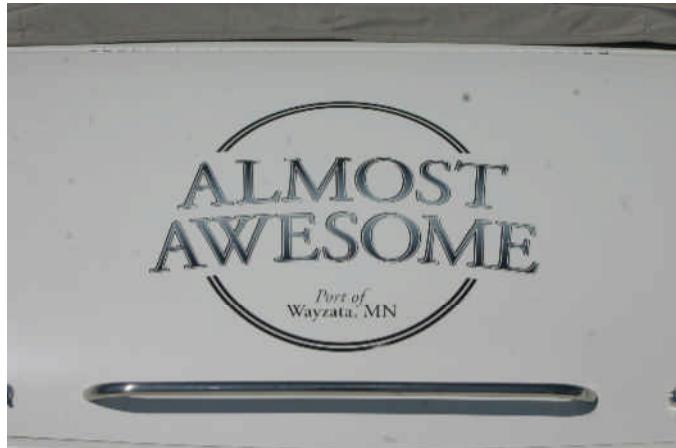
NOTE: USCG Documentation shows the name as "ALMOST AWESOME II" The name on the vessel transom does not match the USCG documentation name. Recommendation change name or documentation to match. USCG CFR 46.67.117.

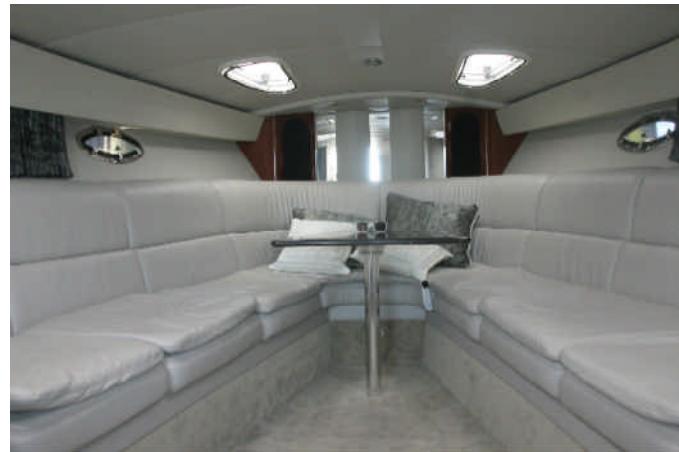
MAIN SALON

Headliner: White padded vinyl. No tears, splits or stains sighted. Excellent condition.

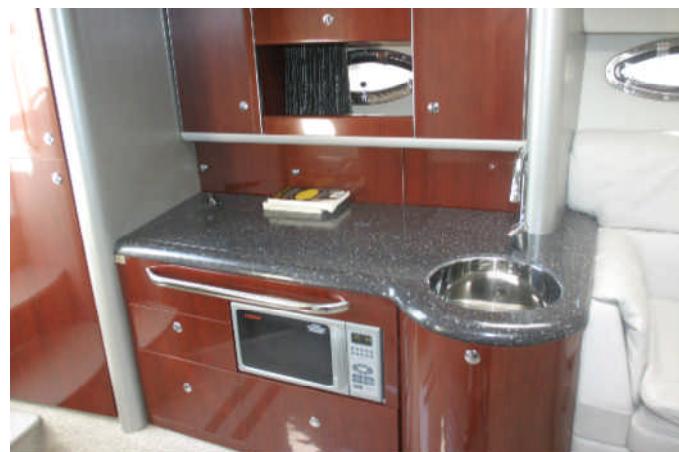
GALLEY

Stove: Kenyon, single burner, with Ceramic glass cooktop, Burners tested and are functional. Power indicator lights are functional. Safety switch functional.

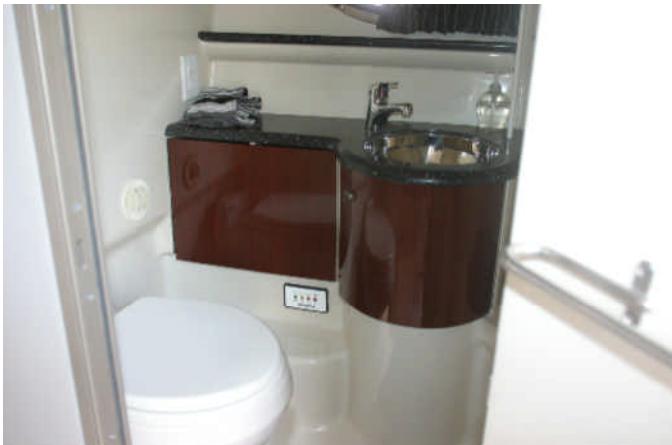
HEAD(S)

Number/Location: One, Starboard side, Midships.

Toilet(s): VacuFlush system, Powers up.

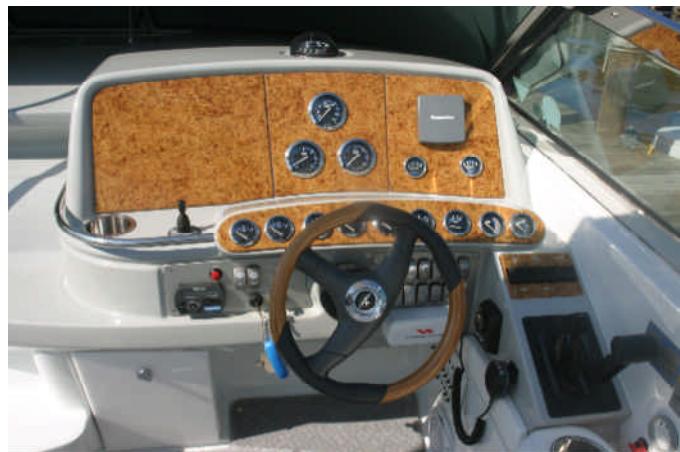
Compass(es): Ritchie, Appears functional.

VHF radio(s): Standard Horizon Quest+ at helm, Serial number was not sighted, unit is built in. Powers up.

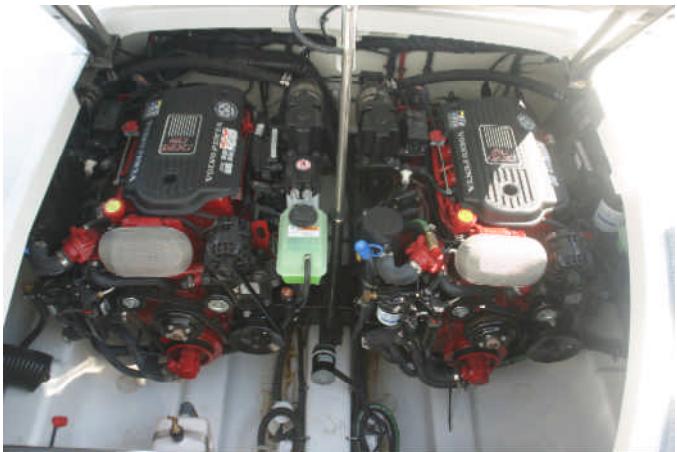
MAIN ENGINE(S)

**Hoses and
clamps:** Good condition-No cracks sighted.

**Exhaust
manifold:** Good condition - no exterior rust sighted, no exterior creaks noted.

Condition summary: The service dates are unknown. Good condition.

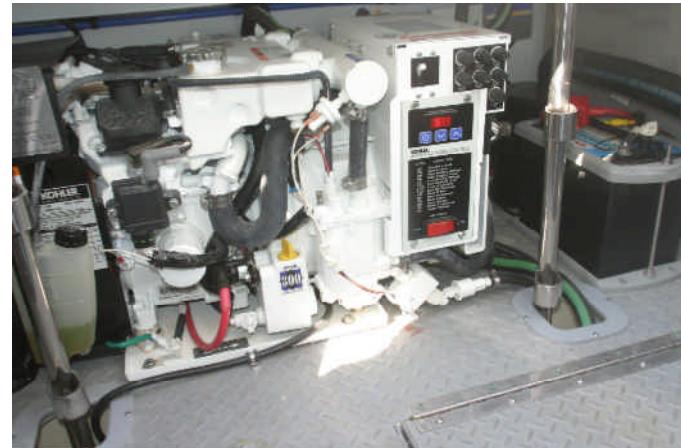
GENERATOR

Condition summary: Excellent condition.
