Bharti MS-Safety Alert Fall from Height (Sep 2020)

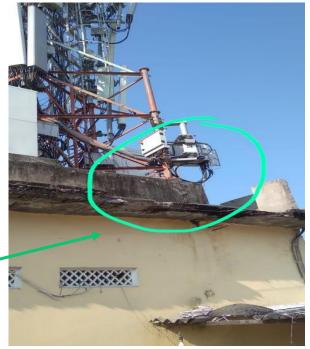
Approx. position of FME before fall

On 3rd September, Ericsson FME was working on 2nd floor RTT site in Banaras, India. FME Visited along with Rigger to attend the Customer complaint at RTT site. During inspection of GSM antenna, FME leg slipped and fell from 2nd Floor to First Floor as there was no Parapet wall/Barrier on the 2nd floor in one side of the roof and FME was not using any fall protection method near unprotected edge of the roof.

- FME failure to undertake assessment of conditions when working on buildings and rooftops
- FME failure to carry out a constant assessment of safe work activity during the work
- Working at height without safety restraint
- Free climbing and ignore protection against falling from height
- No barrier/parapet at outside edge of the Tower

- 1. Never stand on fragile surface (e.g. breakable surface ,asbestos sheets, gypsum board or on sloping roof top.
- 2. Never work close to a roof edge (within 2 meters) without anchorage points and a harness to ensure the risk of a fall is eliminated.

- 3. Job Safety Analysis must include how to safely position, if working on the rooftop structure and away from the roof edge.,
- 4. All RTT sites to be audited for Parapet wall availability and other safety measures
