# WOMEN'S SAFETY AUDIT OF TONDIARPET

## FINAL REPORT

*Prepared by Safetipin*

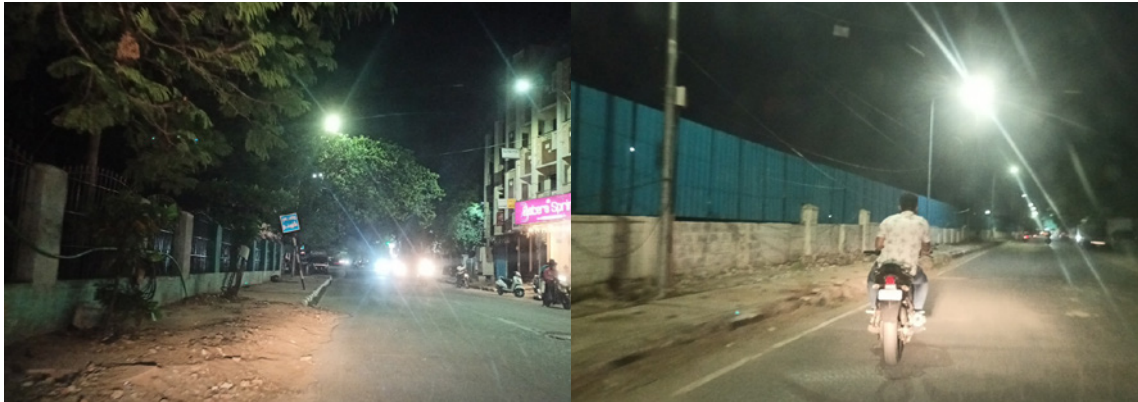
GEO-LOCATED IMAGES

Safetipin identified three types of footpath conditions which mar pedestrian walking experience and cause distress among pedestrians while navigating the streets, especially the vulnerable users. These conditions are namely, one, having no dedicated walking space on the streets, two, having no built footpath, and three, having broken, partly unpaved, discontinuous walking surface on footpaths. We mapped all of the above conditions wherever found in the area and geo-located the information on GIS layers. The composite map below represents all the non-functional footpaths as found on the streets and highlights the intensity of the issue in a large area in the middle of Tondiarpet.

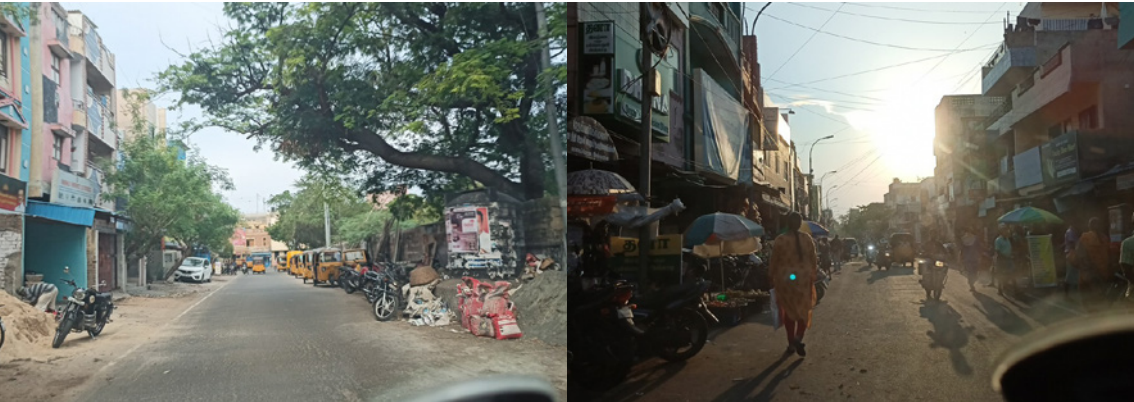
Safetipin identified five types of physical barriers disrupting clear walking space for pedestrians, especially the vulnerable users. These are namely parked vehicles, shop/house extensions, temporary stalls/ vendors, electricity/signage poles, and lastly dumped garbage/construction material. We mapped all of the above when found on footpaths and geo-located the information on GIS layers. The composite map below represents all barriers types found on footpaths and highlights the intensity of the issue. The total number of locations where these obstructions are found are indicated in the legend.

GEO-LOCATED IMAGES  
*Left to right*  
The geo-tagged photos show obstructions on footpaths

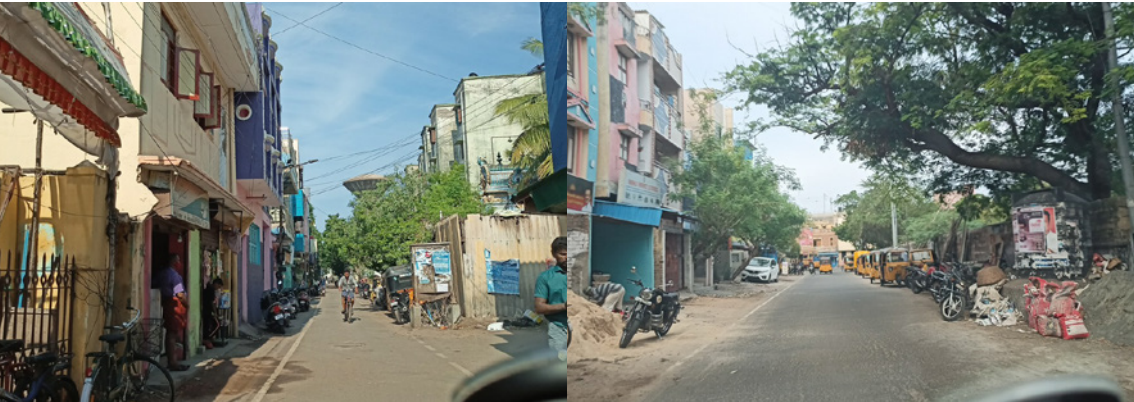
Safetipin identified 544 locations within Tondiarpet where vehicles are parked on footpaths, disrupting clear walking space for pedestrians, especially the vulnerable users. These are mainly two wheelers, four wheelers, small delivery vehicles, auto rickshaws, carts and cycles. We mapped these when found parked on footpaths and geo-located the information on GIS layers. The composite map below represents all locations with parked vehicles and highlights the intensity of the issue. It is found that majority of the footpaths were either occupied by obstructions or did not have a good, at grade, walking surface.

GEO-LOCATED IMAGES  
*Left to right*  
The geo-tagged photos show parked vehicles on footpaths
