# EUREKA DFM

Design for Manufacturability Analysis

Part ID: Unknown  
Date: 2026-06-14 01:08

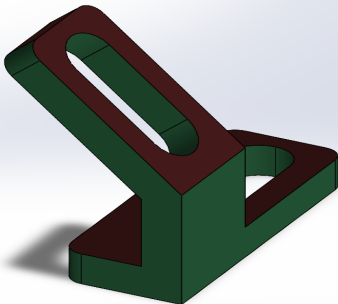
The CAD viewport screenshot on the left shows the model with real-time face highlights indicating DFM risk areas:

- **RED**: Critical violations (wall thickness or corner fillet radius below limit).
- **ORANGE**: GNN high geometric anomaly risk zones.
- **YELLOW**: Warnings / Informational regions (insufficient draft, GDT control).

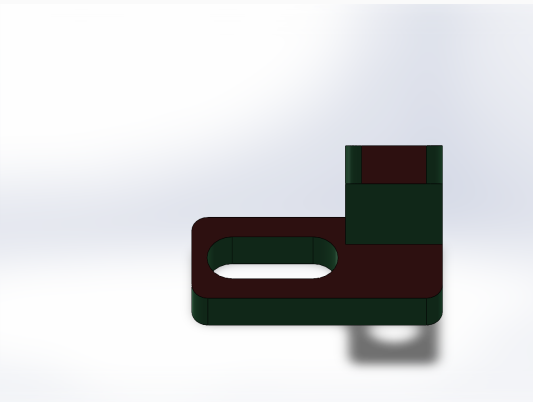
Face: 2 · Plane · 8.0 mm²

### [Severity.CRITICAL] INJ-UNDERCUT-001

**Description:** Face 2 is undercut -- normal opposes pull direction by 135.0deg. Requires side-action or redesign.

**Measured:** 135.0deg from pull  
**Required:** <=90deg (no undercut)

*Face 2 is undercut -- normal opposes pull direction by 135.0deg. Requires side-action or redesign.*

**Fix:** Redesign face to align within 90deg of pull direction, or add a side-action/lifter to the mould tool.

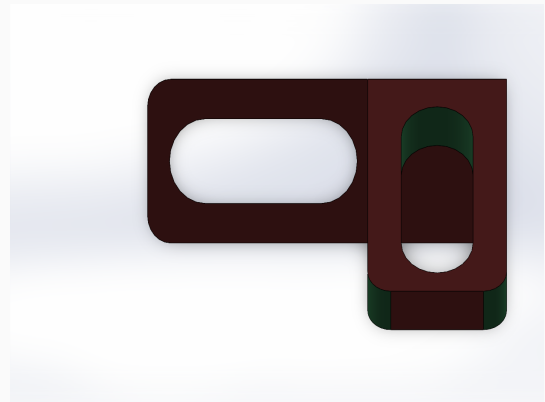
Face: 11 · Plane · 57.3 mm<sup>2</sup>

**[Severity.CRITICAL] INJ-UNDERCUT-001**

**Description:** Face 11 is undercut -- normal opposes pull direction by 180.0deg. Requires side-action or redesign.

**Measured:** 180.0deg from pull

*Face 11 is undercut -- normal opposes pull direction by 180.0deg.  
Requires side-action or redesign.*

**Fix:** Redesign face to align within 90deg of pull direction, or add a side-action/lifter to the mould tool.

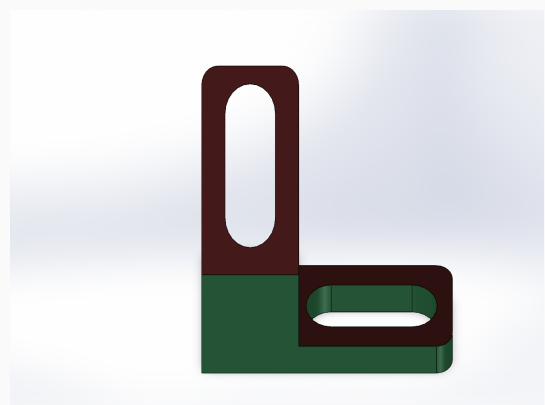
Face: 15 · Plane · 40.8 mm<sup>2</sup>

**[Severity.CRITICAL] INJ-UNDERCUT-001**

**Description:** Face 15 is undercut -- normal opposes pull direction by 135.0deg. Requires side-action or redesign.

**Measured:** 135.0deg from pull

*Face 15 is undercut -- normal opposes pull direction by 135.0deg.  
Requires side-action or redesign.*

**Fix:** Redesign face to align within 90deg of pull direction, or add a side-action/lifter to the mould tool.
