Insulating Concrete Forms as a Blast Resistant Building Material

Force Protection Equipment Demonstration May 6, 7 & 8, 2003 Quantico Marine Corps Base

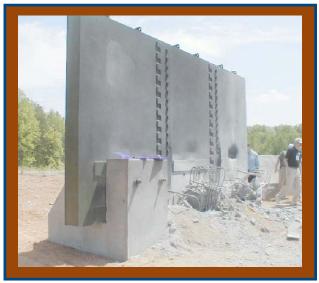
Image 3 - Location of explosive charges

Image 3 – Since the TNT charge decimated the concrete bolster on which it was sitting, the TNT charge was placed on a different bolster each day. This photograph was taken after the second day. The bolster to be used on the third day can be seen in the foreground. (The charge will be placed where the blue folder in the photograph is located.) The remnants of the bolsters used on the first and second day can be seen along the center and right side of the wall. The rebar in the bolsters is #7. Damage to the blast wall itself can also be observed behind the sites of the first and second charges.
