Vehicle Condition Report

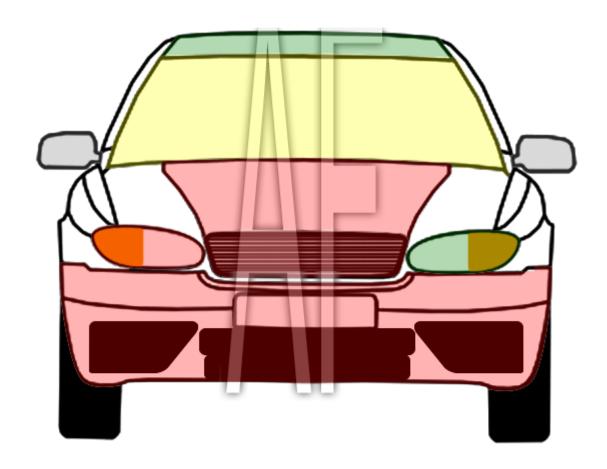
Front side

Roof Condition: Seems OK

Windshield Condition: Minor damage

Hood Condition: Major damage

Grill Condition: Major damage

Front Bumper Condition: Major damage

Right Mirror Condition: Not visible

Left Mirror Condition: Not visible

Front Right Light Condition: Major damage

Front Left Light Condition: Seems OK
