## Pre-Purchase Inspection Report

Audi Tt  
Verified by

**Date**  
2025-03-19
-

**VIN Number**  
XXXXXXXXXXXXXXXXXXXX

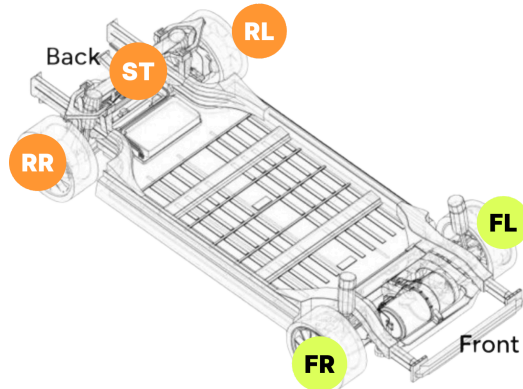
#### ⚠ Rear Right (RR)

Tyre Manufacturer:  
**Nexen Nfera**

Dry cracks  
Worn out

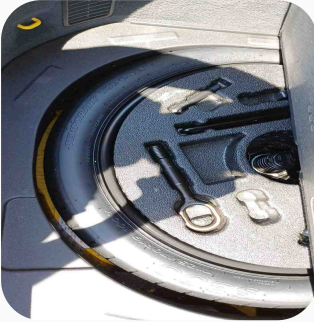
#### ⚠ Spare tyre (ST)

Tyre Manufacturer:  
**Nexen**

Manufacturing Date:  
**03-2016**

Tyre Size:  
**T125/70R19**

Dry cracks

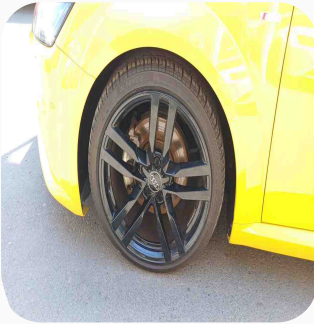
⚠ Rear Left (RL)

Surface Damage

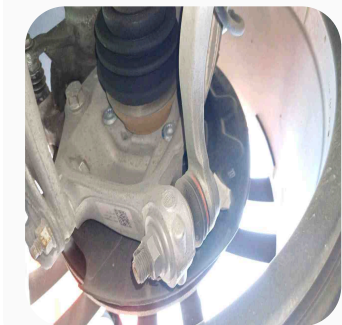
✔ Front Left (FL)

⚠ **DISC**

Need skimming

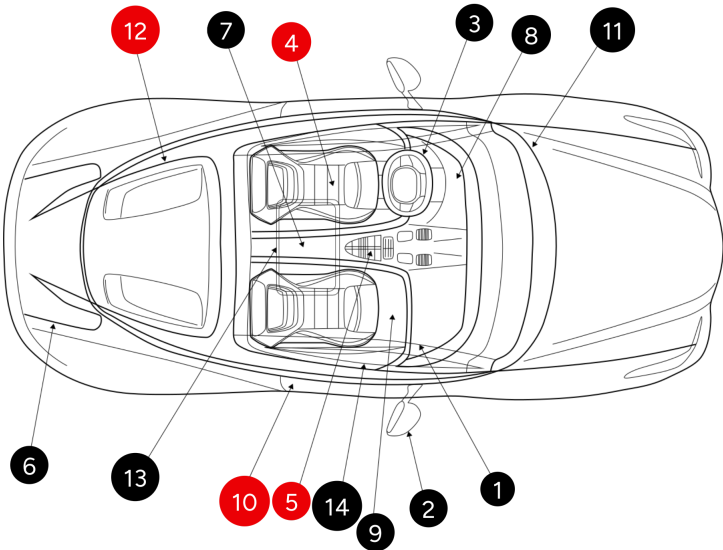
Buttons wear and tear

Wear and tear on driver seat.

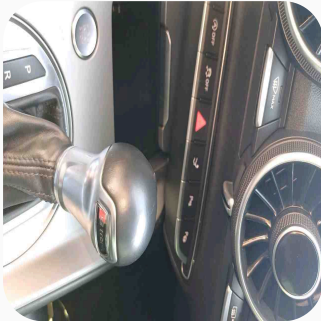
**⚠ (Gear Lever)**

Scratches

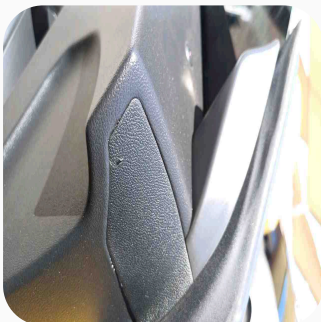
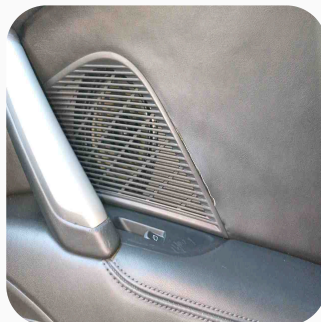
**⚠ (Doors)**

**Damage**

scratches

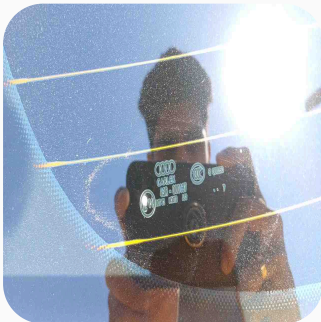
**⚠ (Rear Windscreen)**

**Replaced**

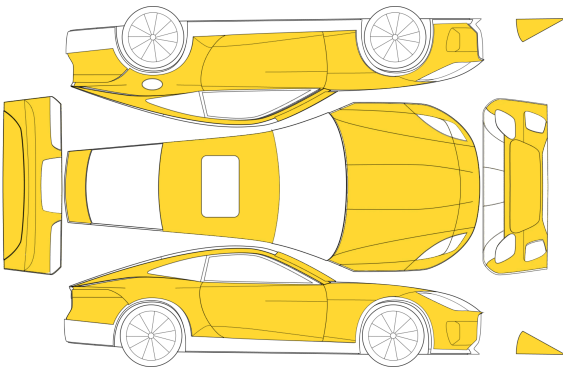
Cosmetic paint found on vehicle body. Silicone stains found on front bumper & head lights. Oil leak detected from multiple places. Suspension faults detected. Number plate light defective warning light showing on instrument cluster. Dirt & water scaling found on engine Bay and Undercarriage. Several error codes were found in diagnosis reports.

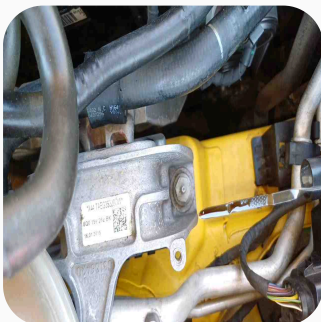
## ⚠ Engine Oil Condition

**Oil is black, needs to be replaced** - Engine Oil Condition Faulty. It is highly recommended to do a major service on the vehicle when buying a used car that doesn't have service history and warranty. Labor Cost: Medium
