**Study of Long Span Bridge Design  
Based on Long Term Maintenance  
in Developing Countries**

A Thesis submitted to the Faculty of Engineering of Kyoto University  
in partial fulfillment of the requirements for  
the Degree of Doctor of Engineering

Tsuyoshi Matsumoto

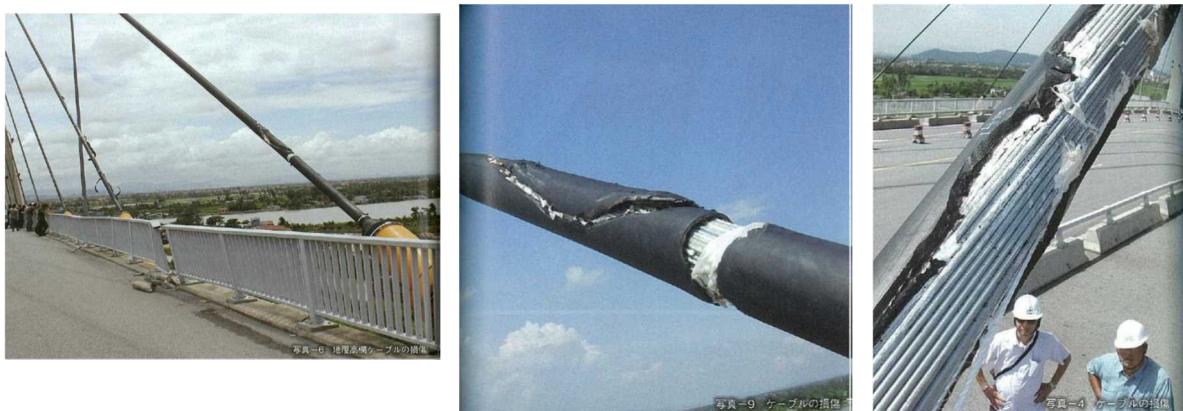
Photo 2.13 Cable damages<sup>20)</sup>

The two damaged cables were replaced as a result of the investigation and consideration. The accident occurred on July 17<sup>th</sup> 2010 and the repair work began in May 2012 and ended in December 2012. On the two damaged cables, no wire breakage was confirmed and there should have been no reduction of the strength. The scratches were only on the surface layer wires and the inside wires were without scratches. However, the surface scratches and the surface corrosion might influence the fatigue strength. The durability of the cables directly affects the durability of the whole cable-stayed bridge so that it was suggested to the Vietnamese side that the damage of the cables needed to be treated immediately and a proper counter measures were needed. The white rust were confirmed on the wire surfaces which were exposed to the outside due to the breakage of PE tube covers and the rain water. It was feared some rain water stayed at the bottom of the cable. The zinc layer (more than 300g/m<sup>2</sup>) of the galvanized wire could disappear easily if it was left untreated. If the zinc layer would be lost, the wire would be corroded consequently and the fatigue strength could be lowered. The correct evaluation of the cable durability was difficult to predict and the long term cable durability could not be assured so that the cable replacement was suggested and the Vietnamese side accepted the suggestion. Then two damaged cables were replaced by two new cables. The cable replacement due to the accident might be a rare case in the world.

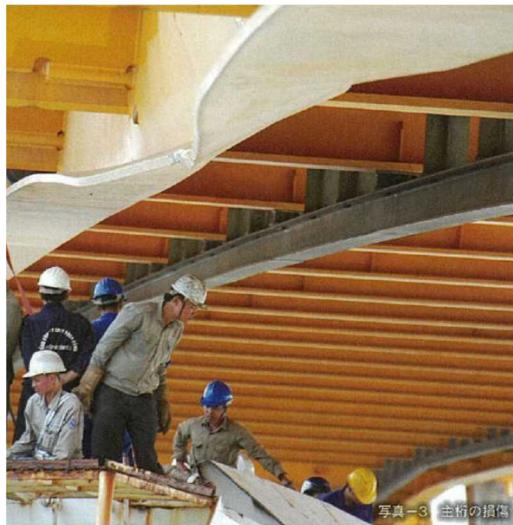
Photo 2.14 Girder damages<sup>20)</sup>

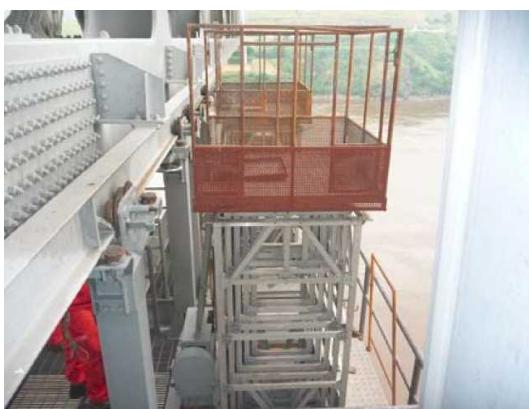
Photo 3.3 Elevating Platform on Inspection Vehicle

The last problem is about the elevating platforms placed on both ends of the under girder inspection vehicle. (Photo 3.3) According to OEBK, this platform can be elevated but cannot be stopped properly and sometimes the platform slips downward. As these platforms are too old and exceed the service life, it is decided to replace them by new equivalent ones.

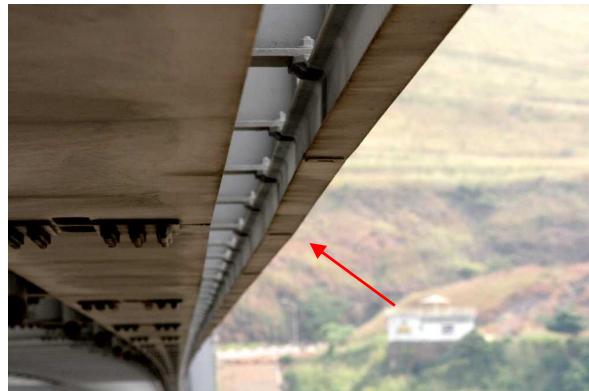
Photo 3.13 Rail bent

shown in Photo 3.9. As this work becomes much safer with the side span inspection vehicles, OEBK strongly requests the installation of vehicles on the side spans. Another problem of the center span inspection vehicles is as follows; One inspection vehicle is supported by four pillars hung from the rails fixed on the truss girder. (Photo 3.2 & 3.10) Between pillars and rails, hand driving gears are installed and the vehicle can be moved manually. Moving the vehicle requires considerable labor, as shown in Photo 3.11. Some driving gears are already broken after about 30 years of service (Photo 3.12). Therefore these driving gears need to be replaced by new ones. Another problem is that as the rail is not straight (Photo 3.13), wheels of driving gears sometimes

From the above experiences, the feedback for the design is as follows; If a girder is too high from the ground, the under girder inspection vehicle is needed. A small rail bent shown in Photo 3.13 is to some extent inevitable so that the adoption of the both sided manual driving gears are recommended. The rail level differences should be erased from the beginning when the manual driving inspection vehicles are adopted.

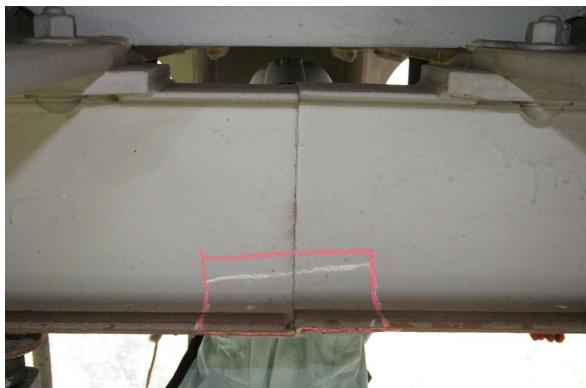
Photo 3.16 Rail level difference

Another problem is the level difference of the rails as shown in Photo 3.16. The difference is small and about 2mm or less. If the vehicles are electrified, this difference is not a problem. But the vehicle is manually driven, sometimes it is stopped at this difference. Then technicians drive back the vehicle and try to pass through the difference with the momentum. There are at least three places of this difference. Then it is decided to grind the surface to erase the difference.

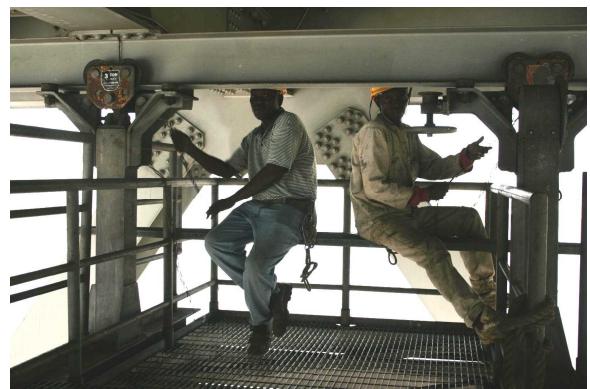
Photo 3.19 Driving vehicle by chains

On the side spans, there is 1% longitudinal gradient as shown in Fig.3.3. When the inside girder inspection vehicle climbs this 1% slope, technicians utilize the chains to rotate the driving wheels and this is a laborious work. (Photo 3.19) But when the vehicle descends down this 1% slope, technicians push forward the vehicle by

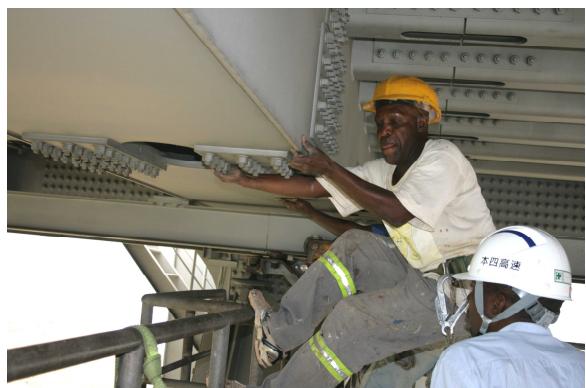
Photo 3.20 Pushing vehicle

holding the steel truss members. (Photo 3.20) It is much faster and easier to push the vehicle by this manner than to rotate the driving wheels by chains, because of the gravity. When engineers and technicians of OEBK inspect the bridge by this vehicle from the tower to the anchorage direction and the work ending time comes, they stop the vehicle near the anchorage, extend the vehicle floor to its maximum and climb up to the bridge deck level as shown in Photo 3.21 with the help of the connection piece of the truss chord and their safety belts. This is because it is too laborious to drive back the vehicle to the tower position, where there is a ladder. As this may be a dangerous practice, it was proposed to install a new ladder near the anchorage, which is the same type of ladder shown in Photo 3.22. At the center span, there are three ladders at every quarter span length, i.e. 1/4 point, 1/2 point and 3/4 point<sup>2)</sup>.

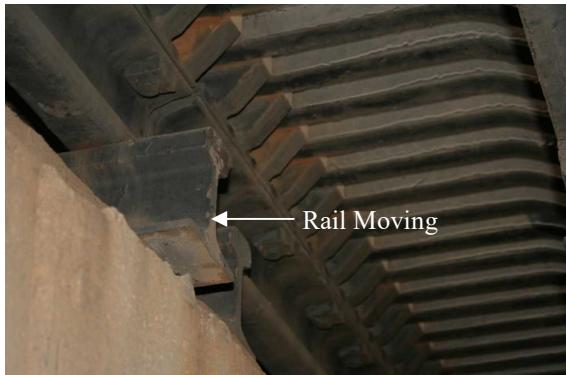
Photo 3.24 Rail Moving of Expansion Joint

The finger expansion joints are installed between the anchorages and the ends of the truss girder. Under the expansion joint, there are several supporting rails. One problem is that some supporting rails are moving out regularly so that OEBK is continuously monitoring these rails and pushes back these rails. (Photo 3.24) To monitor and to push back rails, a scaffolding is indispensable. They manage to reach the place directly under the expansion joint from the inside girder inspection vehicle. The permanent scaffolding is needed. The rails are fixed on the abutment with the structure shown in Fig.3.9. The rubber plates under the rails have deteriorated and the rails may not be fixed firmly. This may be the reason why the rails keep moving out. As it is not easy to change the structure to fix the rails more firmly and OEBK always inspects the condition and pushes back the rails regularly, there are no serious problems so far. Therefore it is judged sufficient to add the scaffolding only.

When the permanent scaffolding under the expansion joint was installed, the concrete surface of the anchorage, on which the scaffolding was planned to be installed, was inspected. The rock pockets and the repaired surfaces were found and it was judged not to install the permanent scaffolding on this surface. Then it was judged that it was better to install a temporary scaffolding with the steel pipes, which could last for a considerably long time.

As the expansion joint is one of the most important parts which need to be inspected regularly, there should be some device to facilitate the inspection from the beginning. One of the method may be to extend the rails of the inside girder inspection vehicles slightly beyond the truss girder end. The rails are shown in Photos 3.17 and 3.19. The rails needs to be extended slightly to avoid the collision against the anchorage surface. By this extension, the inside girder inspection vehicle can move slightly closer to the anchorage and the expansion joint would have been inspected more easily.

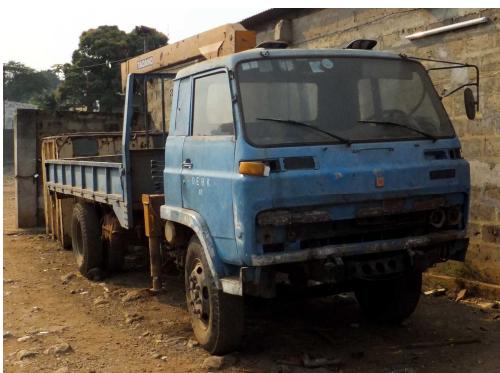
Photo 3.25 4t Truck with Crane

OEBK had one 4t truck with crane, one aerial working platform truck, one 10t truck crane and one backhoe loader. 4t Truck is shown in Photo 3.25. This truck had run already 1,130,000km (far more than 100,000km) and was worn out. This needed to be renewed. The aerial working platform truck is shown in Photo 3.26. This had a performance of 200kg×24m. This truck was used for the exchange of the electric bulbs of lighting poles and the inspection of the main cables. This truck had run more than 730,000 km. The platform could be extended but it could not be rotated because of the malfunction. This truck also needed to be replaced by an equivalent machine.

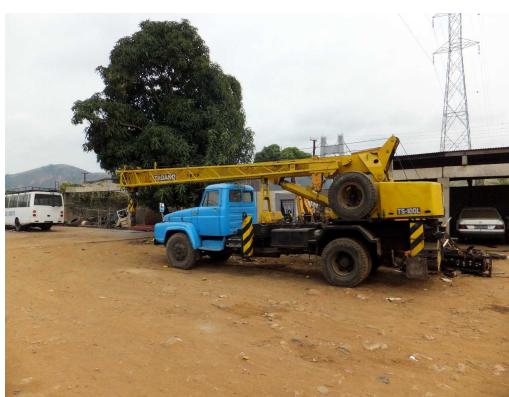
Photo 3.27 10t Truck Crane

The 10t truck crane is shown in Photo 3.27. This is a large truck crane and used for the time of the construction. Therefore for the maintenance activities, this size of large truck crane might not be needed. OEBK used this truck crane to load the cable inspection vehicles on the cables. The outriggers of this crane did not work properly due to the deterioration.

As it was decided not to replace 10t truck crane and this 10t truck crane was no longer reliable due to the deterioration, the size of the truck with crane which could load the cable inspection vehicles on the cables needed to be decided. The loading of the cable inspection vehicles was investigated. At first, it was thought that the loading of vehicles on the cable was easy at the center of the center span or near the anchorages where the cables were the lowest. But the situation was a little complicated because there were lighting poles just beside the main cables and the inspection vehicles could not pass these poles. The situation is shown in Photo 3.29. The lighting pole is quite close to the main cable, the inspection vehicles needed to be placed beyond this pole. The pole is 8.0m high. As shown in Photo 3.30, the vehicle needed to be placed where the hand rope height was about 11.1m. The height and the weight of the vehicle manufactured in Japan is about 2.5m and 332kg respectively from the document of the construction. The height of the vehicle manufactured by OEBK is slightly higher and assumed to be about 3.0m. The weight can be assumed to be 350kg. From these data, the necessary capacity was as follows;

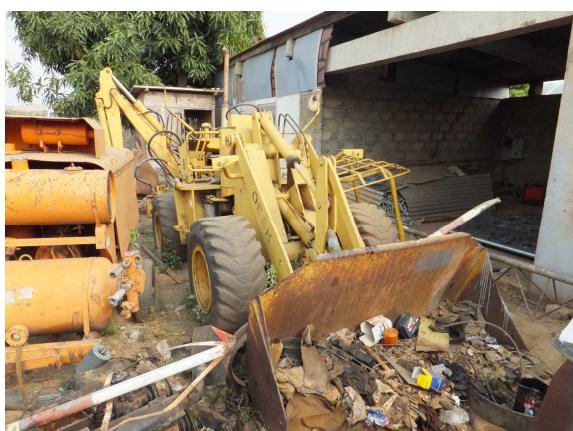
Photo 3.28 Backhoe Loader

The backhoe loader is shown in Photo 3.28. This loader was used for the maintenance of road sections. When this Photo 3.28 was taken, this machine was out of order because of the deterioration of the hydraulic packings. But later this machine was repaired by OEBK and they utilized this machine. This machine is very useful for the maintenance of earthwork sections. But this might not be needed for the maintenance of bridge proper and it was decided not to renew. This is a product of Japanese company. In Kinshasa there is a branch of one European Company which deals with the products of this company. There are many kinds of metal mines in DRC and many products of this company are utilized in DRC. According to this branch, they maintain even older machines than the backhoe loader of OEBK and they could repair the backhoe loader to the complete condition. This information was transmitted to OEBK and OEBK could repair the backhoe loader completely if they so wished.

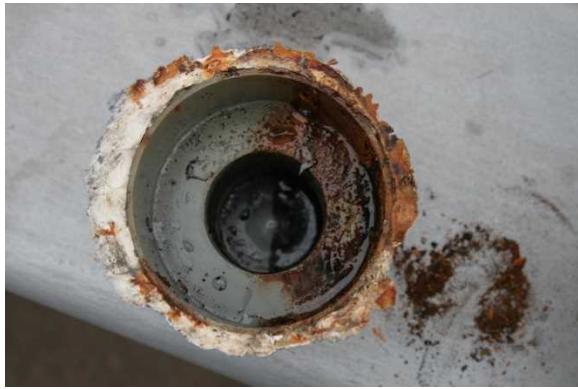
However, some paint cracks were found. According to the investigation of the data given by OEBK, it was found that the adopted paint was not flexible paint. On the other hand, flexible polyurethane paint or flexible fluoro resin paint is adopted for a dry air injection system in Japan because they can prevent air leaking. If it is judged necessary to install a dry air injection system to the Matadi Bridge, the removal of the old paint and the repaint of the cable surface by the flexible paint to prevent air leaking, must be carried out beforehand. The calculated main cable surface area except cable bands is about 1000m<sup>2</sup>, which is needed to calculate the amount of painting materials. One of the cracks is shown in Photo 4.1. One of the other problems was the missing caps of cable band bolts. The inside of the caps of many suspension bridges in Japan is threaded to prevent falling-off and at the same time to make the bands airtight. However, the caps of this bridge were not threaded so that some were missing. Also, some caps were damaged (Photo 4.2 & 4.3). If it is necessary to install a dry air injection system, then all of the caps need to be replaced by the threaded caps.

Photo 4.2 Inside of cap is not threaded

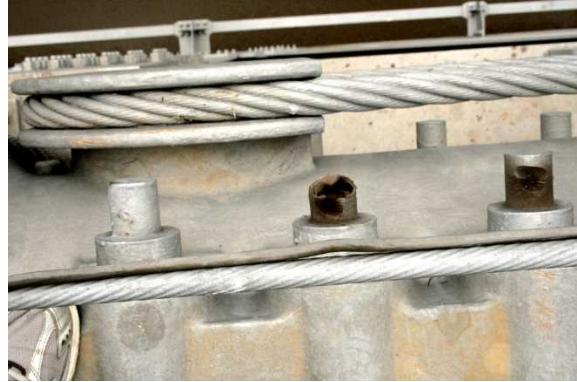
Photo 4.3 Damaged cap (Center)

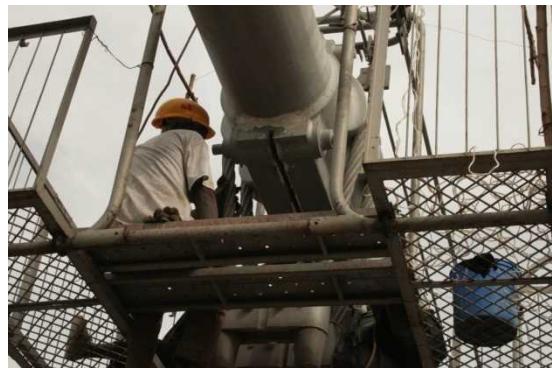
During the inspection, the retaining water at two cable bands was detected by OEBK. The fact that there were no other cable bands which contained water, was also confirmed by OEBK. One cable band was on the upstream cable and was the fifth cable band counted from the center band to Boma (a name of town, refer to Fig.4.1 and 4.9.) direction (Photo 4.4). Near the bottom of this band, there was a swollen point on the cable surface, when this swollen paint surface was opened, water drops came out. After a few days, the water marks on the deck turned to brown as shown in Photo 4.5, which showed the evidence of corrosion inside of the main cable. Photo 4.6 shows the corroded wires seen from the bottom of the band after the removal of sealant putty.

Photo 4.4 Fifth cable band of upstream cable

It was suggested that OEBK keep the bottom open so that the water-retention would not occur again. The other cable band was on the downstream cable and was the fourth cable band (Photo 4.7) counted from the center band

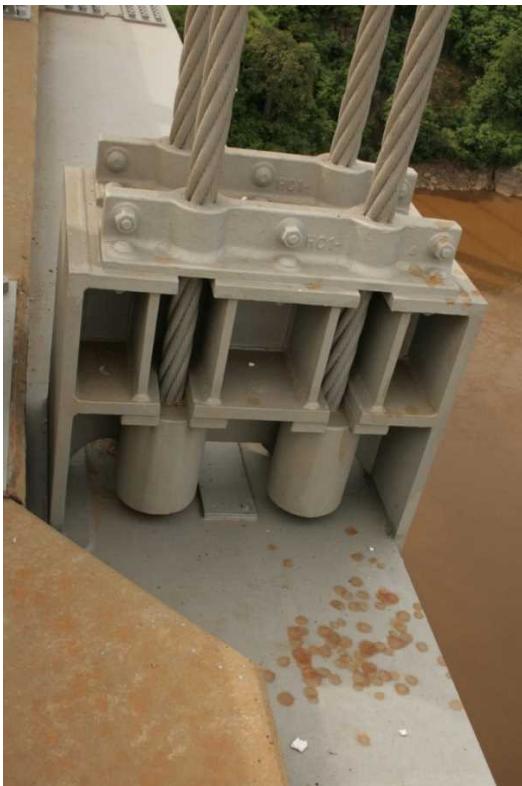
Photo 4.5 Stains of rust water from main cable

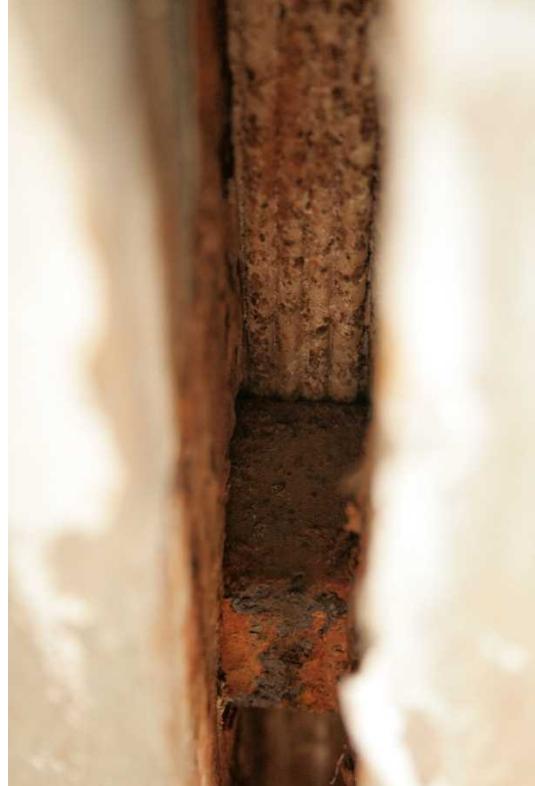
Photo 4.6 Corroded wires seen from bottom of cable band

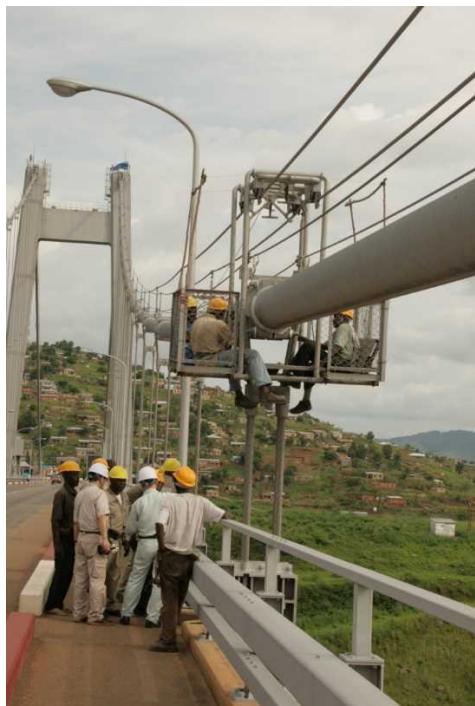
Photo 4.7 Fourth cable band of downstream cable

to Matadi direction. The condition of corrosion inside of this band was slightly better than that of the upstream band (Photo 4.8). To compare the results with the condition of cable bands without water-staying, the sealant putty of the upstream center band was removed and the inside was inspected. The result is shown in Photo 4.9. Only white rusted wires were observed inside of the cable band and the condition was much better.

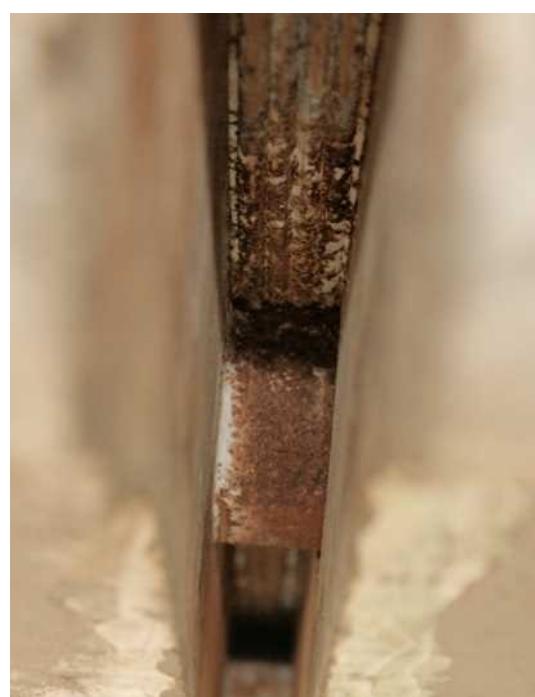
Photo 4.8 Corroded wires seen from bottom of cable band

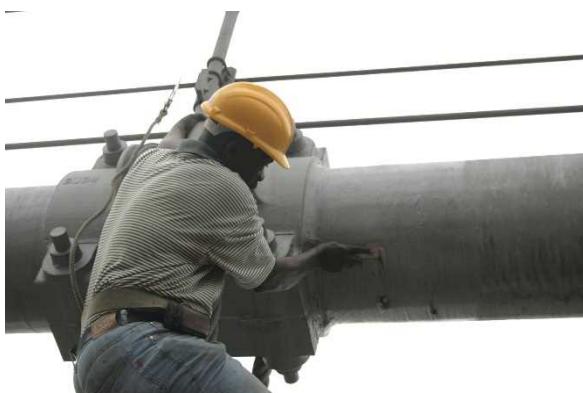
As discussed in Sec.2.2.2, no corosions except for white rusts were confirmed inside of cables bands of suspension bridges of Honshu-Shikoku Bridge Expressway Company. This is also true for the Matadi Bridge as shown in Photo 4.9. But for the Matadi Bridge, a very strange phenomenon was observed as shown in Photos 4.5 to 4.8. The same phenomenon is shown again in Photo 4.19 and 4.20. The inspector of OEBK had already

Photo 4.19 Technician opened swollen paint surface

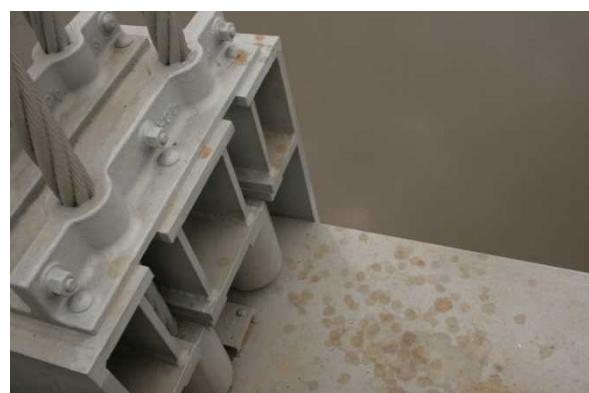
Photo 4.20 Rusty water marks.

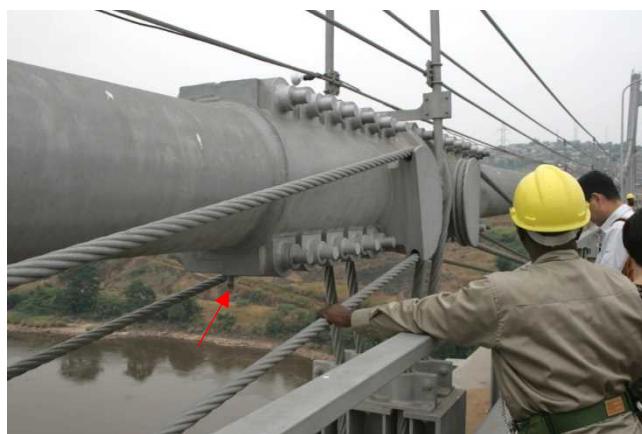
Photo 4.21 Center Cable Band of Matadi Bridge and Drain Pipe

The same method of caulking must have been adopted for the cable bands of the Matadi Bridge. The center cable band is shown in Photo 4.21. In this photo, a drain pipe is seen. Therefore after the completion of the bridge, cable bands must have been well drained and the water retention phenomenon near the cable bands must not have existed. But from 2003 to 2009, the whole bridge was repainted by OEBA<sup>7)</sup>. During this repainting work, OEBK must have painted the cable bands completely and to some extent, closed the lower gaps, too. In Photo 4.19, the lower gap of the band is closed.

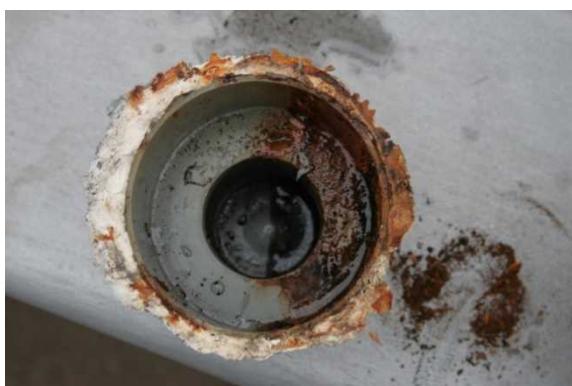
Photo 4.22 Lower cable band bolt cap

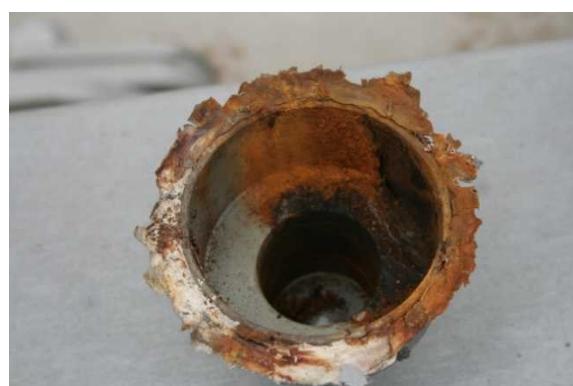
Photo 4.23 Lower cable band bold cap

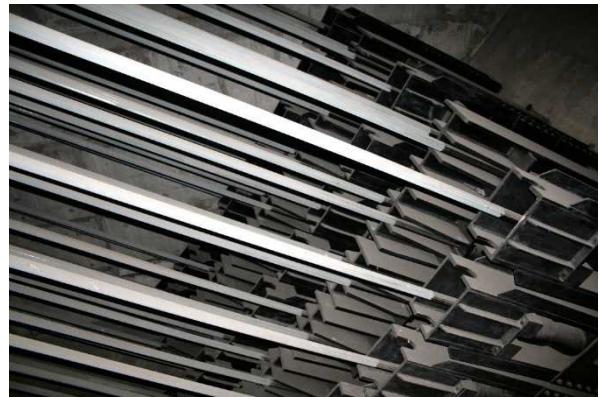
Photo 4.24 Cable strands inside of anchorage

Photo 4.25 Cable strands inside of anchorage

The cables inside of anchorages of this bridge were quite healthy except for white rust as shown in Photos 4.24 and 4.25. This is also the case for the cables inside of anchorages of the suspension bridges of the Honshu-Shikoku Bridge Expressway Company. The splay chamber of this bridge is almost closed to the outside air from the beginning so that the installation of the dehumidifier is easier. To close the chamber from the outside air, minimal work to install doors is needed. But some anchorages of the Honshu-Shikoku Bridge Expressway Company, the splay chambers were quite open to the outside air. To install the dehumidifier, instead of closing the chambers, the whole cable strands were covered with the air-tight tent structure<sup>8)</sup>. For the design of new suspension bridges, the splay chambers should be designed almost closed to the outside air to facilitate the installation of the dehumidifier. As discussed above, two facts are evident. The inside of cable bands cables are healthy and the cables inside of the splay chambers of the anchorages are also healthy. From these facts a new corrosion protection system of main cables can be proposed and it is discussed in Chap.6.

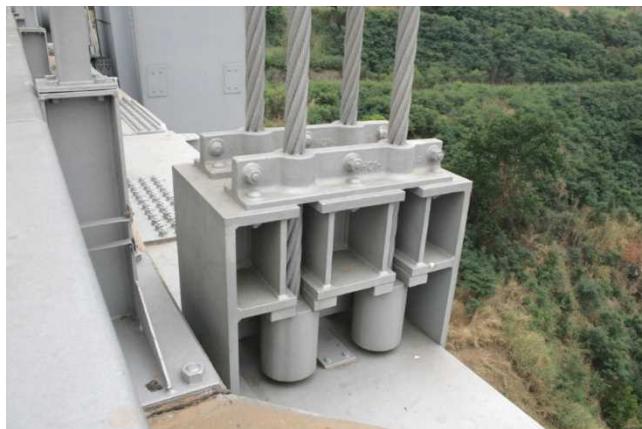
Photo 4.26 Hanger fixing structure

generally speaking C.F.R.C rope does not suffer wind-induced vibrations but the corrosion problems may happen. Compared to the hanger fixing structure of the Ohanruto Bridge, it is very easy to inspect the hanger fixing structure of the Matadi Bridge as shown in Photo 4.26. Although at present these are no corrosion problems, the regular inspection is recommended.

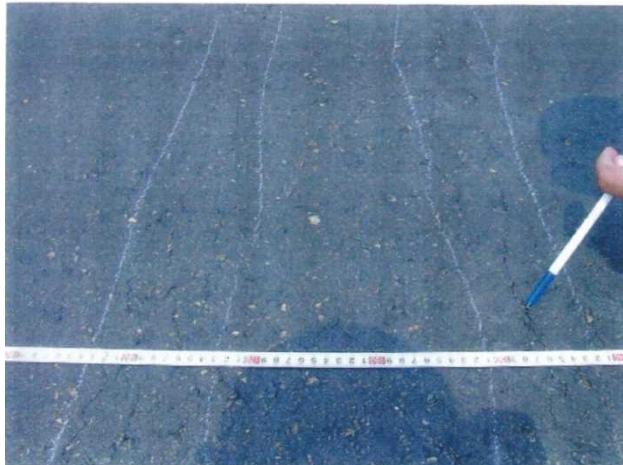
**Photo 5.2** Hair cracks appeared on north, outside lane (June 21<sup>st</sup>, 2002)<sup>6)</sup>.

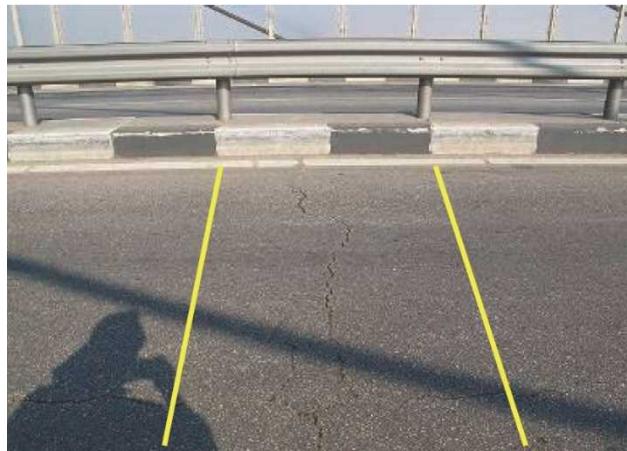
**Photo 5.3** A crack occurred between diaphragms.

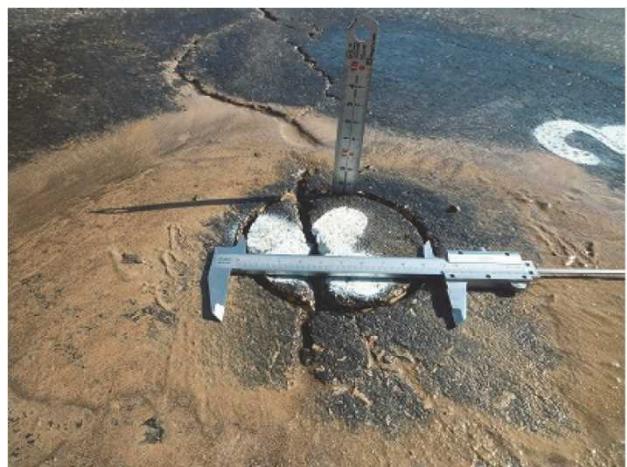
**Photo 5.4** Core boring of cracked pavement.

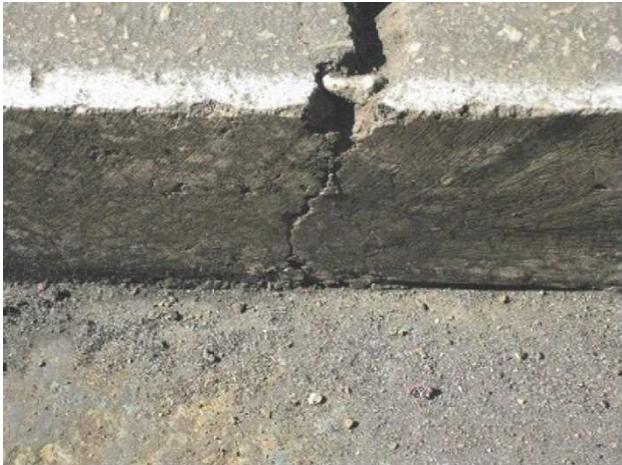
**Photo 5.5** Cross-section of pavement after pavement removal (L2).

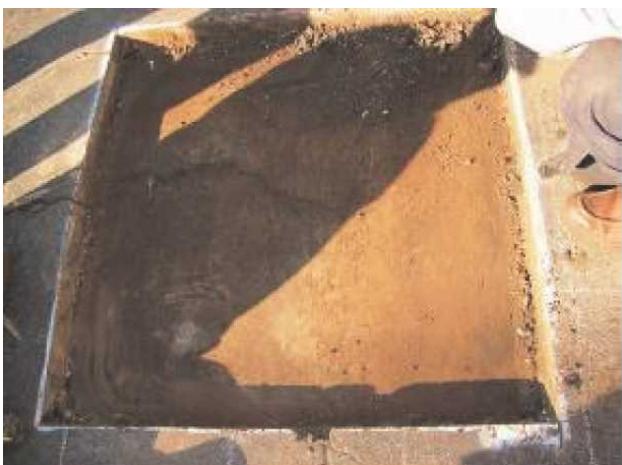
**Photo 5.7** Removed pavement (L1) and red brown substances.

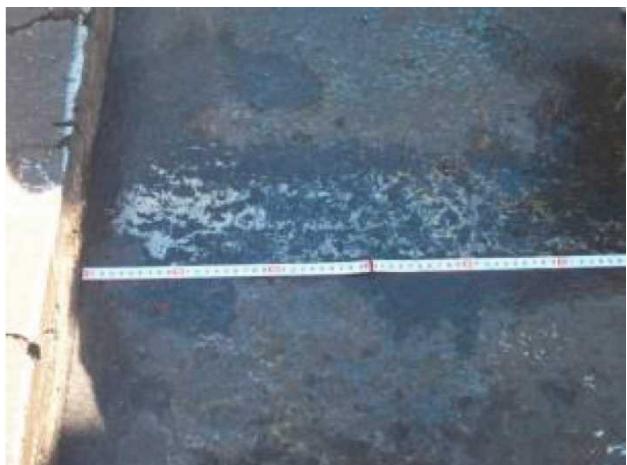
**Photo 5.9** L2 after removal of rust.

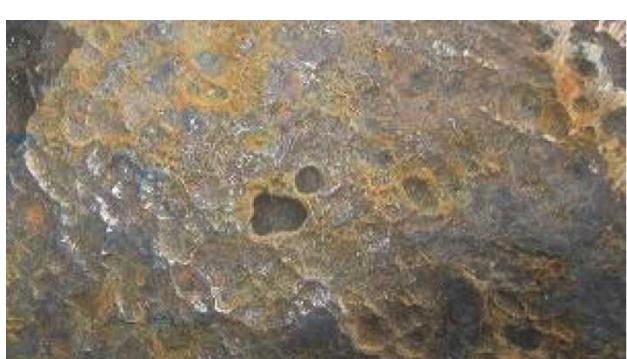
**Photo 5.10** Enlarged surface of L2 after removal of rust.

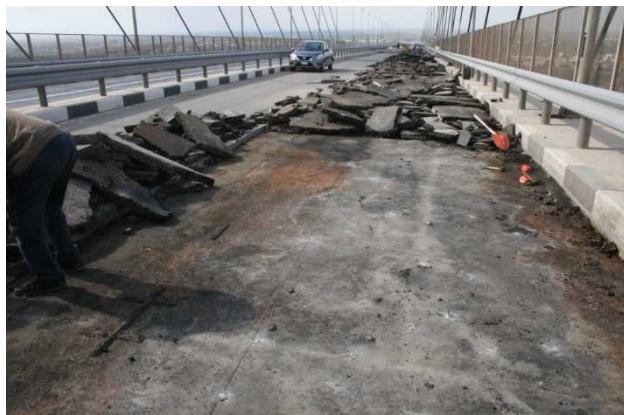
First, the pavement of the north side and outside lane near the west pylon area was removed and the steel deck surface was inspected. As shown in Photo 5.11, on both edges of outside lane, an extensive corrosion was confirmed. At the middle of the outside lane, the condition was better. The left side corrosion might have corresponded to the longitudinal cracks of the pavement, water might have permeated into the steel deck surface and corrosion might have been formed.

**Photo 5.11** Steel deck surface after removal of pavement, west side span near west pylon.

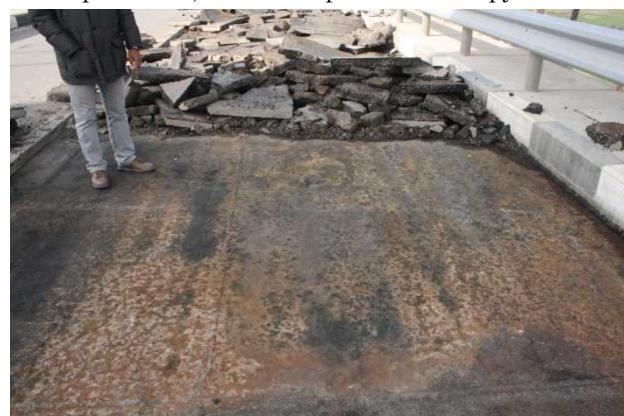
**Photo 5.12** Badly corroded area near west pylon.

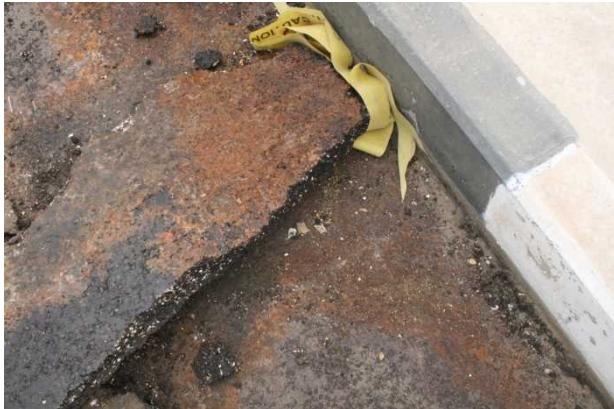
**Photo 5.14** Corroded deck surface and back of pavement near center median.

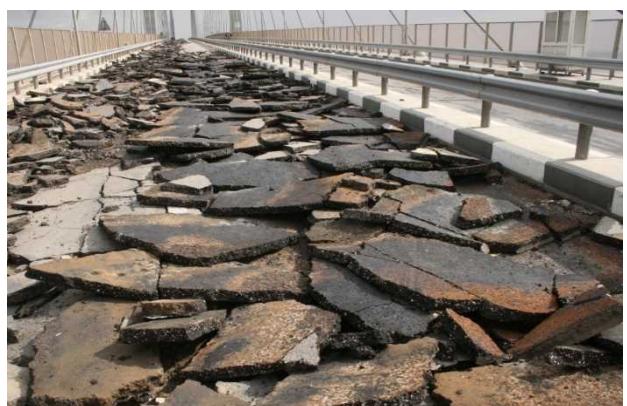
**Photo 5.18** Back of removed pavement, west side span.

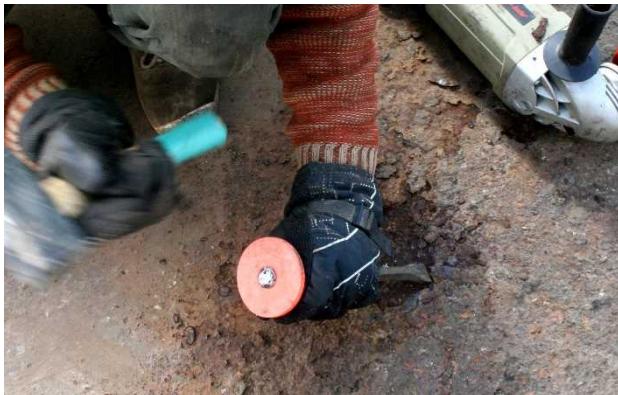
**Photo 5.19** Heavily corroded deck surface, north lane, D point, 58m from west end of bridge.

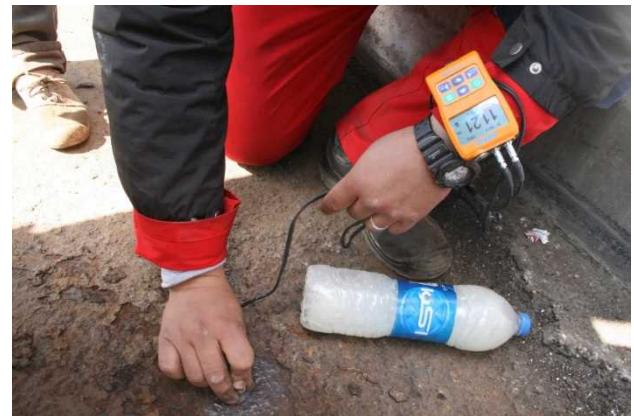
**Photo 5.21** Thickness measurement.  
Thickness was 11.21mm.

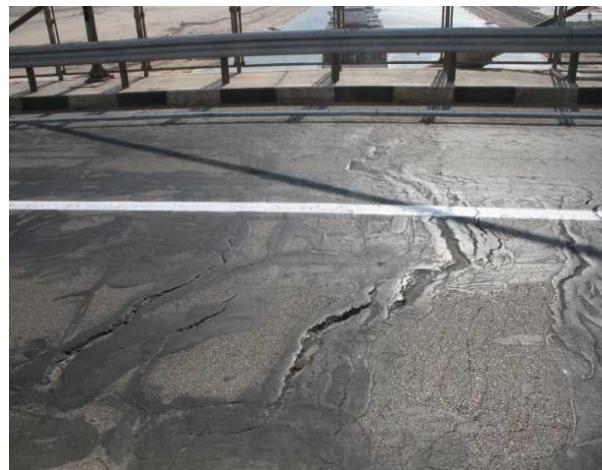
**Photo 5.22** Largest repaired crack on south lane near center of bridge.

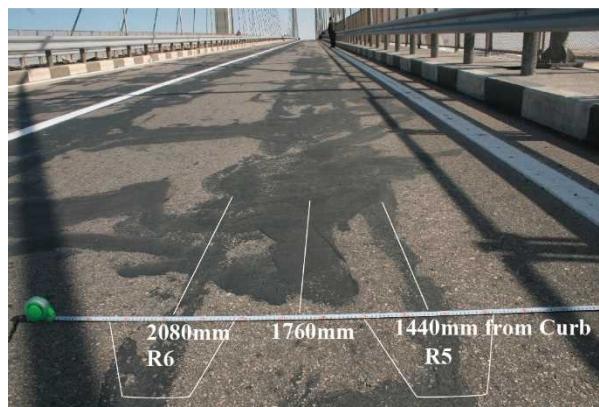
**Photo 5.23** Lines of repaired crack of south, outside lane on west side span (looking east direction).

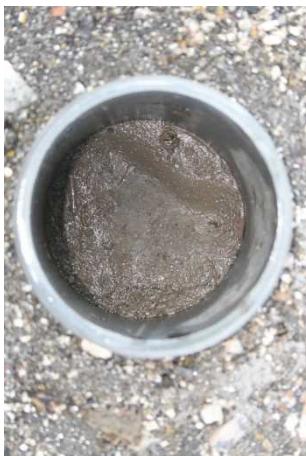
**Photo 5.24** P10 monitor, filled with wet sand.

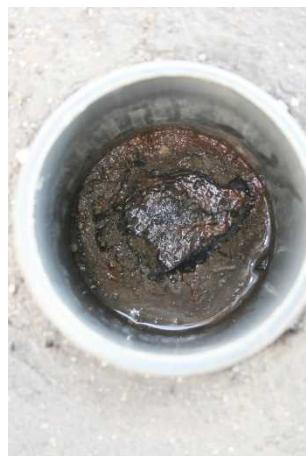
**Photo 5.25** P11 monitor, some water and rusty deck plate.

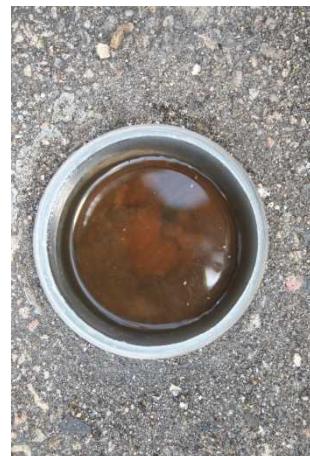
In summer when there are no rainfalls nor foggy days, still some water under the pavement was confirmed. This might be because of the large temperature difference between night time and day time, and dew formed on the pavement. Higher water level was observed at P12, P16, P18, and P20 compared to P9, P6, and P3, probably because of the following reasons: the morning mist was one of the major sources of water supply. The bridge was parallel to the east-west direction. The bridge was the highest at the center and descended down to both sides with 3.3% gradient. The mist occurred only in the morning. As the sun rose, the morning mist disappeared and the dew on the pavement surfaces evaporated due to the sunlight. The incidence angle of the sunlight, however, was different on the east side and the west side of the bridge because of the 3.3% road gradient. The dew on the east side evaporated more than on the west side because of the gradient. This might be the reason why a higher water level was observed at P12, P16, P18, and P20.

**Photo 5.26** P16 monitor, high level of water.

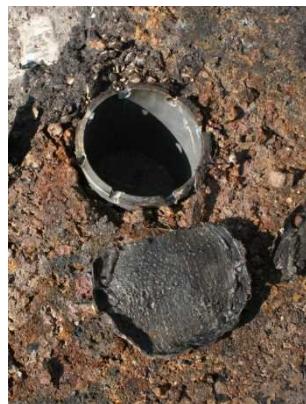
**Photo 5.28** P13 monitor, bottom rubber is removed.

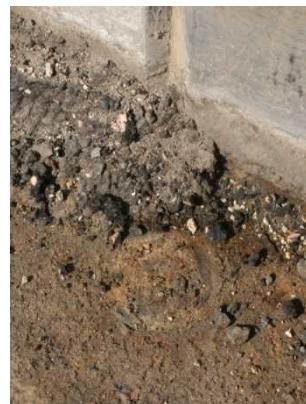
**Photo 5.29** Rusty deck plate below P13 monitor

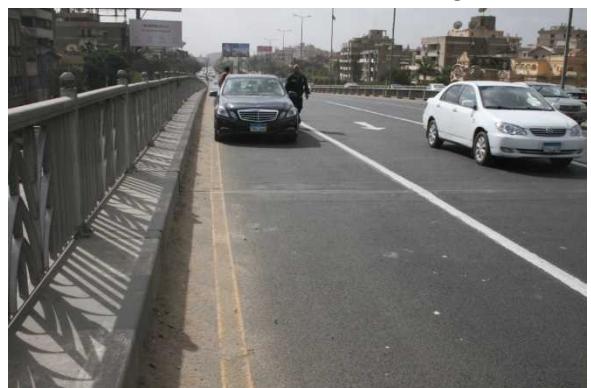
**Photo 5.33** Galaa bridge and resin bonded surfacing.

the International Airport is one example as shown in Photo 5.33. Another example is shown in Photo 5.34. The surfacing already deteriorated. After four to five years, it is believed that the resin-bonded surfacing would deteriorate<sup>2)</sup>. The proposed method by GARBLT is to add a dense-graded asphalt mixture over this resin-bonded surfacing. The Maasara Bridge, an example of this type of pavement is shown in Photo 5.35. This bridge was constructed as a French project. This bridge might have adopted the orthotropic steel deck structure to achieve a shorter construction period. The steel deck consists of (about 3.5m) × (8 to 10m) panels as shown in Photo 5.36. These panels were connected at the site. In Photo 5.35, lateral pavement repairs are visible at about 8 to 10m intervals and these repairs correspond to the connections of the two adjacent panels over the piers. In Photo 5.35, a longitudinal crack is also seen. This corresponds to the longitudinal connection of the two adjacent panels. The condition of the pavement was investigated and the result is shown in Photo 5.37. There were no rusts on the steel deck and the yellow color of Zinc-Chromate Primer still remained. The condition of asphalt pavement was also good. The Maasara Bridge was constructed in 1988 with resin-bonded surfacing. In 1994, the bridge was repaved using the pavement method shown in Fig.5.14. Since then, the bridge has never been repaved. In 2016, this pavement has kept its shape for more than 20 years. Although the amount of traffic on this bridge is not large, sometimes larger trucks pass over this bridge. As there were no experiences related to the Gussasphalt method nor special machines in Egypt, the Maasara Bridge must have been repaved first using the resin-bonded surfacing. The dense-graded asphalt mixture, which could be constructed by the Egyptian contractors, was then applied over the surfacing. This method turned out to be successful in the end. The reason for its success is explained in the next section.

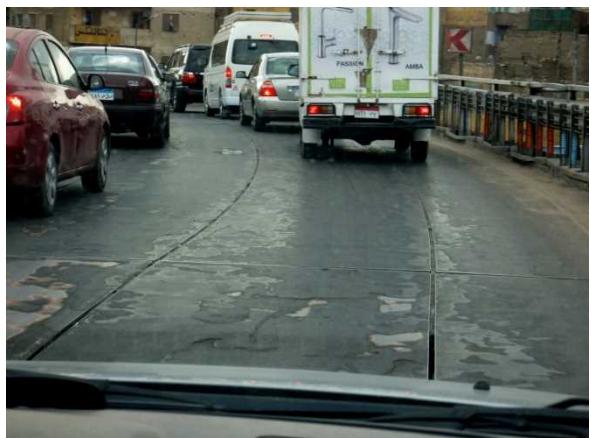
**Photo 5.34** Deteriorated resin-bonded surfacing in Cairo City.

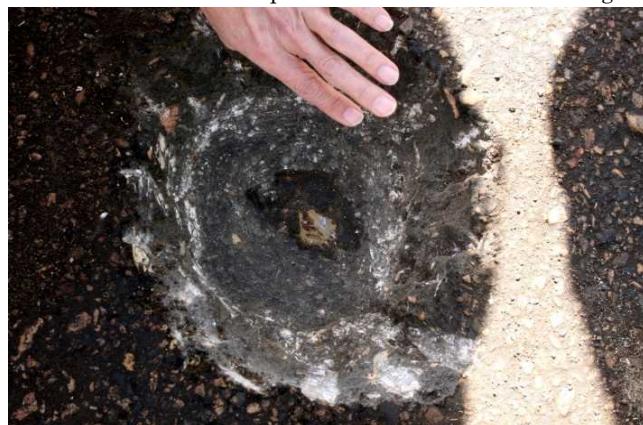
**Photo 5.37** Condition of pavement and steel deck.

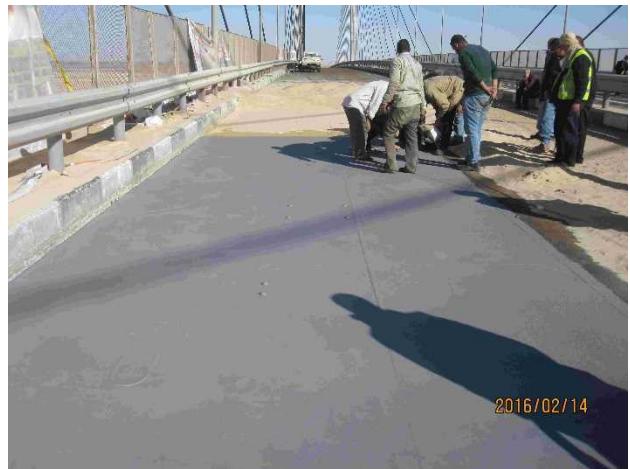
**Photo 5.38** Steel deck surface after sand-blasting.

After the removal of the pavement and the investigation of the steel deck surface of the Suez Canal Bridge, the steel deck surface was sand-blasted to remove the rust, then Zinc-Chromate Primer was applied over the steel deck. The proposed pavement shown in Fig.5.14 was applied. The details of this pavement are shown in Table 5.9. The details of the mixture of tar epoxy and polyurethane were not available. In the pavement design, five alternatives with different bitumen contents, i.e., 4.5%, 5.0%, 5.5%, 6.0%, and 6.5%, were compared on April 20th 2016 and 5.5% ( $\pm 0.25\%$ ) was recommended. In the trial mix, three alternatives with different bitumen contents of 5.50%, 5.75%, and 6.00% were compared on May 28th, 2016. It was decided to adopt 6.00% to ensure higher durability and flexibility. The extraction test result (ASTM D2172) and the Marshal test result (ASTM D 1559) obtained from ACE Consultant, Egypt, which supervised the pavement construction work, are shown in Tables 5.10 and 5.11, respectively. In the actual construction, the bitumen content was between 5.80% (min) and 6.20% (max). The size of coarse aggregate was mainly less than 9.5mm, which was comparatively smaller than those adopted in Japan. This size of coarse aggregate is often adopted for pedestrian pavements in Japan. The sand-blasted steel deck plate is shown in Photo 5.38. The Zinc-Chromate Primer coated deck plate is shown in Photo 5.39. The finished pavement of the North Lane is shown in Photo 5.40. This pavement needs to be monitored carefully for the next two or three years and if no cracks nor potholes are observed, then the effectiveness of this pavement shall have been proven. After about one year, no cracks have been observed. This is a better situation than that of the original pavement. After about nine months, hair cracks were observed in the original pavement.

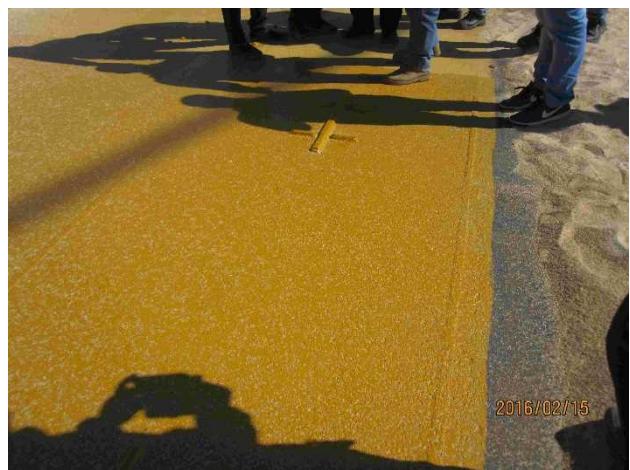
**Photo 5.39** Zinc-chromate primer coated steel deck.

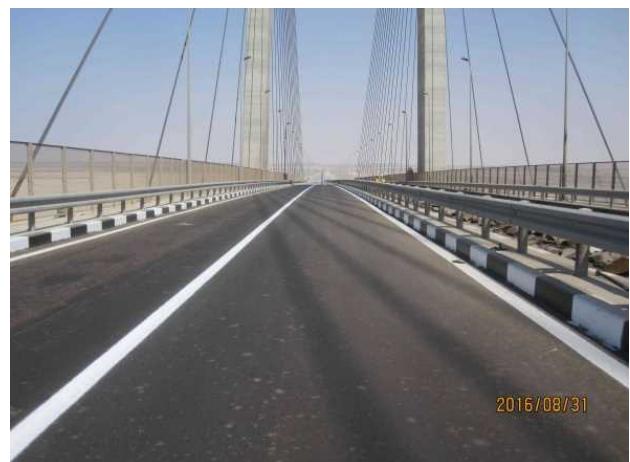
**Photo 5.40** Newly finished pavement of Suez canal bridge.

This method does not exist in Japan. There is a possibility that this method will be successful for the Suez Canal Bridge. A careful observation of the pavement for the next few years can determine its success. The idea behind this pavement is as follows: First the sand-blasted deck plate is coated with Zinc-Chromate Primer to prevent rust. Over this primer, a thick mixture of tar epoxy and polyurethane is applied. Then the coarse aggregates are scattered to form a resin-bonded surfacing. The mixture works as a bond to fix aggregates and also as a paint to protect the steel deck at the same time. As the surface of the resin-bonded surfacing is only the surface of aggregates, it may be able fix the asphalt pavement above it firmly. The friction between the resin-bonded surfacing and the pavement must be quite large. The adhesion between the resin-bonded surfacing and the steel deck must be large, too. In Photo 5.34, the worn-out resin-bonded surfacing is shown without peeling off. This may prove that the adhesion between the surfacing and the steel deck is large. As the adhesion between the steel deck and the resin-bonded surfacing is large, and the adhesion between the resin-bonded surfacing and the asphalt pavement is large, the whole pavement system is firmly fixed on the steel deck. This may be the reason why this pavement lasted for a long time despite the traffic load without developing cracks. If this method is proved to be durable and effective, this method will be welcomed by many developing countries, because it is very difficult to repave long span bridges with the Gussasphalt method in these countries. In Japan, coal tar and chromium are hazardous to human health and are already banned<sup>11)</sup>. If this method is tried in Japan, Zinc-Chrome Primer can be substituted by Inorganic Zinc-Rich Paint for shop painting and Organic Zinc-Rich Paint for the site painting. Tar epoxy can be substituted by the modified epoxy. As one good example will not assure future effectiveness, more investigations and trial tests may be needed.

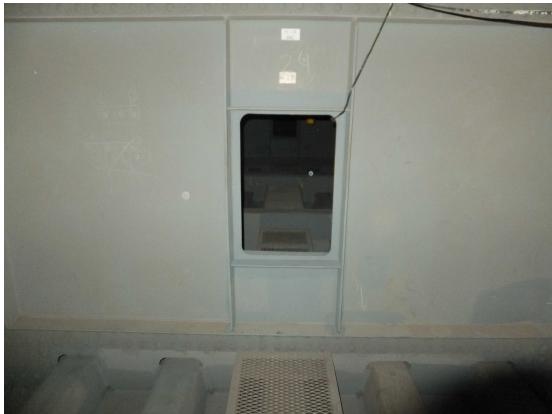
Photo 5.41 Center manhole on full-web

A full-web diaphragm. On these diaphragms, there is only a small manhole of  $750 \times 500\text{mm}$  as shown in Photo 5.41 and it is very difficult to pass through these manholes.

The box girder consists of 3 cells divided by longitudinal full-web stringers. On the stringers, only small manholes of  $600 \times 400\text{mm}$  exist as shown in Photo 5.42. It is very difficult and laborious to pass through these manholes. As these manholes are always utilized for the inspection works, these manholes should be designed as large as possible to facilitate inspectors to pass through. As a better example, the manhole of  $1100 \times 900\text{mm}$  on the diaphragm of the Ikuchi Bridge is shown in Photo 5.43. This manhole is quite easy to pass through. The girder height of the Ikuchi Bridge is 2.7m at the center compared to 2.6m of the Suez Canal Bridge. The Suez Canal Bridge could have adopted larger manholes. In Photo 5.44, another example is shown. The box girder of the Third Kurushima Kaikyo Bridge. This bridge adopted the truss structure diaphragms, which is easy to walk through. It is important for bridge designers to design the inside of box girders so that the maintenance works can be done easily, otherwise inspectors do not want to go inside.

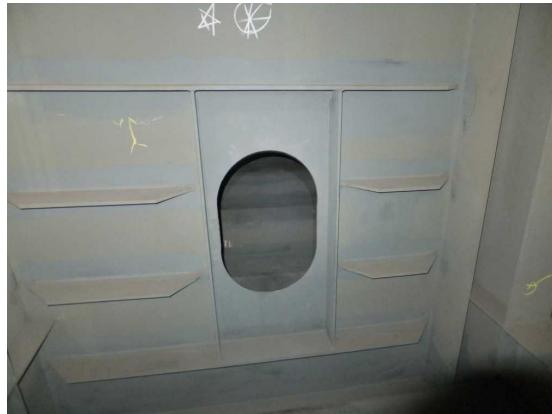
Photo 5.42 Manhole on stringer

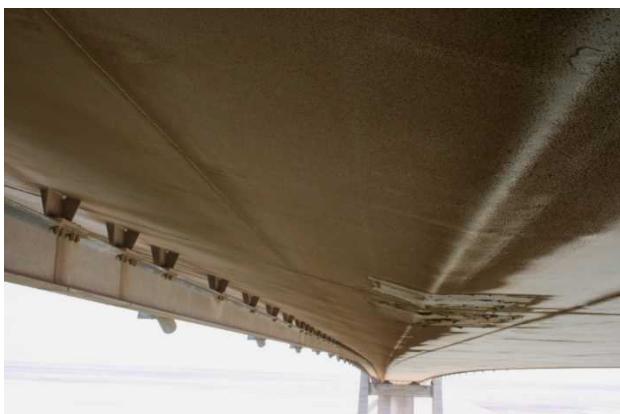
**Photo 5.45** Bottom flange of box girder, although covered with fine sand, condition was good.

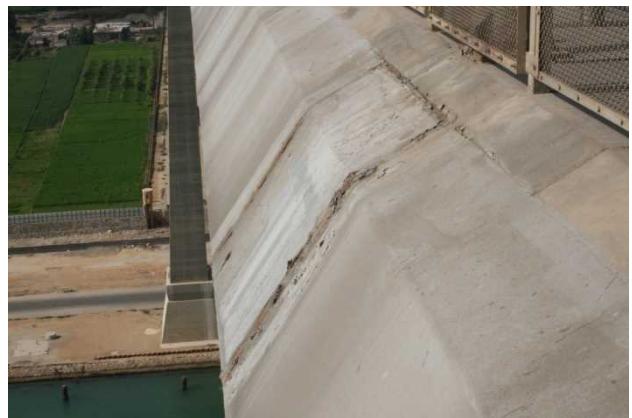
**Photo 5.47** Severe corrosion found on welding bead of wind fairing.

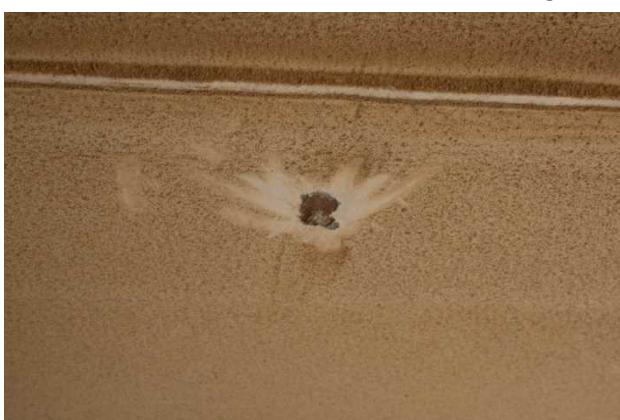
**Photo 5.46** Spot rust on bottom flange, this kind of rust was sometimes found.

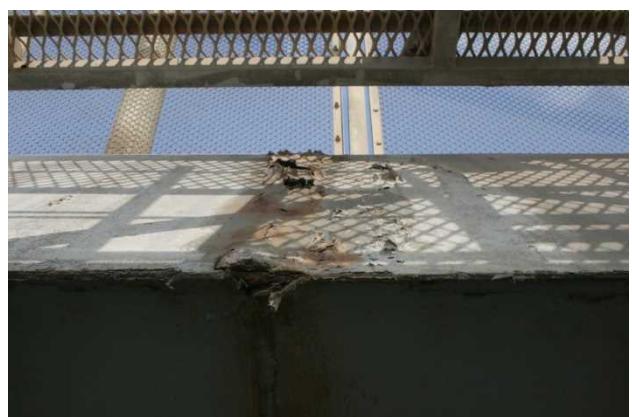
**Photo 5.48** Corrosion of **Photo 5.47** seen from beneath.

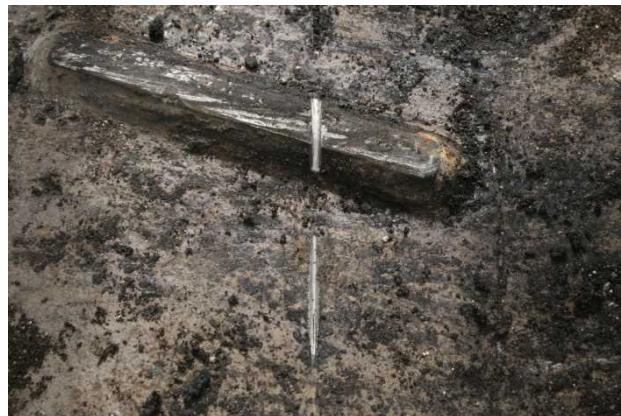
During the pavement removal work, the remaining hanging hook on the steel deck and the steel deck itself were slightly cut by pavement cutting machine as shown in Photo 5.49. Later the cuts were smoothed to avoid stress concentration and to erase the possible cause of the fatigue cracks. The smoothed result is shown in Photo 5.50.

**Photo 5.49** Cutting hanging hook and steel deck by pavement cutting machine.
