**Study of Long Span Bridge Design  
Based on Long Term Maintenance  
in Developing Countries**

A Thesis submitted to the Faculty of Engineering of Kyoto University  
in partial fulfillment of the requirements for  
the Degree of Doctor of Engineering

Tsuyoshi Matsumoto

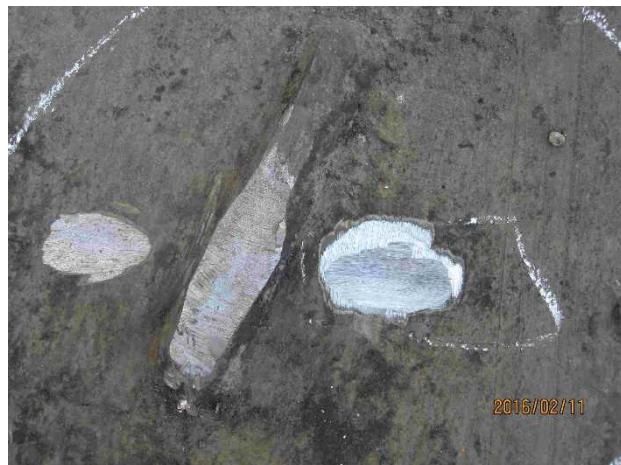
**Photo 5.50** Smoothened surface of cuts.

During the pavement removal work, the remaining hanging hook on the steel deck and the steel deck itself were slightly cut by pavement cutting machine as shown in Photo 5.49. Later the cuts were smoothed to avoid stress concentration and to erase the possible cause of the fatigue cracks. The smoothed result is shown in Photo 5.50.
