Forensic Analysis of Water Damaged Mobile Devices

Aya Fukami and Kazuhiro Nishimura

National Police Agency of Japan

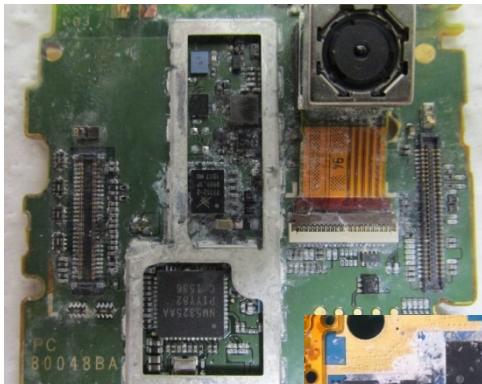
*What are those white contaminants?
Chip transplants really necessary?*

- Disassembling
- PCB cleaning
- Drying

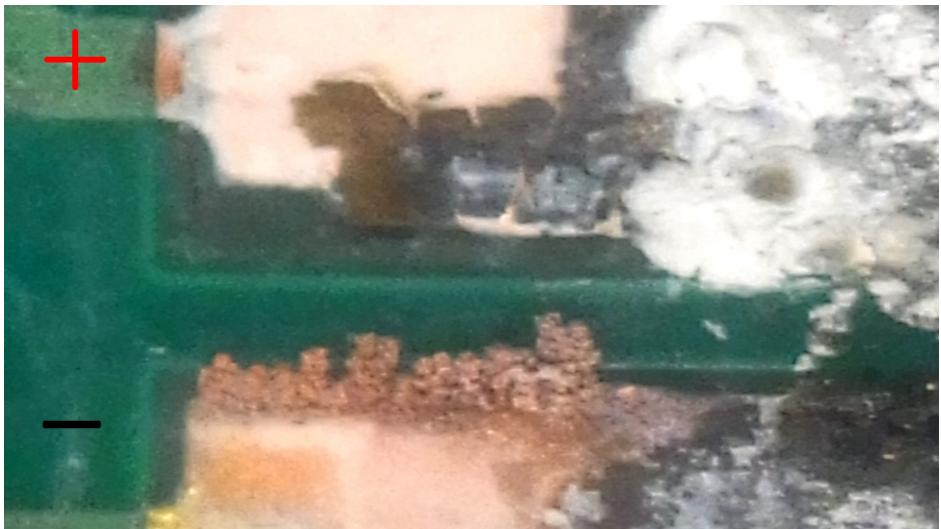
Metal Corrosion by ECM

Open circuit

Short circuit

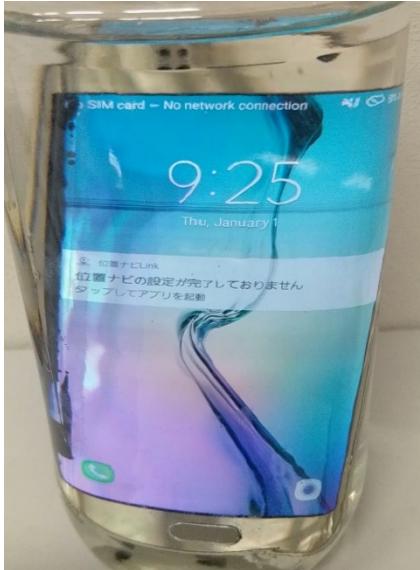
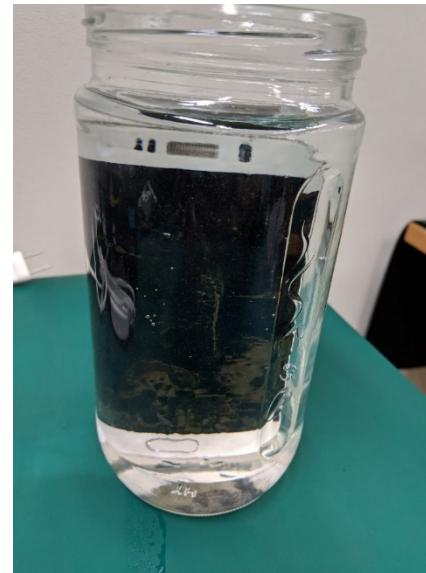
- Samsung Galaxy 6s Edge & LG Nexus 5X
 - Two each, one submerged while running, another while turned off
 - Battery fully charged
 - Left in tap water for three days

Samsung S6 edge	LG Nexus 5
Turned on	PMIC damaged, swap needed	Display connector corroded
Turned off	PMIC short circuited no swap needed	No repair needed after cleaning
